Queenstown Lakes District Council
c/o Edward Guerreiro
Stantec
Unit D1.03
19 Grant Road
Frankton
Queenstown 9300

Heritage Assessment: Butler's Green Retaining Wall (Road Reserve, Town of Arrowtown)

This heritage assessment has been prepared for Queenstown Lakes District Council (QLDC), c/o Stantec, in relation to the proposed remediation of the stone retaining wall located adjacent to Butler's Green.

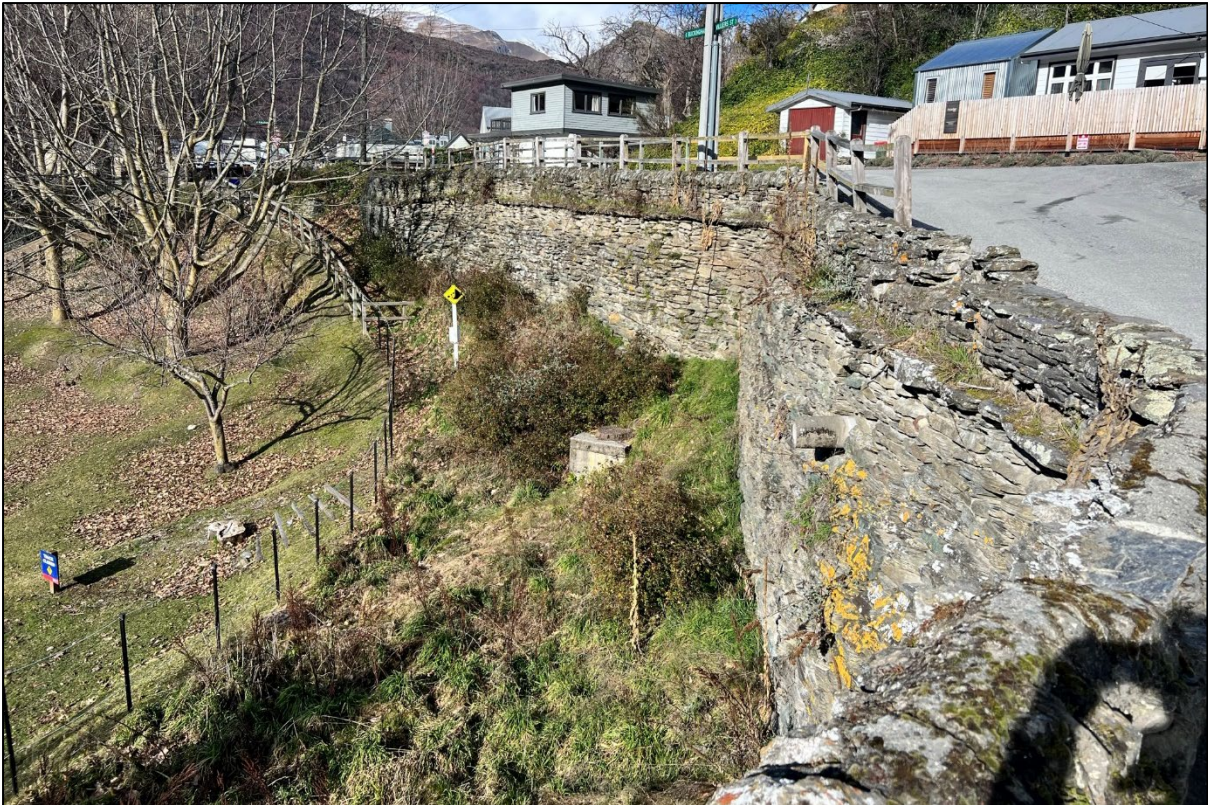
Figure 2. Butler's Green wall looking east along Buckingham Street.

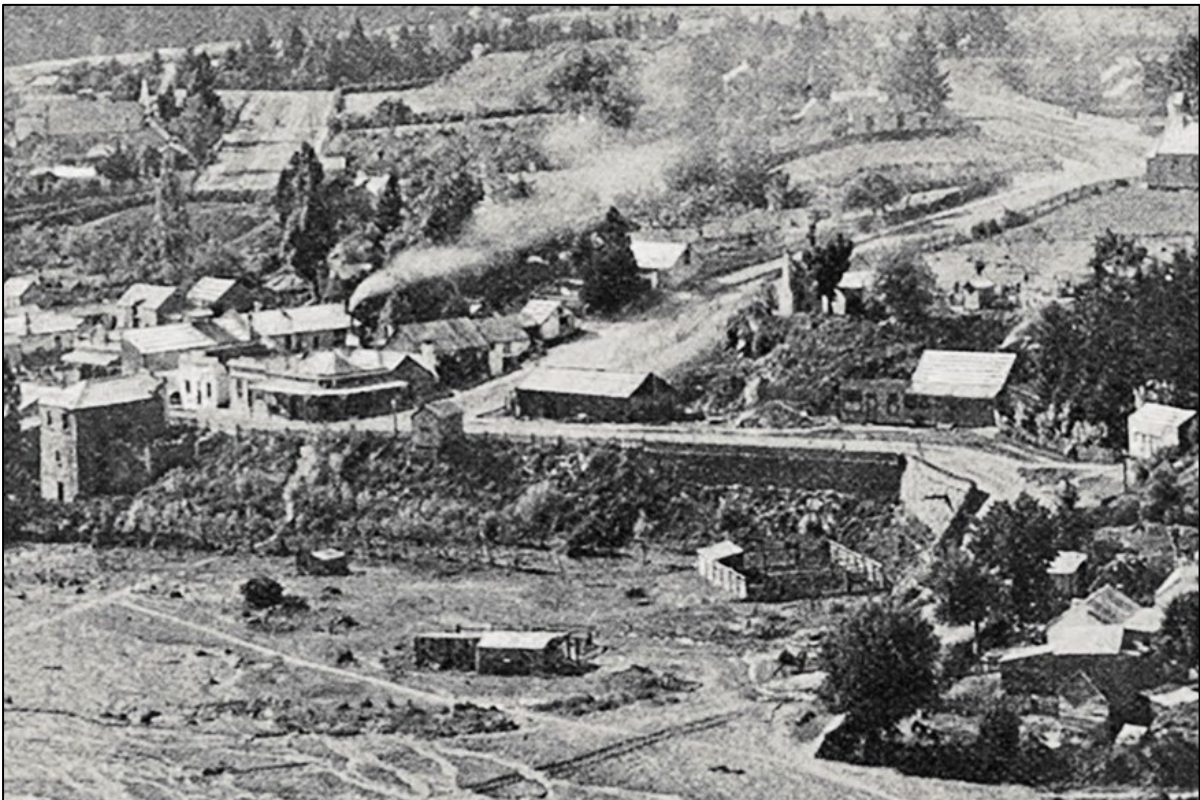
Figure 6. Butler's Green wall, circa 1890s, showing the height of the parapet above road level.²⁷

It is unclear what works have been undertaken on the wall since its construction. There is evidence that some repairs have been undertaken with concrete and some coping stones have been lost. The ground level has also been raised over time, with the parapet wall now largely sitting in line with the road surface. This has likely created increasing pressure on the retaining wall; there have been reports of the wall bowing since at least 2006.²⁸ Overall, however, the original form of the wall as built in 1886 is still readily recognisable today, including its stacked schist construction, horizontal line of capping stones, remaining sections of parapet with vertical copings, and projecting cast iron outlet pipe (see Figure 6).
