Arboricultural Assessment

Site Address:	St Omer Park Lake Esplanade Queenstown
Client:	Queenstown Lakes District Council
The Proposal:	Arboricultural assessment of mature poplar trees growing within St Omer Park utilising resistograph tests

Date of Report:	January 2014

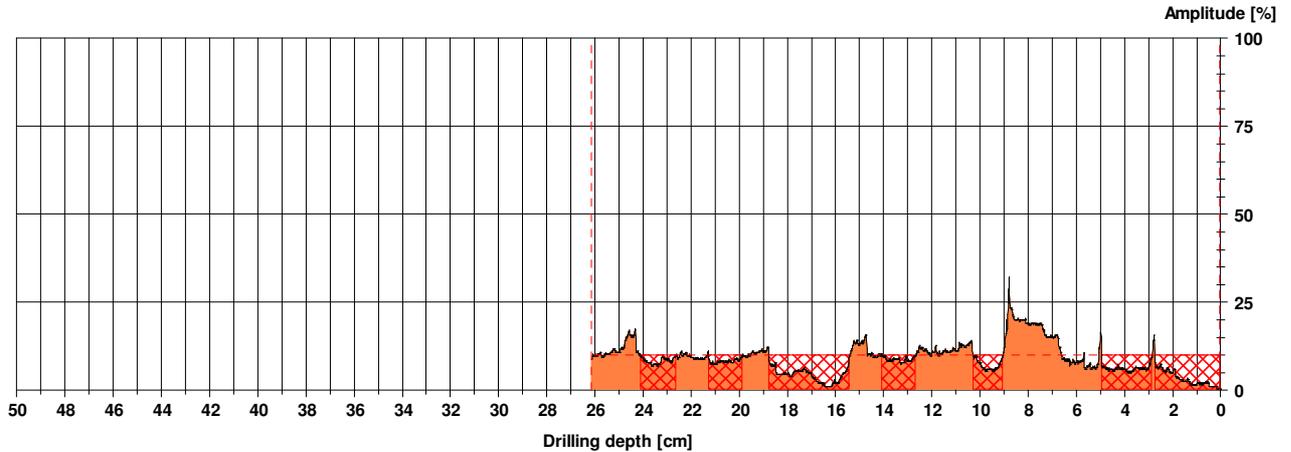
Figure 1: Tree No.1 - Lombardy poplar drilled on the western side of the tree. The readings show a generally low amplitude. The red cross hatch areas indicate decay

Tree No.	Species	Height (m) and Girth (mm)	Target Description	Occupancy Rate	Tree Assessment and Comments	Resistograph Analysis	Recommendations
1.	Lombardy poplar <i>Populus nigra</i> 'Italica'	30 6000	Park and footpath Carriageway Guest house	Frequent Frequent Frequent	Tree growing by lake edge. Good crown health and foliar density, 90% live crown ratio. Single trunk becoming multi-stemmed. Co-dominant stems and tight branch unions present within crown. Suspected heart wood decay. Trunk forms large buttress roots	Decay detected within western side of tree	Remove to ground level

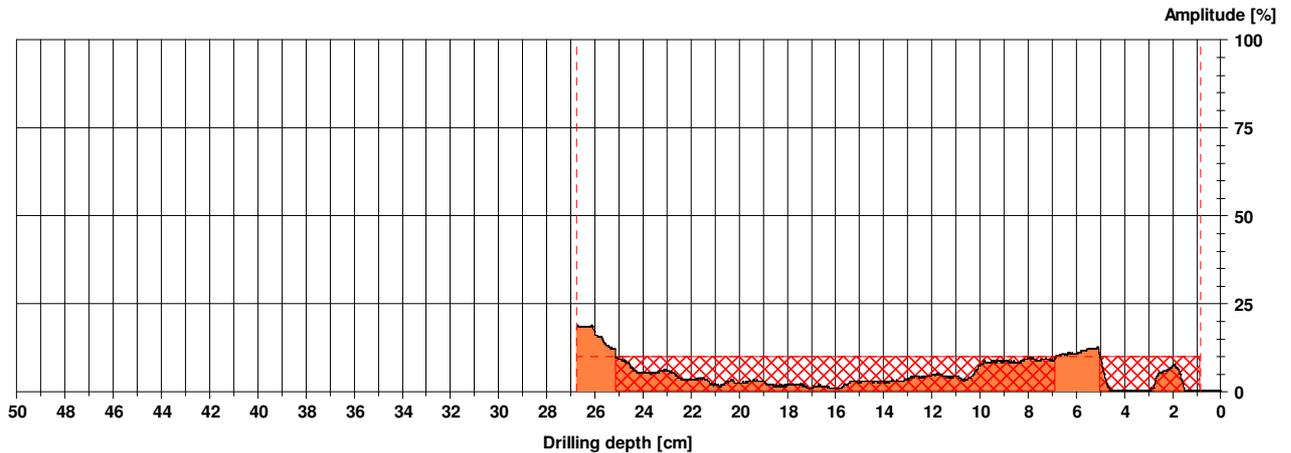
Figure 2: Tree No.9 - Lombardy poplar drilled on the northern side of the tree. This is an example of a reading that shows a considerable amount of decay present within the wood – as depicted by the low amplitude of the graph. The red cross hatch areas show the extent of the decay

9.	Lombardy poplar <i>Populus nigra</i> 'Italica'	30 4000	Park and footpath Carriageway Parked cars Residential dwellings	Frequent Frequent Frequent Constant	Single stemmed tree, good crown health and foliar density, 80% live crown ratio. Pavement over 40% of root zone. Tree growing in close proximity to Lake Esplanade	Decay detected within northern side of tree	Crown reduce as part of a tree management and removal program. Monitor/inspect tree annually or following an extreme weather event

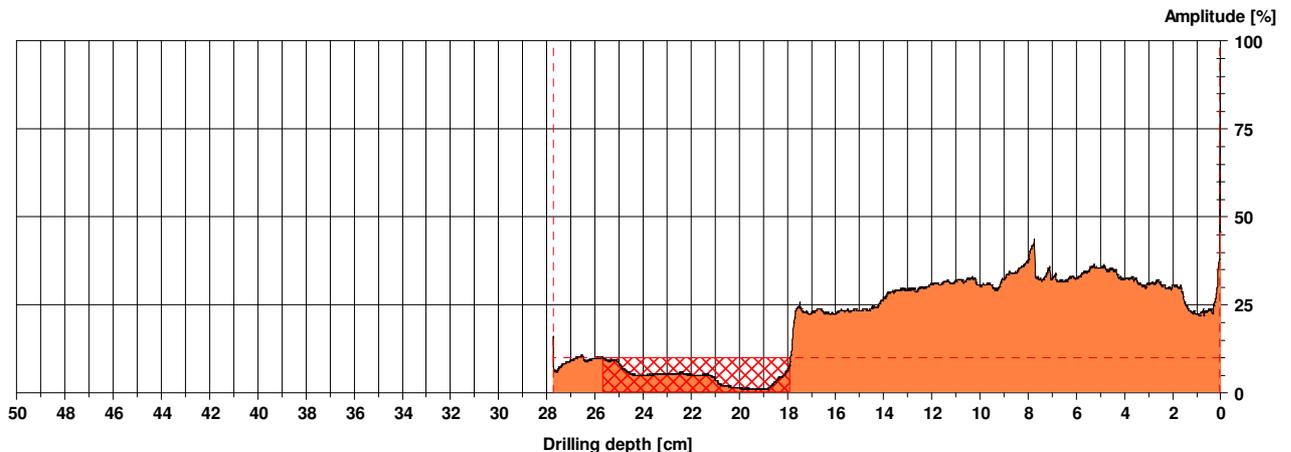
Figure 3: Tree No.3 - Lombardy poplar drilled on the northern side of the tree. The readings show a higher amplitude indicating structurally sound wood followed by a sudden dip in amplitude approximately 180mm within the tree which indicates an area of decay

3.	Lombardy poplar <i>Populus nigra</i> 'Italica'	30 4500	Park and footpath Carriageway Parked cars Motel	Frequent Frequent Frequent Constant	Single stemmed tree becoming multi-stemmed 3m from base. Good crown health, 80% live crown ratio. Co-dominant stems and tight branch unions present within crown and trunk. Tree growing adjacent to the Lombardy poplar that failed on the western side. Tree bears an approx 5° lean to the north	Decay detected within northern side of tree	Remove to ground level

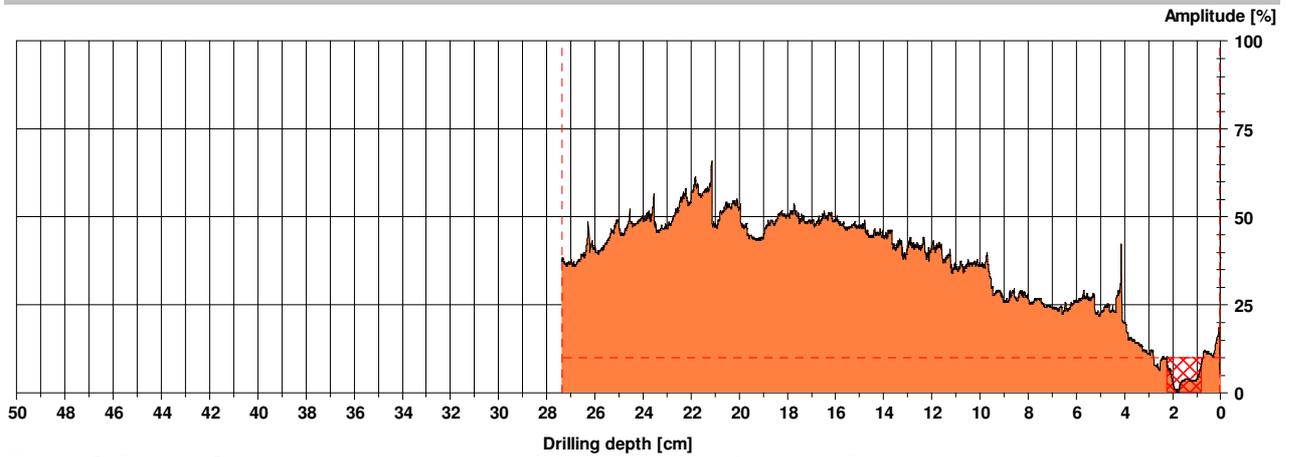
Figure 4: Tree No.3 - Lombardy poplar drilled on the western side of the tree. The readings show a high amplitude which is indicative of structurally sound wood

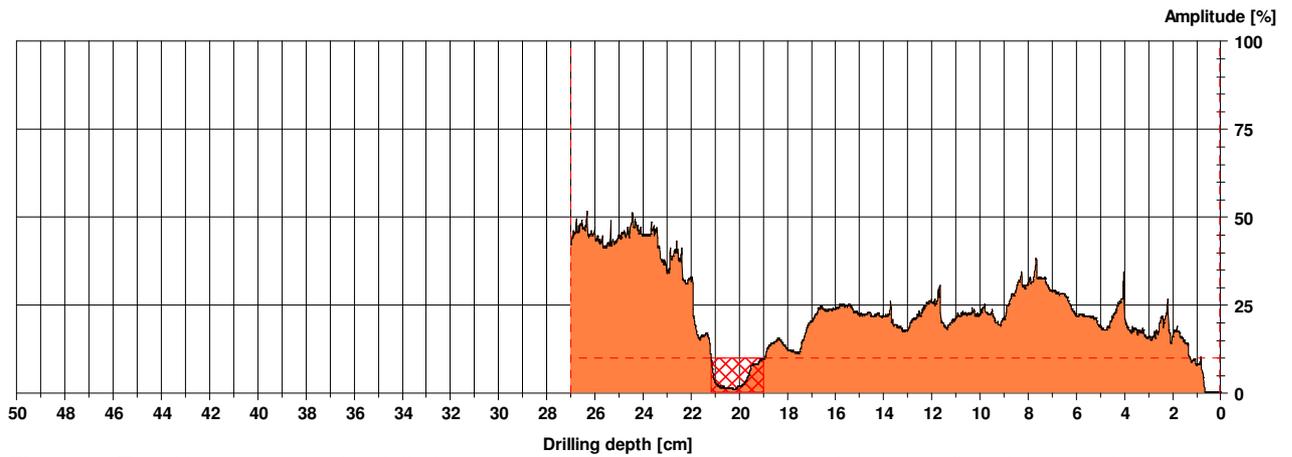
Figure 5: Tree No.2 - grey poplar drilled on the northern side. The readings show a small cavity approximately 200mm inside the tree

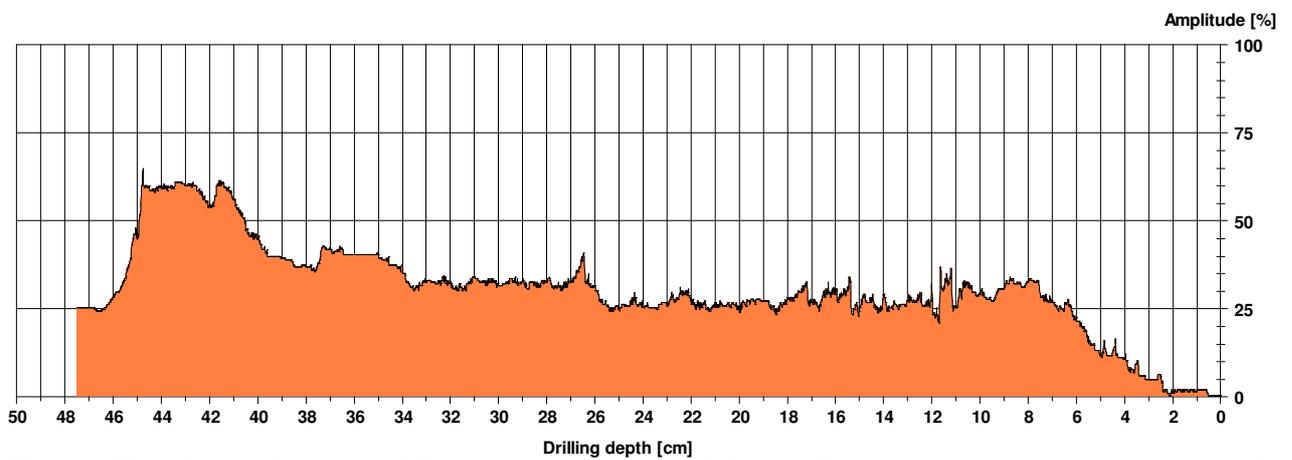
Figure 6: Tree No.23 - black poplar drilled on the southern side of the tree. The readings show a high amplitude which is indicative of structurally sound wood

23.	Black poplar <i>Populus nigra</i>	25 4500	Park and footpath Carriageway Parked cars	Frequent Frequent Frequent	Single stemmed tree, good crown health, 80% live crown ratio. Pavement over 35% of root zone. Typical form	No decay present in area of the tree that was tested	Dead wood/ maintenance prune. Monitor/inspect tree annually or following a severe storm
