22 September 2014

Clutha River Track, Albert Town

Introduction

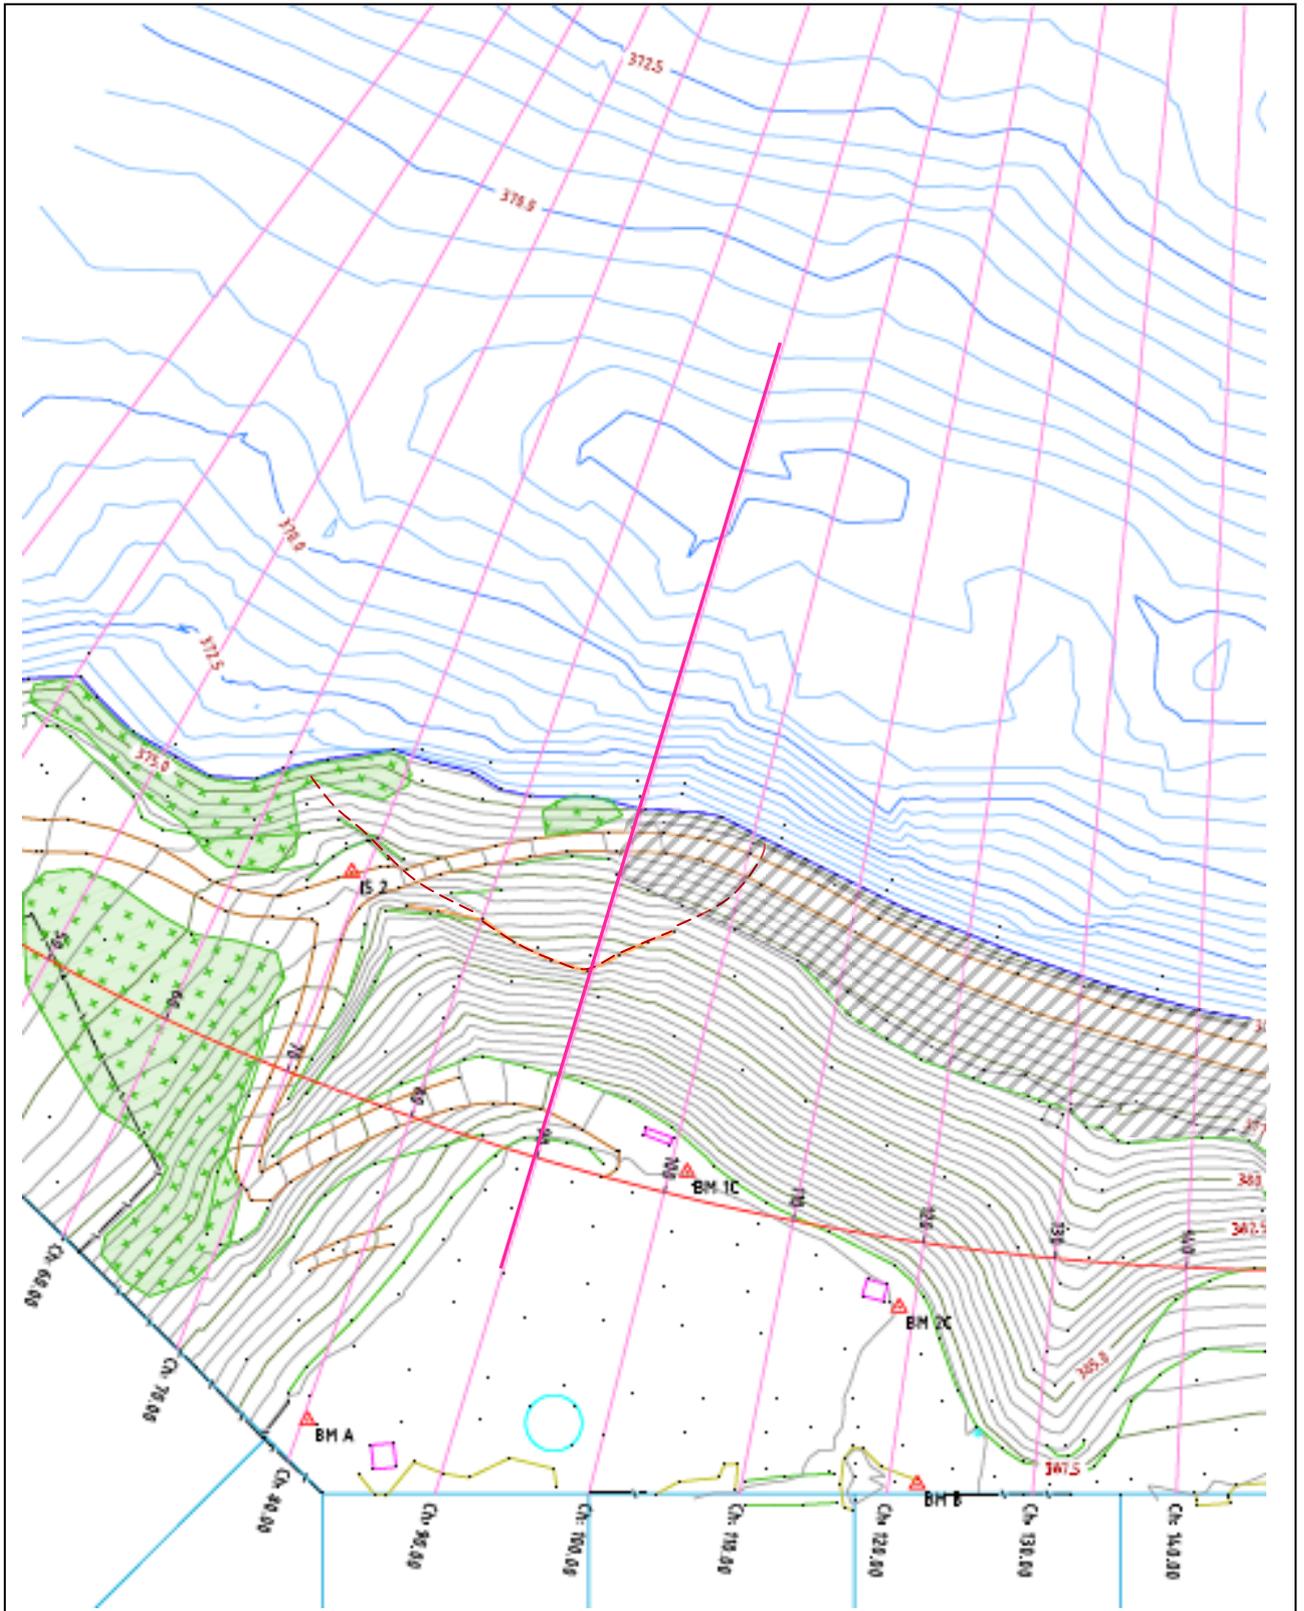
It was noted that heavy rock armouring had been placed on the river bank from approximately Ch 90 downstream to the bridge (see Figure 1). From the surveyed cross sections (e.g. Ch 100), the armouring reaches down to around RL 370 compared to the deepest part of the channel which is at RL 367.45. Upstream of Ch 90, the river bed appears to be lined with cobbles up to 300-400 mm in a fine grained matrix.

<p>PROJECT: Clutha River Track; slip between Ch 60-100</p>	<p>FIGURE: 1</p>
<p>JEFF BRYANT GEOCONSULTING LTD</p>	<p>DESCRIPTION: Slip scarp marked by red dashed line. Overbank armouring marked by hatched area. See Figure 2 for section line along Ch 90.</p>	<p>Scale: 1:666.67</p> <p>Report:</p> <p>Date: 23/09/2014</p>
