Appendix 1: Flood Event Photographs

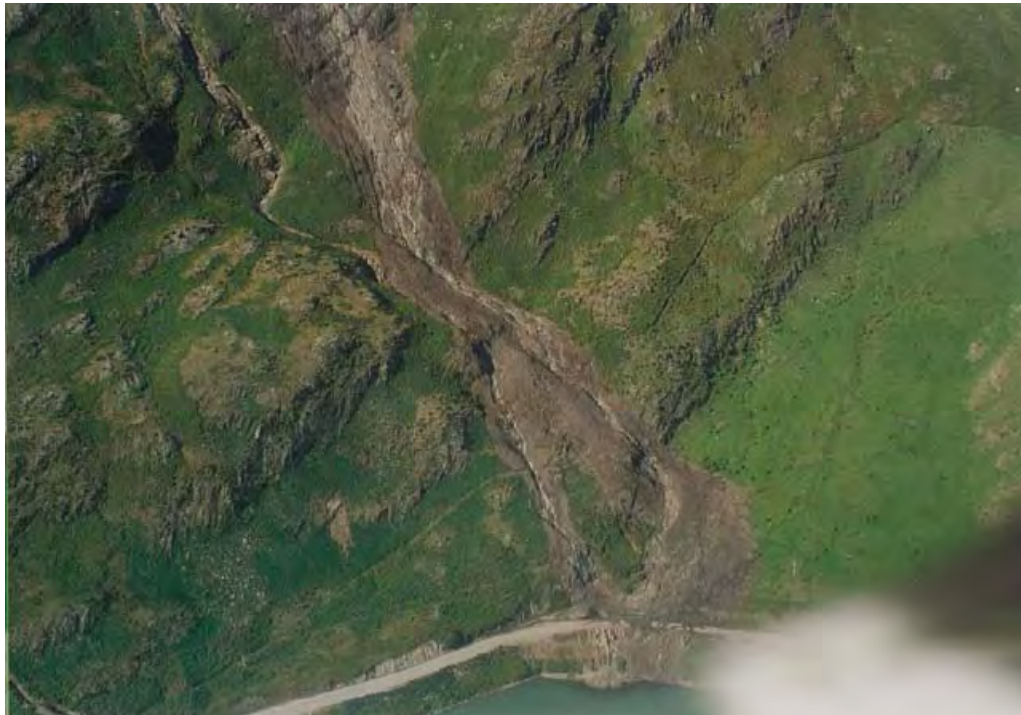
Figure 10: Slip on G Burdon's land, The Neck, 1994.

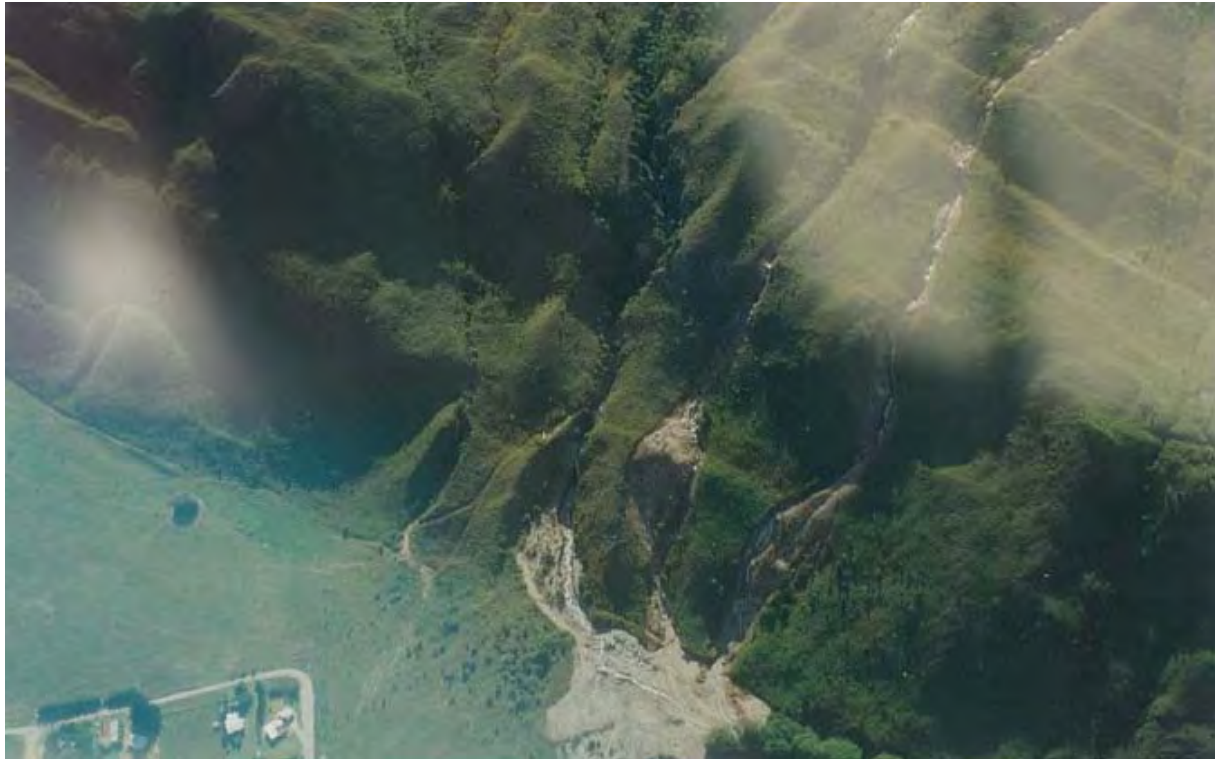
Figure 15: Makarora township (south) and Township Creek, 1994.

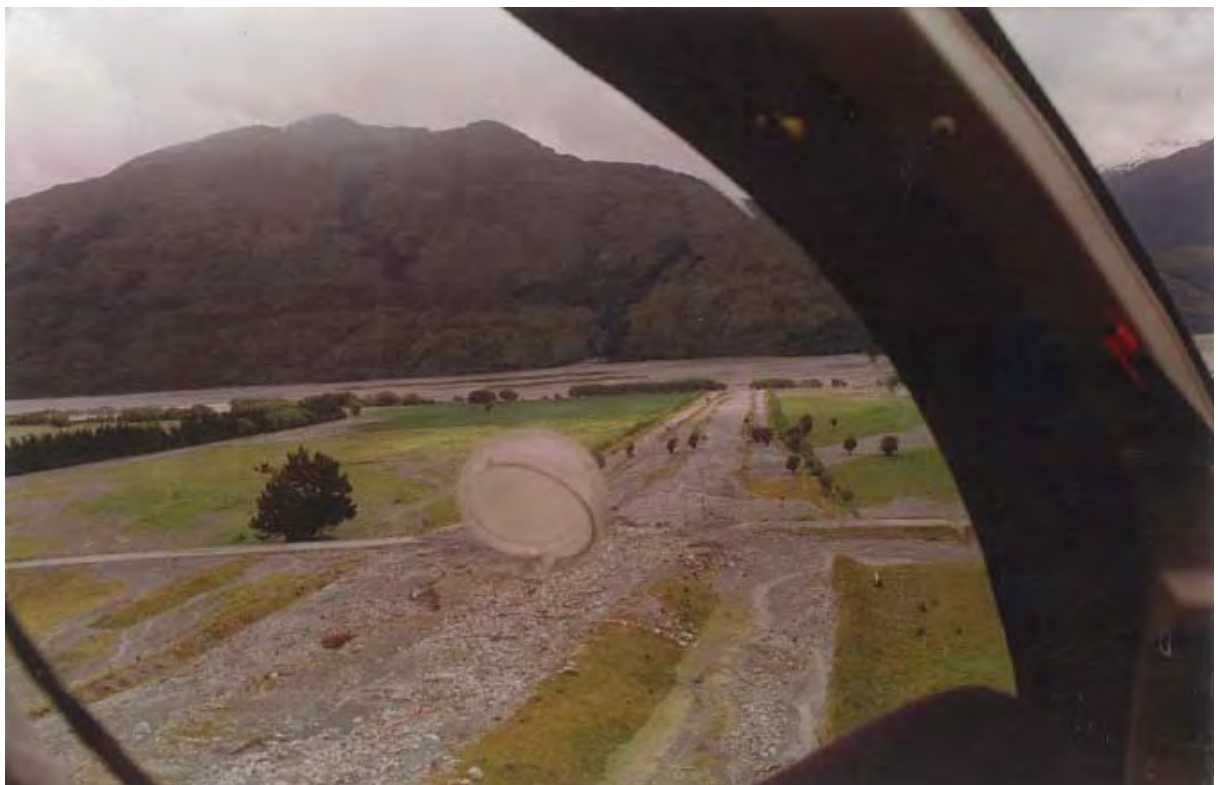
Figure 16: Township Creek, 1994.

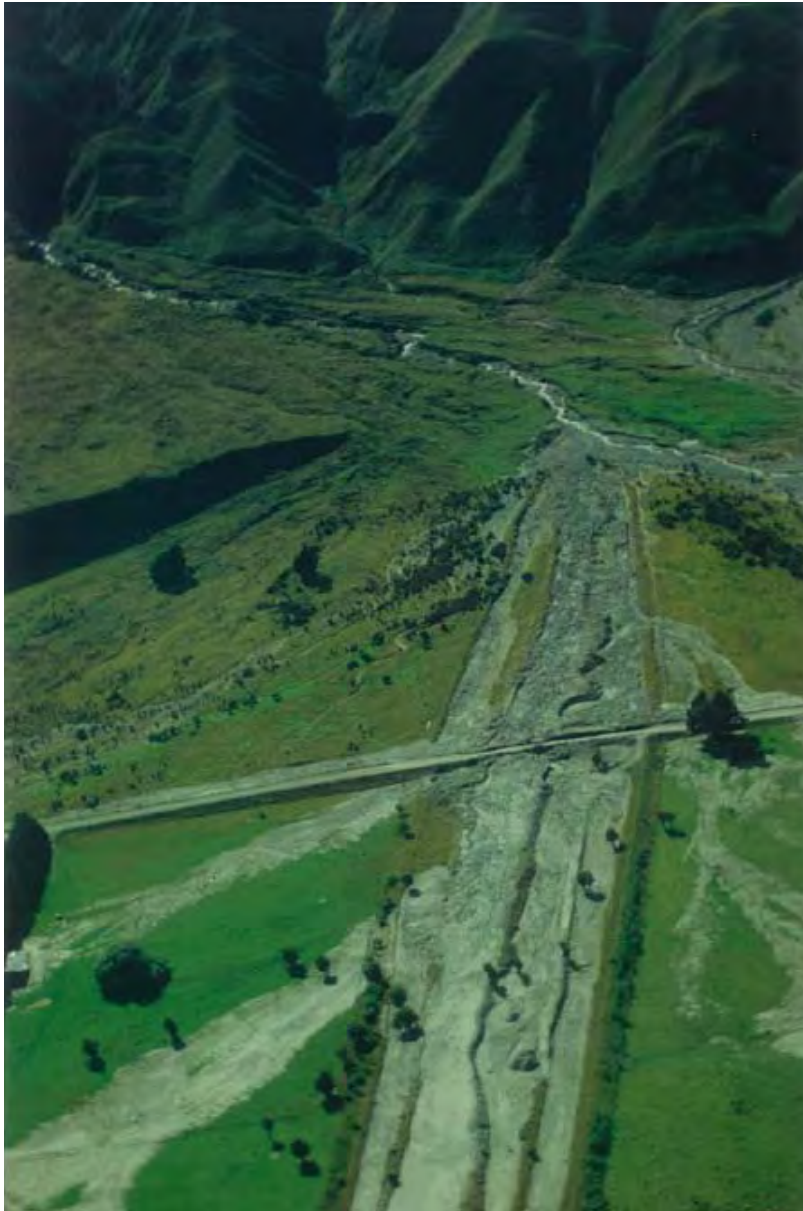
Figure 17: Flaxmill Creek, 1994.

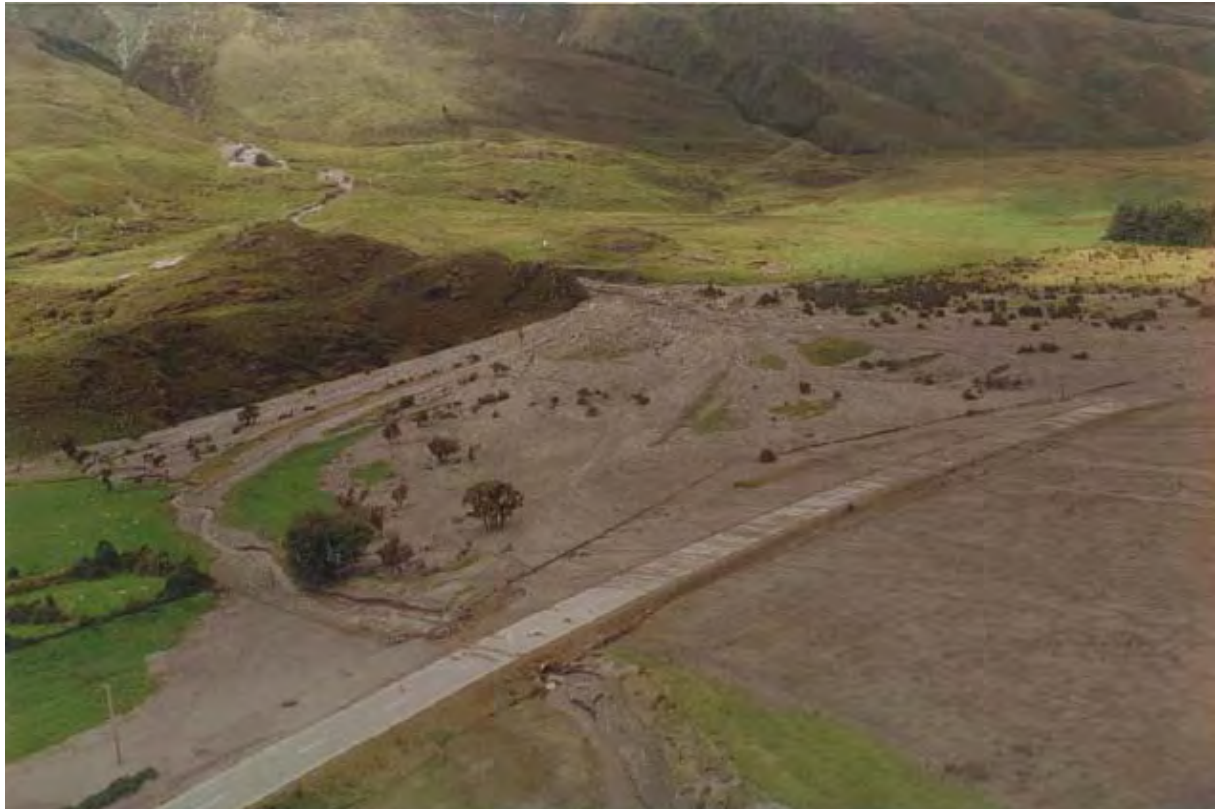
Figure 18: Flaxmill Creek, north branch (1994).

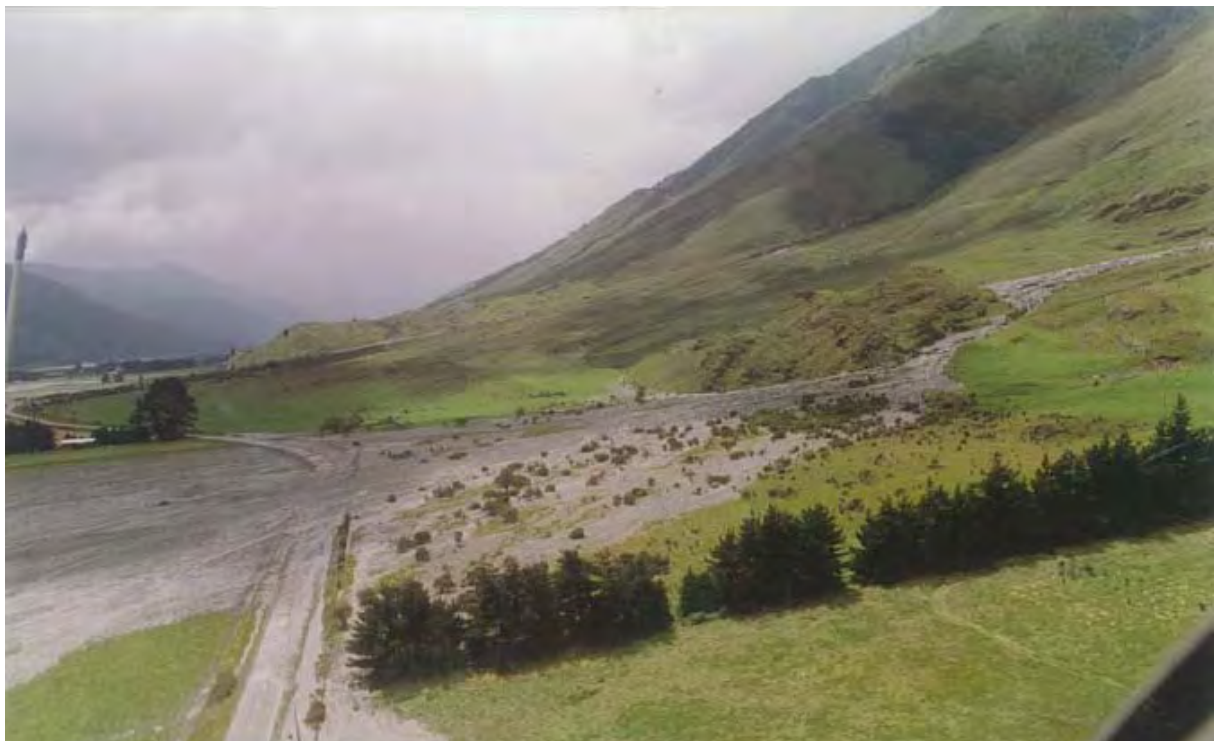
Figure 19: Cemetery Creek, 1994.

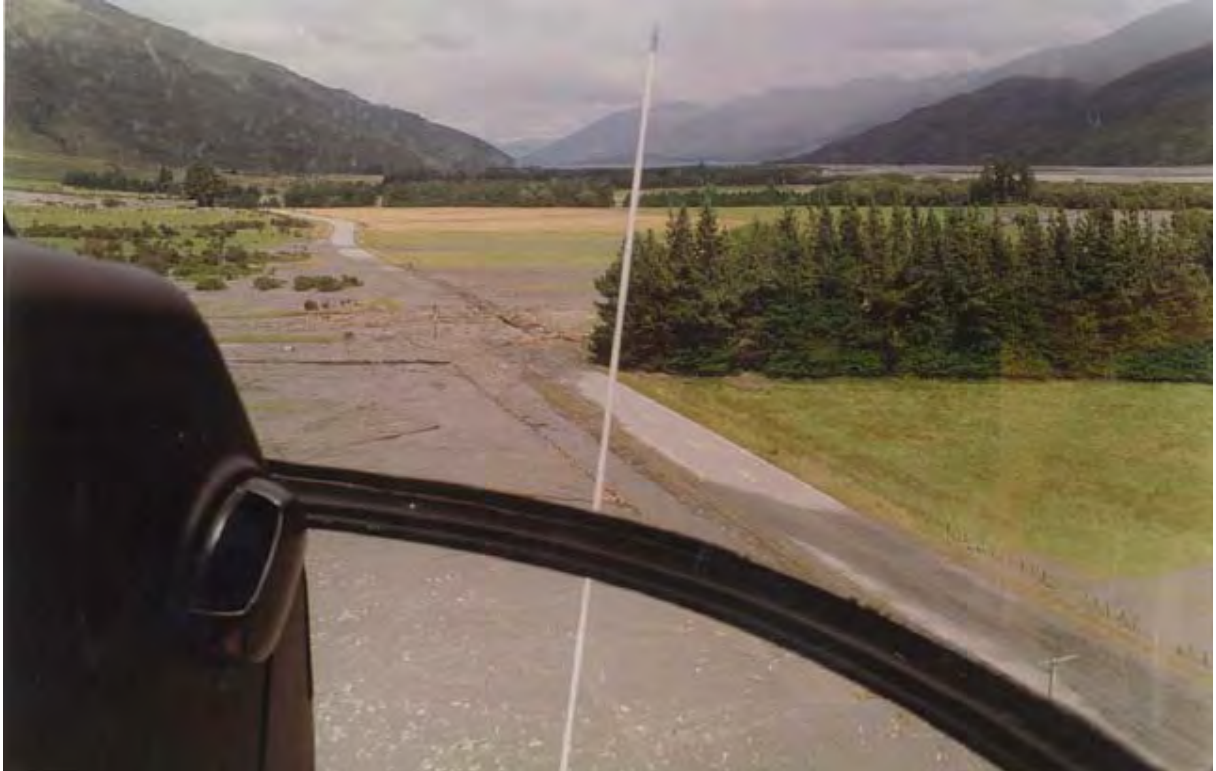
Figure 20: Cemetery Creek looking north, 1994.

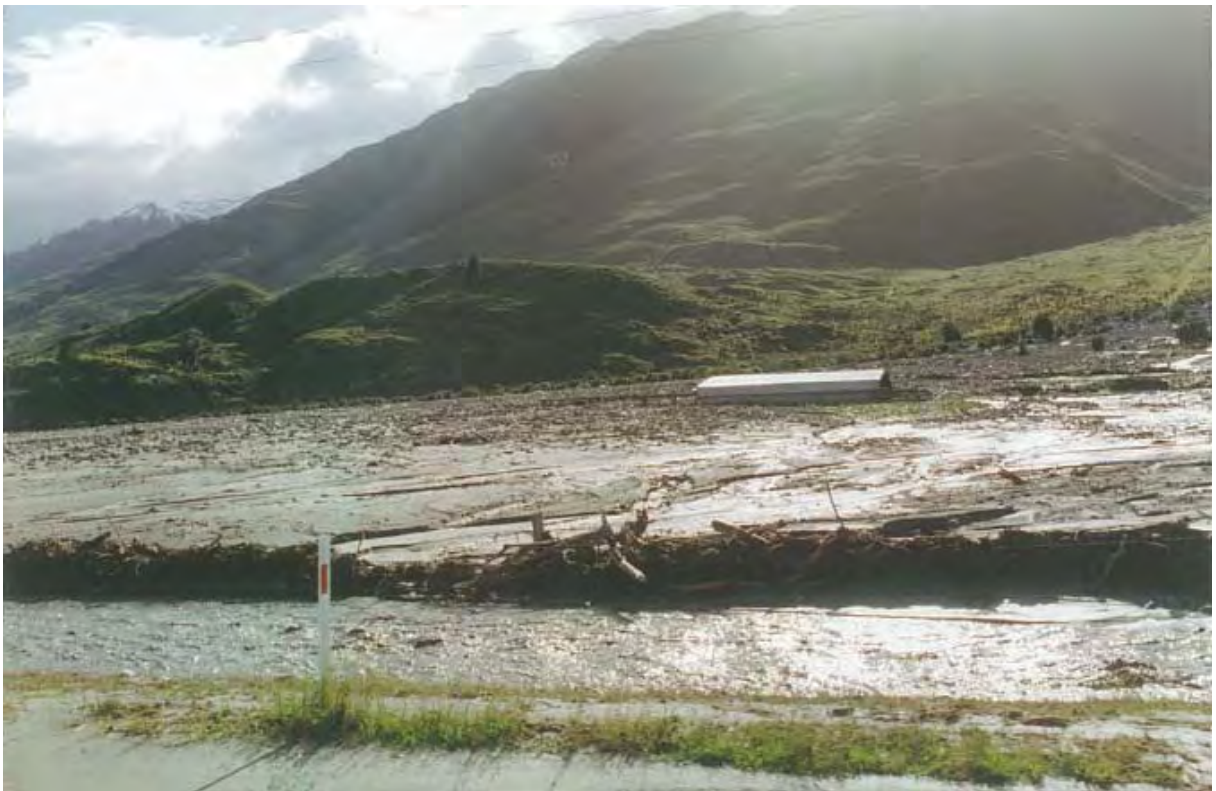
Figure 21: Boggy Creek, 1994.

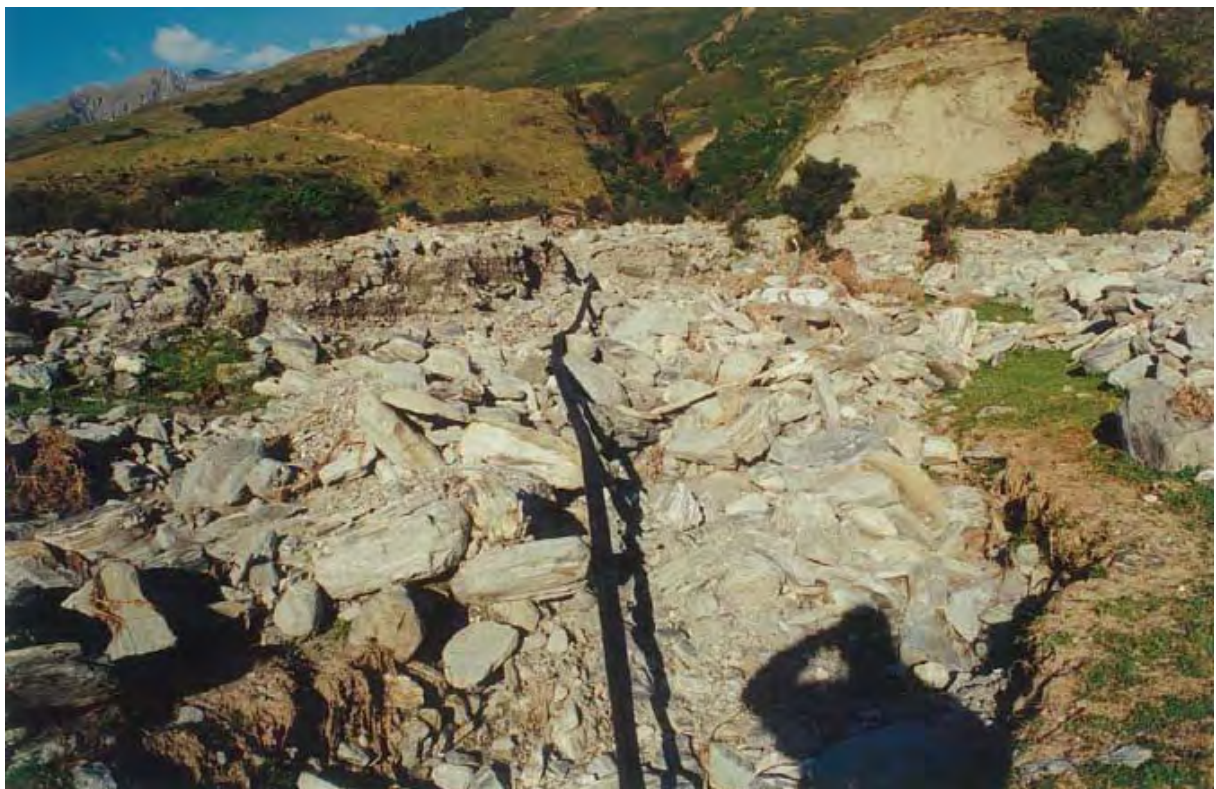
Figure 23: Ewings Creek from SH6, 20th January, 1994.

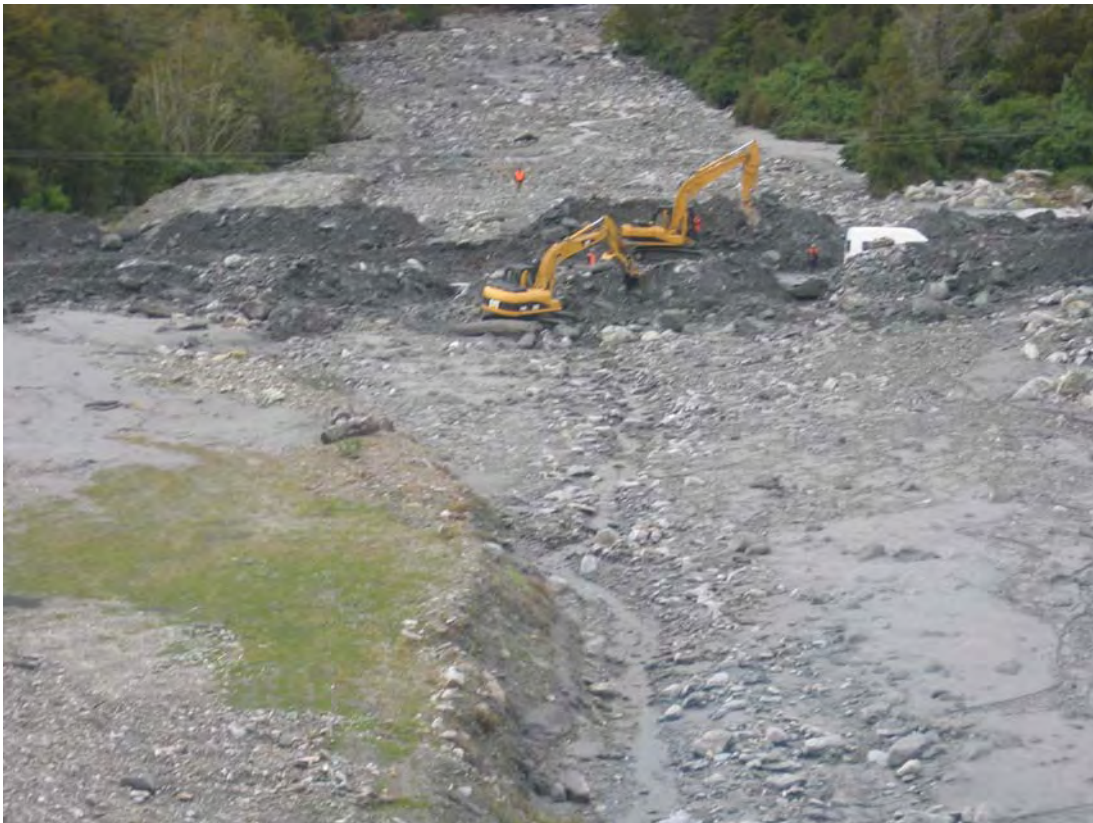
Figure 25: Pipson Creek showing SH6 (location of digger) and contributing slip (top right).

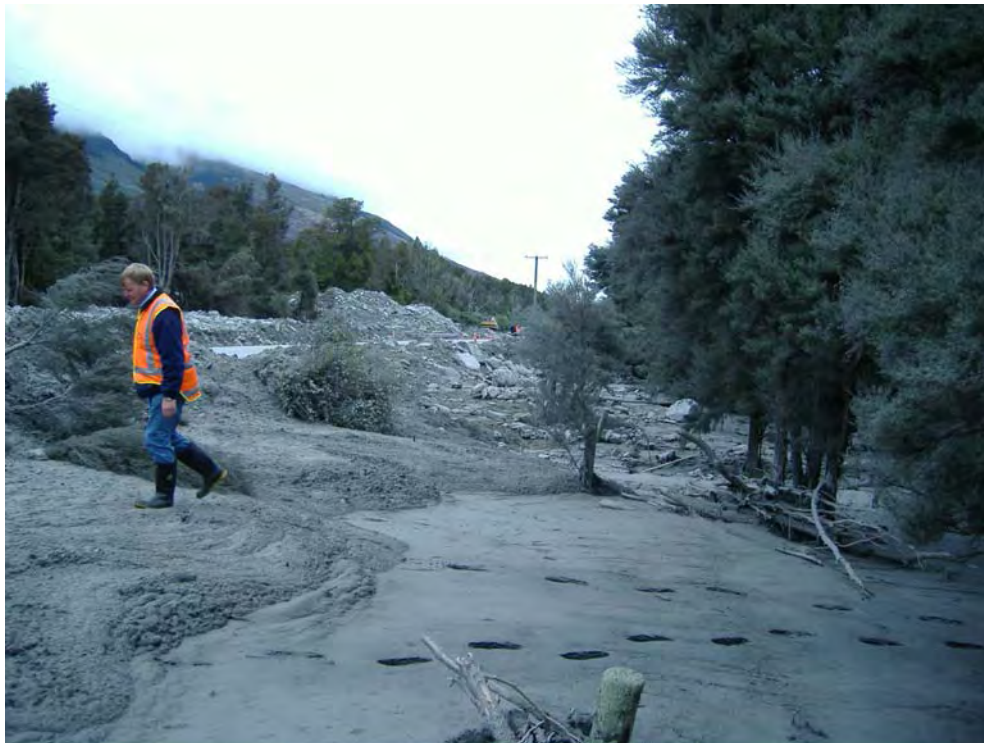
Figure 26: SH6 at Pipson Creek, showing debris from the 2006 event.

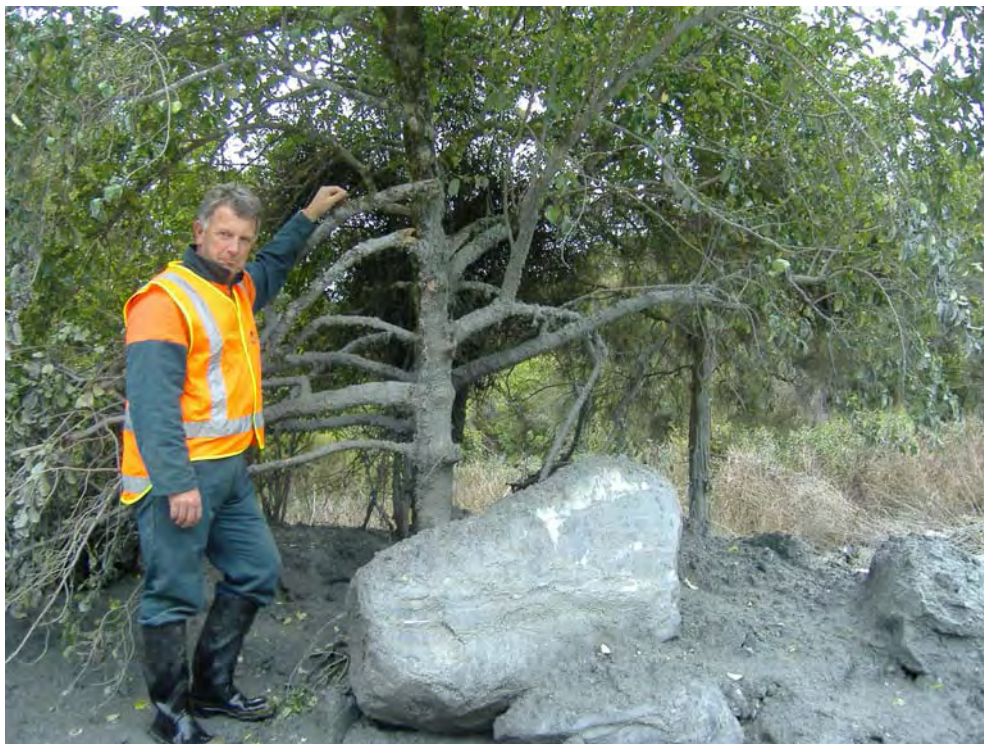
Figure 27: Debris on true right of Pipson Creek at SH6, showing depth of flows during 2006 event.
