Environmental Consultants Otago Ltd

**Preliminary Site Investigation
For Soil Contamination
Ayrburn Farm and Waterfall Park
Residential Development
341 -345 Arrowtown – Lakes Hayes Road, Wakatipu**

November 2016

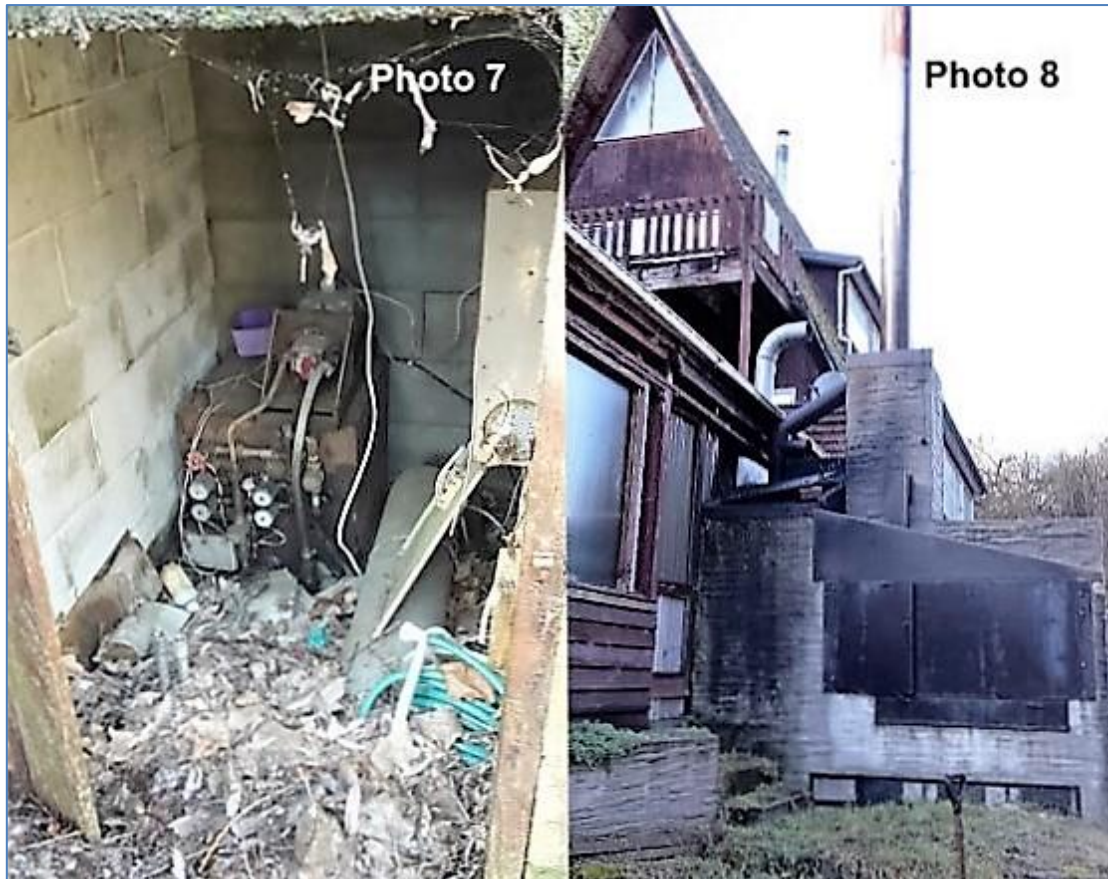
There is large burner that appears to have been used to heat the A-frame building that is built against the wall of the building as is evident in Photo 8. On inspection this was found to contain a large grate that indicates that it appears to have been fuelled with firewood. There is no visible sign of any liquid fuel supply or fuel tank adjacent to the building. The building has external drainage and grease traps, but no evidence of a disposal field was observed. While the building is in a poorly maintained state, it remains sound. It is noted in the QLDC LIM that the roof of the building is fibre cement sheet and the site inspection confirmed this. The roof is sound and there is no evidence of broken sheet on the site surface in the vicinity of the A-frame building. A "plant room" associated with the A-frame building, as evident on a set of plans discussed in Section 2, was inspected and found to be a bare room with a wooden floor that was elevated well above the ground on pole foundations. No evidence of any past installation was evident either from within or underneath this room.

Figure 15: Mill Creek Gorge/Waterfall Park photos with Photo 7 showing the equipment in the shed by the road near the entrance to Waterfall Park, which appears to be some form of fluid pump; Photo 8 shows the A-frame building and the heating furnace.

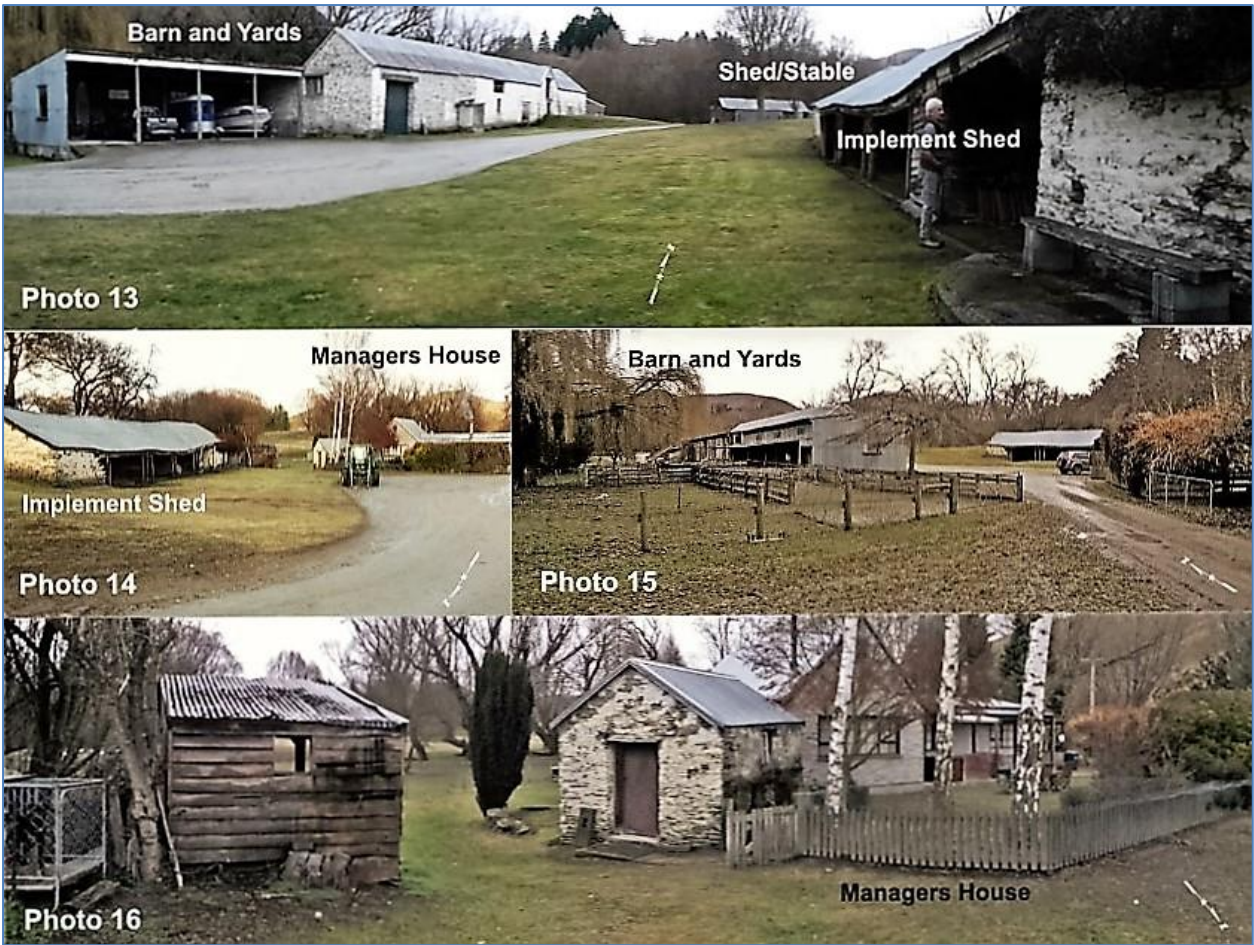
Two UST's were observed during the site inspection. One of these is located at the mid-point of the front wall of the Barn/Woolshed, a tank vent pipe and hand pump on an upstand were observed during the site inspection, and these features are associated with

In Photo 14 shows the farm manager's house (far right in the photo), two small sheds (to the left of and in front of the farm manager's house in the photo), and the Old Implement Shed (far left) with the gravel parking and hardstand that now forms the centre of the farmyard precinct in the foreground. Photo 15 shows stock yards against the rear (western) wall of the Barn/Woolshed. These are constructed of tanalised pine indicating that they are of relatively recent construction and these remain a part of the farm operation and are in good repair and well maintained. Photo 16 shows the farm manager's house and garden and two small sheds adjoining it from a similar but closer view than that in Photo 14. The first shed is a stone building, painted white, with a concrete floor that the Bonisch Map of the site (Figure 7) identifies as a dairy; the second adjacent shed is a wooden structure that appears from inspection to have been a milking byre. These old sheds appear largely unchanged from when they are inferred to have been built in the 1860's and, while still reasonably sound, are not currently in use. The farm managers house has a septic tank located within the lawn area on its southern side. The larger timber shed marked as Shed (stables) in Figure 4 and visible in the centre left of Photo 13 stands alone on the eastern side of the hardstanding area, and the interior of this structure is shown in Figure 19. It is presently used primarily for storing equestrian equipment and appears from inspection to have been erected for this purpose. Two ASTs, presently in use, are located to the north of this old Shed (stables) as seen in Photo 10, Figure 17. These two ASTs, are both in use and are well maintained. Light diesel staining is visible at their base, which is unbunded.

Figure 18: Four close views of the farmyard. Photo 13 shows the eastern face of the Barn/Woolshed. A disused UST is located between the small shed built against the Barn wall and the earth ramp. The Old Implement Shed is on the left of Photo 14 and the farm manager's house on the right, with the milking byre and stone dairy located between the two. Photo 15 shows the Barn and the yards against its rear (western) wall. Photo 16 shows the farm manager's house, with the dairy (centre) and milking byre (left).

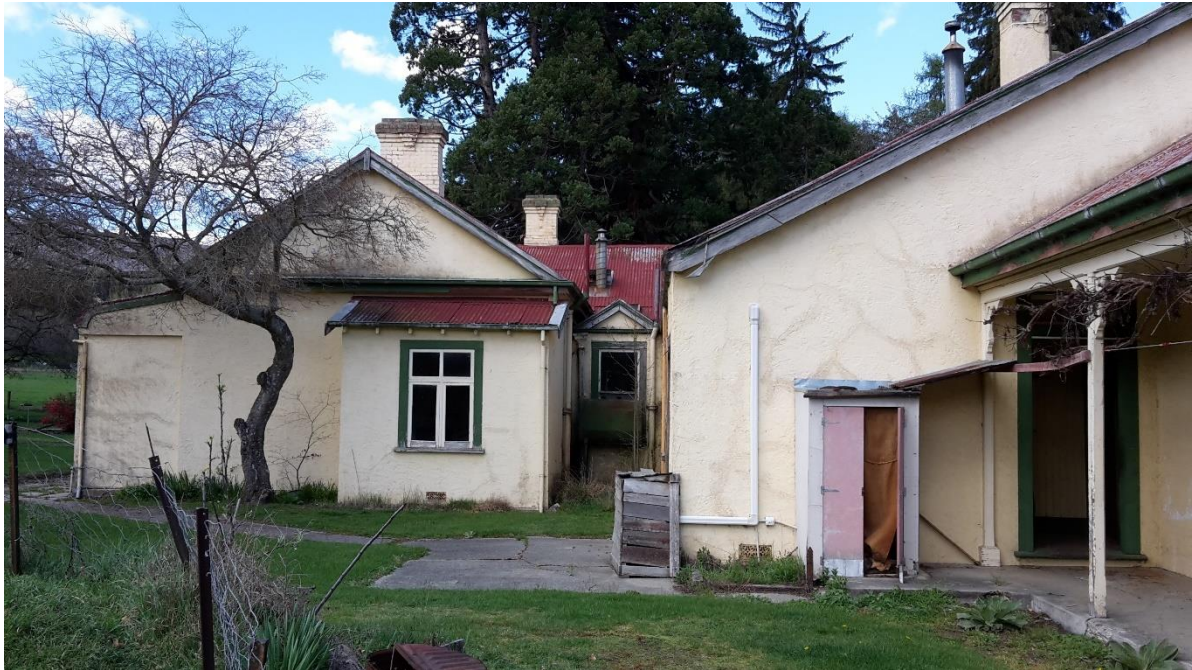
Figure 21: The homestead rear wall and back door with a 500l heating fuel tank on a stand in the recess beside the annex at the centre of the photo.

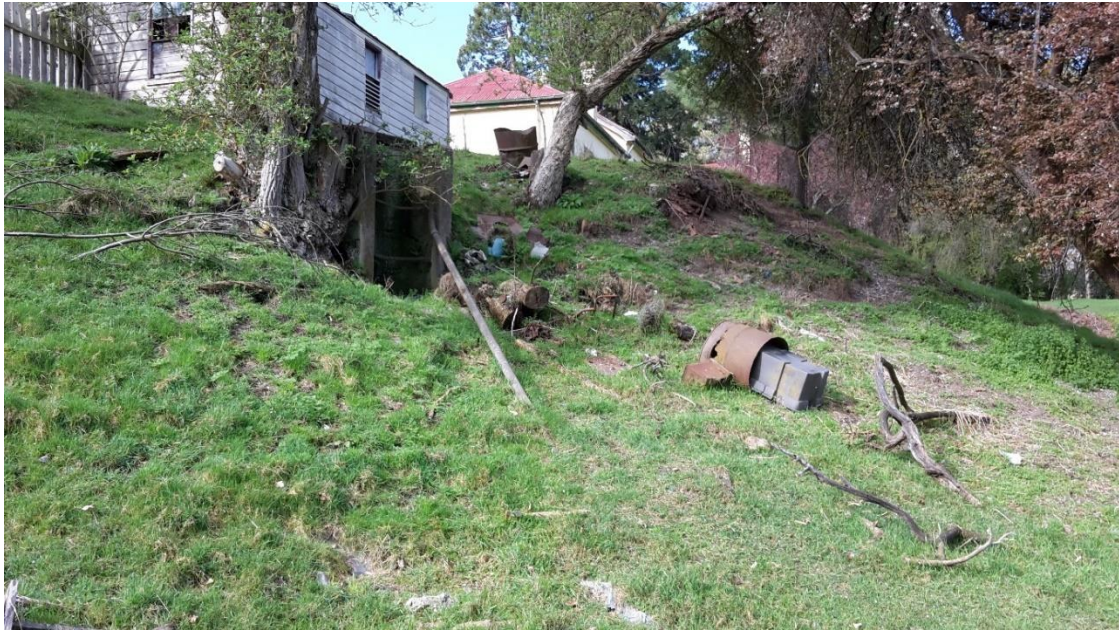
A concrete structure that appears to be a septic tank is located at the rear (south) of the homestead and appears to discharge over the bank to the lower terrace. There is a veneer of rubbish deposited across this slope that is embedded in the soils on the bank and this appears to date back a considerable period. Visible remnants of rusted metal containers and bottles are scattered across a quite wide area from the top to bottom of the slope shown in Figure 24. The septic tank structure is visible to the left of centre of this image with a pipe extending down slope from the top of the tank.

Figure 23: Rubbish on the slope at rear of homestead. Concrete structure and pipe to the left of centre appears to be a septic tank.

The rubbish dump on the bank to the south of the homestead also warrants further investigation as it is the only evident site where rubbish has been dumped within the farm and it would not be unexpected that containers for agricultural chemicals were stored in the utility buildings behind the homestead, which leads then to the possibility that empty containers have been disposed over the bank. While one arsenic exceedance is observed,

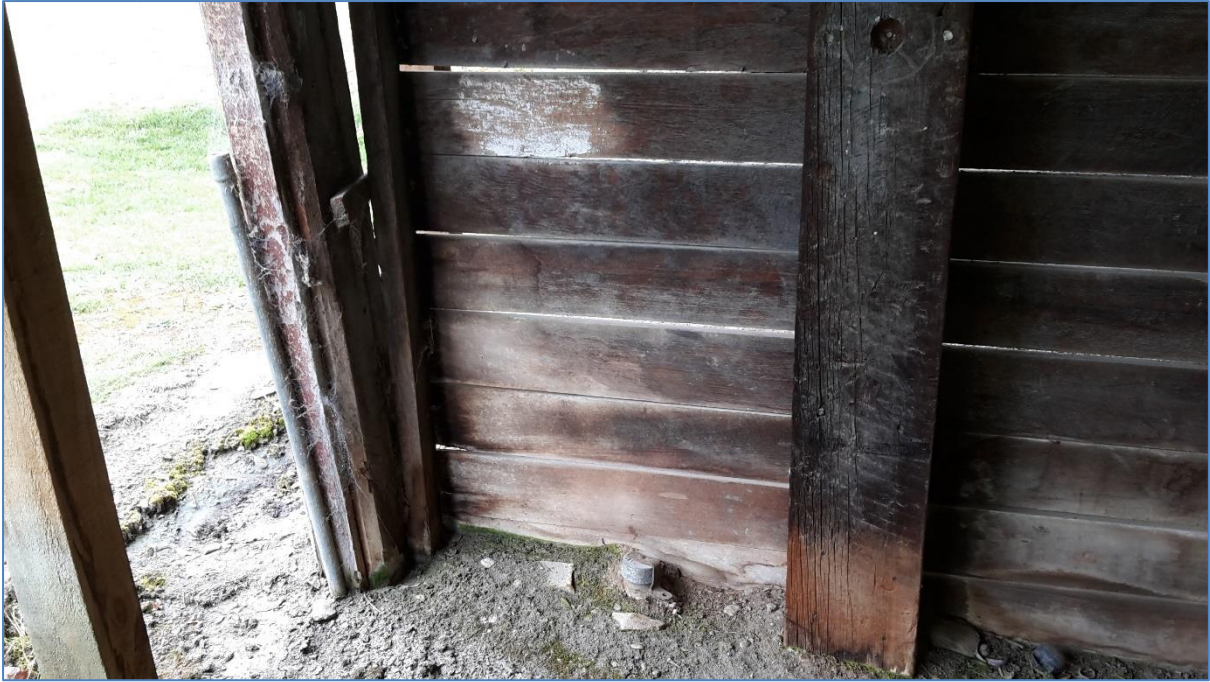
the UST mentioned in Section 2, which was discovered in interviewing the farm manager. The second UST was not discovered during the desk-top study, and was observed during the second site inspection within the structure shown on the far right of Photo 13 labelled "Old Implement Shed" in Figures 4 and 7. This building is now unused other than that a car covered by a dust sheet is stored in one bay. For this second UST, there is a UST tank fill point a pipe that appears to be a tank breather and some bolt holes and an imprint on the wall that is suggestive of an old hand petrol pump. The presence of this UST was not discovered during the desk-top study, as the farm manager was unaware of its presence. The building in the centre in Photo 13 is labelled as a Shed(stables) in Figure 4 (not labelled in Figure 7), and is discussed below.

Figure 25: Fill point, tank breather and mounting point for pump against an internal wall in the Old Implement Shed, all serving as indicators of the presence of a second UST at site.

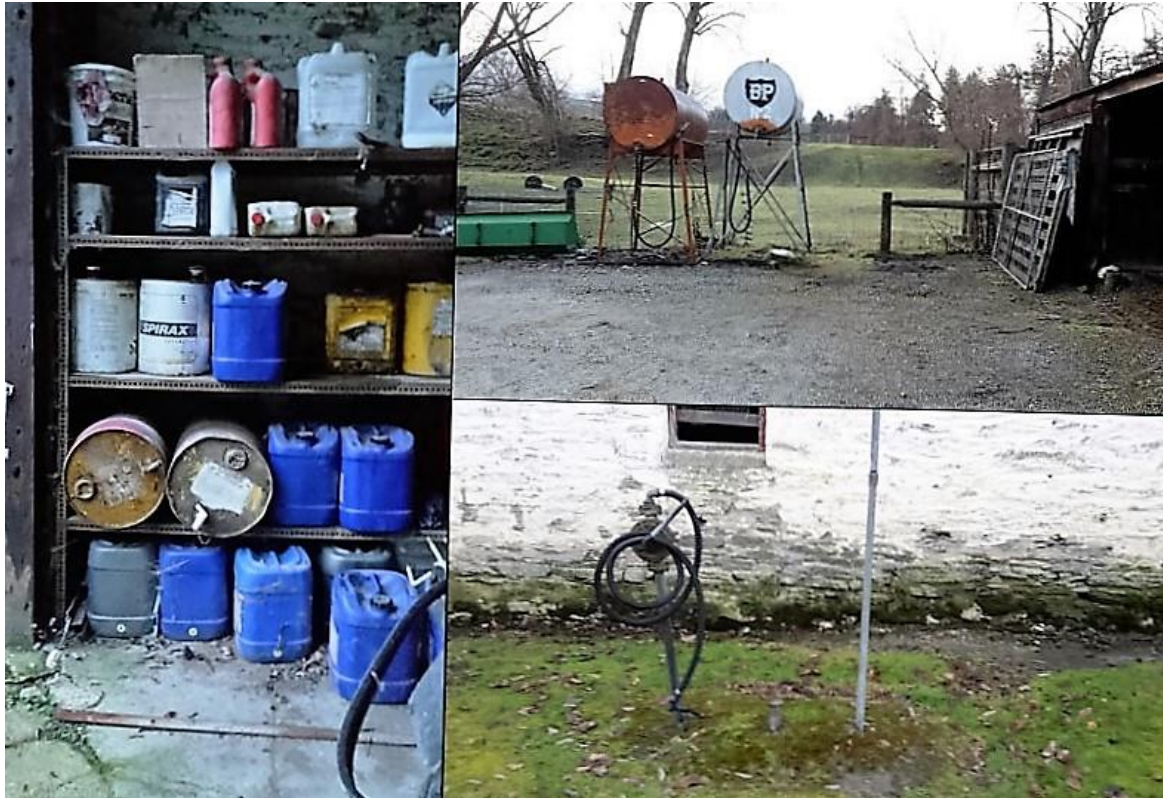
Figure 26: Photos of some of the visual cues for potential contamination that were observed during the site visit; left – drum store adjoining the Barn/woolshed/; top right – the two diesel ASTs by the Shed(stables); and bottom right – evidence of the UST against the eastern wall of the Barn/woolshed.

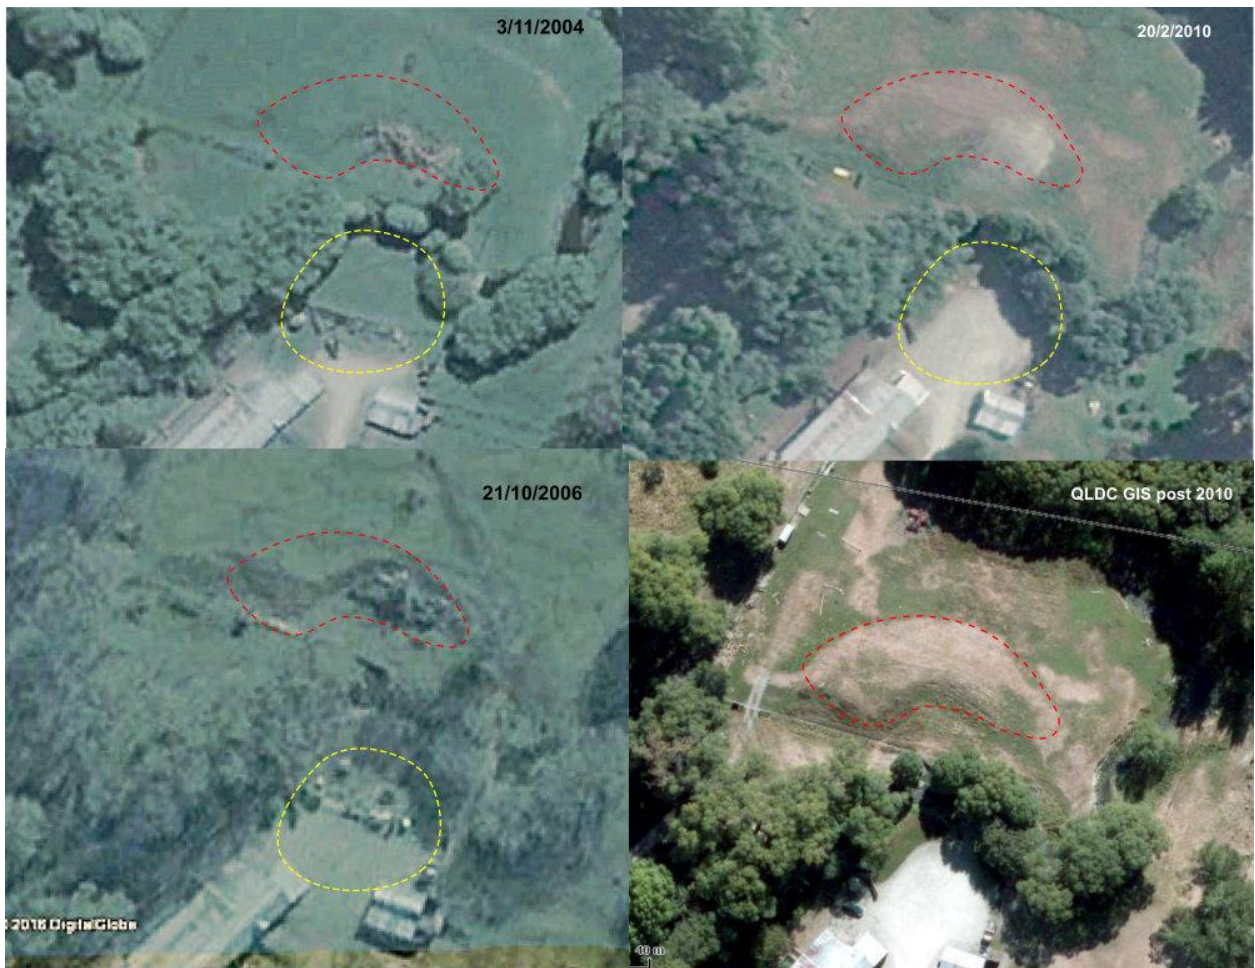
During site inspection there was no evidence of this discovered on the ground, however the aerial photos suggest that the landform has been altered sometime after 21/10/2006. During the same period, an area of land north of the yards and barn was excavated and a gravel apron was laid, as also indicated in Figure 27 (yellow dashed line). There is a track through Mill Creek between the two locations as well, which lend support to an assumption that material was excavated from one location and placed in the other as fill. Mr Glendining when asked about landfilling at this location advised the old fencing and similar materials may have been buried at this location but that he had no knowledge as to whether other material had been disposed to this location particularly relating to the disposal of the remains of the sheep dip and surrounds. The landform that is evident from the dry mound visible in the photo in the lower right hand of Figure 27 indicates a more substantial body of fill at this location. The “tail” that connects this landform with the farm track to its’ left that is visible in both of the post-2010 photos is also suggestive of heavy vehicle tracking having occurred at this location. If this location has been used to dispose of material cut from the vicinity of the barn and yards it could represent a significant deposit of contaminated material.

Figure 27: Sequence of four photos of a possible fill area near the Barn/woolshed & Yards. The photo sequence is top left, 2004; bottom left, 2006; top right, 2010; bottom left, from the QLDC, undated but post-2010 (all other photos from Google Earth). This sequence suggests that the area outlined in red has been filled sometime over this period, which is also contemporaneous with the excavation and metaling of an extensive area adjoining the northern end of the Barn/woolshed & Yards. This excavation is an area of the site that is closely associated with potentially contaminating activities.

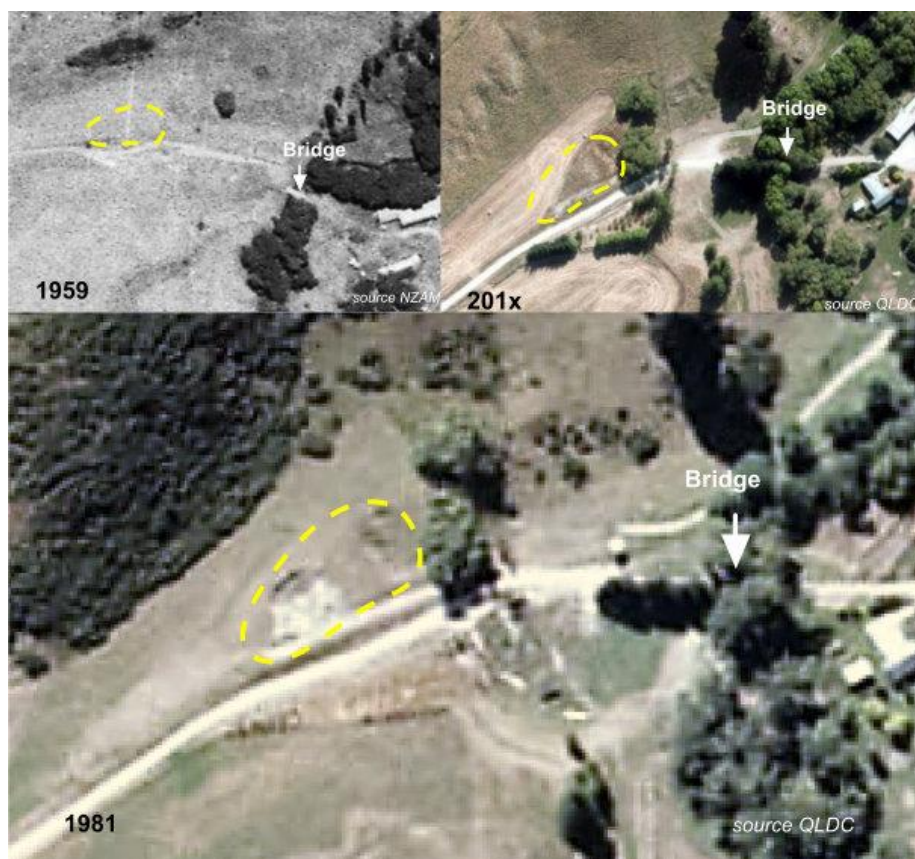
Mr Glendining also advised that metal scraps have sometimes surface when he grades the farm road to the west of a bridge where the road runs through a cutting in the terrace face. He considered that this may indicate an old farm landfill in the area. There was no evidence of landfilling at this location during site inspection, but a comparison of aerial photographs from 1959, 1981 and from the QLDC GIS (which is undated but expected to be post 2010) shows that in 1981 there what appears to be a small disturbed or excavated area adjoining the farm track, and that this has been covered over since that time. This feature is marked on the three dated photos in Figure 28. This feature should be subject to investigation prior to development.

Figure 28: Possible farm landfill site (outlined in yellow dashed line) located by the main farm track west of the farmyard.

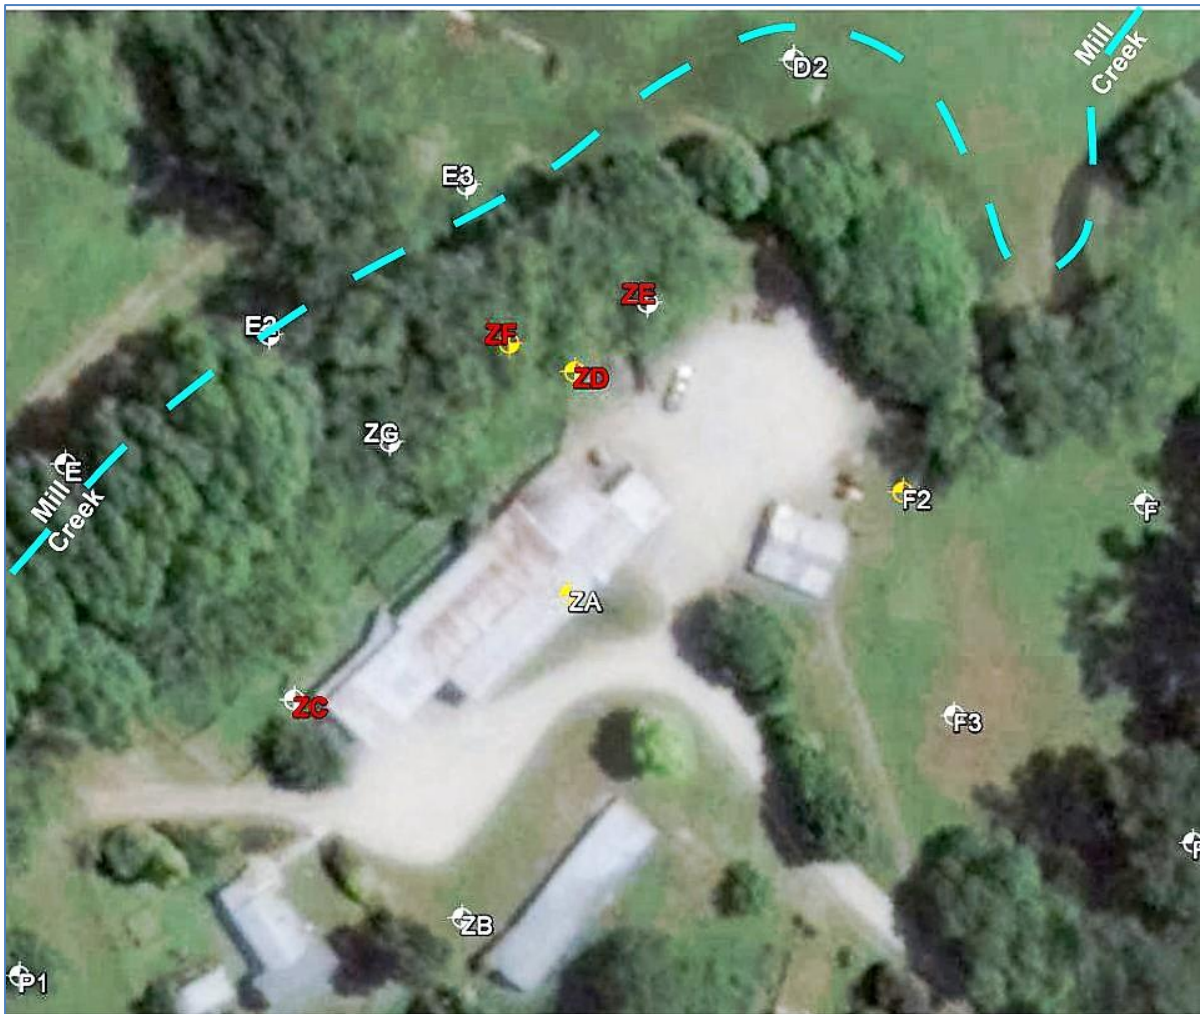
Figure 35: Sampling locations with exceedances of the Residential SCS for arsenic and lead. Arsenic exceedances exist at the locations with orange symbols and lead exceedances exist at the locations with red sample name labels.

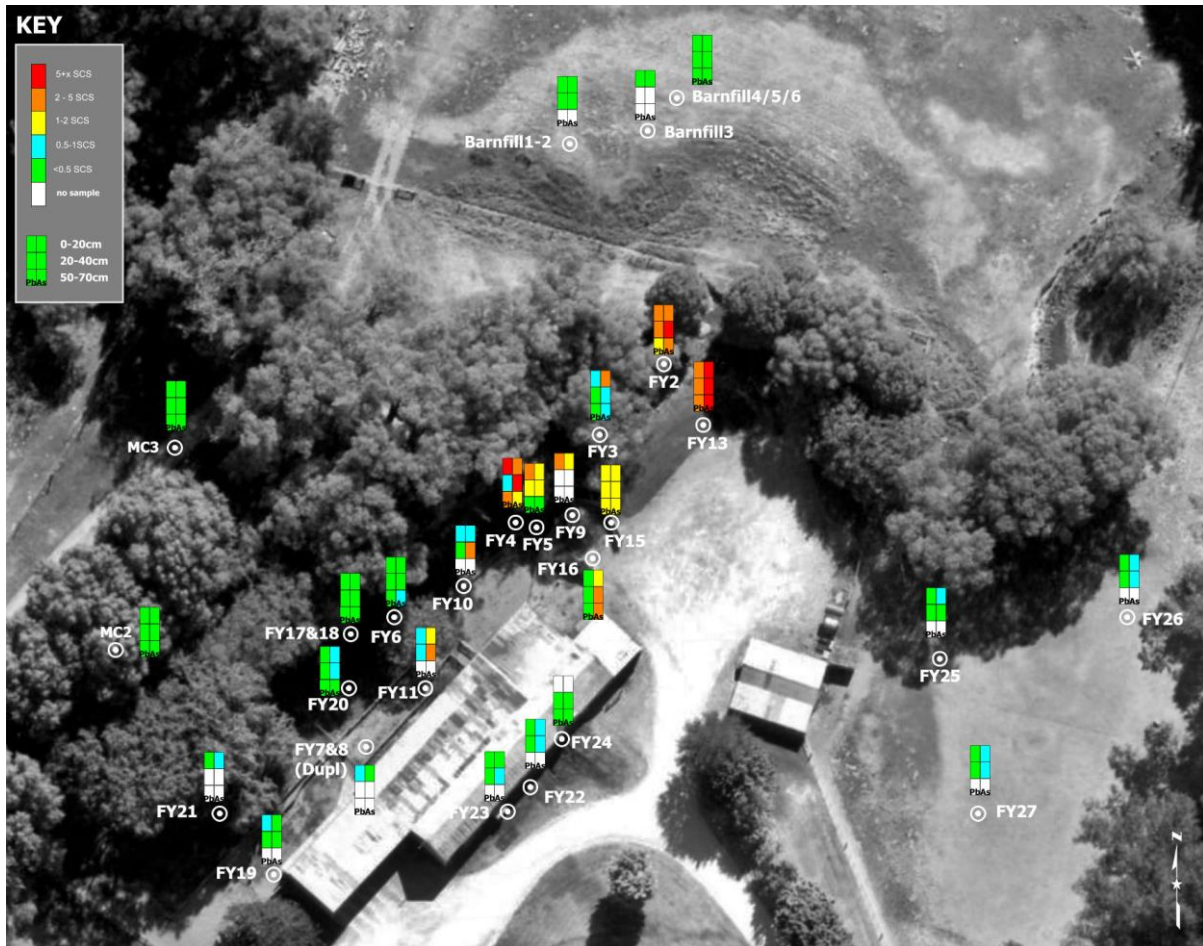
Figure 36: Sampling results from the second round of sampling shown for arsenic and lead for samples at the northern end of the farmyard and showing the high levels of arsenic and lead at the location of the former sheep dip at the northern end of the Barn/woolshed (image QLDC GIS).

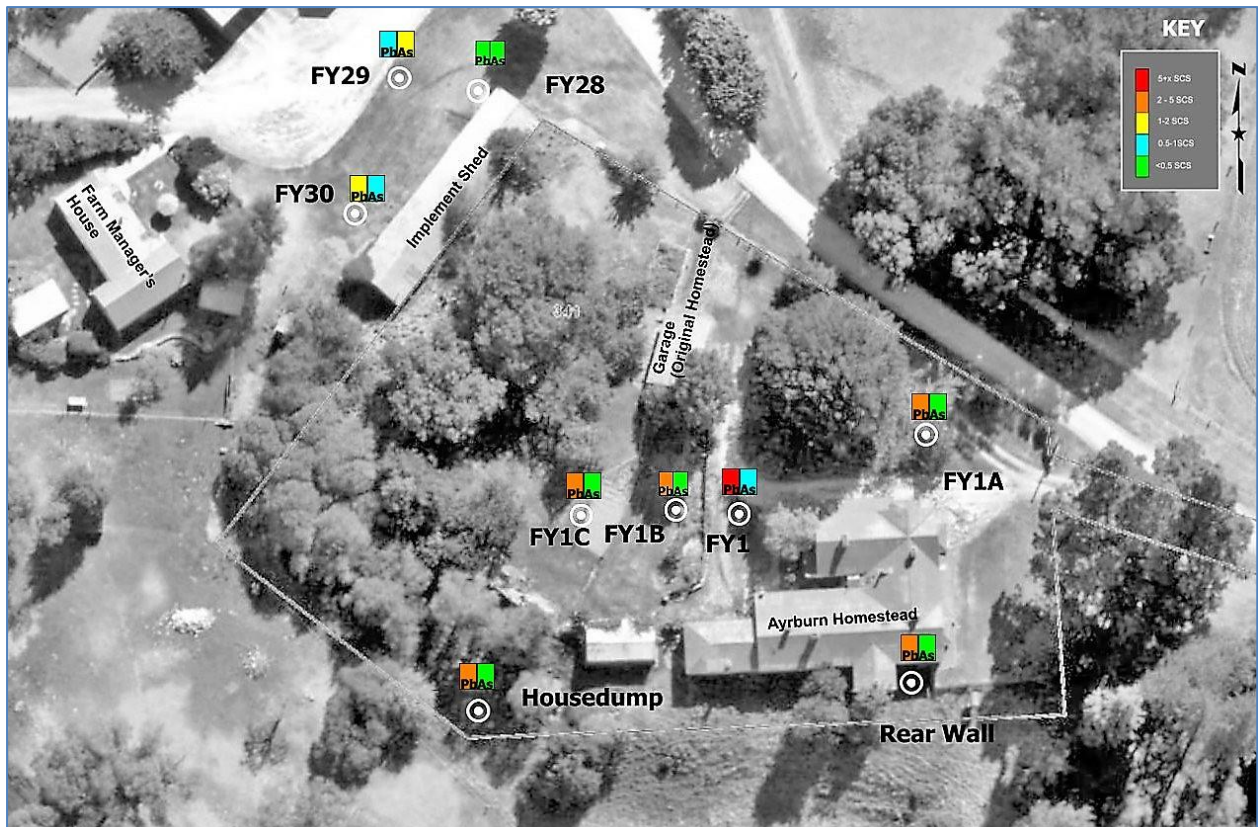
Sampling in the Homestead immediate curtilage found significant exceedances of the Residential SCS for lead in all the samples, locations for which cover a large part of the garden area surrounding the homestead. The results also show cadmium and zinc approaching the Residential SCS at one location. Cadmium and lead are used as pigments in older paints and lead was also used in primers. The limited sampling adjacent to the homestead does however suggest that the lead contamination is far more extensive than a "paint shadow" usually is, even for an old site. More detailed sampling and analysis, including sampling at depth, would be required to provide any more substantive conclusion with regards to the site conditions adjacent to the homestead.

Figure 37: Site sampling in the southern part of the farmyard (Old Implement Shed area) and the Homestead immediate curtilage; results show lead exceedances across the homestead grounds (Image QLDC GIS).
