Project/File: 310206053

Date: 17 December 2025

Reference: Skippers Bridge Cables**Executive Summary**

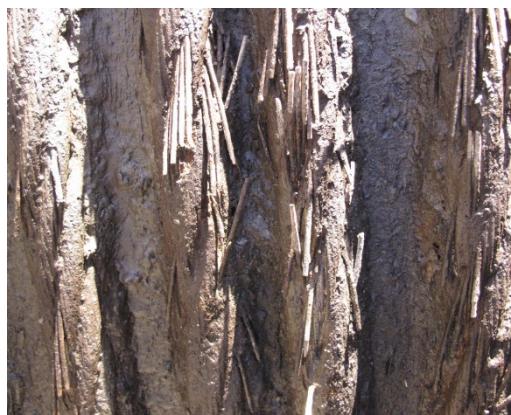
The cable damage is believed to be caused by Stress Corrosion Cracking. Additional stress caused by the cable bend radius over the plate on the TL is believed to be a contributing factor to the damage.

Figure 1. Broken Wires on the TL upstream cables

We are unable to reliably calculate the remaining strength of the damaged cables as fine, but undetectable, cracks may be present throughout the buried section of the cables. Load testing runs the risk of causing a catastrophic cable failure. As the individual wires of the cables crack the load on the remaining wires will increase and the rate of crack propagation and resulting capacity loss may be increasing. For this reason, we are unable to confirm if the bridge is safe under any loading regime. Rapid brittle failure of the cables under minor load is possible.

Due to extensive brittle failure of the wires in the Skippers bridge cables we are unable to confirm the load capacity of the cables. Consequently, we recommend that the bridge is closed to pedestrians and vehicles until repair, or replacement, can be implemented.

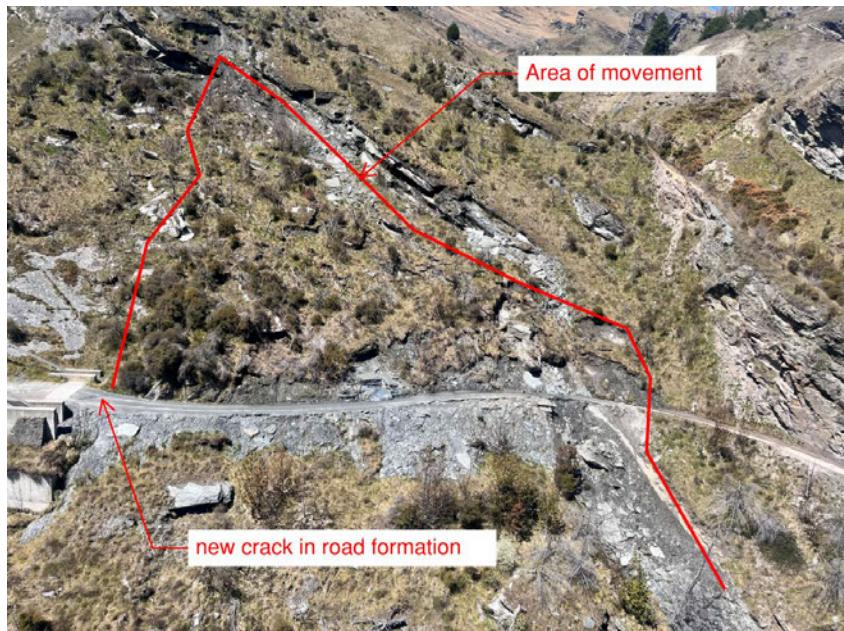
On the TL side the schistosity dips toward the Shotover River at a significantly adverse angle, (approximately 40°) and the soil overlying the rock is slipping on this plane. The northern margin of this slip is immediately adjacent to the TL cable anchorages. This is shown in the figures below

Figure 3. Area of instability adjacent to TL cable anchorages

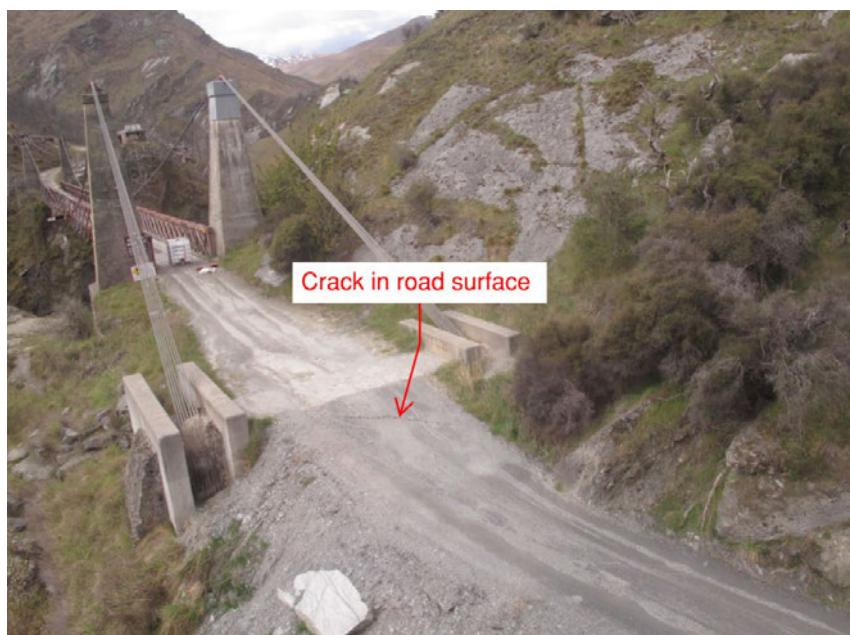
Figure 4. Crack in road surface immediately adjacent to cable anchorages on the TL taken in November 2025.

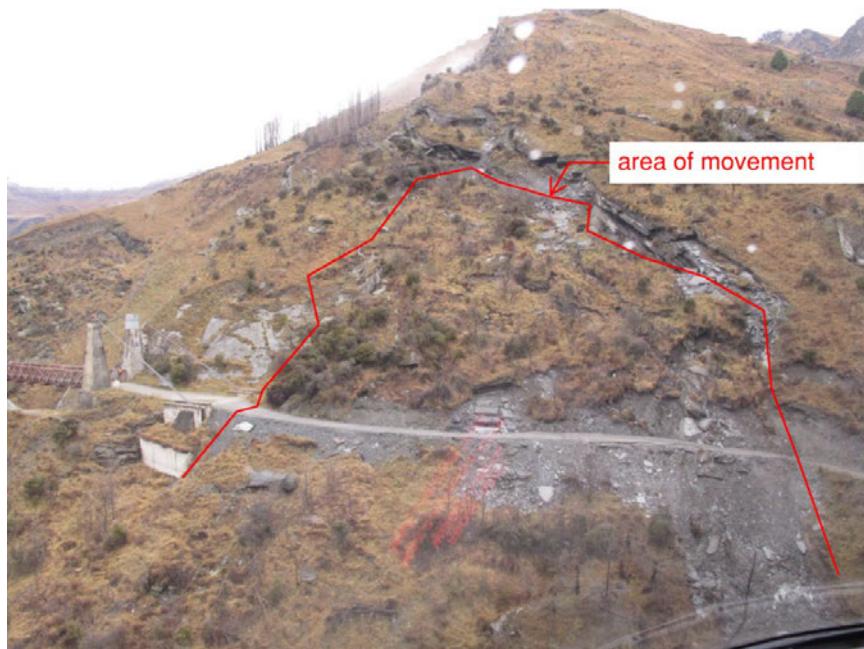
Figure 5. Unstable area showing its proximity to the TL anchorages

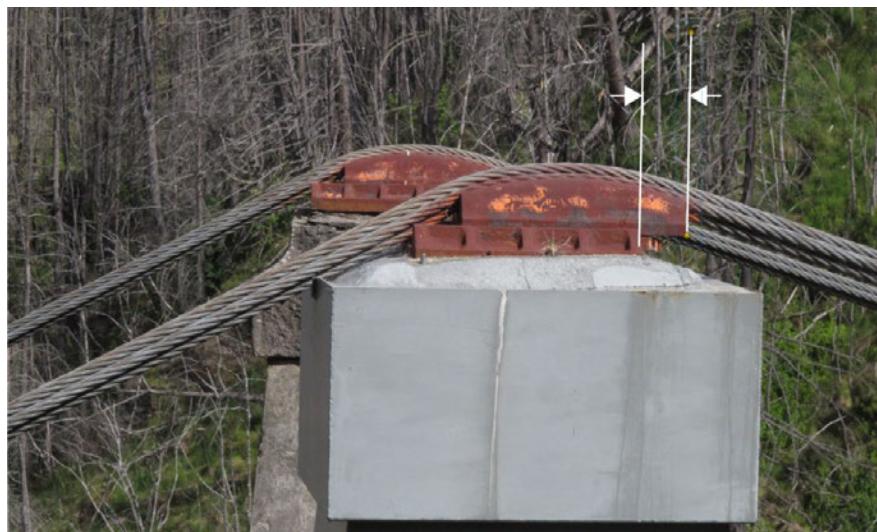
In 2003 the Stoney Roller bearings on the towers at the TL were observed to be displaced by approximately 120mm. The cause of the movement of the bearings was thought to be relaxation of the TL cable anchorage. As a result, hold down blocks, placed over the cable 'roll over' blocks and rock bolted to the rock below were constructed to hold down the anchorages. This work was carried out in 2004. Since this time no further movement of the bearings has been observed. The displacement of the bearings is shown in the figure below.

Figure 6. Displacement of the Stoney Roller bearings toward the span on the TL

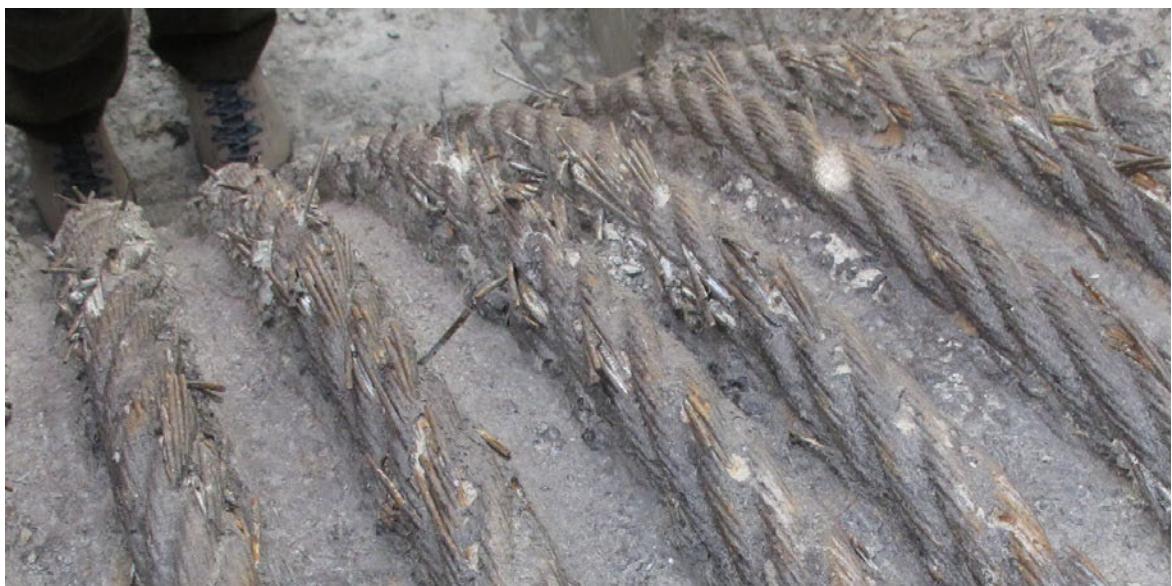
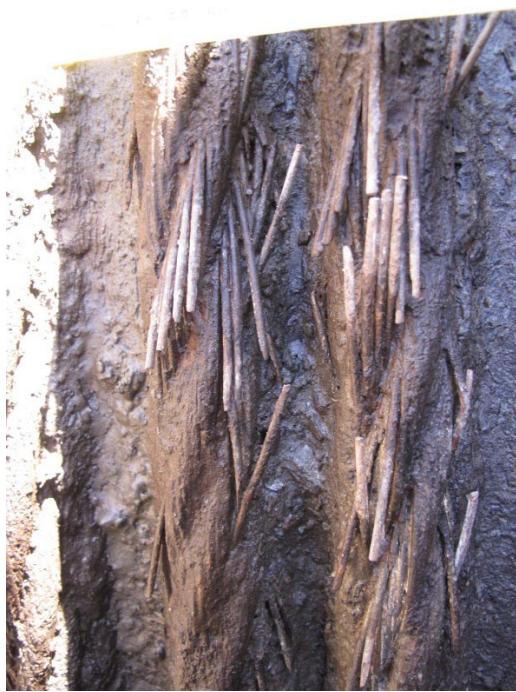
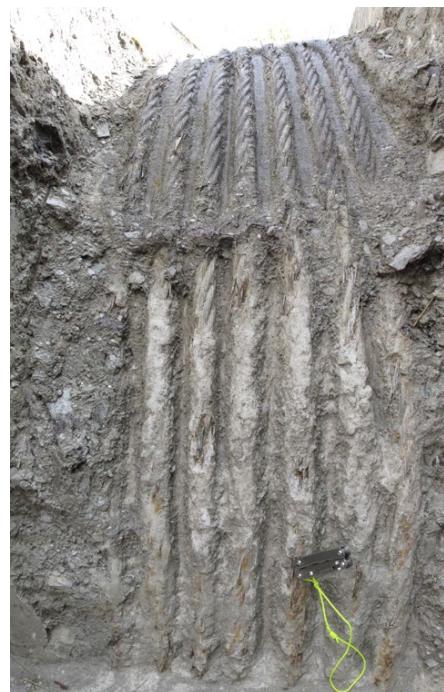
- The upstream (US) TL cables are embedded into a concrete slab approximately 700mm below the earlier excavation level.
- The US TL cables have broken wires throughout the previously buried area
- Approximately 1.5m of further excavation was undertaken on the TL DS cables. These cables also have broken wires, although fewer than the TL US anchorage

Figure 8. Excavation and cable damage on the TL US anchorage

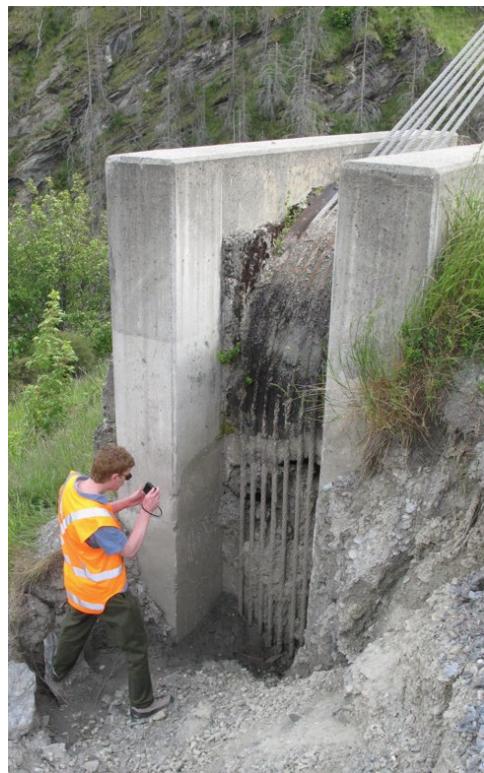
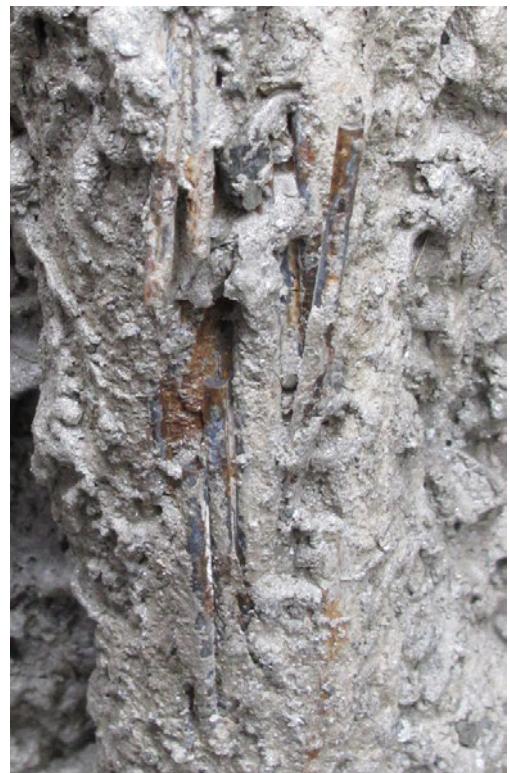
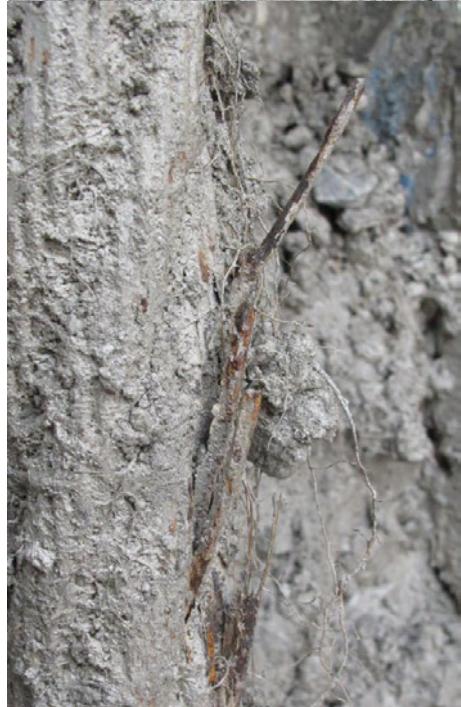
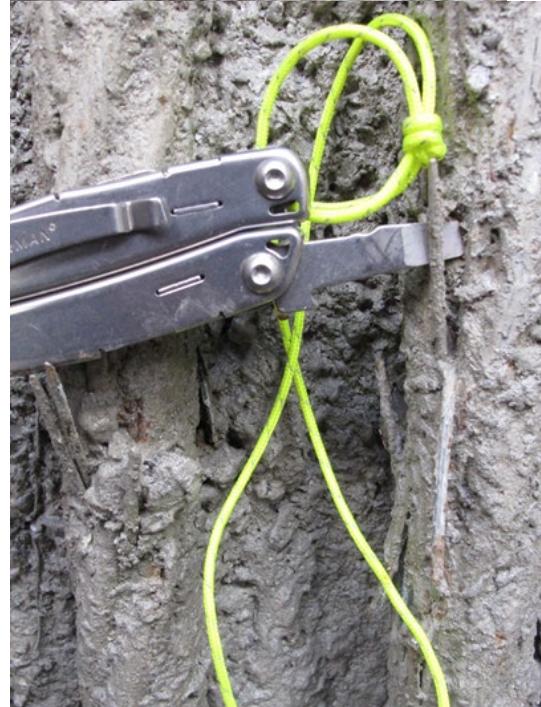
Figure 9. Cable damage on DS TL cables

The highest concentration of broken wires occurs where the cables pass over the roll over plate, but there are still a number of broken wires in the vertical section of the cables which has been buried below the roll over plate.

We consider that the most likely cause of the damage to the cables is Stress Corrosion Cracking. Stress has been increased where the cables are wrapped over the roll over plate.

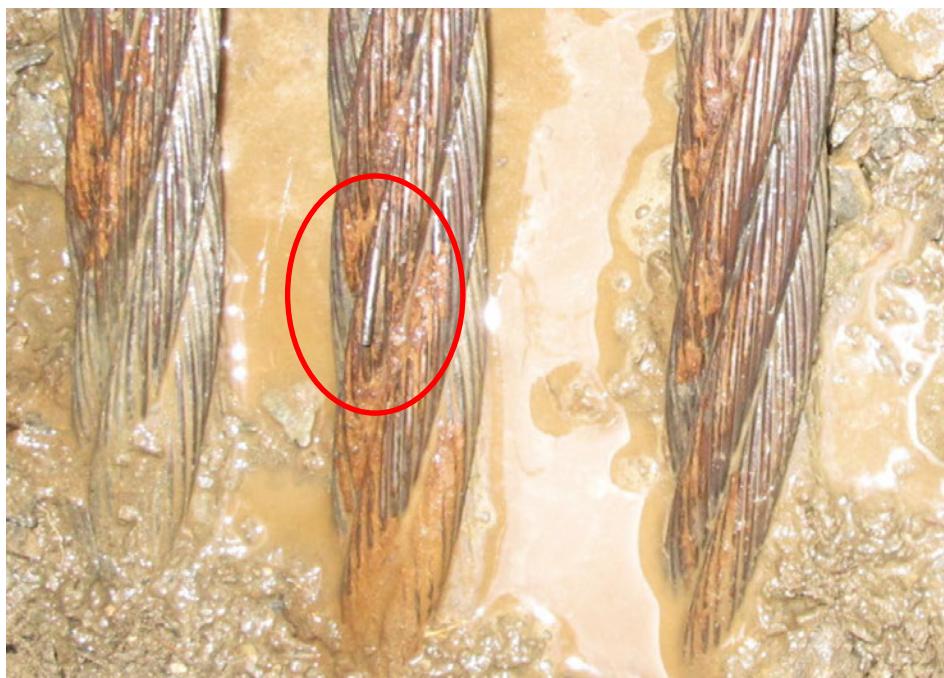
Only shallow excavations were undertaken on the TR of the bridge. These excavations revealed limited cracking of the individual wires, but we cannot rule out the possibility that greater damage exists in a location on the TR that was not inspected.

Figure 10. Cable on TR with rust and a single broken wire evident

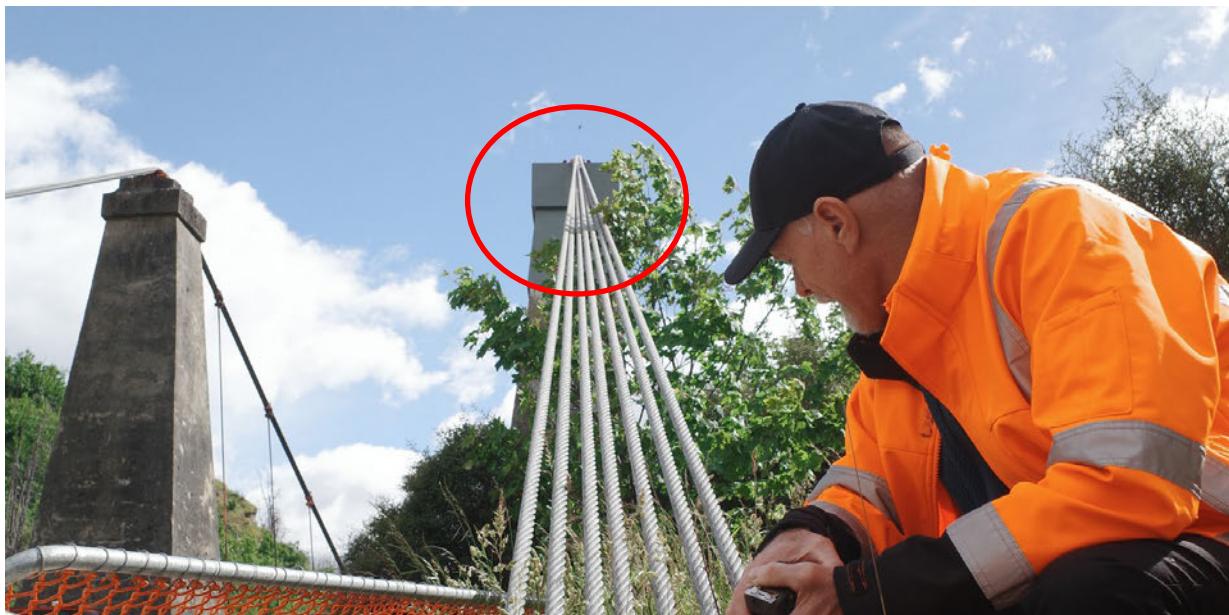
Sequential individual cable replacement is not possible as the cables are bundled together over the bearings on the towers and across the span. Consequently, only the upper two cables can be readily replaced as the other cables are directly below the upper two and are inaccessible. The cables along the span between the towers are also bundled together. This is shown in the figure below.

Figure 11. Bundling of the cables over the tower and span

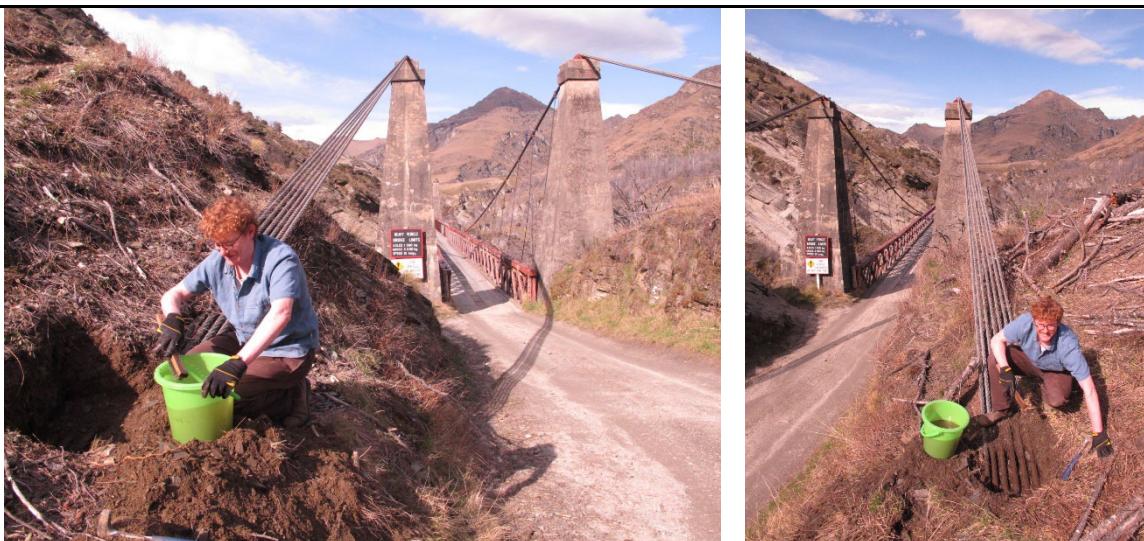
Shallow pits were excavated on the two TR cables where these disappeared into the ground. There is no cable roll over on the TR. On both the US (upstream) and DS, TR cables no significant corrosion or cable damage was detected.

Figure 3. Excavation and cable cleaning on the True Right, Upstream and Downstream sides

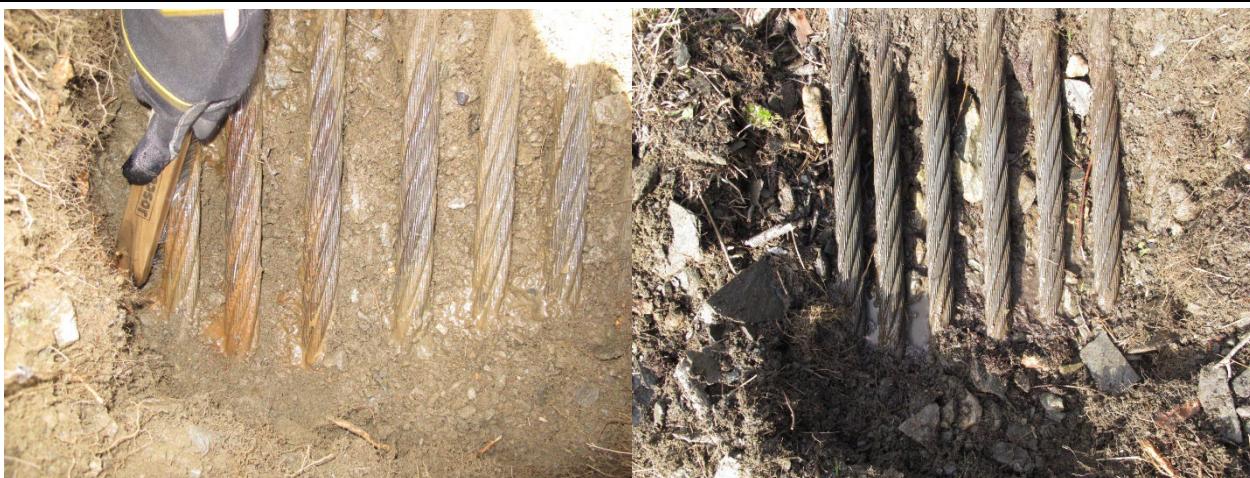
Figure 5. True Right, US cable- insignificant corrosion and no broken wires located

Figure 4. TR, downstream cables. No significant corrosion and no broken wires detected

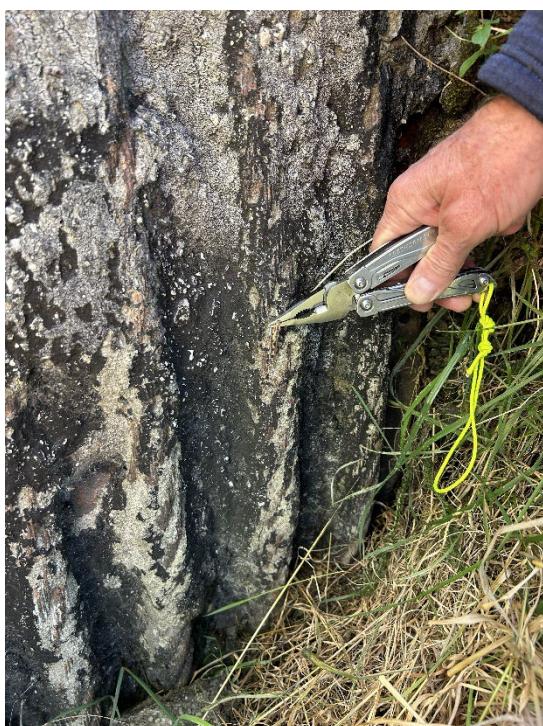
Figure 6 limited number of damaged wires on True Left downstream

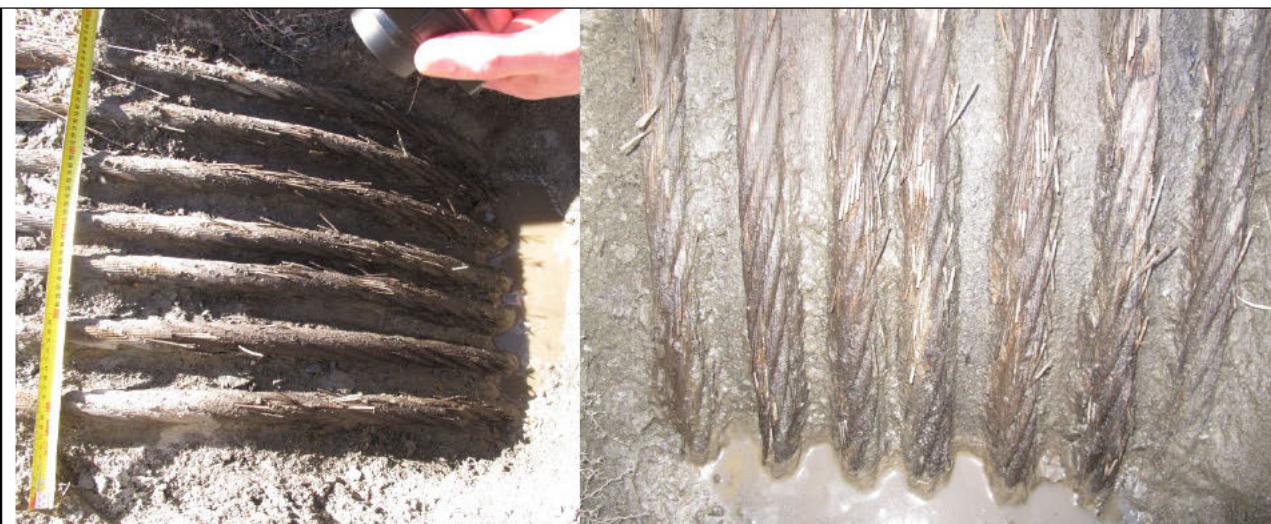
The existing excavation on the TL US and DS locations was extended. There is extensive damage to all seven cables over the steel roll over plate on the TL US side where the cables were previously buried.

Figure 7 Cable Damage at rollover. Behind the cables is a radiused steel plate. The water visible was used to wash the cables

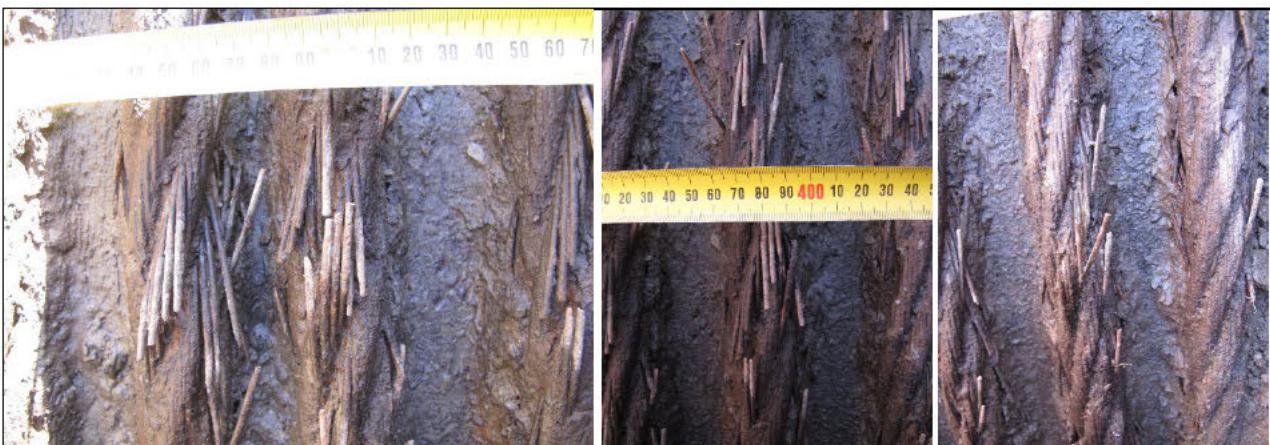
Figure 8. Cable damage on the True Left Upstream side

Significant damage was detected only on the True Left Upstream Anchorage. This is the only area where the cables are both buried and pass over a radius plate.

We recommend that the bridge is closed to traffic immediately and further investigation of the TL US cables are made. We recommend excavation down to expose the vertical section of the cables below the roll over plate. Downer have been requested to close the bridge immediately, and to mobilise a small digger to expose the cables on the TL by removing the soil.

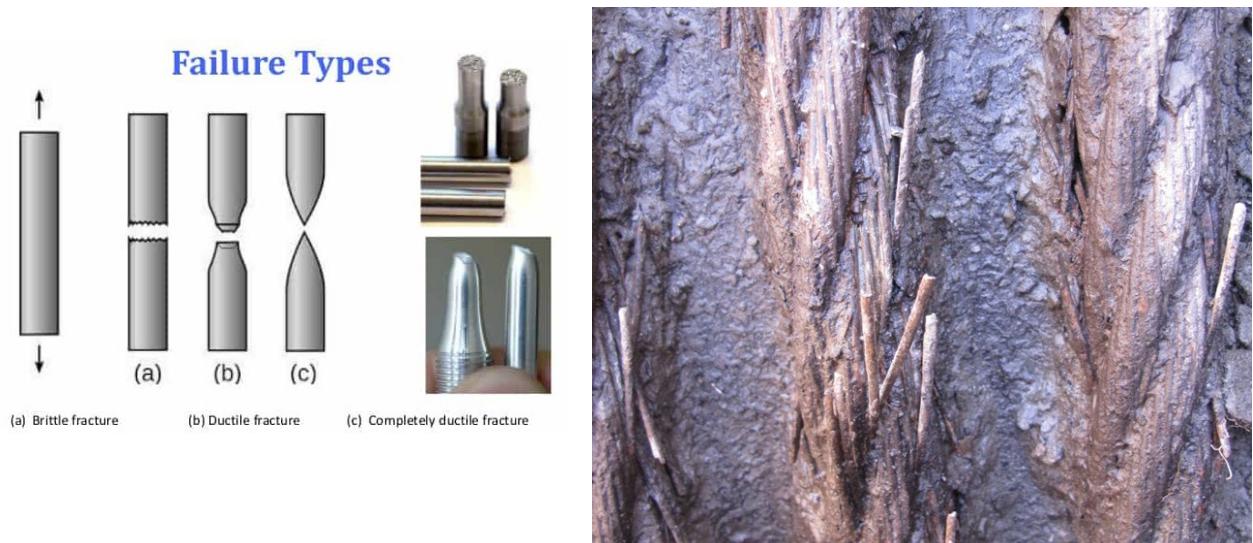
Over a length of approximately 700mm where the cables pass over the plate there are a significant number of broken wires. The breaks of the wires are brittle and not ductile as there was no evidence of yield or necking of the wires.

Figure 9. Example diagram and photo of brittle failure of the wires on the TL US location

Consequently, we believe that the most likely cause of the damage is stress corrosion cracking. But it is possible that some other, currently undefined, mechanism may have caused the damage.

We anticipate it may be possible to repair the damage by capturing the cables above and below the damaged area with a epoxy grouted steel jacket around each cable and connecting these over the broken area with a reinforced concrete block. This block would extend over the damaged area at the radius location. Further investigations required to confirm the practicality of this repair method.

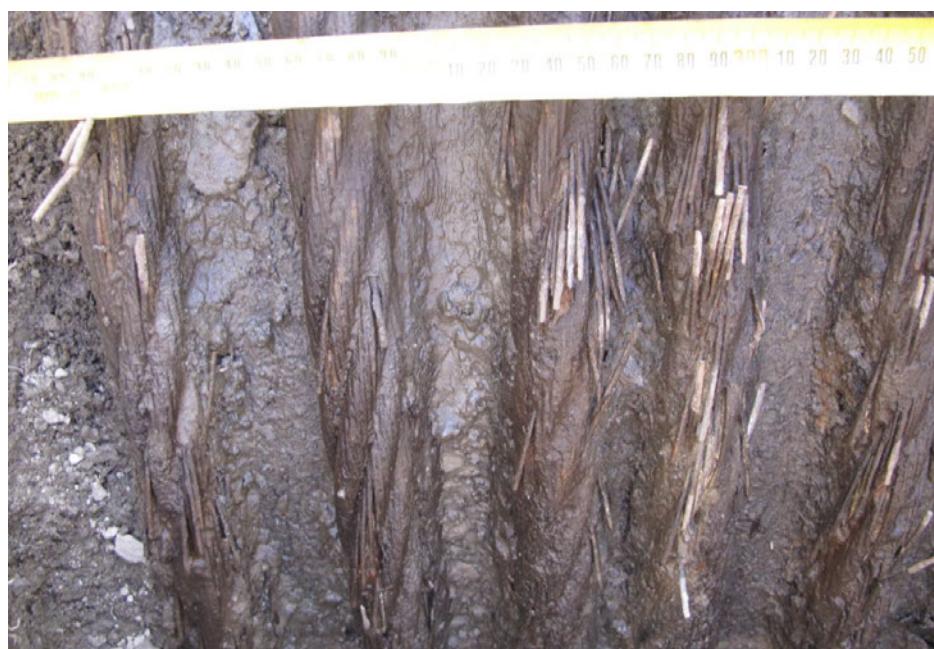
- The centre four cables are estimated to have between 50 and 60% section loss
- The four outer cables are estimated to have approximately 30% section loss

Figure 10. Damage to the two downstream most cables and the central three cables

This is a significant risk as the extent of the damaged cables cannot be accurately assessed and there may be a major reduction in the capacity of the cables at this location.

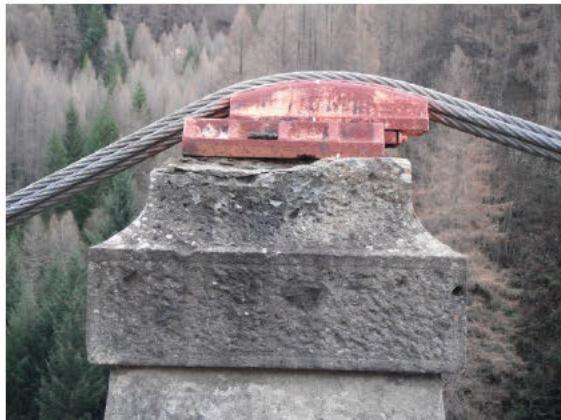
Figure 5. Displaced Stoney Roller bearings on both towers on the TL side 2013. The movement indicates possible relaxation of the TL cable anchorages and introduces eccentric loading onto the top of the tower.

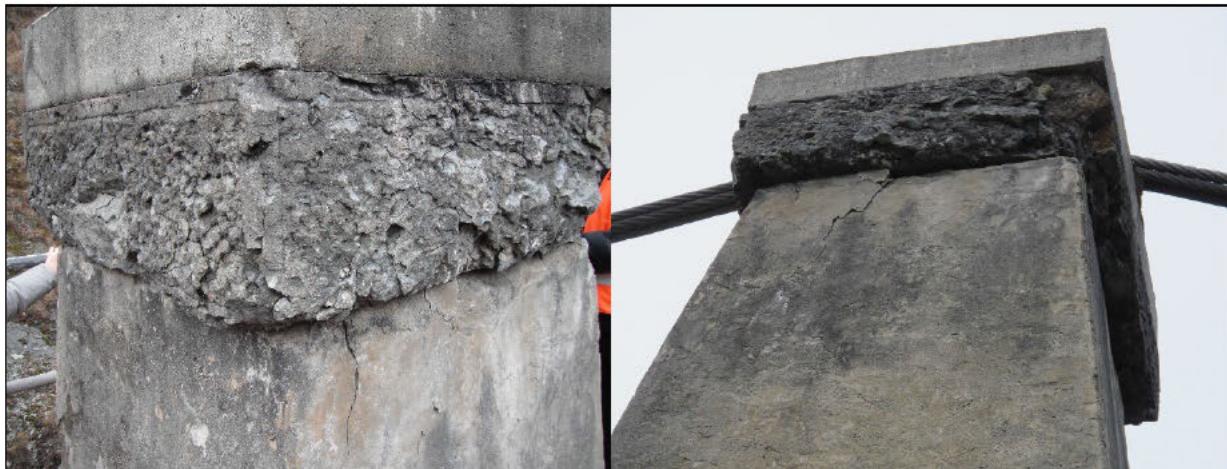
In 2013 significant deterioration of the TL upstream tower capping block, and the concrete tower immediately below the capping block, was detected. The upper part of the tower, including the capping block, was repaired with grouted steel jacket as shown below.

Figure 6. TL upstream tower capping block deterioration and cracking in the tower in 2013 prior to repair of the tower

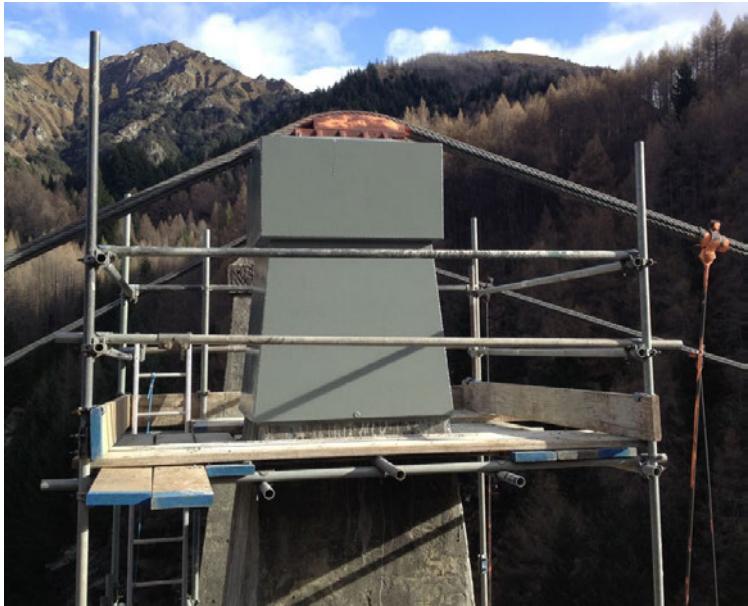
Figure 7 the steel jacket grouted around the capping block and top of the TL upstream tower where cracking of the top of the tower was occurring

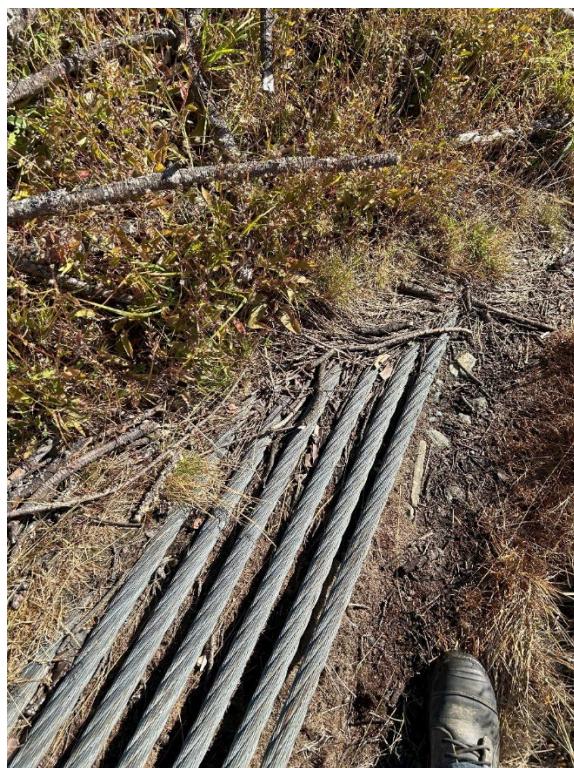
Figure 16. Cables on TR entering the ground with only galvanising of the cables for corrosion protection. No significant corrosion was observed in this location

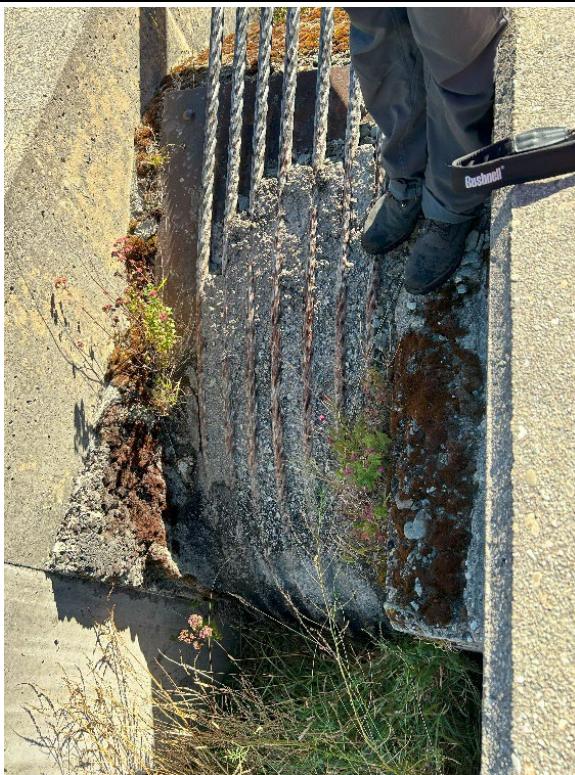
Figure 18. Saddle at TL downstream anchorages where the cables change direction into the anchorage shaft. Note rust on cables

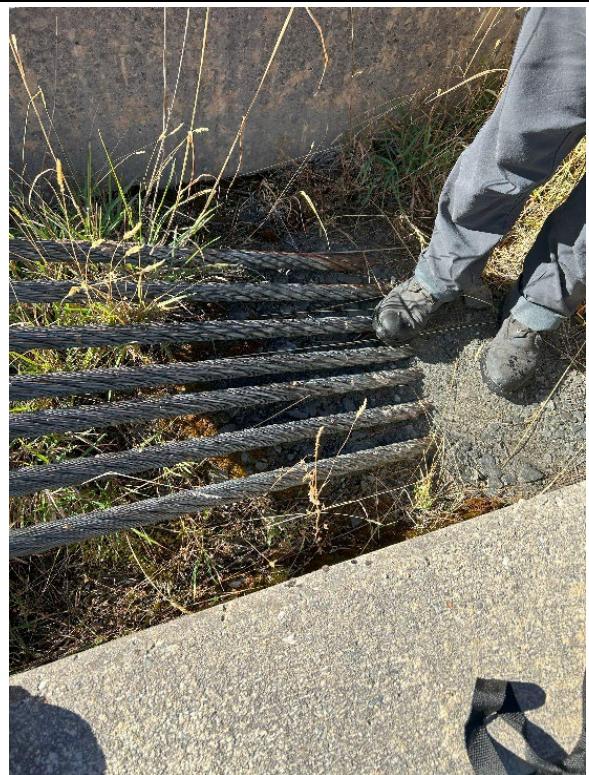
Figure 19. Cables entering anchorage concrete on the TL upstream anchorage. Also localised corrosion here

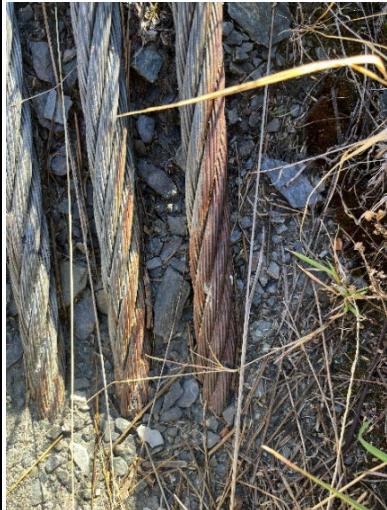
Figure 21. TR upstream surface corrosion of cables

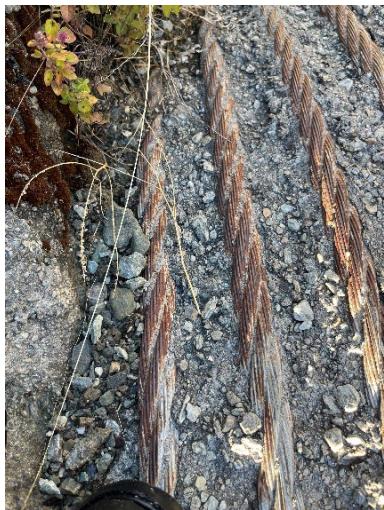
Figure 22. TR downstream surface corrosion of cables

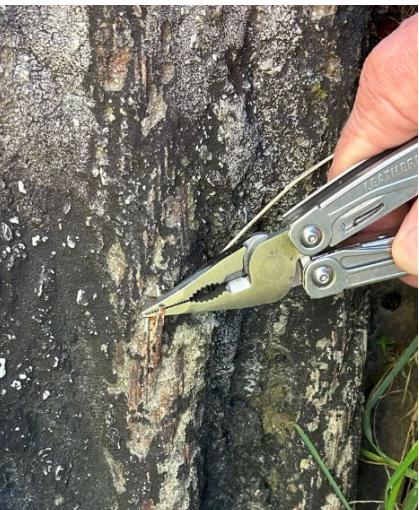
Figure 20. TR Downstream broken strands

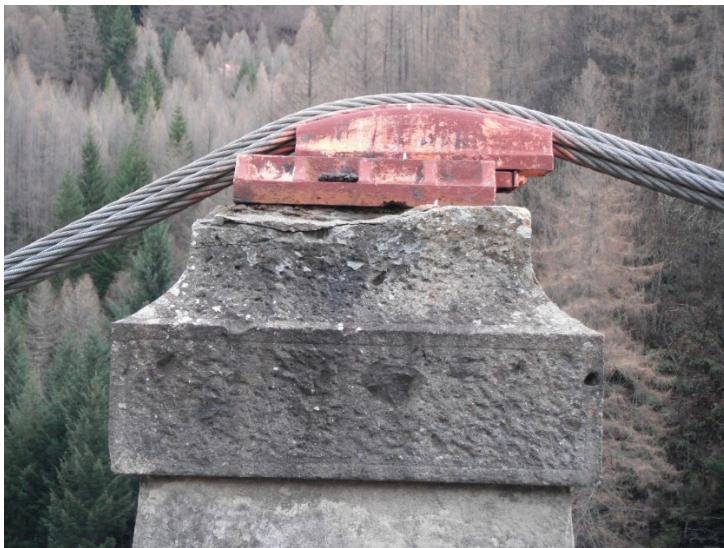
The towers currently appear to be in acceptable condition. There is some degradation of the basalt capping stone on the TL downstream tower and it is anticipated that a new steel jacket will be required around this within the next 10 years. This is shown in the photograph below.

Figure 23. Decay of the TL downstream tower basalt cap and displacement of the bearing

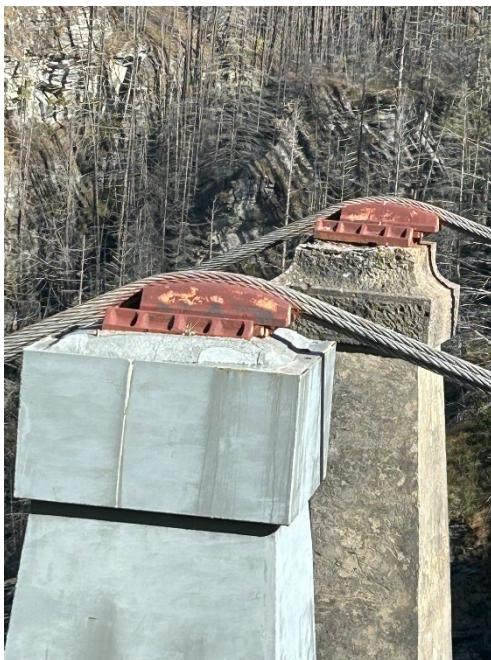
Figure 24. TL towers and displaced bearings. Decay of downstream TL basalt capping block visible. Steel jacket installed in 2013.

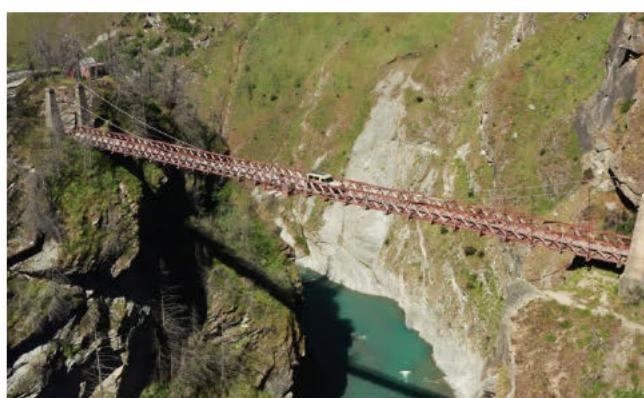
Figure 27. TR abutment and potentially unstable blocks on the bluff (looking upstream)

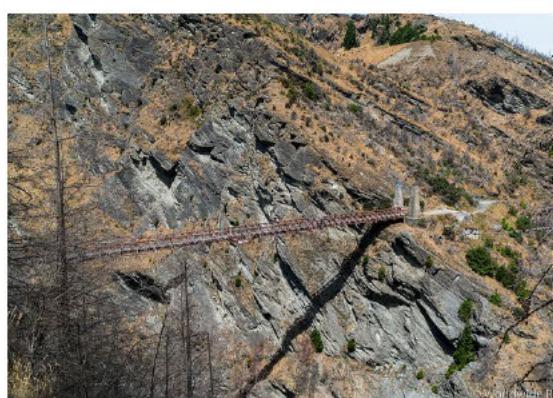
Figure 30. TL abutment and bluff with adverse schistosity (looking upstream)

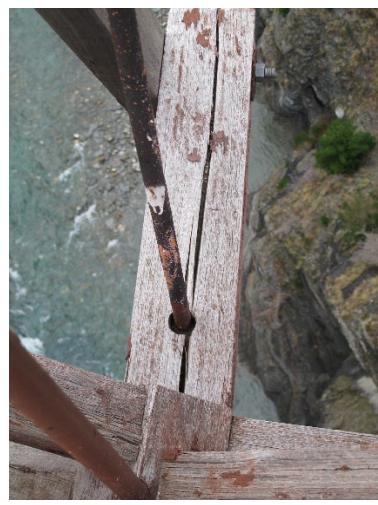
*Figure 32. hanger/transom connection
(split transom replaced after
this photograph was taken)*

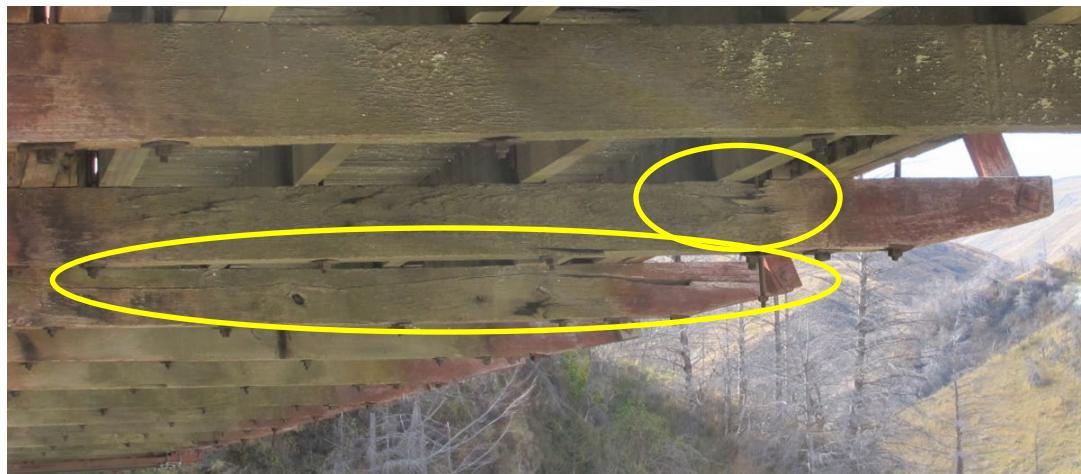
Figure 33. typical damaged transoms (these have been replaced since this photo)

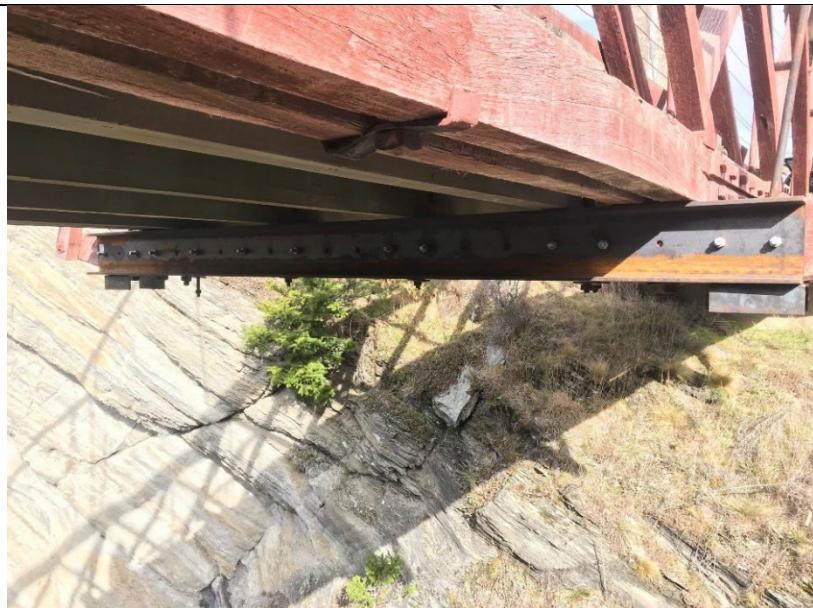
Figure 34. Transoms supplemented with steel channels

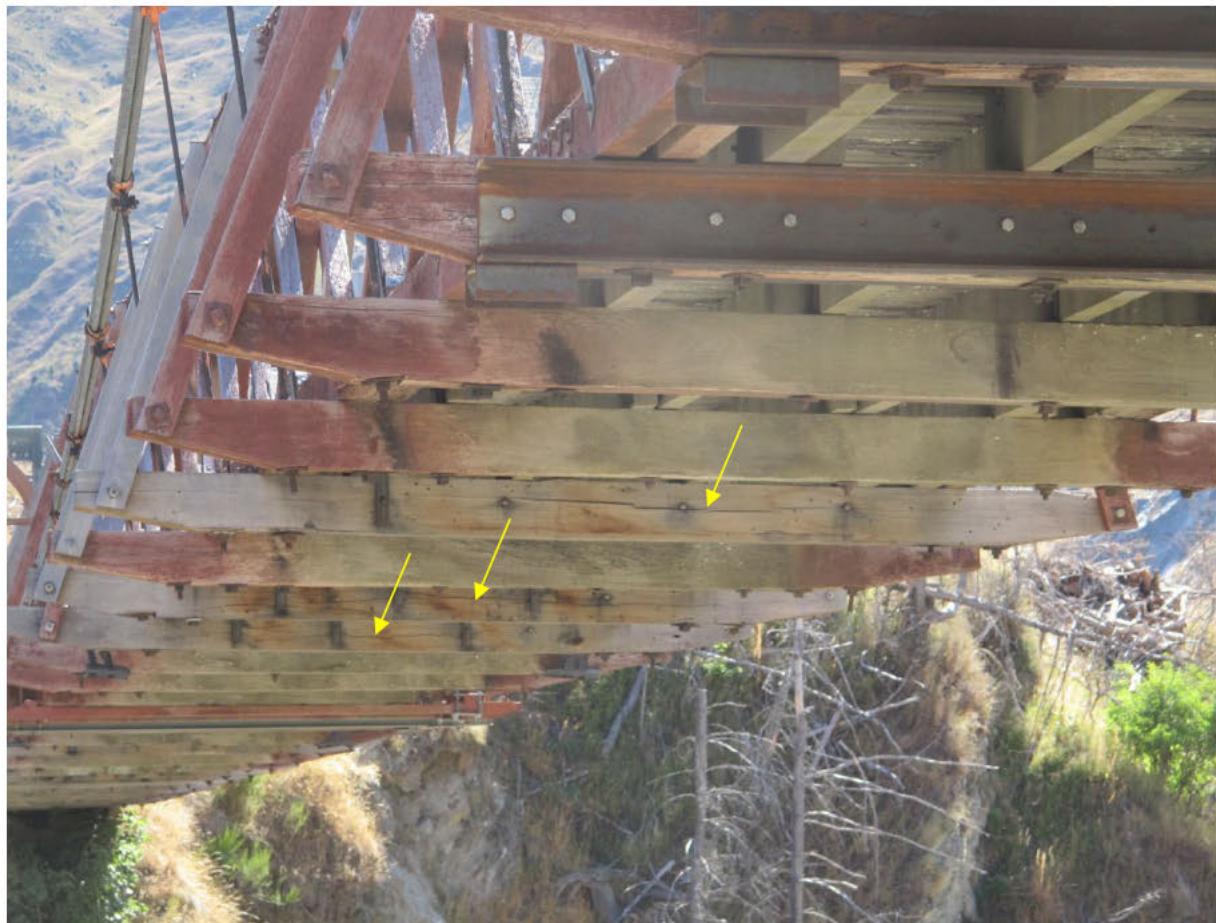
Figure 35. Three timber transoms, replaced within the last four years, identified by the new steel angles to the stringer beams above, which have longitudinal cracking, probably due to drying shrinkage since placement

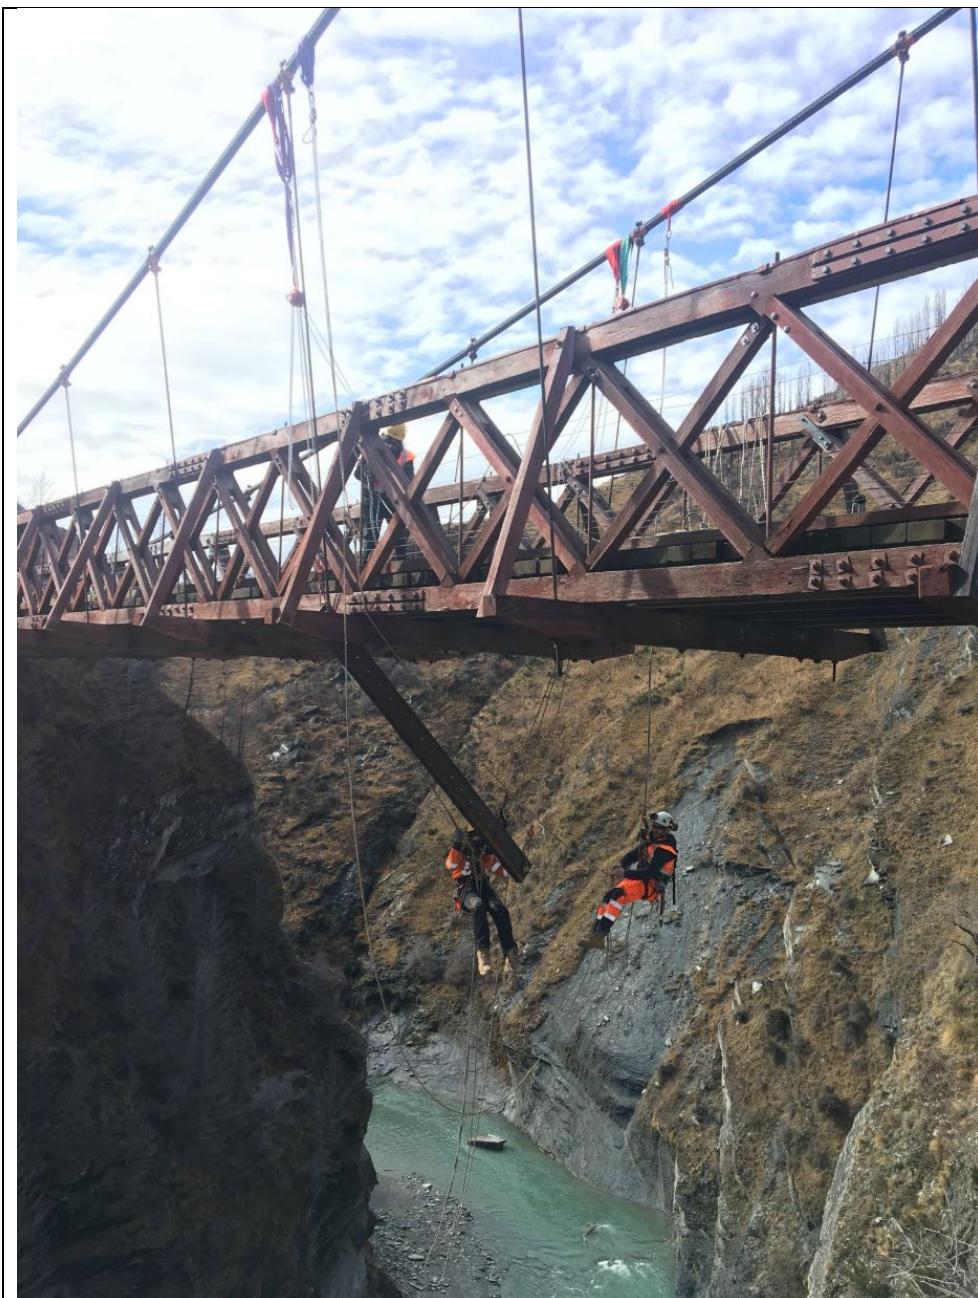
Figure 36. bolting channel section to strengthen a transom in 2019

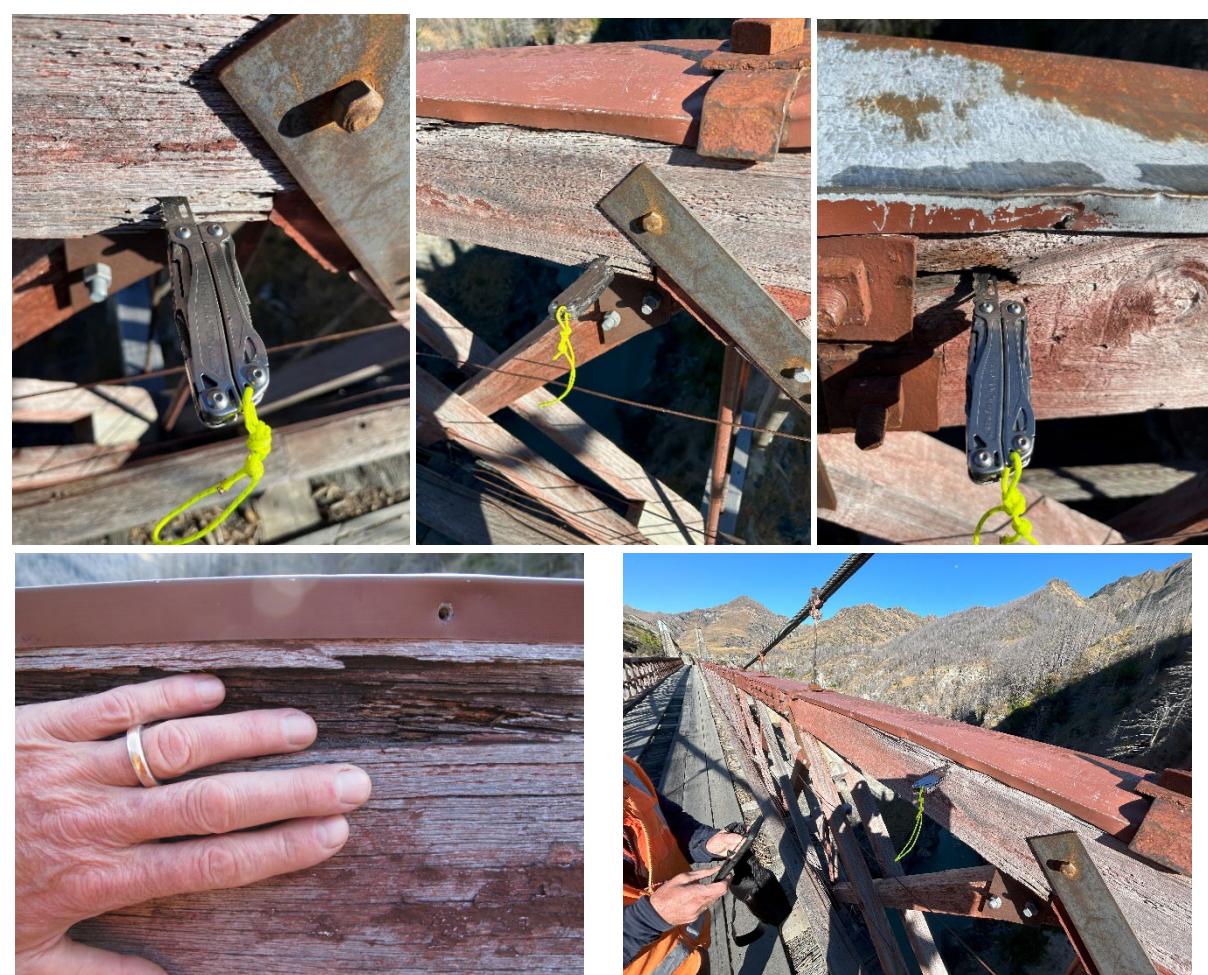
Figure 37. decay in the top chord of the trusses and steel plates to locate the truss cross bracing
