Project/File: 310206053

Date: 17 December 2025

Reference: Skippers Bridge Cables**Executive Summary**

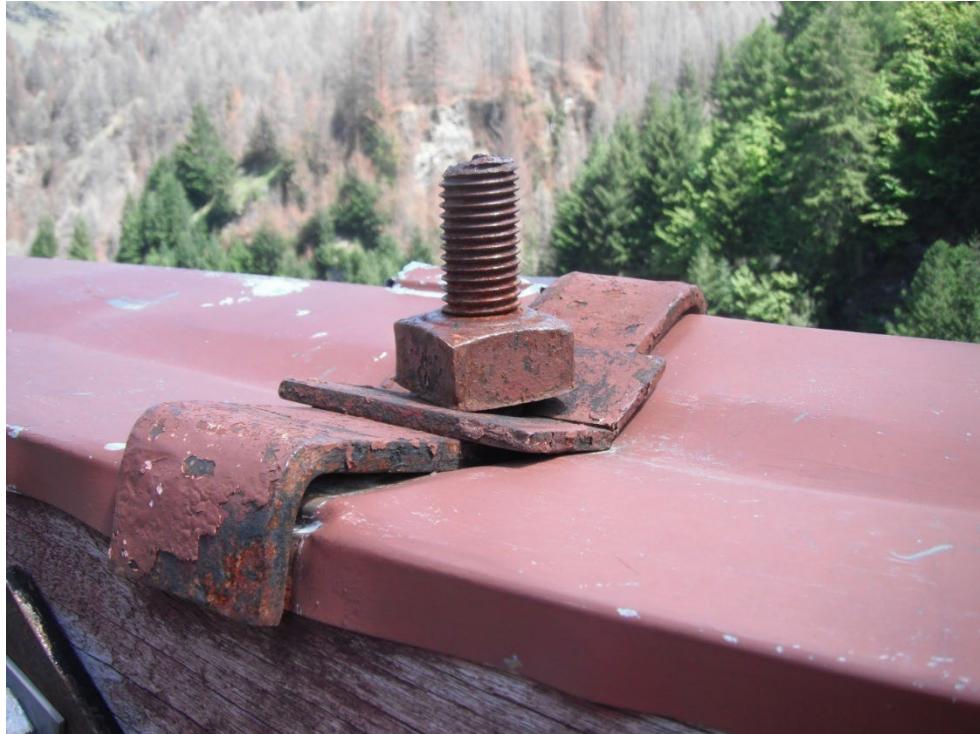
Figure 38. local buckling in truss flashing which may indicate decay of the timber below

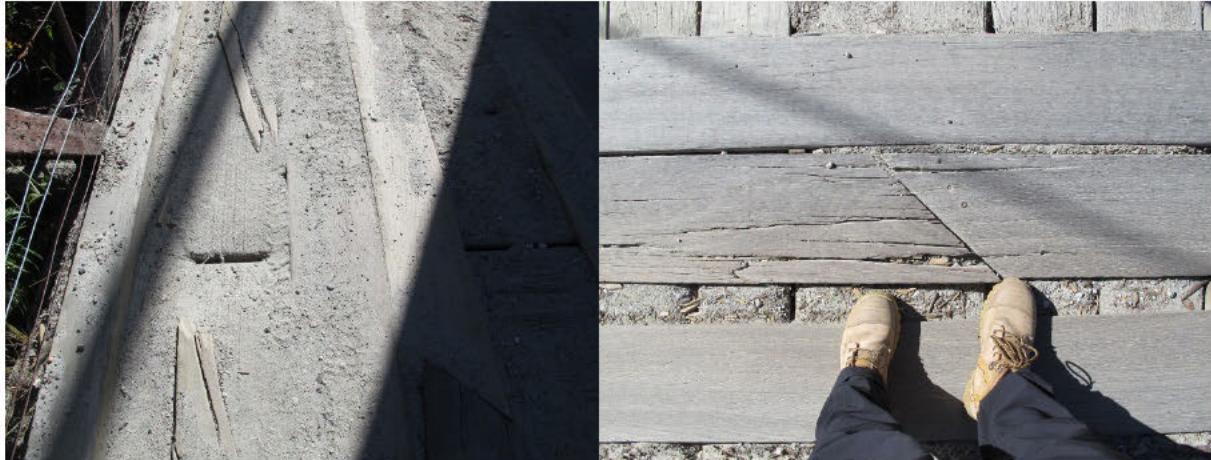
Figure 40. Degraded and split running planks on the TR end of the bridge

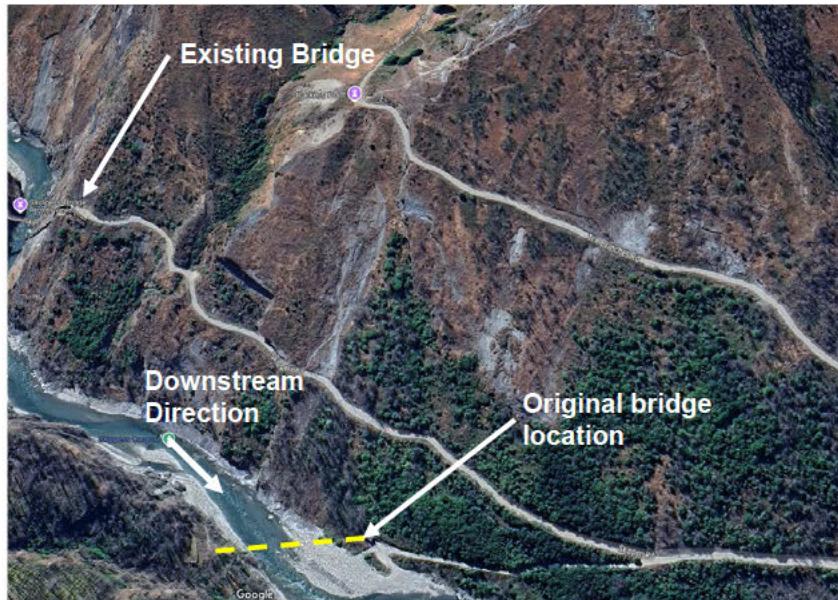
Figure 41. Adverse orientation of the schist planes on the TL side and the nominal first bridge location
