## **Preliminary Environmental Site Investigation at Stonehenge Road, Wanaka**

**Prepared for:** Northlake Investments  
Limited c/- David Osborne

**Date:** 30/01/2026

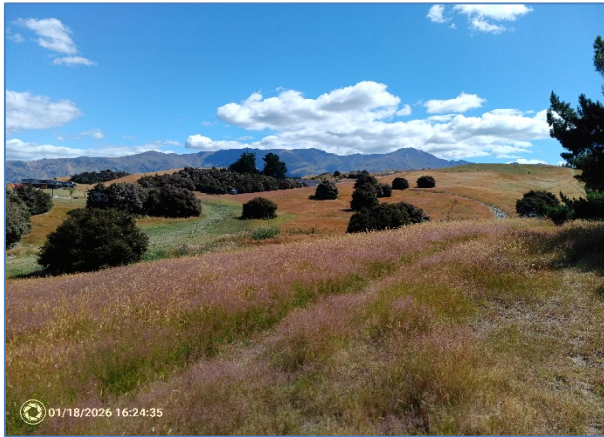
Photo 1: Northern portion of the site, viewed from the north facing south west.

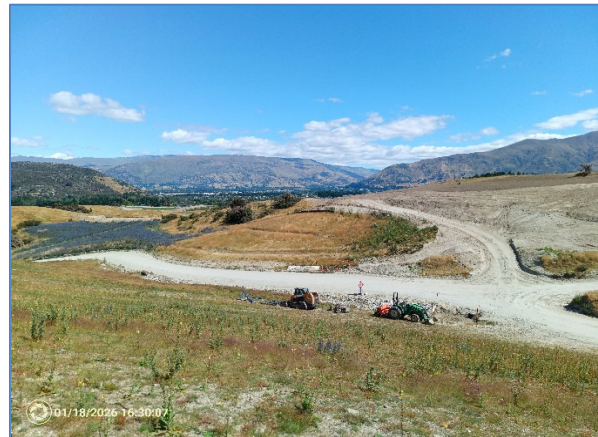
Photo 2: Western-central portion of the site, viewed from the north west facing south east.

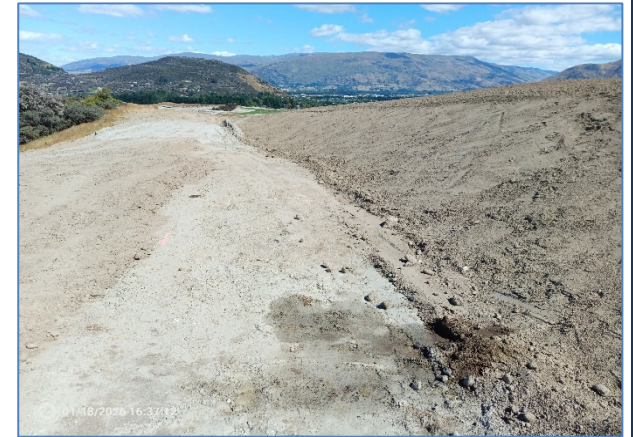
| Visible signs of contamination | A small hydrocarbon stain was observed at the site surface on one of the new tracks being installed in the south western portion of the site. |

Photo 3: South western portion of the site, showing a small fuel spill.

If any material that shows signs of potential contamination (visual or olfactory indicators such as chemical odours or abnormal stains) is unearthed in the future, work should stop immediately and a suitably qualified environmental practitioner should be engaged to assess the risk to human health prior to recommencing earthworks.

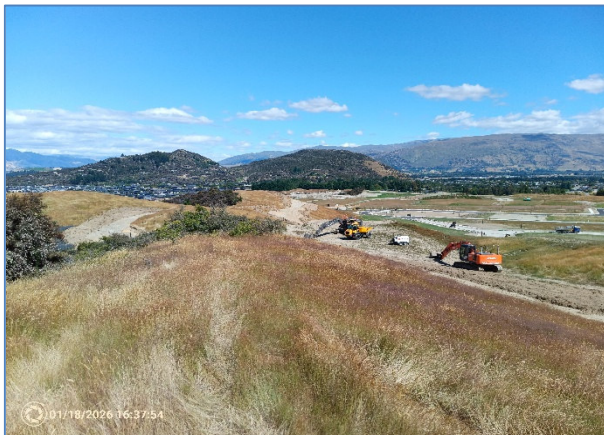
Photo 4: Southern portion of the site, viewed from the north west facing south east.

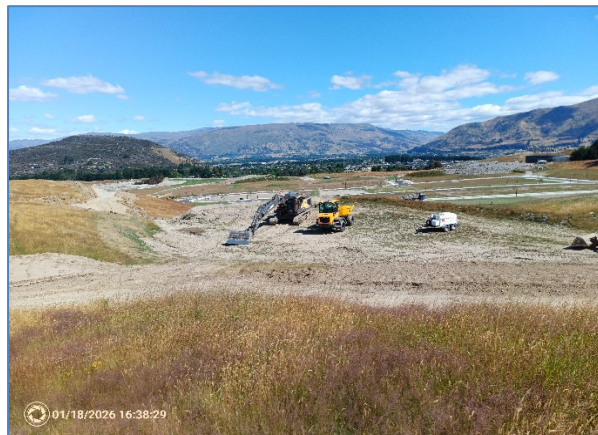
Photo 5: Southern portion of the site, viewed from the north west facing south east.

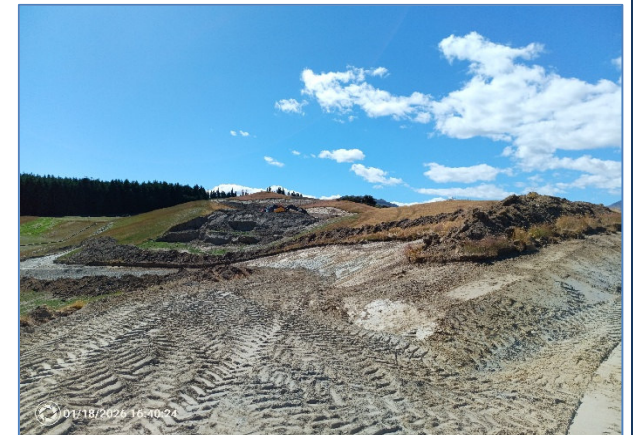
Photo 6: South western portion of the site, viewed from the south facing north west.

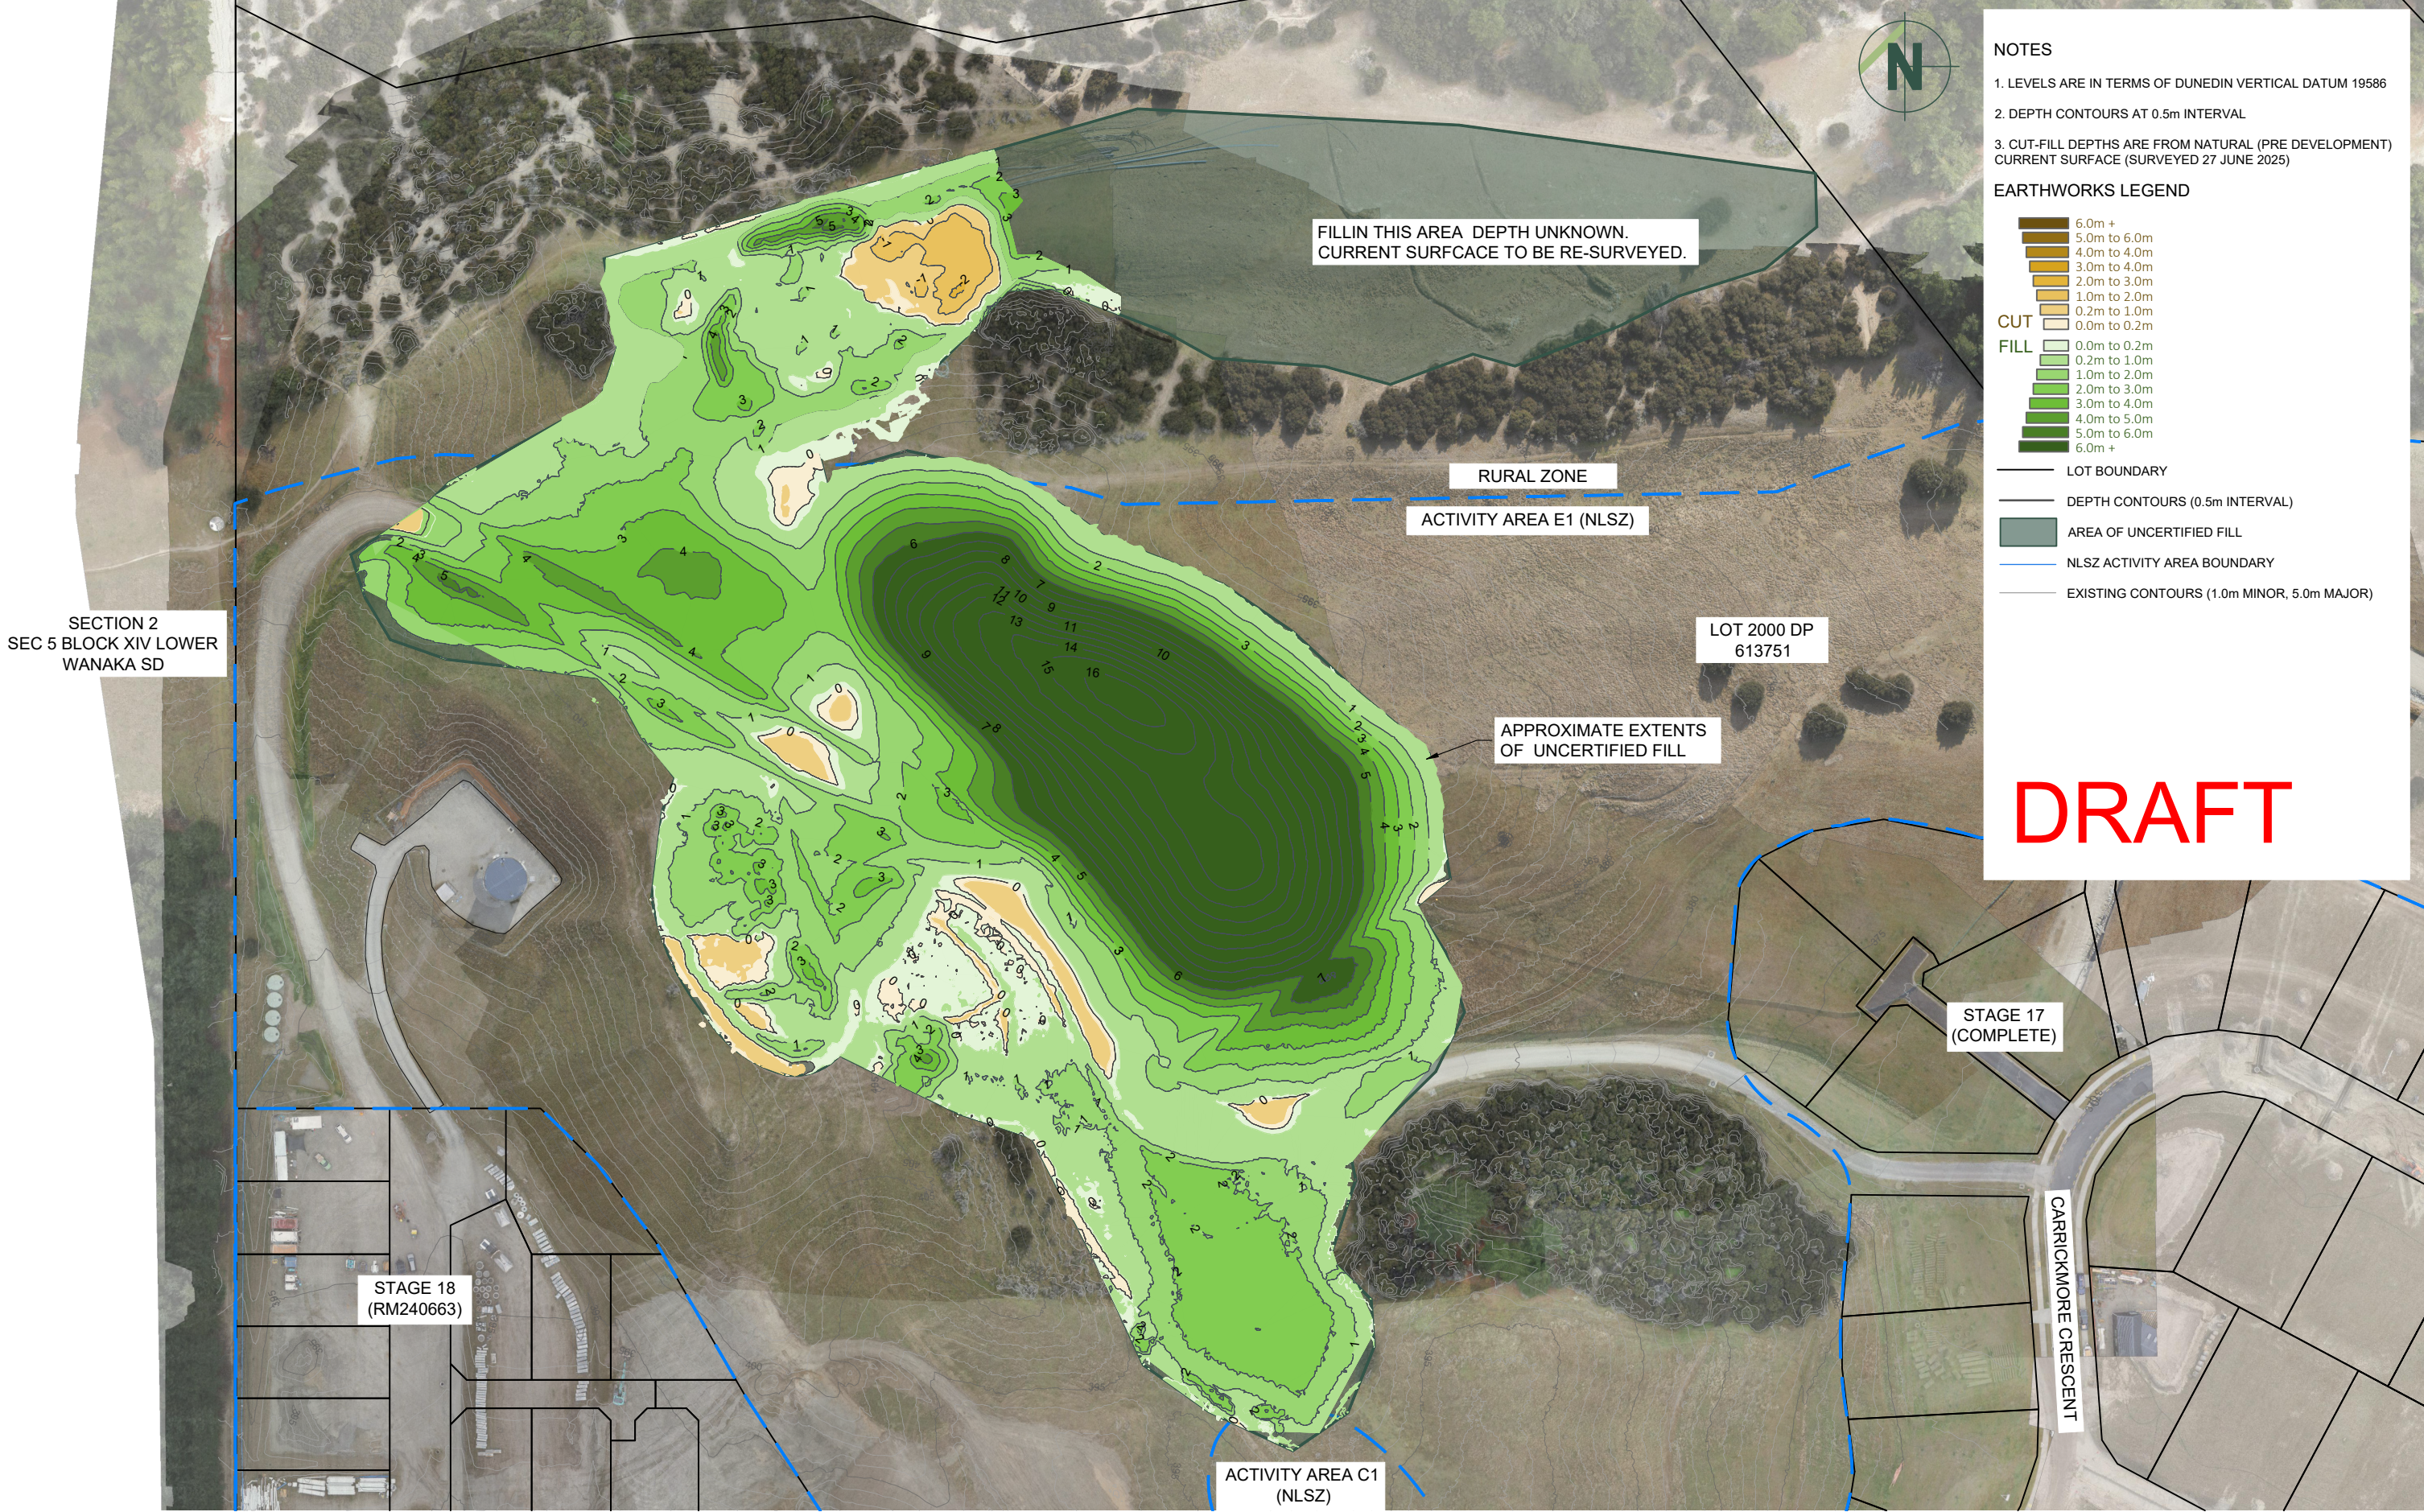
### Uncertified Fill Locations

- Mr Osborne indicated that a significant proportion of the site contains uncertified fill (topsoil), which was placed on the site during the development of the neighbouring residential areas, towards the south east, which required the topsoil to be stripped and placed elsewhere. Mr Osborne also indicated that some concrete, hardfill (aggregate) and tree stumps were included in the uncertified fill. A plan showing the locations of the uncertified fill is provided in Appendix 3;
- Mr Osborne is not aware of any potential sources of contamination within the site boundaries.

- This category is represented by the placement of uncertified fill at the site. Given the source location of the material, the risks to human health are considered to be very low.
