ROYDEN THOMSON, GEOLOGIST

13 February '06

**HENLEY DOWNS: GI**

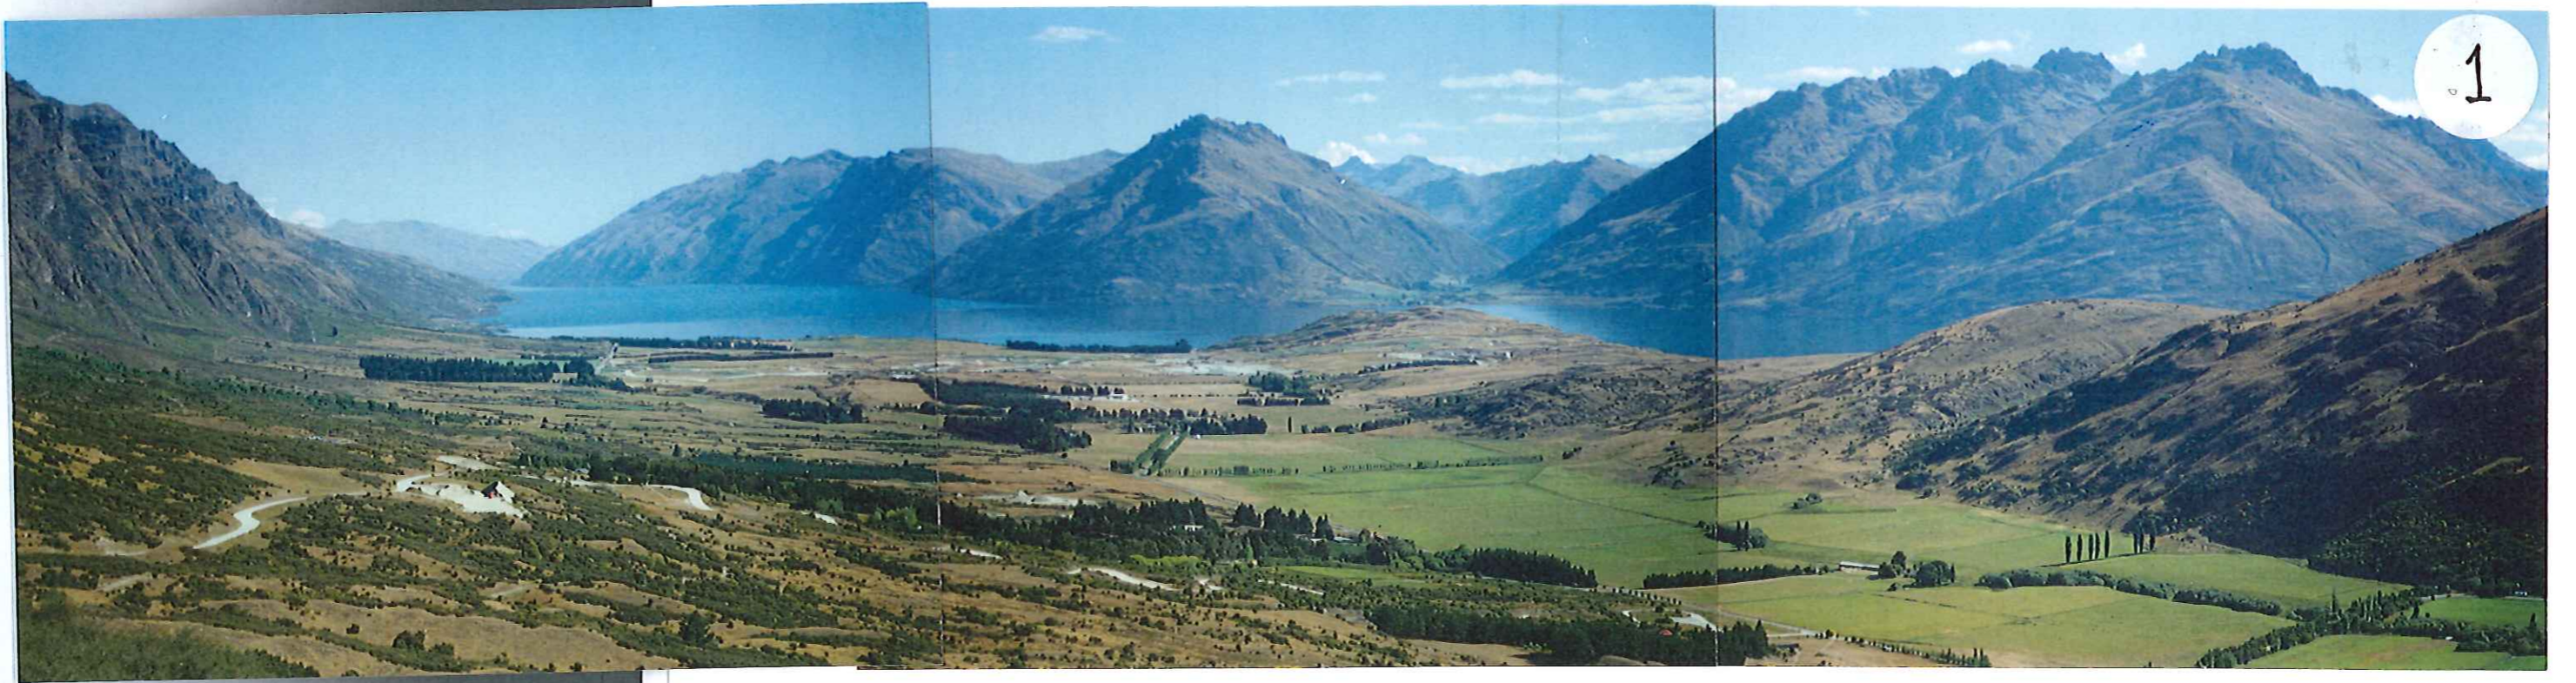
- No potential to impact on the site from the east as The Remarkables are too remote (Photos 1, 3) and the schist is competent.
- The terrain to the west is too benign to present rockfall hazards to proposed development areas.

| Photo Nbr. | Description |
|---|--|
| 1 | General view of property from the north-east.<br>Proposed development areas are in the central valley at photo centre. Stream catchments are all to the east, draining off The Remarkables, at left. |

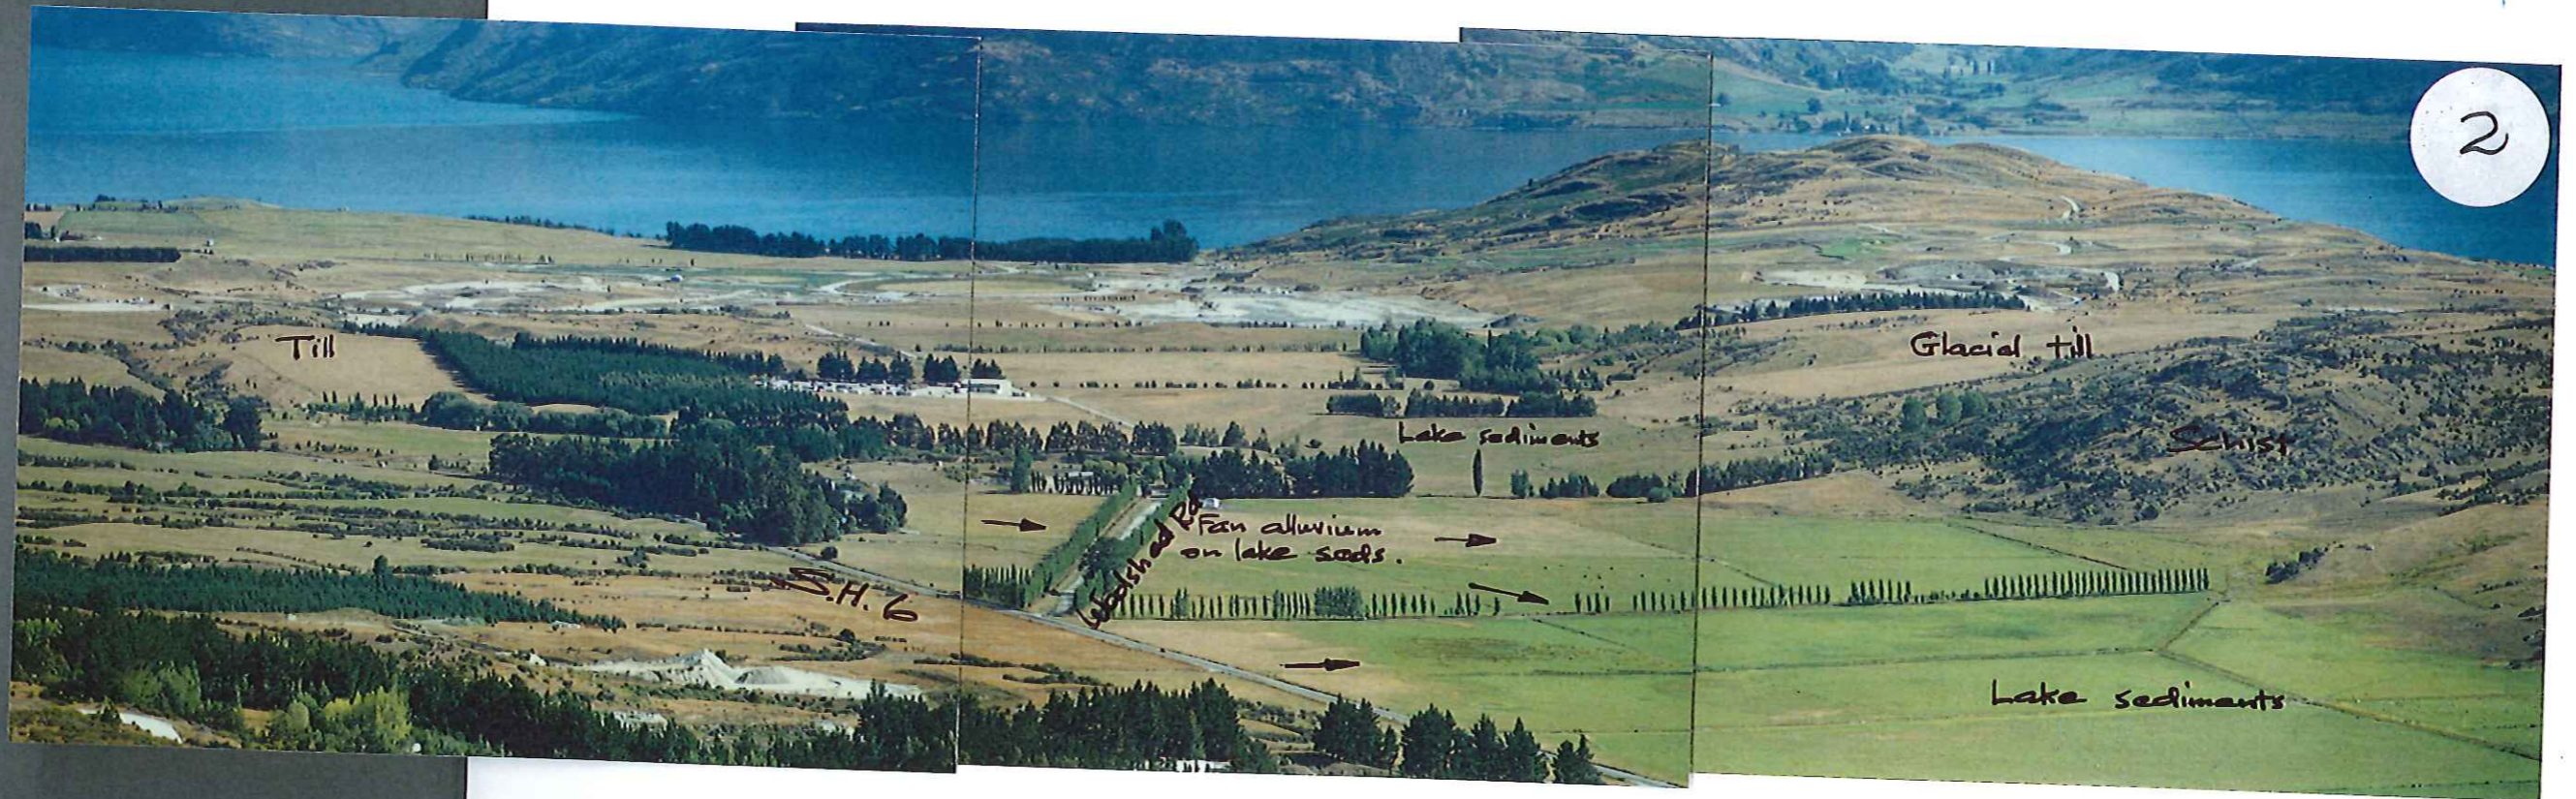
| Photo Nbr. | Description |
|---|--|
| 2 | Annotated photo of the valley floor through the interest area. Lower relief areas are mantled by fine lake sediments or relatively young fans. |
