GeoSolve Ref: 180668
31 January 2019

Coneburn Development Site, Kingston Road, Queenstown Preliminary Geotechnical Report

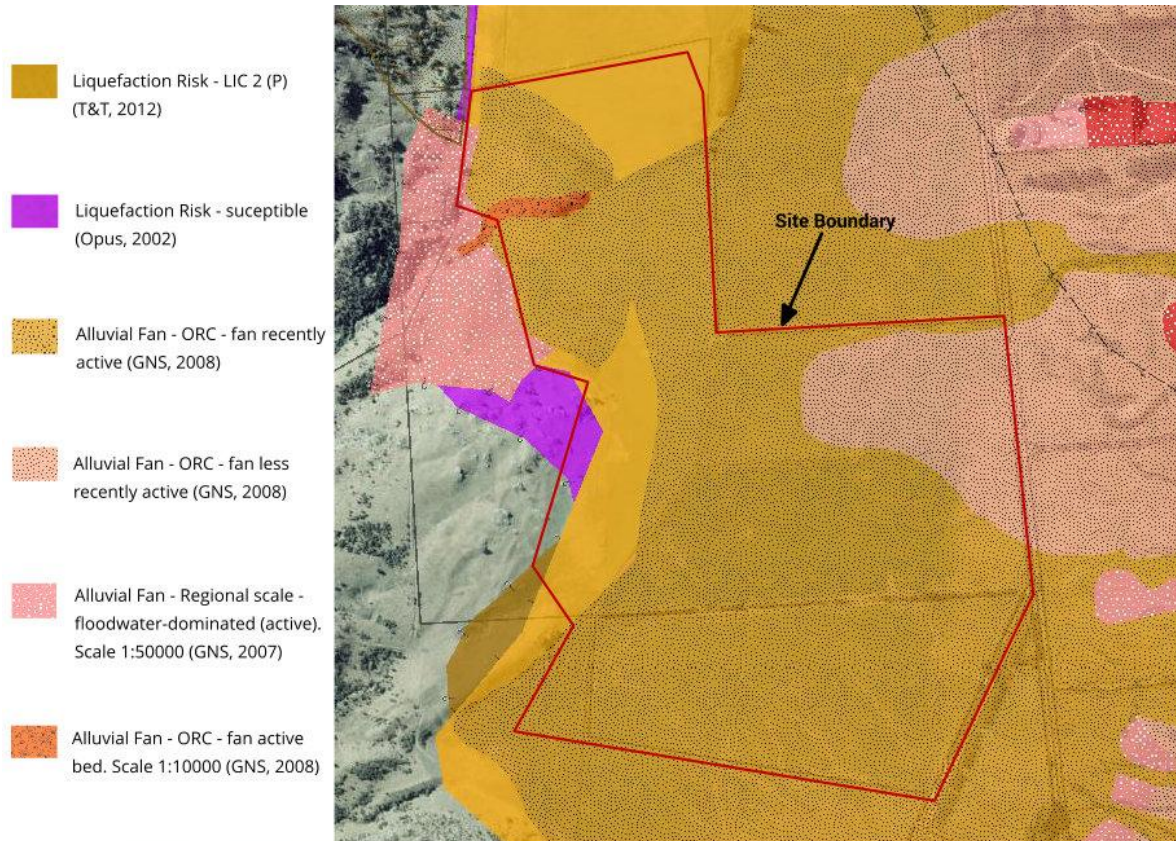
Queenstown Lakes District Council (QLDC) hazard mapping indicates the subject site to be affected by an alluvial fan and liquefaction hazard risk (Figure 1.1).

The site is located within an area with soils identified as being 'susceptible' to liquefaction and 'Liquefaction Risk: possibly moderate (LIC 2)'. The liquefaction risk zones cover the extent of the site, apart from a small area by the western site boundary.

The site is also located within an area affected by alluvial fan hazards 'fan recently active', 'fan less recently active' and 'floodwater-dominated (active)'. The hazard zones encroach into the north western, southern and eastern areas of the site, as shown on Figure 1.1. The hazards zones were determined by Geological and Nuclear Sciences (GNS) in 2007 and 2008 by regional scale 1:10,000 and 1:50,000 mapping.

Figure 1.1: QLDC liquefaction hazard and alluvial fan hazard mapping extents relative to the site boundary

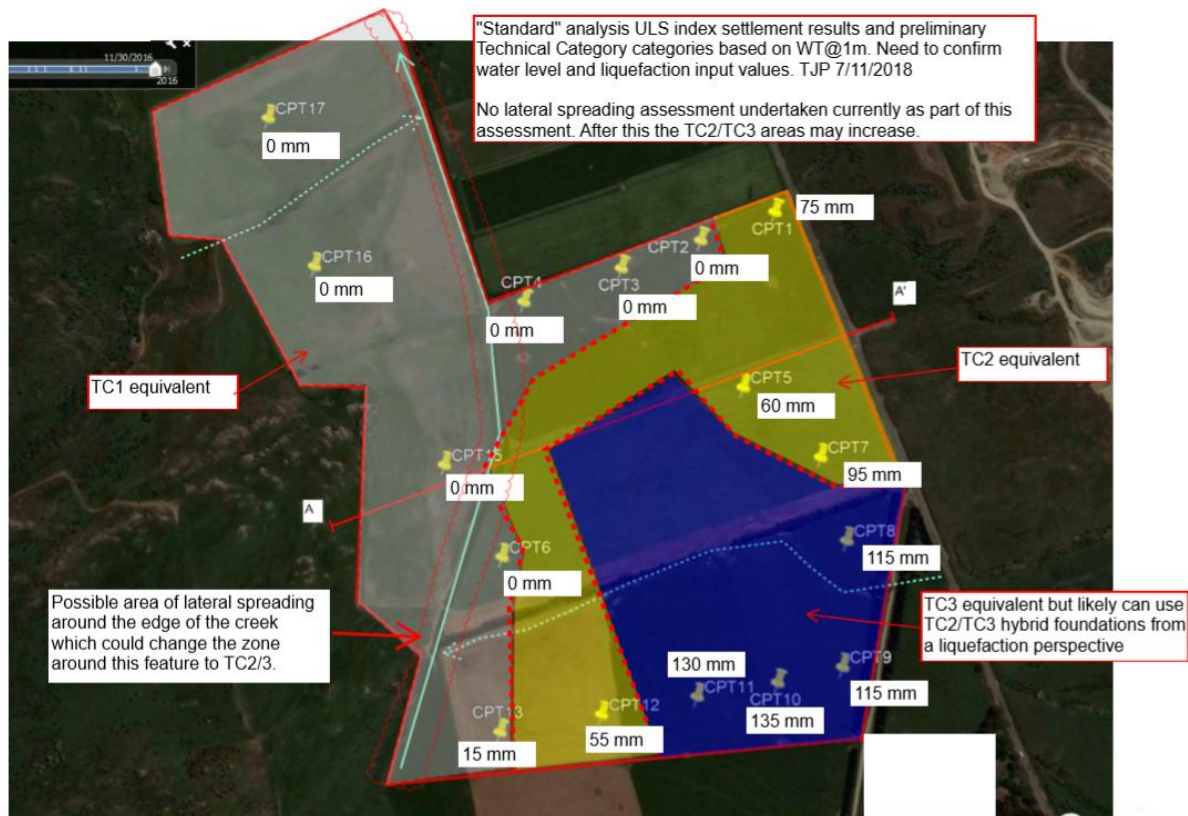
Figure 1.2: Showing the preliminary ULS index settlement results.

Figure 1.2 provides a summary of the standard MBIE liquefaction analysis procedure for each CPT test. Overall there is a clear trend of worsening risk of liquefaction induced ground deformation towards the south and east, with surface settlements of up to 135 mm shown in this area under ULS seismic loading conditions. It should be noted that a worst-case groundwater level of 1.0 m was used for the preliminary liquefaction assessment, as this was observed in many of the test pits and some of the CPT's.

As discussed in Section 4, groundwater is expected to be perched at shallow depths, with the regional groundwater being at 15-20m+ depth. The liquefaction analysis is therefore considered to be conservative. A deeper groundwater level will improve the vertical ground settlements shown in Fig 1.2 above.

The results of the Scala investigation indicate weak surficial soils are present within the outlined TC1 and TC2 areas (Figure 1.2) and a deeper embedment depth of the timber pole foundation system is likely to be required for an MBIE Type 1 Surface Structure.

To refine the liquefaction analysis additional investigations, including the installation and monitoring of piezometers, would be required to model the groundwater regime with more accuracy. In the absence of such data, conservative assumptions have been applied and it is possible that the extent of liquefaction prone land may be reduced when assessed with more accuracy. Similarly, this analysis has not accounted for the prospect of modifications resulting from civil works that may be targeted to reduced liquefaction risk.

- Investigations (Test pit, Borehole, DPH or similar) to confirm the ground water conditions more accurately in key zones, foundation and pavement issues;
- Further CPT testing around the identified boundaries shown on Figure 1.2 to better define them;
- A lateral spreading assessment around the creek;
- Alluvial fan and rock roll assessments;
- Additionally, if desired, it is possible to adjust the standard MBIE procedure with specialist engineering assessment. This type of assessment has recently been

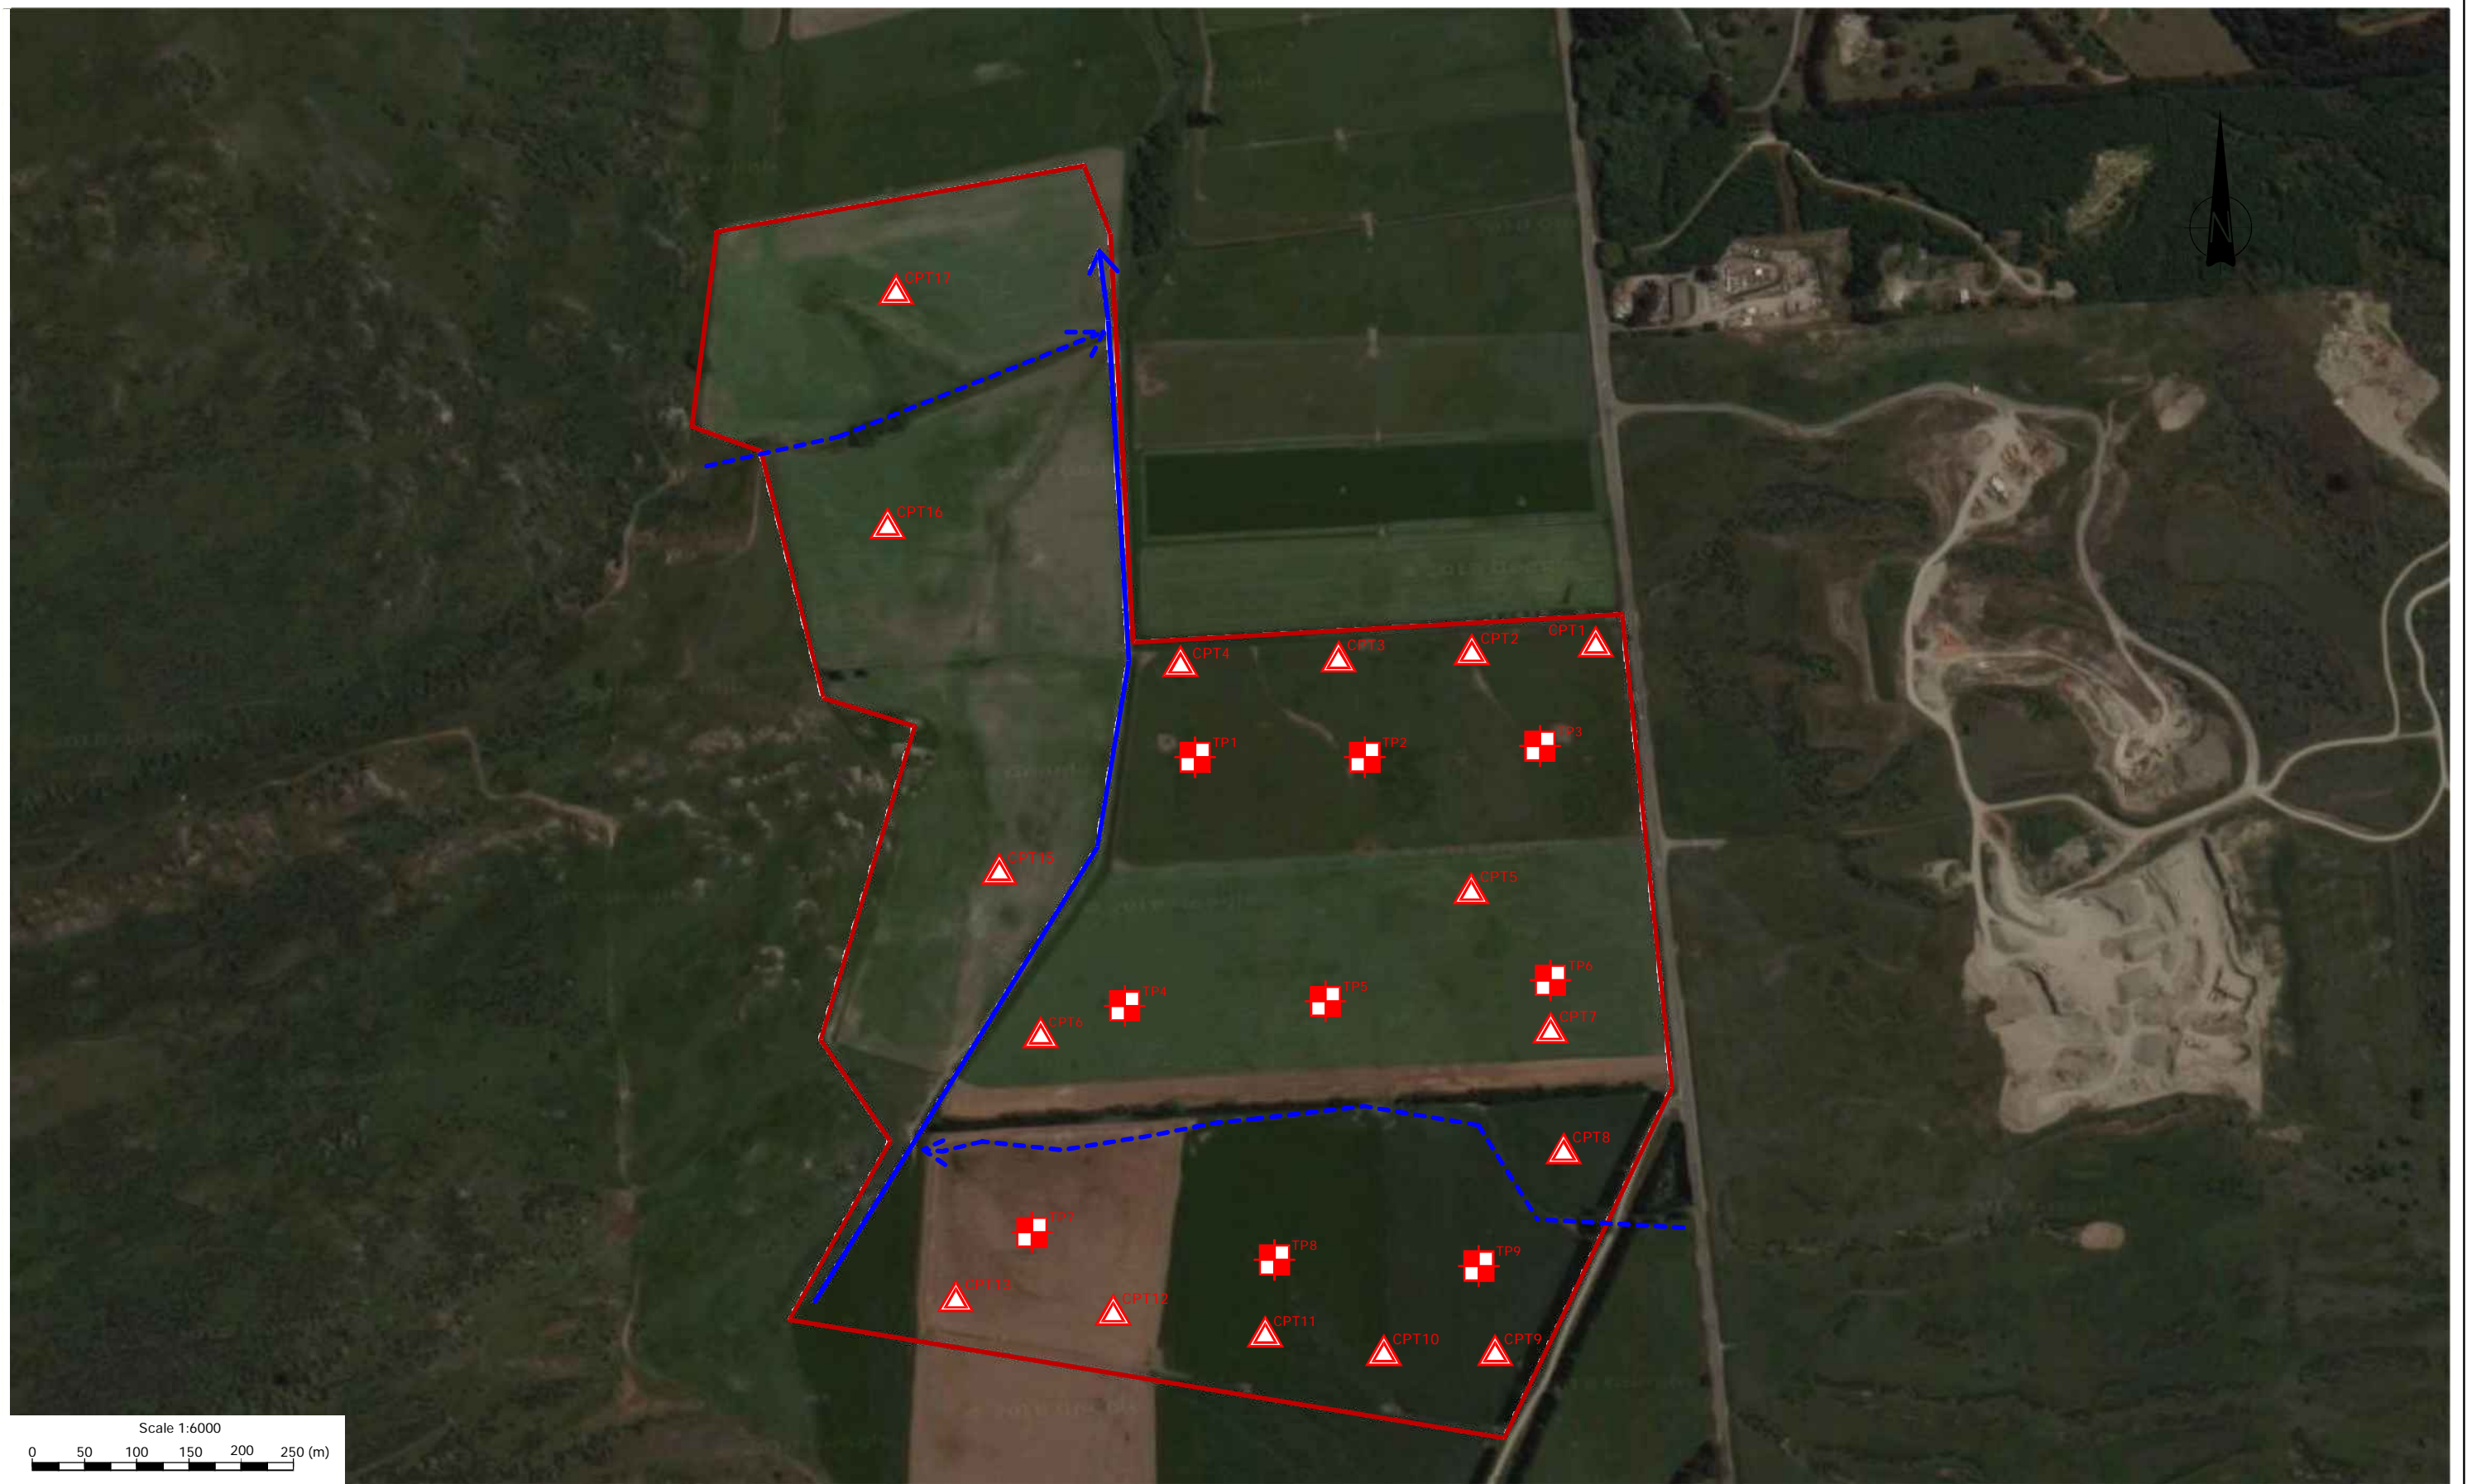
FIG No:
 FIGURE 1

Highlander Trust Ltd
 Special Housing Area Approval
 Coneburn Valley SHA
 Site Investigation Plan

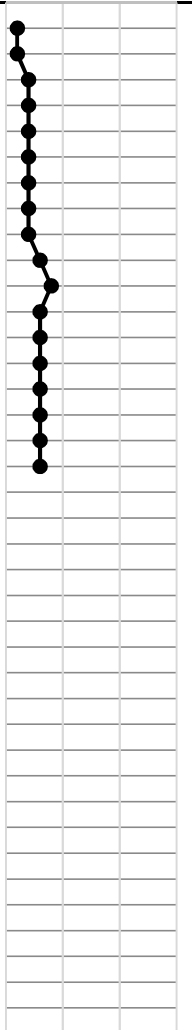
TP 7

Dark brown, organic sandy SILT. Soft. Moist.		Seepage @ 0.6 m

Brown grey, sandy SILT. Non-dilatant. Soft. Bedded. Moist.			
0.8	LAKE SEDIMENT

Grey brown, sandy GRAVEL. Gravel is fine to coarse, subangular to subrounded. Loose to medium dense. Bedded. Wet.			
4.0	LAKE SEDIMENT

COMMENT: Water inflow ~1-2 l/s @ 0.6 m. Test pit collapsing	Logged By: PGF
	Checked Date: 16.01.19
	Sheet: 1 of 1

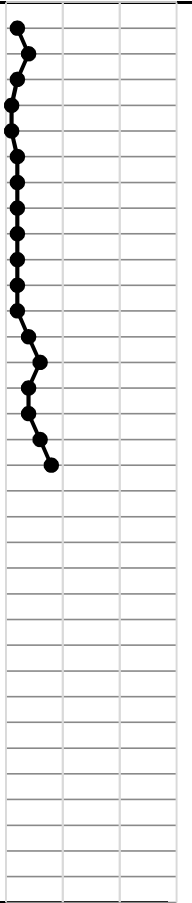
TP 9

Dark brown, organic sandy SILT. Soft. Moist.		Seepage @ 2.8 m

Dark grey, SILT with trace of sand and clay, lenses of sand and gravel. Sand is fine. Gravel is fine. Some dilatancy. Soft. Sub-horizontal bedding and laminations. Moist to wet.			
3.0	LAKE SEDIMENT

Grey, sandy GRAVEL. Gravel is fine to coarse, subangular to subrounded. Loose Bedded. Wet.			
3.5	LAKE SEDIMENT

COMMENT: Strong water inflow 10 l/s @ 2.8 m. Test pit collapsing	Logged By: PGF
	Checked Date: 16.01.19
	Sheet: 1 of 1
