**Ballantyne Road, Wanaka**

**Geotechnical Investigations for  
Plan Change**

**June 2010**

**Job no: 892097**

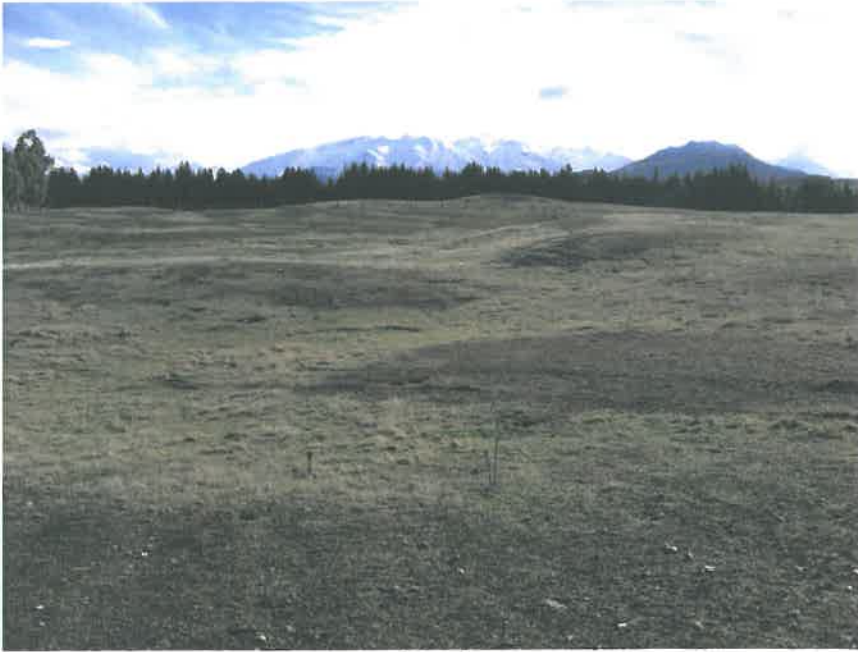
To the north-east of Ballantyne Road lies a region of low hummocks and hollows, with up to about 5m of relative vertical relief (Photo 1). This is interpreted as "kame and kettle" topography, associated with fluvio-glacial deposition in contact with glacial ice.

**Photo 1** - Hummocky 'kame and kettle' topography in fluvio-glacial gravels.

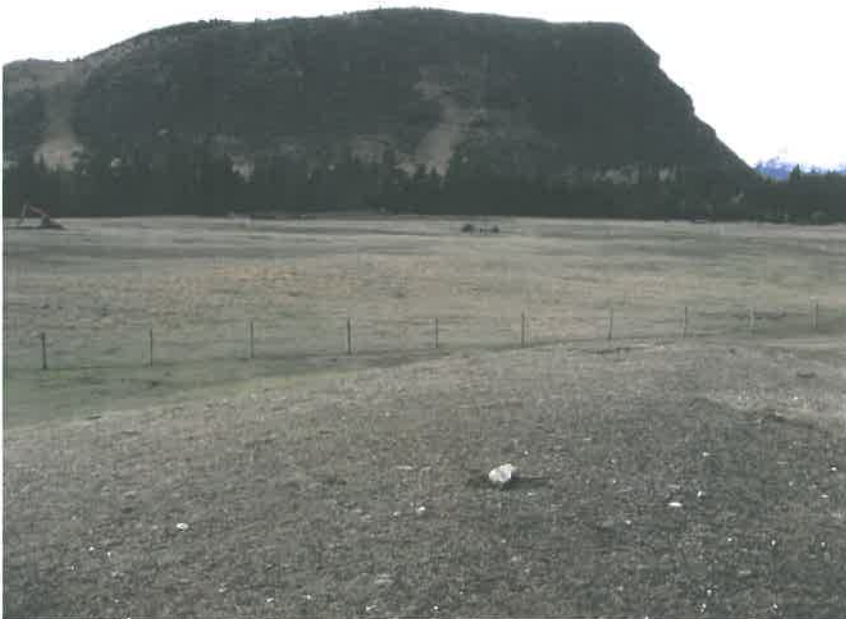
To the north of the hummocky topography lies a region of gently-terraced fluvio-glacial outwash channels (Photo 2). These extend north towards SH84, with a prominent incised channel lying between the back boundary of the Robertson property and the highway. The southern margin of the channel is marked by a terrace riser several metres high.

**Photo 2** - Outwash channel area, looking NE towards Mt Iron from margin of hummocks.

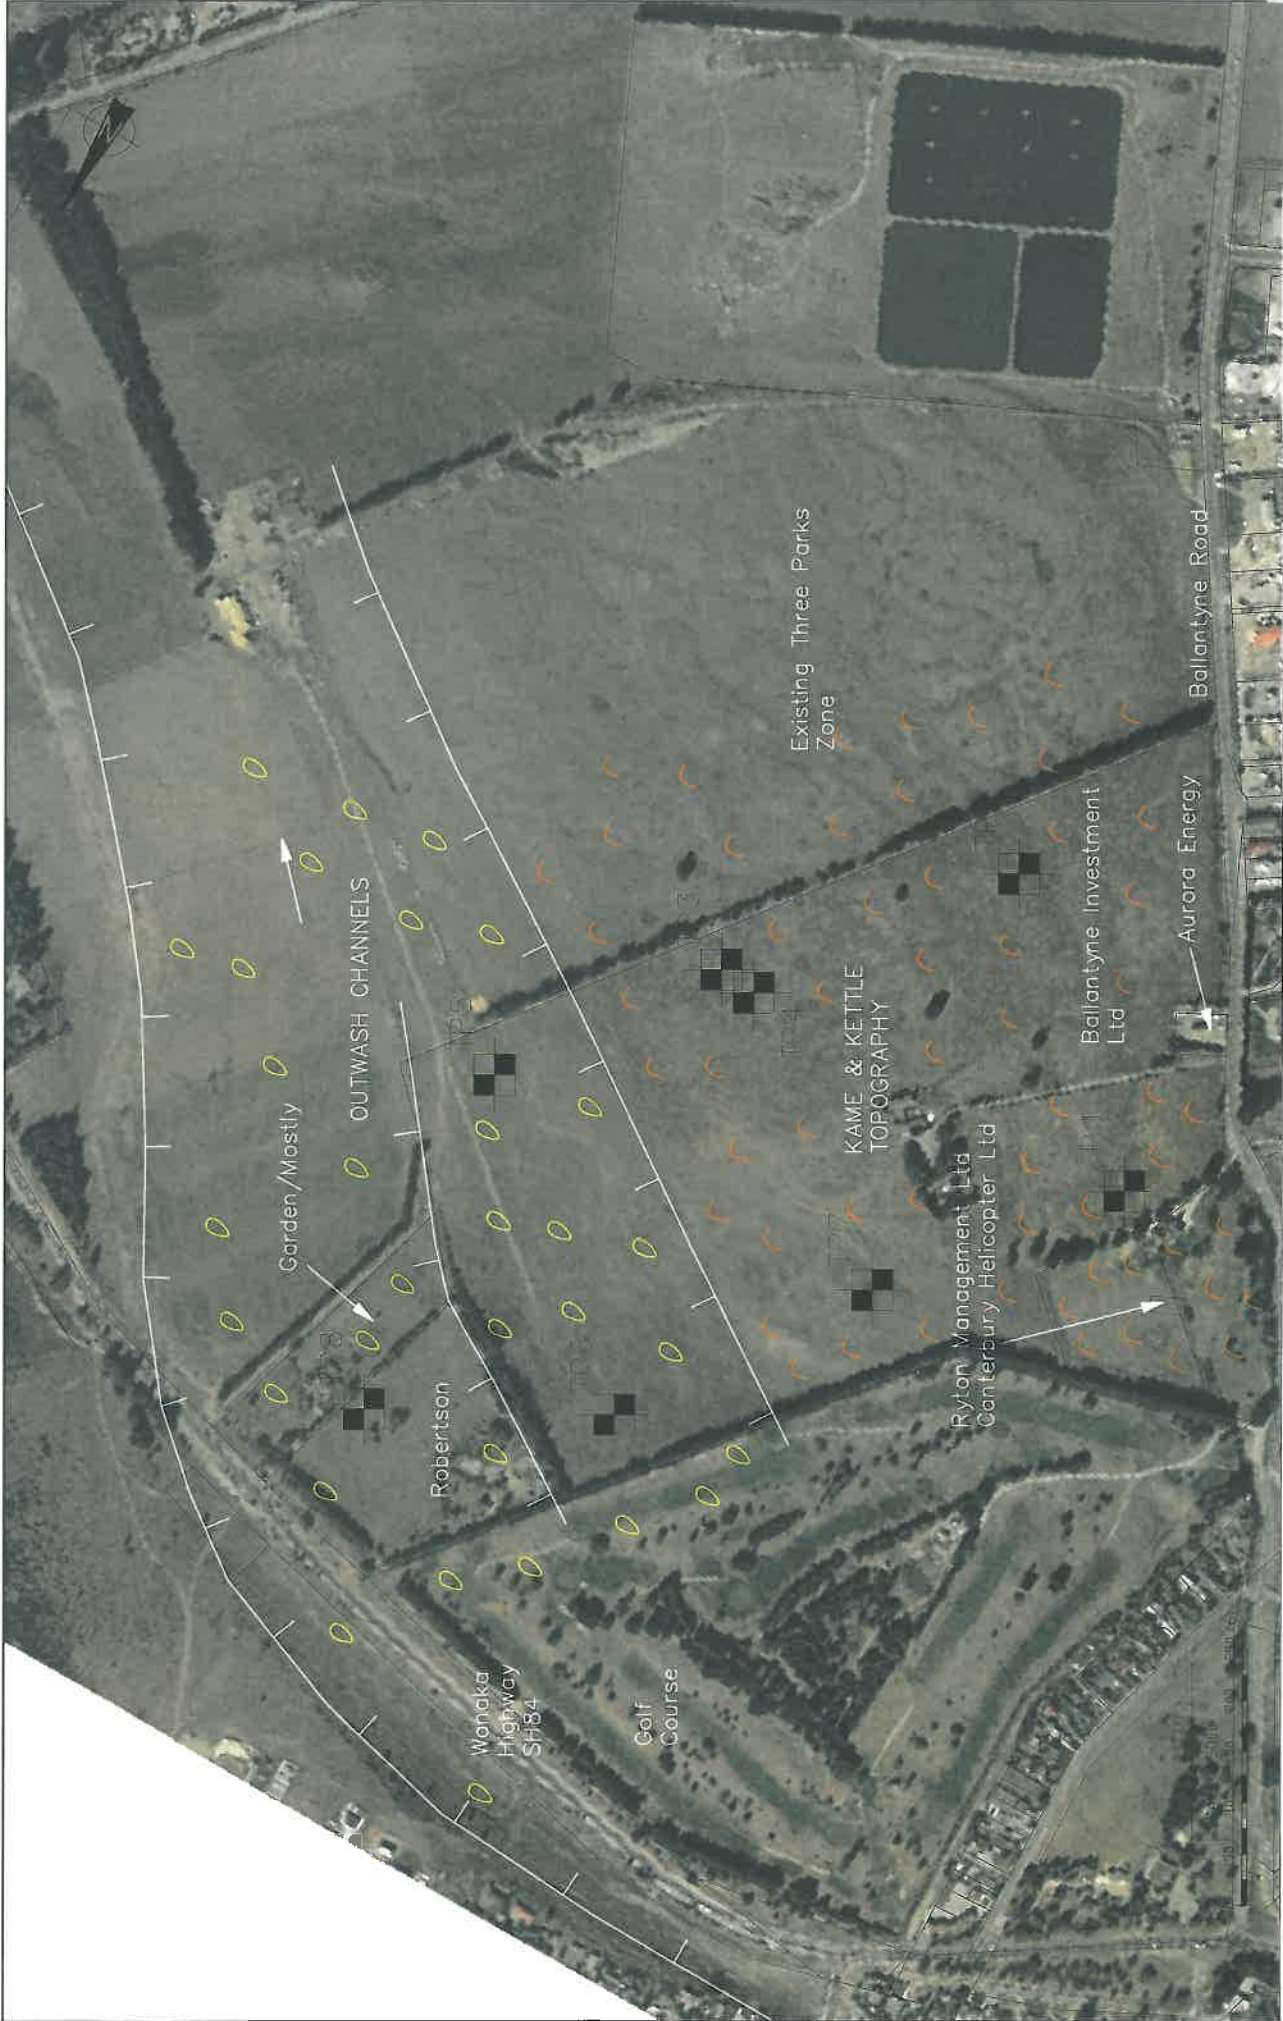
The land involved in the proposed plan change is currently owned by Ballantyne Investments, Aurora Energy, Robertsons, Gordon/Moseby, Ryton Management Ltd/Canterbury Helicopters Ltd (see Site Plan, Fig 1). This preliminary assessment report covers geotechnical issues, natural hazards and stormwater disposal by soakage.

The preliminary study area lies between Ballantyne Road, and the Wanaka Highway (SH 84), immediately to the east of the current Three Parks zone (Fig 1). The Ballantyne Investments land has been used for deer farming, the Aurora Energy land is a transformer substation, and the remaining properties are rural lifestyle blocks with dwellings.

Two distinctive types of topography are found within the plan change area (Fig 1).

Eight test pits were excavated to investigate the subsurface geology, with an average spacing of about 250m (see Fig 1). The test pit logs are contained in Appendix B.
