Geotechnical Report for Resource Consent

This report presents the results of a geotechnical investigation carried out by GeoSolve Ltd in order to assess natural hazard risk and provide geotechnical inputs for a proposed subdivision, McDougall's Block, consisting of 15 additional lots within Lot 6 DP 344432 and Lot 1 DP 425263, Cardrona Valley. An existing dwelling is present within Lot 6 DP 344432 and a previously consented building platform is present within Lot 1 DP 425263, which is labelled Lot 16 as part of this investigation.

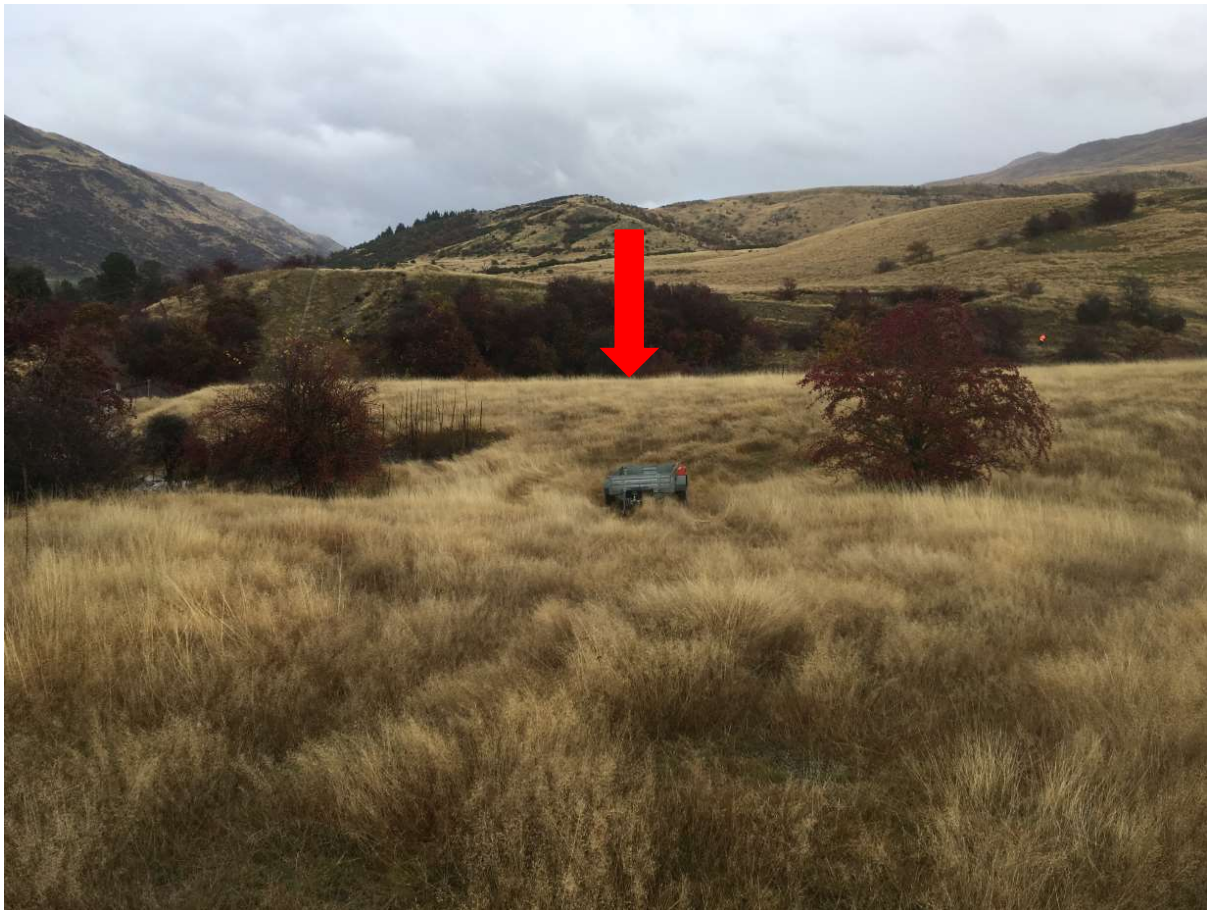
Photo 1. Site photo looking southwest across Lot 1 (building platform indicated by red arrow).

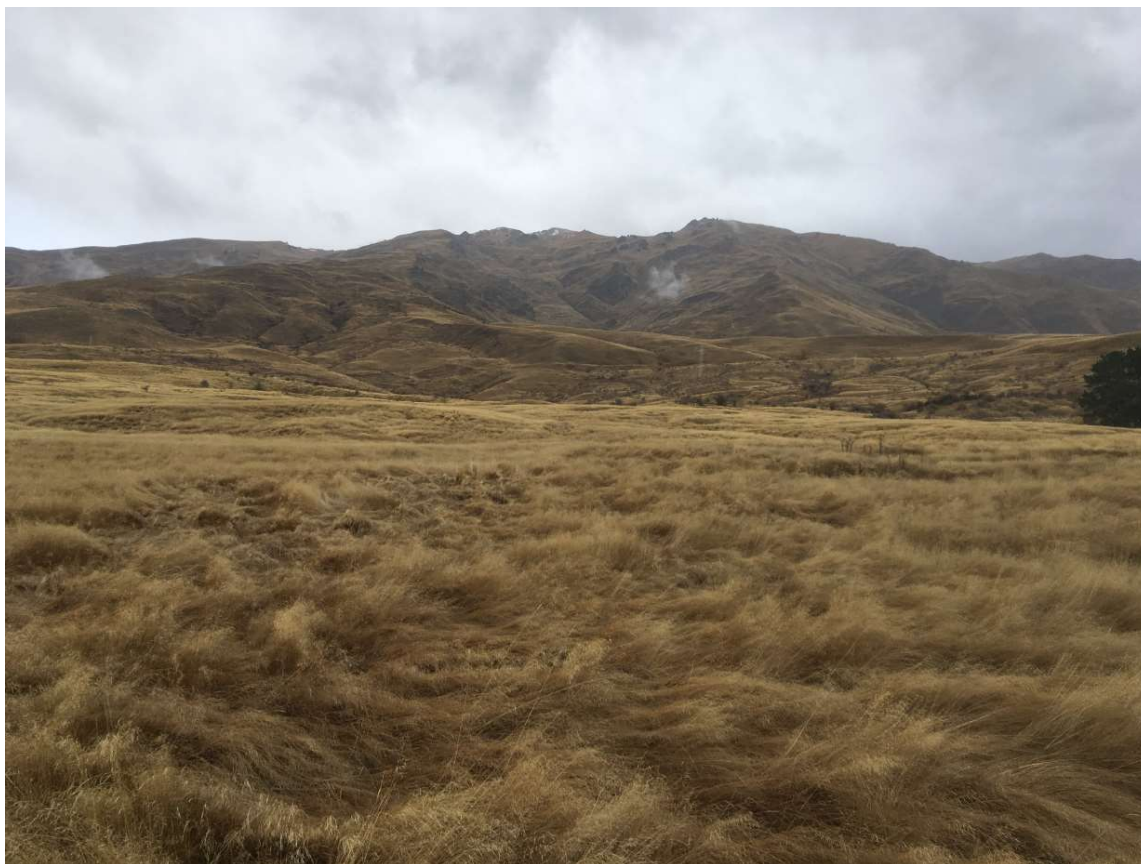
Photo 2. Site photo looking west across the main development area (Lots 2-15).

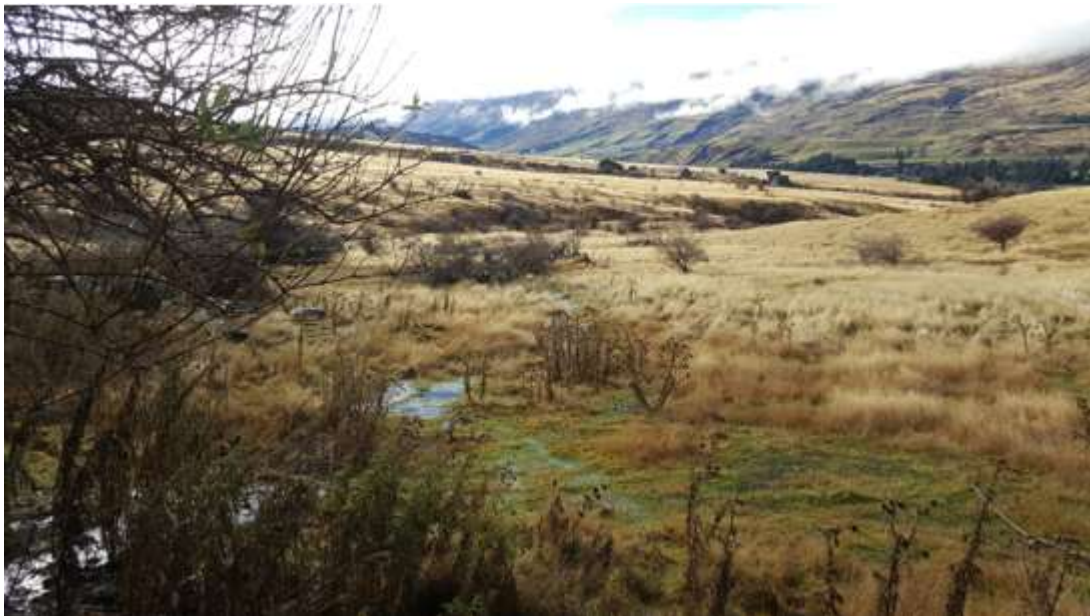
The spring flow and overland flow path resultantly flowed directly through the proposed Lot 11 building platform as shown below in Figure 2.

Figure 2: Site view looking northeast across the southern extent of the Lot 11 proposed building platform. Spring/overland flow combined to pass through approximately the southeast corner of the platform.

The permanent groundwater table is expected to lie at moderate depth however spring flows and overland flow paths show moderate subterranean flows across the majority of Lots 2-15.

through the existing water races it is recommended that these are cut-off to inhibit additional water entering the site.

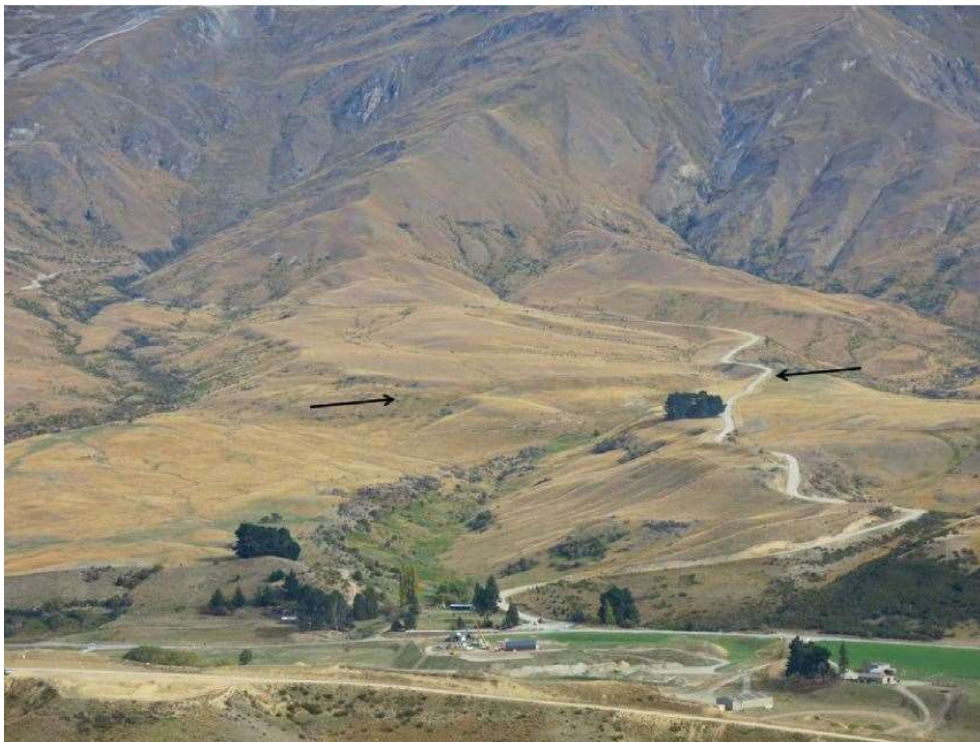
The fault trace is not observed within the floor of Pringles Creek and is projected between the fault trace in Figure 3 and the elevated fan terrace at the subject site.

Examination of aerial photography shows the fault trace to terminate within the south facing landslide area located to the north of Pongs Creek. This is in agreement with the location of the mapped feature on the QLDC planning maps.

Figure 3. “View towards the west Cardrona Valley. The Cardrona Skifield access road runs lower right to upper left across the ridge. A visible, active trace of the NW Cardrona Fault is highlighted between the two arrows” (Source: Seismic Hazard in the Queenstown Lakes District, August 2015).

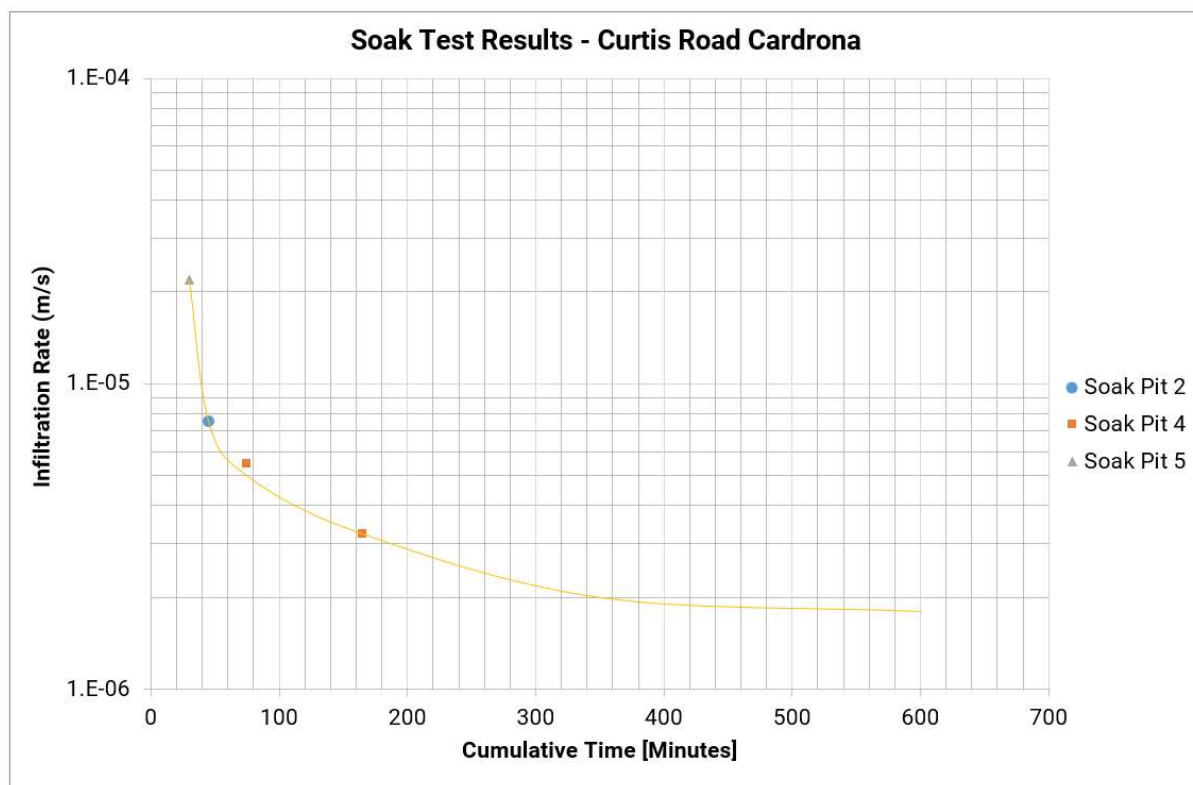
Figure 4. Measured vertical infiltration rate graphed against test duration with the estimated long-term trend shown in yellow.

As soakage tests were undertaken as small hand dug pits within machine excavated pits of maximum dimensions of 0.4x0.35 m (length by width) it is recommended that additional testing is completed. Tests were not able to be completed at a larger scale at this time as access was not available to the test locations with a water cart. It is recommended that

soakage rates should be assessed with larger scale longer duration tests to confirm soakage rates when access is available with a water cart at the site.

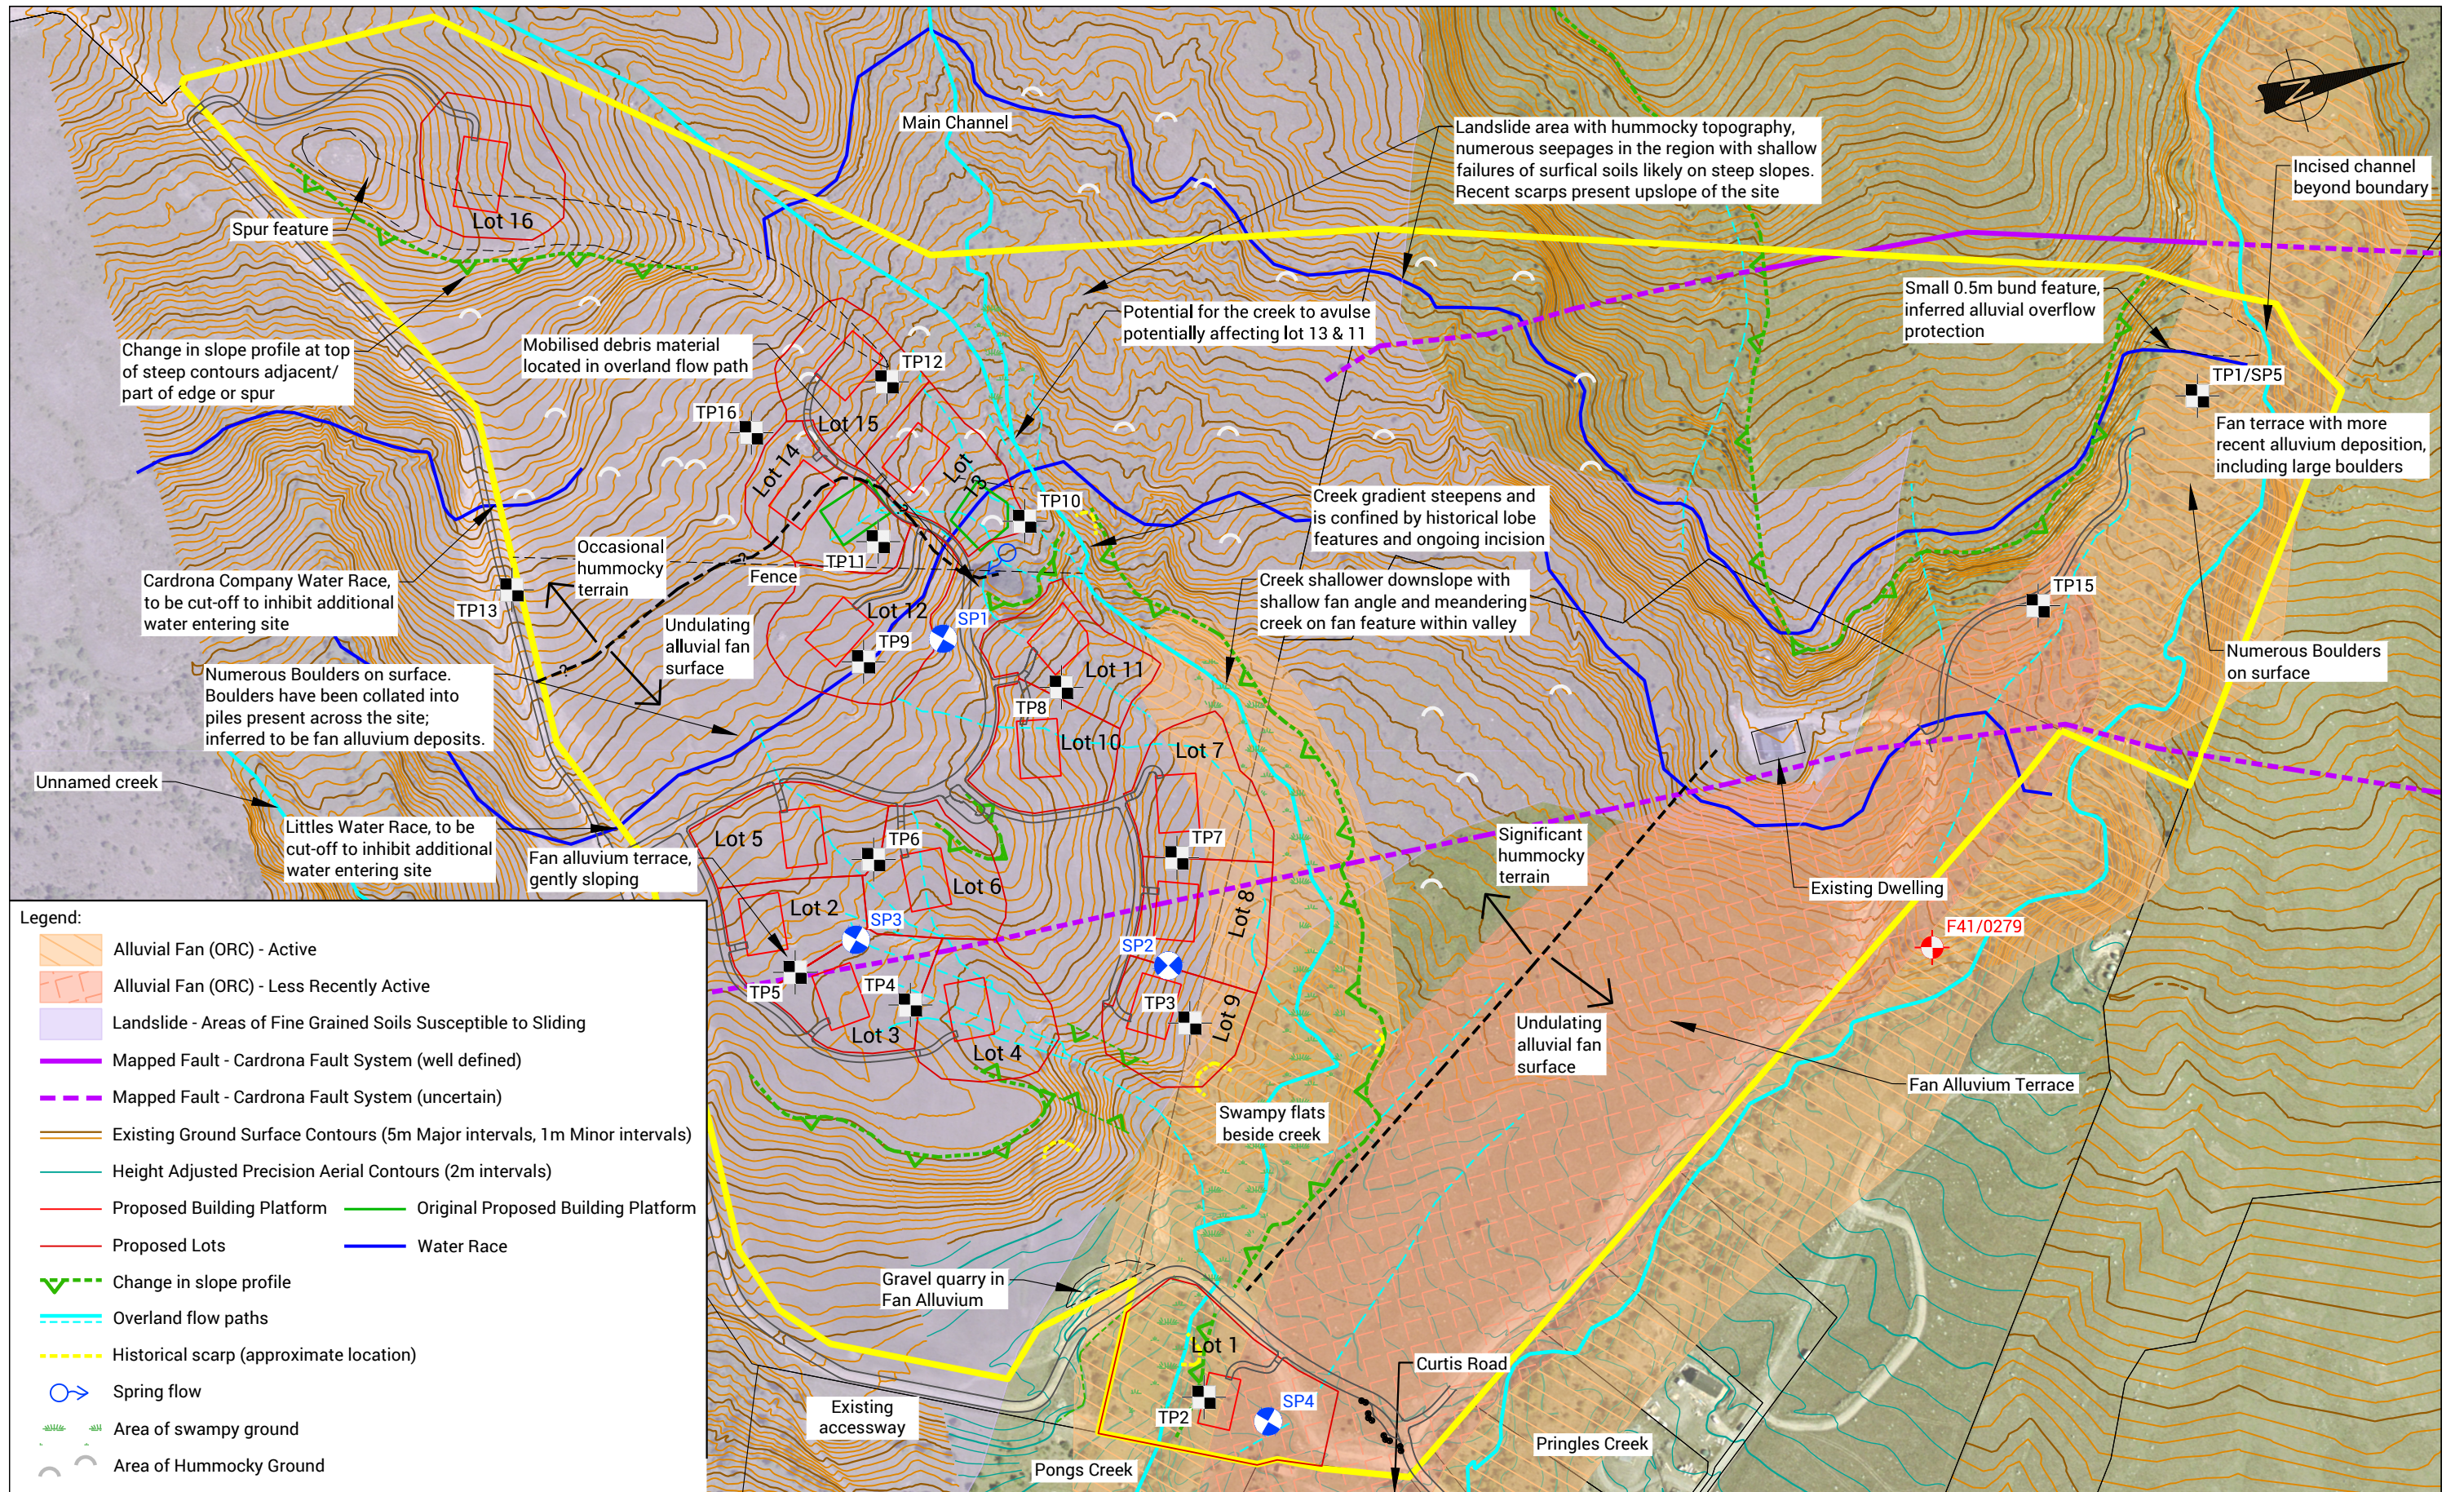
FIG No:
Figure 1b

An area of inferred landslide activity, which is shown on the QLDC hazard maps, lies within the site boundary. This landslide is classed by QLDC as "areas of fine-grained soils susceptible to sliding". This is sourced from IGNS QMAP 1:50,000 Compilation Sheets. This landslide feature is shown to affect Lots 2 to 16 inclusive, as shown on Figure 1b, Appendix A.

Additionally, isolated small volume shallow seated slope failures were also identified on steep slopes within the site, as shown in Figure 1b, Appendix A. One of these features is located in close proximity to the building platform of Lot 1 and further information regarding the slope stability of Lot 1 is discussed in Section 6.8 of this report.

According to QLDC hazard mapping, Lots 1, 7, 8, 9 and 11 are mapped as an active fan in the ORC alluvial fan mapping, as shown on Figure 1b, Appendix A.

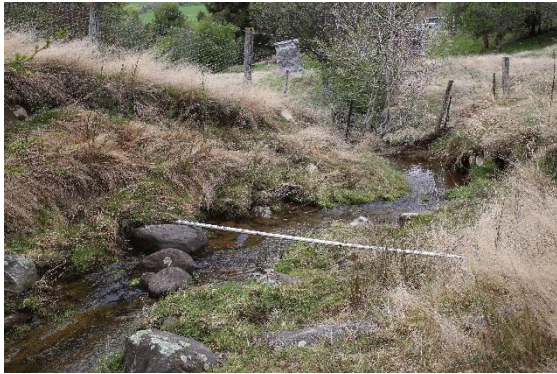
Photo 1. Pongs Creek at lower property boundary. Width 2.8

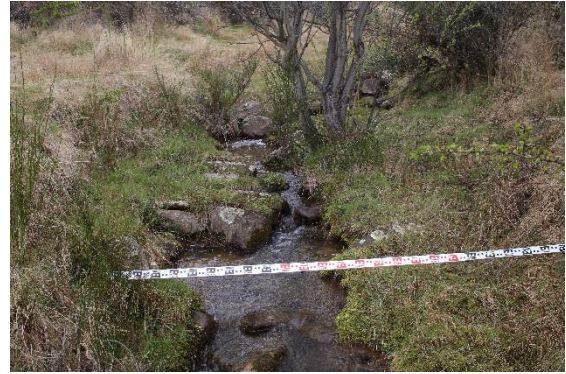
Photo 4. Pongs Creek. Typical upper section. Swifter flowing, well contained Width 1.7

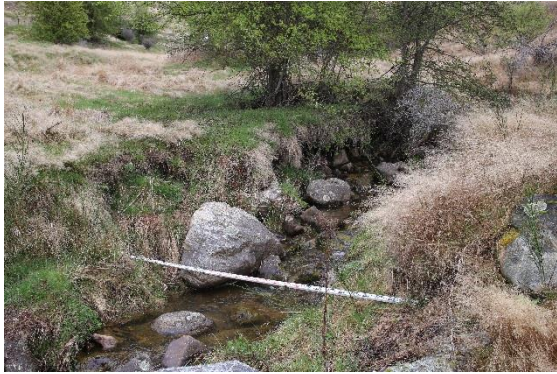
Photo 2. Pongs Creek. Typical lower section. Well contained. Width 1.6

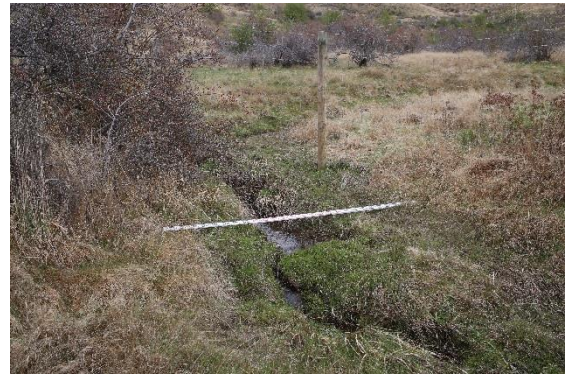
Photo 5. Pongs Creek at upper property boundary. Width 2.3

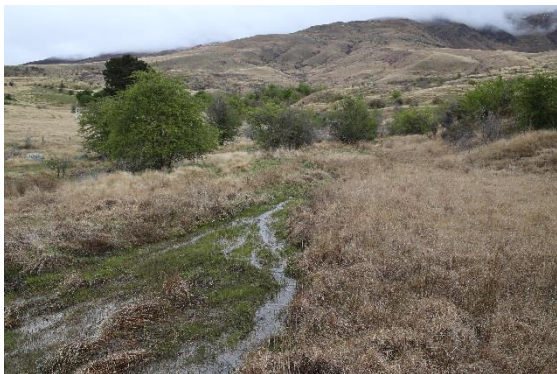
Photo 3. Pongs Creek. Very slow flowing through some parts of central section

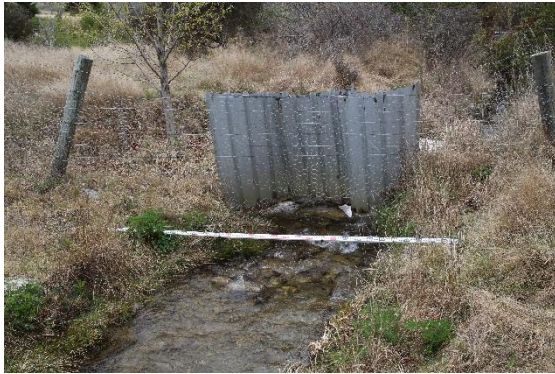
Pringles Photo 1. Pringles Creek at lower property boundary. Width 1.7

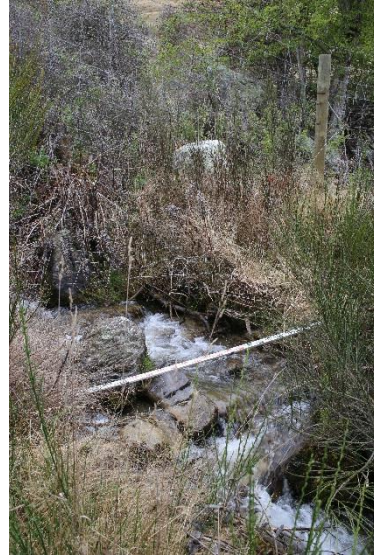
Pringles Photo 4. Pringles Creek at Upper property boundary. Width 2.4

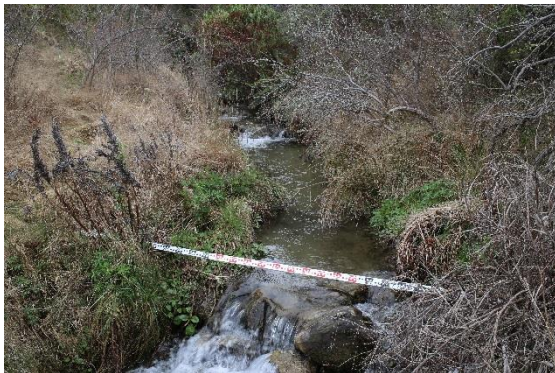
Pringles Photo 2. Pringles Creek. Typical swift flowing mid section. Width 2.1

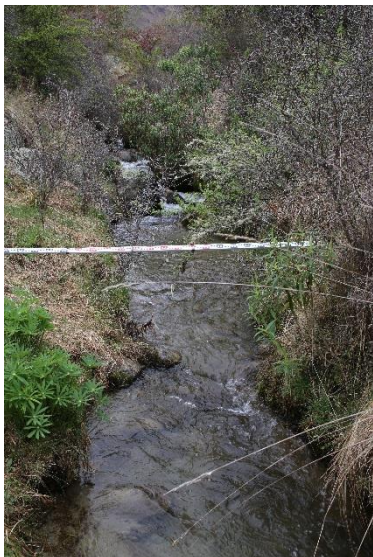
Pringles Photo 3. Pringle Creeks. Swift flowing midsection. Well contained within defined river banks. Width 1.6
