Title | Taitara: September / October 2024 Weather Event

A Weather Event Network Damage Report – Sept / Oct 2024 v3

Reference: Crown Range Road Multiple failures between gates and summit Queenstown side

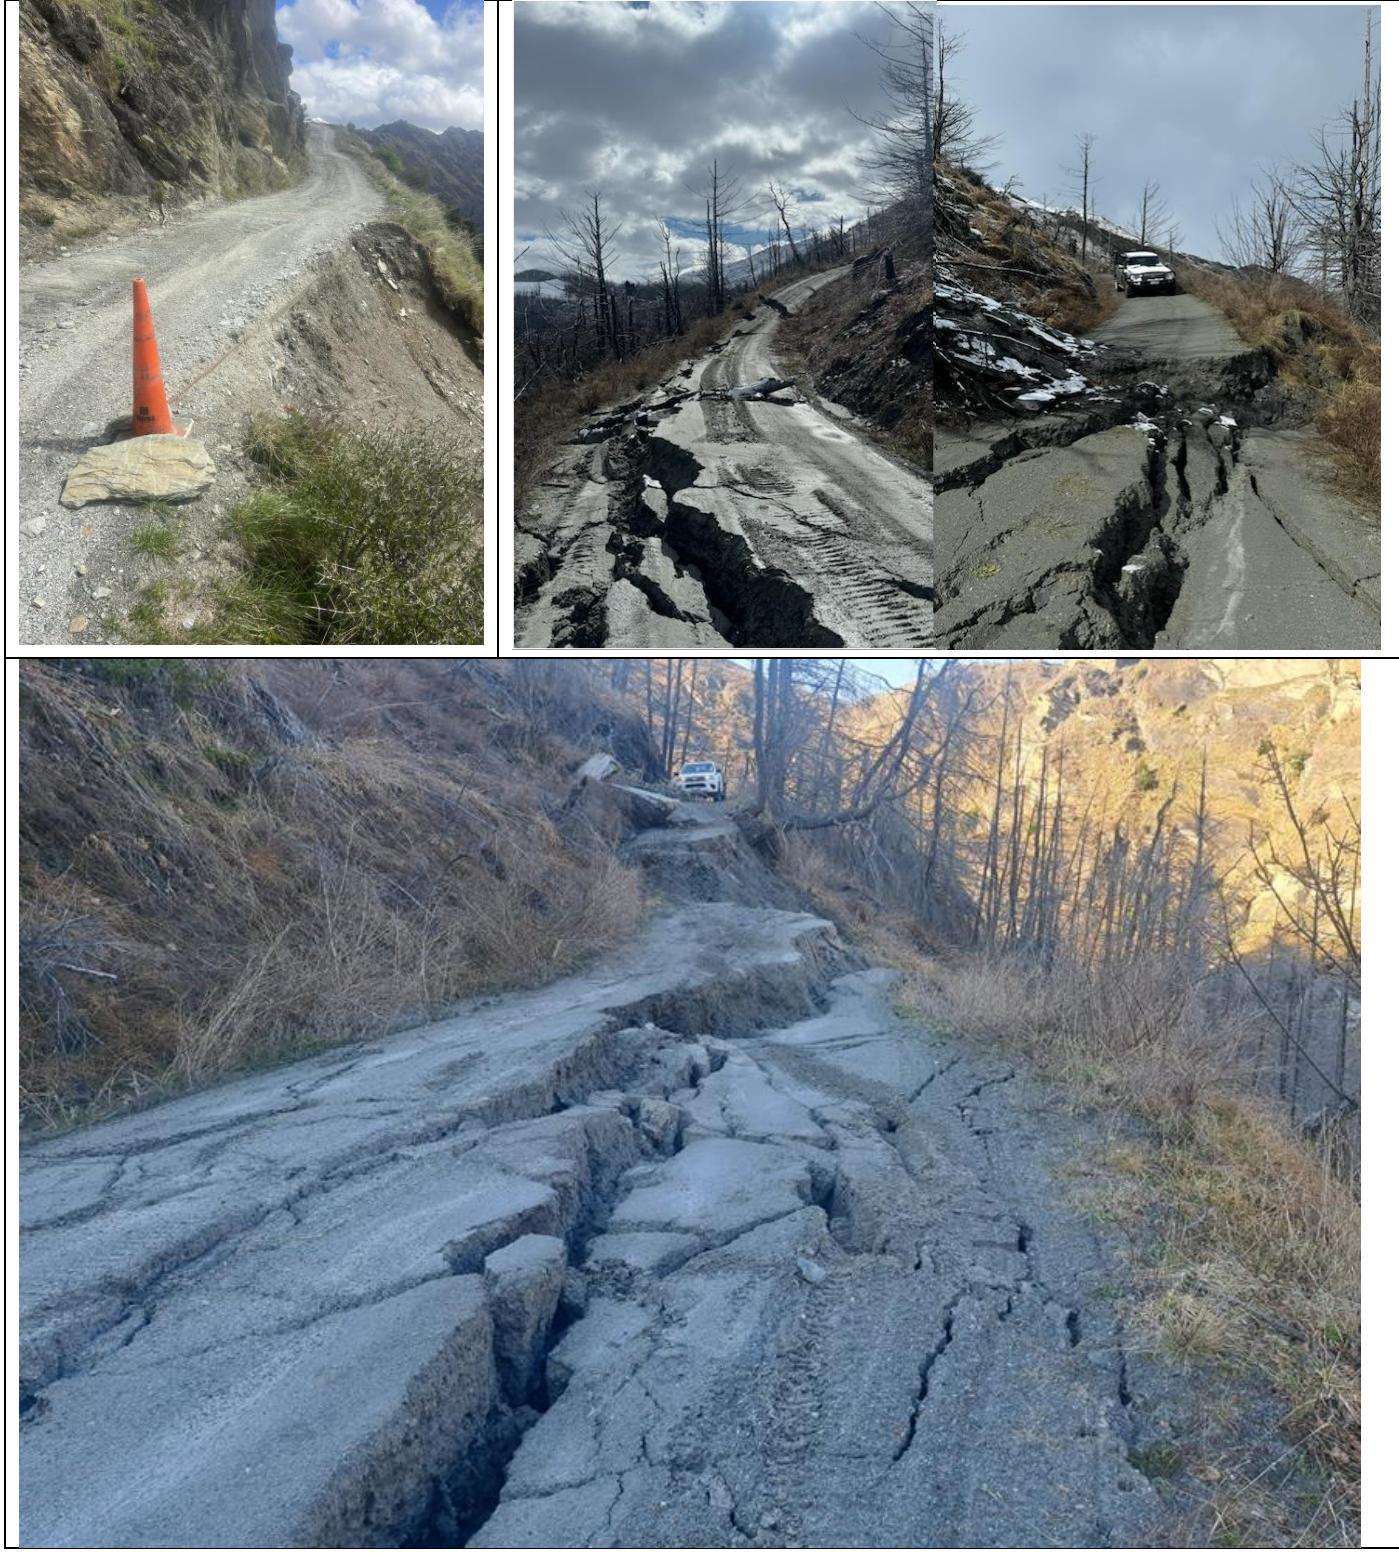
Both sections of road have been opened to road access, however the road sections are still in vulnerable conditions in the event of another weather event. Long – Term remediation repairs could consist of upgrading drainage structures, completing some retreat works on banks. Some areas would not be viable to attempt long-term repairs as hillsides are extremely high and steep elevation.

Current Status of Road: (As of 4/12/2024) Road has been fully opened. The surface after the branches intersection to the bridge could benefit from a grade. We will look to grade before the holidays. There is a weeping patch after wong gongs which needs some rock in it to future proof it. This will be done in the coming fortnight. Drainage work is still required along the length of the road where little slips and slumps have fallen into the water tables. I will estimate this being another 1 week to 10 days on the wheeled excavator between skippers and Branches Road to get pavement conditions on the road to acceptable drivable standards for public road users. Both sections of road have been opened to road access, however the road sections are still in vulnerable conditions in the event of another weather event. Long – Term remediation repairs could consist of upgrading drainage structures, completing some retreat works on banks. Some areas would not be viable to attempt long-term repairs as hillsides are extremely high and steep elevation.

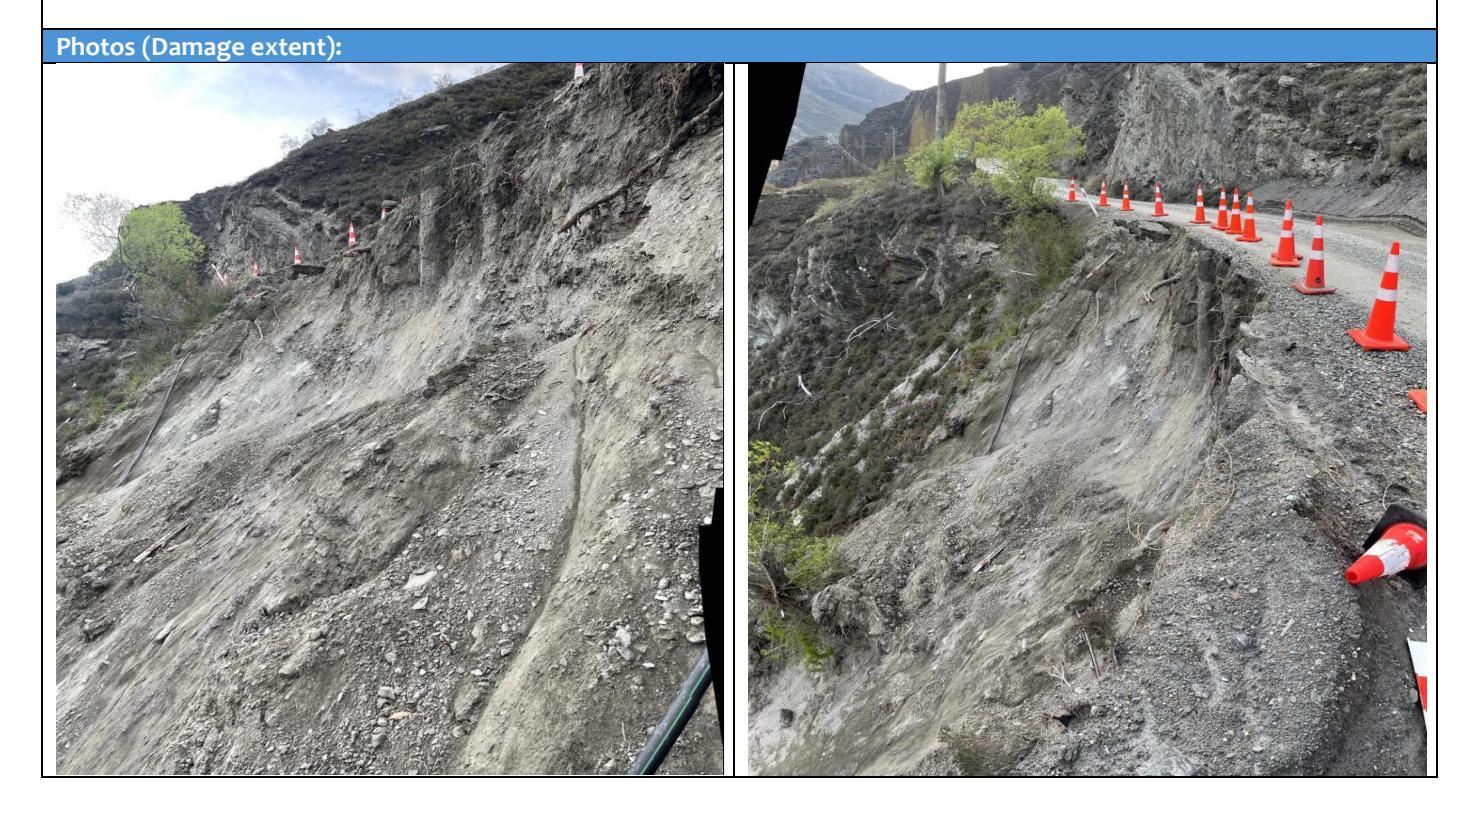
Road has dropped out from further from and existing retaining repair. The road services an Orchard Farm at the end of the road, low vehicle volume road. The dropout/washout has extender for approx. 21m and across the existing repair. The dropout shoulder footing has dropped away and the opposite bank cliff has potential of slipping also. Road is extremely narrow through this section. Vehicle limit required to reduce the risk and close road during events.

- 1. Baley Bridge Install and Lease for 5 years (Cheapest Solution- \$350,000.00 Install and Lease 5 years).
- 2. Slip Retreat and Dropout Repair (\$500k-\$600K Depends on Design).
- 3. Do Nothing-Monitor Road under Restriction- Placement of closure during events (\$19,200.00 Estimate over 24 months).

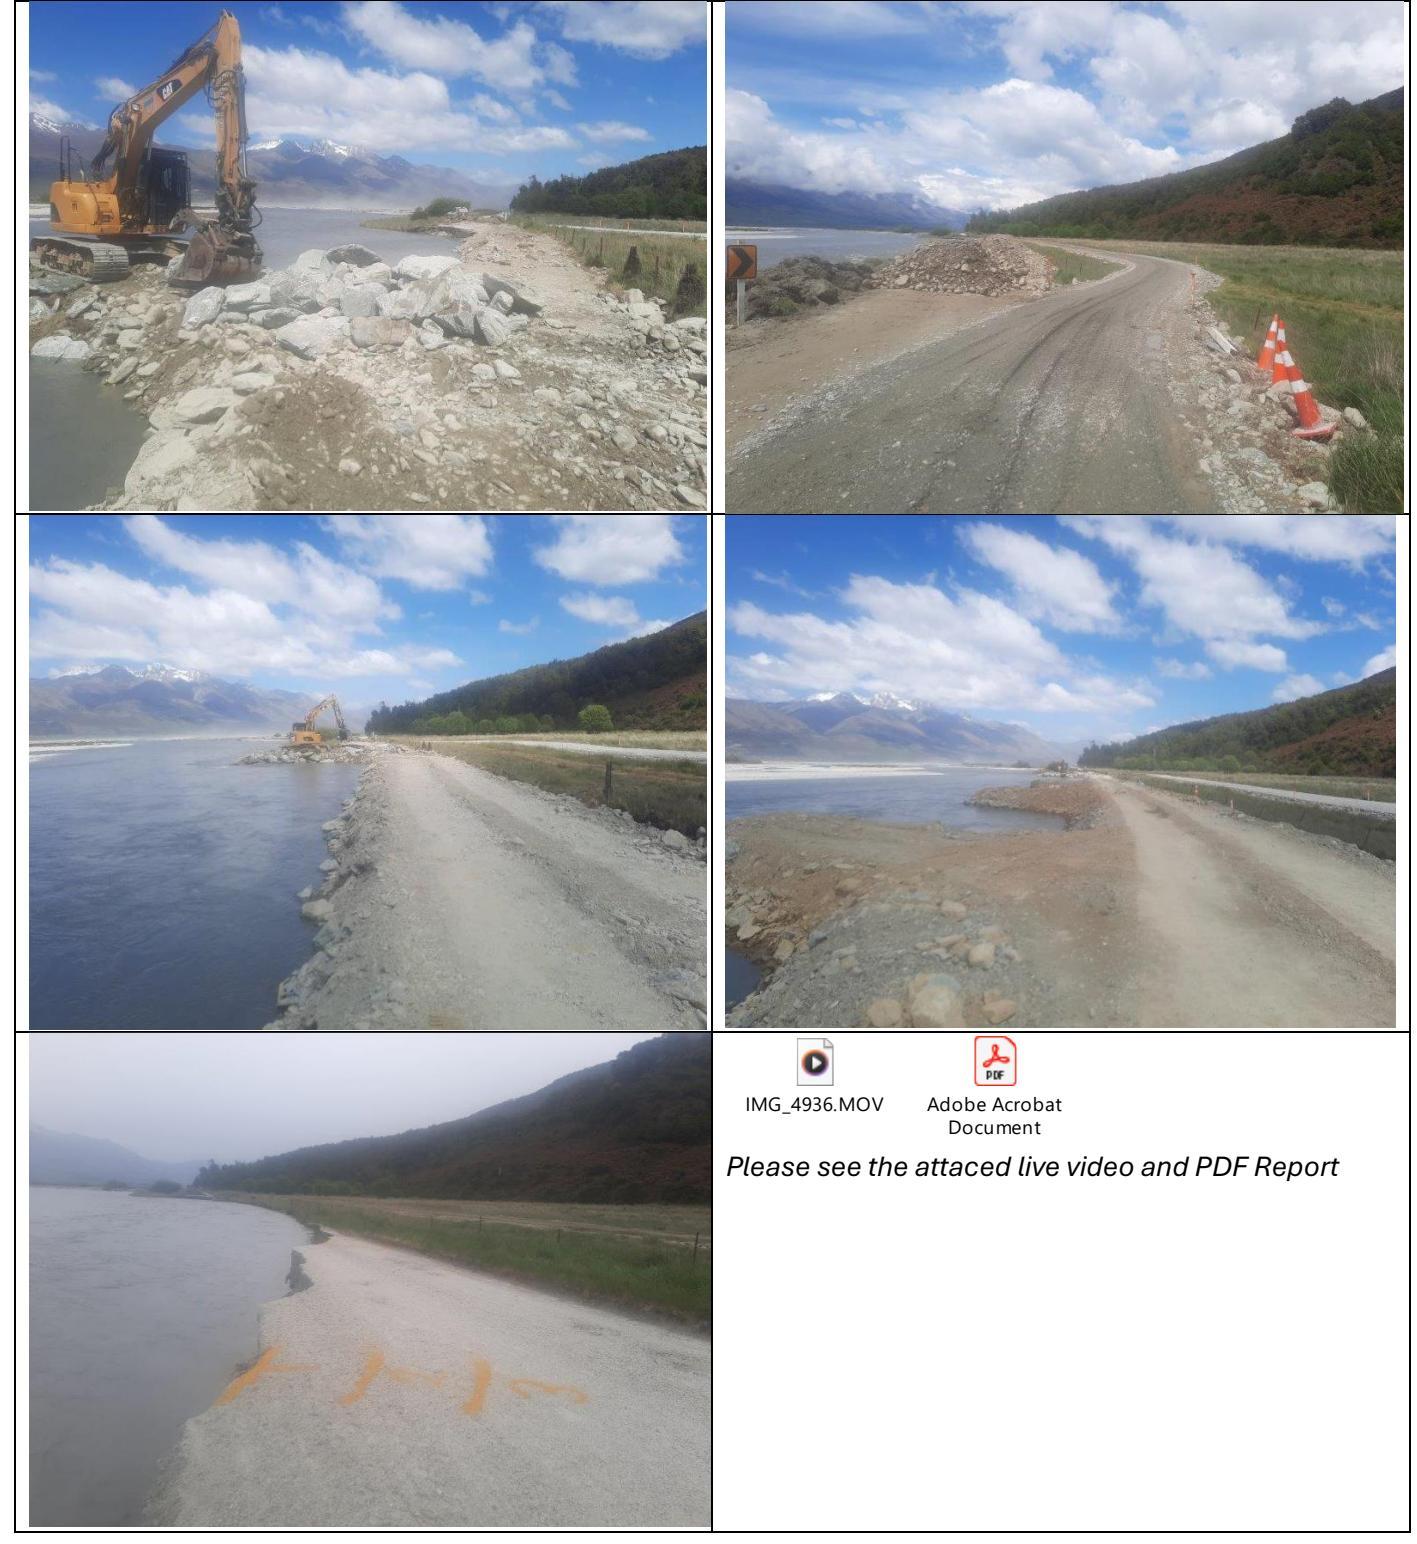
Temporary Road have been built through private property adjacent to the road. Access for Local residents have been reinstated until long-term planned works are approved and initiated.

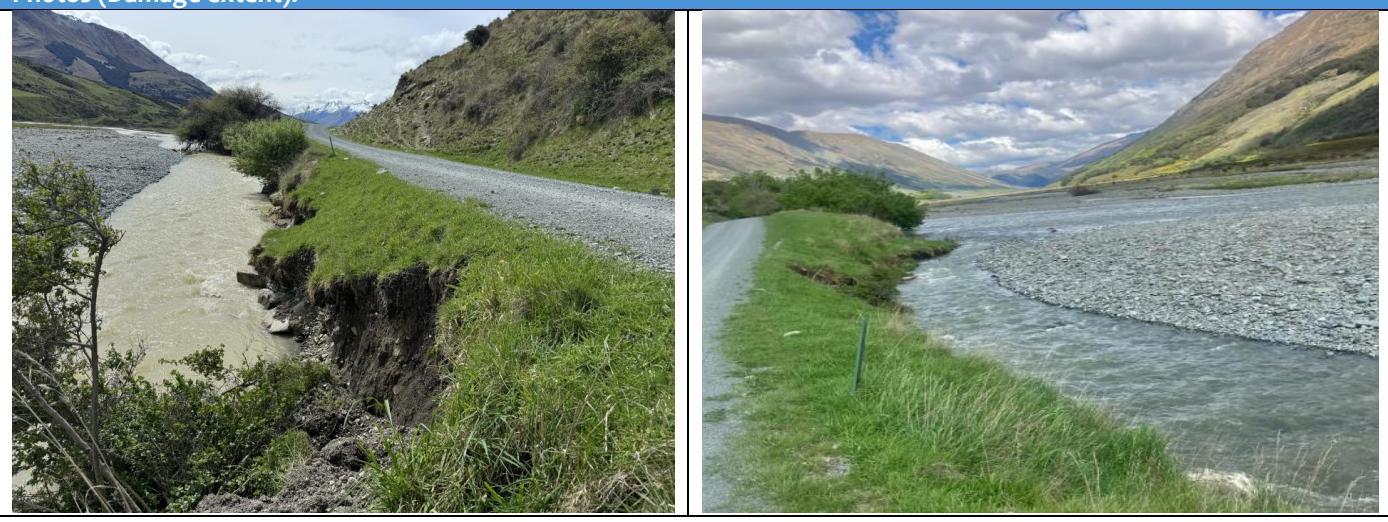
After the rains at the end of October the riverbank next to the Von Road has been chewed out much in the same way that Kinloch Road has been. This is in a different area to the one which we have previously repaired. In the next very large rain event, the road could be compromised. At this stage I have not engaged Derek/Stantec to have a look. Please advise what course of action you would like us to take, inspection by Downer and or Stantec, via helicopters, driving etc. A noteworthy point is Te Anau earthworks who we use for repairs to this section of road are already in the valley undertaking work for South roads who have the maintenance contract for the other part of the Von Road. If we did want to take any action, then we would be well placed to do so this side of Christmas. Derek and I at Rich's agreement are going to inspect the damage to Kinloch Road at the end of this week. Derek will follow up after we have had the site visit.

Road has been made safe with some signage, the shoulder is eroded and road is in a vulnerable state in the event of significant weather impact. Proposal presented and will await approvals or instruction.

Long-Term Designed Repair: Establish 20/30t excavator on site. Establish moxi on site. Retrain river back into previous more desirable channel using digger. Use material from channel retraining to reprofile riverbank to previous form. Place bidim over new bank down to 1m below water level. 100mm beach material placed on top of bidim. Place 600t of rip rap rock on reprofiled bank for 80m. Rock to be carted from quarry in Mossburn.

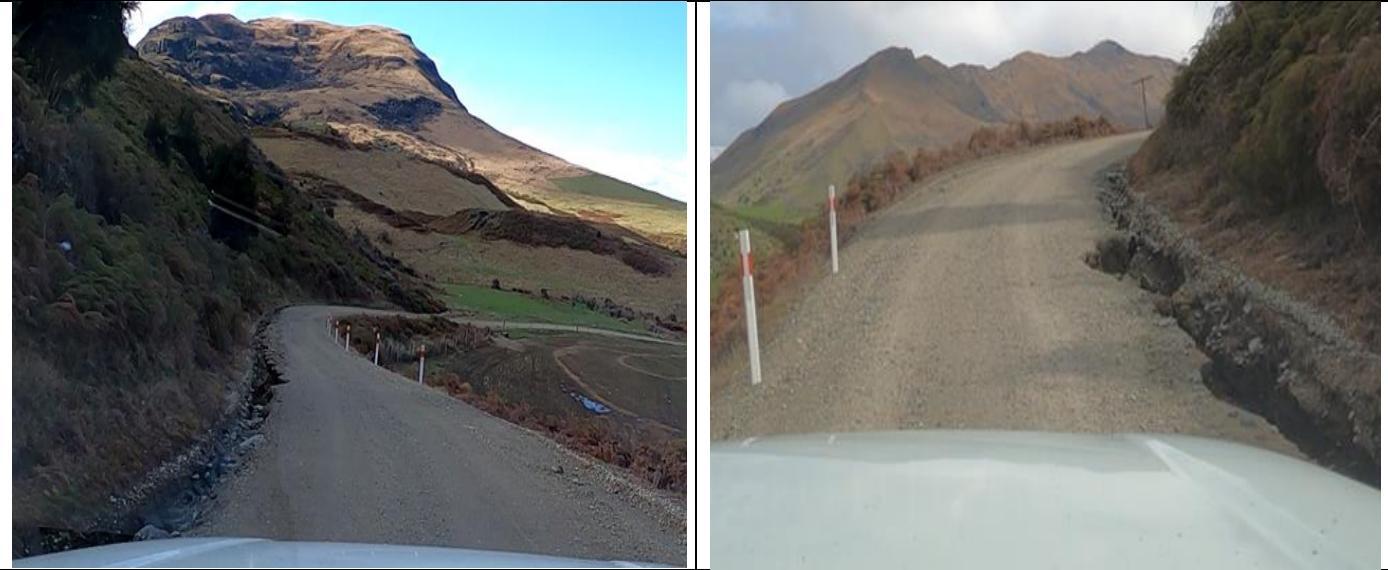
Severy scouring formed along road shoulder and very deep and dangerous. Team has responded and repaired road. Shoulder shaped and collapsed, materials imported and packed in layers and compacted. Drainage cleaned, formed and reinstated.

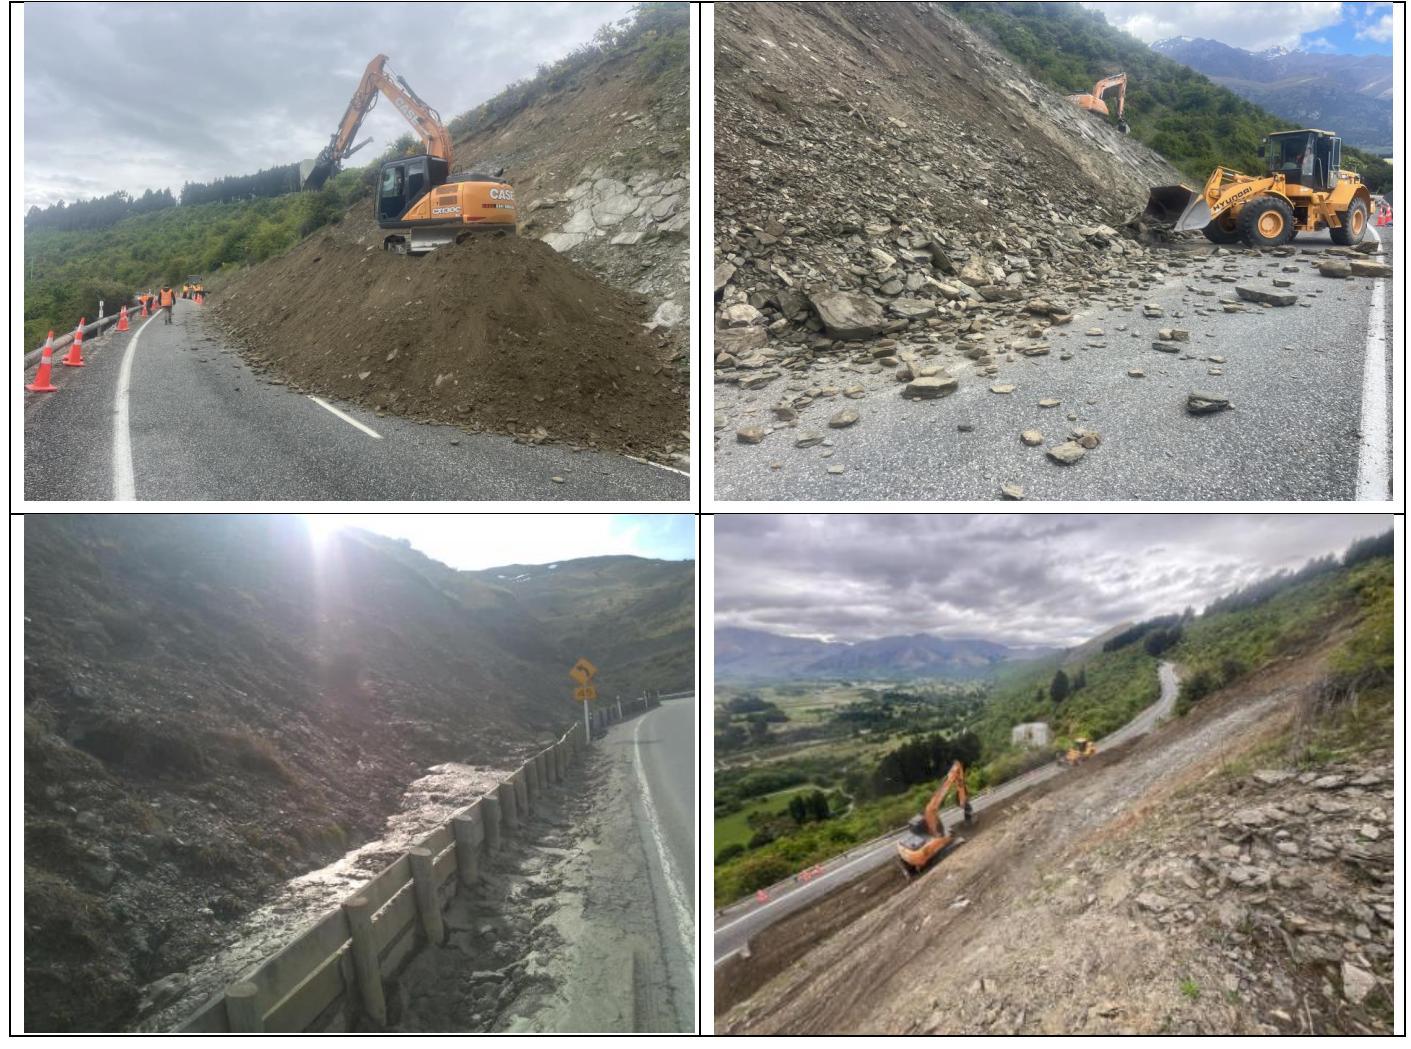
At the top of the slip are a series of vertical scarps and open cracks. The exposed scarp faces are up to approximately 1.5m high. Downslope of the scarps is an area of loose chaotic slip debris which is translationally sliding down the slope. Approximately 10-15m above the road there is a significant bulge as the translational slip debris is bulging outward , potentially because the toe is held up by the road but the weight of the debris sliding down is causing the bulge. I have been passing the slip on a regular basis as I have been undertaking work at Cardrona. It is clear that the slip is still moving, and the bulge is shedding material which falls to the road below. I am aware that Downer is regularly clearing this area of the road due to the ongoing shedding of debris from the bulging area.

The slip is clearly still moving. To exacerbate the situation, the translational sliding has caused the material to become noticeably looser, and further open the scarp cracking at the top. The combination of loose chaotic material and the open scarp cracking at the top will allow further water ingress into the sliding material. Thus, with further rain I would expect the slip to become more active due to water entering the ground. Water in the ground will increase the mass of the slipping material and will reduce the effective resistance to sliding along the sliding plane. It is entirely possible that further rain will cause a complete, and potentially rapid, collapse of the loose material.

Major slip works in this section of the road has been completed including the major slip removal and retreat at Rp 1264. Other minor slips and retaining barriers cleaned and repaired close to the summit. Remedial slip and barrier work still to be completed under static site control approx. 5 days for the remainder of the works.

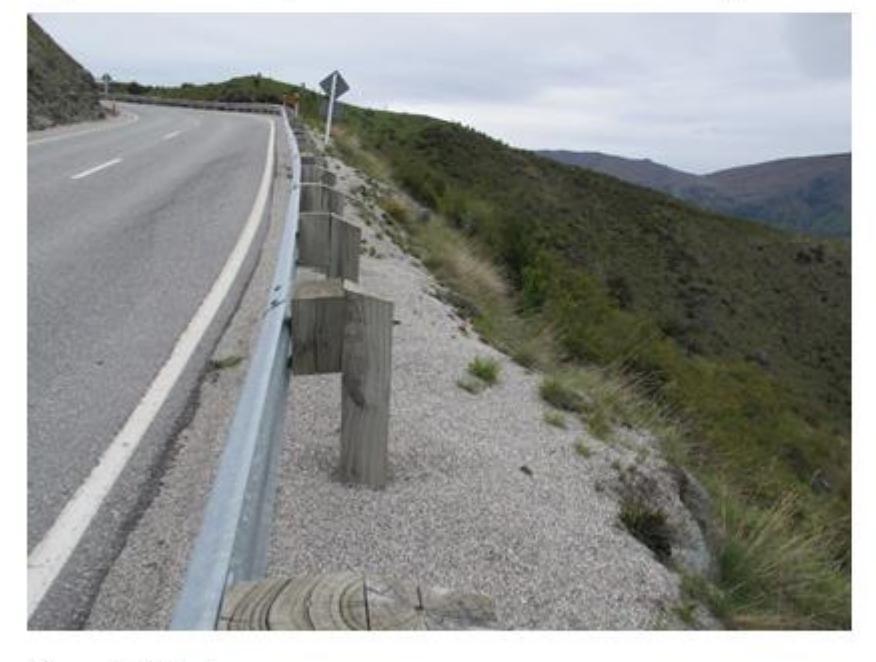
Site 1 is cracking in the middle of the downhill lane approximately 250m downhill of the viewing area. There is minor cracking in the seal on the outside lane which indicates a possible shoulder failure propagating into the lane. The guard rail posts are not visibly out of plumb or translated and thus, if settlement is occurring, it is minor. The edge line was not interrupted or cracked and thus the cracking may be indicative of a pavement failure rather than instability. This is shown in the photograph below.

Possibly localised pavement failure rather than instability

Recommended action for discussion Asphalt Patch

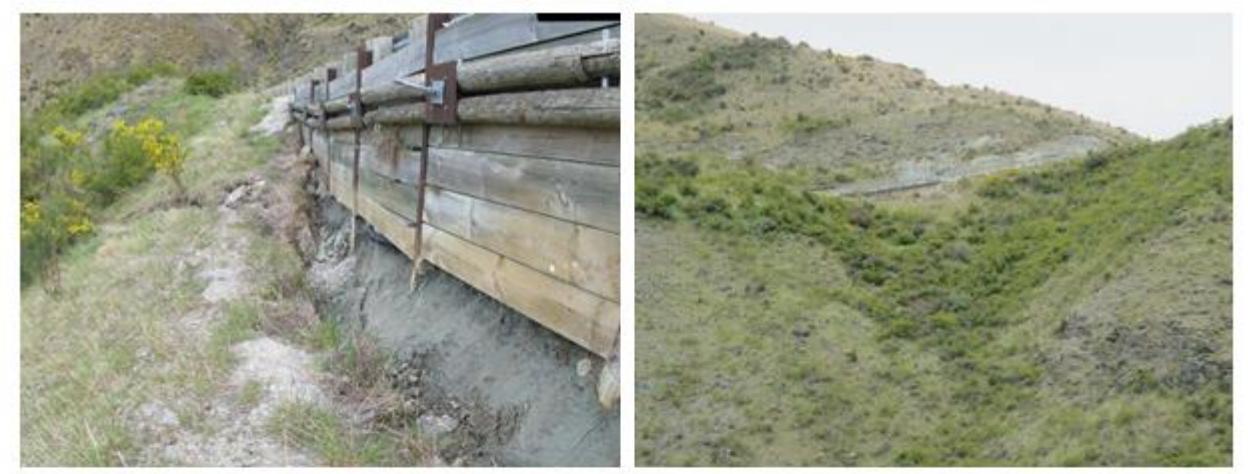
Site 2 is an existing steel pile and timber lagging wall tied back with self-drilling anchors with timber post walers. The wall was constructed 11 years ago. A significant portion of the hillside has mobilised immediately below the wall. The soil from the toe of the wall has moved out and down approximately 1m and this movement has left the bottom section of the piles exposed. The slip appears to be extensive and there are tension cracks propagating diagonally down slope on both sides of the wall.

Figure 4. Site 2 with slope failing and sliding away from toe of retaining wall.

2.	Existing tied back post wall, slope failing from toe	Urgent	Add additional row of lower anchors and walers between exposed posts before wall is damaged

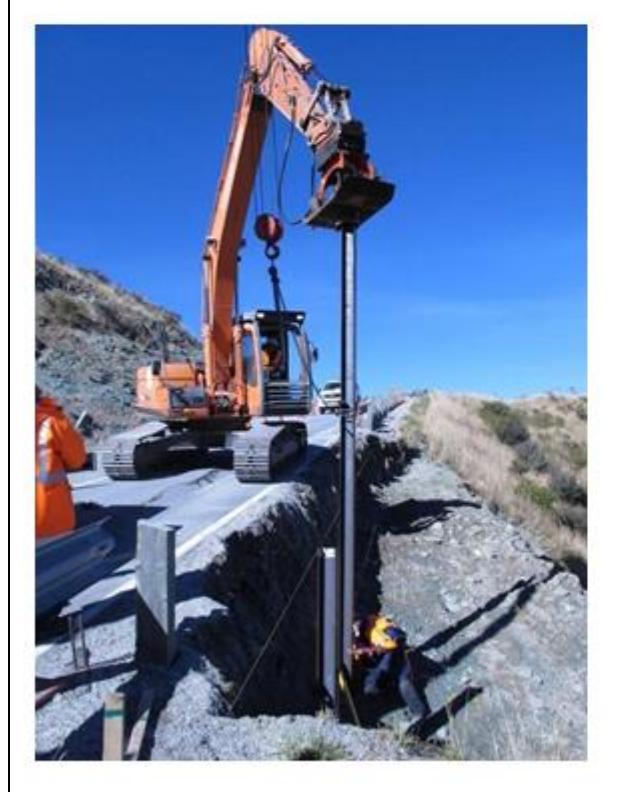
Figure 5. Pile driving at site 2 during construction 11 years ago, showing the length of the piles. The working shelf has completely disappeared.

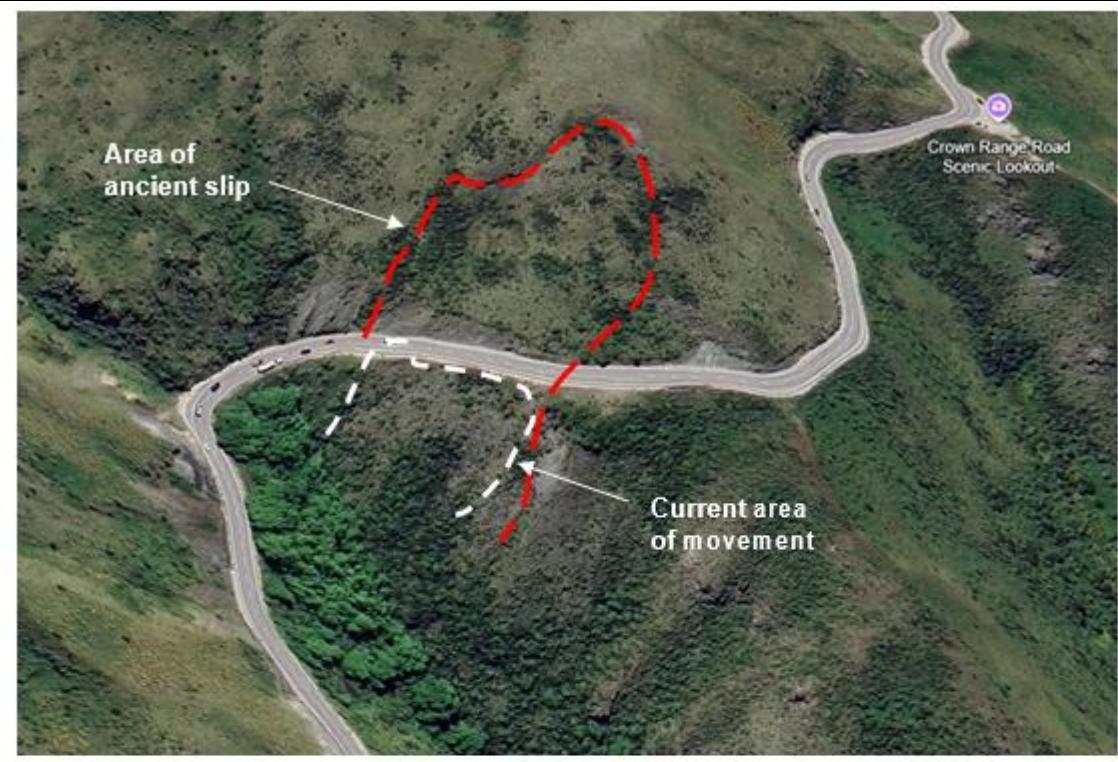
Figure 6. Inferred extent of potential slope instability at site 3 from Google Earth. Historic head scarp above the road is clearly visible.

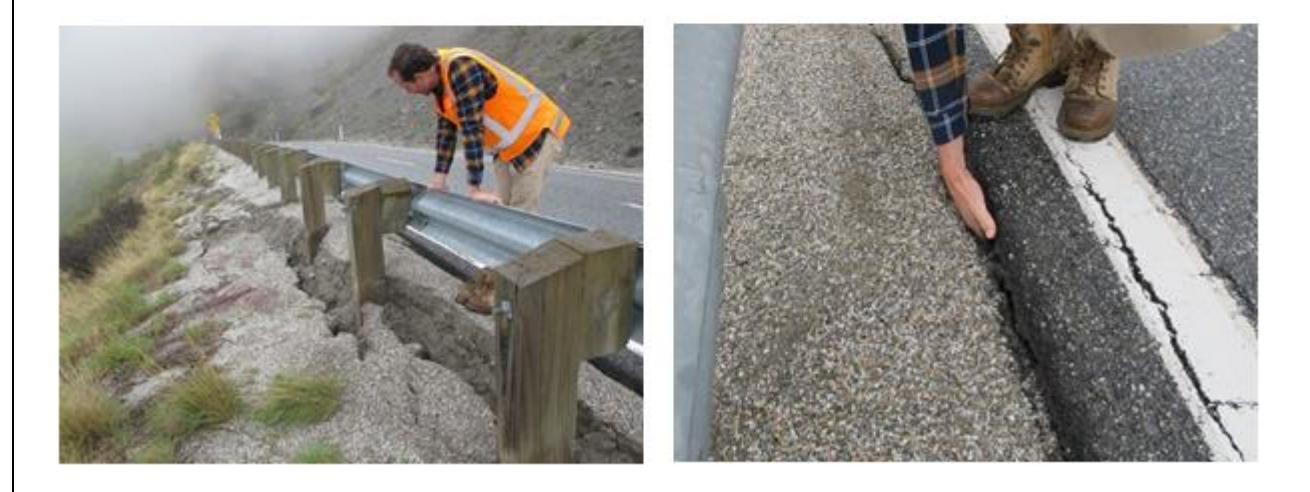
Figure 7. Cracking and settlement at the road shoulder at site 3.

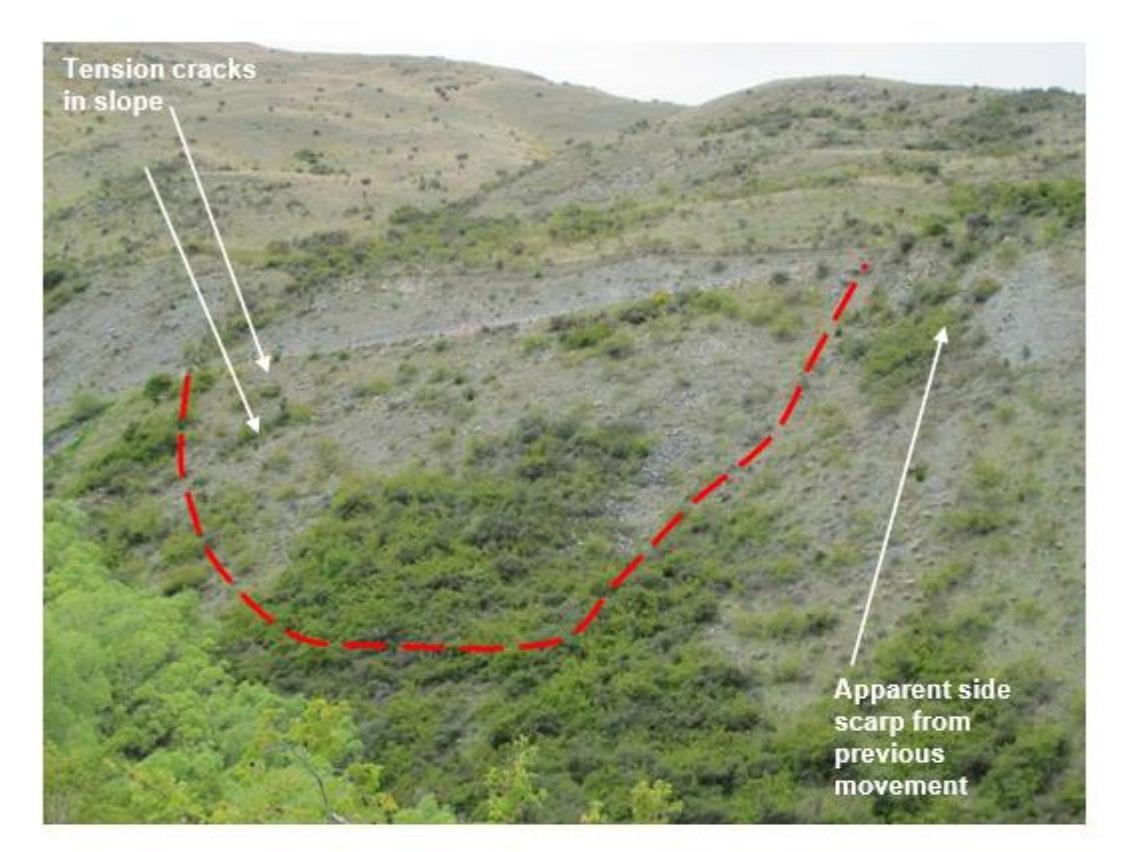
Figure 8. Inferred area of current land movement at site 3, slope tension cracking arrowed

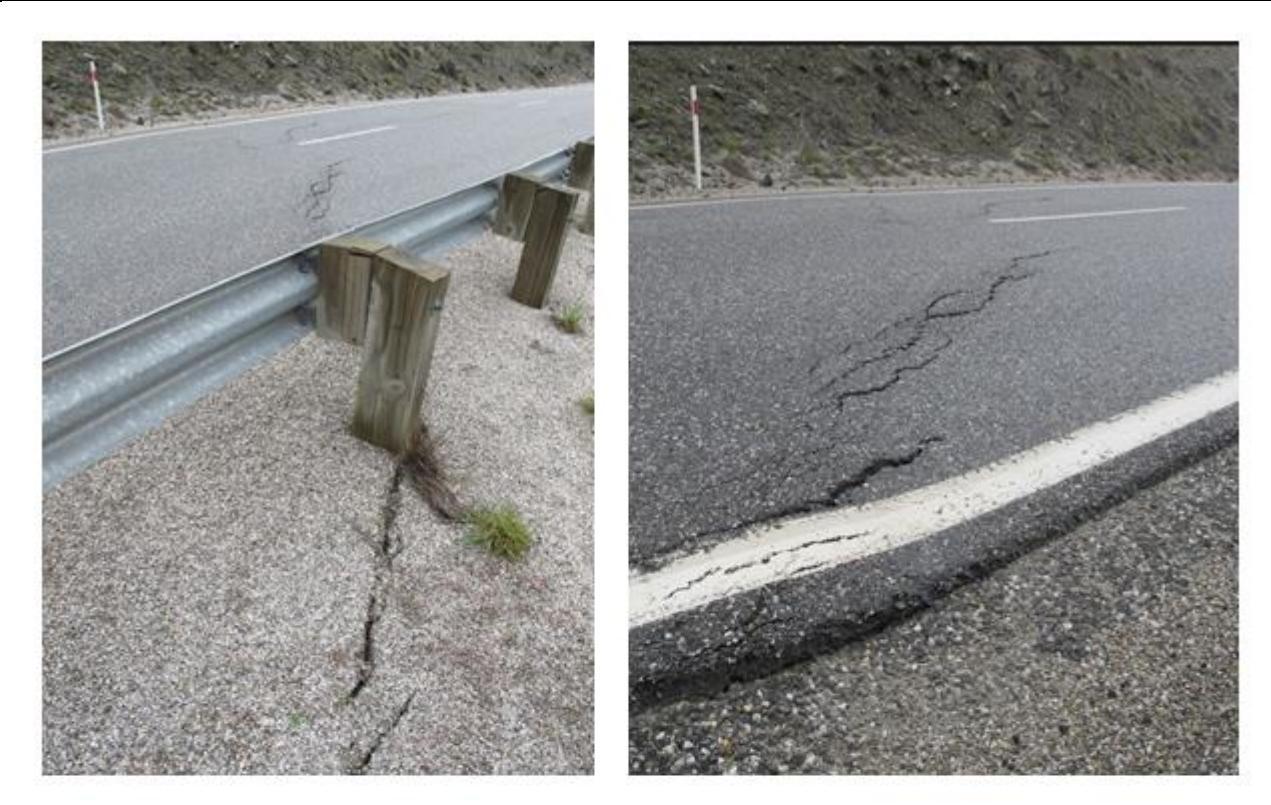
Figure 10. 50mm settlement in the pavement at site 3

It appears that the movement observed is limited to the area below the road and that the complete ancient landslide, which extends above the road, has not remobilized. Fortunately for much of the length of the slip, at the eastern side, the failure appears to be downslope of the road shoulder. The deeper-seated failure under the formation at the western end is more difficult to address.

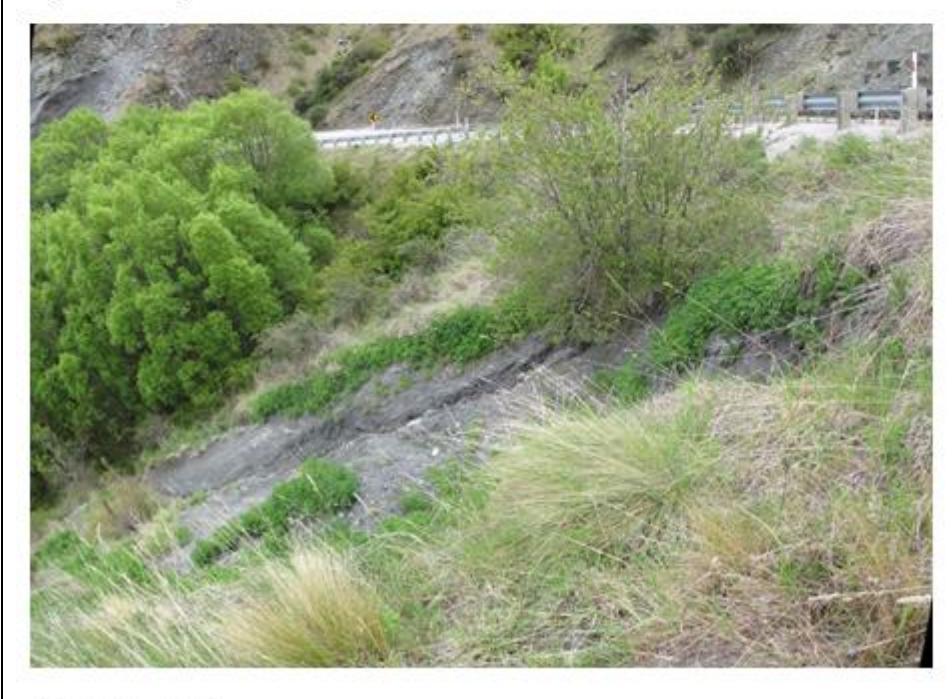
Figure 11. Site 4

Site 4 is a surface slip below the road level between site 3 and the adjacent creek. This site is immediately adjacent to site 3 and may be caused by the same features. Currently site 3 does not propagate as far as the road shoulder and there no sign of this causing immediate instability to the road was observed. Thus, at this stage no further action on site 4 is recommended as there are more significant adjacent issues to be addressed.

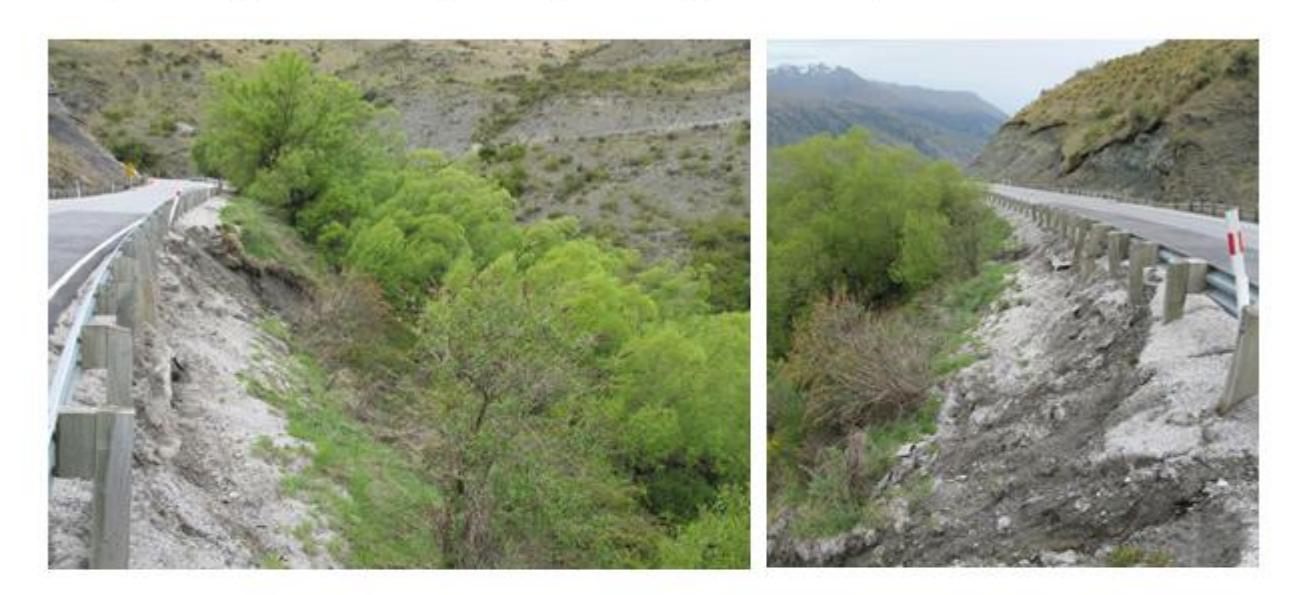
Figure 12. Site 5.

The slip has left approximately six guard rail posts unsupported. The slip is shown below.

This site warrants a structural repair. The two likely solutions are either a tied back gabion structure or a tied back driven soldier pile design as proposed for site 3. A tied back gabion structure has a risk of foundation failure below and would require substantial road excavation and associated delays. A driven soldier pile solution as proposed for site 3 will be less disruptive to construct than a gabion solution. The proximity of rock on the Wanaka side is a risk as there may be rock present that prevents piles from being driven to the desired depth.

- · Excavate a working platform
- Drive 12m long UC piles at approximately 1.2m crs
- Drill 12m long ground anchors between piles at bench level
- · Place timber lagging between piles, above the level of the ground anchors
- Weld SHS walers above and below the ground anchors and fix anchor to walers with steel anchor plate.
- · Backfill against timber and reinstate guard rail

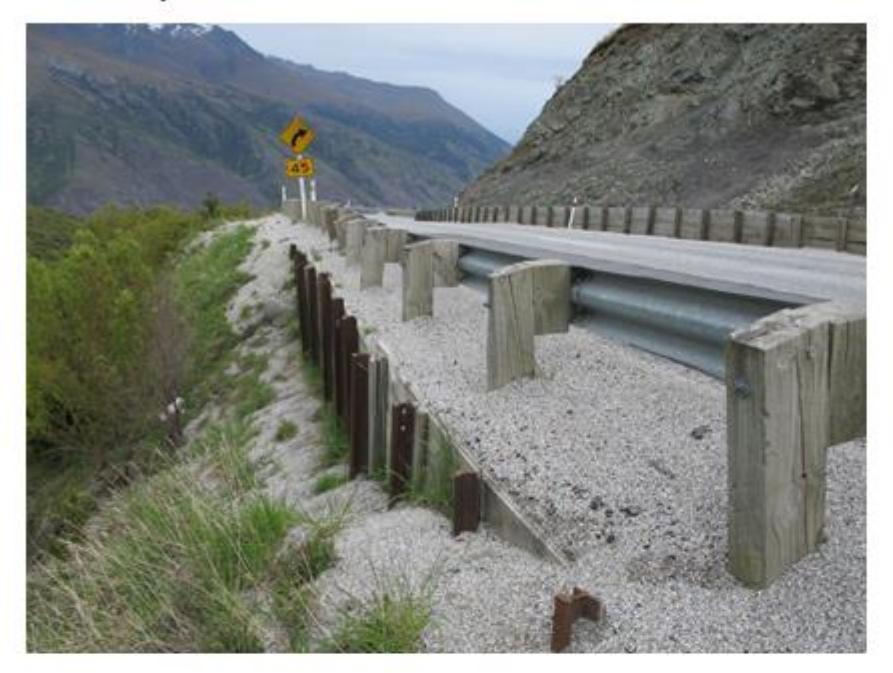
Site 6 is an existing cantilevered driven rail iron retaining structure which appears to be functioning satisfactorily. No action is warranted at this site.

Figure 13. Site 6 driven rail iron wall

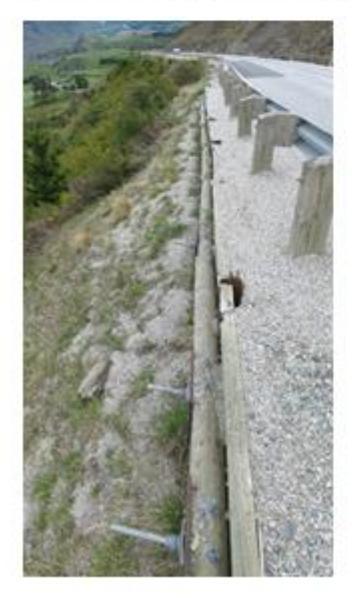
Figure 14. Site 7.

Site 7 is an existing tied back driven UC retaining structure which appears to be functioning satisfactorily. No action is warranted at this site.

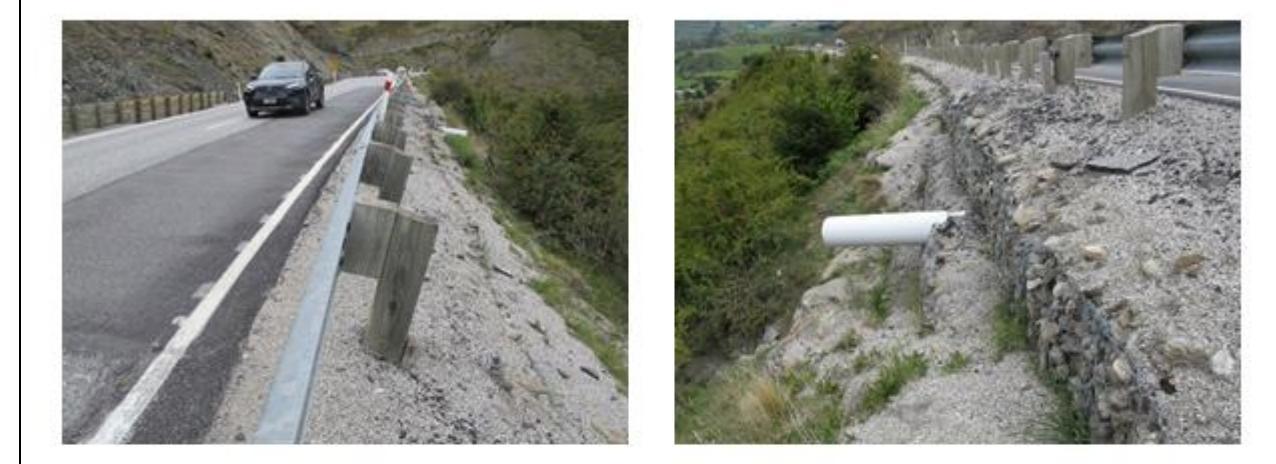
Figure 15. Site 8

Site 8 is an existing gabion wall. The gabions appear to be settling slowly, and the guard rail posts are no longer vertical. The road pavement has recently been patched over top of longitudinal cracking. Currently there is no indication for immediate concern about this site and it is of the lowest priority in this area.

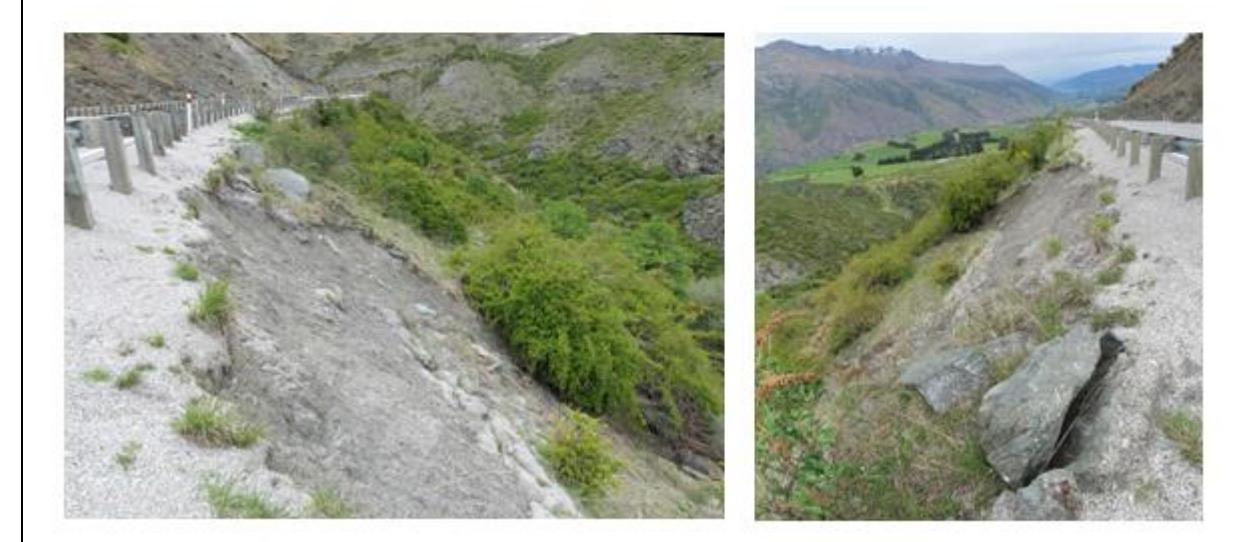
Figure 16. Site 9

Site 9 is a spectacular translational slip that extends further than the eye can see down slope. The slip is 18m wide and does not currently affect the guard rail or the road formation.

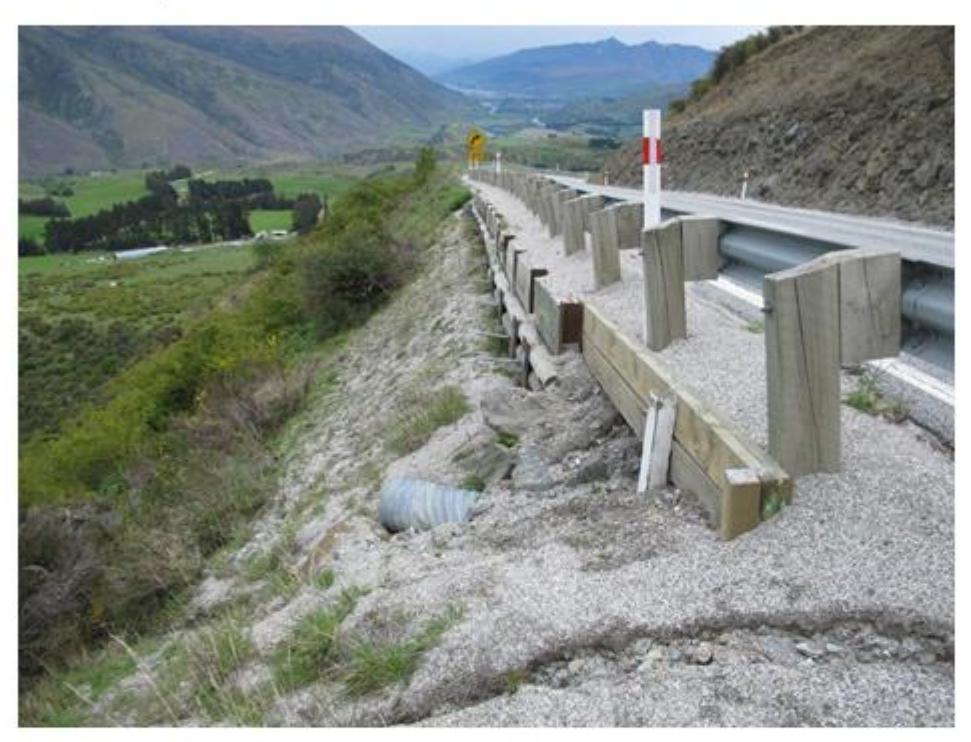
Figure 17. Site 10.

Site 10 is an existing driven tied back steel post retaining structure and is functioning adequately. No action is required at this site.
