**Geotechnical/Natural Hazard  
Assessment  
Three Parks Land, Wanaka**

**March 2007**

Date: March 2007  
Reference: 6CWM03.46 006DD  
Status: FINAL

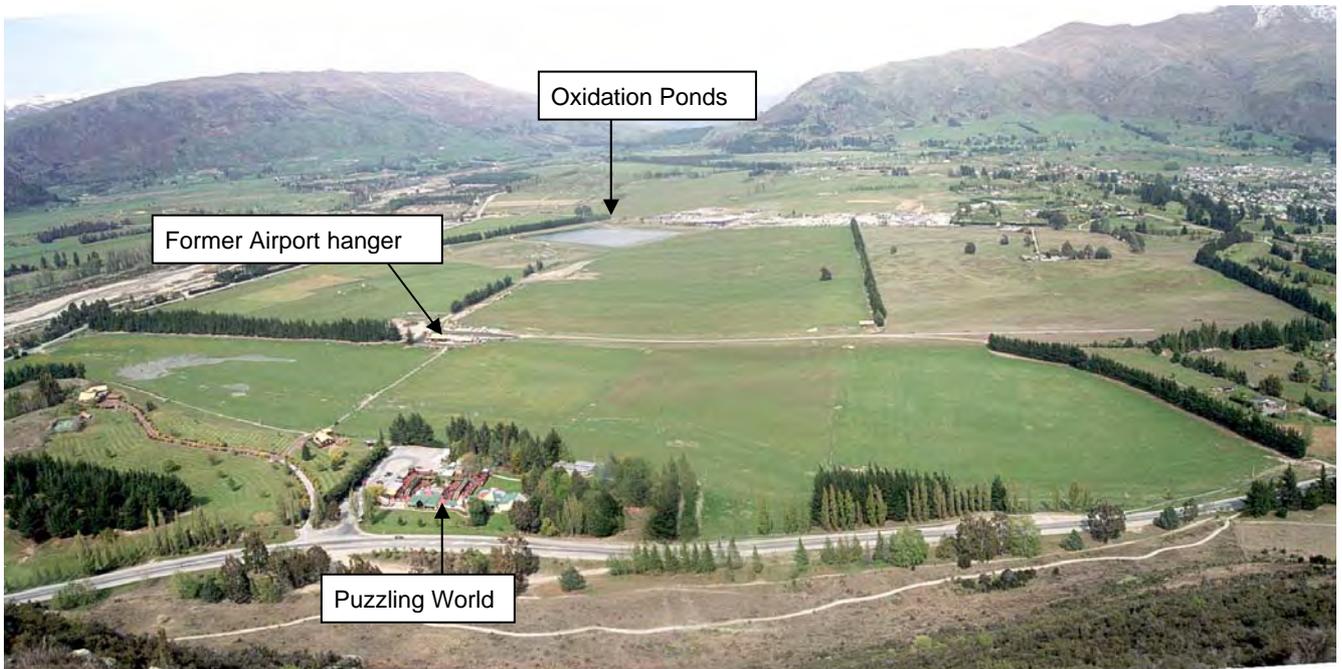
The site is located on an old alluvial landscape formed during the Last Glacial Advance (15-23ka); an overview of the site is shown in Photo 1. As indicated by the topographical map for the region (NZMG, Sheet F40), as well as a survey of the oxidation pond area, average elevation across the site is roughly 320 m above sea level. The topography across the site is gently rolling between old river channels with slopes generally ranging between 0 - 5°. The Cardrona River is located 150 – 200 m east of the eastern property boundary while land to the west is slightly higher in elevation with similar rolling plains topography. The site is bounded at the north by State Highway 84 and Mt. Iron.

Photo 1 - Overview of site from Mount Iron (October 2006).

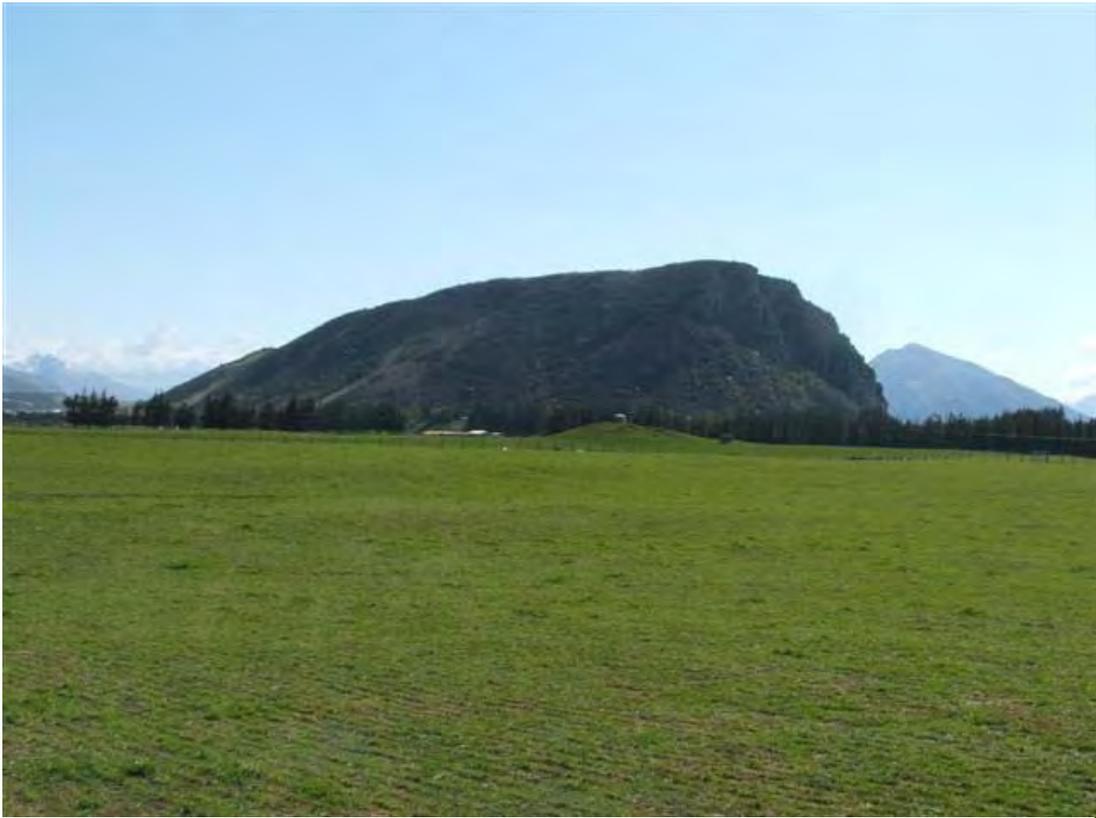
Due to the relatively flat topography, there are no landslide/rockslide/fall hazards on site. The Northern-most portion of the site, which is bounded by the State Highway, is located approximately 100m from Mt Iron (Photo 2).

An assessment of aerial photography and information gathered from the site visit was made to assess the landslide and/or rockfall/slide hazard posed to the development site from Mt Iron. The schist outcrop that makes up Mt Iron is well vegetated and historic aerial photographs do not show any evidence of instability of the slope. There is also no evidence of rock surrounding the slope on the side of the Wanaka State Highway. The whole schist outcrop is dipping away from the site 15° to the North-west. Landslide and/or rockfall/slide risk to the site from Mt Iron is very low.

Photo 2 - Mt Iron to the North of the proposed development site (October 2006).

There is no evidence of landslides or rockfalls affecting the area from Mt. Iron. We recommend that the slope be observed following major seismic event, severe storm or incidence of rockfall.

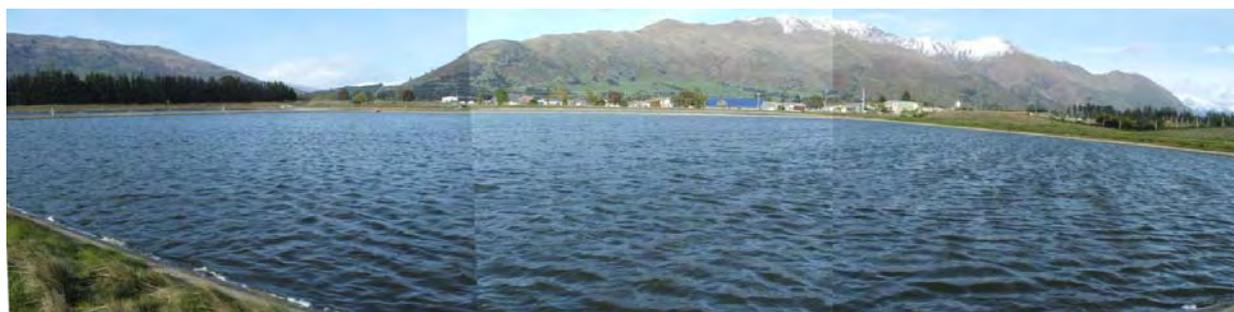
The oxidation ponds were constructed in the mid to late 1970’s but in November 1976 were not yet installed. The system consists of three oxidation ponds that receive wastewater from Wanaka via a pipeline along Ballantyne Road (Photo 3). The treated water is then piped along Riverbank Road and discharged into the Clutha River near Albert Town.

Photo 3 - Looking southwest over the largest of the oxidation ponds (October 2006).

It had been recognized that water quality at the discharge point does not always comply with consent conditions. Given this and other land development pressures at the current oxidation pond site, a Joint Working Party Group was formed in March 2003 to investigate alternative options and locations for Wanaka's waste treatment under an initiative entitled, "Project Pure". The final report by this working party indicated that the preferred option involves moving treatment elsewhere while the existing oxidation ponds are to be decommissioned and the site rehabilitated.

The sludge and clay layer would need to be removed to restore the natural drainage before development of the area could be undertaken. Further tests would be required to assess the suitability of the material beneath these ponds for foundations and pavements.

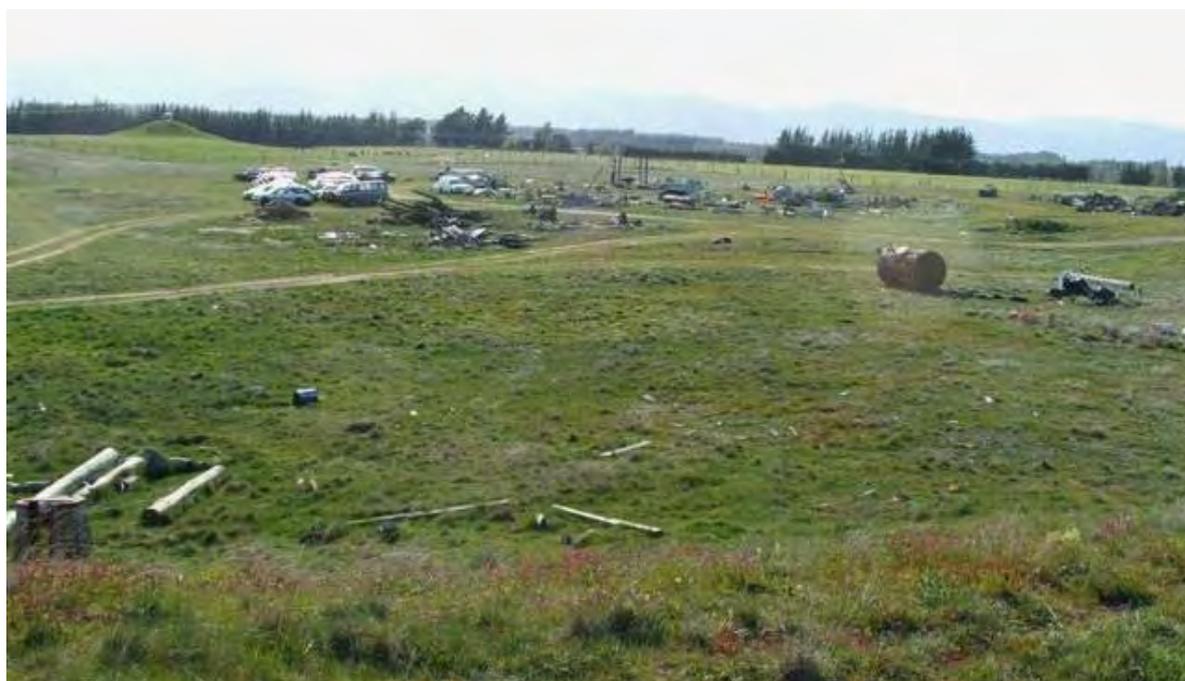
It has been observed that the area east of the oxidation ponds has historically contained a number of car wrecks, large drums/tanks, rubbish and other metal debris. The use of this area for storage of these types of materials continues today as observed during the site walkover inspection (Photo 4).

Photo 4 - Looking east over car wrecks, metal debris and other rubbish to the east of the oxidation ponds (October, 2006).
