In the matter of a submission under clause 6, Schedule 1 of the Resource Management Act 1991 on Stage 3B of the Queenstown Lakes Proposed District Plan

**Statement of Evidence of Grant Meldrum**

# Walter Peak High Country Farm

## *Debris Flow Hazard Assessment*

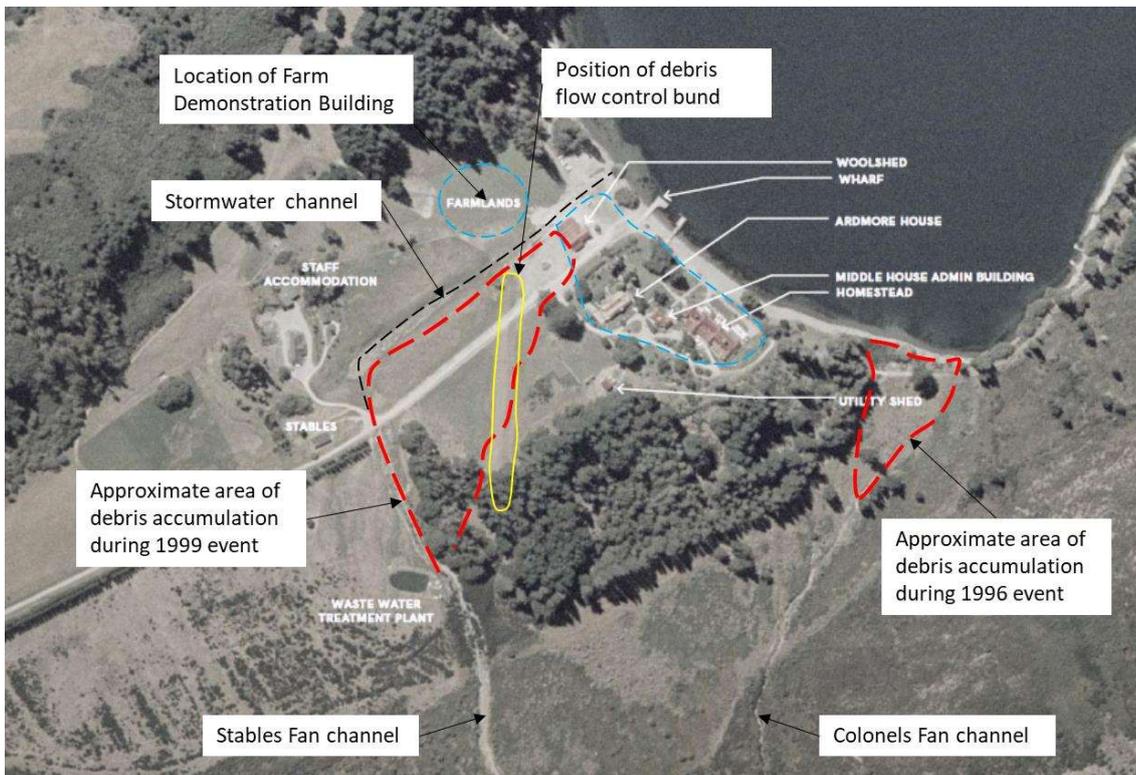
**Figure 2: Existing layout of WPHCF facilities including debris flow channels, debris accumulation areas. Areas delineated in blue area the main areas of congregation. Image after Beca 2017.**

The ground surface typically grades towards Beach Bay at up to about 1V:10H. A natural watercourse flows towards Beach Bay between the old woolshed and the Farm Demonstration Building and this watercourse carries most stormwater flows (Figure 2).

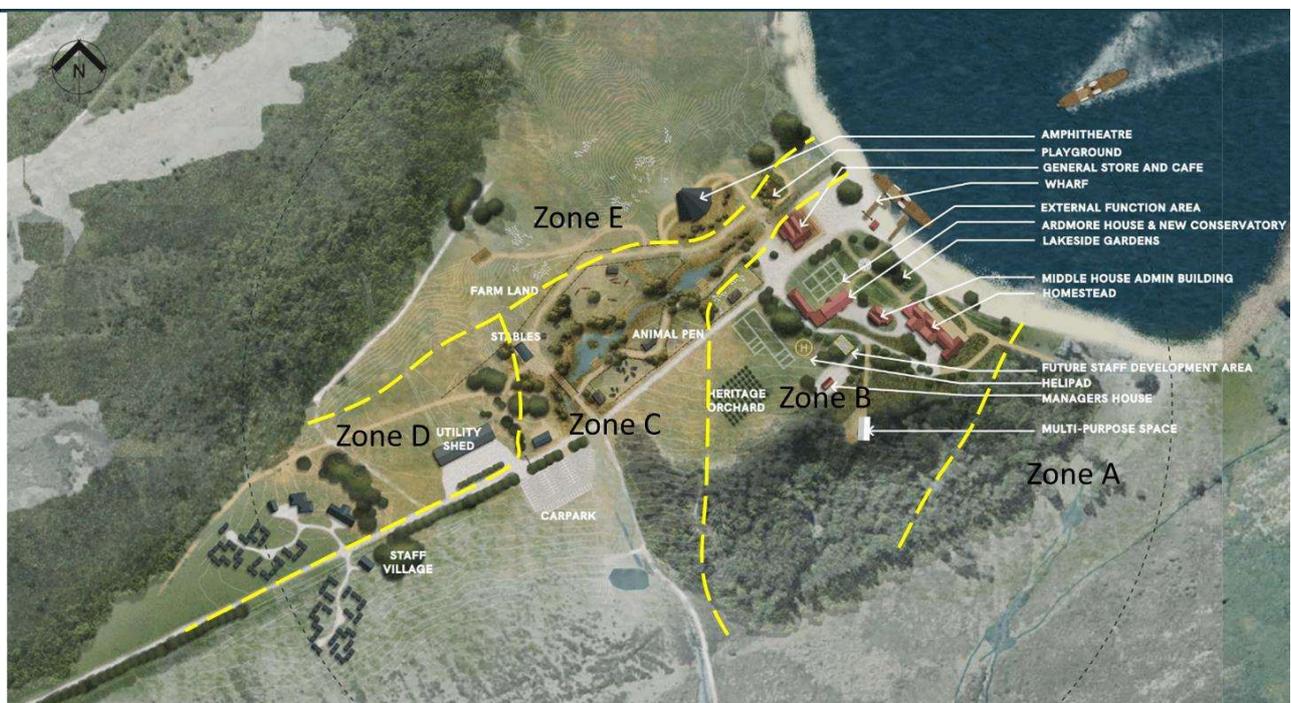
Figure 5: Plan of WPHCF showing key elements of the site development and five zones inferred to have similar lives risk levels. Base image after Beca (2017).

27. Zone A and C are at a higher risk from effects of debris-flows as they are on the upstream side of protection works.
28. Zone B is primarily occupied by the tourism operations at the site. These areas are only populated by a small number of persons outside business hours. Debris flow risk will only occur during periods of extreme rainfall and should these occur during business hours it is considered that management systems can remove patrons and staff in a timely manner and before potential debris flow risk is heightened.

33. The areas designated Zones A and C in the Golder report are part of the area of active management of debris-flows. These areas are at moderate to high risk of Natural Hazard (depending on the nature and scale of any new building or structure) and should not have buildings or structures used for living purposes.
34. Structures of an ancillary nature (Level 1 buildings as defined in the Building Act) would be suitable on these areas.
35. The above opinions are given on the basis that the existing protection structures are maintained and any future debris that is intercepted by these structures is removed as soon as reasonably practicable following the debris-flow event.

- The distribution of visitors around the site increases the life risk in those areas with the highest population density, in particular the area around restaurant facilities (Zone A) and the Farm Demonstration Building (Zone E). For debris flows similar to the observed events, these buildings are located in distal areas of the debris fans where the likelihood of damaging debris flow impact is relatively low. In addition, the buildings where visitors and staff congregate offer some protection against the type of debris flows that have been observed at WPHCF. However, the level of protection afforded by each building and how this might help to mitigate the life risk from debris flows has not been assessed.

- 1) A detailed review of the existing defensive measures is recommended to allow an evaluation of the likely effectiveness of these structures at protecting the most vulnerable parts of the operation. This review should include an assessment of the carrying capacity of the channels and effective height of the bunds with a view to identifying deficiencies that need to be addressed.

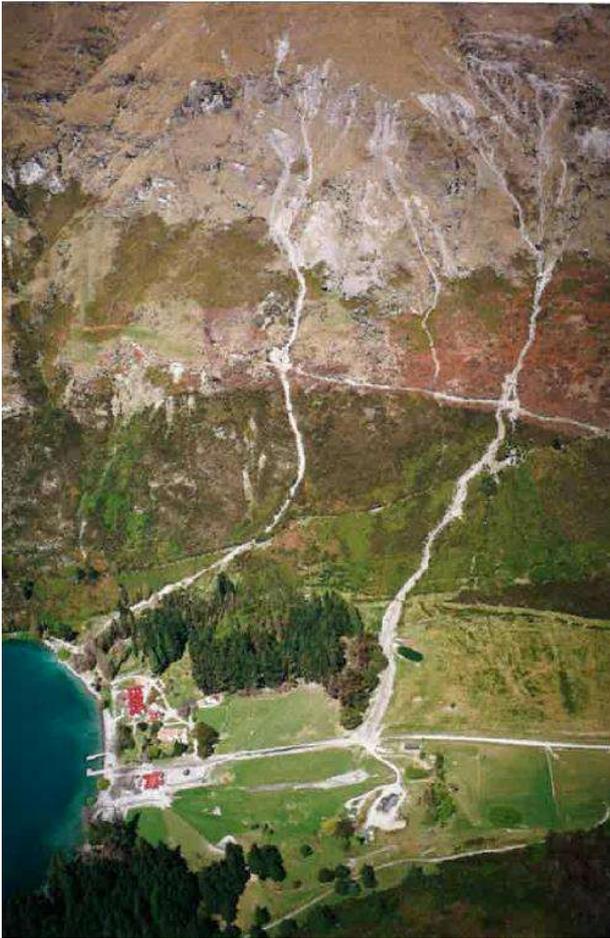
A debris flow affected the Colonel's Fan channel in 1996 following of a period of heavy rain (Figure 2). This debris flow affected the area south of the homestead with debris reaching the lake (refer to photograph A1 in Appendix A). No damage occurred to the homestead and there were no injuries. Following this debris flow,

**Photograph A1: Debris flow channels from 1996 debris flows showing source areas in the upper part of the image and two prominent channels (Colonel's Fan on the left and Stables Fan on the right). Note that little debris affected the buildings.**

Mr McQuilkin used an excavator to clear debris and construct a series of bunds to direct debris in future events away from the homestead.

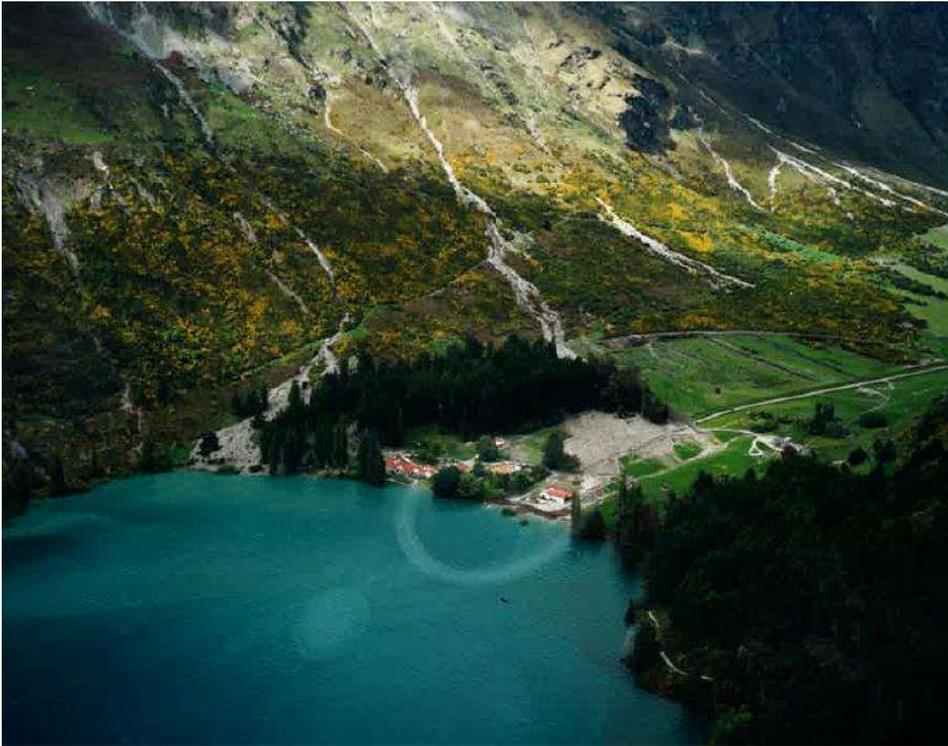
The Stables Fan debris flow (Figure 2) in 1999 was witnessed by Mr McQuilkin who was manager of the facility at the time (Photographs A2, A3 and A4 in Appendix A). This debris flow event deposited in the order of 10,000 m<sup>3</sup> of debris over an area with a maximum deposited thickness of 2 to 3 m of bouldery gravels in and around the WPHCF site. The Stables Fan debris flow occurred following a period of prolonged rainfall during November 1999. NIWA records indicate that 243 mm of rainfall occurred in Queenstown between the 15 November and 18 November 1999, while the average monthly rainfall for November in Queenstown is 63 mm. Mr McQuilkin remembered high flows in the various catchments above WPHCF and the rapid deposition of the debris over a period of a few minutes. Levees of debris adjacent to the channel suggests that the debris was transported as a debris flow but was finally deposited on the flat lower slopes of the fan as bedload (suspended sediments in water) carried by the flood flows. No damage to the key buildings on the site occurred and there were no injuries. A tractor and outbuildings, including the stables, were inundated and partially buried.

**Photograph A2: Effects of the 1999 debris flow. Note additional debris affecting the Colonel's Fan and significant debris deposited to the right of the buildings on the Stable's Fan. (Photograph courtesy of Real Journeys.)**

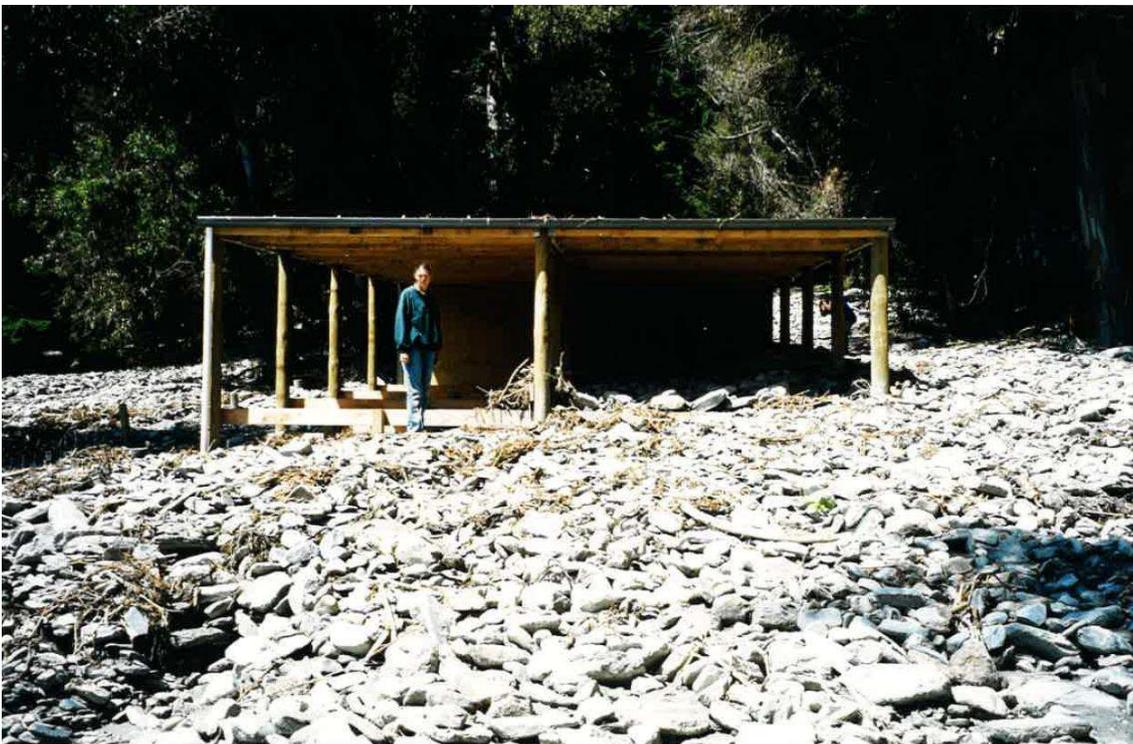
**Photograph A3: Deposition of boulder gravel on the Stables Fan following the 1999 debris flow. The building is the old stables that was inundated by about 1.5 m and was subsequently abandoned.**

Following the 1999 debris flow on the Stables Fan, debris was reshaped to form a 200 m long bund, 2-3 m high, between the main channel of the stables stream and the Old Woolshed and Ardmore House (Figure 2). This bund directs flows into the main surface water channel between the Old Woolshed and the Farm Demonstration Building. In addition, the main channels of the Stables and Colonel's Fans (Figure 2) were cleared of debris to increase the flow capacity and the excavated material placed on the down slope side of the channel as a bund. The stream that runs between the Woolshed and the Farm Demonstration Building and carries storm water from Stables Fan into Beach Bay has been armoured with boulders and is fenced to exclude the public.

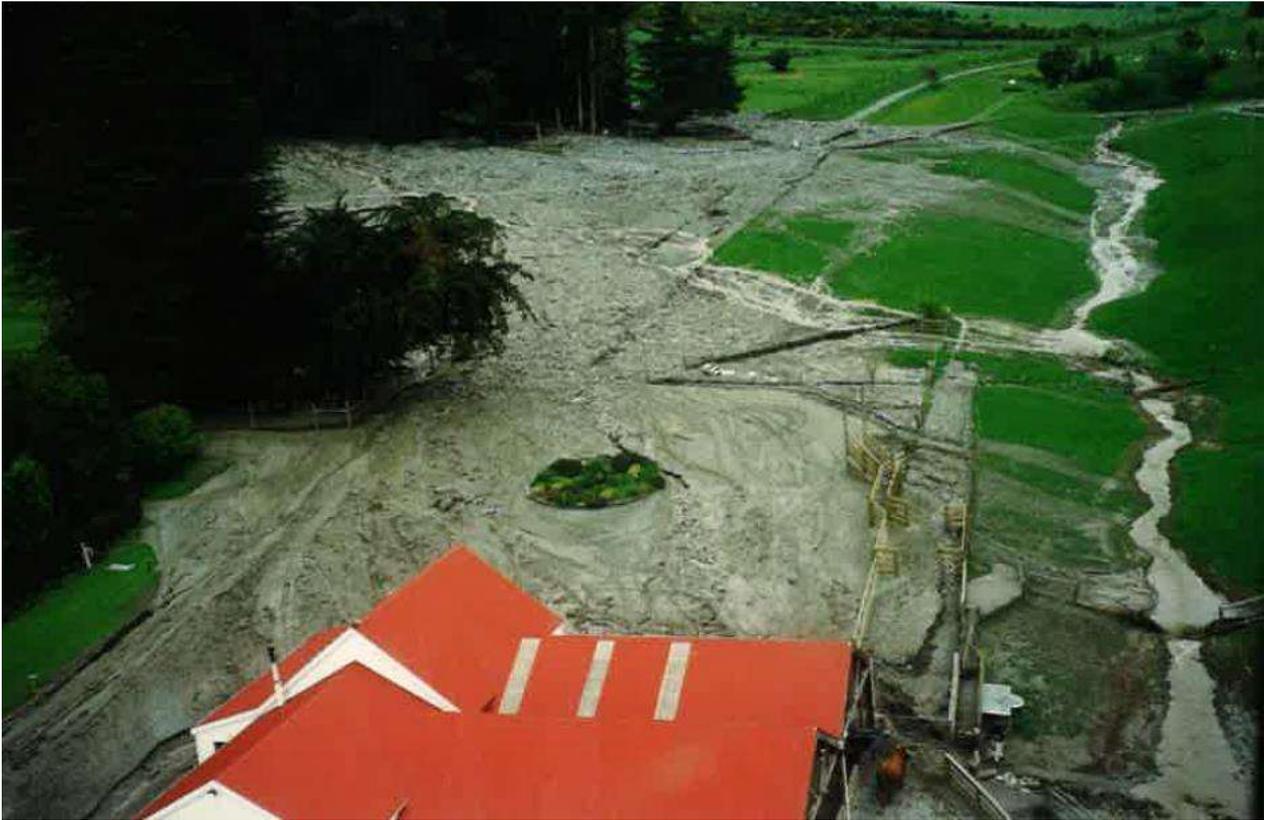
**Photograph A4: Debris inundating the area west of the woolshed (foreground) in 1999. Note the main stormwater channel on the right of the image. (Courtesy of Real Journeys).**

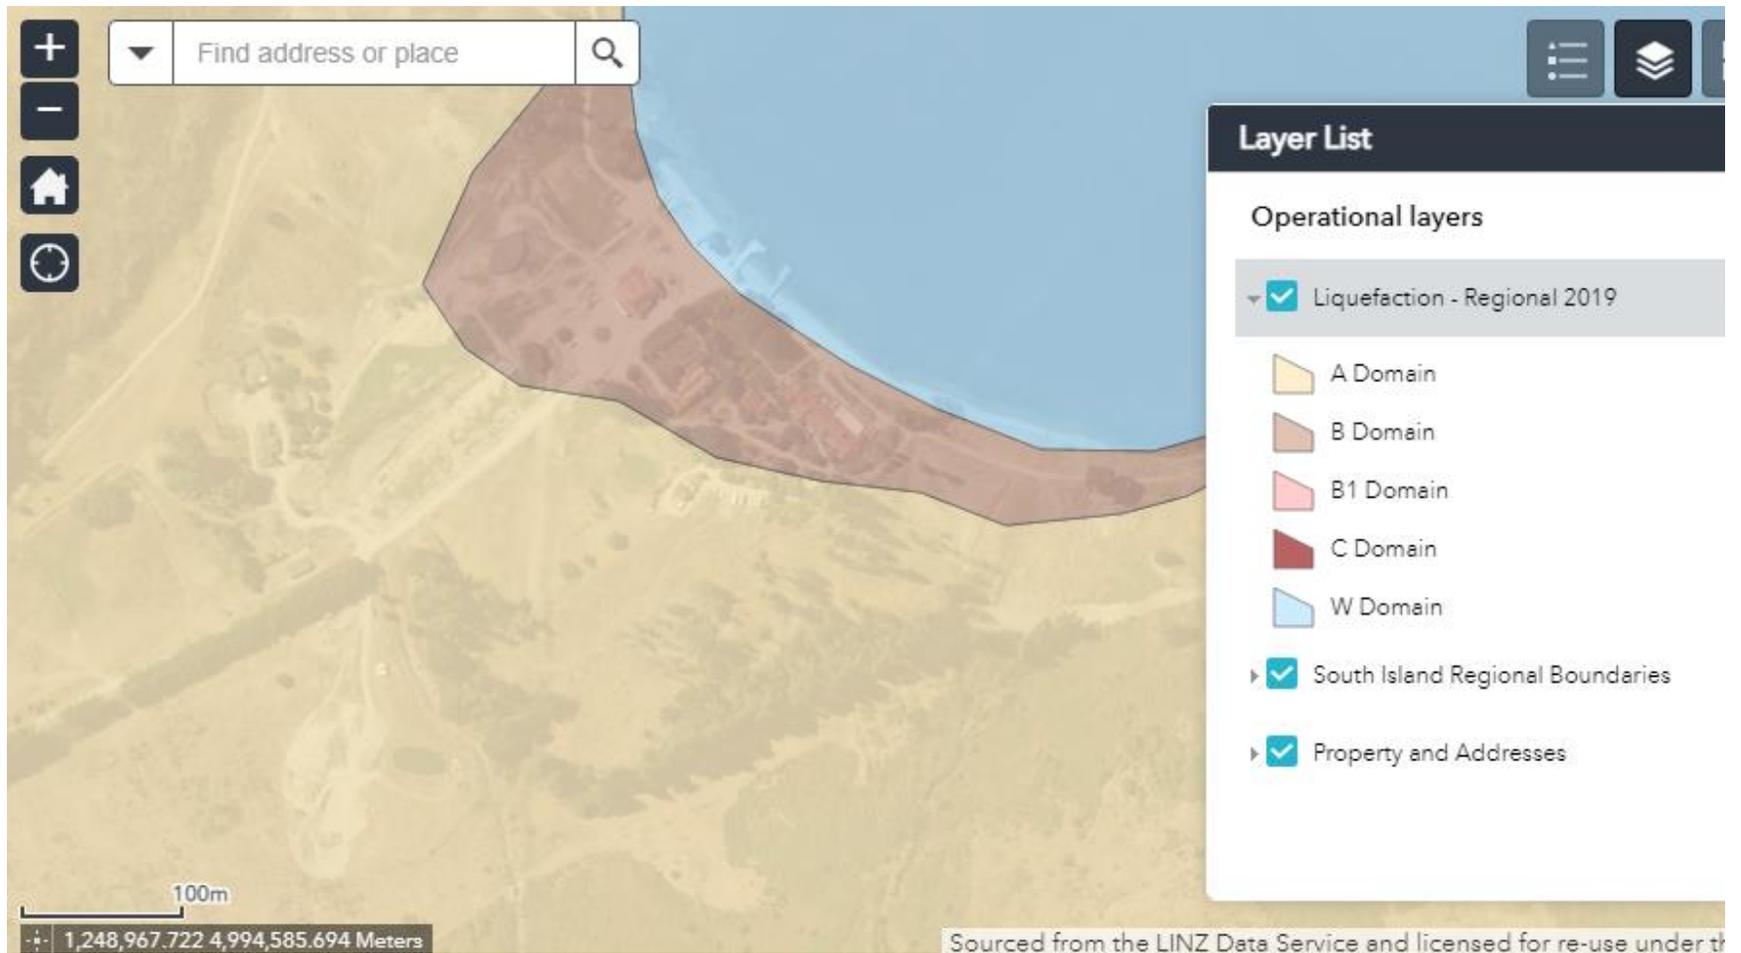
24. The area identified is within the domain B is defined as “may possibly cause land damage from liquefaction” and should be considered a “liquefaction awareness zone”. These are at the lower end of natural hazard risk.

Liquefaction Zones – Domain A Unlikely to have liquefaction damage, Domain B May have liquefaction damage

25. Construction of buildings on land that may be subject to liquefaction damage is covered within the New Zealand building code verification method B1/VM4. Any necessary mitigation will be able to be addressed at the time of building consent applications.

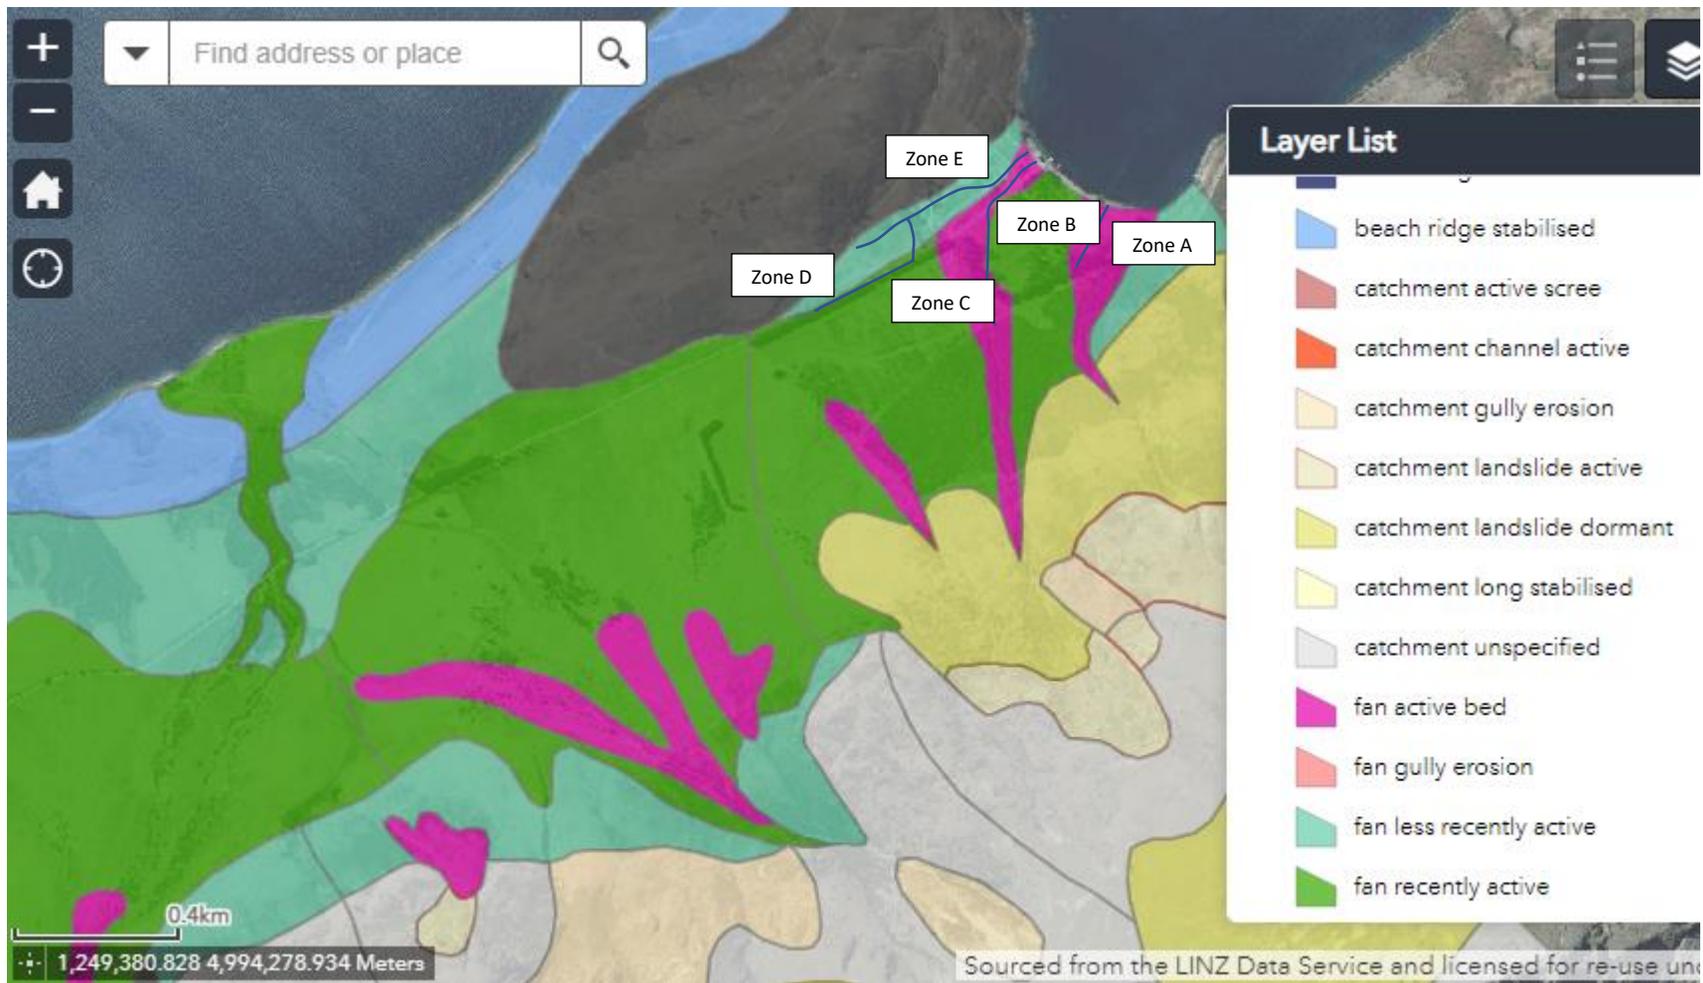
29. It is my opinion that the areas to the north of Mount Nicholas – Beach Bay Road excluding the area within Zone C from the Golder report are at low risk of debris-flow natural hazard. This includes the areas of alluvial fan and the hill between Beach Bay and the main lake to the north.

Golder report Zones superimposed on ORC hazard map for alluvial fans
