**Gibbston Valley Station Development**

**Resource Consent Application**

**Preliminary Geotechnical  
Investigation and Natural Hazard  
Assessment**

**4 April 2008 – Final Issue**

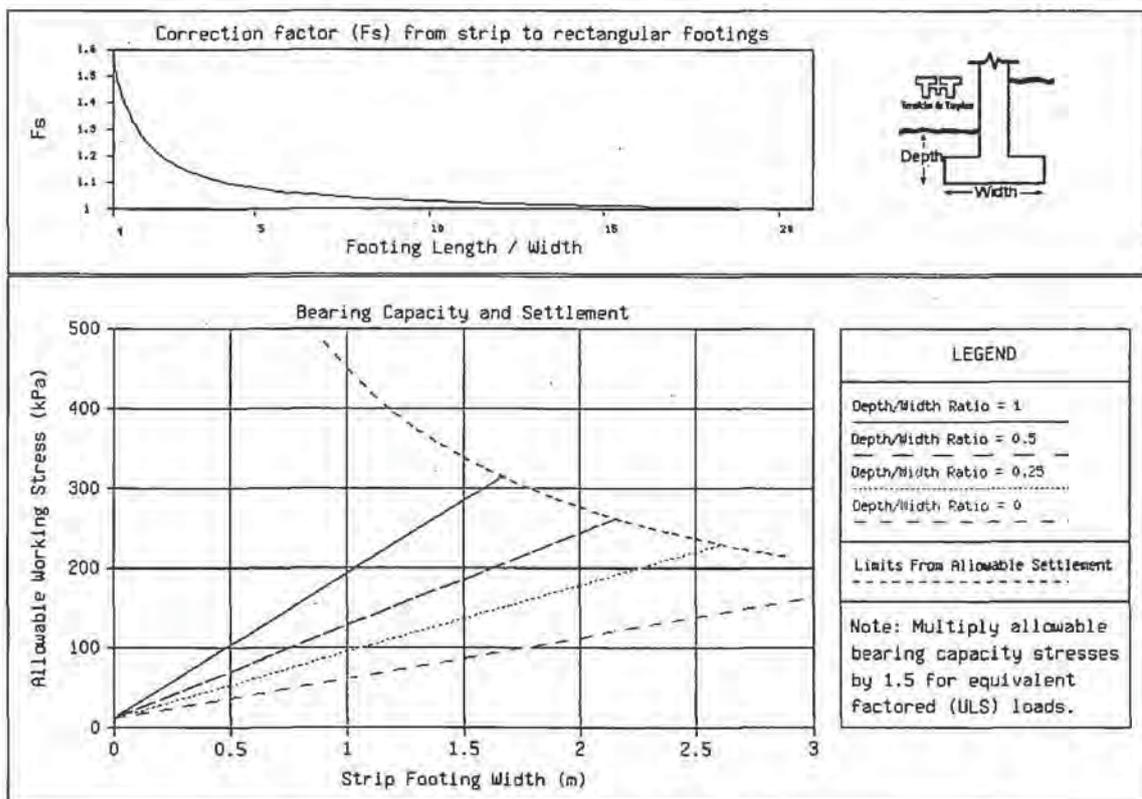
**Figure 7.1: Preliminary Recommendations for Working Stress of Footings bearing on Alluvial Fan Deposits or Engineered Fill overlying Alluvial Fan Deposits**

Figure 7.1 provides recommendations for foundation working stresses governed by bearing capacity (for narrow footings) or settlement (for wide footings) for foundations bearing on Alluvial Fan Deposits or Engineered Fill overlying Alluvial Fan Deposits.

From Figure 7.1 it can be seen a working bearing stress of approximately 80 kPa is recommended for a 300mm wide by 400mm deep strip footing bearing on Alluvial Fan material or Engineered Fill overlying Alluvial Fan Deposits. This corresponds to a factored (ULS) bearing capacity of approximately 120kPa and a geotechnical ultimate bearing capacity of 240kPa.

Figure 7.1 and 7.2 have been developed based on methods recommended by Peck Hanson and Thornburn (1974).

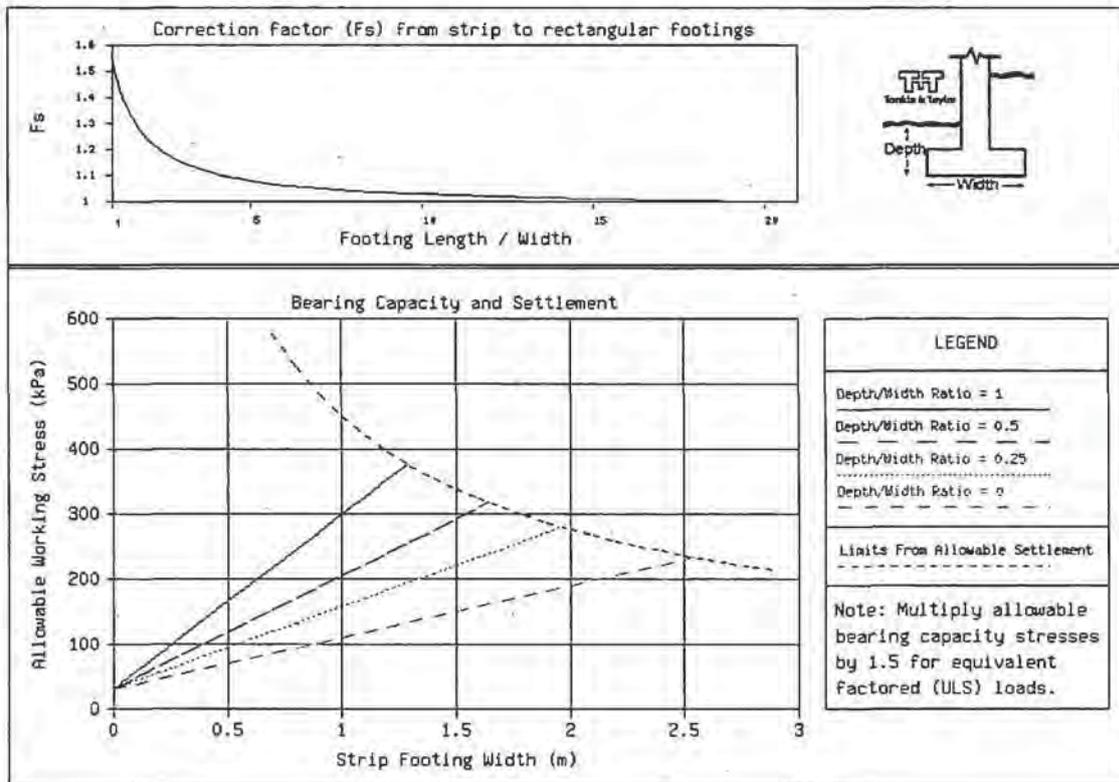
**Figure 7.2: Preliminary Recommendations for Working Stress of Footings bearing on River Gravels or Engineered Fill overlying River Gravels/Schist Bedrock**

Figure 7.2 provides recommendations for foundation working stresses governed by bearing capacity (for narrow footings) or settlement (for wide footings) for foundations bearing on River Gravels or Engineered Fill overlying River Gravels/Schist Bedrock.

From Figure 7.2 it can be seen a working bearing stress of approximately 120kPa is recommended for a 400mm wide by 400mm deep strip footing bearing on River Gravels or Engineered Fill overlying River Gravels/Schist Bedrock. This corresponds to a factored (ULS) bearing capacity of approximately 180kPa and a geotechnical ultimate bearing capacity of 360kPa.

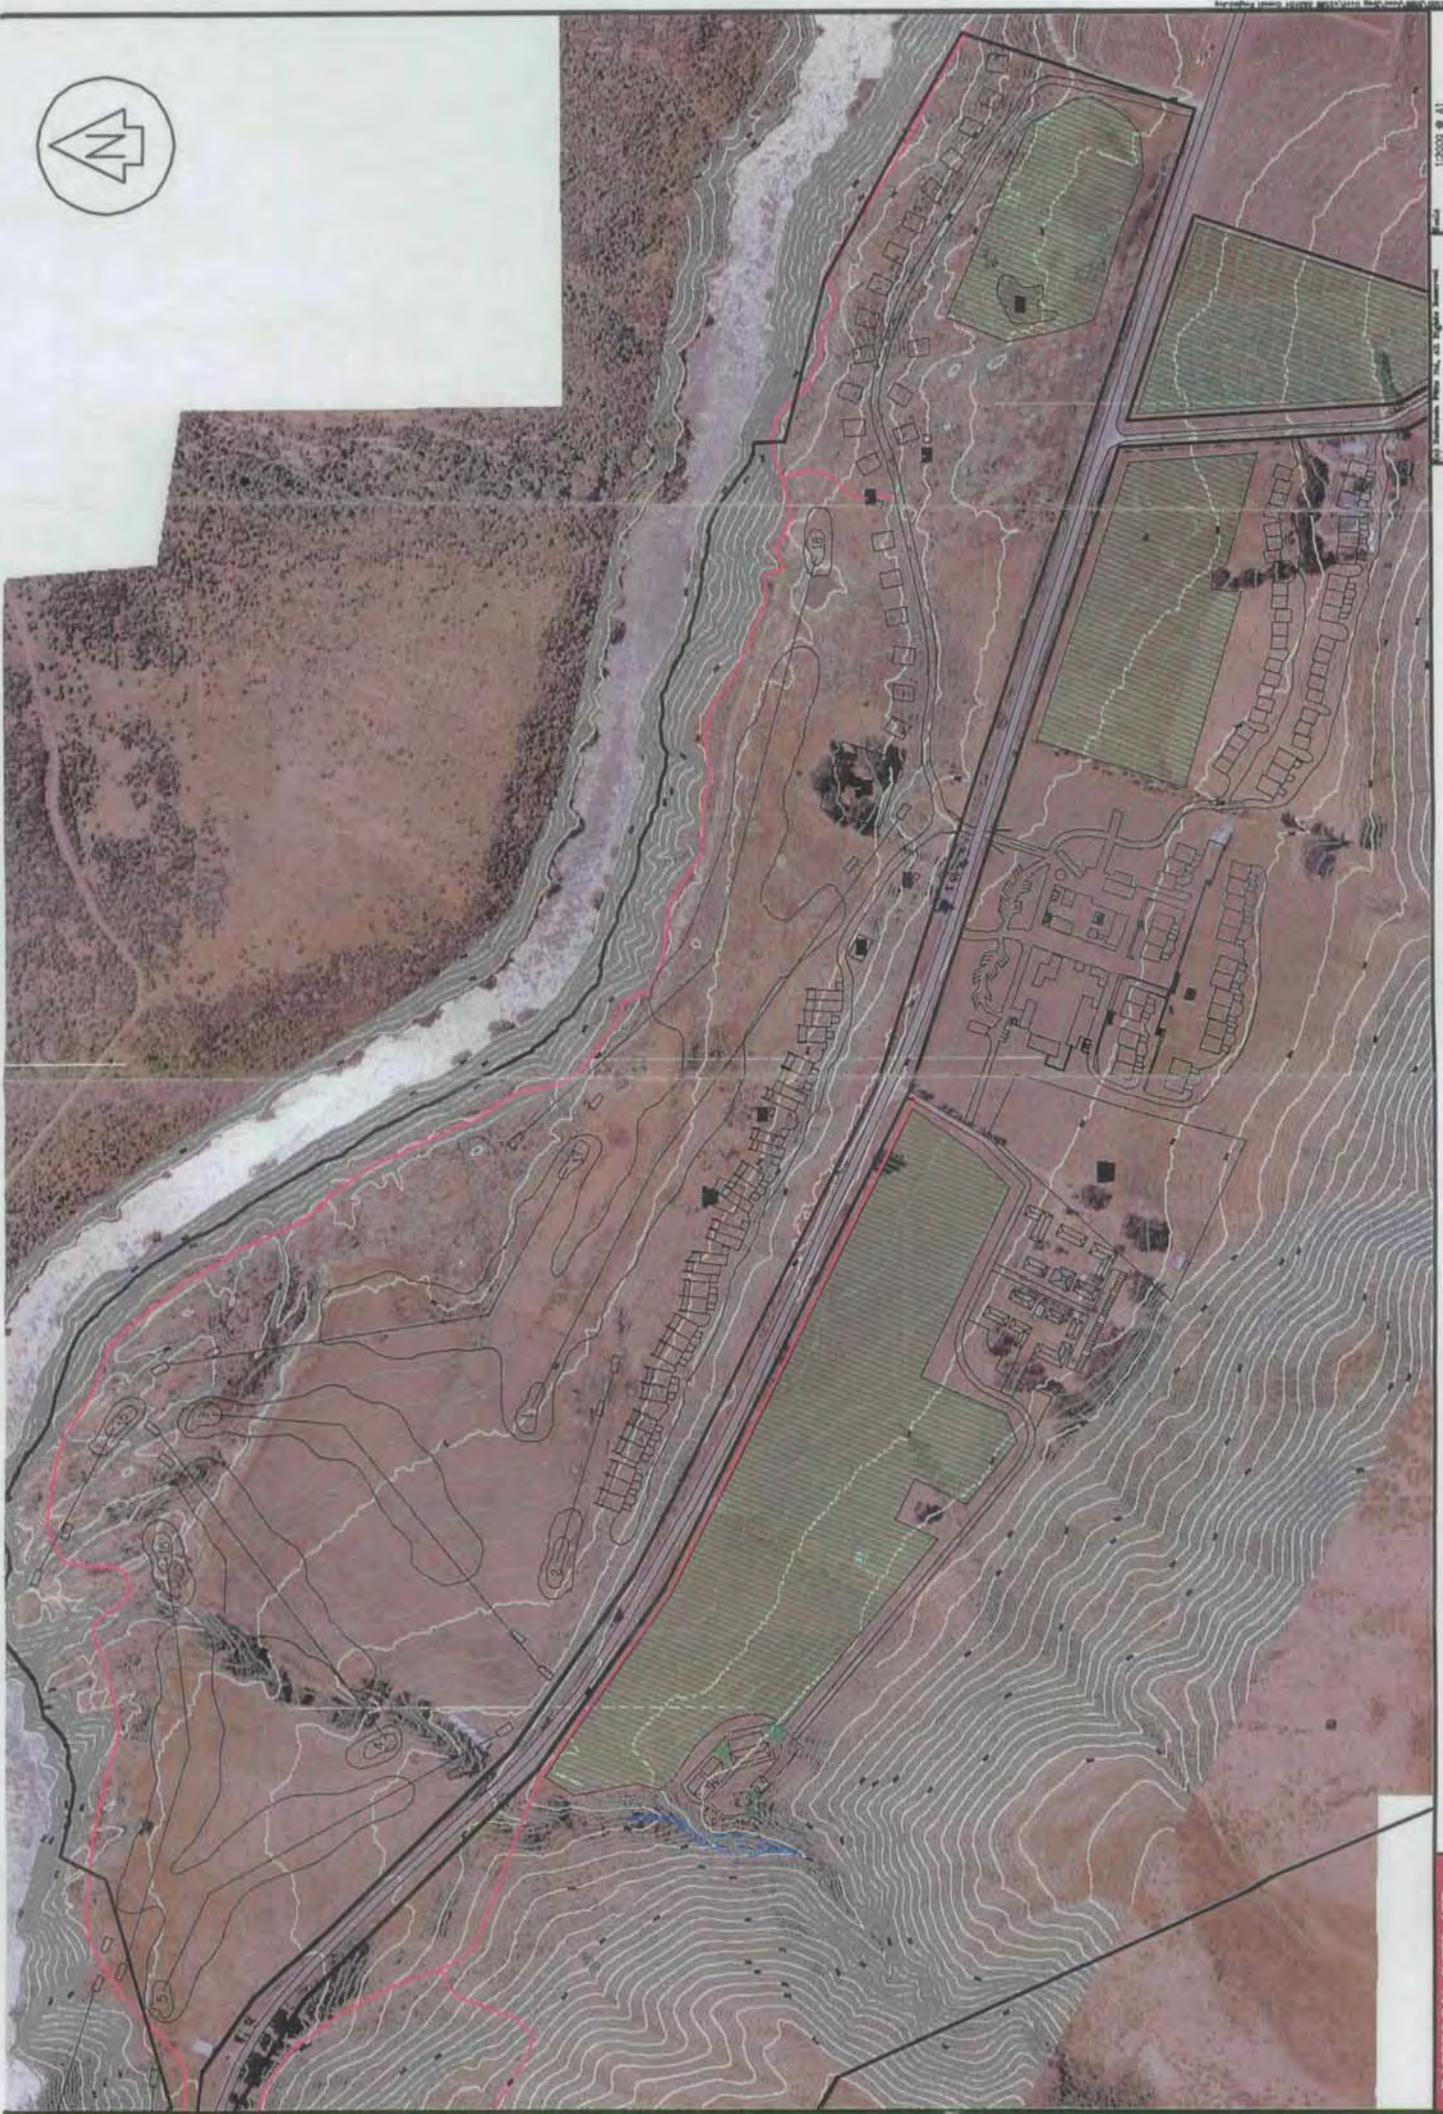
Gibbston Valley Station 1st Feb. 2008

- **Patterson Pitts Ltd. plan titled Gibbston Valley Station 1 Feb 2008, (preliminary western development plan)**
- **Patterson Pitts Ltd. plan titled Gibbston Valley Station 1 Feb 2008, (preliminary eastern development plan)**
- **Patterson Pitts Ltd. plan titled Central Area Gibbston Valley Station dated 24/10/2007, (preferred eastern development locations)**

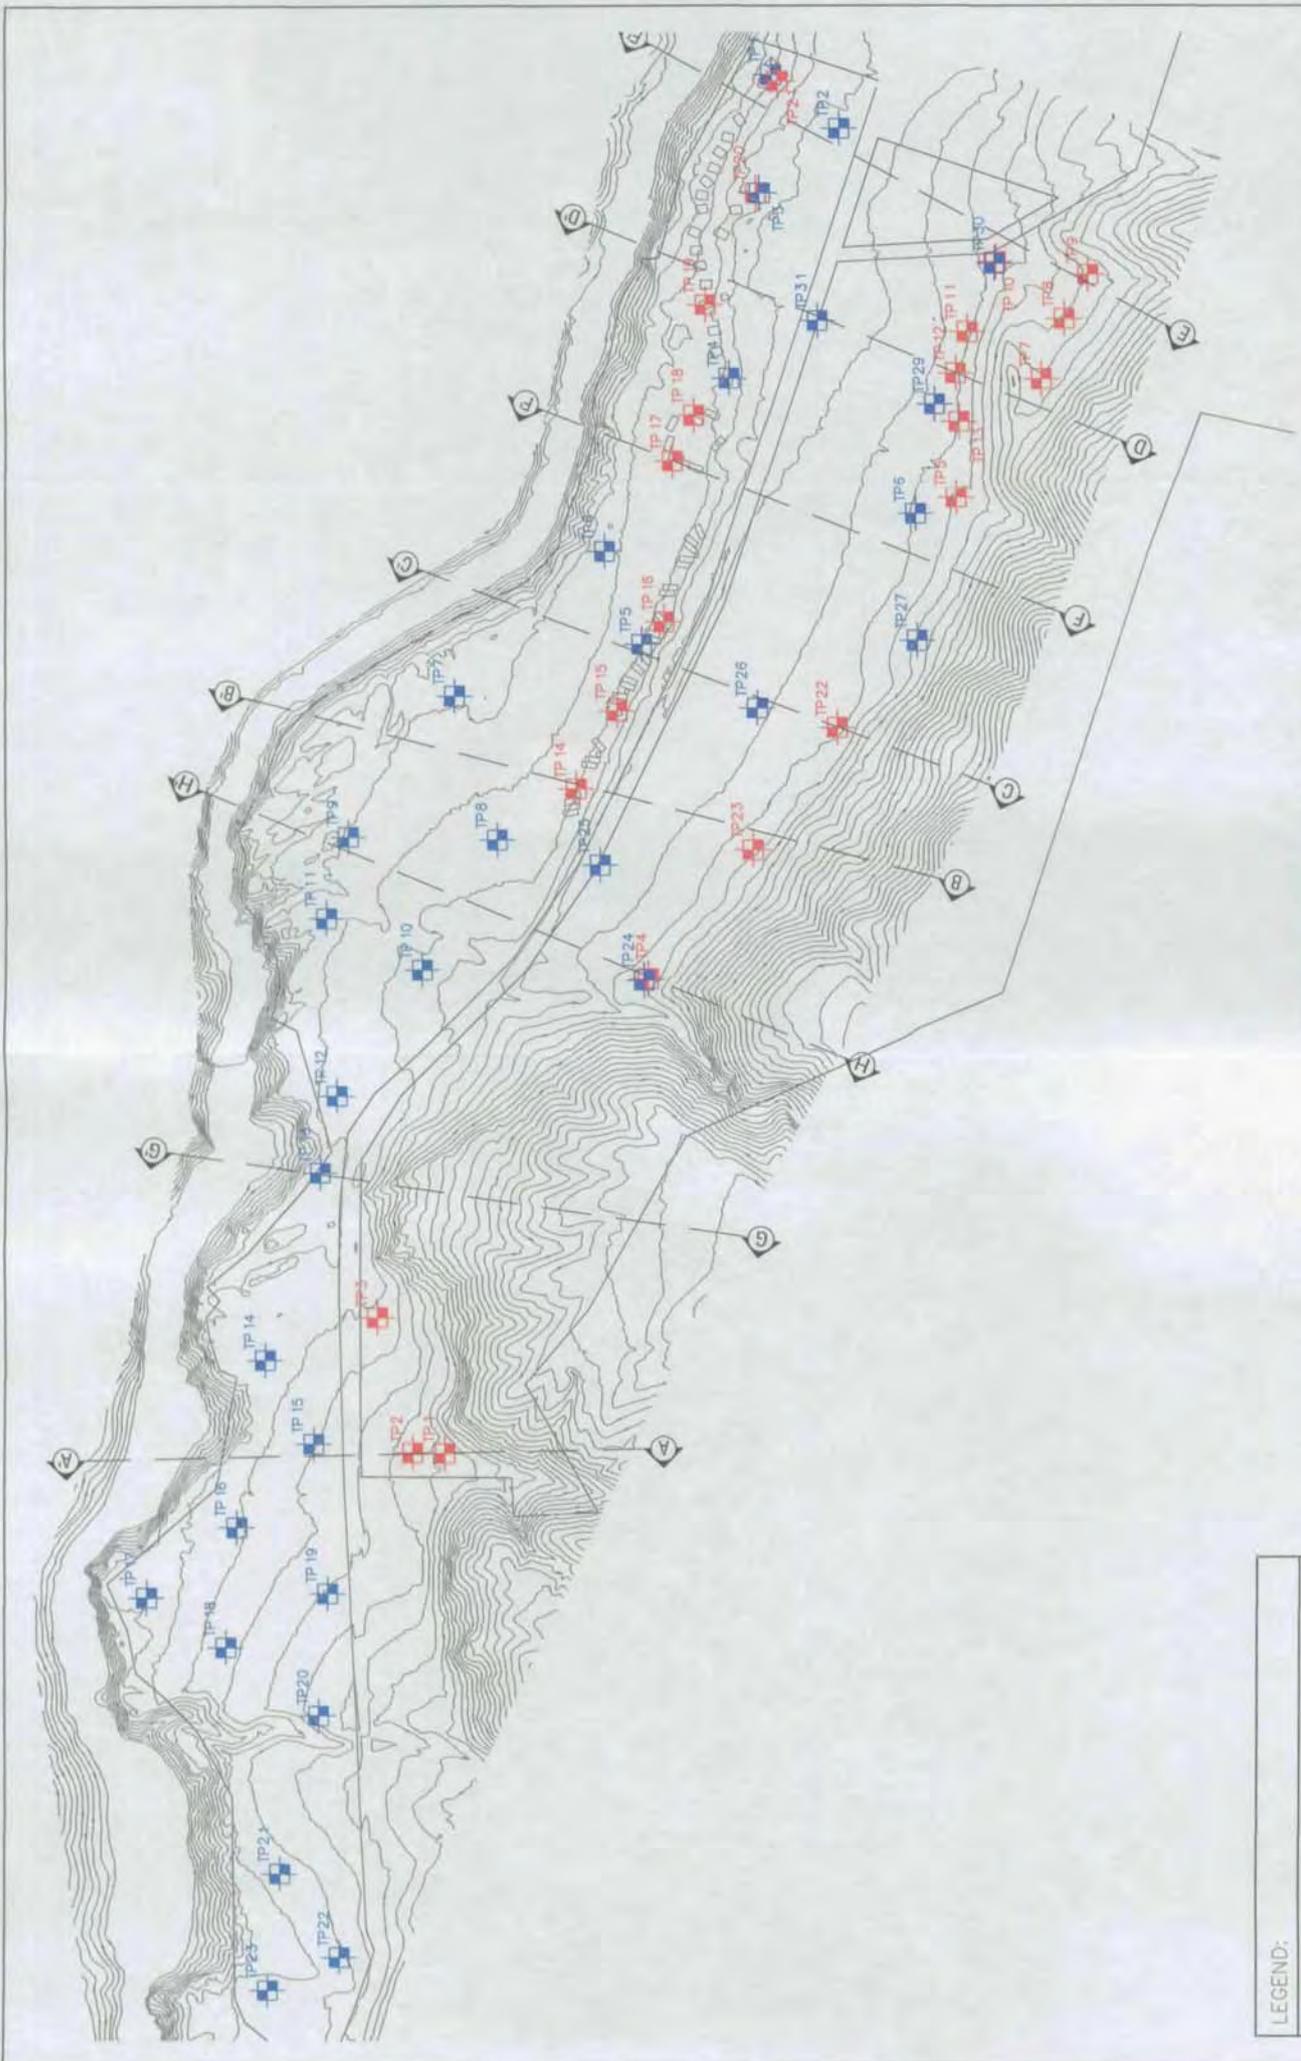
GIBBSTON VALLEY STATION LTD.  
 GIBBSTON VALLEY STATION DEVELOPMENT  
 GIBBSTON VALLEY  
 Test Pit Investigation Plan

An additional 30 shallow test pit excavations were undertaken by Duffil Watts Consulting Group (DWK) as part of a water infiltration assessment. The locations of these test pits are also shown on Figures 1b and 1c. Three of the test pit locations (T&T test pit locations TP4, TP20 and TP21) were used for both geotechnical and infiltration assessment purposes.

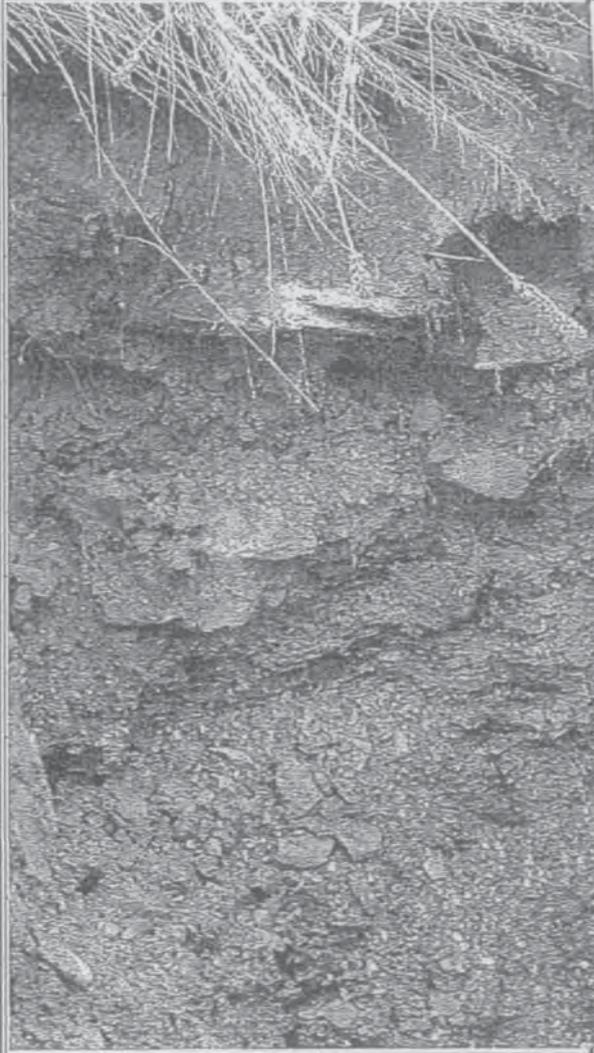
# TEST PIT LOG

0.0	STRATA DESCRIPTION	USCS	Graphic Log	Water Table	Samples	S.P.T		SCALA PENETROMETER (mm/blow)				0.0	
						N	uncorrected	34	50	100	150		
0.0	brown silty sand , moist soil with 15% roots, massive structure, well graded, firm soil strength and tightly packed	ML	X										0.0
0.5	brownish grey silt loam, massive structure, firm soil strength well graded and tightly packed with fine, medium and coarse schist gravels and cobbles	SM	X										0.5
1.0	Grey crumbly folded schist, with 50% fine gravel, 20 % medium gravel and 10 % coarse gravel	GW	X										1.0
1.5													1.5
2.0
