# Wanaka Catchment Group Alpha Burn Station Land Environment Plan.

# Wanaka Catchment Group, Alpha Burn Station Land Environment Plan

Draft Wetwell Intake Concept for Damper Bay DB3.0

This report presents the results of geotechnical assessment undertaken by GeoSolve Ltd to determine the geological conditions and confirm the suitability of the site for a development at Damper Bay, Wanaka.

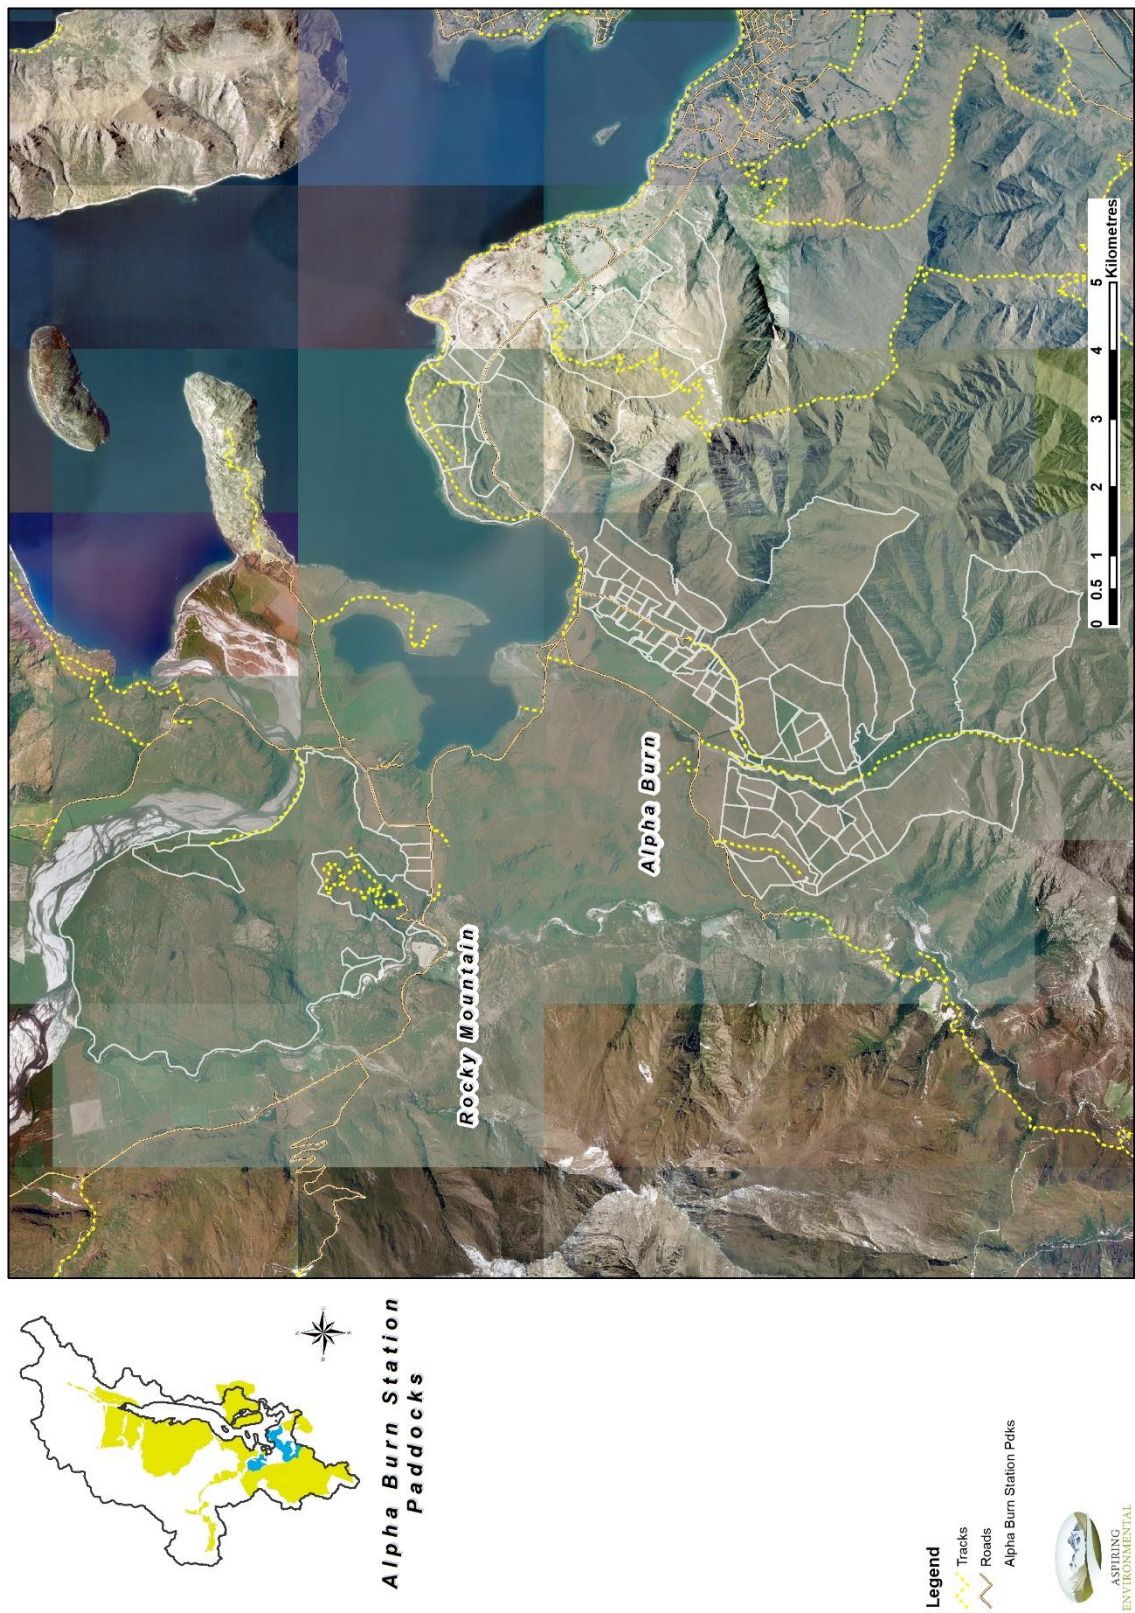
Figure 3: Farm Map and paddock outlines.

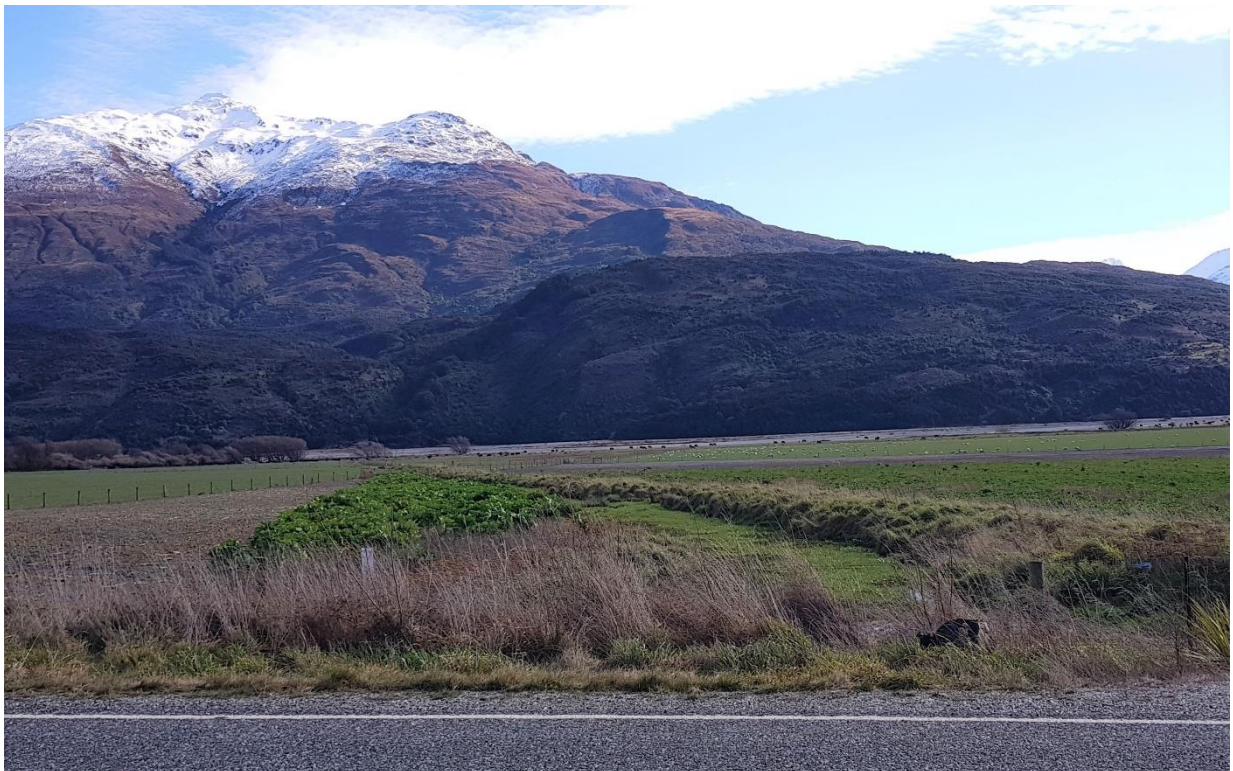
*Figure 9: A grazed winter crop paddock with the critical source area left un-grazed.*

- Ensure stock have adequate feed and are transitioned to crop appropriately
- Use narrow breaks with long faces that are moved more frequently to improve feed utilisation.
- Graze from the top of a paddock to the bottom (down slope, especially towards water ways).
- Back fence regularly.
- Keep stock out of damp areas in paddocks such as gullies and swales or leave these critical source areas un- grazed until the end of the crop.

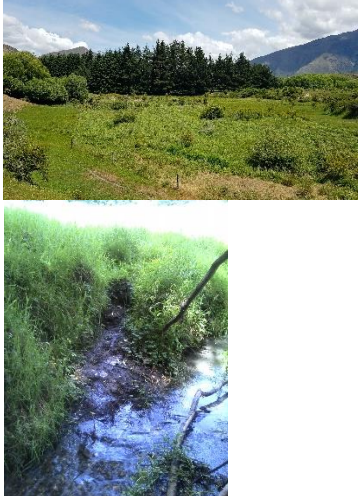
Challenge	Primary issue	Description / Activity	Photo Example	Priority	RMA Rules	How to manage
Wetland Enhancement	Water Quality – Excellent Wetland development already in place, collects irrigation race and farm runoff. Primary stream fenced to the confluence with Alpha Burn.	A very small section of waterway has bank erosion / access for faecal contamination below wetland.

1	ORC 6A Schedule 15 + 16 WQ Standards	<p>Still some strategic fencing required. Permanent fencing / provide strategic stock access and manage/ minimise stock crossings and bed disturbance as per ORC Rules.</p> <p>Benefit - Include in OVERSEER as a managed watershed. Reduces phosphorus loss and Nitrate loss at a block level.</p>

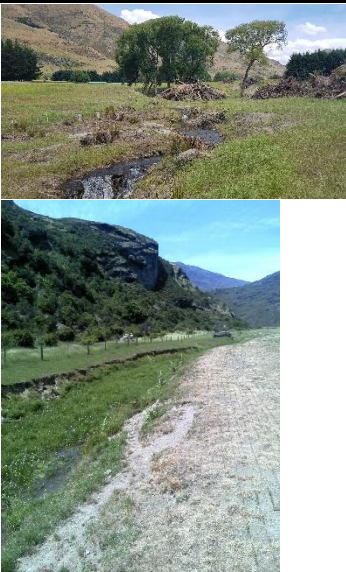
Stock Access Management	Several streams / wetland areas flowing through paddocks have direct stock access, especially cattle access. Alpha Burn, Fern Burn, Diamond Creek and Motatapu could be riparian planted and fenced aesthetics and WQ.	Bank erosion / access for faecal contamination, dead stock. Alpha Burn proximity to the Glendhu Campground.

2	ORC 6A Schedule 15 + 16 WQ Standards	<p>Consider temporary /permanent/ fencing of water race / provide strategic stock access and manage/ minimise stock crossings and bed disturbance as per ORC Rules.</p> <p>Fence where practical and/or provide stock water troughs. Retire riparian sections.</p> <p>Alpha Burn and Diamond Creek is a priority as they have visual bank erosion and pugging.</p> <p>Programme:</p> <ol style="list-style-type: none"> <li>1. Alpha Burn</li> <li>2. Diamond Creek</li> <li>3. Motatapu River – TBC</li> <li>4. Fern Burn</li> </ol>

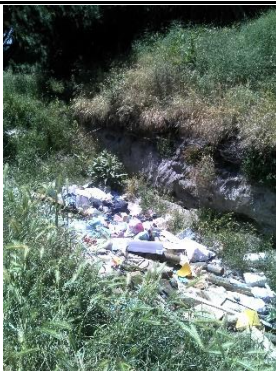
Dead Hole/ Rubbish Management	Risk to water quality / ground water. Within 20m of a waterway. Aesthetics.	Faecal contamination, dead stock.

3	ORC 6A Schedule 15 + 16 WQ Standards, Human Health.	Remove from proximity to Alpha Burn Creek
Public Access	Public interacting with farm area and effecting management. Higher fire risk, rubbish, human faecal matter and elevated risks for stock health - Mt Roy Walking Track / Dampier Bay Track / Diamond Lake Track	Human Faecal Contamination, Biosecurity Risks

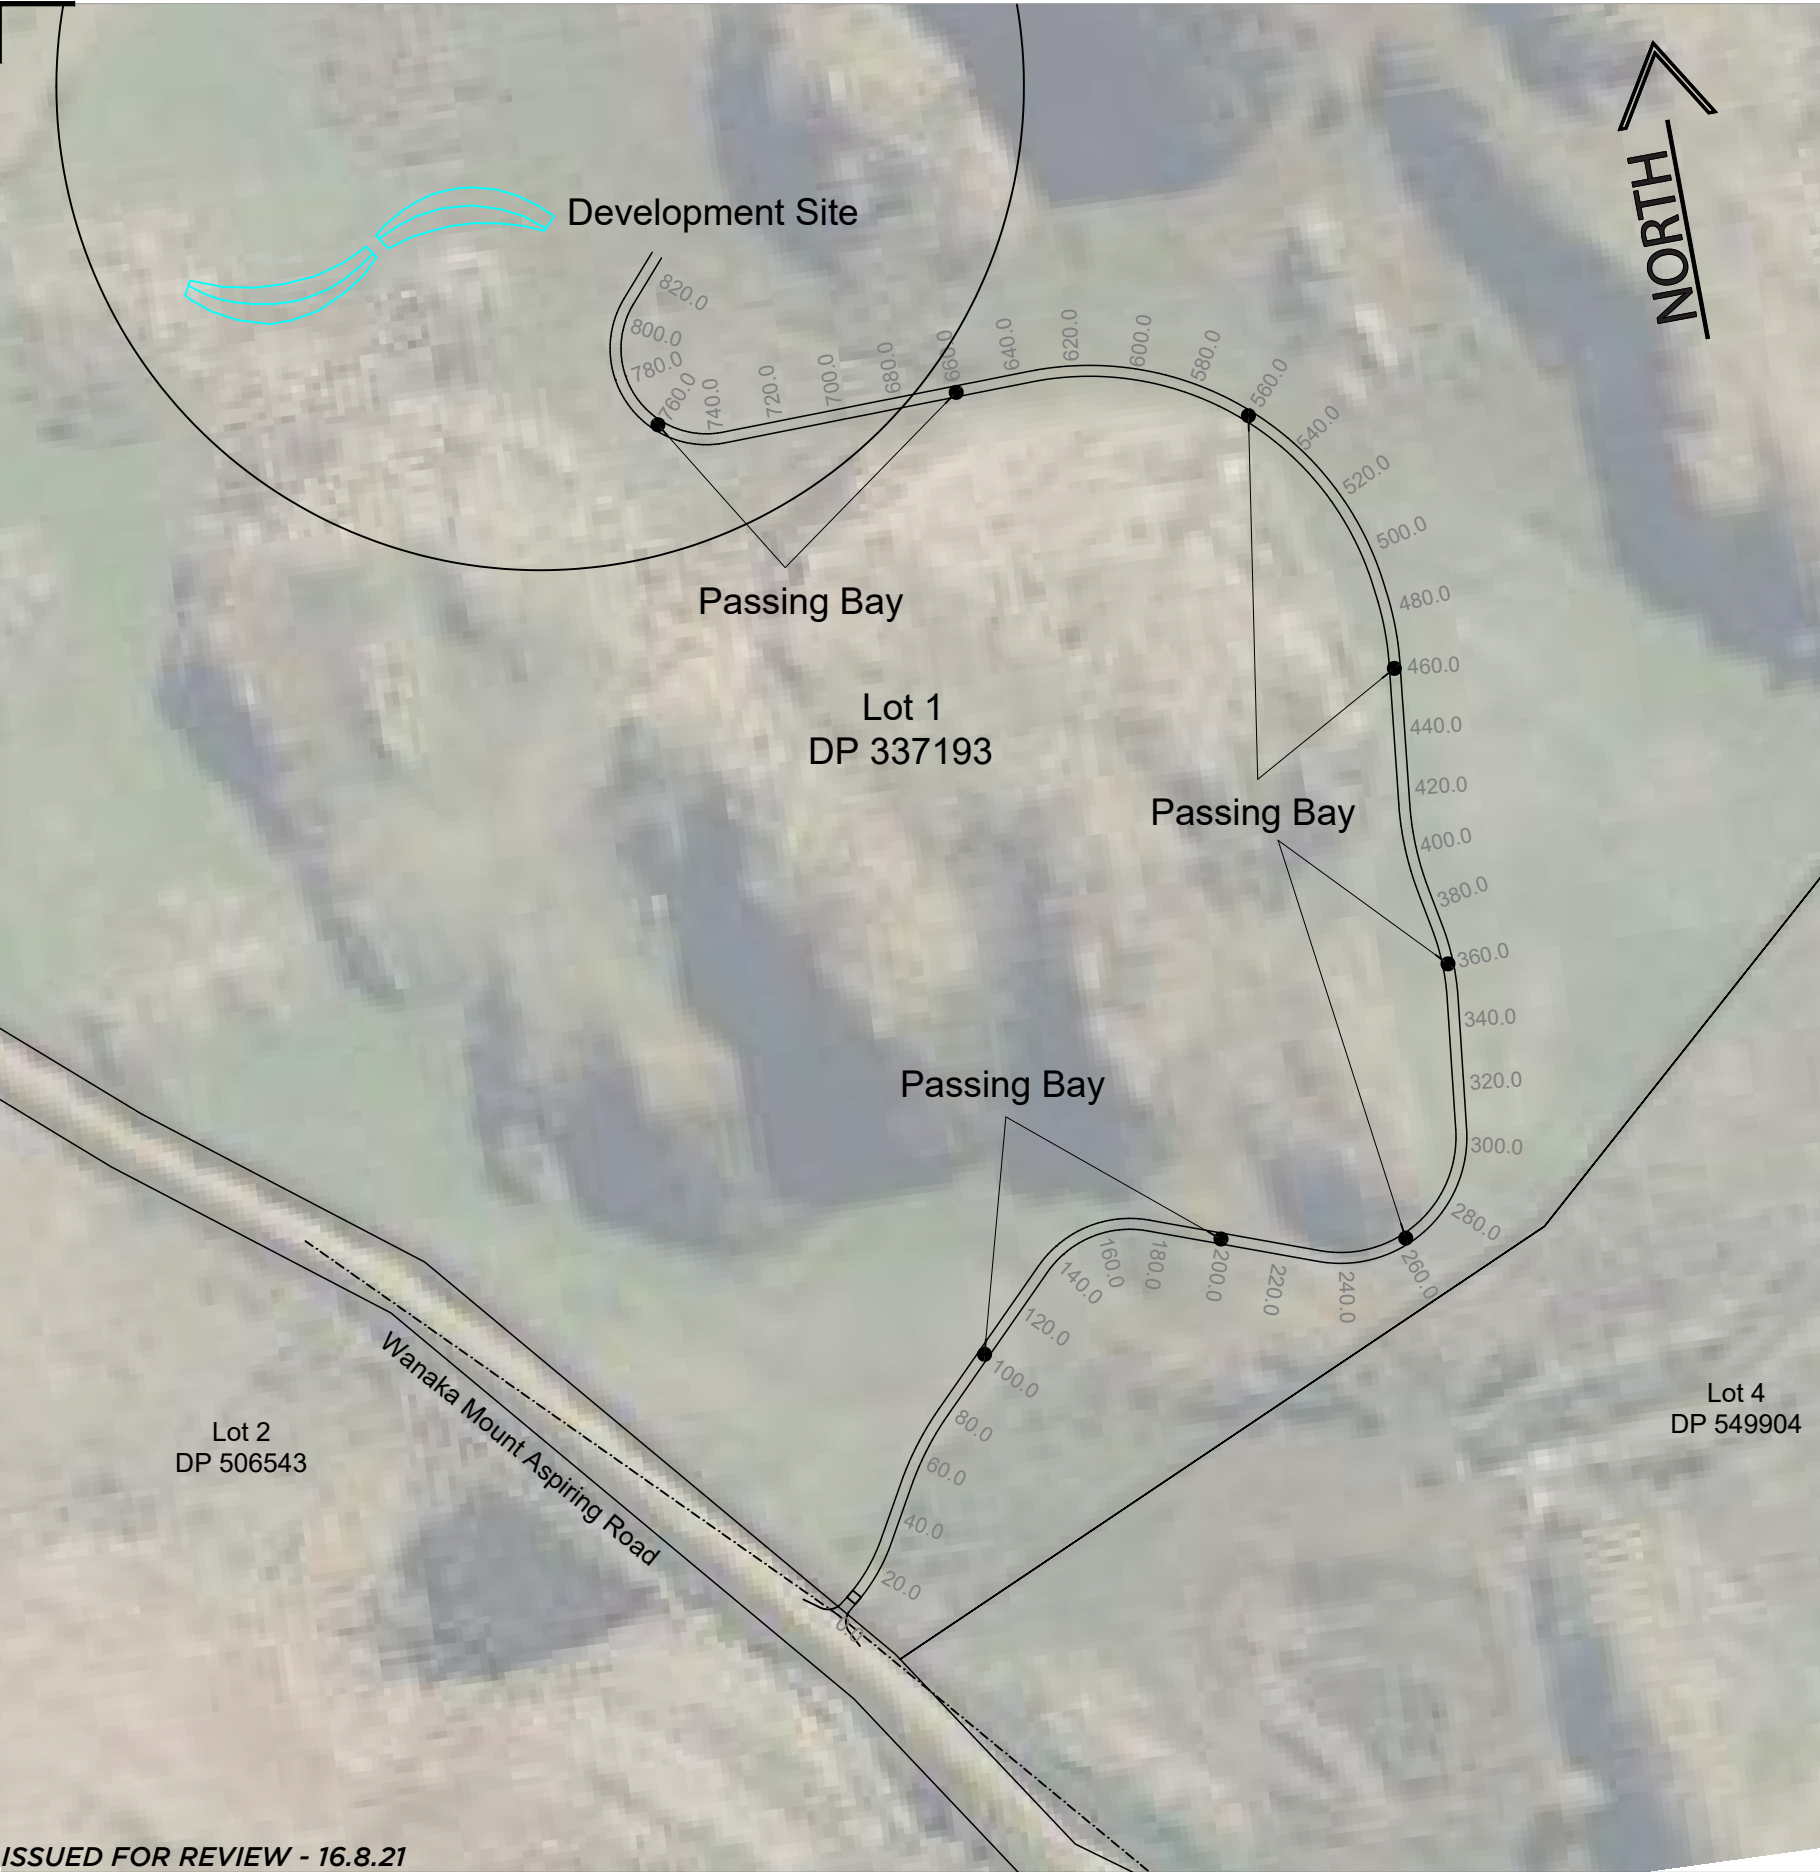
**PROPOSED ACCESS FORMATION**  
150mm compacted AP40 on  
compacted cut to fill  
SCALE 1:100

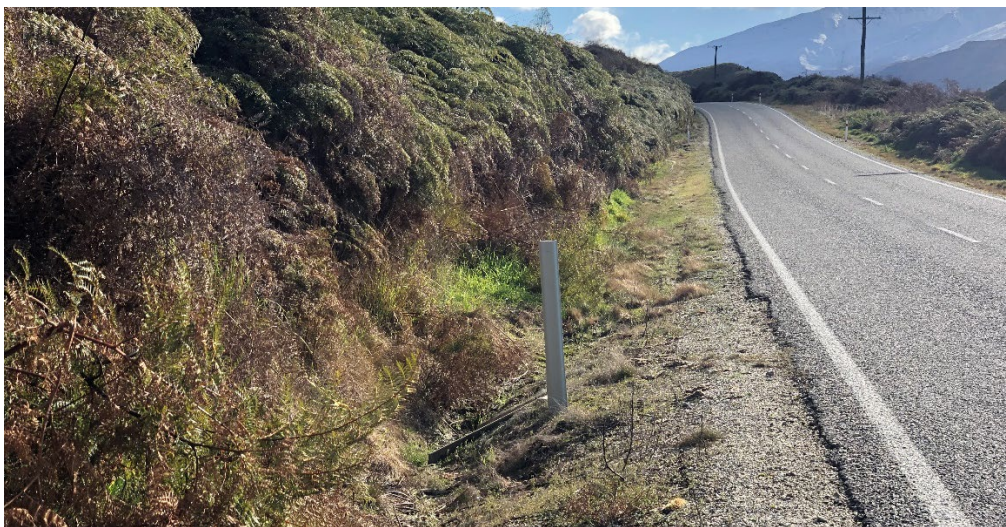
Figure 3: Culvert approx. 7m east of access

10. There is an existing culvert (refer to **Figure 3**) approximately 7m east of the access which is approximately 2.0m from the edge line<sup>3</sup>. On the southern side there is also a reasonably deep swale adjacent to a steep embankment.

11. The location of the swale will not affect the ability to achieve the tapers either side of the access on the same side of the road as the application site, in accordance with Diagram 9. However, it will constrain the ability to provide the seal widening on the opposite

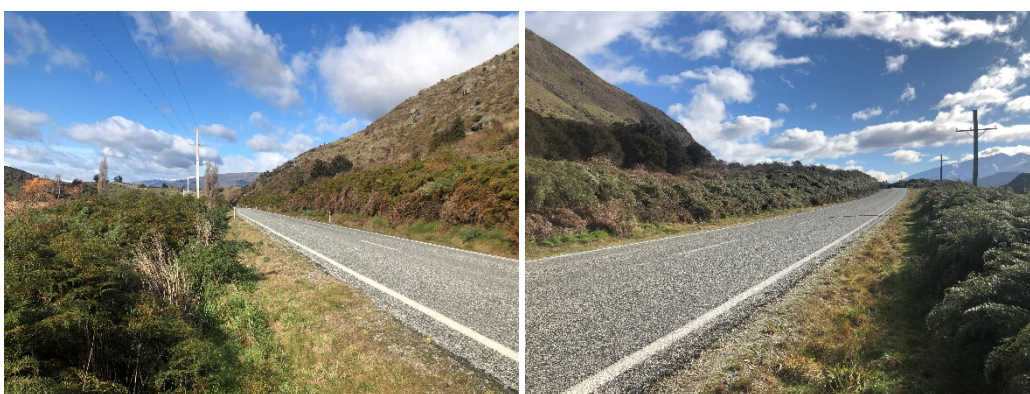
Figure 4: Sight distance from the proposed access to the east (left) and west (right)

15. The Proposed District Plan requires 250m sight distance in each direction from the access along Wanaka Mount Aspiring Road. In this instance there is approximately 203m sight distance to the east and 212m site distance to the west as shown in **Figure 4** below. The sight distance is primarily constrained by the vertical and horizontal alignment of the road.

14. In respect of safety, in the unlikely event that a vehicle did have to wait to turn right into the site, there is some 203m forward visibility to the access for north-west bound traffic. The Austroads Guide to Road Design Part 4A, Table 3.1 recommends an approach sight distance of 165m -179m based on a 2.0 - 2.5 second reaction time and a design speeds of 100km/h. This is readily met and ensures approaching drivers would have sufficient time to see and avoid a collision with any vehicle waiting to turn at the access albeit as outlined above no such delay is anticipated.

16. Whilst 250m sight distance would be desirable, it is noted that Waka Kotahi NZTA's *Road and Traffic Standards 6 Guidelines for Visibility at Driveways* would require a low volume access (less than 200 vehicle movements per day) to a collector road, to provide 160-190m sight distance for a 100km/h and 110km/hr operating speed respectively. Noting this is readily met, and that the access location maximises sight distance in each direction, the proposed access location is considered to be appropriate for the safe and efficient use of the access.

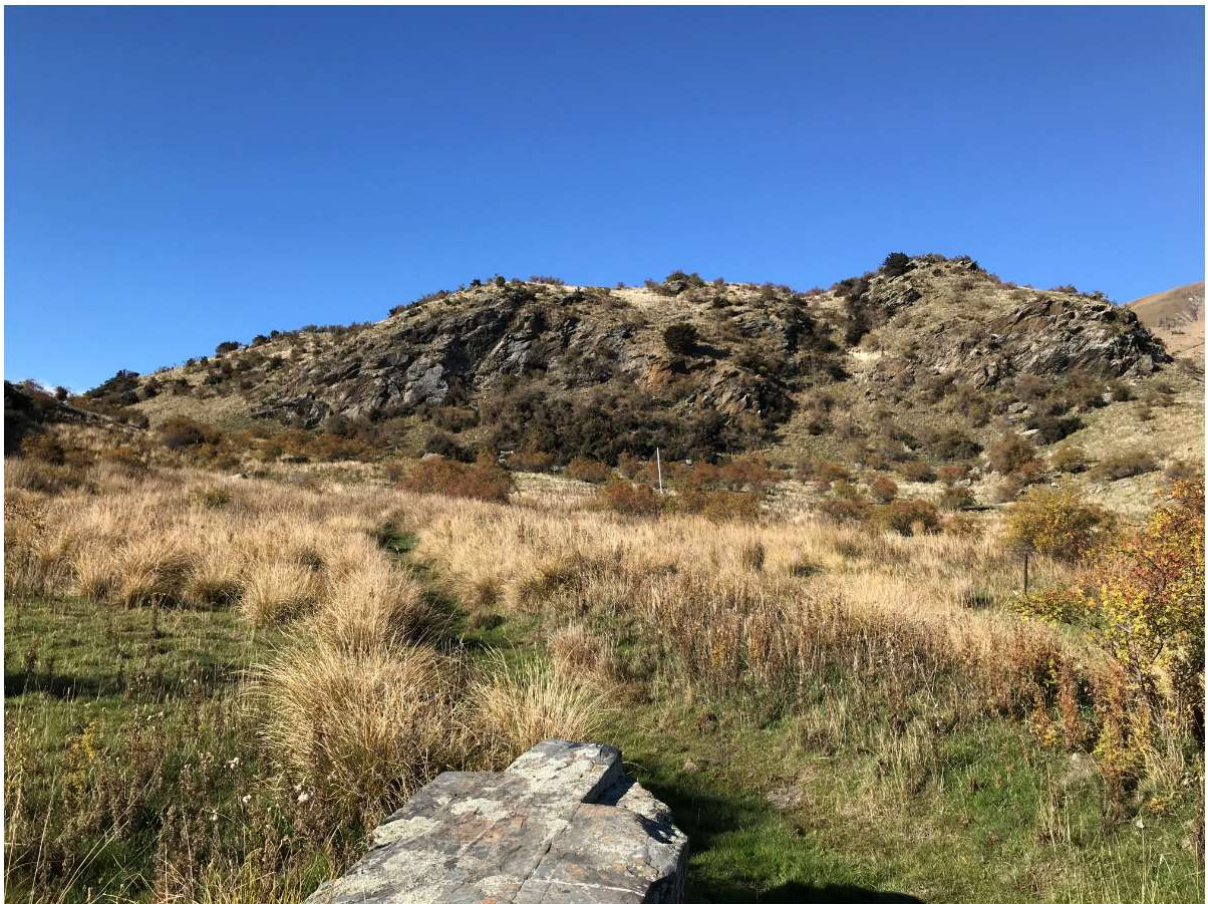
**Photograph 1: Photo of rock fall source area one, two and three (looking south). A tabular rock fall boulder is shown in the foreground.**

- General fretting/spalling of small individual rock debris (0.3 m diameter) occurs on a regular basis from the bluffs during typical daily conditions;
- Mapped fallen boulders from the source area bluffs typically ranged in size from 0.5-1.5m<sup>3</sup> in volume and are elongated to tabular in shape.
- Four main rockfall source areas are present for the subject site, for the purposes of this report they have been labelled Source Area One to Four.
- The indicative locations of the mapped rockfall boulders are shown in Figure 1a, Appendix A.

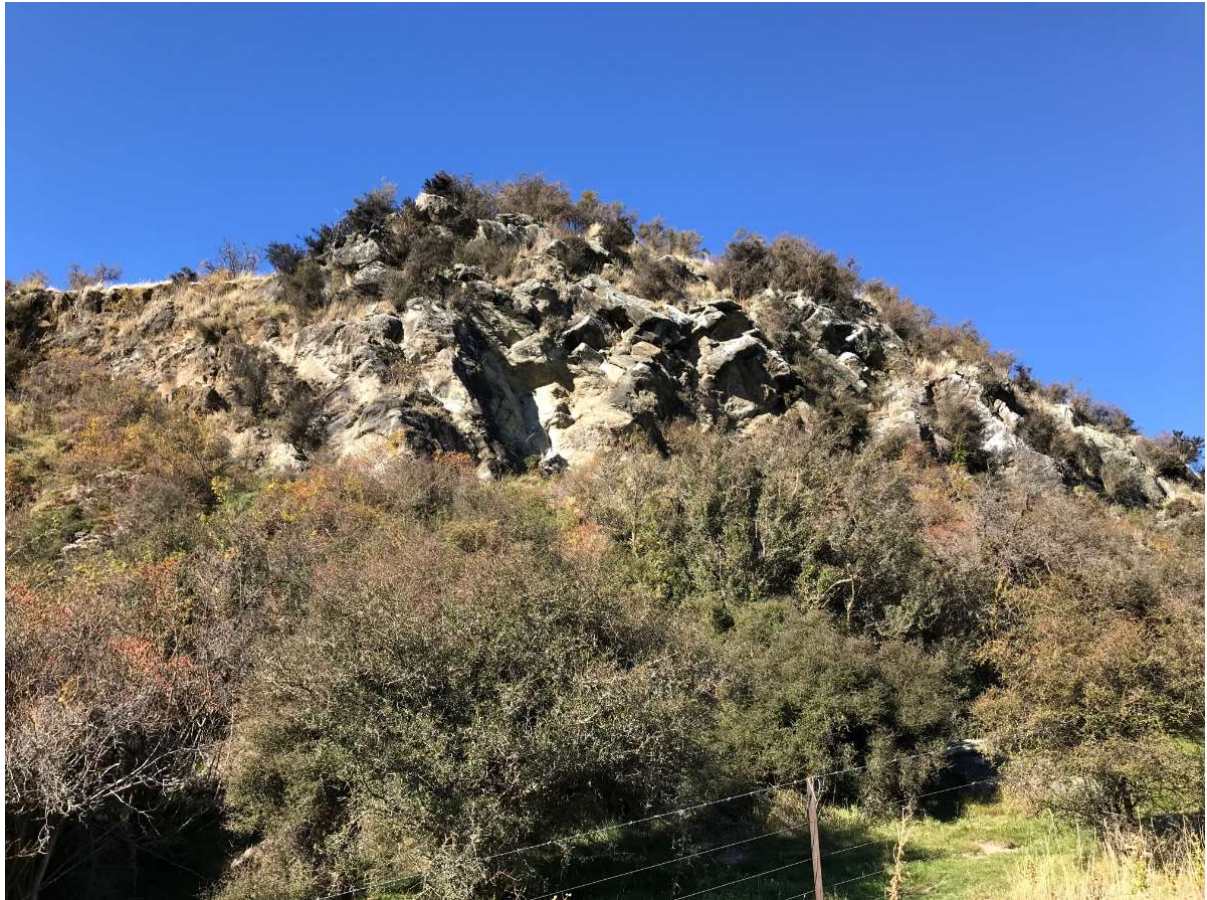
**Photograph 2: Photo of rock fall source area four (looking south east), located behind the owners building.**

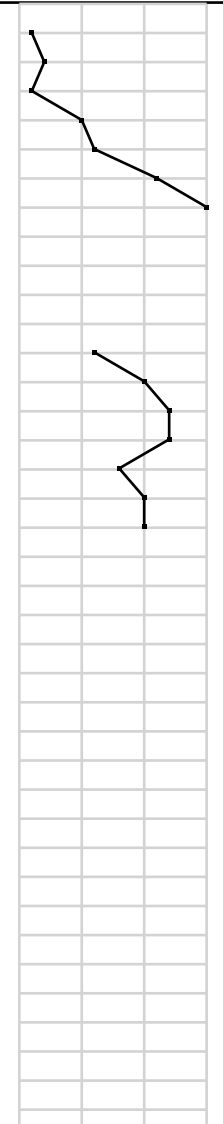
ALLUVIAL GRAVEL	Fine to coarse GRAVEL with some silt and sand; brownish grey. Medium dense; moist; sand, fine to medium; gravel, subrounded.

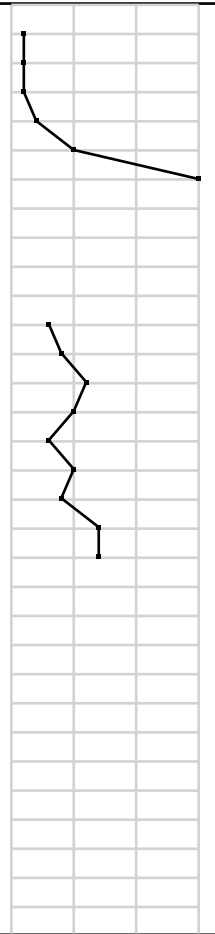
ALLUVIAL GRAVEL	Sandy fine to coarse GRAVEL with minor silt and boulders; brown, bedded. Loose; moist; sand, fine to coarse. Schist angular colluvium boulders up to 300 mm diameter. 0.3m

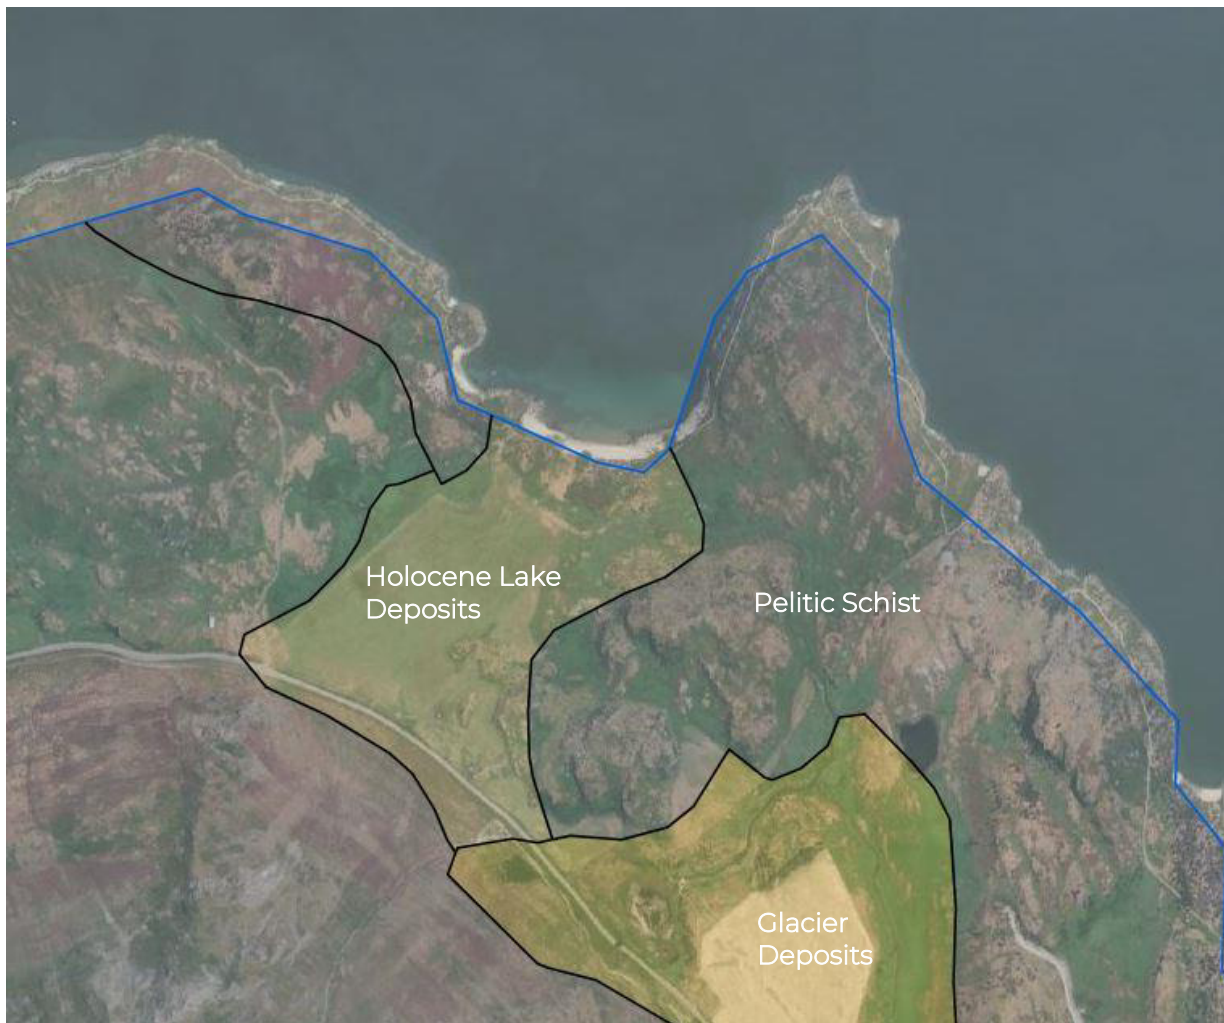
Figure 3: Extract from GNS Webmaps (accessed May 2021)

A review of the GNS Active Faults Database indicates that the nearest active fault is the Highland Fault (#8187) which runs north to south approximately 6.5km southwest of the site. There is no further information available relating to this fault. (GNS Science, 2021)
