GEOTECHNICAL INVESTIGATION REPORT

JOB TITLE	NEWMAN SUBDIVISION GEOTECH
ADDRESS	PT SECTION 1 SO 23541 MCDONNELL ROAD ARROWTOWN
JOB NUMBER	50595
	13 February 18

50595 Newman Subdivision Geotech Report

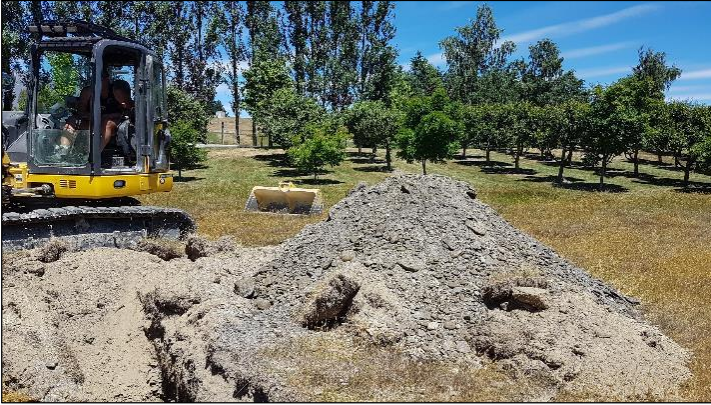
Photo 1: Looking south across Lot 2, indicates the gravel material excavated from Test Pit 2.

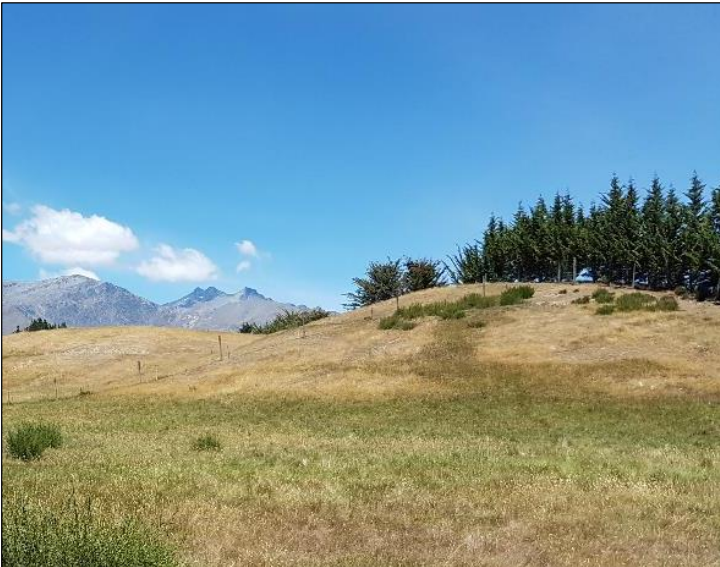
- The vegetation below the irrigation race was also noticeably greener than the vegetation above. The irrigation race is not a lined structure and was evidently seeping into the down slope soils.

Photo 2: Looking south west across Lot 4 indicates green pasture where seepage from the existing water race is located.

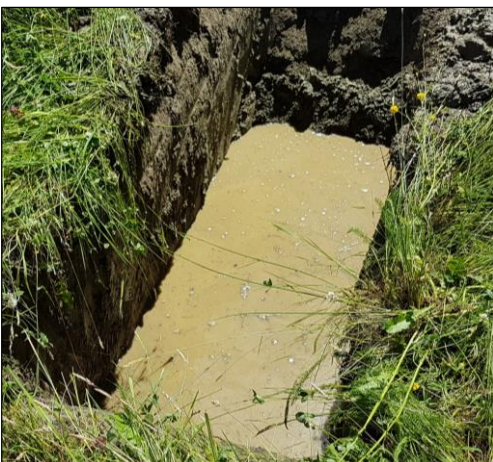
The test pits conducted within the depression indicated inflow of groundwater when the fine grain sand material (Sand Alluvium) was exposed. The fine grain sand indicated it had greater permeability than the overlying silt material and topsoil capping. The silt material, labelled as Loess, was dry/moist indicating the underlying groundwater had not risen high enough to reach this layer into the soil.

Photo 3: Indicates groundwater 800 mm below surface of Test Pit 8

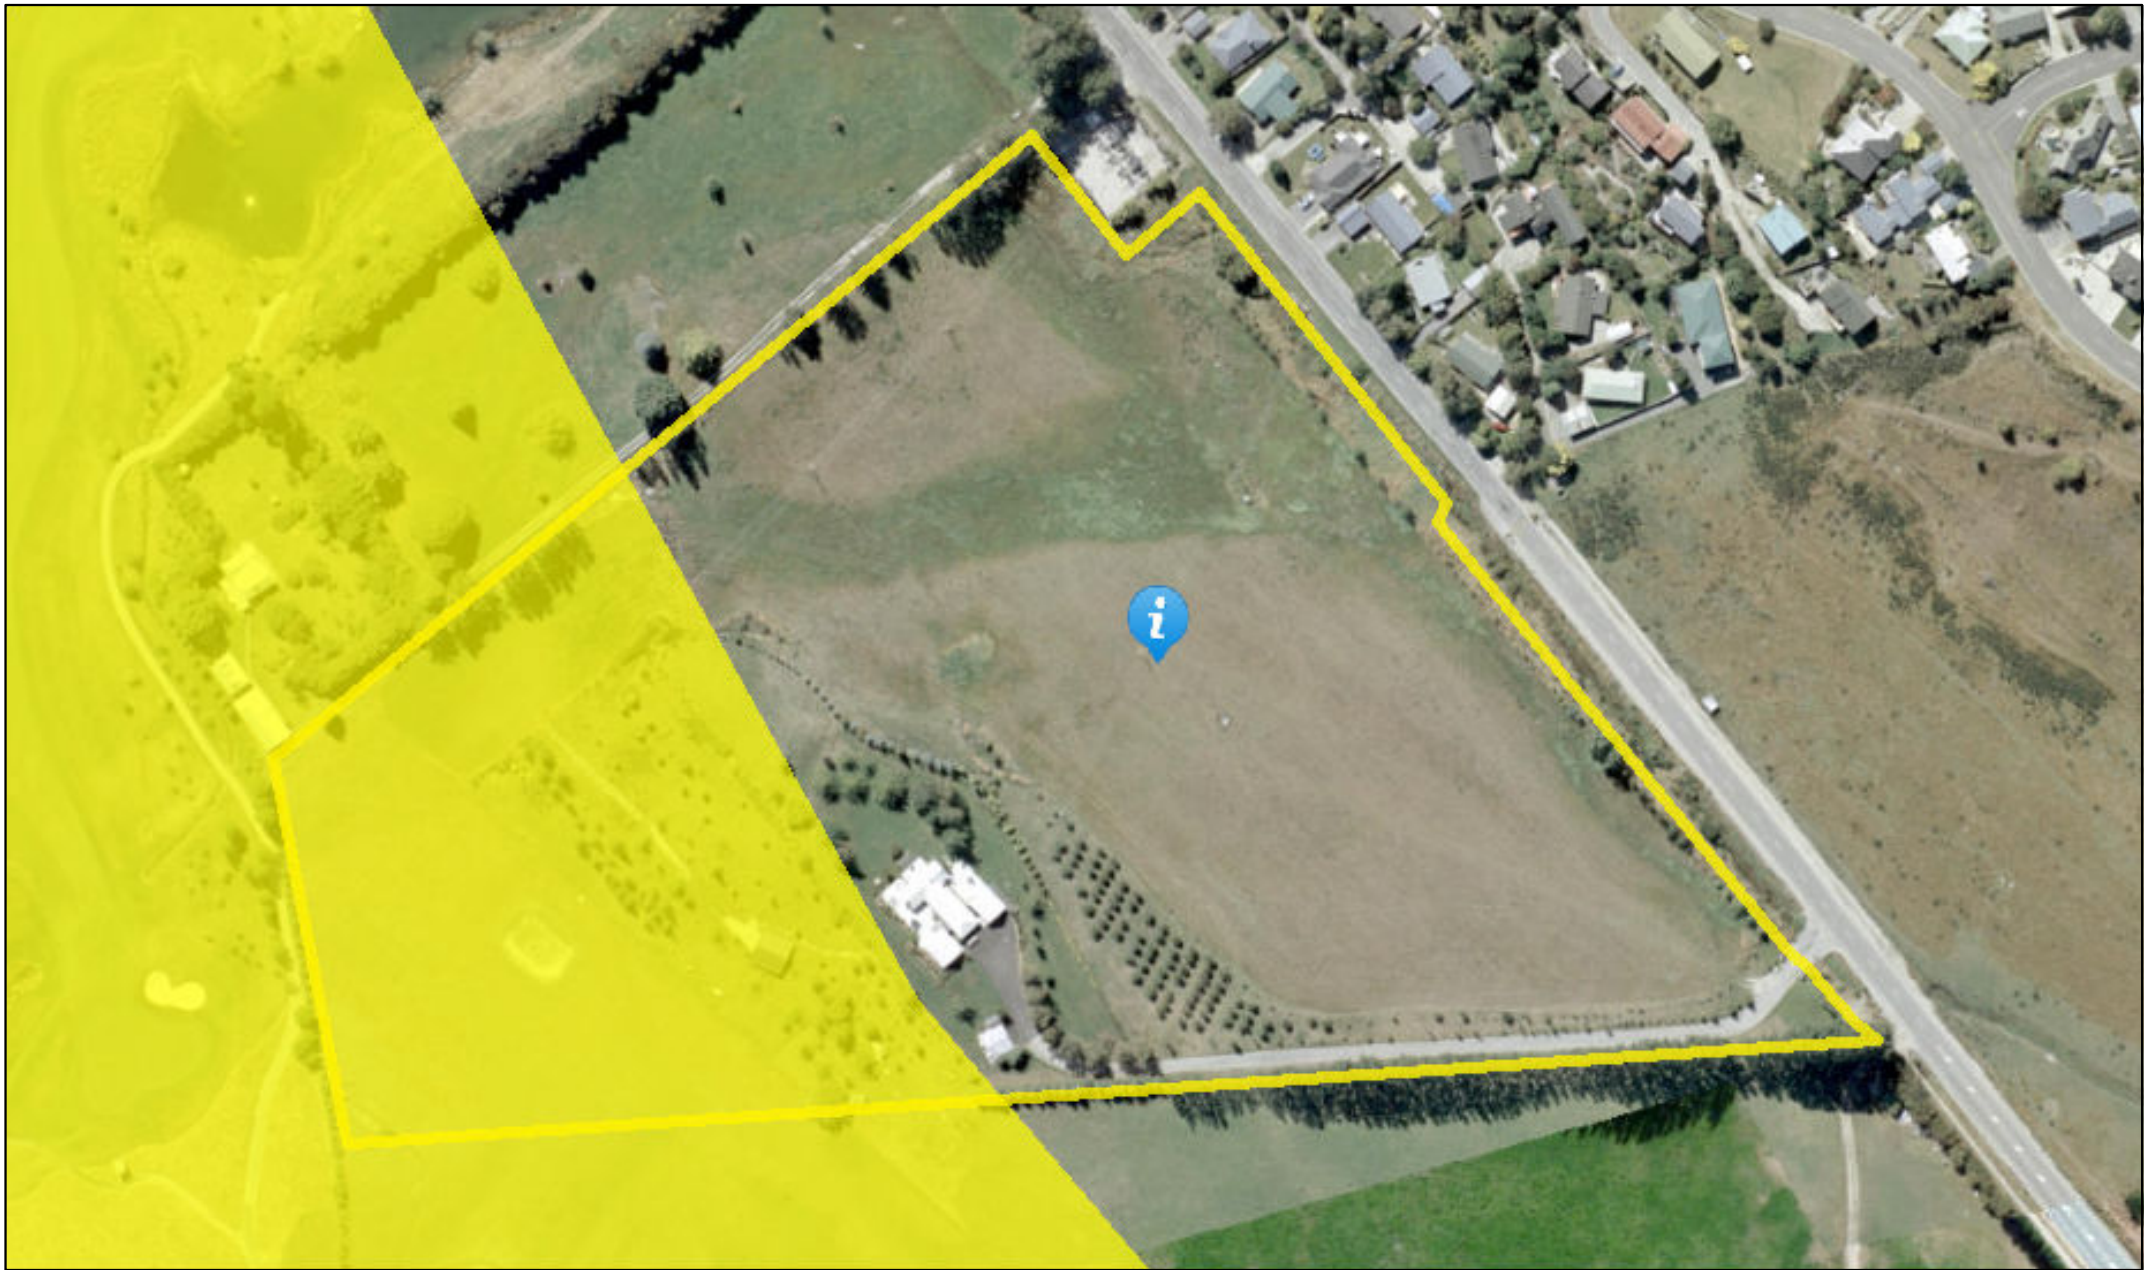
Hazards

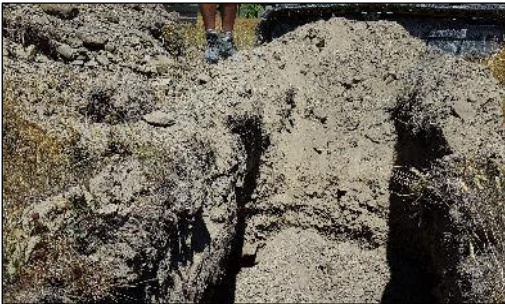
1.2	.Ooo.Ooo. .Ooo.Ooo. .Ooo.Ooo. .Ooo.Ooo.	Sandy Cobbly GRAVEL; grey/brown; medium to coarse grain sand; fine to coarse sub angular to sub rounded gravel; sub angular to sub rounded cobbles; medium dense to very dense

1.6	.Ooo.Ooo. .Ooo.Ooo.			
			2.0		End of test pit, unable to excavate further due to test pit walls collapsing		
			2.4

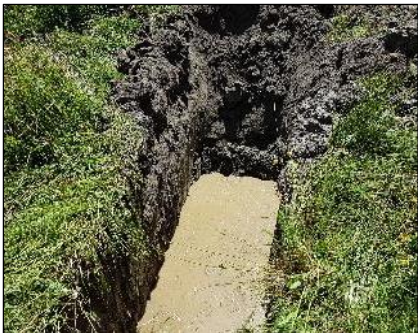
STRENGTH TESTING	GROUNDWATER	SAMPLES	DEPTH (m)	GRAPHIC LOG	SOIL / ROCK CLASSIFICATION, PARTICLE SIZE CHARACTERISTICS, PLASTICITY, COLOUR, WEATHERING, SECONDARY AND MINOR COMPONENTS	MOISTURE CONDITION	SOIL / ROCK TYPE, ORIGIN, DEFECTS, STRUCTURE, FORMATION
			0.4	ψψψψψψ ψψψψψψ xxxxxxxxxx xxxxxxxxxx xxxxxxxxxx xxxxxxxxxx xxxxxxxxxx	SILT; brown; organic; 50 mm rootlets throughout, organic	D	Topsoil
			0.8	xxxxxxxxxx xxxxxxxxxx xxxxxxxxxx xxxxxxxxxx xxxxxxxxxx	SILT; light brown; massive; rootlets throughout; dense to very dense		Loess Colluvium
			1.2	SAND; grey; fine grain sand; massive	W	Sand Allivium
			1.6			
			2.0			
			2.4	End of test pit, test pit filled with groundwater to 800 mm below the surface whilst logging.		
			2.8			
			3.2			
			3.6			
			4.0
