# Queenstown Gardens Safety Report

Produced for Queenstown Lakes District Council

Date: 23/08/2017  
Reference: 6-XQ066.02  
Status: for Release

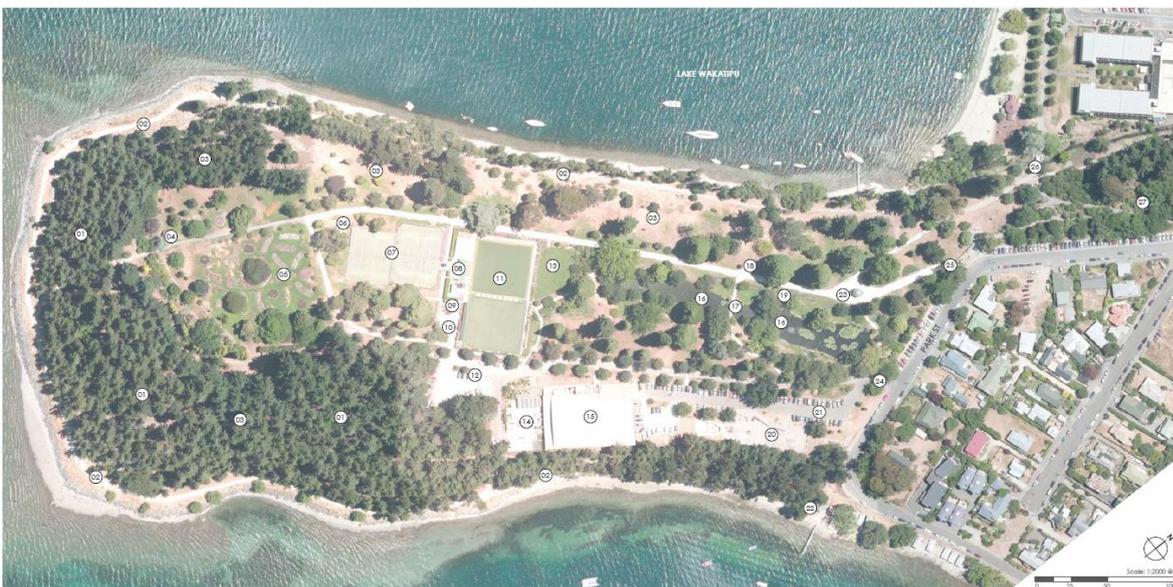
The existing layout of Queenstown Gardens is shown below. In order to cater for increased visitors, a future plan has been designed to improve the facilities and user experience in the Gardens.

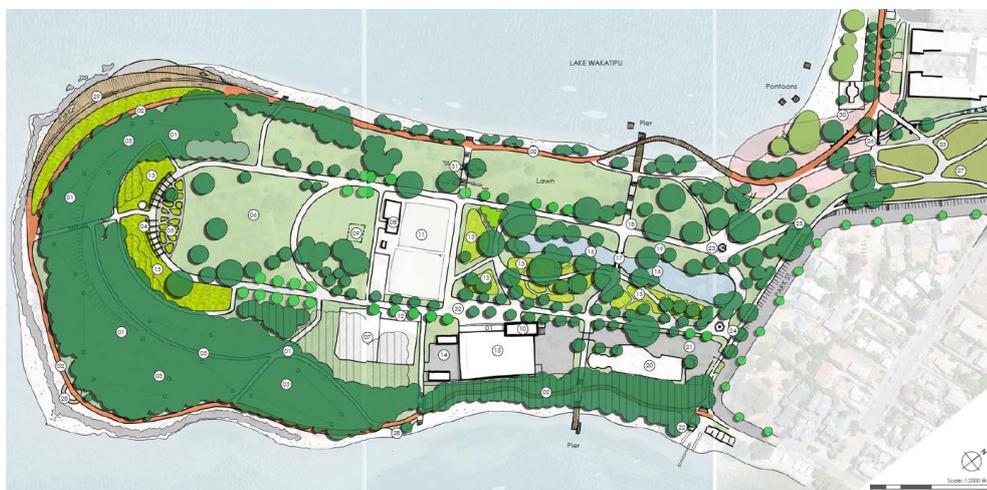
The only provided information is a proposed landscape plan for the gardens. The complete plan is attached as Appendix 1. This was prepared by Reset Urban Design in April 2017 and was primarily focused on landscaping and design features, rather than detailed consideration of user safety.

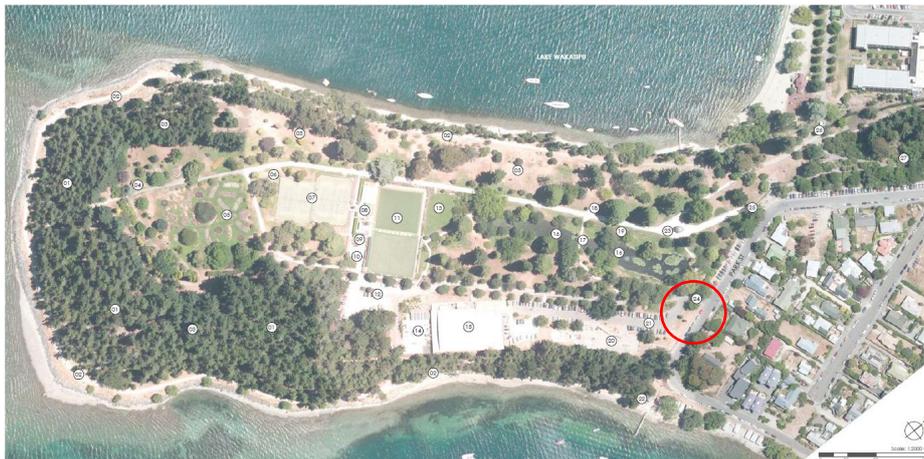
### 4.1. Vehicle Entrance/Exit

#### Serious

The current vehicle entrance has multiple reasons for concern. The probability of a crash is common, and due to the nature of mixed vehicle/cyclist/pedestrian collisions death or serious injury is likely.

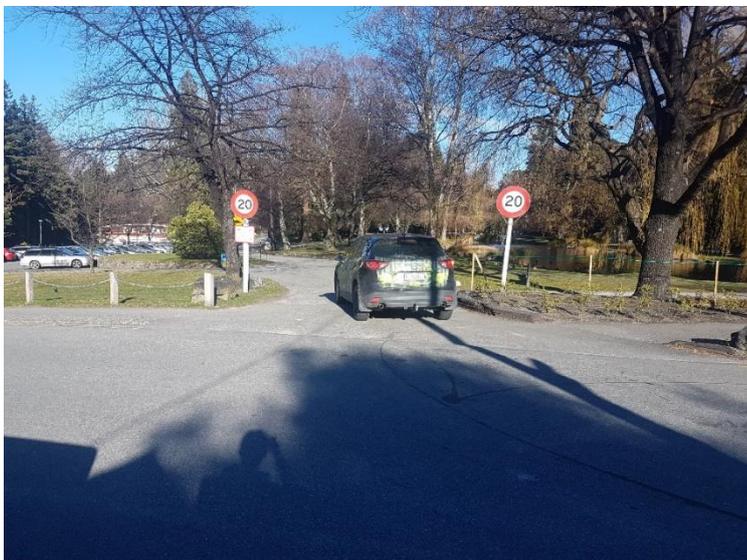
#### 4.1.1. Narrow Entry

The current vehicle entry is 3.5 to 4m wide. This is not adequate to allow for two-directional traffic. As such vehicles perform unorthodox movements and inappropriately give-way to exiting vehicles in order to enter.

In order to improve user safety, the current vehicle entrance should be widened to accommodate vehicles moving past each other.

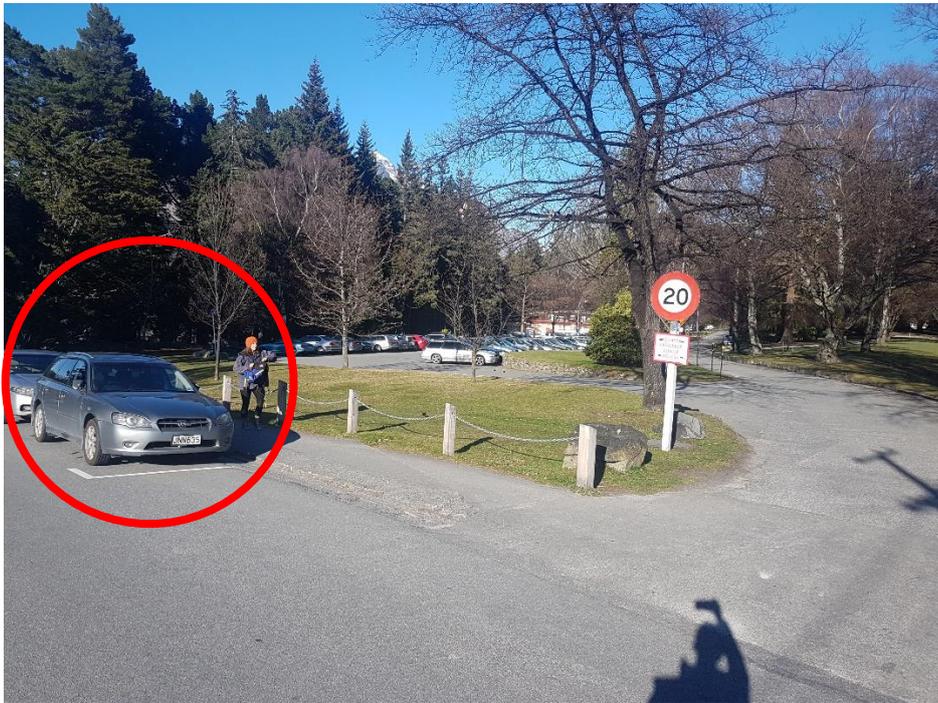
**4.1.2. Sight Distance for Exiting Vehicles**

The current roadside parking along Park St severely limits sight distance to the south for vehicles exiting the gardens. The issue is worsened by the slop of the Road, meaning oncoming vehicles are nearly impossible to see without slowly edging out into the live lane.

In order to improve sight distance for exiting vehicles, some current parking spaces should be removed from Park Street

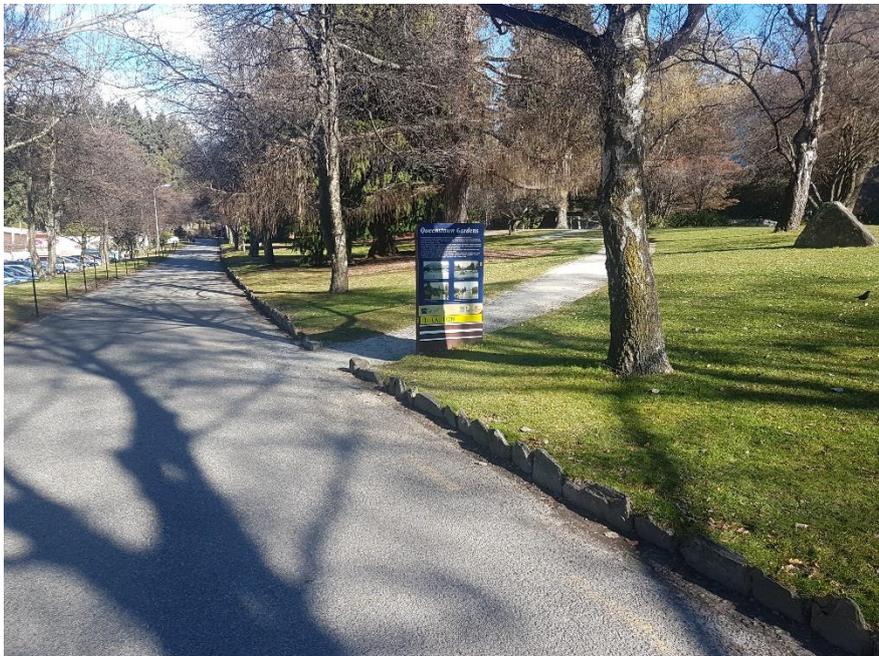
**4.1.3. Unsealed Path Termination**

An unsealed footpath from within the gardens terminates directly into the Entry/Exit junction. There is no clear direction for pedestrians, and as a result pedestrians are likely to be present at the junction

Pedestrian/Cycle path crossings should be relocated further back from the junction with Park Street, and clearly marked so that both the vehicle users and cyclists/foot traffic are aware of the crossing. Improvements in marking and alignment of the crossing will help prevent confusion for cyclists and pedestrians, potentially resulting in these user groups using the vehicle accessway less frequently. Relocating the crossing points will also allow for improved visibility.

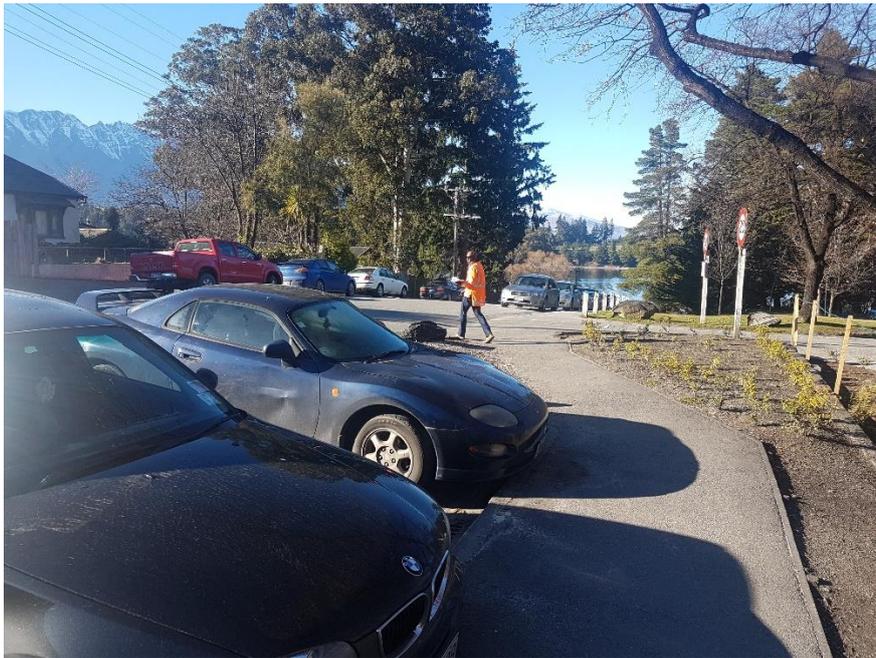
**4.1.4. Sealed Path**

The sealed shared use path on the west side of Park Street crosses at the vehicle entrance/exit junction with Park Street. Vehicles turning right into the gardens are unlikely to see any cyclists travelling southbound on the path which crosses directly through the entranceway.

The path also enters on an alignment that is likely to direct any southbound cyclists out onto Park Street and potentially into oncoming traffic.

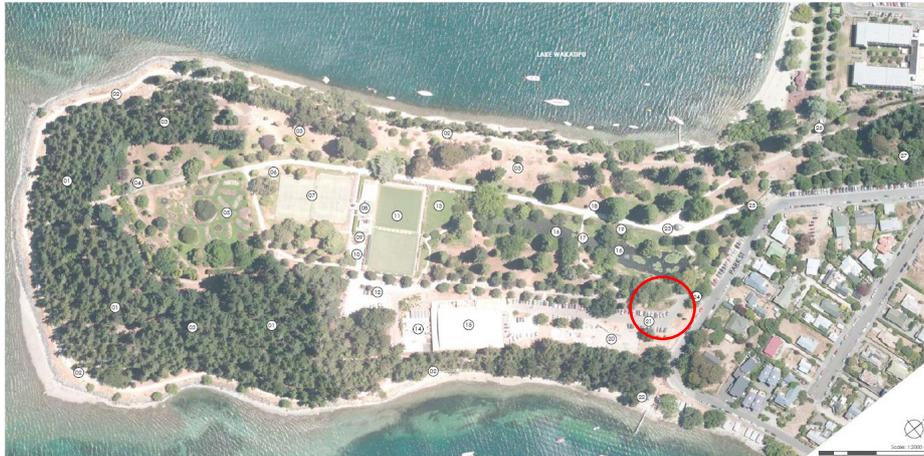
**4.2. Ice Rink Carpark Entry**

**Moderate**

The Carpark entry is such that low speed vehicle collisions are expected to be common, though death or serious injury is unlikely to occur as these are primarily low speed vehicle vs vehicle collisions.

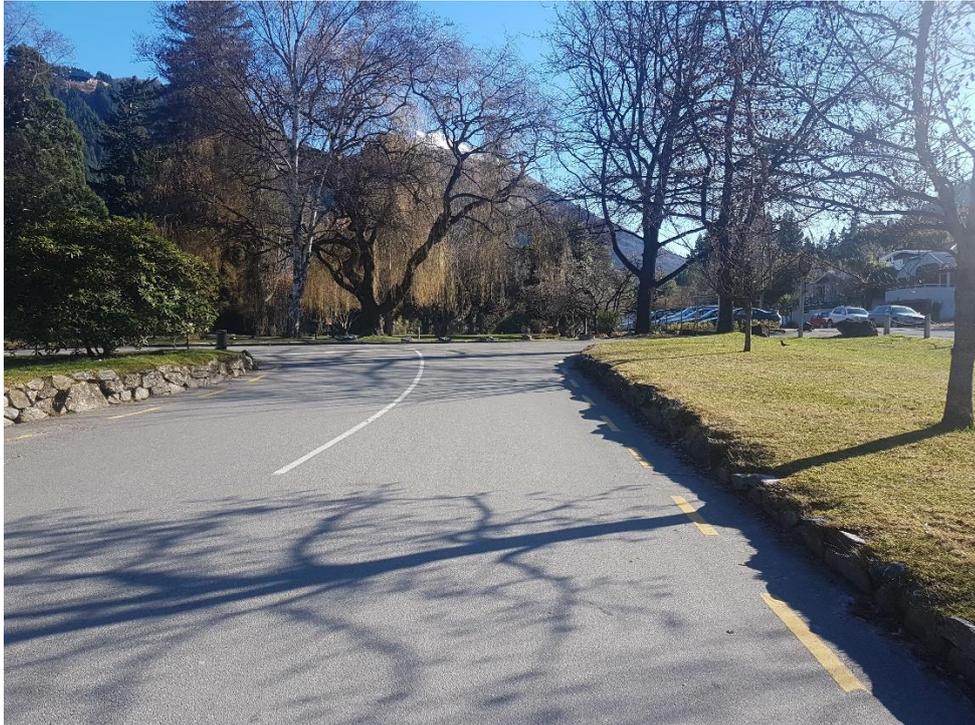
**4.2.1. Narrow Entry**

The Current vehicle entry is quite narrow. While on site it was witnessed that vehicles would often wait for others before using the entry/exit as there was not comfortably enough room for vehicles to pass each other.

In order to improve user safety, the current vehicle entrance should be widened to accommodate vehicles moving past each other (2 way traffic).

If possible the intersection should be slightly re-aligned during this process to allow for better visibility. Ideally the entrance should be at a 90 degree angle to the main gardens drive.

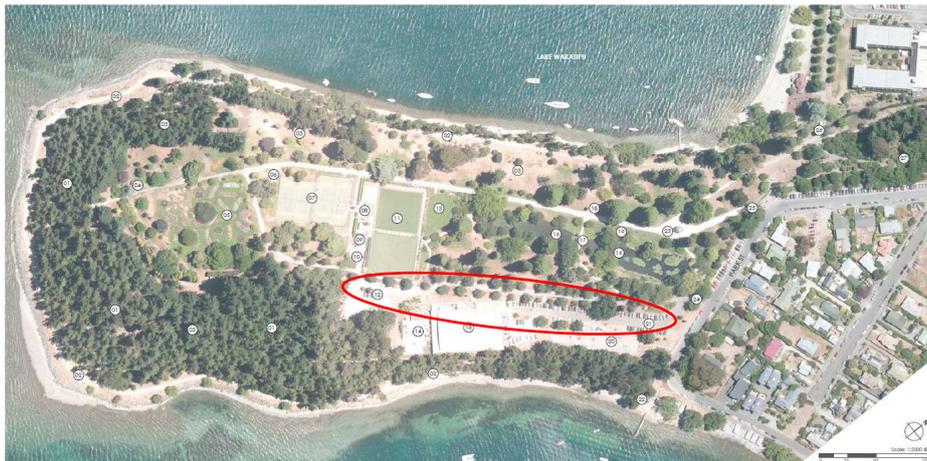
**4.3. Main Garden Driveway**  
**Significant**

The driveway often has a mix of vehicles and pedestrians. Collisions are expected to occur occasionally, however serious injury is likely to result due to vehicle – pedestrian collision.

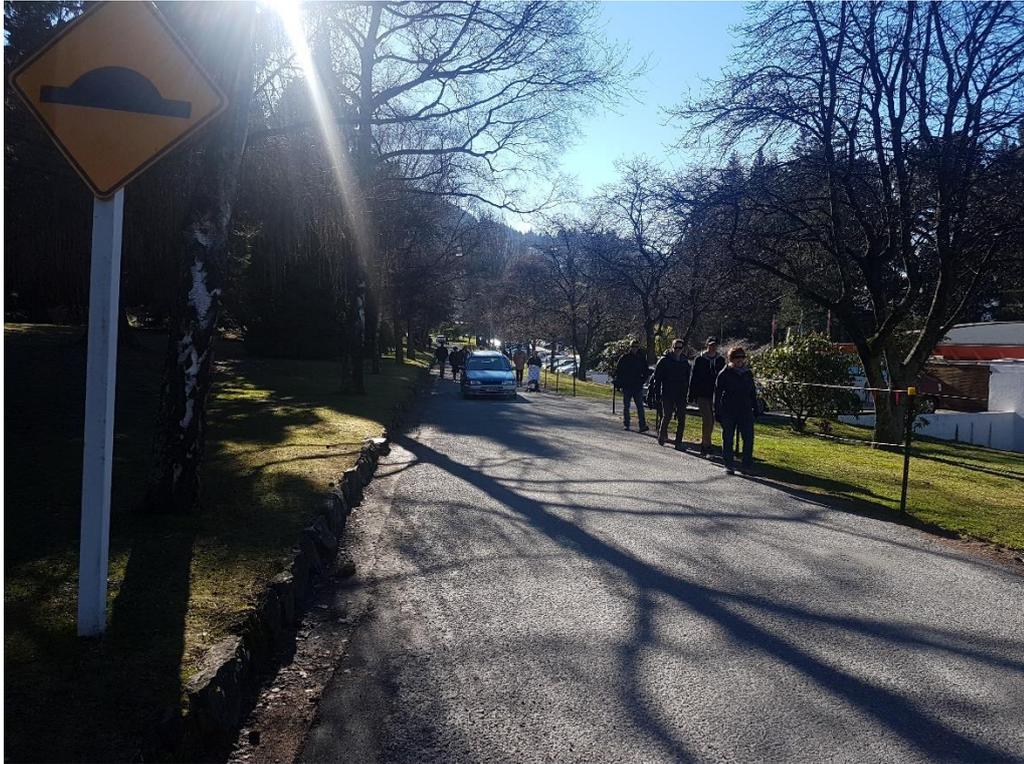
**4.3.1. Narrow Width of Carriageway**

The main gardens driveway is currently too narrow to comfortably allow two-way traffic. It was observed that vehicles had to slow down excessively and perform careful manoeuvres in order to pass by one another.

The main driveways width should be slightly increased to allow two vehicles to move past one another. Care should be taken not to widen this so much as to encourage a higher operating speed.

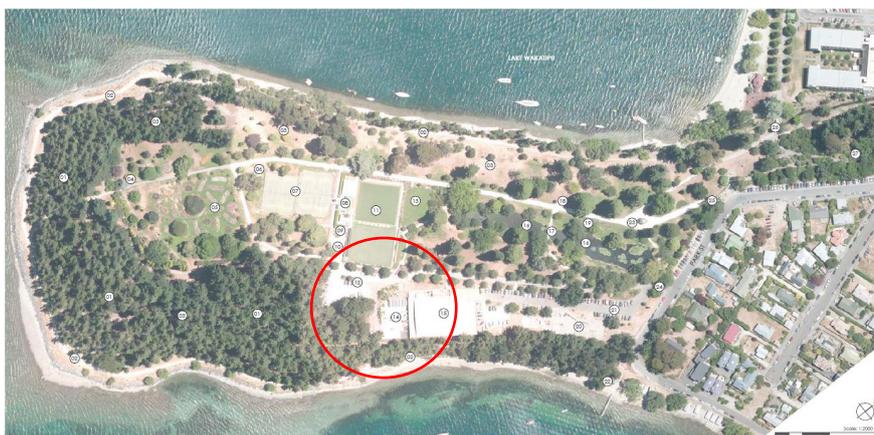
**4.4. Tennis Club, Bowls Club, & Maintenance Lot Access and Parking Significant**

Access and parking for the maintenance lot, tennis and bowls clubs is located at the western end of the main garden driveway. There is also a public toilet located in the tennis club carpark. Similar to the driveway, there is often a mix of vehicles and pedestrians. Collisions are expected to occur occasionally, however serious injury is likely to result due to vehicle – pedestrian collision.

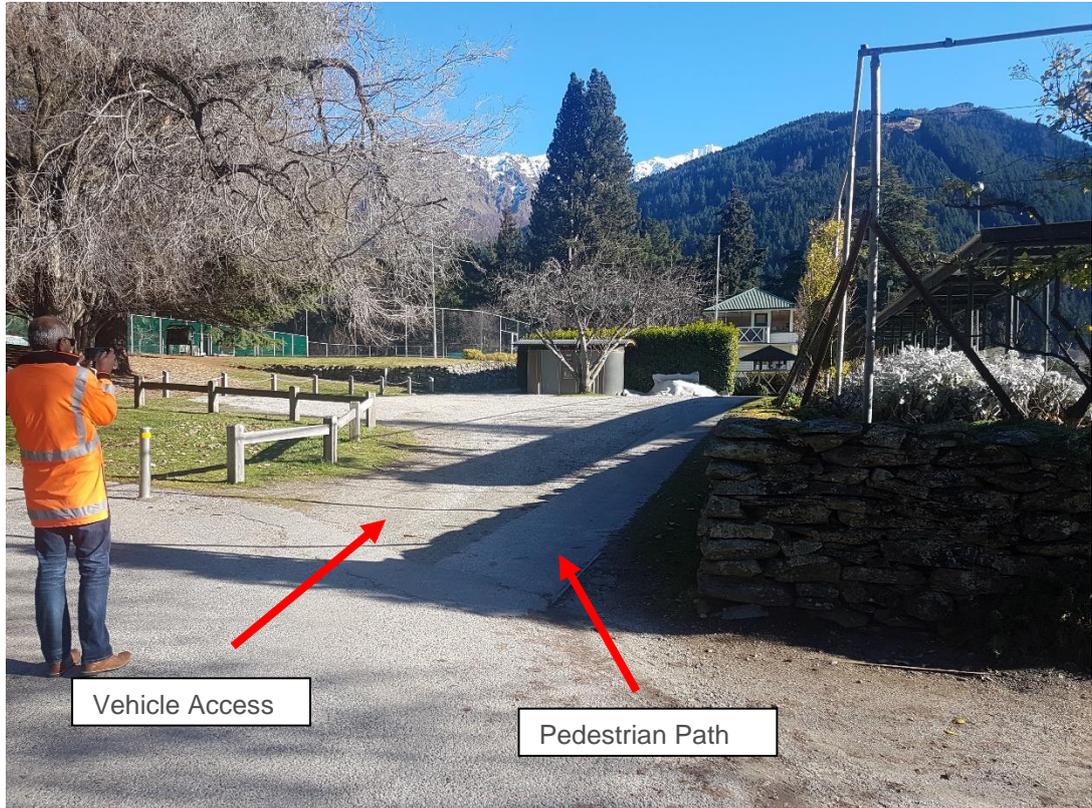
4.4.1. *Pedestrian/ Vehicle Interaction*

There is currently several footpaths directly connected to the carparks. Several of these lead into trafficable areas in ways which are not conducive to adequate sight distances, and could result in Pedestrian-vehicle interactions.

Pedestrian crossing points are also not marked clearly, and vehicles/pedestrians may be unaware of the potential for interaction. This may result in users not being as cautious as they need to be at a crossing point.

Pedestrian areas should be clearly marked as such, and possibly delineated with flexible plastic bollards or similar. This will allow clearer zoning so pedestrians and vehicles have a better idea of where to look out for other users.

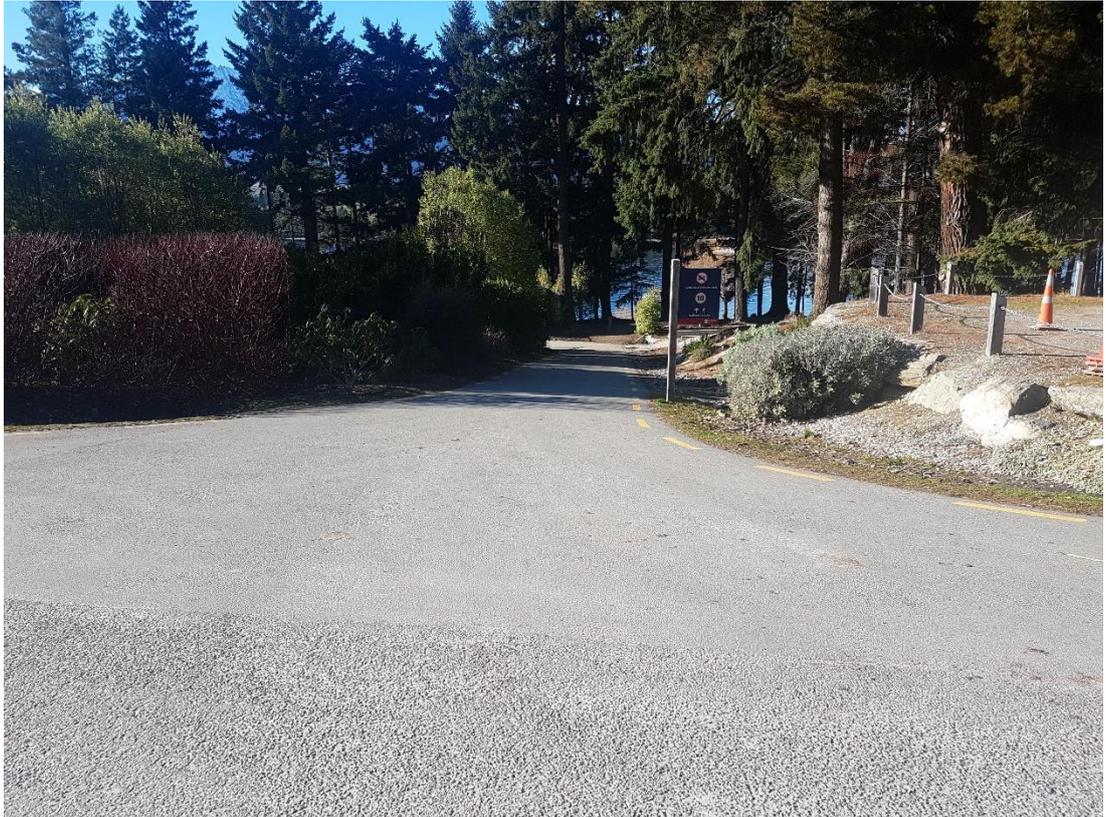
4.4.3. *Narrow maintenance access*

The access way into the maintenance lot is not wide enough for two-way traffic. This may result in vehicles waiting on the main gardens driveway in order to allow vehicles to exit before being able to enter. This is not likely to cause major issues given the low volume of traffic expected to use this access way.

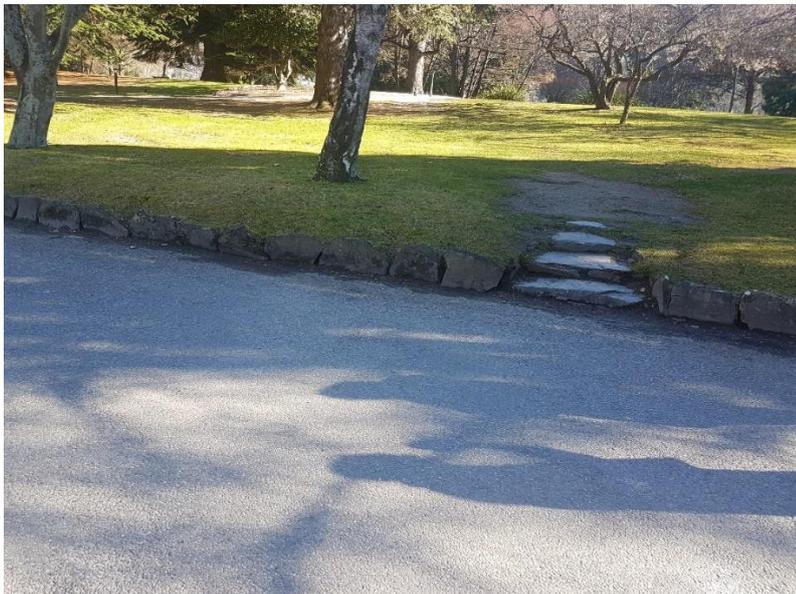
Many paths begin or terminate in unusual places which is likely to result in users ending up in areas trafficable by vehicles. There are several steps leading to no paths as shown in the picture below. There is also a severe lack of ramps suitable for wheelchair or pram access.

Increased clarity of the paths in the gardens should be a target. This will result in less users on vehicle access ways, and specified paths for cyclists to use in order to help reduce potential pedestrian-cyclist collisions.

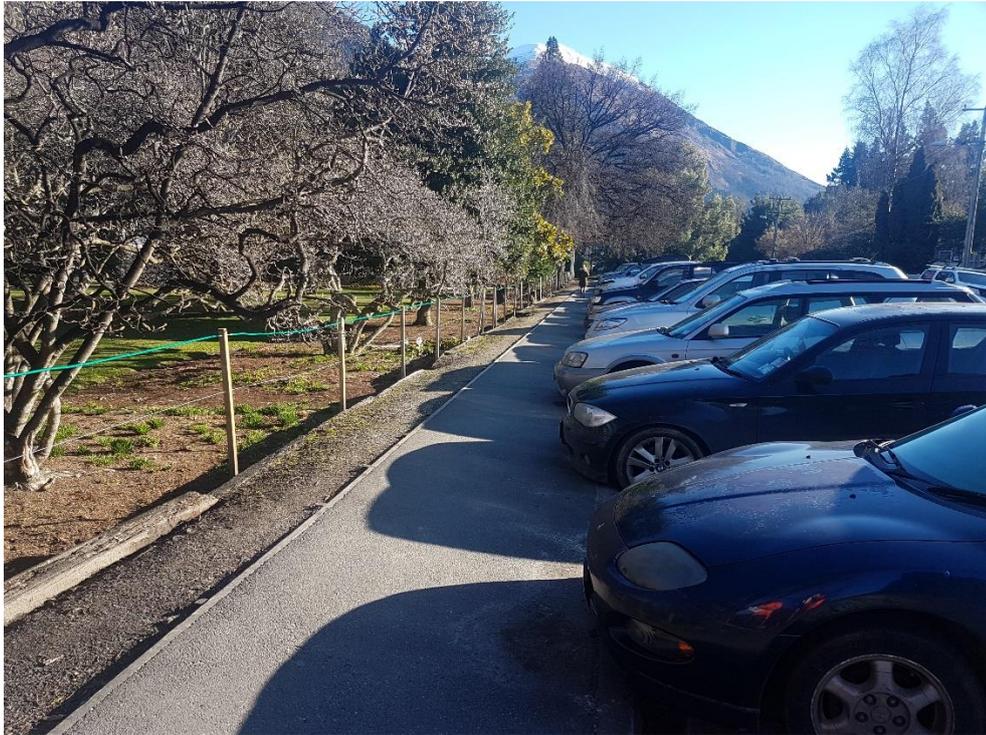
The current path along Park Street is un-able to accommodate two-way traffic due to parked vehicles overhanging the footpath/cycle way which restricts its width severely as shown in the picture below.

The current cycle path along Park Street is not suitable. It is recommended a suitable cycle path be constructed inside the Queenstown gardens boundary, away from the road.

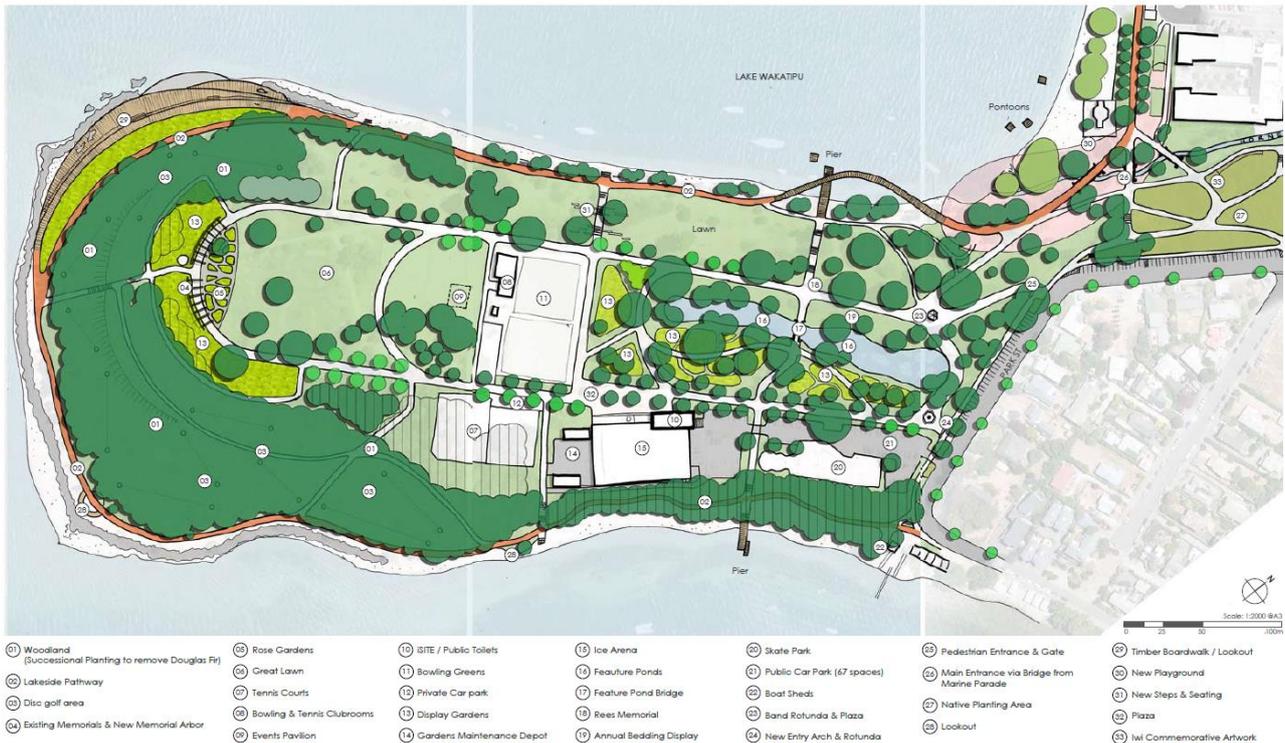
The proposed layout is shown below. The layout removes general vehicle access from the main gardens driveway, relocates the main vehicle entrance to the Ice Rink carpark, and adds connection to the Maintenance Lot along the south (lake side) of the skating rink. These changes are done with the aim of improving functionality and ease of use for all, however there is a heavy focus towards improving the user experience for pedestrians and cyclists. Accompanying these main changes are several changes to the landscaping and path designs. These changes are aimed to improve the user experience in the park, and are not generally a concern in terms of safety.

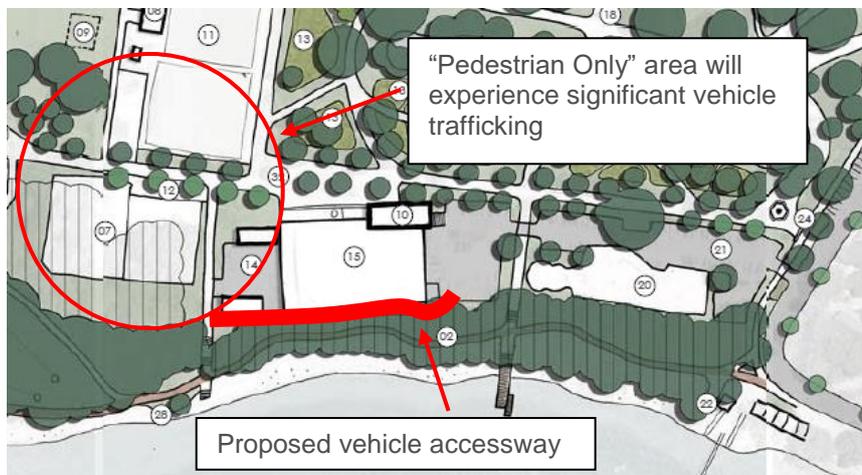
The proposed vehicle access along the south side of the skating rink will be used to connect to the new private Tennis Carpark (Number 12 on map), the maintenance lot and the bowls club. As such the traffic volumes expected would not be insignificant. It is therefore expected that the connection would be wide-enough to accommodate two-way traffic.

In order to use this vehicle access, vehicles would have to utilize the skating rink carpark as a thoroughfare. This significantly increases the likelihood of problems in the carpark. The connection also joins onto the existing one way maintenance lot access, which would have to be widened to two lanes in order to accommodate increased traffic.

The plan indicates the area to be pedestrian only, but due to it also being the vehicle access there is likely to be significant conflict between the two user groups. Of particular concern is the Walkway down to the beach, which appears relatively narrow for the expected volume of bi-direction mixed vehicle/cycle/pedestrian usage.

The proposed vehicle access way through the carpark and around the ice rink does not appear suitable to cater for the volume of traffic expected. It is therefore recommended that vehicle access be maintained along the main gardens drive.

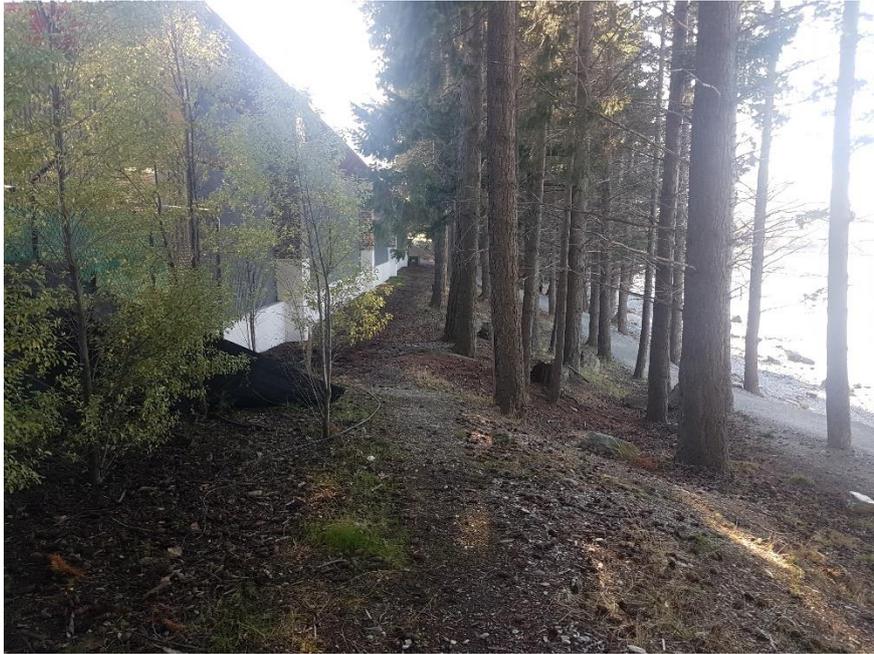
The Proposed accessway its self is likely to require extensive safety work due to its proximity to the Queenstown-Frankton beachfront shared use trail.

It is expected the trail would need to be relocated further towards the lake in order to allow room next to the skating rink for a dual carriageway. Relocating the trail is likely to prove difficult however, both in terms of community acceptance, and the physical works required as the trail would likely need to traverse over the rocky beach on a boardwalk or similar.

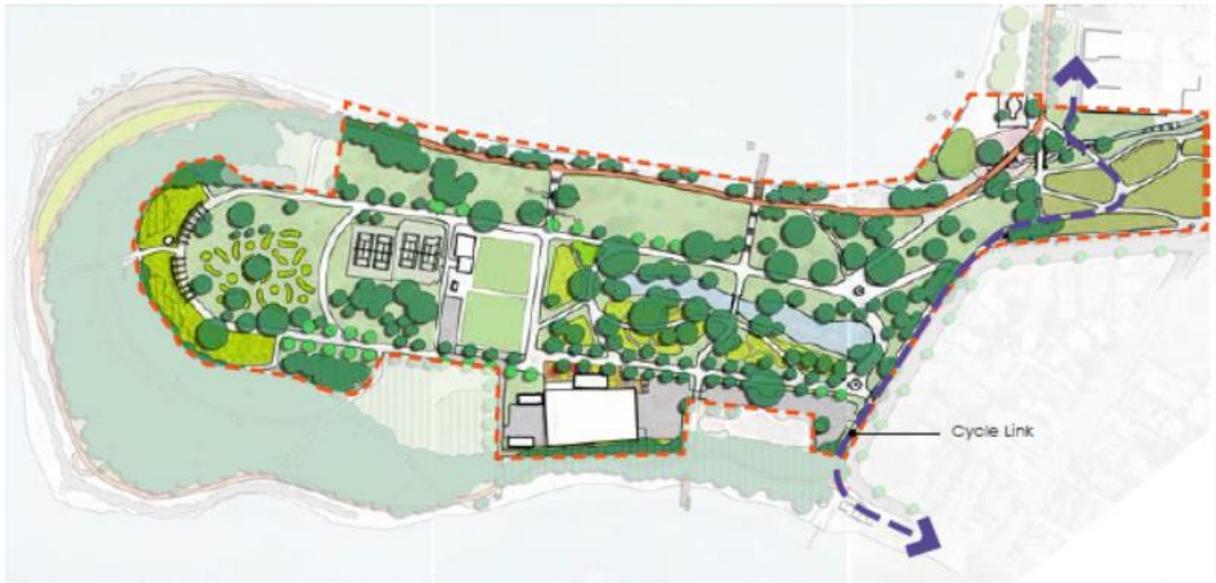
The cycle path is proposed to link through the area by traversing the outskirts of the gardens.
