Client/Location:
WATERFALL PARK DEVELOPMENTS LTD
LOT 1 DP 540788

Purpose/Drawing Title:
NORTHBROOK - ARROWTOWN STORMWATER LAYOUT

Northbrook Arrowtown
Graphic Attachment to Landscape Assessment Report

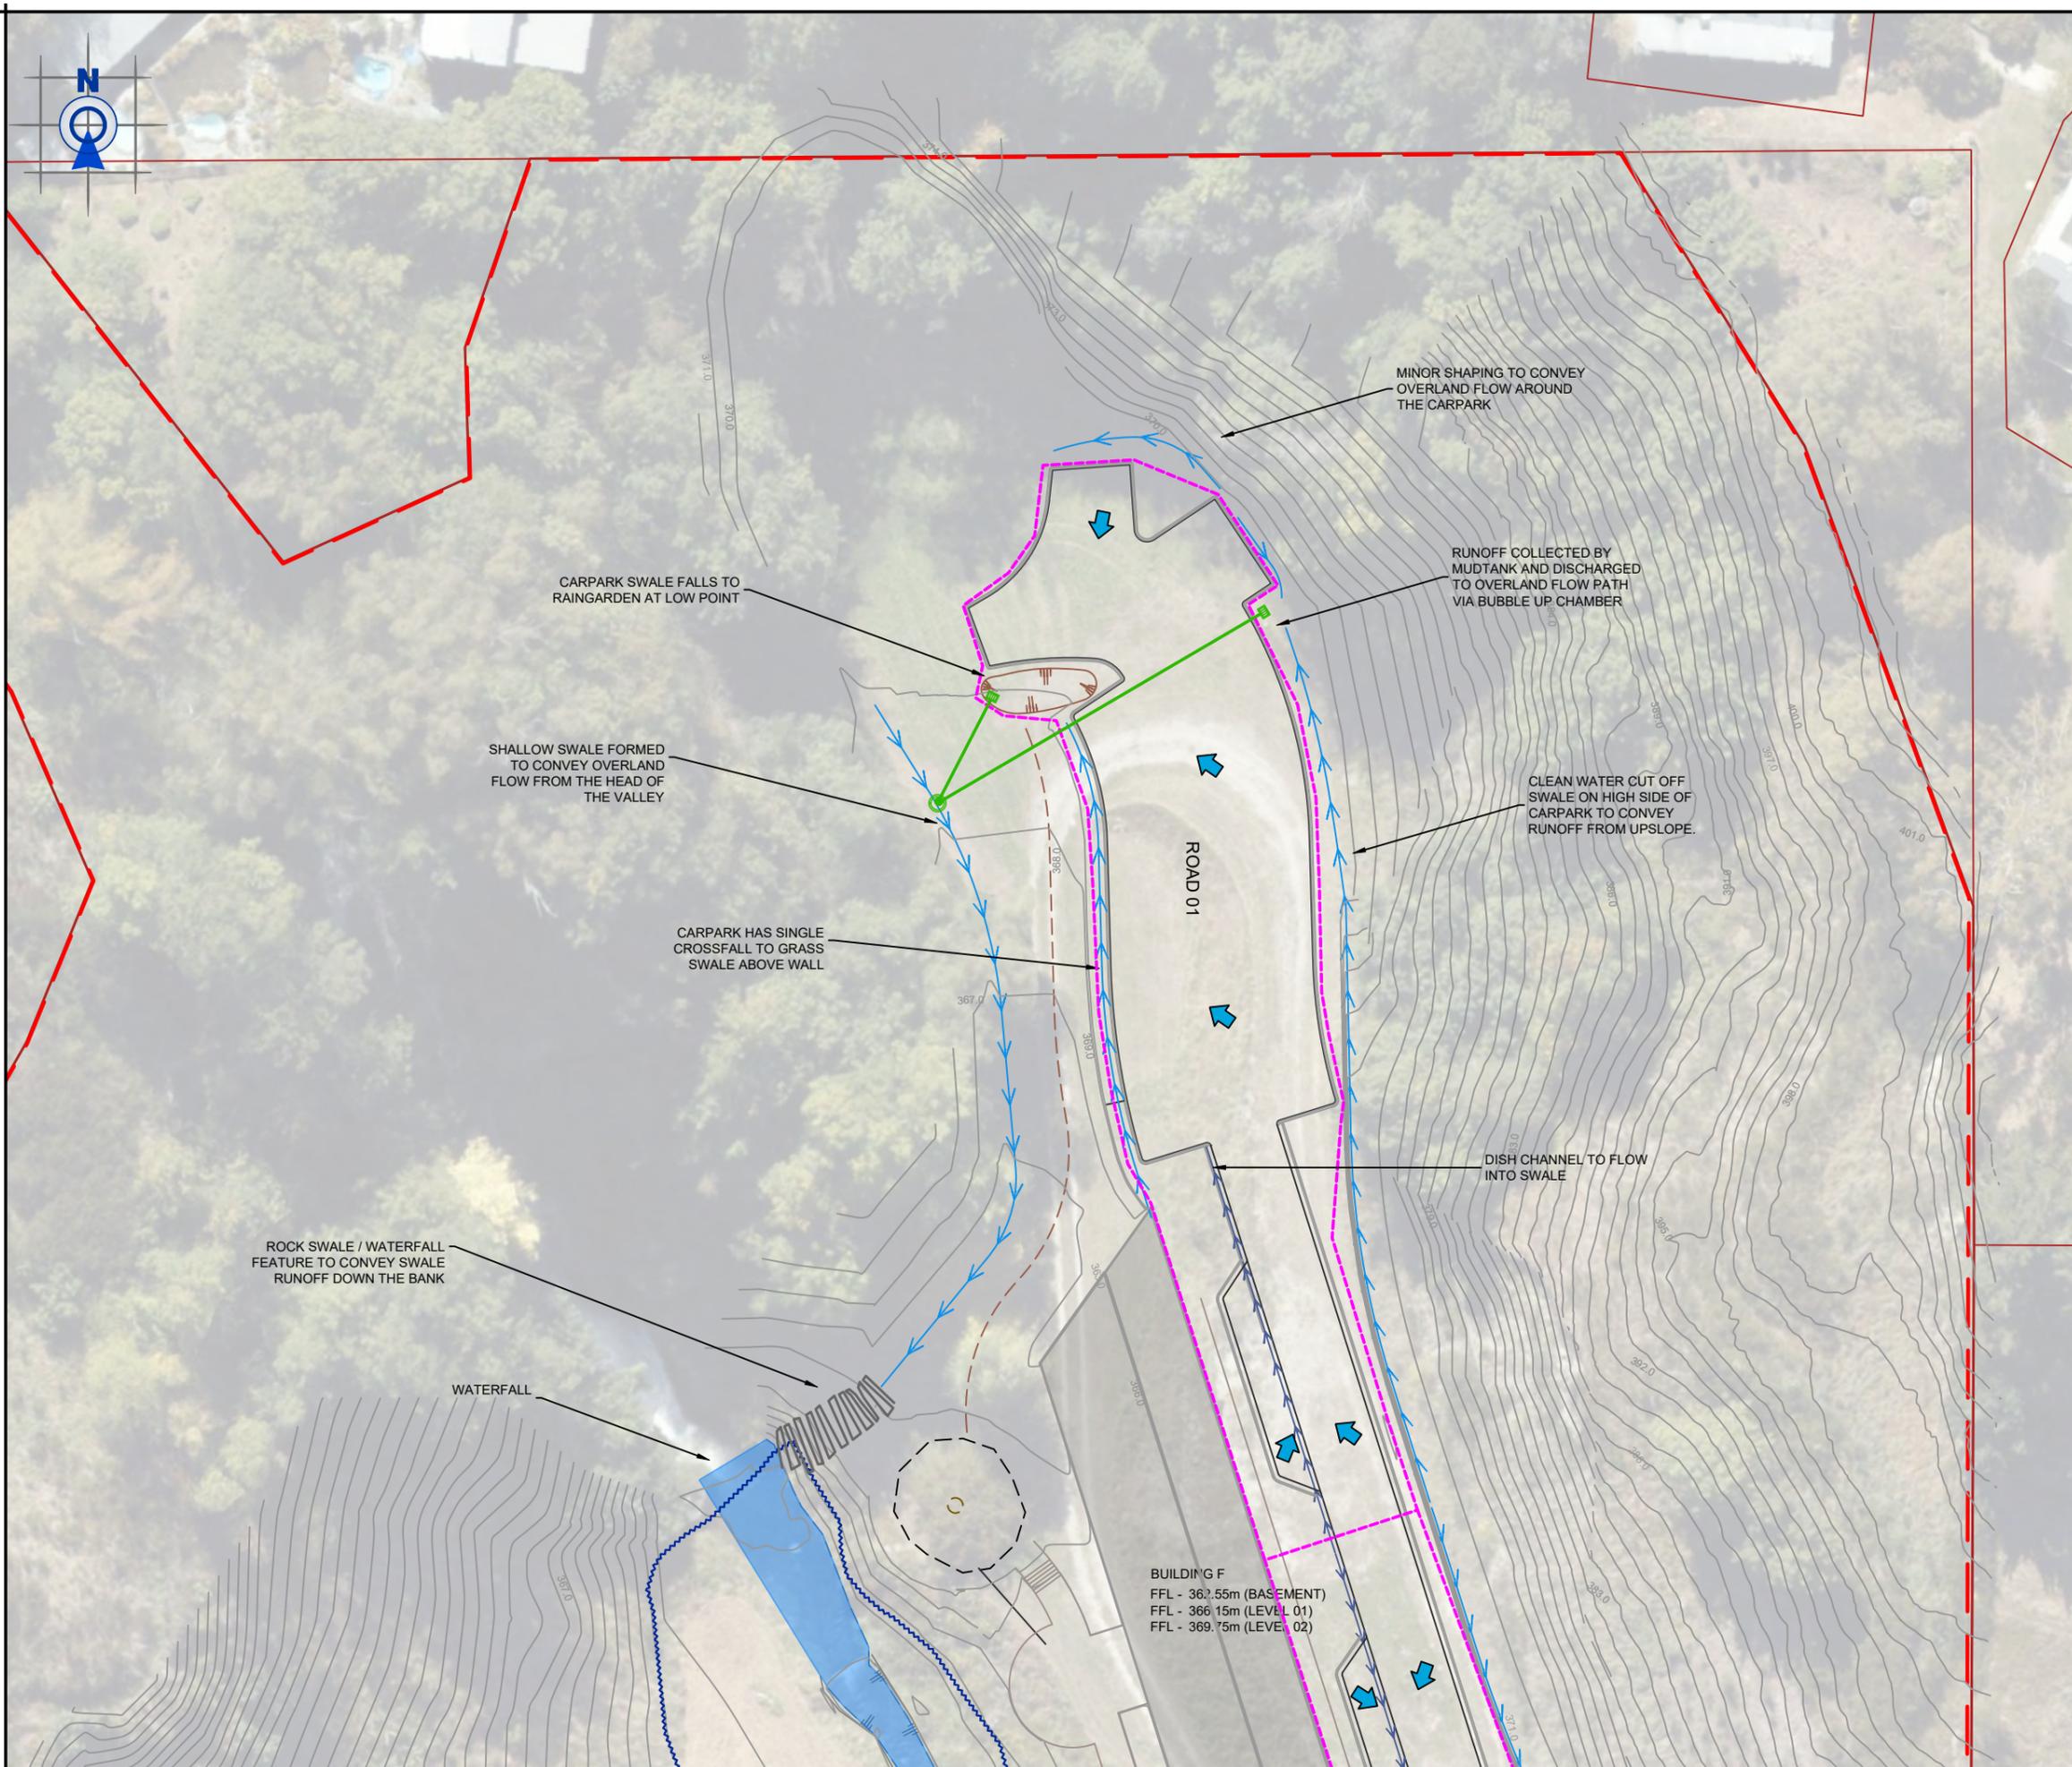
- NOTES**
1. REFER TO CKL REPORT FOR DETAILS OF SW TREATMENT
 2. ROOF RUNOFF WILL BE PIPED DIRECTLY TO OPEN SWALES AND BE CONVEYED TO MILL CREEK.
 3. ALL CATCHMENT EXTENTS SHOWN ARE INDICATIVE ONLY, AREA MAY CHANGE DURING DETAILED DESIGN.

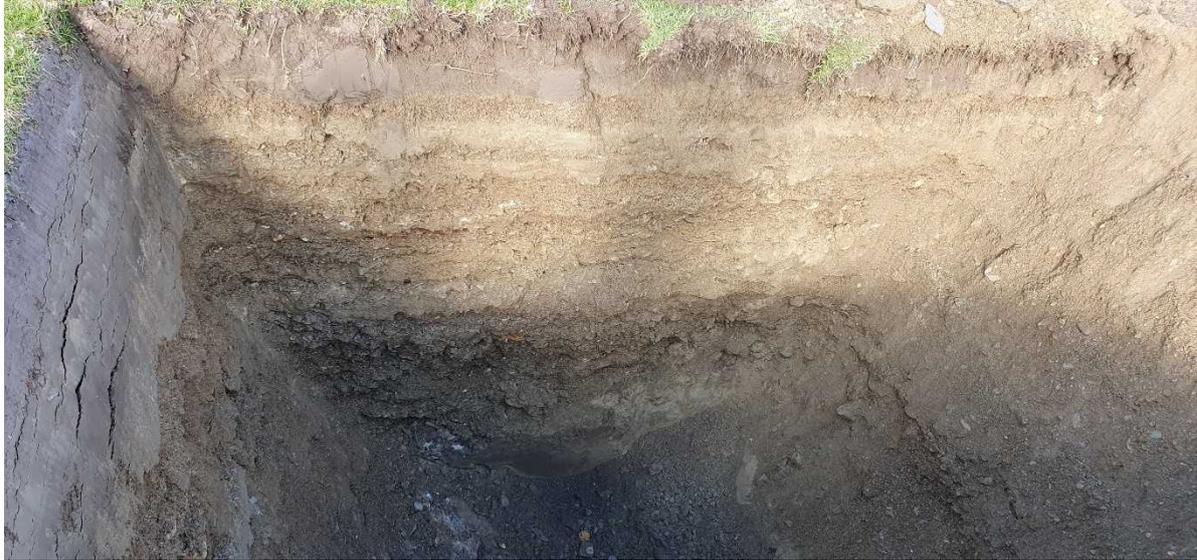
Photograph 1: Test Pit 1.

<u>Borrow Area</u>			
<ul style="list-style-type: none"> • Test pits 1 and 2 revealed well-graded, sandy GRAVEL at depths between 0.2 and 2.2 m. These soils will be suitable to be used as engineered fill. 			
<u>Soakage Testing</u>			
<ul style="list-style-type: none"> • Permeability testing for Soak Pits 1 and 2 were completed at 2.3 and 1.0 m depth respectively. • The calculated infiltration rates were: • Soak Pit 1 = 7 mm/hour; Soak Pit 2 = 90 mm/hour. 			
Please note that Soak Pit 2 was carried out 20 m away from Mill Creek. Groundwater inflow was recorded at a depth of 2.4 m within Soak Pit 2.

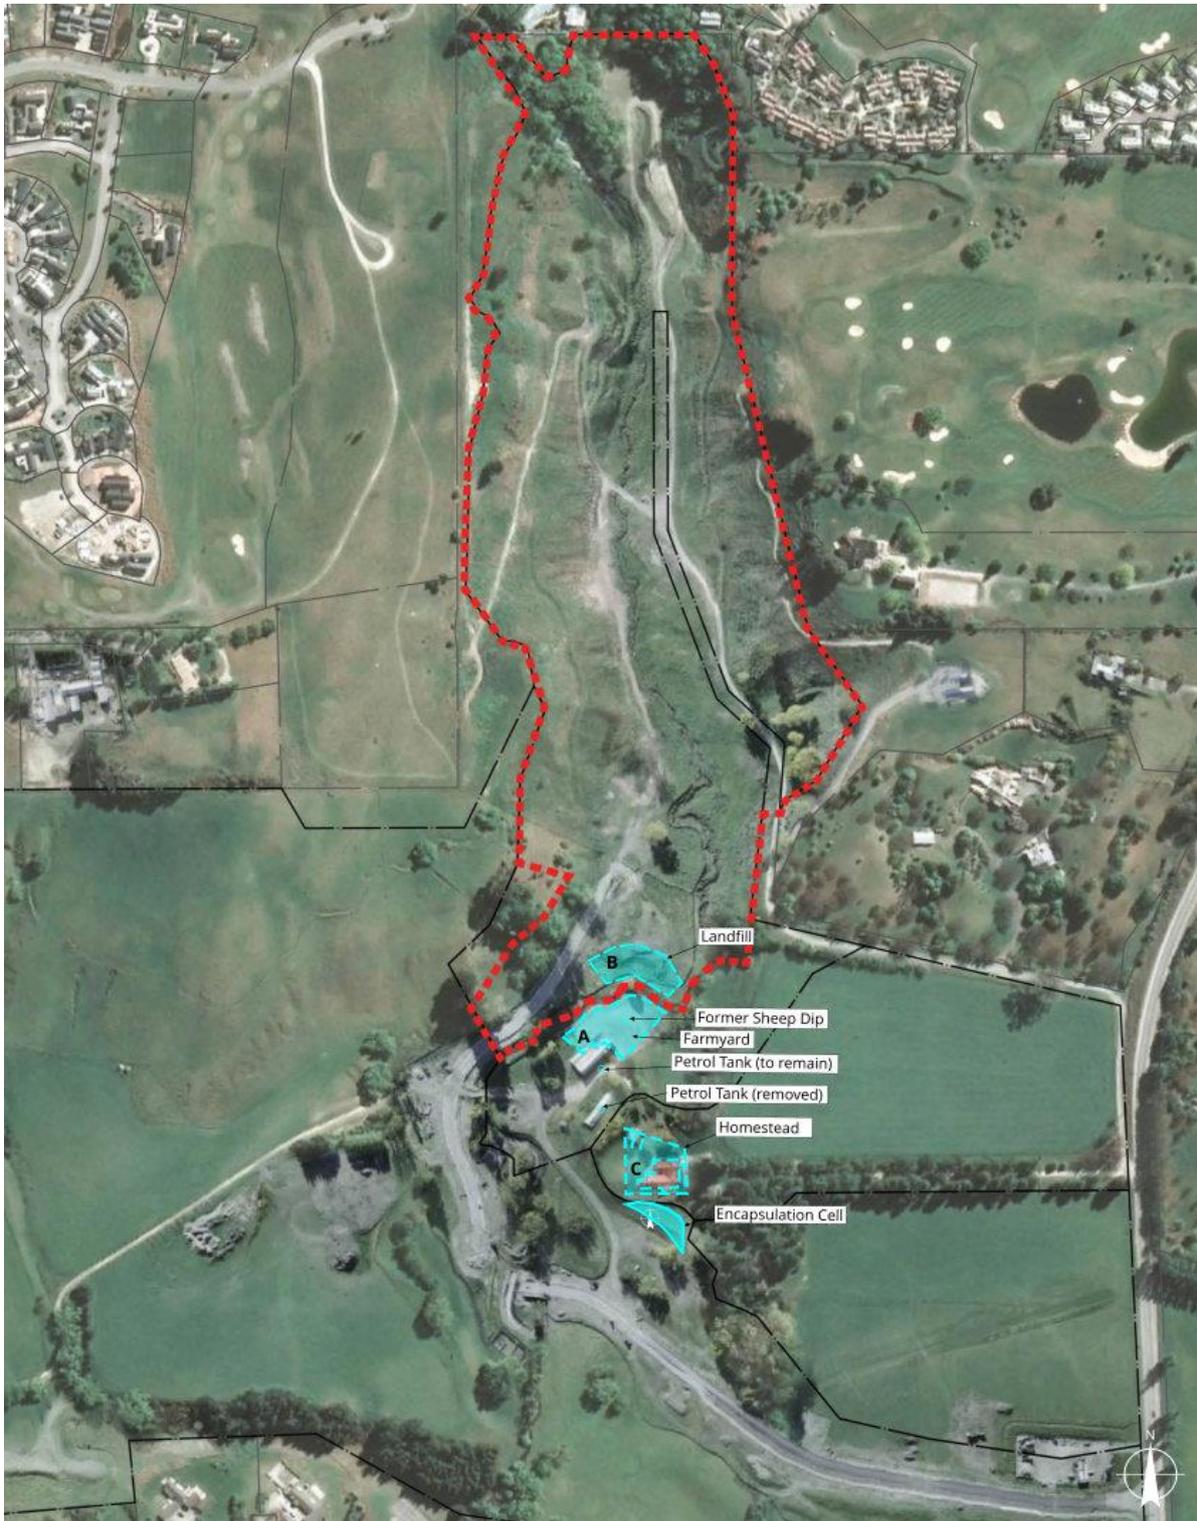
define the HAIL sites within the property by ascertaining the extent of contamination in the three sites (A, B and C) and to inform remediation options. Remedial earthworks were subsequently undertaken under consents RM181597 and RM18.426.01-03, with contaminated soils removed from the sites being placed into a purpose designed Encapsulation Cell to isolate contaminants and prevent remobilisation. The location and extent of the sites and the Encapsulation Cell is shown in Figure 3 in turquoise. Site B is located within the application boundary.

Figure 3: Site layout showing the locations of the contaminated sites (A, B and C) and the Encapsulation Cell in turquoise. The site boundary is shown in red.

The PSI found exceedances of the applicable soil contamination standard (SCS) for arsenic and lead in the soils around the existing homestead, farmyard buildings and the adjacent landfill. The soil sampling across the greater part of the property found contaminants were present at concentrations that are likely to be the natural background levels. A DSI was undertaken to better

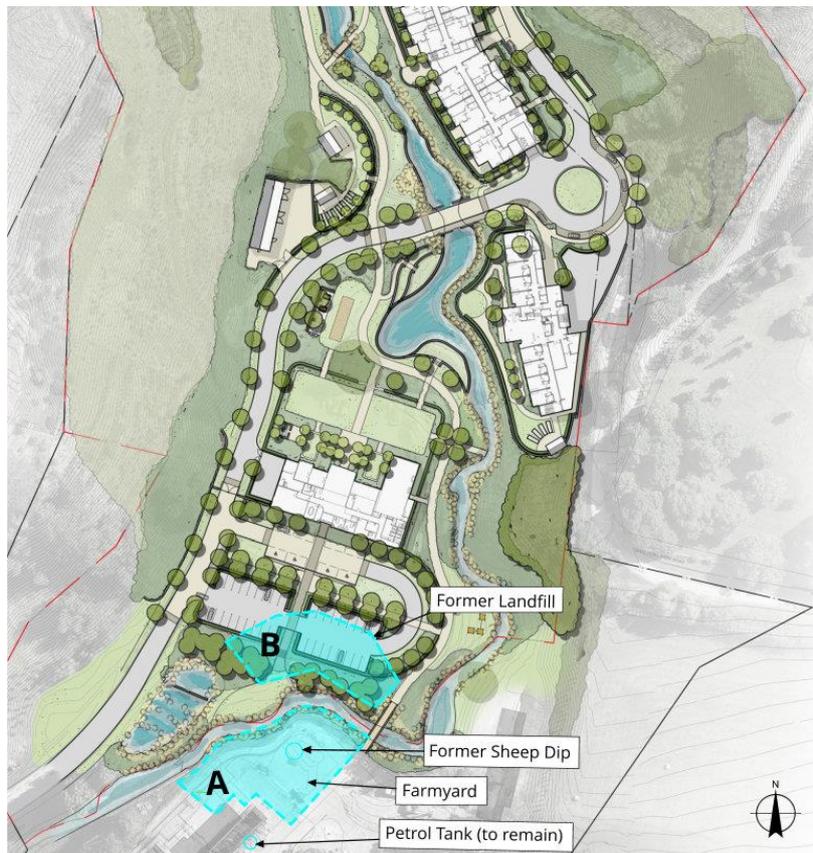
Figure 4: Concept Plan of the Building A in relation to Site B (October 2022).

Figure 4 shows the proposed site layout in relation to Site B. Building A is designed as the Arrivals and Amenity building, containing the main reception in addition to a pool, gym, cinema, library and cafe. A hard-surface car parking area and associated landscaping will be constructed over Site B. These activities are more consistent with commercial land use which is highly unlikely to present a risk to human health or the environment.

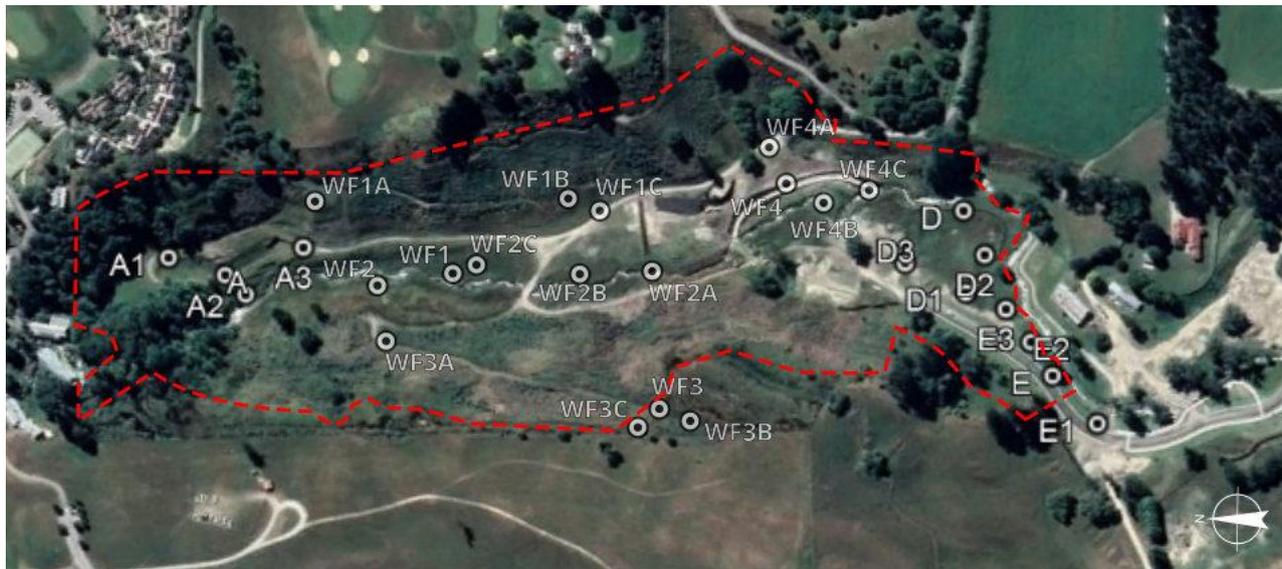
Figure 6: Sampling locations from the PSI undertaken in 2016, with the application boundary shown in red.

The sampling locations from the PSI within the application boundary are shown in Figure 6 and the results are summarised in Table 2. Surface soil samples were collected in groups of 4, analysed as one individual and a composite of three subsamples to increase the sampling density while

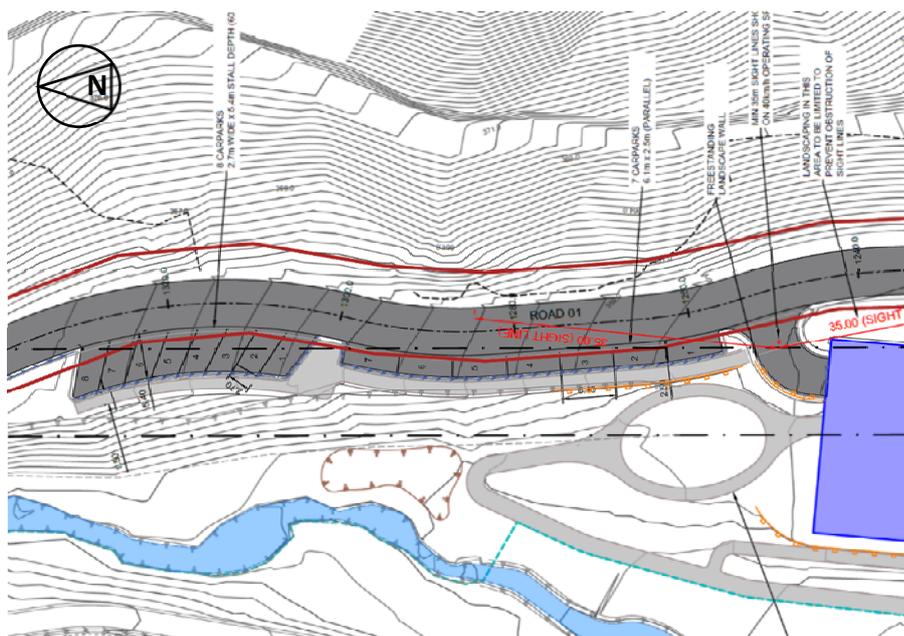
There are 15 parking spaces provided on the western side of Ayr Avenue to the north of Building E. Seven of these are provided in parallel format and eight are provided at an angle of 60 degrees.

Figure 4: Kerbside Parking North of Building E (Extract from Paterson Pitts Drawing)

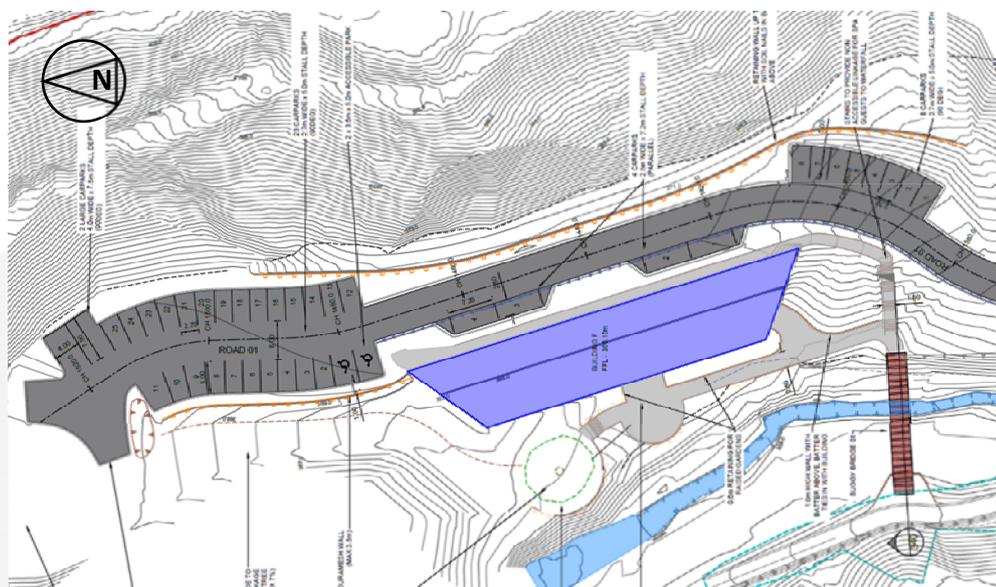
There is a total of 39 car parks proposed around Building F. Of these, 8 are provided to the south the building on the eastern side of Ayr Avenue in 90-degree format, with four parallel spaces on the western side of the road. It is understood that these four parallel parks are for pick-up and drop-off and very short-stay parking. Just north of Building F is a car park with 28 spaces of which two are marked for mobility impaired people and two are noted as being large car parks.

Figure 5: Parking Near Building F (Extract from Paterson Pitts Drawing)

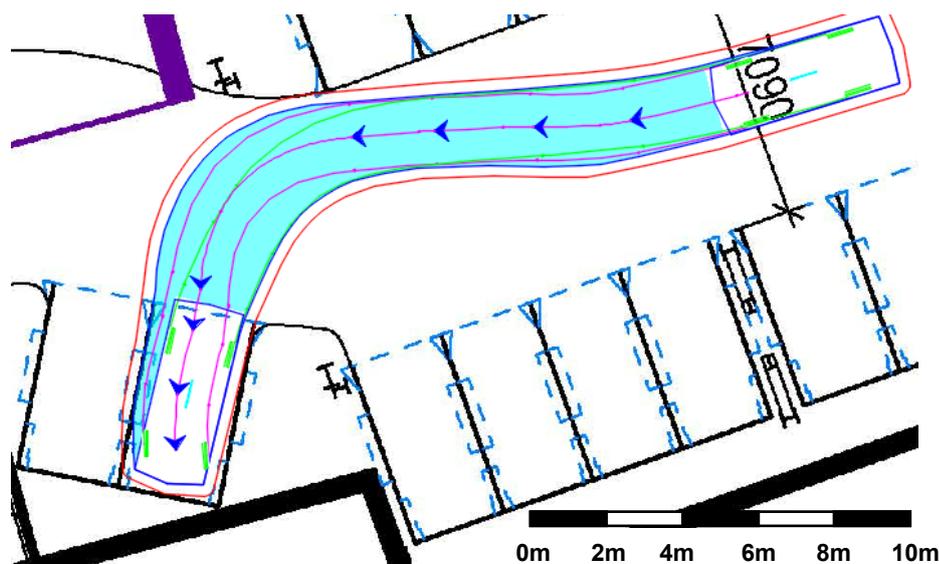
As noted above however, there is one parking spaces within the basement where the proposed dimensions appear to fall below the anticipated values. Tracking curves for vehicles entering and exiting this space is shown below. In these Figures, the cyan line is the vehicle bodywork and the thin red line is a clearance of 0.3m around the bodywork.

Figure 7: B85 Car Entering Space 74

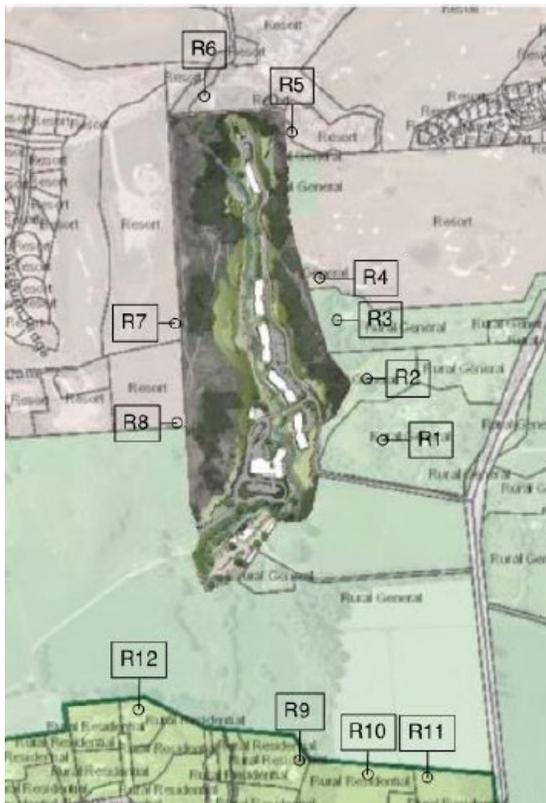
Figure 1: Noise measurement and assessment positions

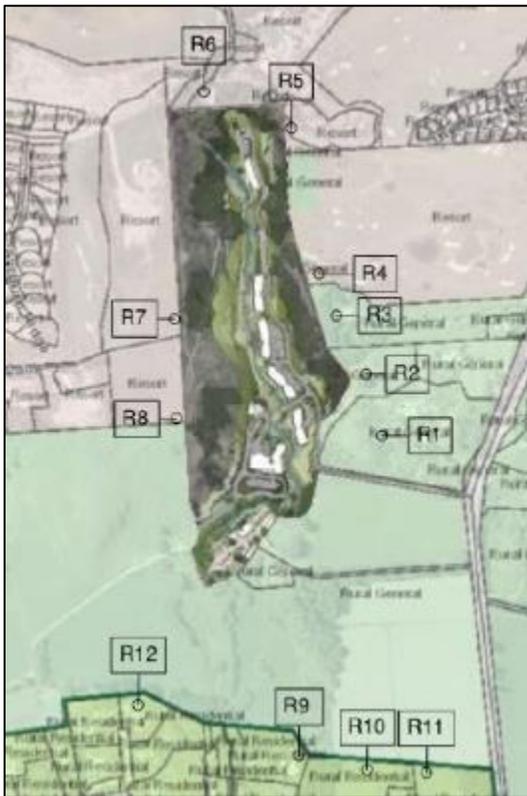
Figure 1: Noise measurement and assessment positions

1. Noise from the site shall comply with the following noise limits:
 - (a) Sound from non-residential activities measured in accordance with NZS6801:2008 and assessed in accordance with NZS6802:2008 shall not exceed the following noise limits at any of the points marked R1-R12 in Figure 1 below:
 - (i) daytime (0800 to 2000 hrs) 50dB LAeq (15 min)
 - (ii) night-time (2000 to 0800 hrs) 40dB LAeq (15 min)
 - (iii) night-time (2000 to 0800 hrs) 70dB LAFmax
 - (b) The noise limits in (a) shall not apply to construction sound which shall be assessed in accordance with NZS6803:1999.

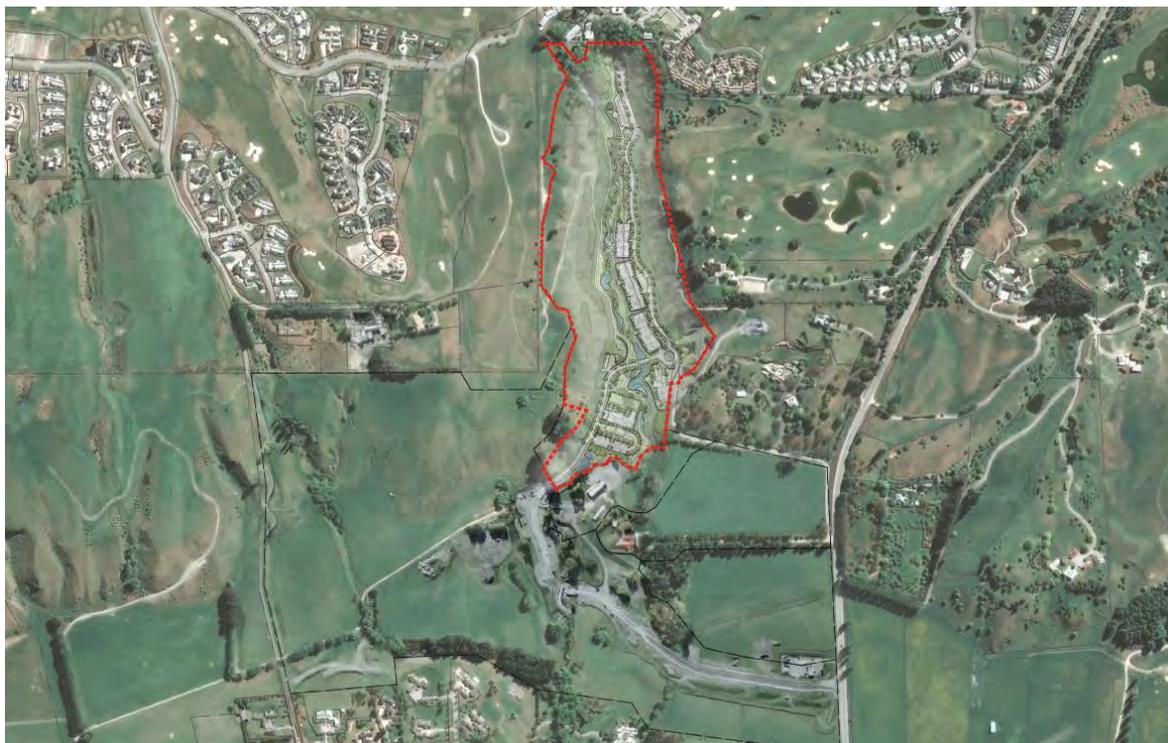
Figure 2.1 – Site Location Plan

The subject property is located approximately 2km south of Arrowtown and 1km north of Lake Hayes. It is accessed via Ayr Avenue off the Arrowtown - Lake Hayes Road the Site, see Figure 2.1 below.

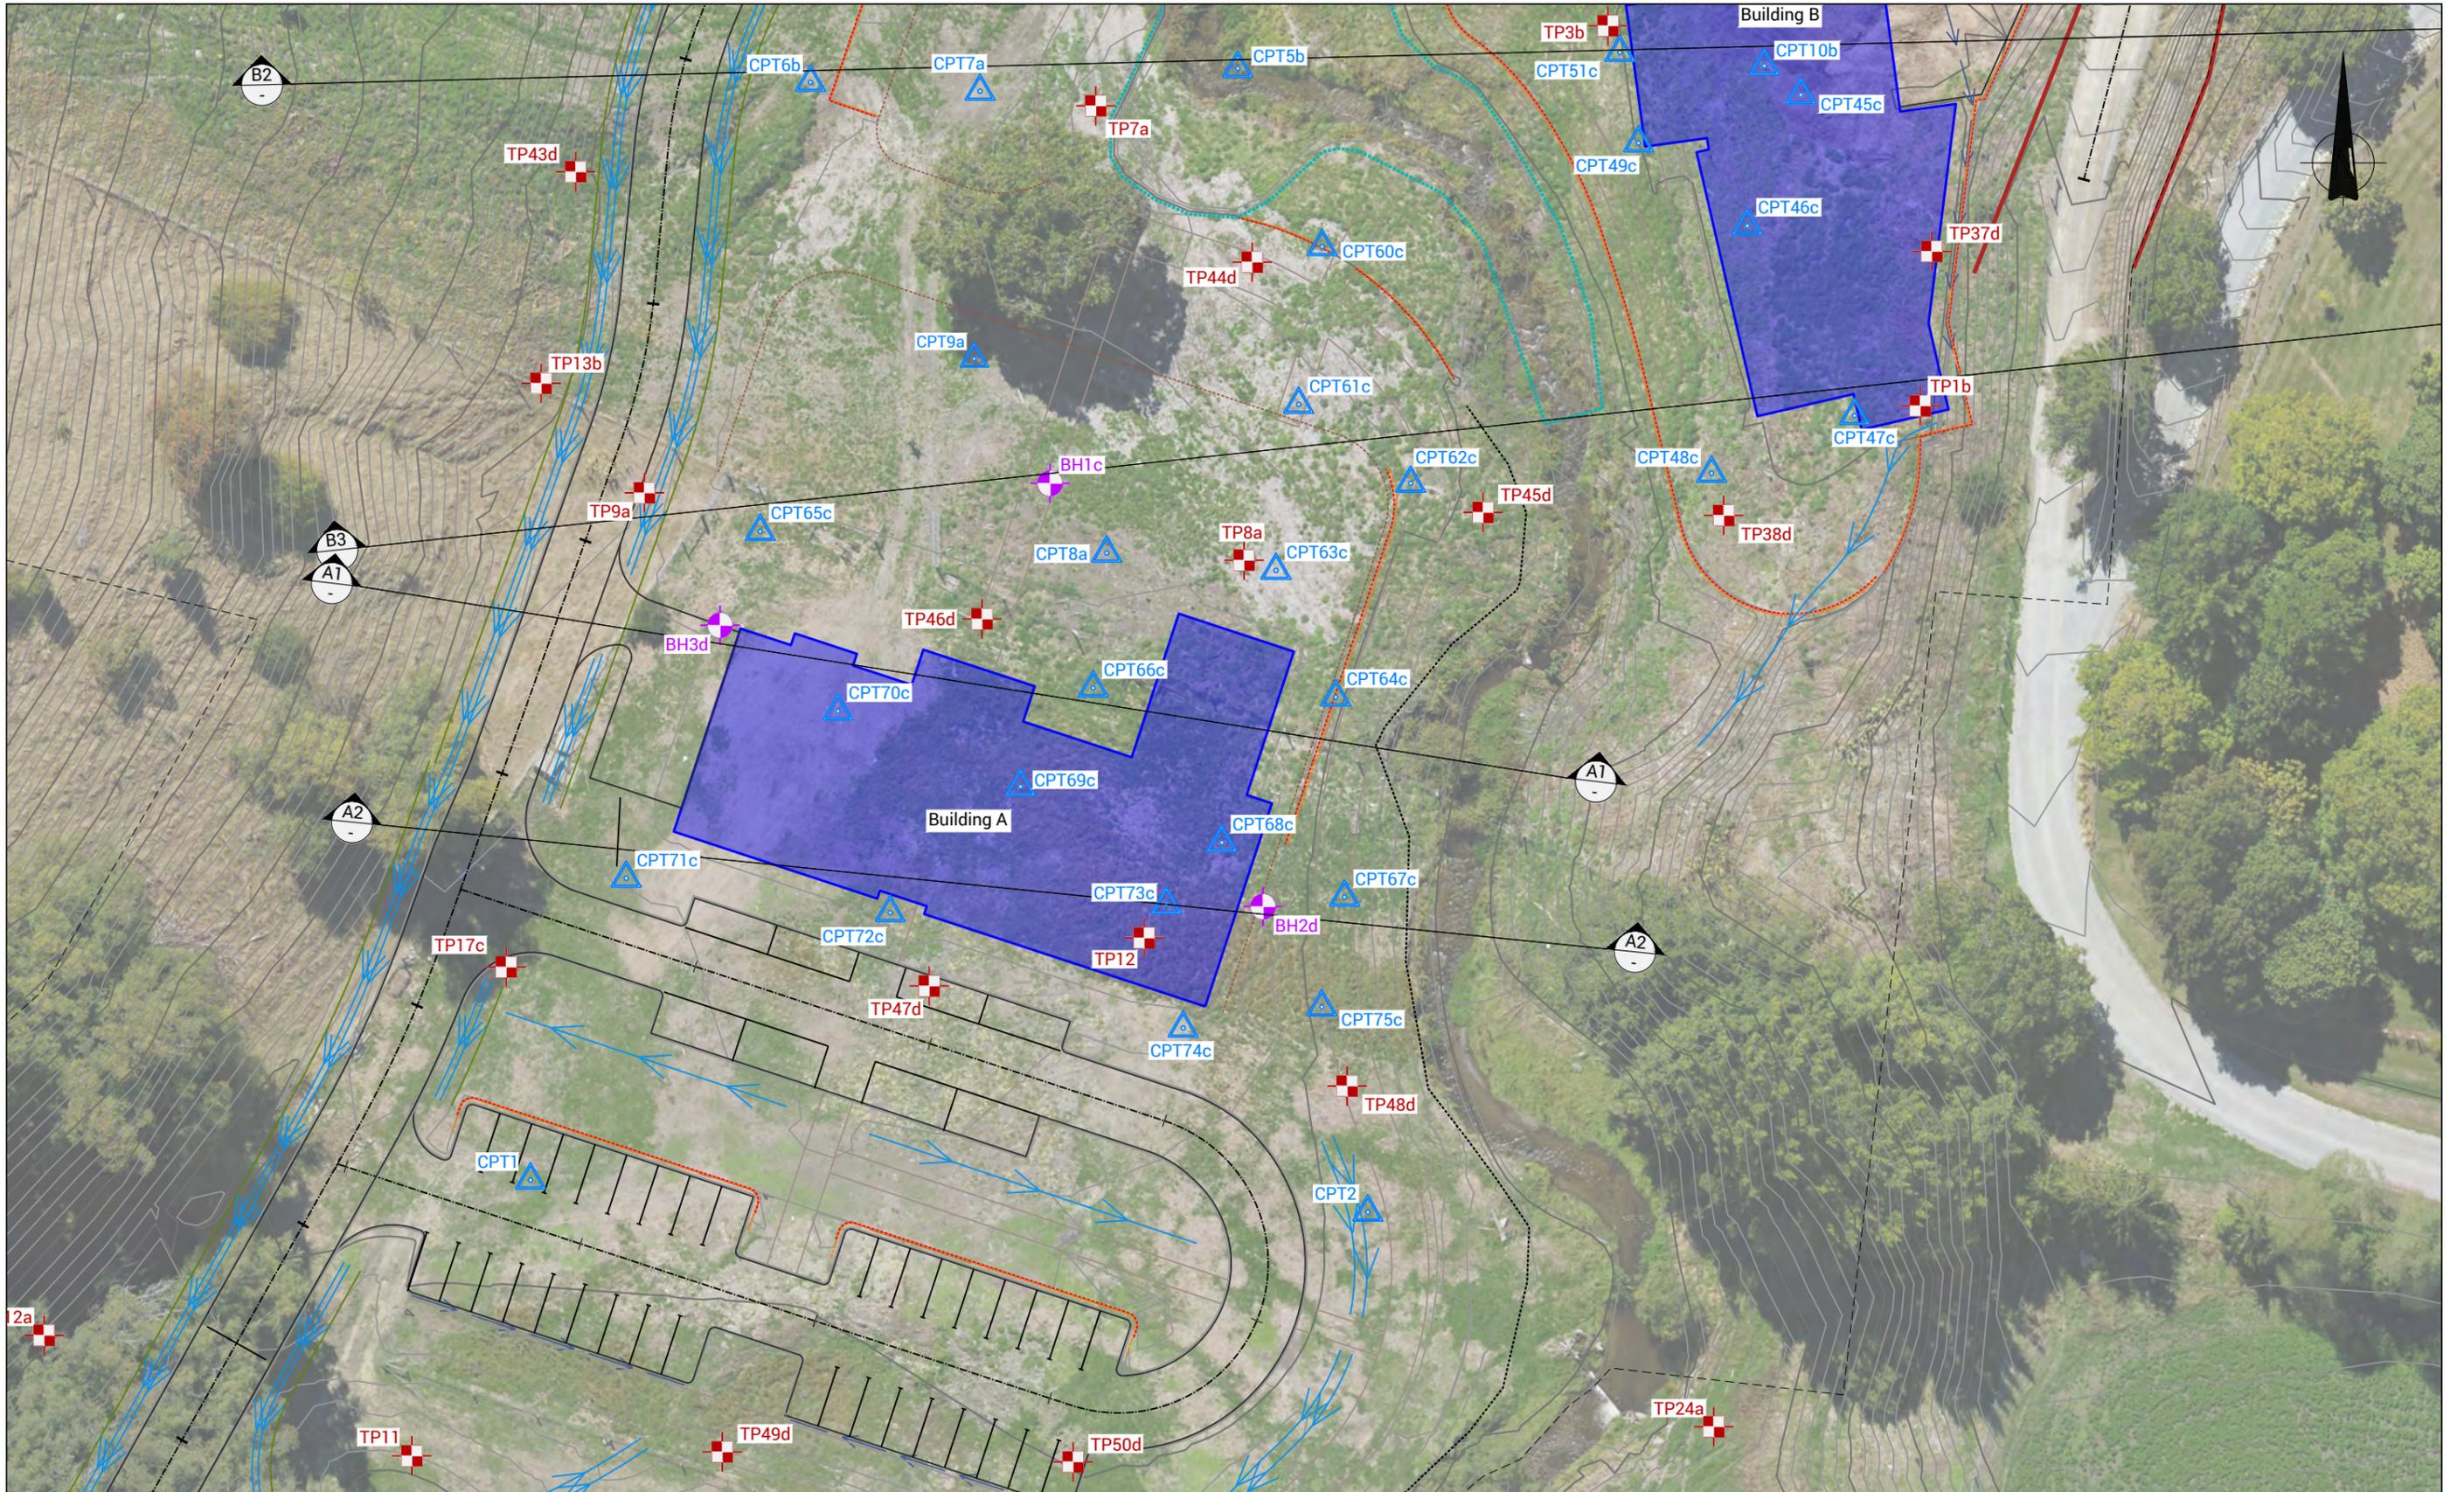
FIG No:
Figure 1a

- Legend:
- Proposed Contours (Source: Patterson Pitts Feb.23)
 - Test Pit Locations
 - Borehole Locations
 - CPT Locations

We understand the proposed development comprises the construction of a later living development. Multiple accommodation buildings up to five storeys, some with basements, and associated facilities are proposed. The general layout of the development is shown on the Figure 2.1 below and Figures 1a to 1f, Appendix A.

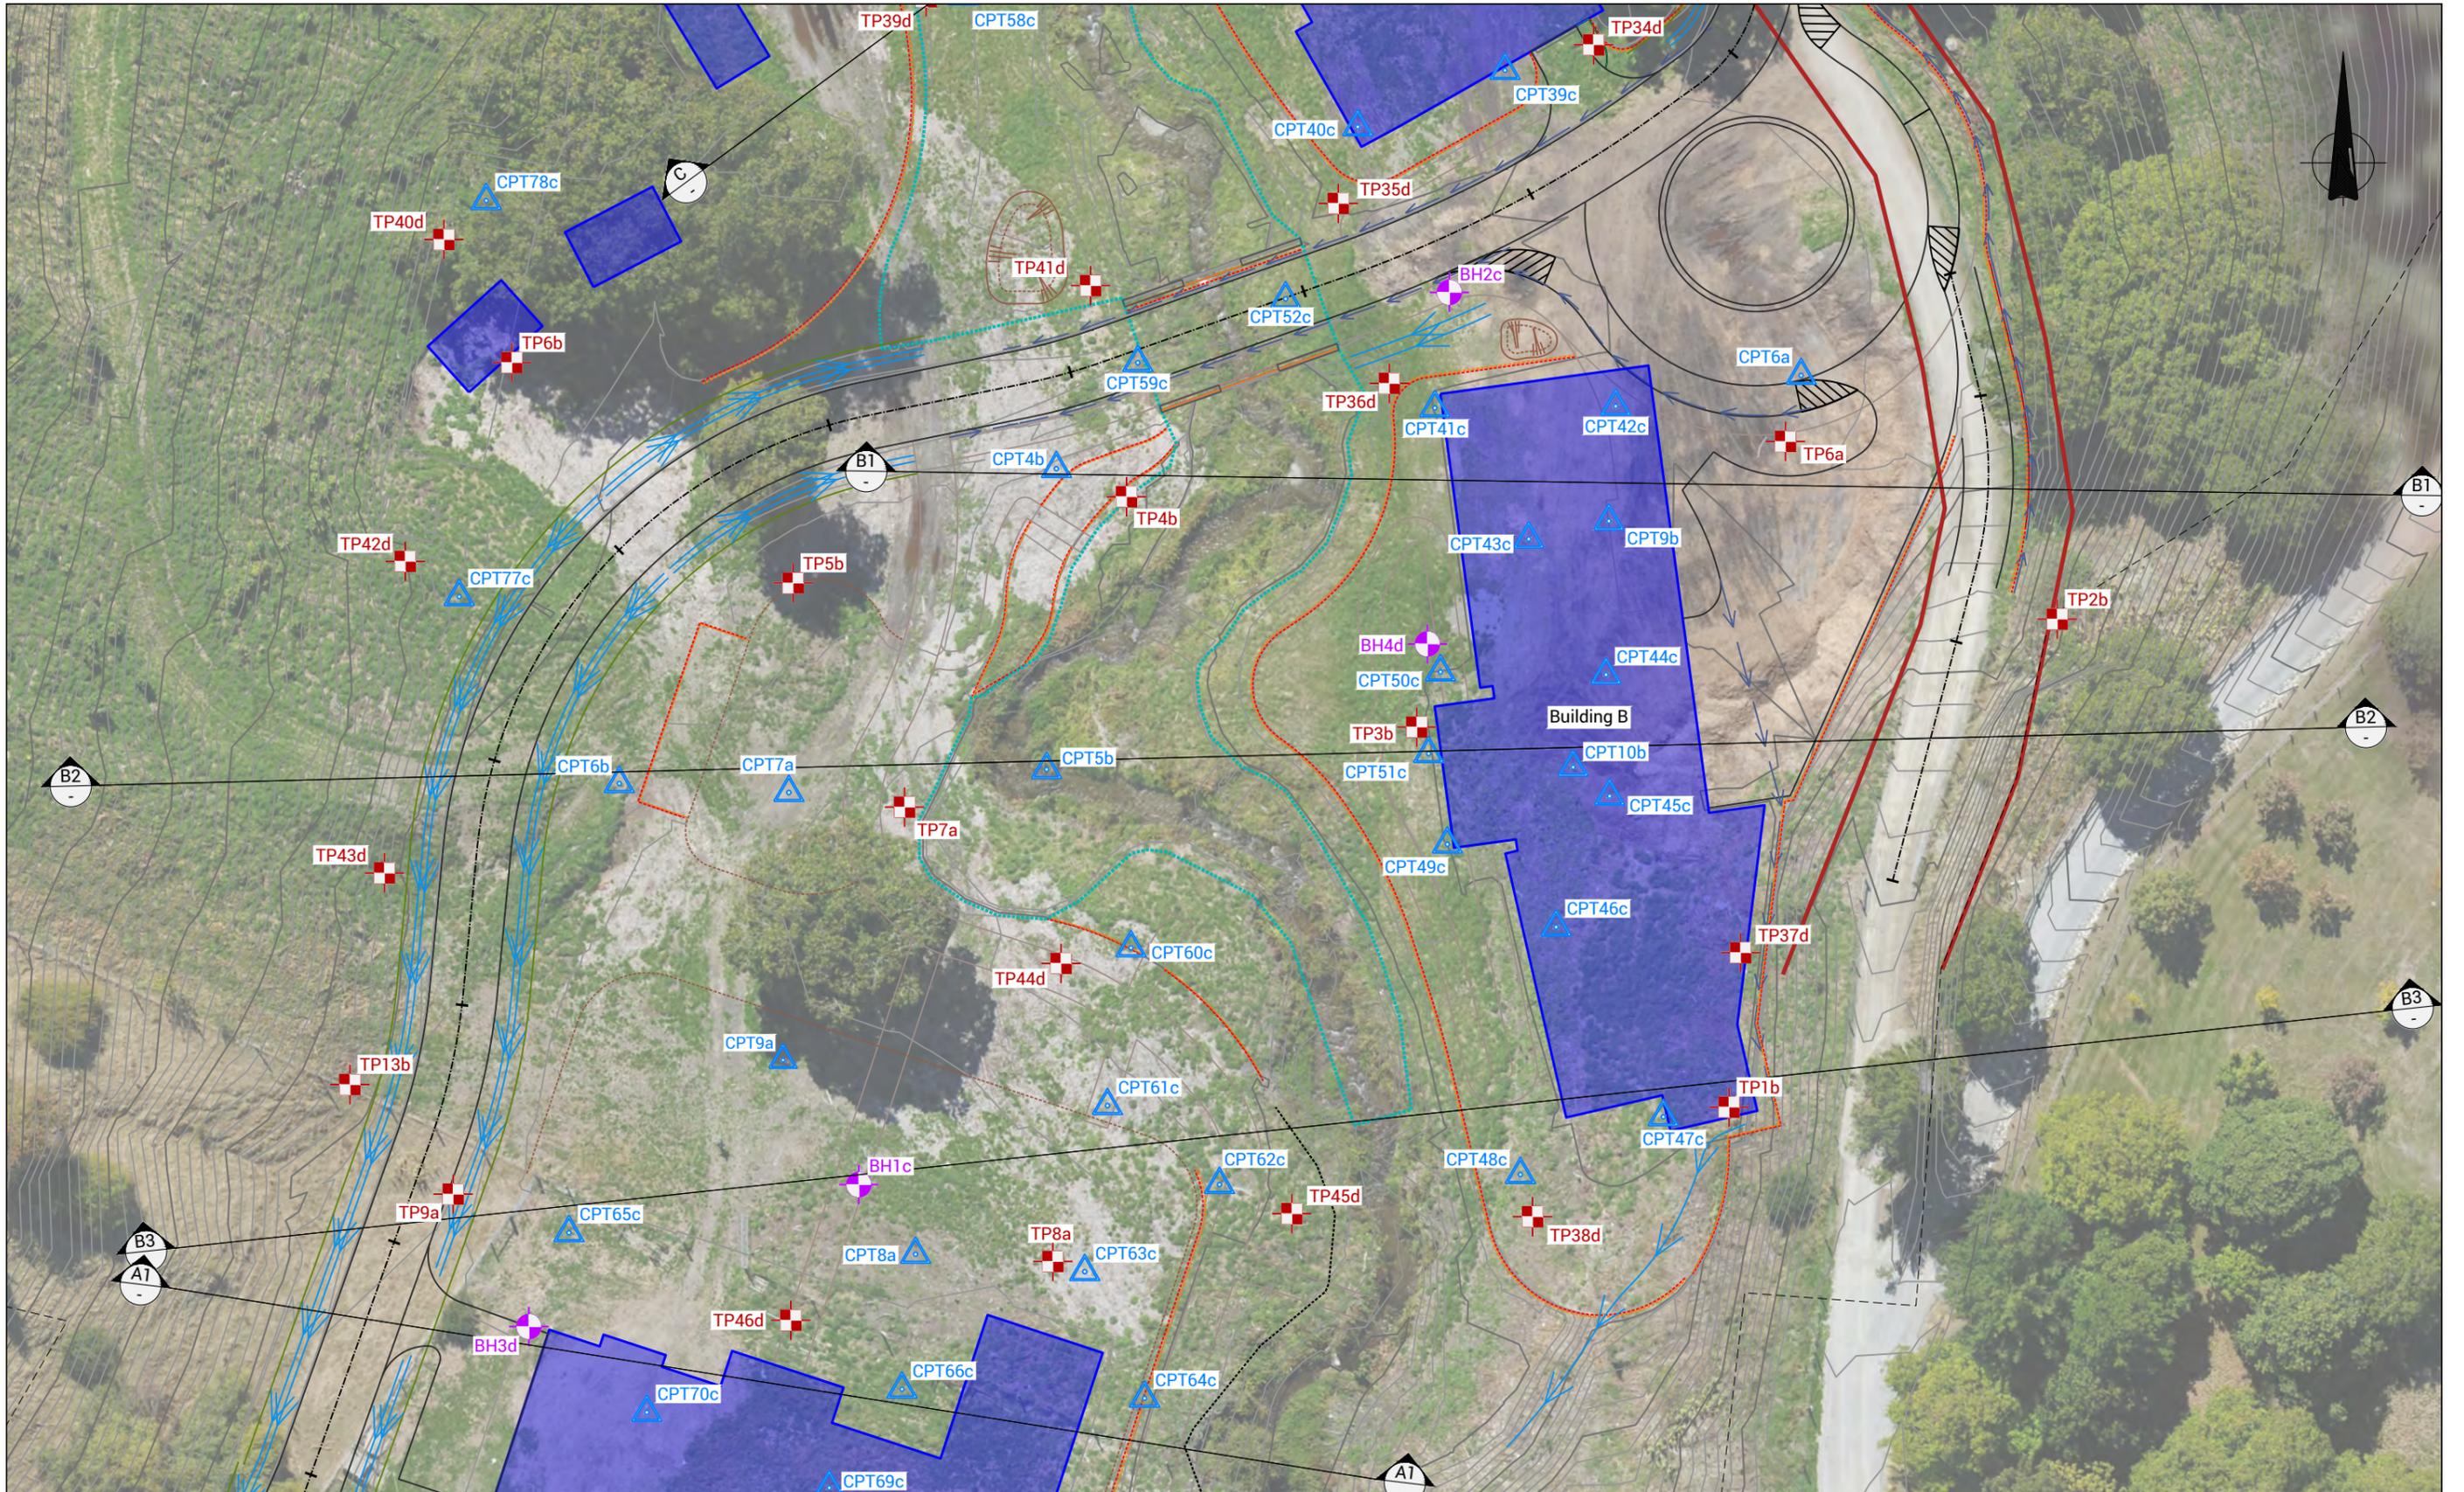
FIG No: Figure 1b

- Legend:
- Proposed Contours (Source: Patterson Pitts Feb.23)
 - Test Pit Locations
 - Borehole Locations
 - CPT Locations
