Client/Location:
WATERFALL PARK DEVELOPMENTS LTD
LOT 1 DP 540788

Purpose/Drawing Title:
NORTHBROOK - ARROWTOWN STORMWATER LAYOUT

Northbrook Arrowtown
Graphic Attachment to Landscape Assessment Report

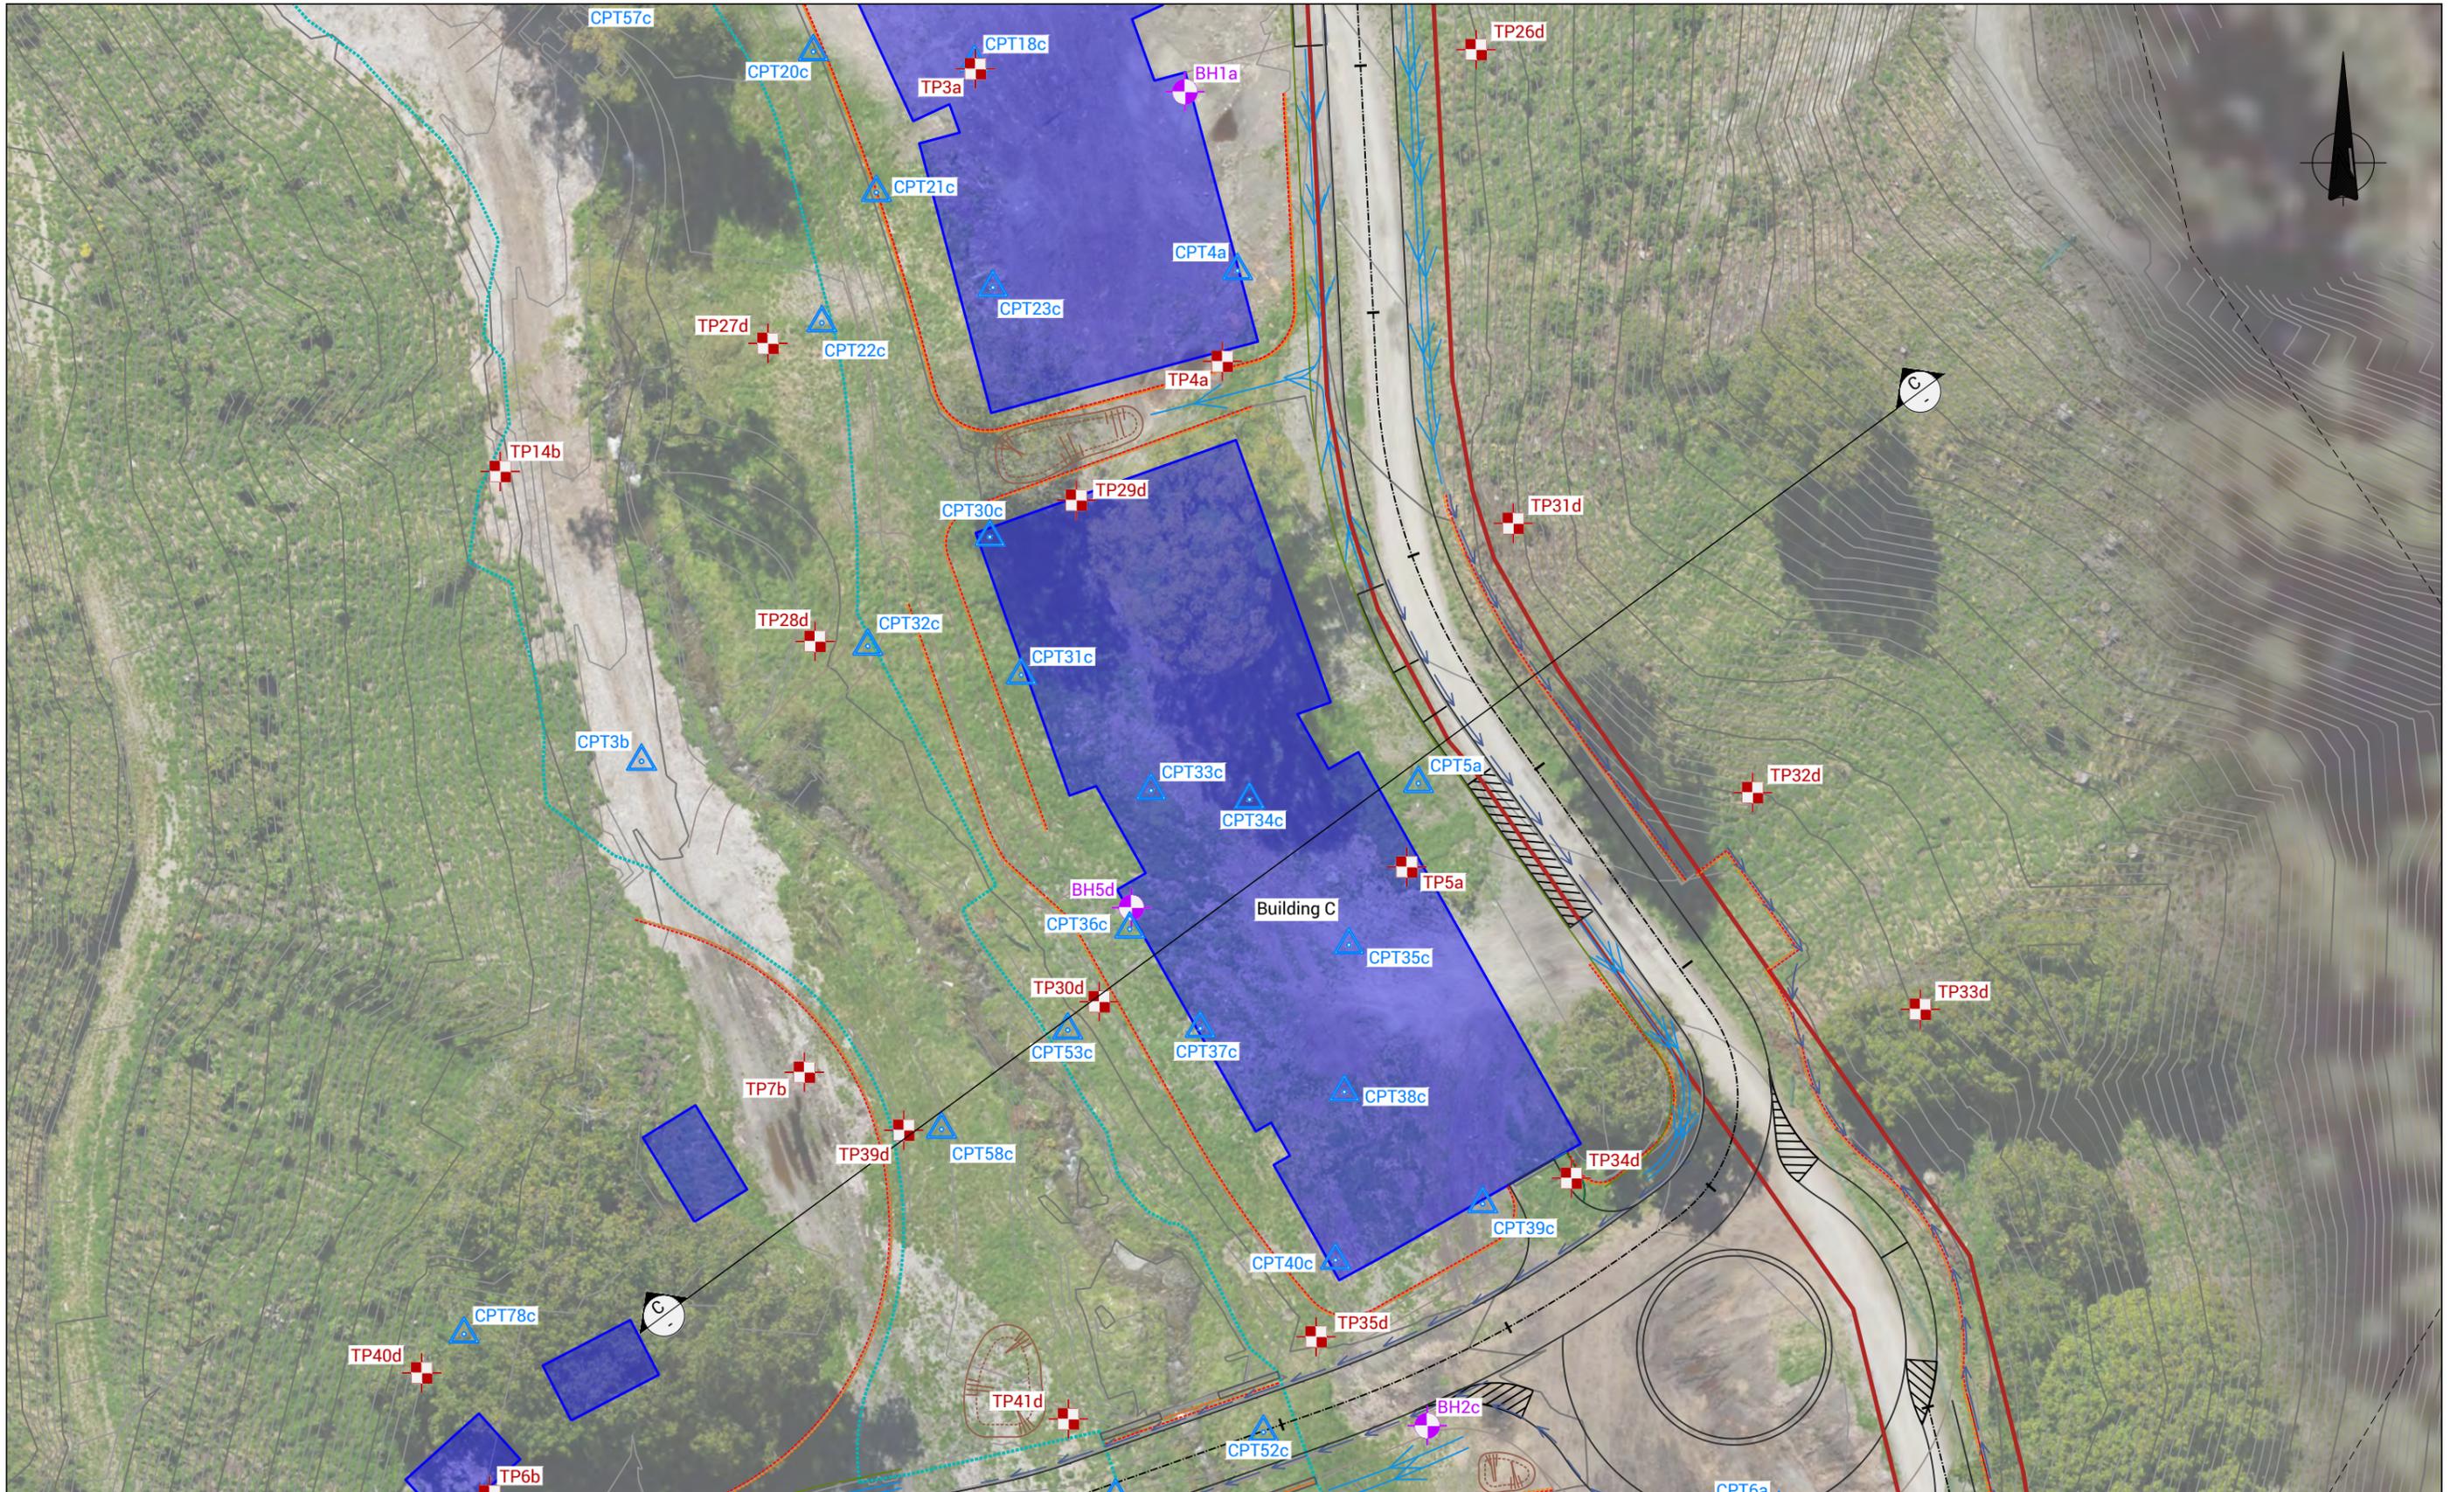
FIG No: Figure 1d

- Legend:
- Proposed Contours (Source: Patterson Pitts Feb.23)
 - Test Pit Locations
 - Borehole Locations
 - CPT Locations

We understand the proposed development comprises the construction of a later living development. Multiple accommodation buildings up to five storeys, some with basements, and associated facilities are proposed. The general layout of the development is shown on the Figure 2.1 below and Figures 1a to 1f, Appendix A.

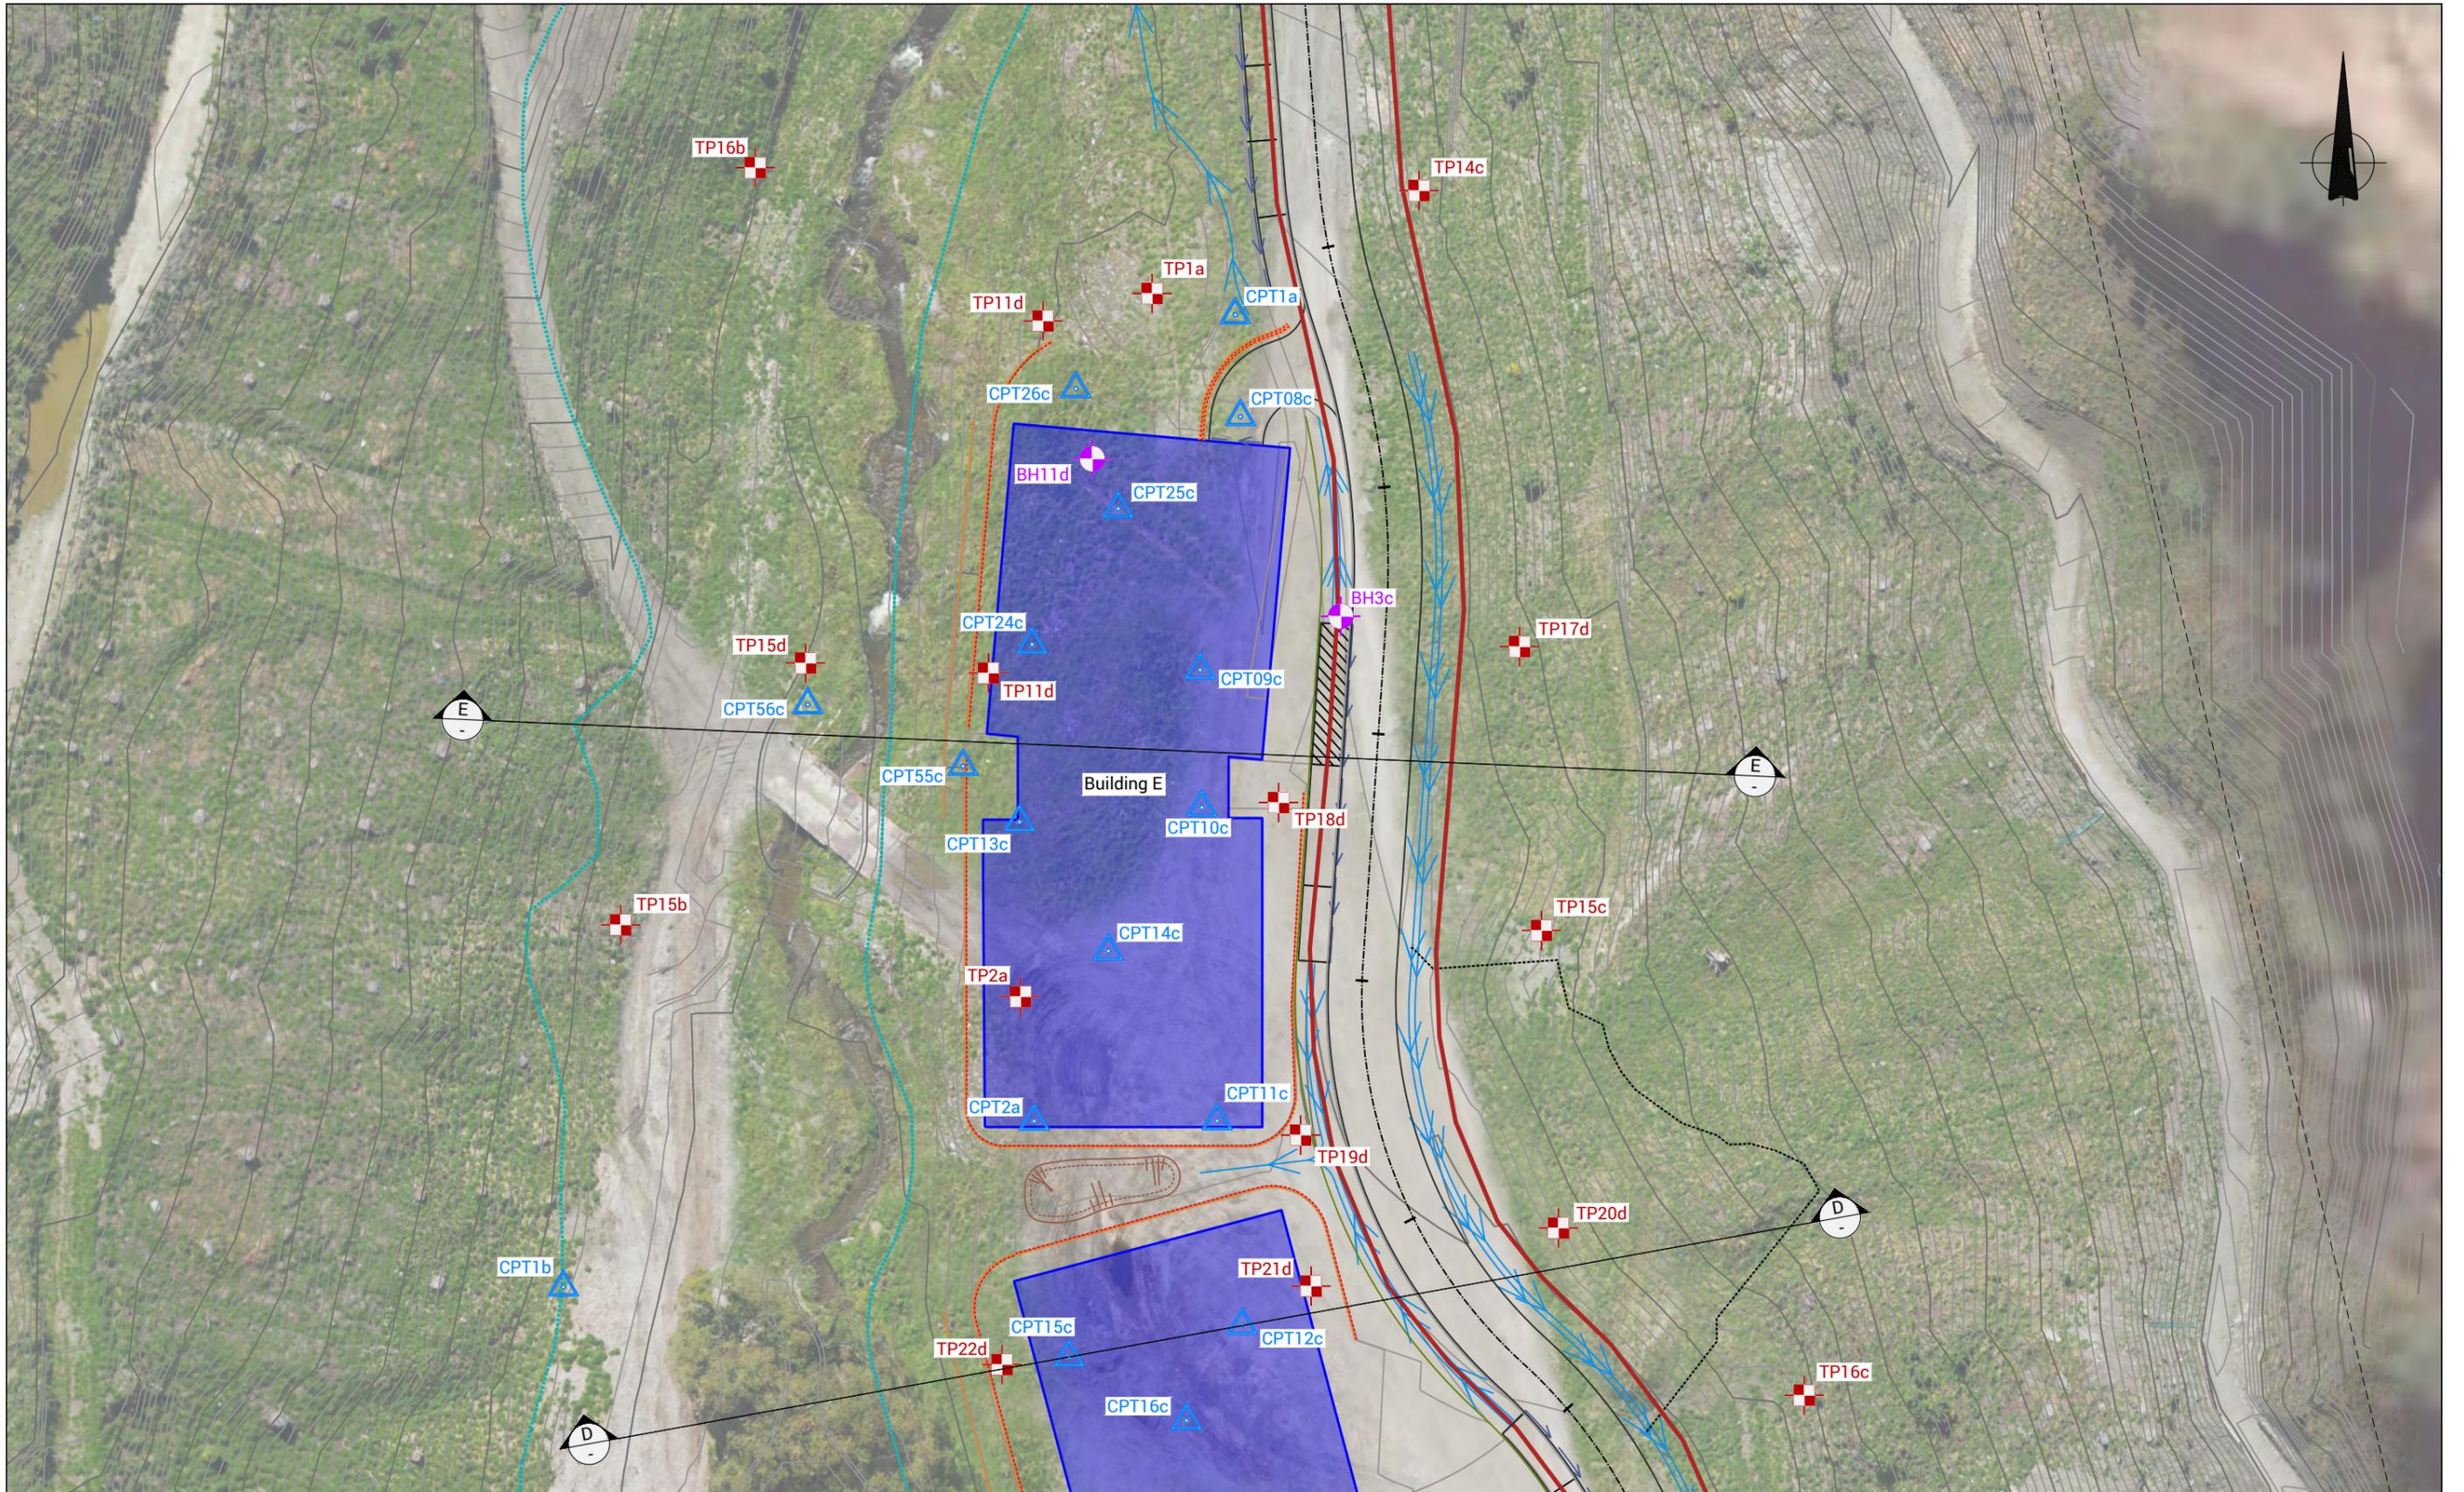
FIG No:
Figure 1e

- Legend:
- Proposed Contours (Source: Patterson Pitts Feb.23)
 - Test Pit Locations
 - Borehole Locations
 - CPT Locations

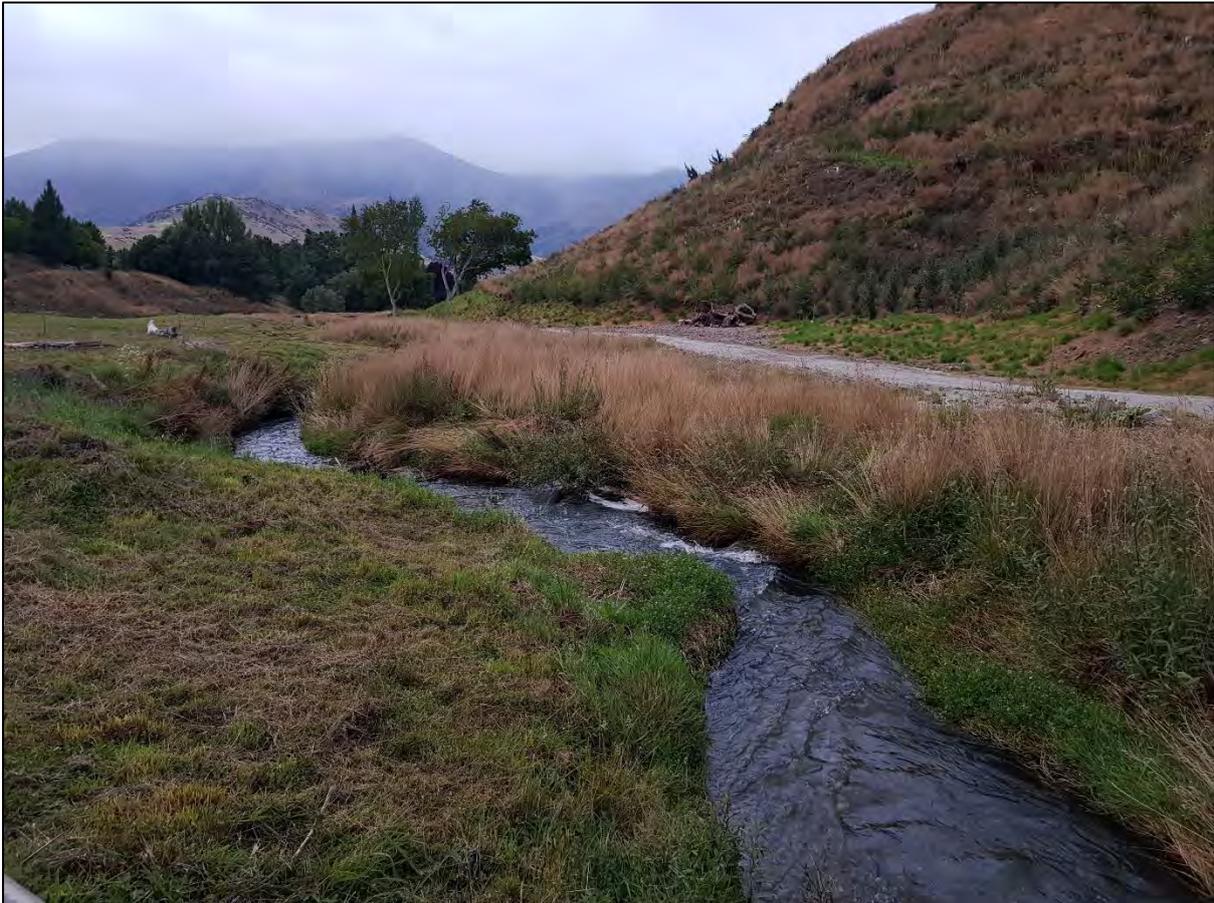
Through the Site, and elsewhere between Waterfall Park and Lake Hayes, the main channel of Mill Creek is confined and is relatively stable. The channel stability is indicative of a relatively stable flow regime typical of a stream downstream of a lake or wetland as shown in the purple area of Figure 2.2. The median dry weather flow is of the order of 350 litres per second (l/s). The stability of the flow regime creates an attractive habitat for fish and therefore Mill Creek is a valuable fish spawning area. Figure 2.3 shows the stream appearance and is typical of what can be seen throughout the Site.

Figure 2.3: Mill Creek Environment (Prior to Development)

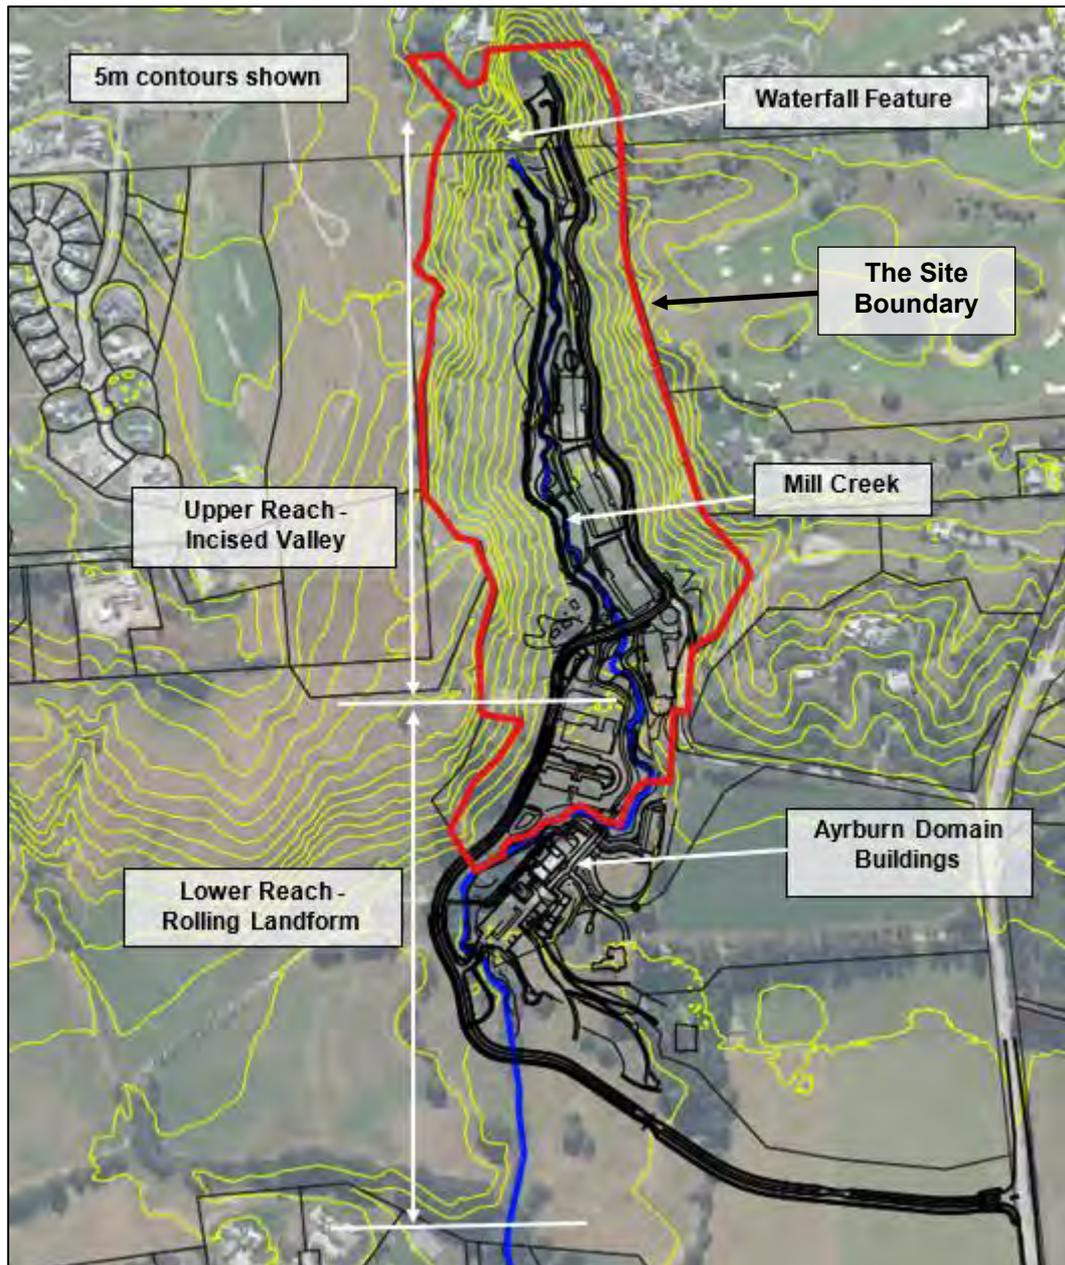
At the southern end of the incised valley, Mill Creek then flows through a shallow terraced landform at the northern end of the east bank floodplain adjacent to the main channel.

Figure 2.4: Existing Mill Creek Locality

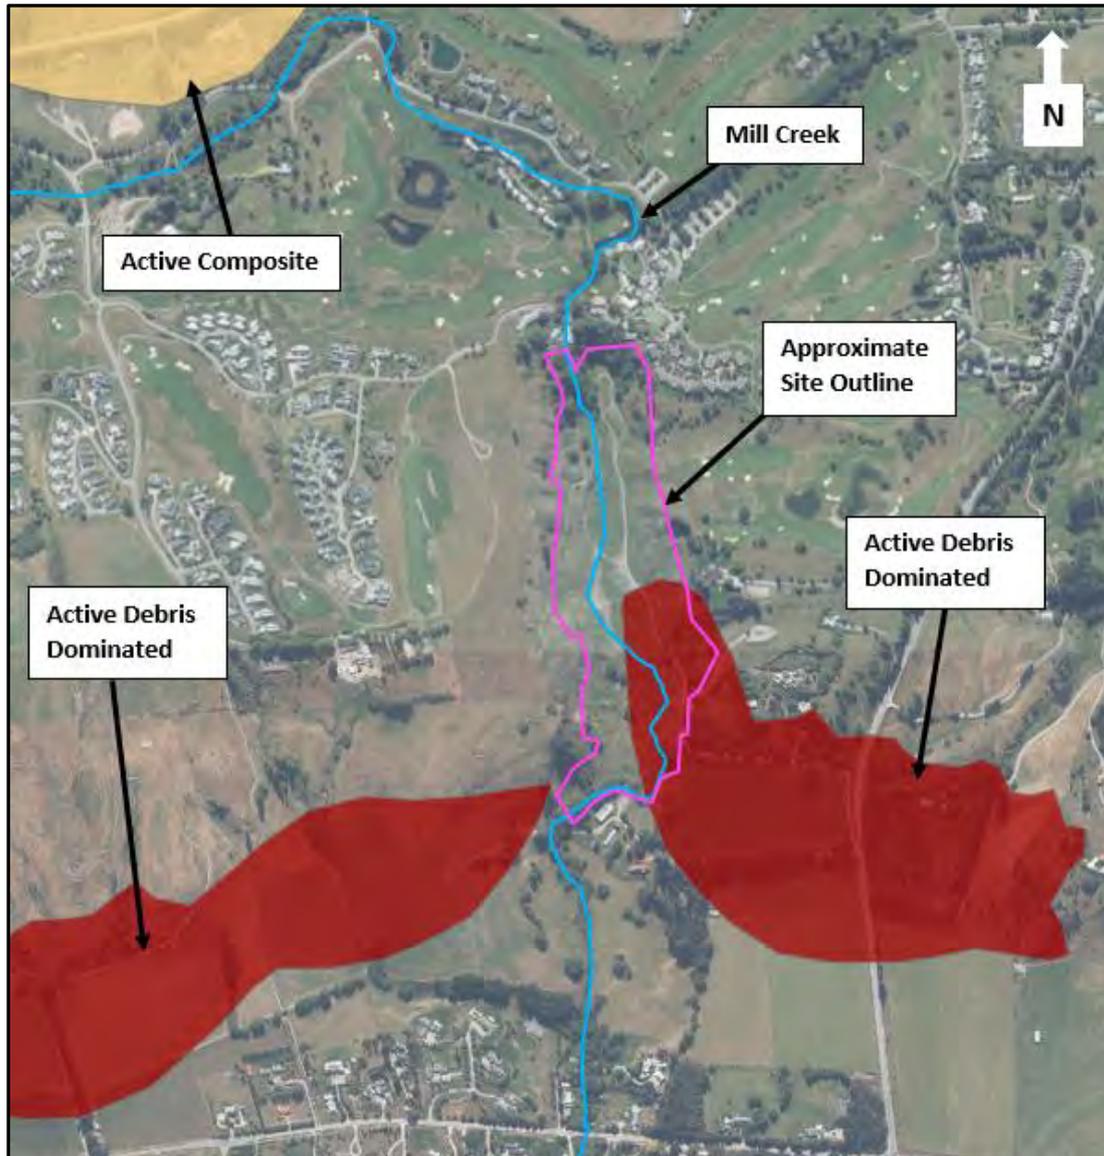
Figure 2.5 below shows an alluvial fan hazard area in relation to the Site (taken from the Otago Regional Council Hazard Map). The upstream hazard is characterised as Active Composite and the hazard partially within the Site is characterised as active debris dominated, as noted in the ORC Hazard Register Data.

Figure 2.5: Hazard Information – Alluvial Fan – Otago Regional Council Hazard Register Data

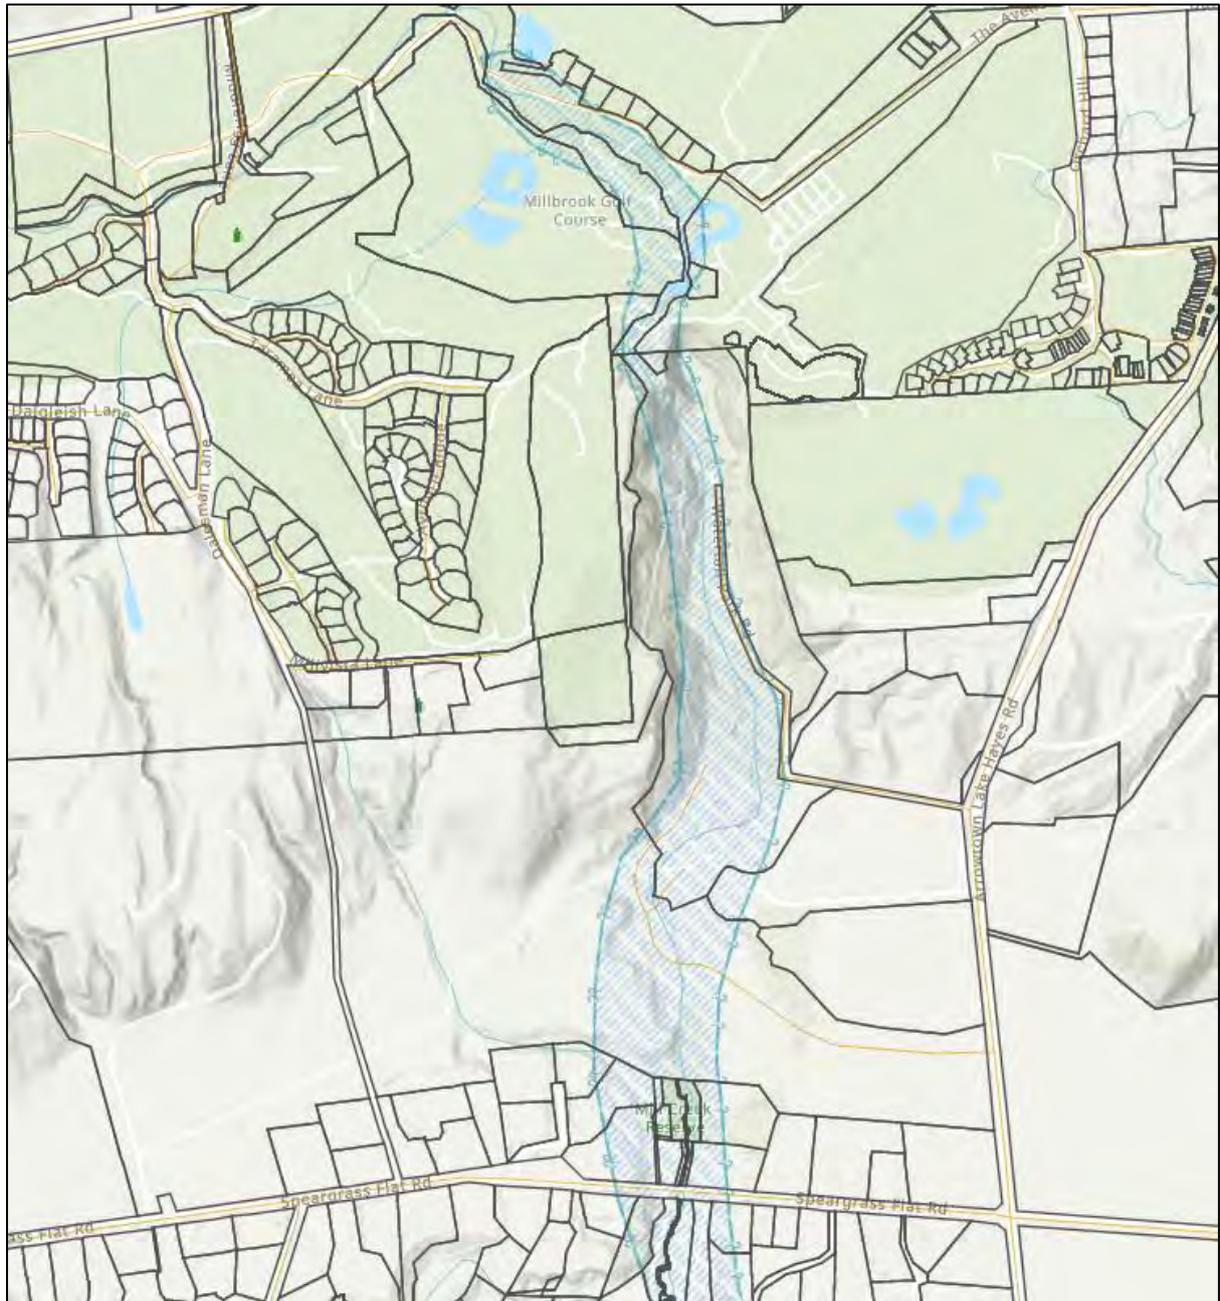
Figure 2.6 below shows an indicative flooding hazard associated with Mill Creek through the Site (taken from the Queenstown Lakes District Council hazard maps – based on ORC flooding data from 2012). The updated Otago Regional Council hazard maps do not show a flood hazard in this area.

Figure 2.6: QLDC Hazard Map – Flooding

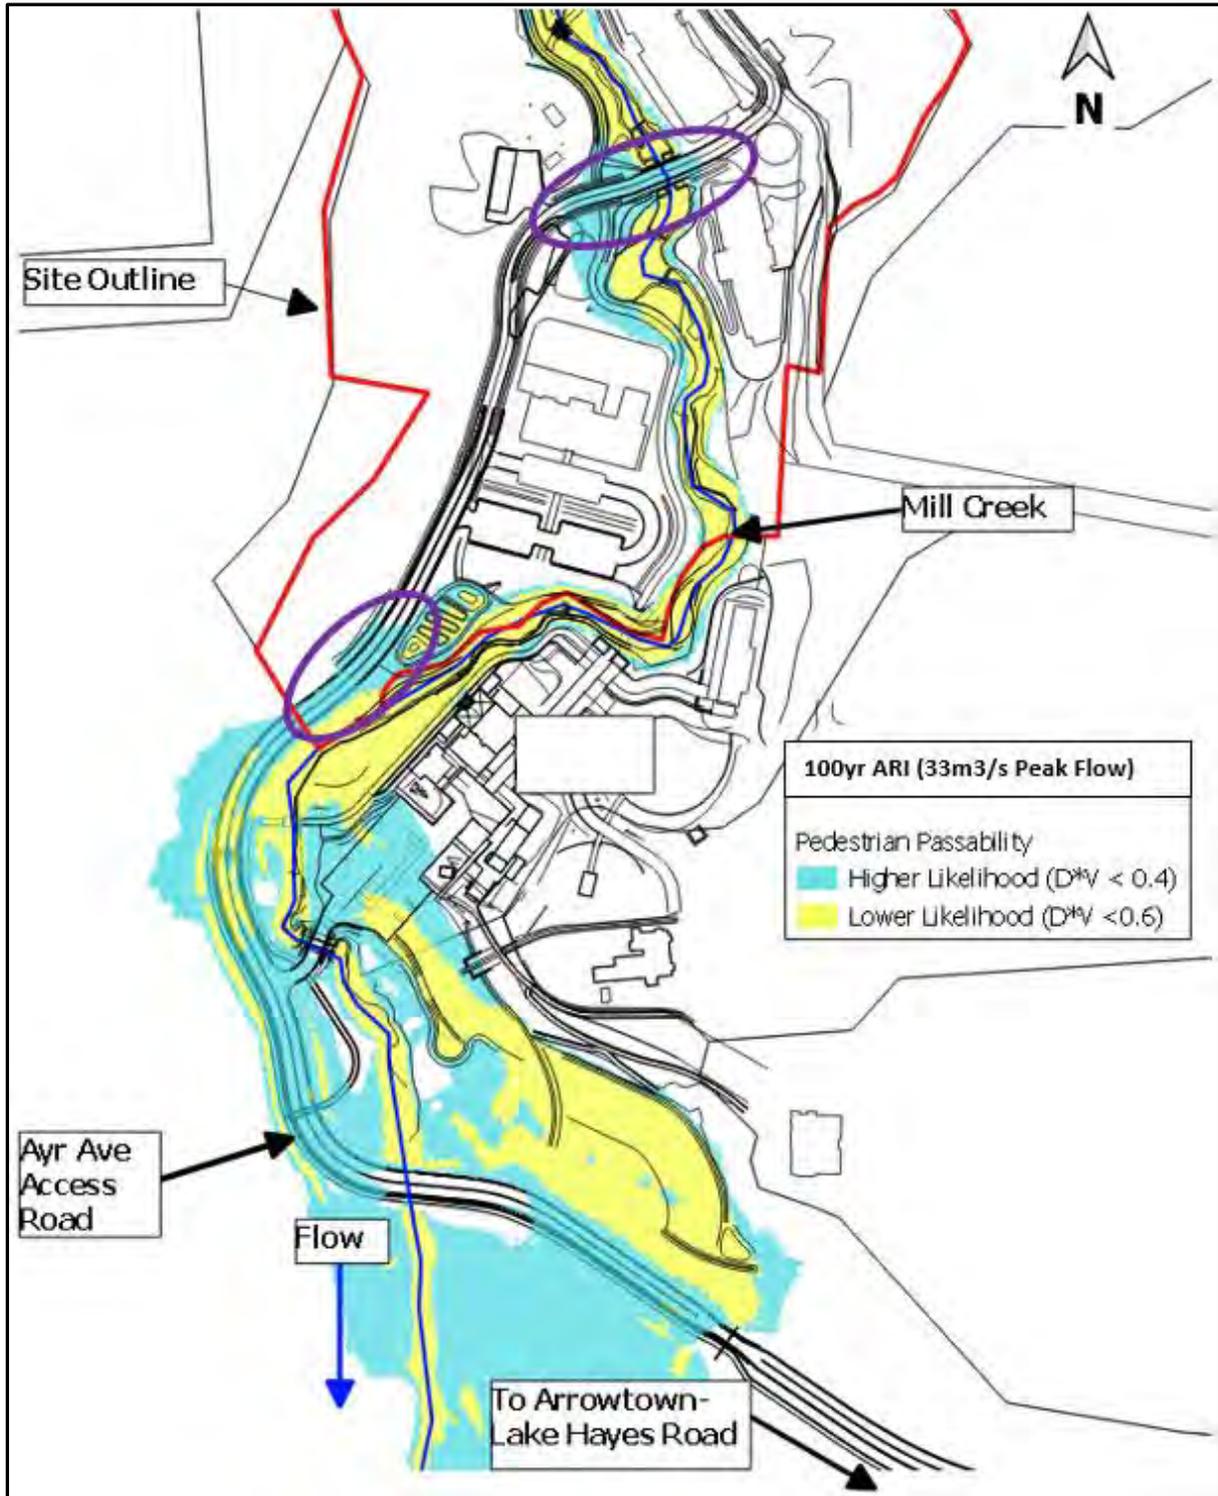
Note that pathways running along the creek edge have been excluded as part of this assessment as these would be closed during flooding.

Figure 7.2: Ayr Avenue Access Road Pedestrian Access Map for the 100-year ARI Event

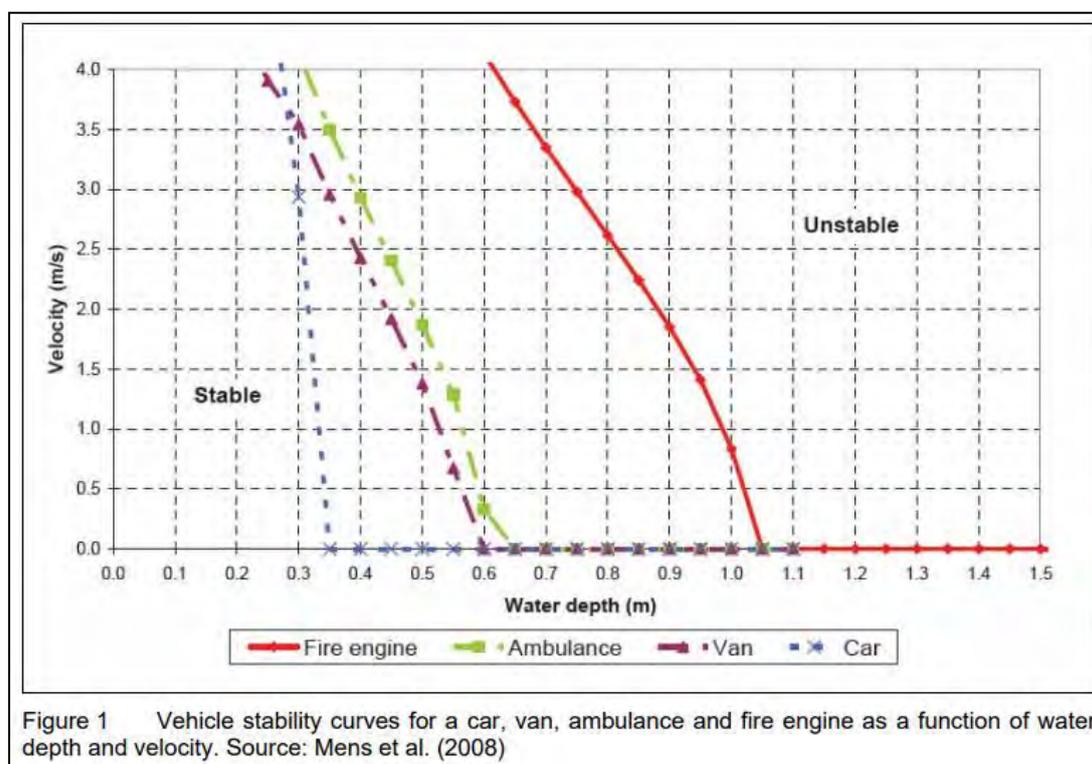
Figure 7.4: Vehicle Stability Curves – GSN Report

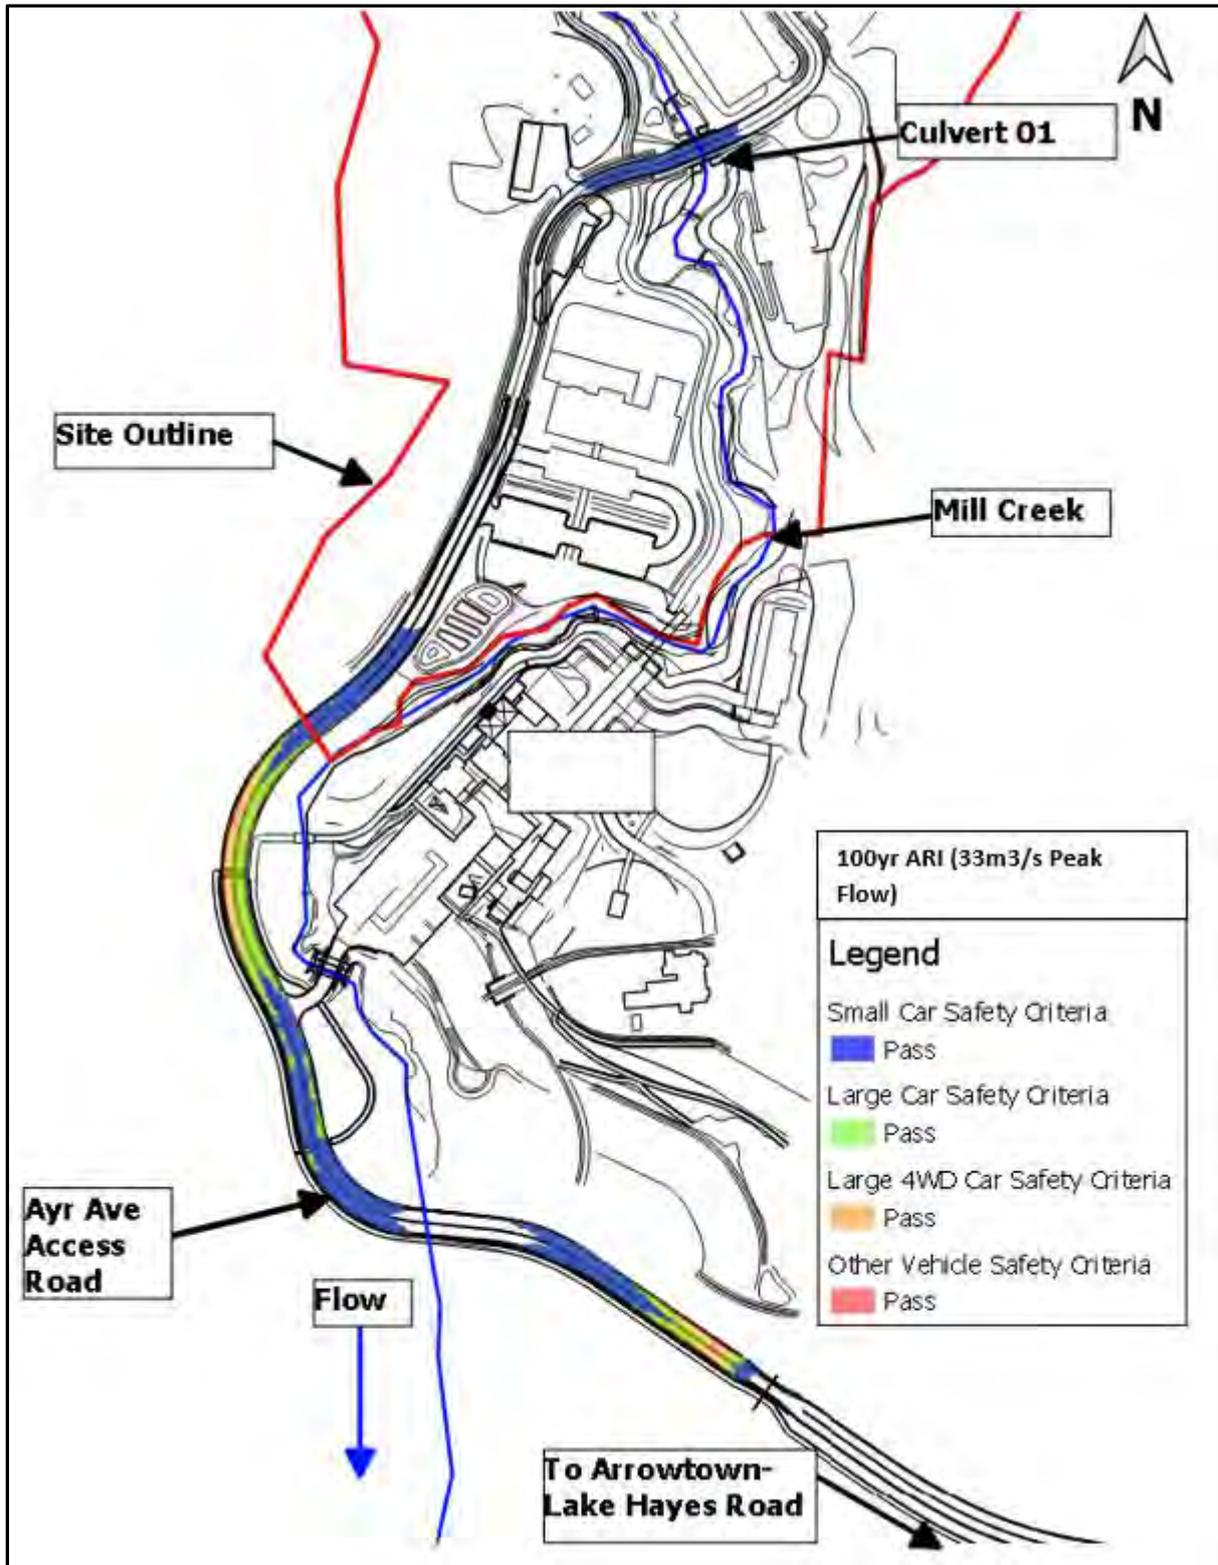
Figure 7.5: Ayr Avenue Access Road Extension 100-year ARI Hazard Vehicle Serviceability Safety Criteria Map

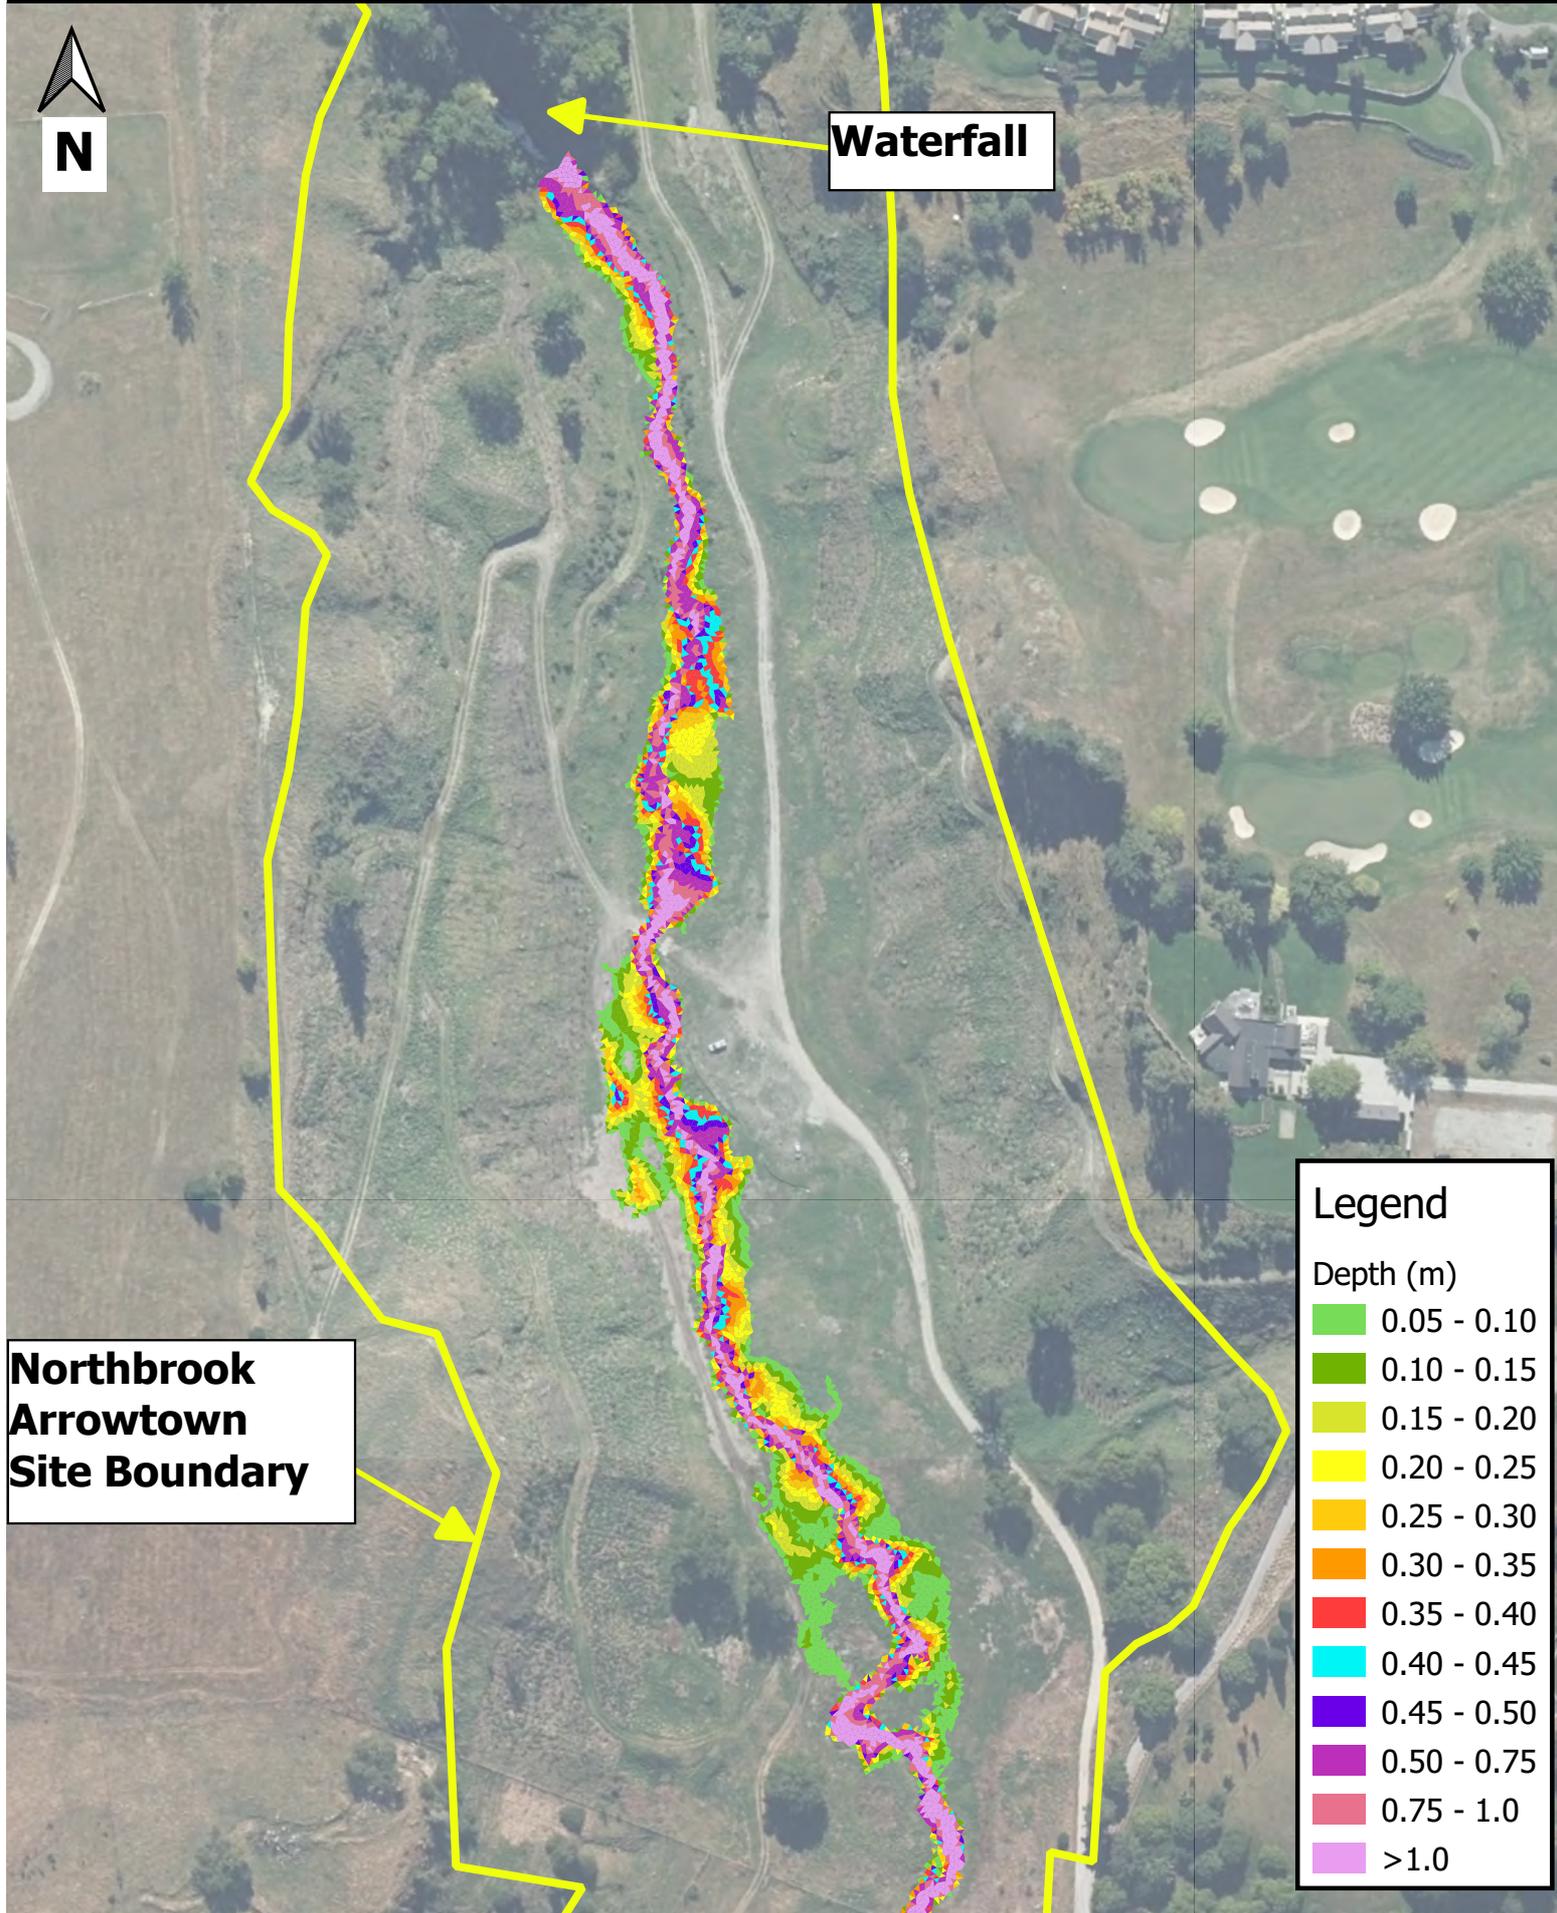
**Pre-Development 20yr ARI (8.5 m³/s) Mill Creek Peak Flow
Flood Depths - Lower
29/09/2022**
