Queenstown 04

Queenstown 05

Queenstown 06

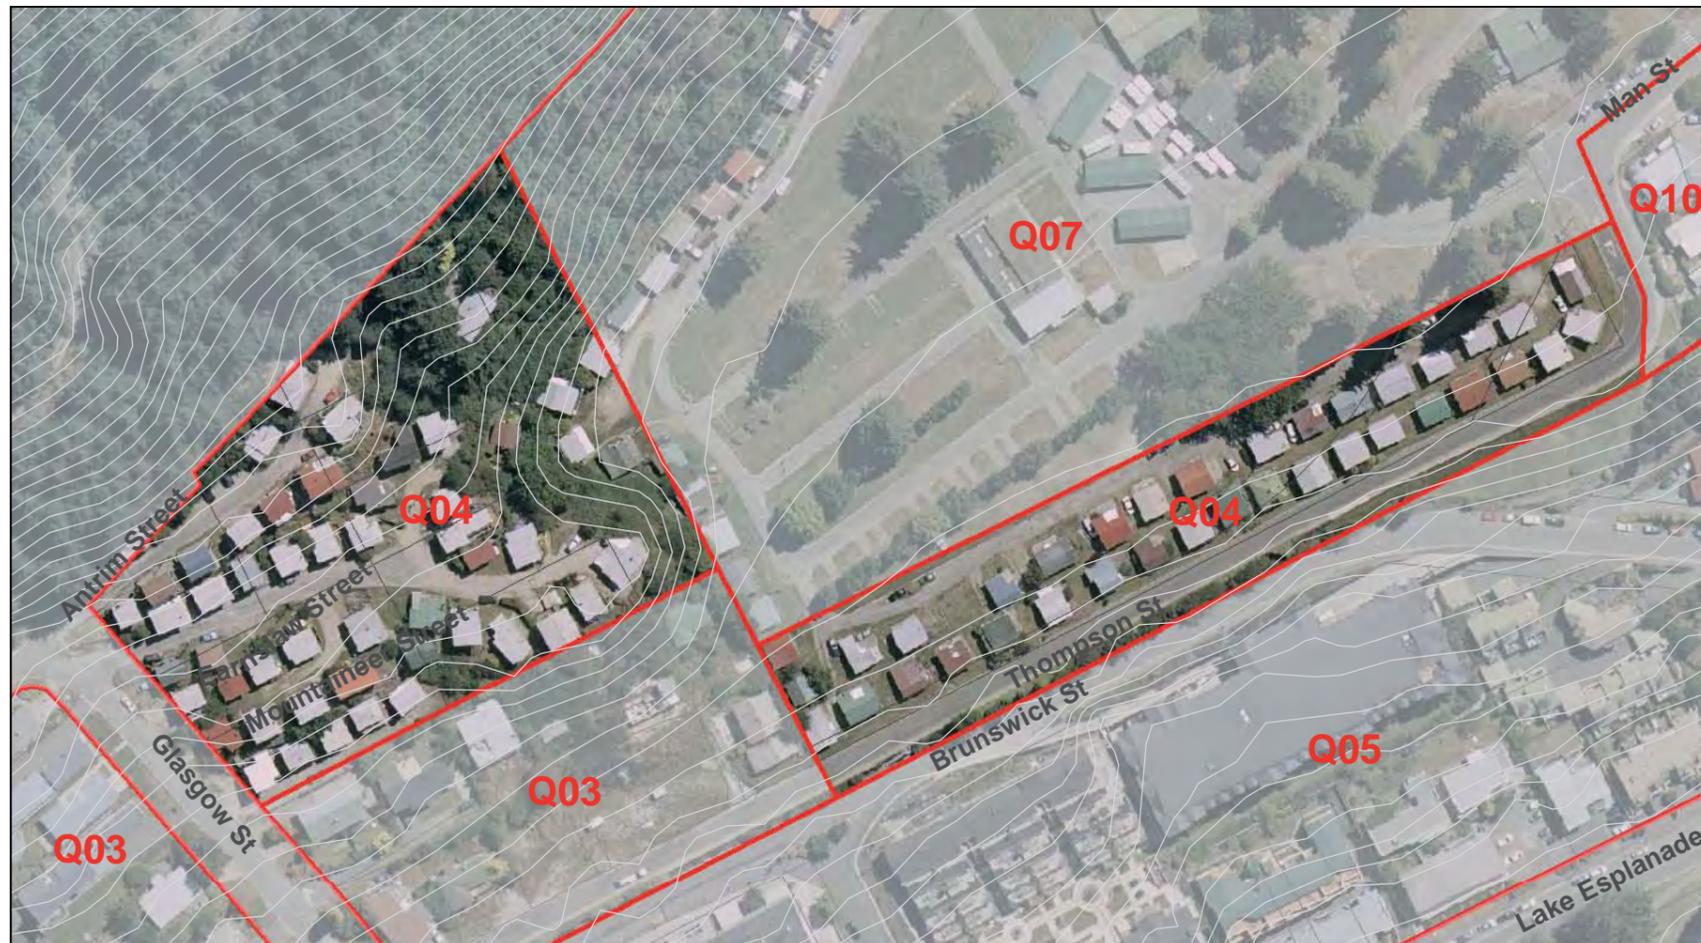
Aerial Photo

This character unit is divided in two parts. One part is located at the top of Glasgow Street and the other along the northern edge of Thompson Street. This is a small but distinctive character unit bounded by the steeply wooded slopes of Ben Lomond Scenic Reserve to the north, Glasgow Street to the west and the Lakeview Motor Camp to the east. The boundary with Q03 and Q05 to the south and west is demarcated by a change in building scale and a steep level change.

This character unit exhibits an *intimate scale* arising from a combination of small and closely spaced cabin-type buildings of both one and two storeys. The absence of substantial vegetation conveys a *dominant balance* of buildings. The similarity of building form and spatial separation provides a *strong cohesion*, despite being in a *poor condition*. Although the buildings are not particularly of heritage status, but there is a distinct sense of an overall *historic maturity* partly owing to the gradual diversification (e.g. materials and colours) these buildings have experienced over time, yet without losing their original form.

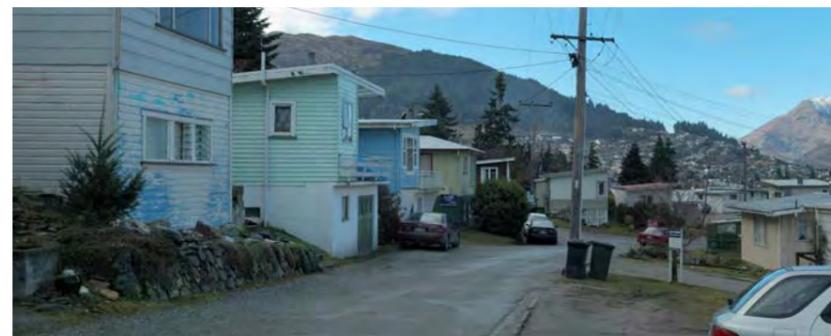
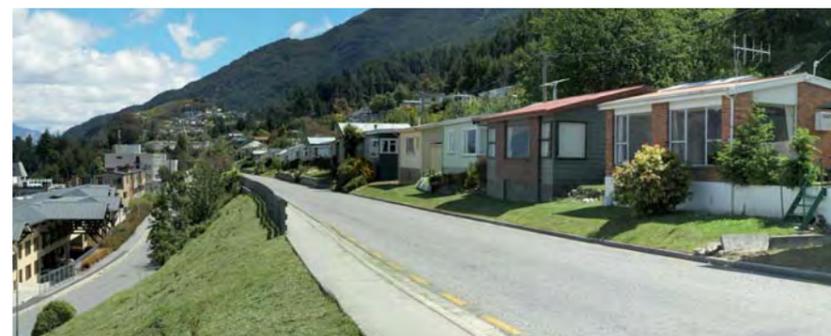
Representative Photos

- Small one and two storey detached cabins of similar age and building style
- Cabins have a consistent façade line and narrow separation distance with a strong repetitive pattern
- Building forms dominate with low surrounding vegetation, particularly on hilly slopes where cabins are built over garages or semi-basements

- Early example of multi-unit development on large lot sizes
- Glasgow Street cabins more clustered and irregular than those along Thompson Street due to a more square site and hilly topography

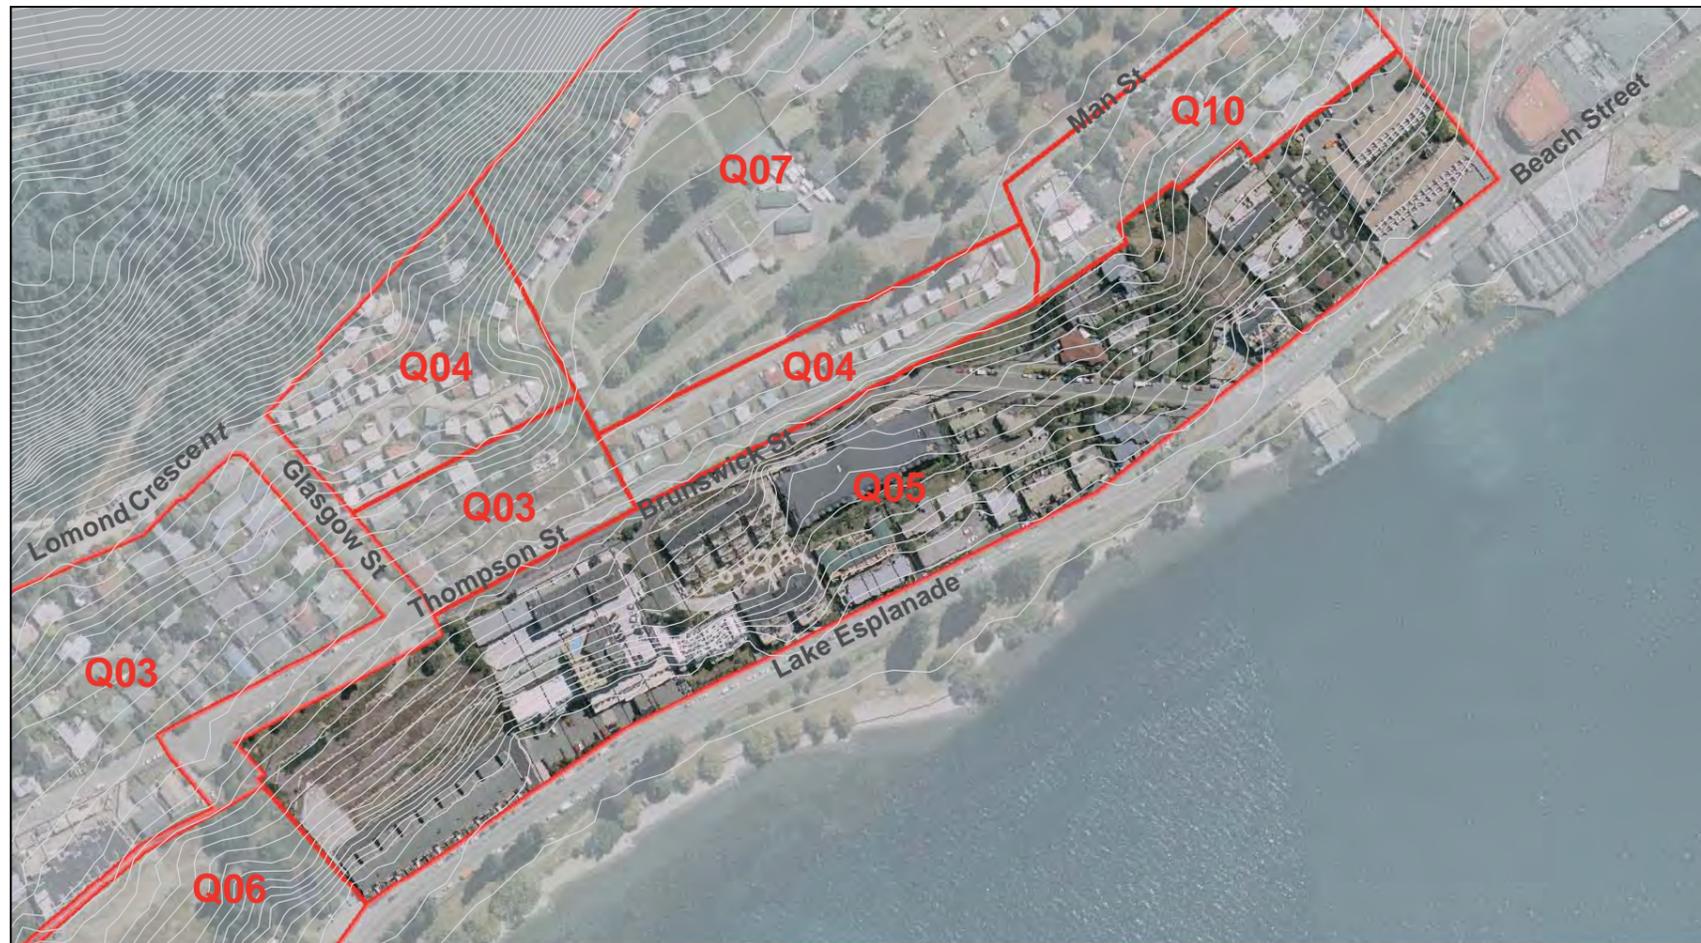
Aerial Photo

This character unit is located between Lake Esplanade and Thompson Street and occupies the lakeside frontage and the steeply rising embankment behind. The eastern boundary is aligned with Hay Street adjacent to the town centre. The western boundary meets reserve land, which links through to One Mile Creek.

The characterisation identifies the unit as a *substantial scale* with a *hard-edged balance* given numerous large developments in close proximity with high site coverage and slope modification. The varied style and size of buildings within the unit results in a *mixed cohesion*, which is partially compensated by the establishment of a relatively continuous frontage along the lake edge. The mix of older buildings with recently completed developments or those still under construction gives the unit a *young maturity*. The buildings and landscape is generally in a *managed condition*, with a closer attention to maintenance in the vicinity of the larger complexes.

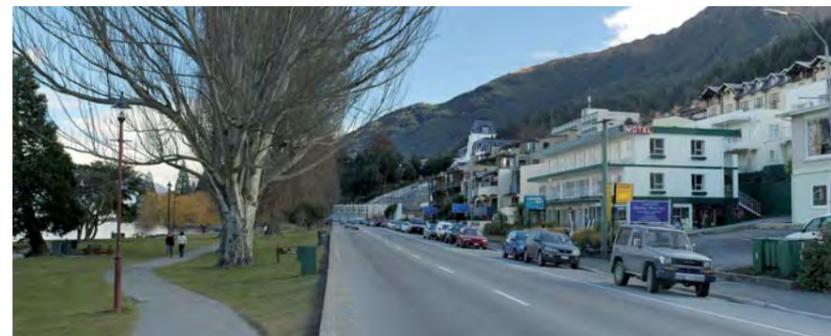
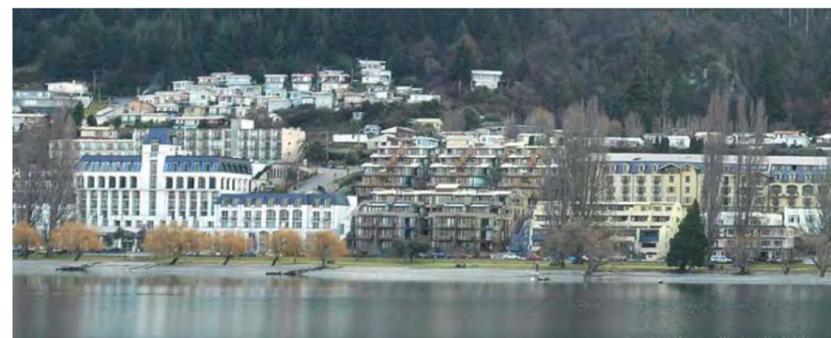
Representative Photos

- Predominance of large multi-unit and multi-storeyed developments extending laterally across the hilly to steep embankment.
- Extensive ground modifications for increased building height and underground parking with little vegetation coverage
- Open boundary treatments with drop off areas dominating building setbacks

- The unit contains one of the principal concentrations of visitor accommodation in the town
- Smaller scaled buildings are located along Brunswick Street with Rotary Park located centrally within the block between Brunswick and Lake Streets.

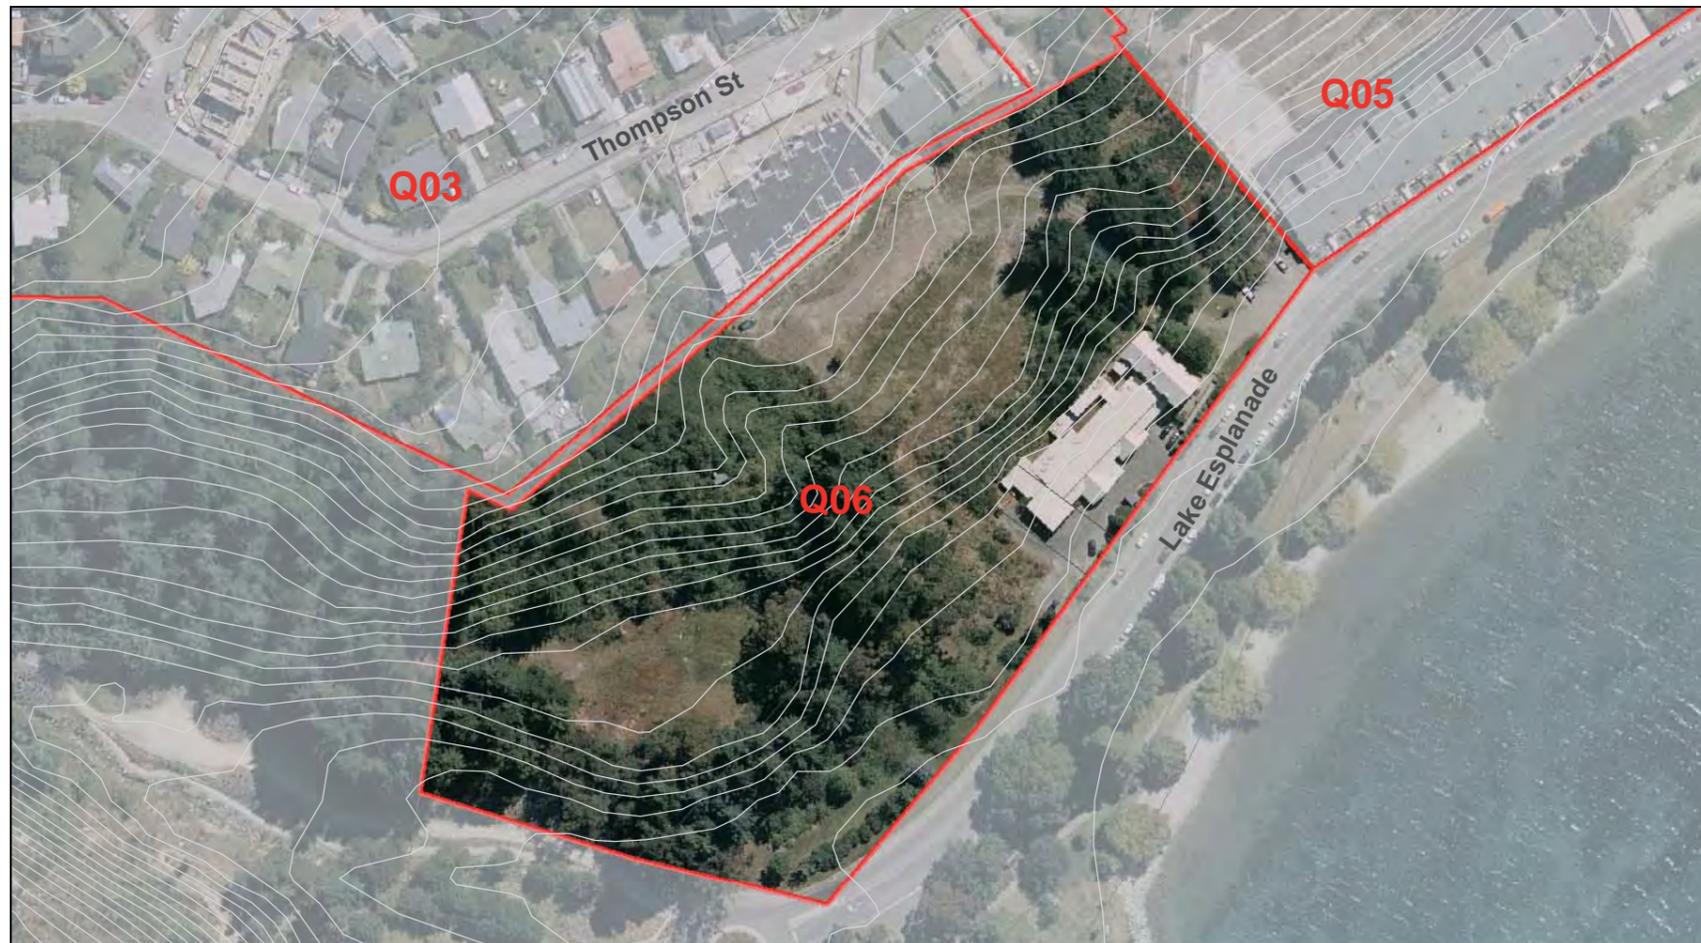
Aerial Photo

This character unit lies immediately to the west of Q05 at the edge of the intensive development along Lake Esplanade. It is bounded to the north by the boundary of Q03 and extends westwards to One Mile Creek, which shares similar characteristics. This unit contains a substantial amount of reserve land across the middle and lower slopes of the lake embankment.

The characterisation identifies a **large scale** landscape composed of established exotic woodland, with several enclosed clearings. As principally woodland, it is of an **established maturity** and of a **verdant** appearance. It has a **consistent cohesion** only compromised by a large building complex along Lake Esplanade. It is considered in **reasonable condition** with minimal maintenance throughout the reserve land.

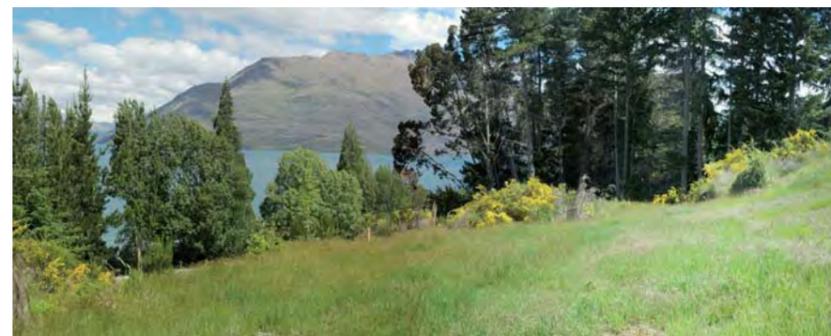
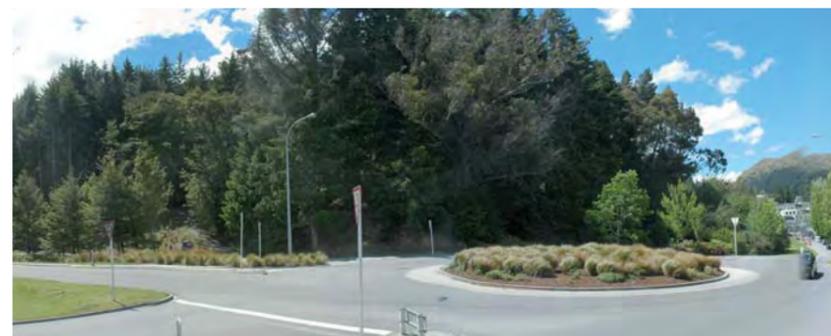
Representative Photos

- Hilly to steep lakeside embankment
- Extensively wooded in exotic vegetation
- Several large clearings with low grassland cover

- Linked to a more extensive and consistent area that extends to the north and west up One Mile Creek.
- Landscaped areas around the Fernhill Roundabout at the gateway to Queenstown are well managed. This, combined with a vegetated embankment, buffers urban development at the entrance into central Queenstown.
- A large isolated building at the toe of the embankment slope adjacent to Lake Esplanade is currently operating as a youth hostel
