Queenstown 19

Queenstown 20

Queenstown 21

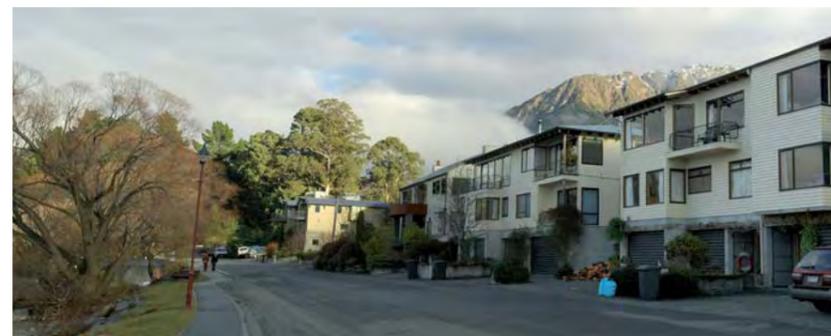
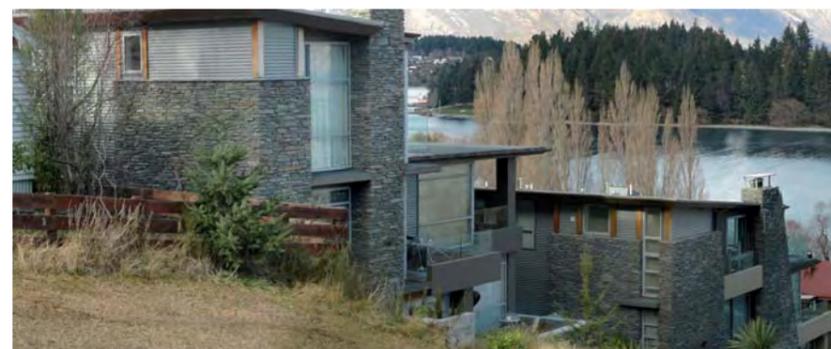
Representative Photos

- A strong contrast between some isolated single storey cottages and three storey multi-unit developments with only a few duplex residential units present
- Buildings cut into hilly land with accommodation commonly built on top of ground level garages
- Low shrub and ground cover vegetation with minimal tree planting or formal boundary fencing

- The vegetated Leary's Gully is a prominent topographical feature interrupting the lakeside embankment
- Older buildings associated with the Copthorne Hotel occupy a large parts of the lake edge along Park Street and are in generally poor condition

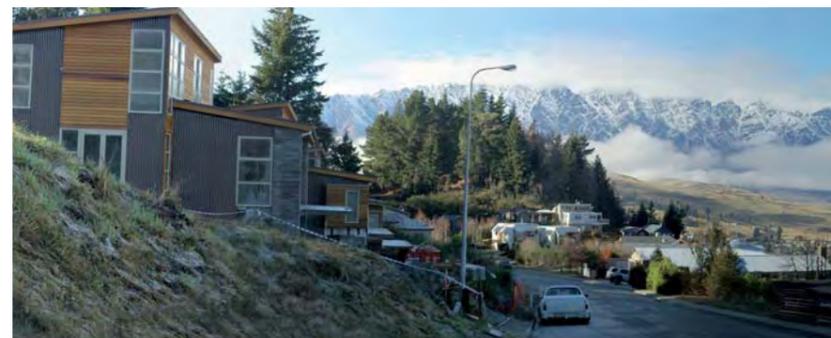
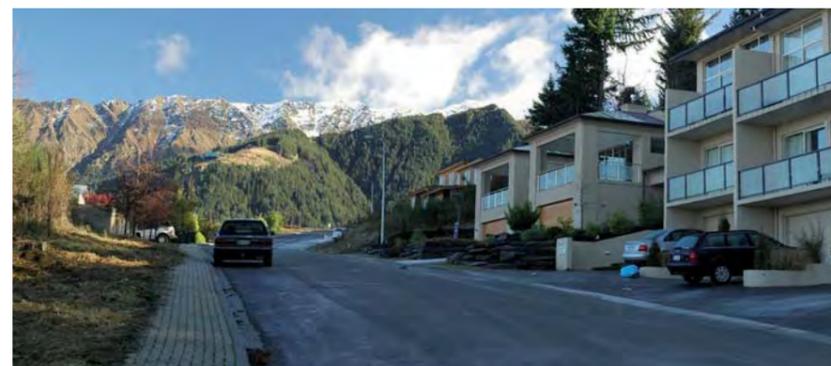
Representative Photos

- A recent subdivision with multi-unit developments stepped down and into hilly slopes, many with steep access ways to parking garages.
- Development is strongly related to slope contours with buildings often sunken down or elevated above street level resulting in contrasting heights either side
- Extensive ground retention works with low shrub or ground level planting with little boundary fencing and short building setbacks

- A number of undeveloped sites with potential for similar development patterns to expand into Q21
- The character unit is isolated from other high density residential zones with more suburban planting and streetscape arrangements on Belfast Street

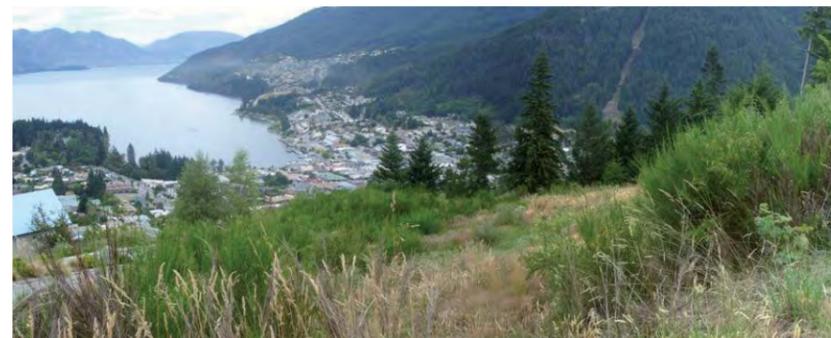
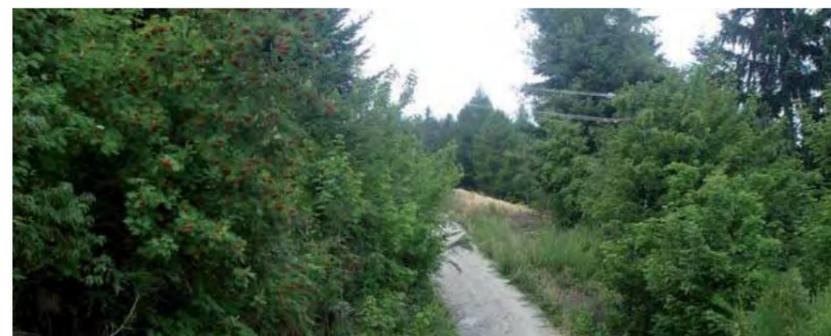
Representative Photos

- Hilly slope with no built forms interrupting the topography
- Wooded clusters of exotic vegetation with areas of lower scrub
- A network of informal unsealed vehicle tracks and walking paths.

- Linked to a more extensive and consistent woodland area that extends into the Queenstown Hill Recreation Reserve
- A large water tank, powerlines, and a small area of scrub clearance in the south east corner of the unit are notable features.
