02 September 2021

Reference No. 21490001_7407-001-LR-RevA_DRAFT

REVIEW OF NATURAL HAZARD ASSESSMENTS FOR PROPOSED CONEBURN INDUSTRIAL AREA PLAN CHANGE

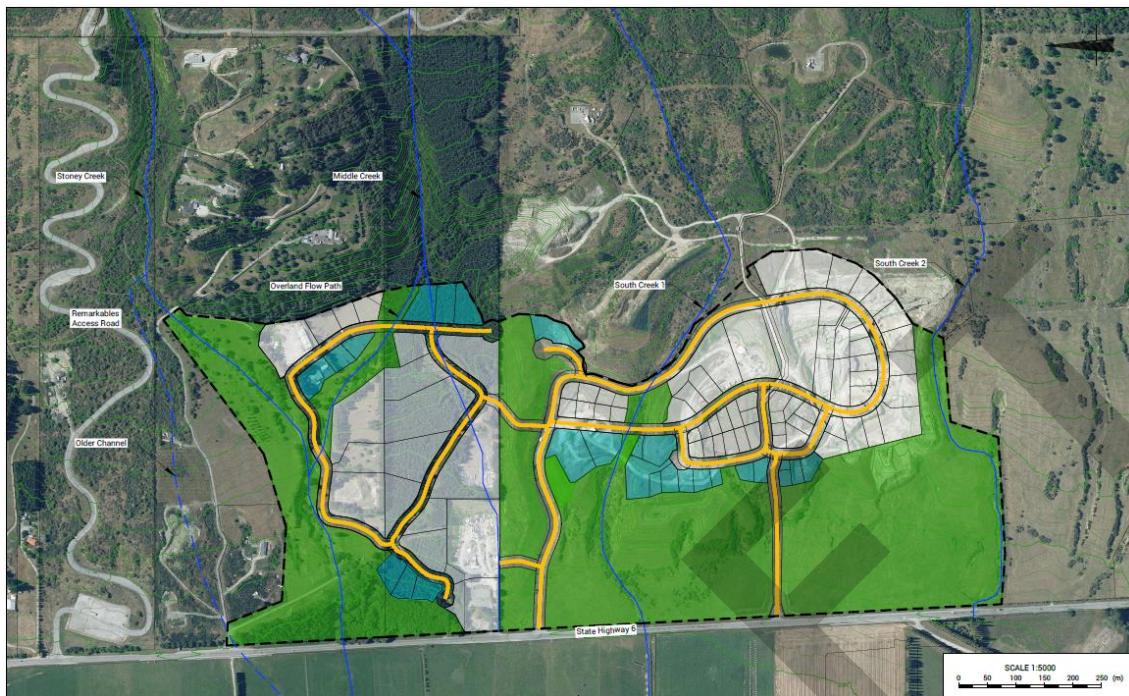
Figure 1: Proposed Coneburn Industrial Zone site plan (Figure 1a in Geosolve report July 2021).

- Building lots are proposed outside of the natural water courses, with zones either side specified as 'Open Space – no buildings or structures' in Geosolve's Figure 1a.

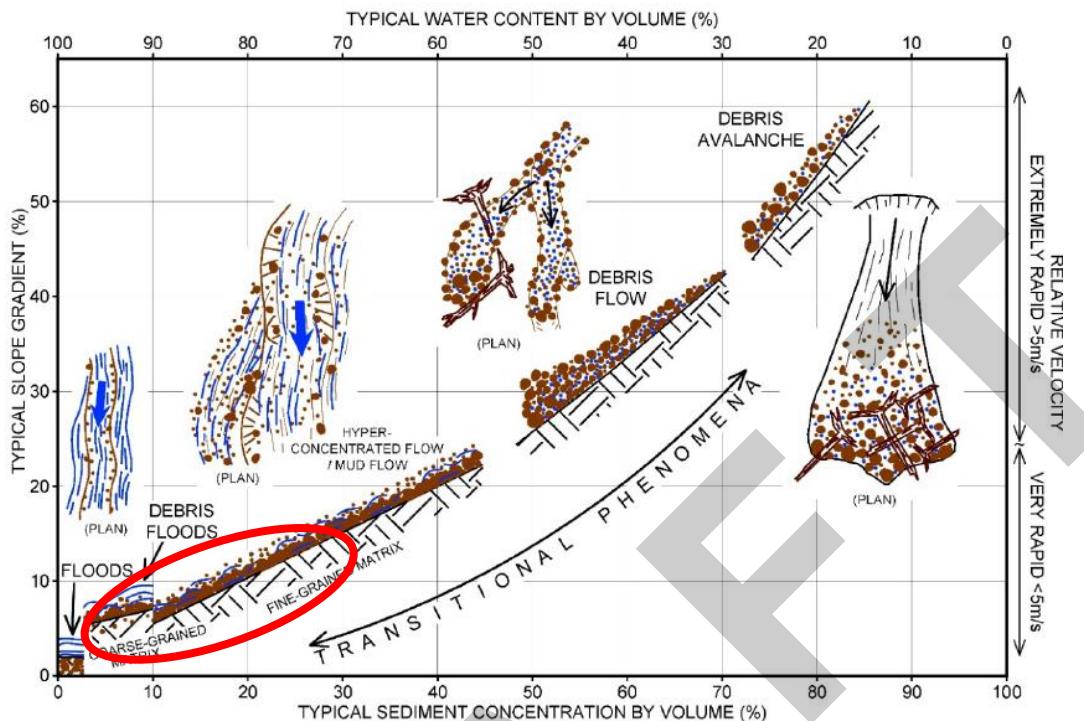
Figure 4: Debris flow/flood diagram indicating effect of slope on flow type. Red zone is likely to be consistent with Coneburn development conditions. After BGC (2020)³.

- It is difficult to represent the many uncertain variables in a debris flow/flood event scenario (water flow, debris volume, type, speed debris enters the water flow, percentage of debris etc). Geosolve's conclusions regarding the potential for debris flood (not debris flow) are consistent with empirical studies, including a separate source shown in Figure 4.

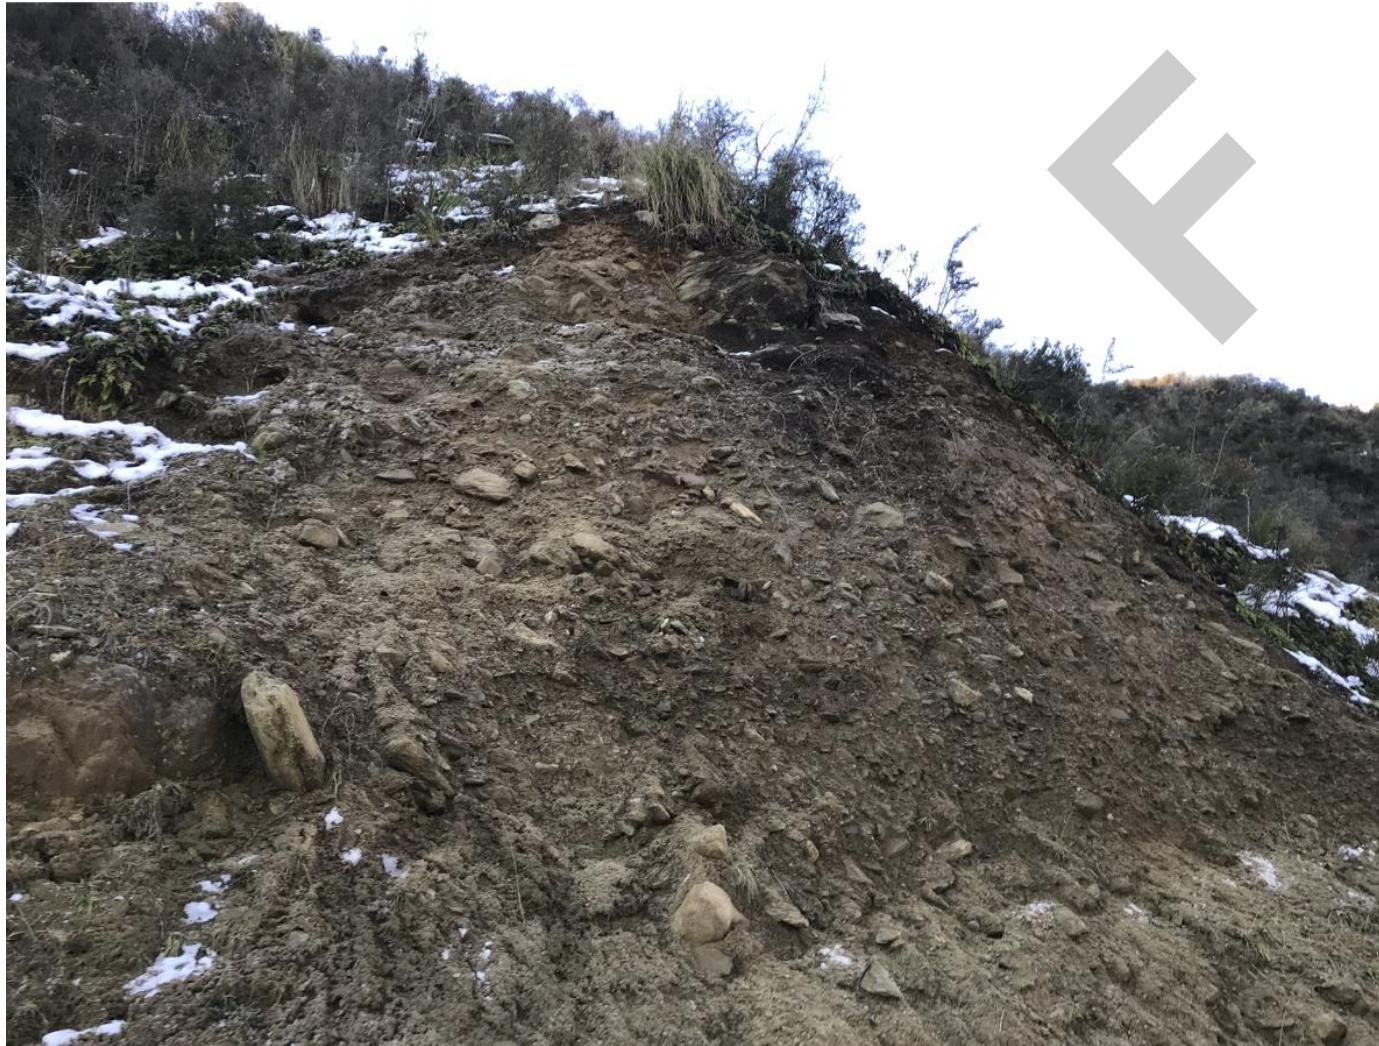
Photograph 1: Road cut for access to 216 Remarkables Ski Field Access Road. RL ~520 above the site. Showing coarser material with cobbles & boulders inferred from debris flow/flood deposition in the higher elevation transfer zone.

- A debris flood environment is supported by empirical studies of landslide runout, which suggest that the catchment height and the low angle of fan slope at the proposed development are indicative of a relatively low stormwater energy environment. This is supported by site photographs of exposed material attached to this letter² that show generally small-sized material in creek banks (in Photograph 5 in South Creek 2, large boulders are interpreted to be glacially deposited and not carried by modern storms).

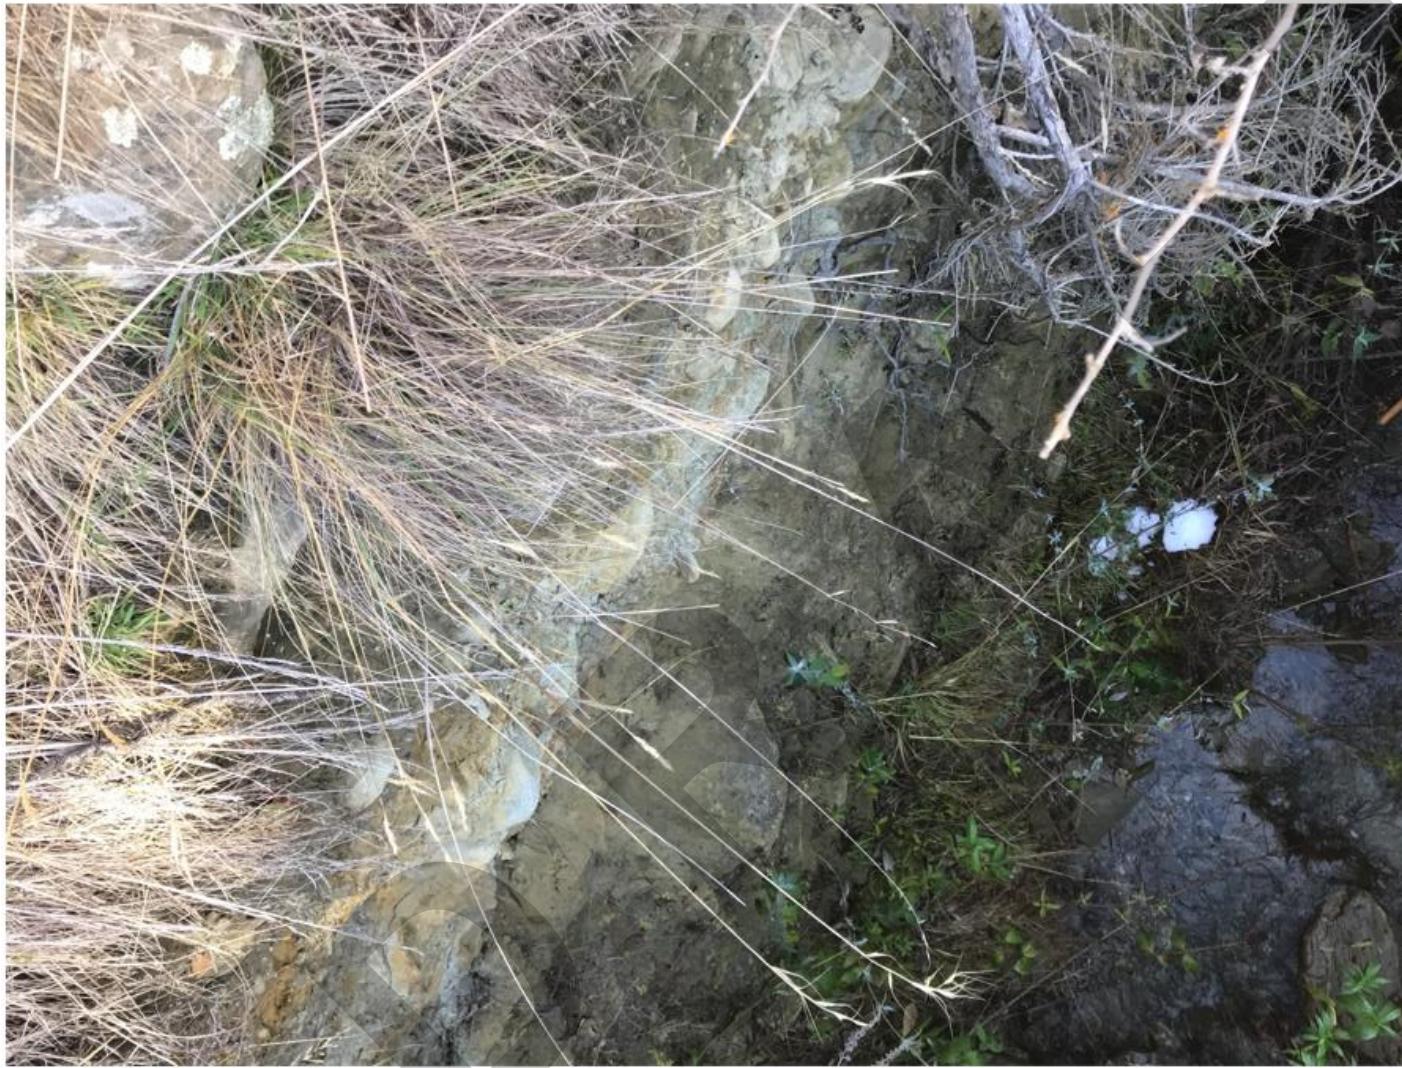
Photograph 2: Incised Stoney Creek channel. RL ~440 above the site. Showing finer material with cobbles from material debris flow deposition in the lower elevation transfer zone

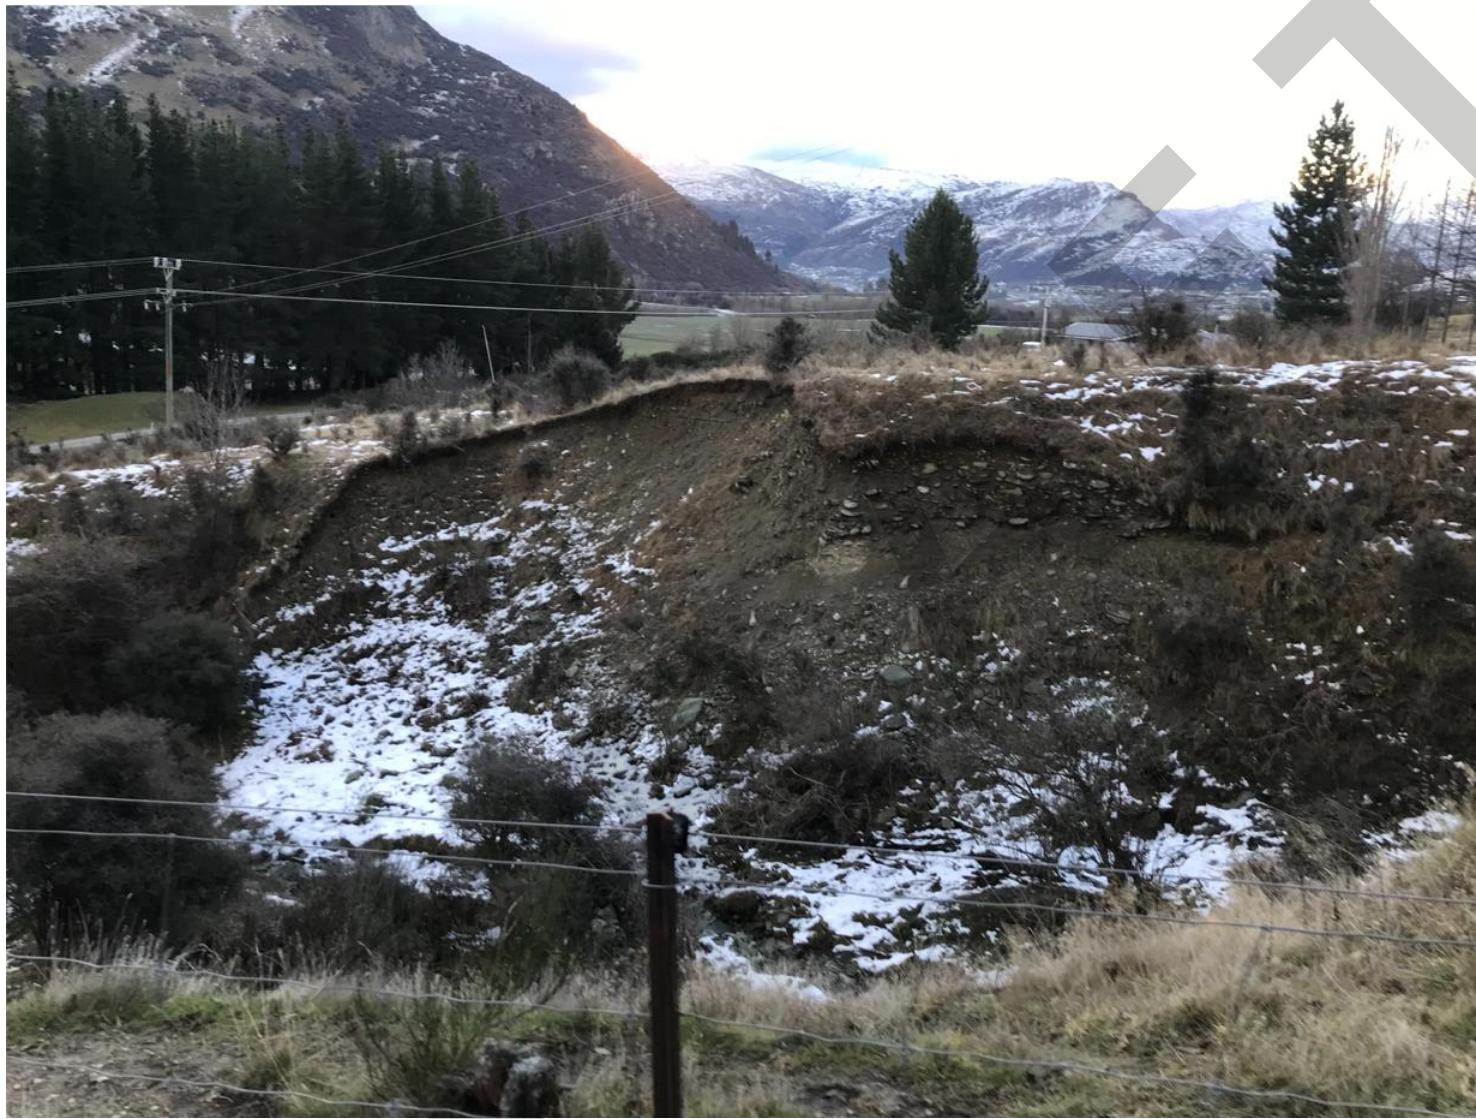
Photograph 3: Stoney Creek channel. RL ~340 within the site. Showing limited coarse material from debris flood deposition in the depositional zone.

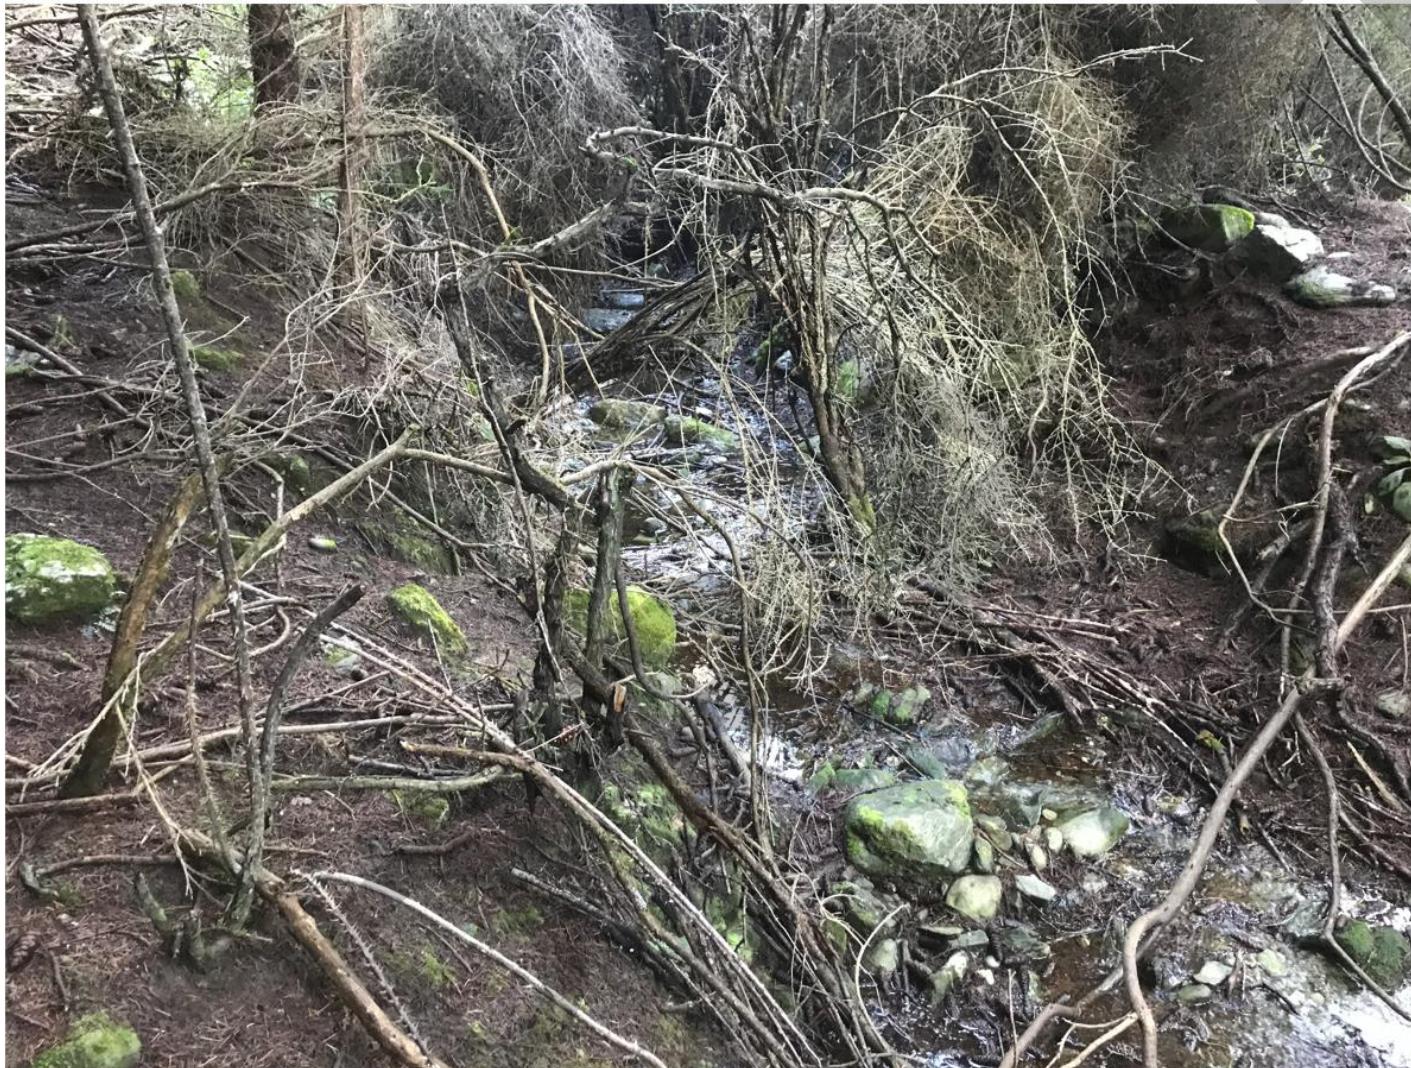
Photograph 4: Middle Creek channel. RL ~430 above the site. Showing limited coarse material from debris flood deposition in the depositional zone.

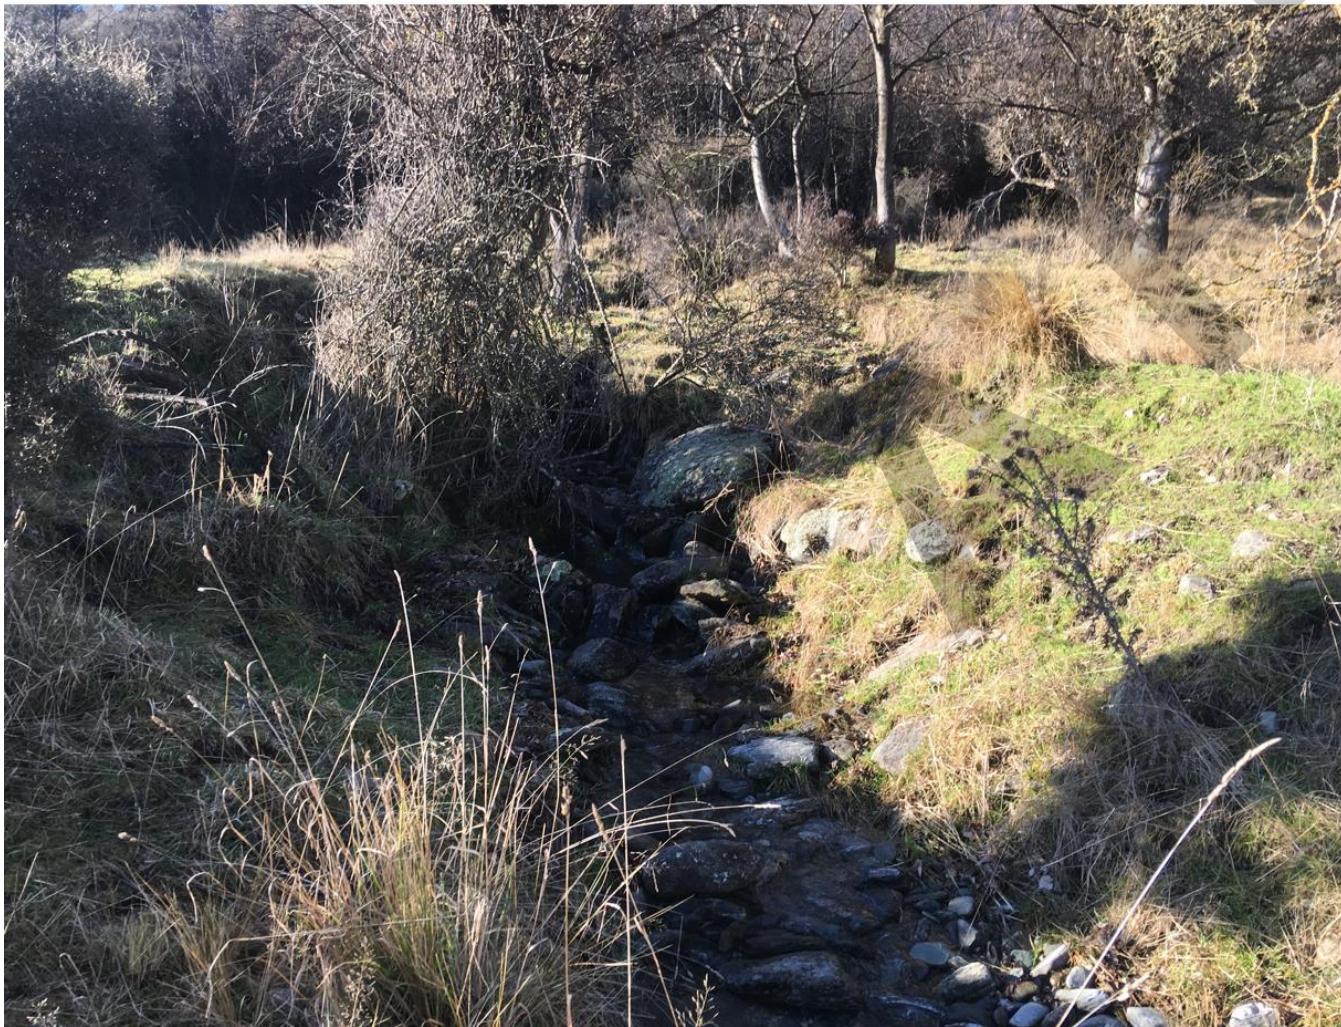
Photograph 5: South Creek 2 channel. RL ~400 above the site. Showing limited coarse material from debris flood deposition in the depositional zone.
