### Assets & Infrastructure Committee

**Title | Taitara:** Ramshaw Lane Bus Stop

| B | Independent Safety Review of Bus Stop Locations on Ramshaw Lane, Arrowtown |

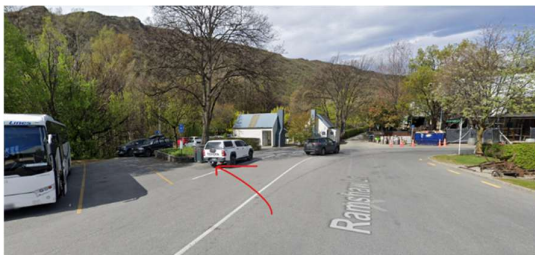
Figure 1: Original Bus Stop Position

A temporary bus stop was subsequently installed nearby, which required the removal of eight car parks.

Screenshots of both the original and temporary stops are presented below.

The original bus stop location is considered unsafe and should not be utilised in the current form, considering the significant user safety impacts of the current road configuration. The significant infrastructure changes to make this location safe do not appear appealing unless undertaken as part of significant township improvements programme.

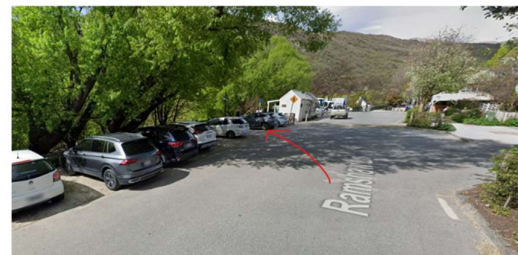
Figure 2: Current (temporary) Bus Stop Position

- The temporary stop is positioned in line with live traffic, and vehicles have been observed overtaking stationary buses and then braking suddenly to avoid pedestrians.
- The Community Association has requested that the original stop be reinstated, subject to the necessary safety improvements being implemented.

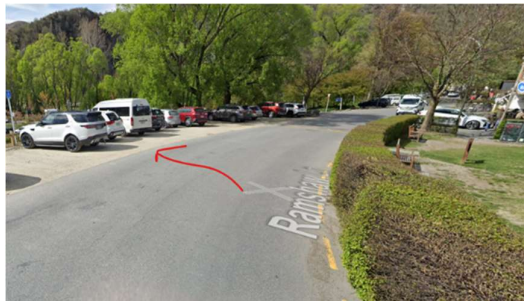
Figure 3: Temporary Bus Stop Position

In the meantime, we are proposing to relocate the temporary stop to the location illustrated in Figure 3 to address the safety concerns raised.

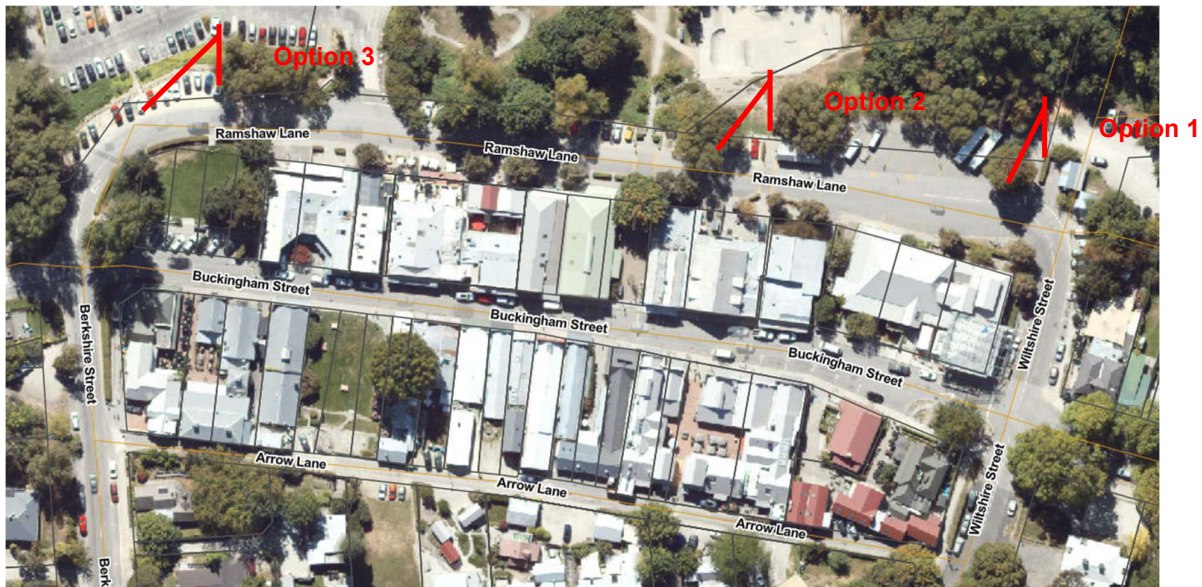
*Figure 4: Bus Stop Positions to be assessed (indicated)*

The individual site locations are identified in *Figure 4*.

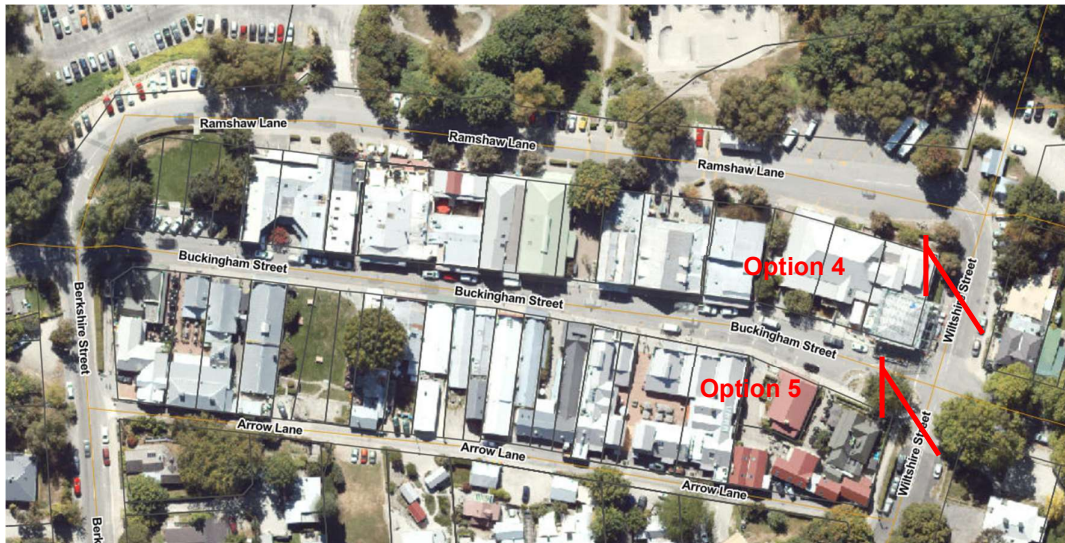
Figure 5: Alternate Bus Stop Locations Identified. (indicated)

During the site visit, additional locations were identified, with a quick assessment of matters explored. These are identified in *Figure 5* and detailed in Option 4, Alternate Bus Stops.

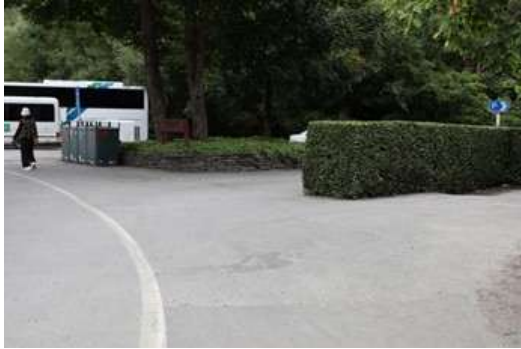
People alighting from the tour coaches mix and mingle within the road lanes, due, in part, to lack of effective and safe pedestrian movement space. As stated, there was mixture of front in parking and rear in parking. This resulted in passengers alighting from the vehicle and mixing in between stationary vehicles, at the same time other vehicles were parking into an available space, as demonstrated in Figure 9.

*Figure 8: Pedestrian movement from public toilets across bus parking*

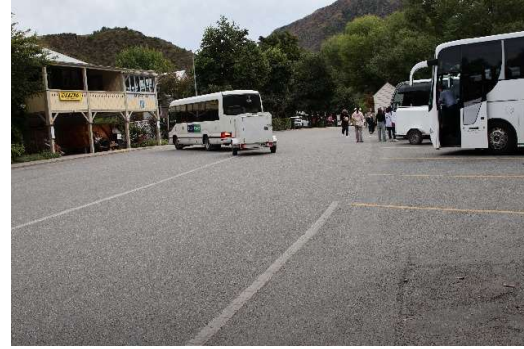
*Figure 9: Bus parking. Mixture of front in and rear in parking with passengers intermixing between bus.*

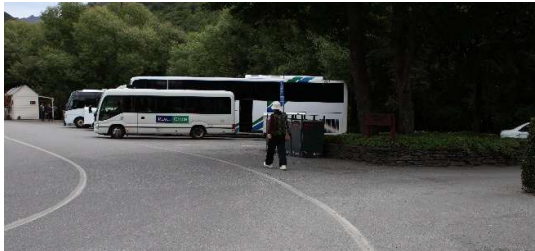
*Figure 10: Original Bus Stop Position. Note short length available at rubbish bins.*

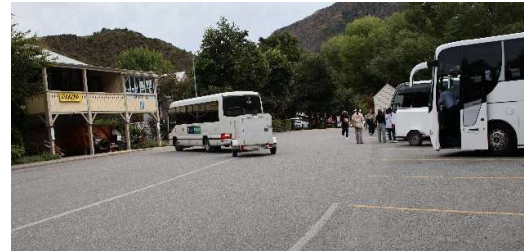
*Figure 11: Coach with trailer manoeuvring in area of bus stop.*

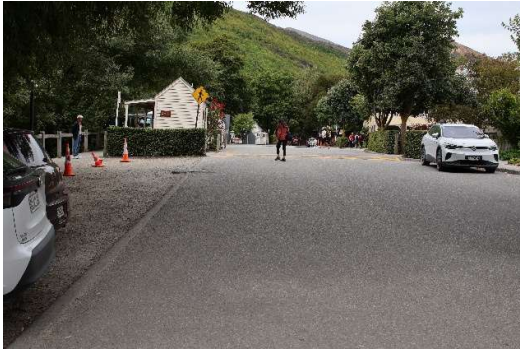
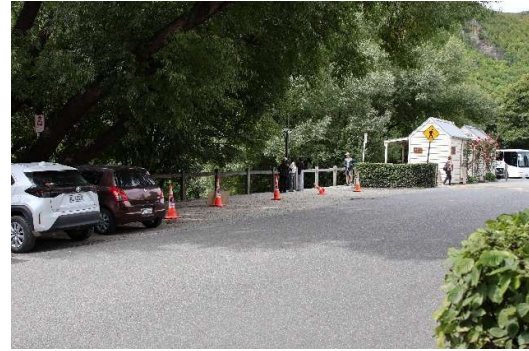
Figure 12: Current Temporary Bus Stop Position

Option 2 considers the temporary bus stop currently located south of the public toilets located opposite the movement path through the shops, onto Buckingham Street.

A large tree overhangs the parking areas, with low branches in the space that could be occupied by campers or larger vehicles. At the time of the inspection a portion of the perpendicular parking was coned out, with signs indicating a bus stop. This limits use, with drivers of larger vehicles often not identifying the hazard until they commence a turn in movement, then requiring them to reverse out due to the hazard. This limitation is not conspicuous, and results in undesirable vehicle movements.

The raised crossings are located at the pedestrian desire lines and appear to be frequently used. Pedestrians were observed to be hesitant at times not understanding the priority at these crossing points, as while raised, they are not formed as a formal pedestrian crossing. Experience overseas reveals that international rules in some locations give priority to the pedestrian, regardless of a formal zebra crossing.

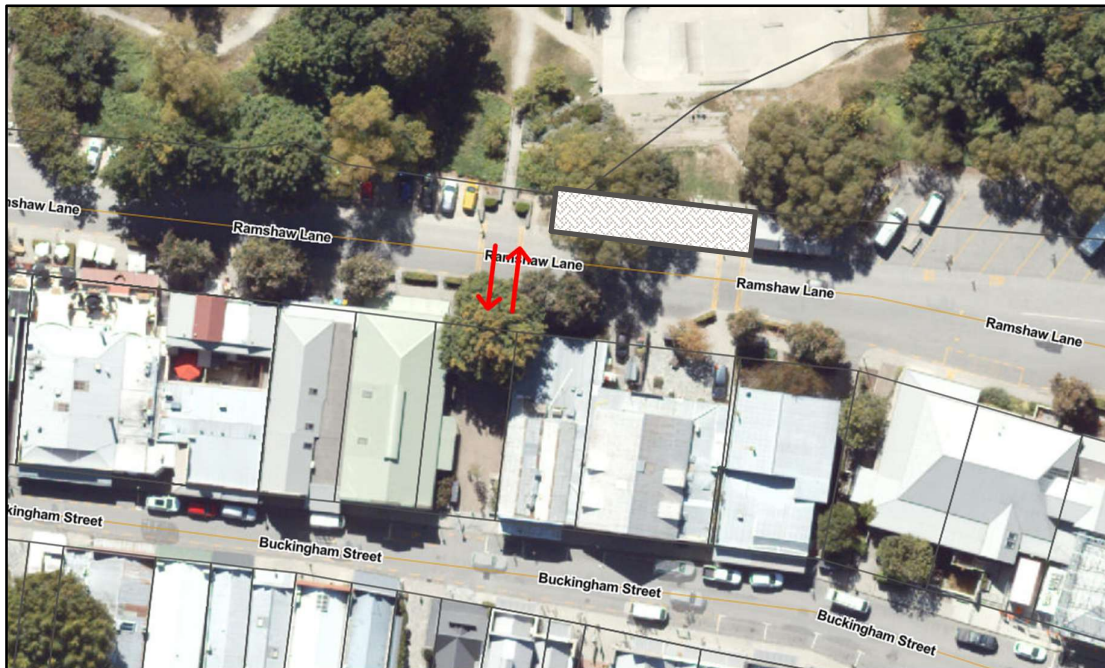
An overview of the bus stop location is given in Figure 14 below. The available movement path to and from Buckingham Street is indicated by arrows.

Figure 14: Pedestrian movement path to walkway towards Buckingham Street

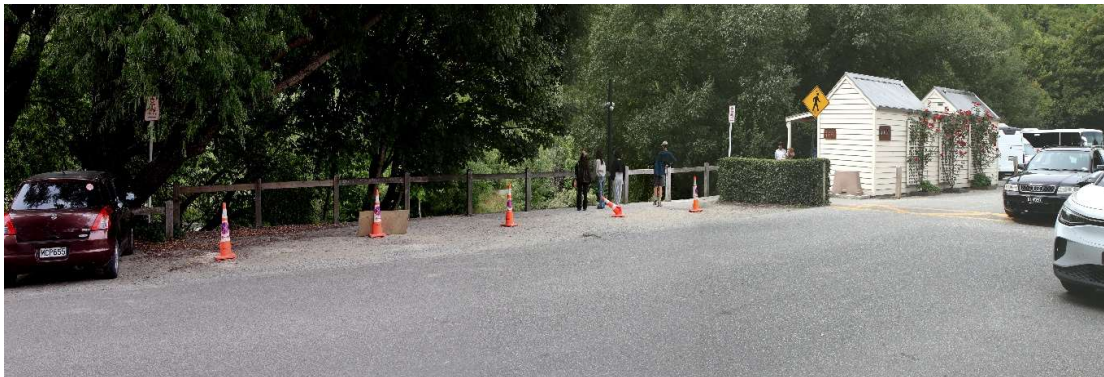
*Figure 15: Temporary Bus Stop Position (marked by cones and barely visible signage, no pavement markings indicating a bus stop)*

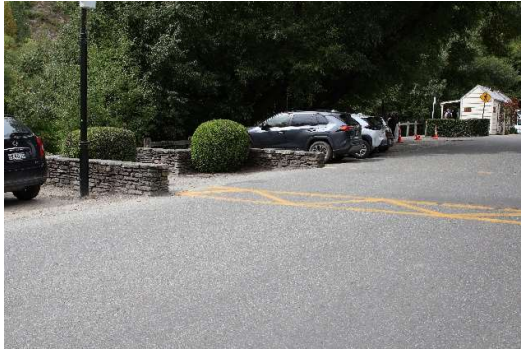
*Figure 16: Pedestrian platform (west). Note schist wall at edge of parking space.*

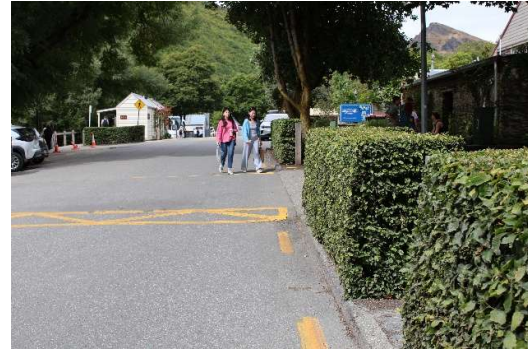
*Figure 17: Pedestrians walking along live lane to access walkway to Buckingham Street.*

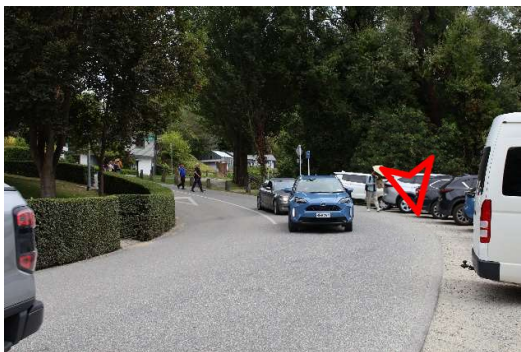
A temporary bus stop could be established within the perpendicular parking area immediately north of the Buckingham Street / Berkshire Street / Ramshaw Lane crossroad intersection.

Figure 18: Alternate temporary bus stop (arrowed)

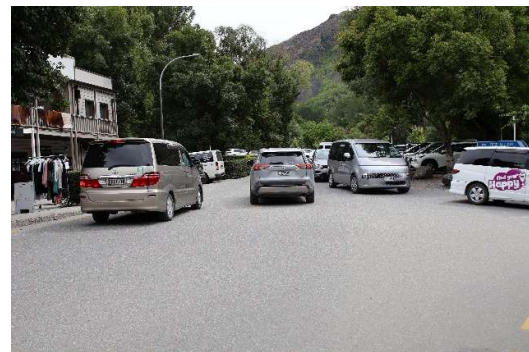
Figure 19: Congestion caused by access and egress movements to lower car park.

At the time of the site inspection, significant congestion was observed with drivers wishing to access the main Ramshaw Car Park via the ramp to the lower parking area. Delays in the circulation of drivers in the lower area caused a queue to form back into the Ramshaw Lane / Buckingham Street intersection. Drivers approaching from Wiltshire Street, wishing to turn right into the lower car park area caused additional congestion as they blocked all movement along Ramshaw Lane for the westbound direction.

It is recommended that this bus stop not be developed and utilised without significant infrastructure change, and analysis of potential congestion impacts.

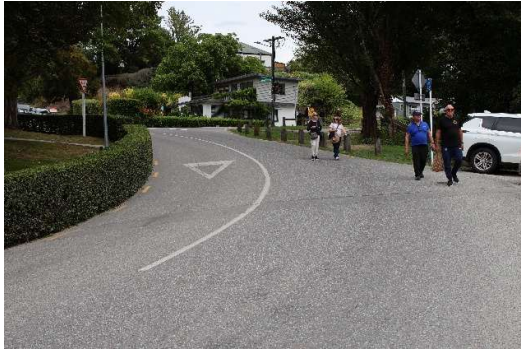
*Figure 20: Pedestrians required to utilise traffic lane to access vehicles and parking*

- A lack of suitable footpath and pedestrian movement facilities near the proposed bus stop. Pedestrians were observed walking along the traffic lane, unaware of traffic behind them, especially with silent EV type vehicles.

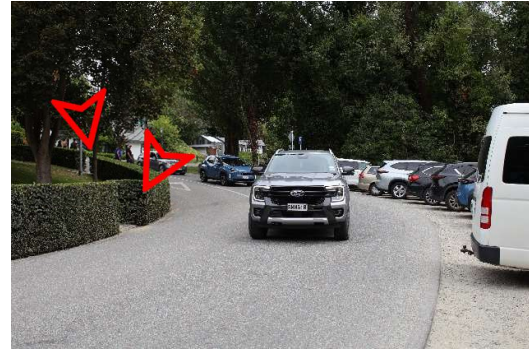
*Figure 21: Two current access gaps in hedging (arrowed)*

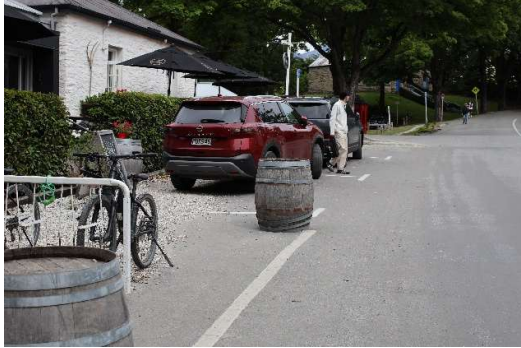
The storage area and cycle racks are currently situated within the defined P120 parking zone. Observations on site indicated that this large area is not effectively utilised, with hap-hazard parking

Figure 22: Current three parks and cycle storage

The implementation of the sectioned off area for bikes has a significant impact on available parking in this area. The actual land occupied by cycle parking is small, compared to the area sectioned off.

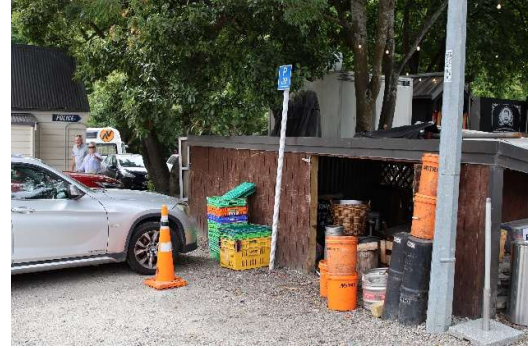
controls (barrels) placed to prevent parking in this area. It is not clear if the time restricted parking designation remains, or if it has been revoked. Given the presence of the signs, I have assumed that the parking zone is legitimate, therefore any parking restriction features installed would be contrary to the permitted time restricted parking designation.

Figure 23: business storage. Note P120 sign within storage area.

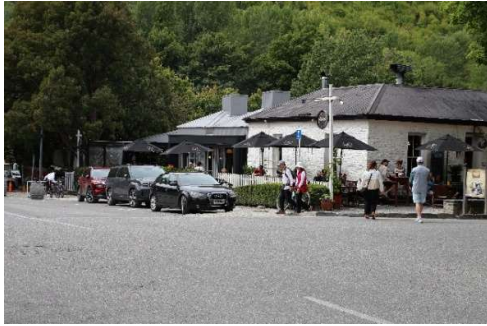
*Figure 24: Note lack of suitable pedestrian facilities at Buckingham Street / Wiltshire Street intersection.*

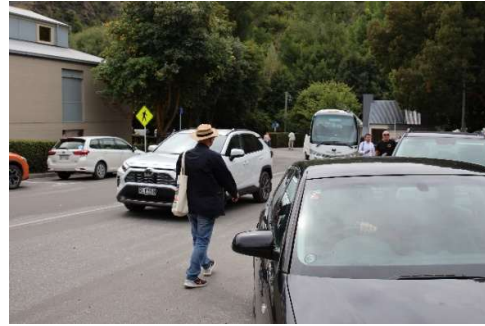
*Figure 25: Note orientation of car (foreground) accessing park closest to Buckingham Street Intersection. Pedestrian movement along edge of traffic lane.*

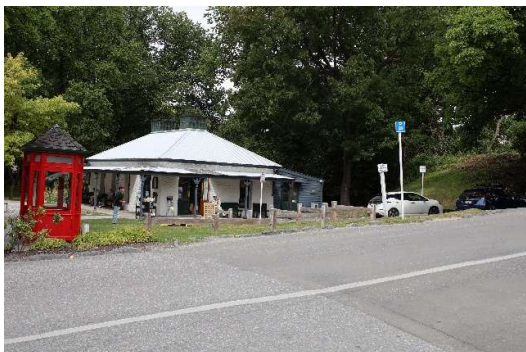
A single car park is located opposite the red phone box, alongside the public library site and reserve land. This single park is time restricted as P120. At the time of the site inspection, the park was infrequently utilised, despite the parking pressures observed.

*Figure 26: Single parking space, outside library site.*

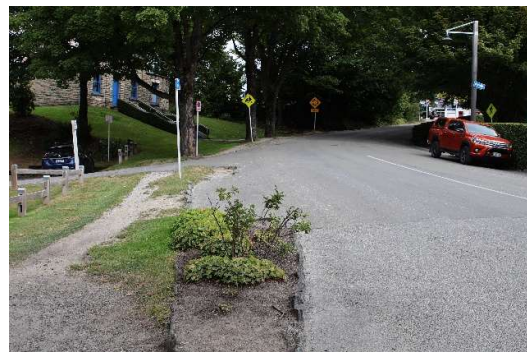
*Figure 27: Shoulder formation outside library site.*

An earth path is currently formed alongside Wiltshire Street, with similar poor levels of path and kerb protection at the Buckingham Street / Wiltshire Street intersection. Library users have limited off street parking formed.

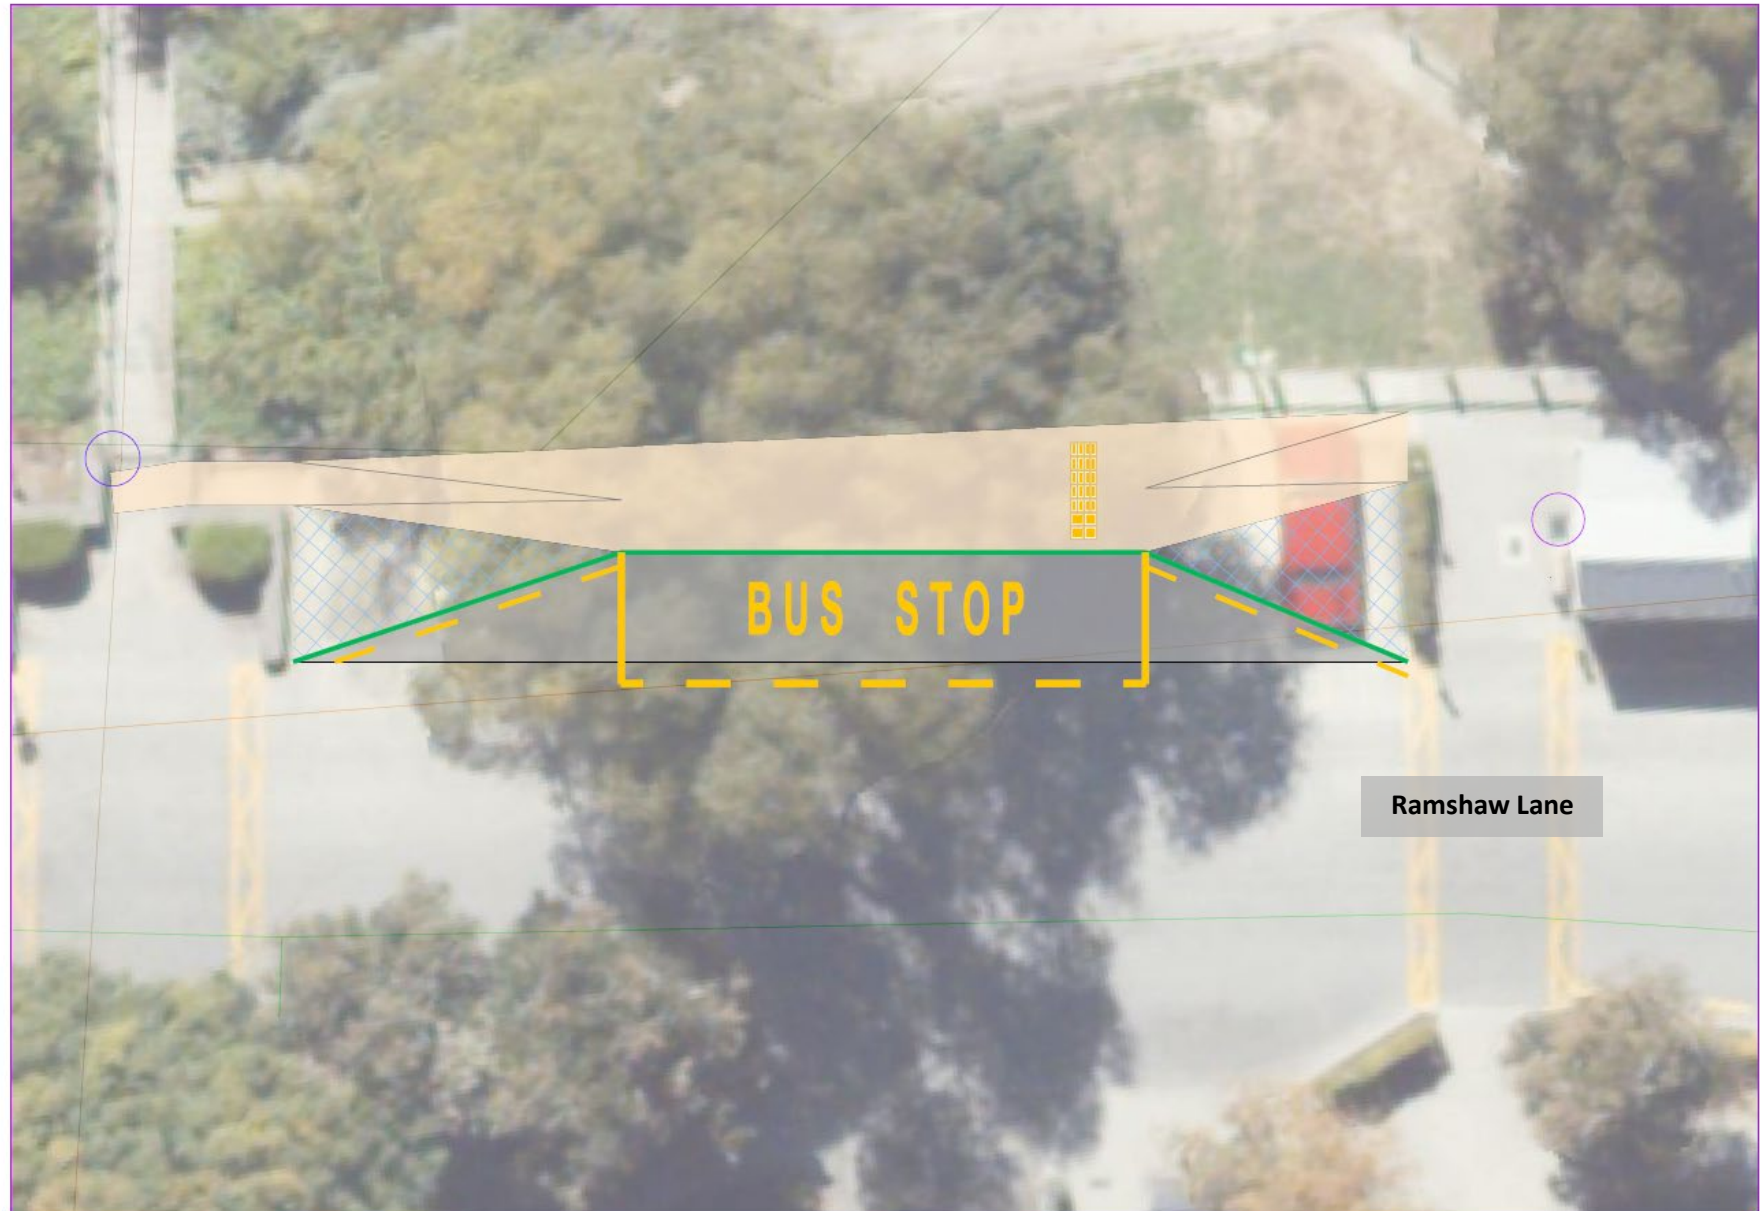
## Attachment D: Bus Stop Layout

| Map Ref. | Reference to relevant section in QLDC Bylaw 2025 or Land Transport Road User Rule 2004. | RAMM Road Id | Road Name | Description of issue | Restriction Type | Action Required | Hours of operation | Use mobile roads or RAMM to get OPR for road direction / RPs. | | | | Physical works completed |
|---|---|---|---|---|---|---|---|---|---|---|---|---|
| 1 | 17 Bylaw | 234 | Ramshaw Lane | No stopping lines required for bus exit taper. | No Stopping | Mark no stopping lines. | At all times | Left | 195 | 200 | 5 | No |

1. **Note** the contents of this report; and
2. **Approve** changes to the existing restrictions to enable bus stop construction as set out in Attachments C and D. These will come into force once constructed, sign posted and line marked.
