## GEOTECHNICAL INVESTIGATION REPORT

| PROJECT STREET ADDRESS | Northlake Subdivision, Special Zone, Wanaka |
| RDA JOB NAME | 54054 Northlake Residual Geotech |

## SUMMARY

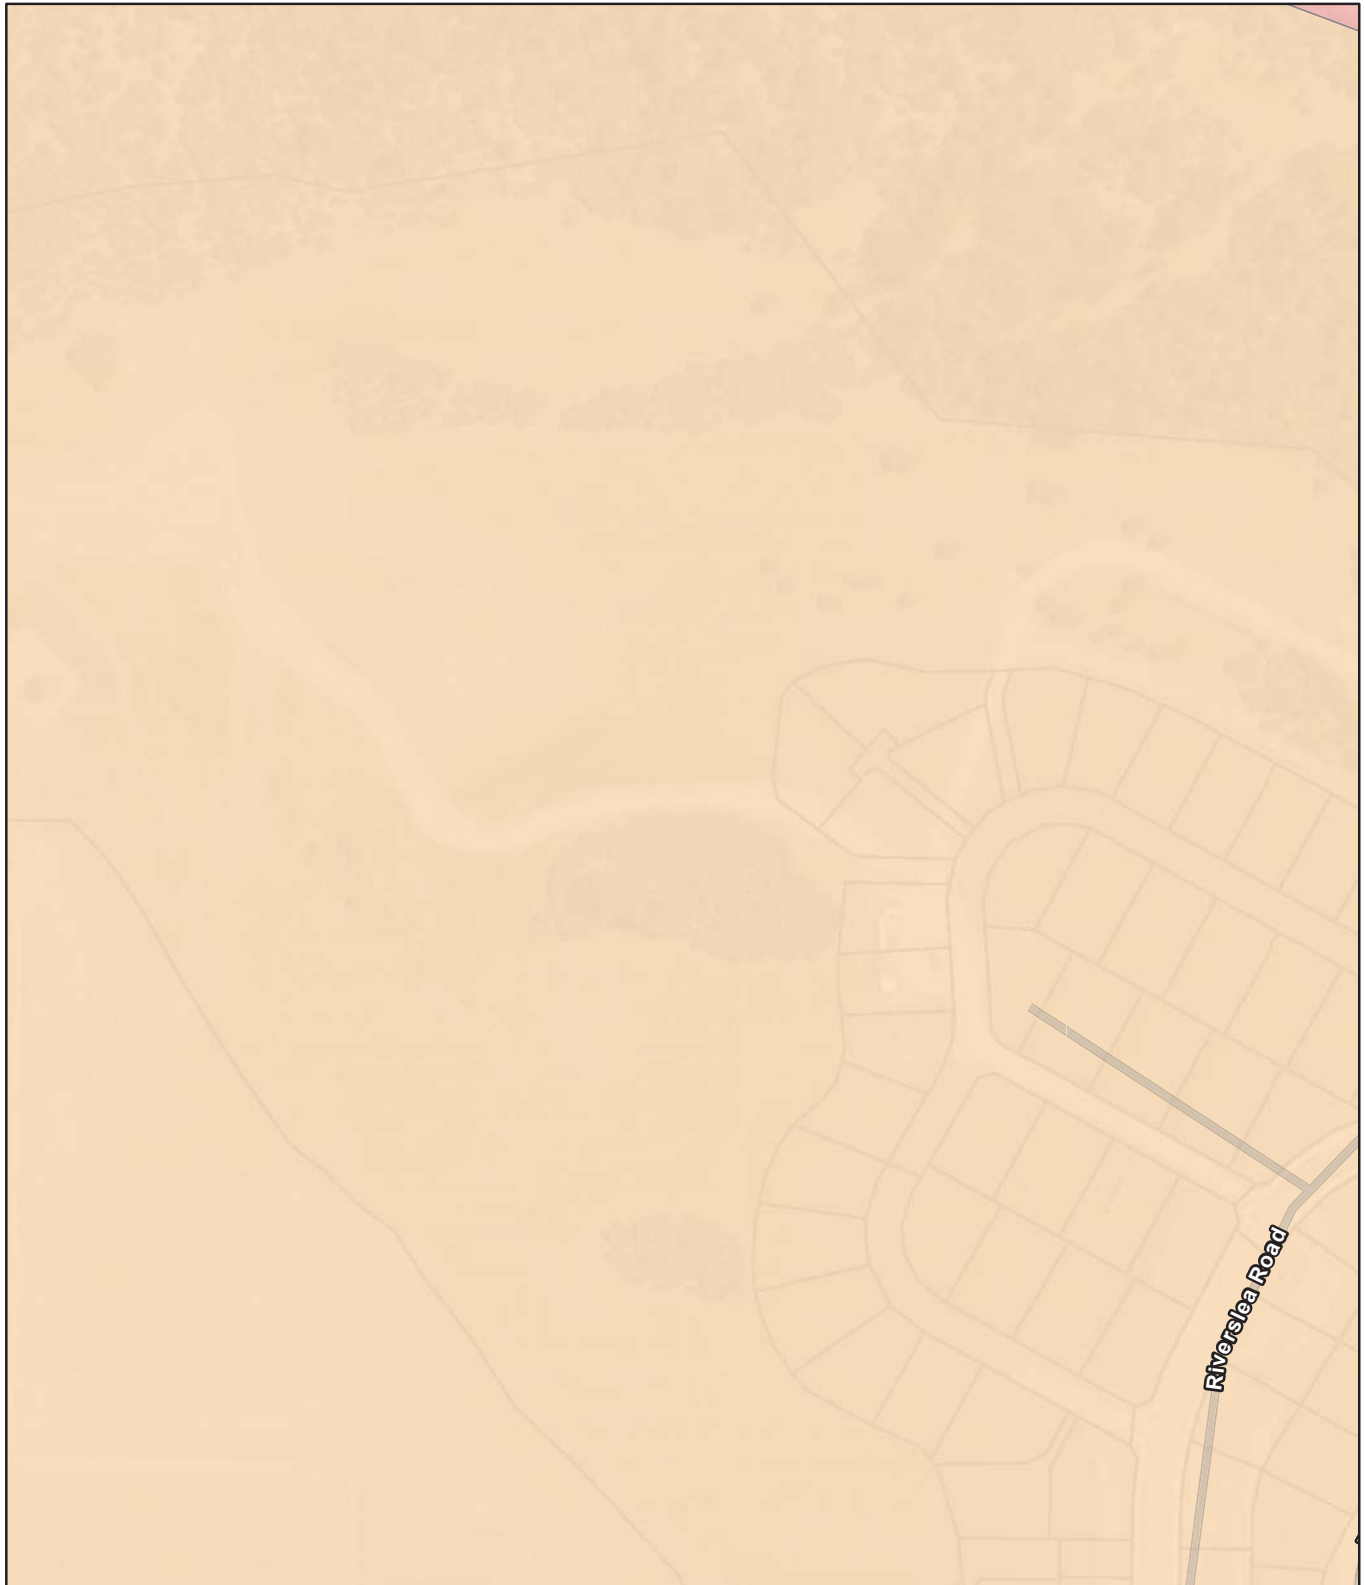
# Natural Hazards Map Print Out

Liquefaction Awareness Areas Otago

A review of the Queenstown Lakes District Council webmap shows that the liquefaction Risk is stated as being LIC 1 -Nil to low risk, refer to the Tonkin & Taylor Liquefaction Hazard Assessment attached in Appendix C. This site is also not expected to have groundwater in the upper 10 metres and relatively dense natural soils; therefore, very low liquefaction risk for the site is present due to the site soil conditions present.

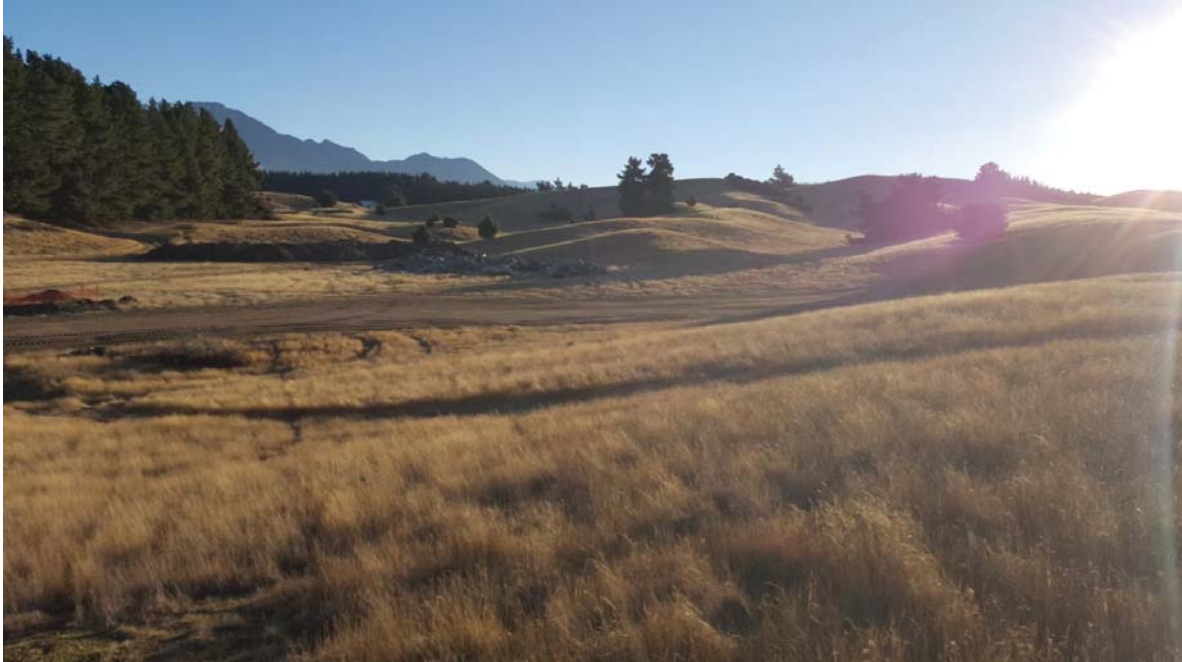
**Photo 1. View of the site looking northwest from TP23.**
