Queenstown 25

Summary Description

Queenstown 26

Queenstown 27

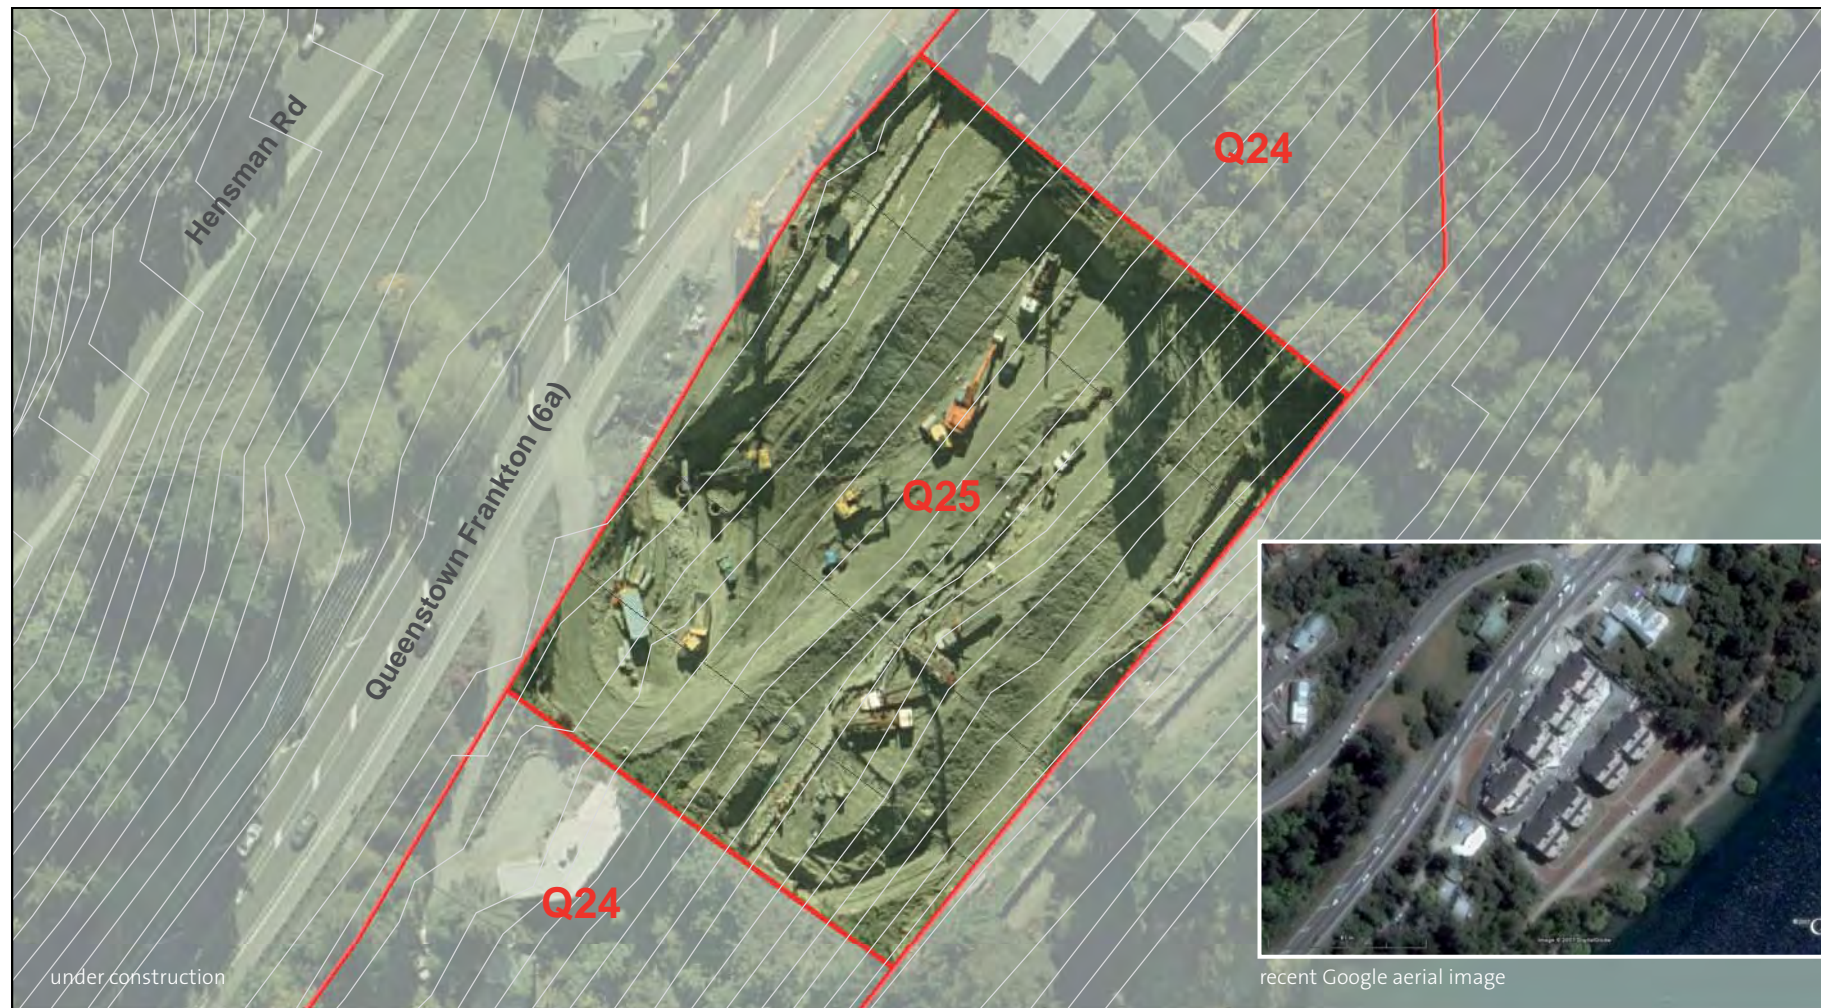
Aerial Photos

- A comprehensive multi unit development split over two five storey constructed terraces
- Extensive and highly engineered retention structures allowing the built form to be stepped deeply into the steep embankment slopes accommodating basement car parking
- Road boundary setback dominated by hardstand and vehicle ramps with low shrub and groundcovers used on internal courtyards and along Frankton Track.

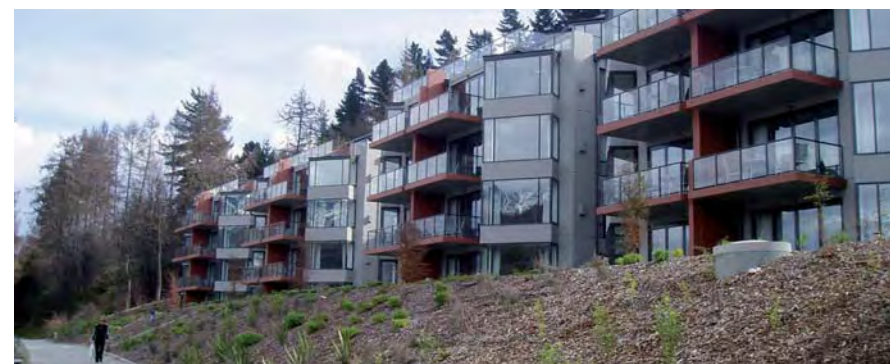
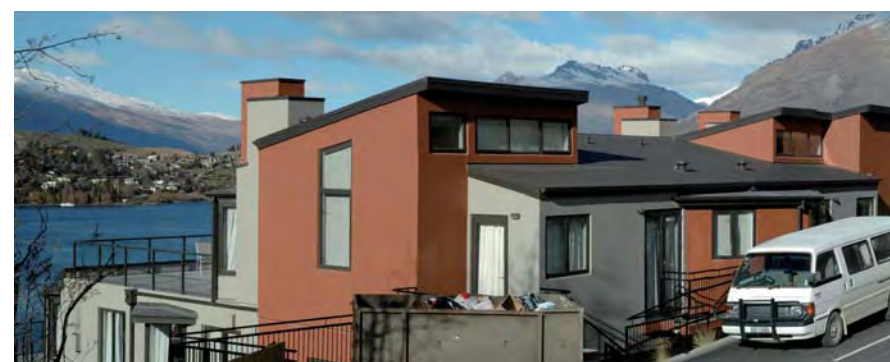
Representative Photos

The characterisation identifies this comprehensive development to be of a **substantial scale** based on the extensive bulk and mass of the building and high site coverage. Its appearance to both Frankton Road and Frankton Track is considered to be of a **hard-edged balance** with little or no softening vegetation and a very prominent built form. As a consequence of its comprehensive development style it exhibits a **strong cohesion**, though this is confined to a single site which is in contrast to the adjacent vegetated slopes. As a recent development involving widespread modification of the topography the unit has a distinctly **young maturity**, which is currently in a **managed condition**, particularly within the formal internal courtyards.

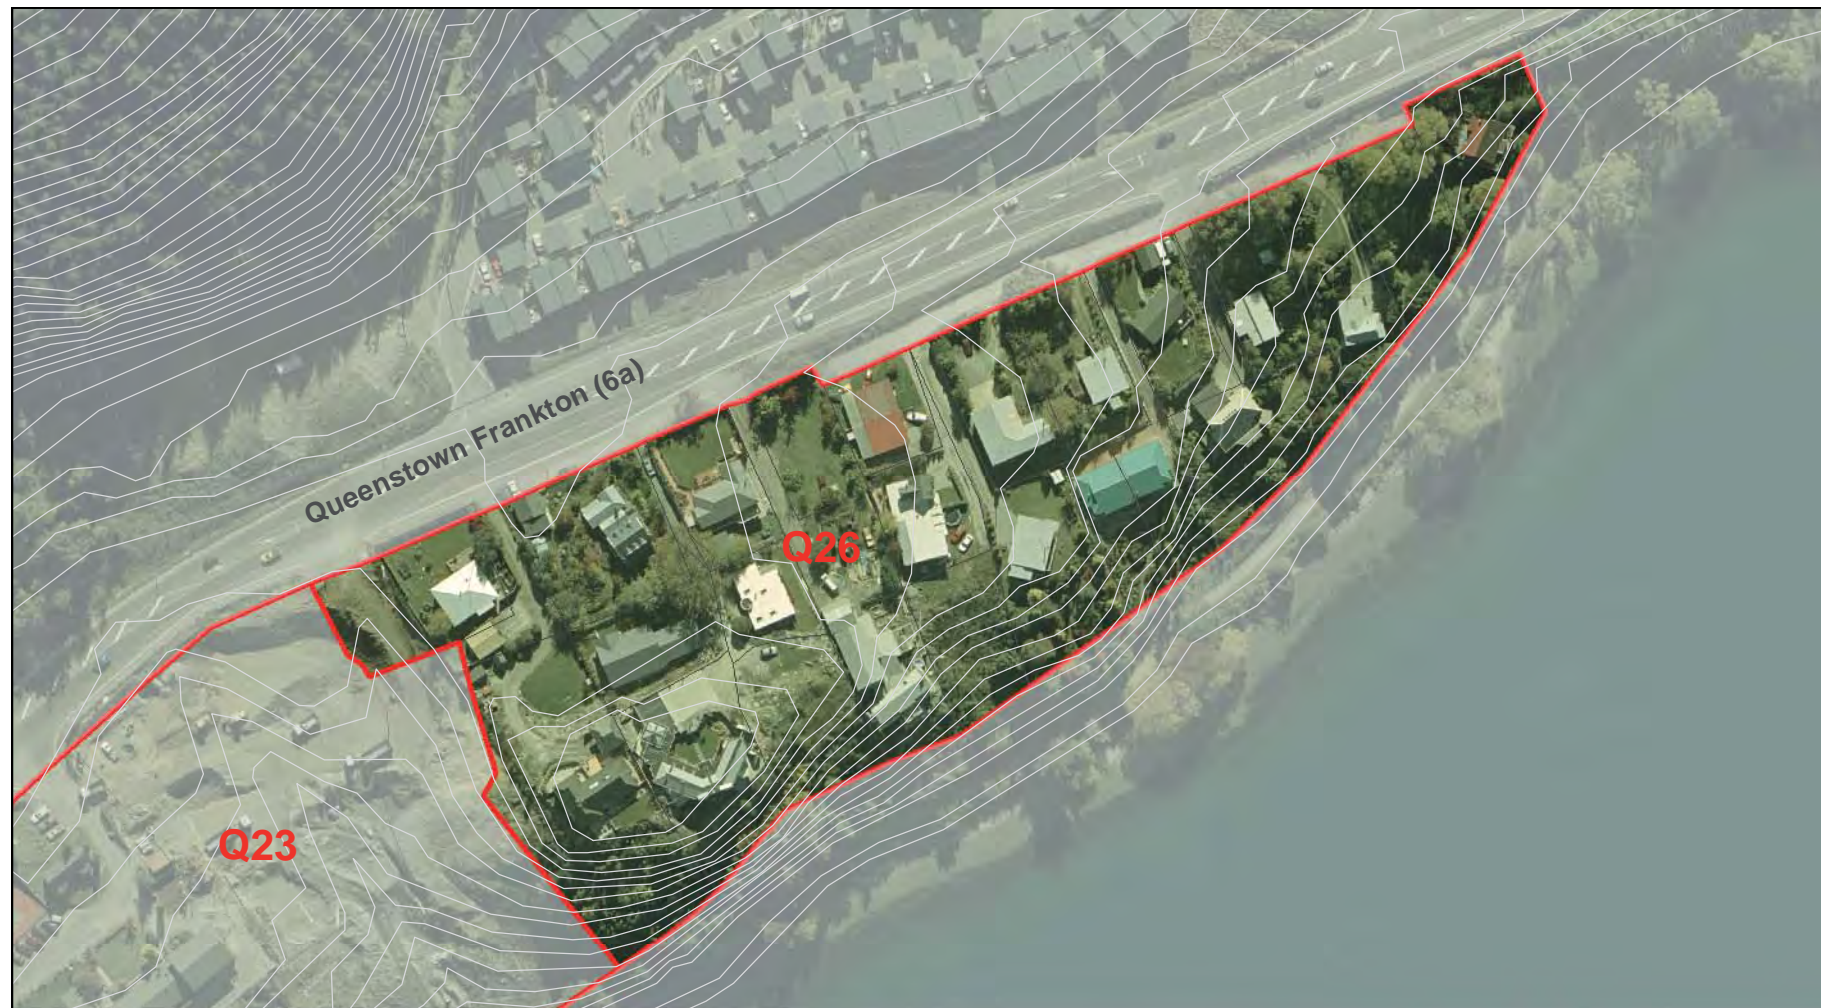
Aerial Photo

- Detached one and two storey buildings on gently undulating sites, which then fall away steeply to the lake in the western part of the unit
- A single urban block with widespread infill development on moderately sized lots
- Deep road boundary setbacks with individual or shared accesses and informal boundary treatments of small trees and shrubs planting

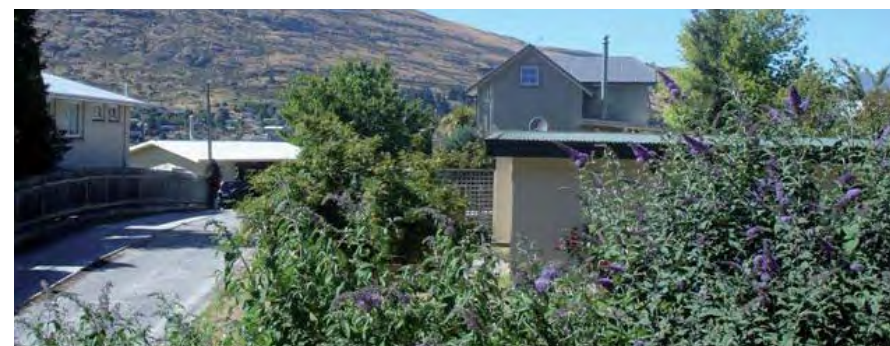
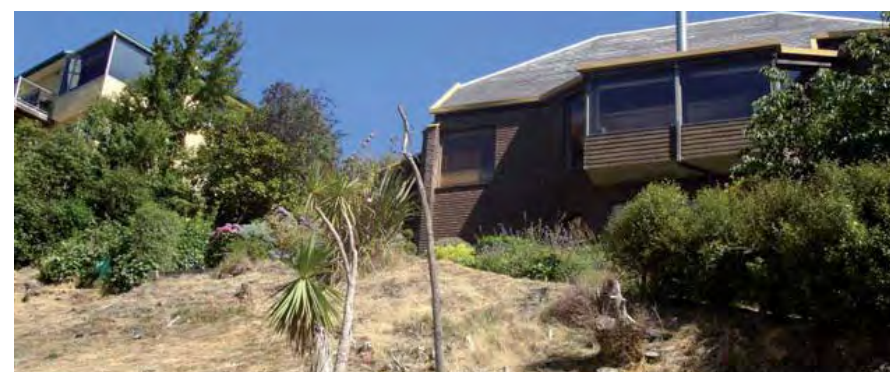
Representative Photos

The unit is characterised by built form of a *small scale* comprising of largely single storey detached buildings. The relatively low building coverage allows small (and some larger) trees and shrub planting to establish around property boundaries which is accentuated by the vegetated steeper slopes to give an overall *vegetated balance*. A variety of building style, age, and orientation results in a *mixed cohesion*. The number of older dwellings, age of trees and lack of major earthworks ensures the unit has an *established maturity*, though this is eroded slightly by several recent developments. The appearance of this character unit reflects a *reasonable condition* where material quality and maintenance is modest.

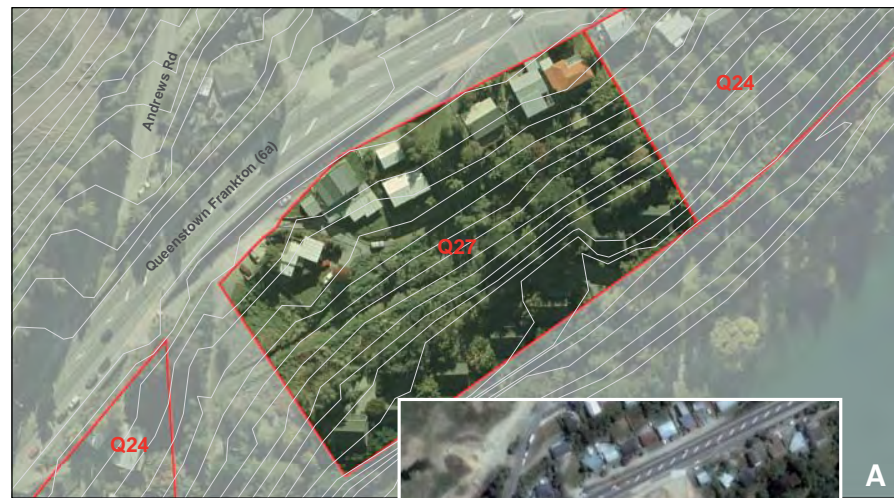
under construction

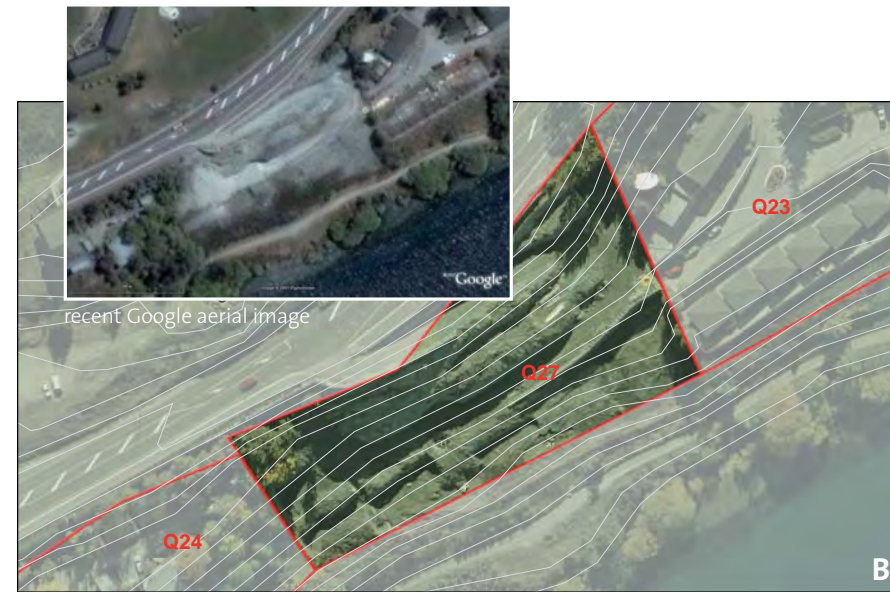
under construction

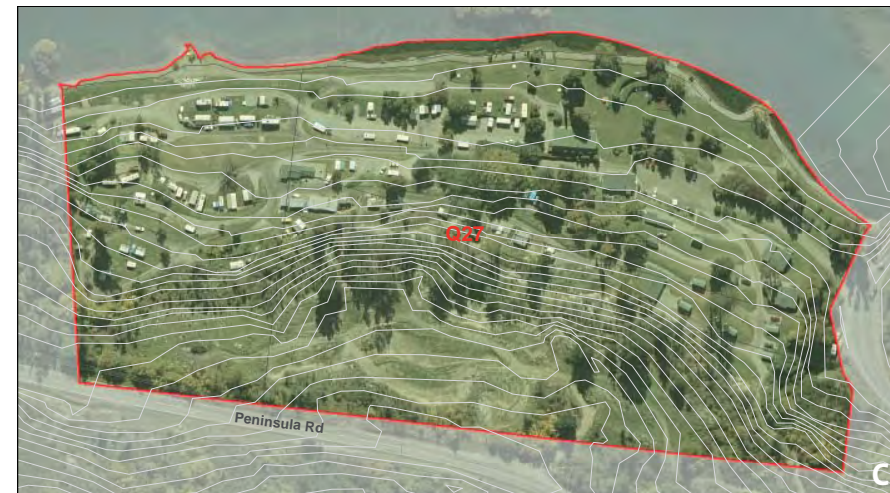
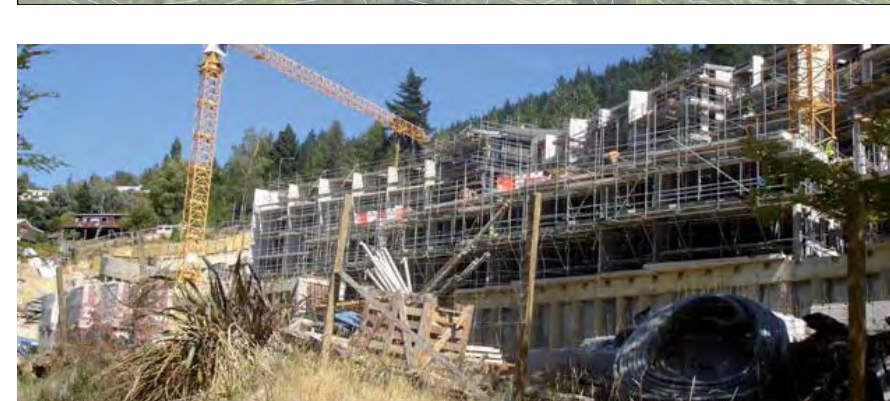
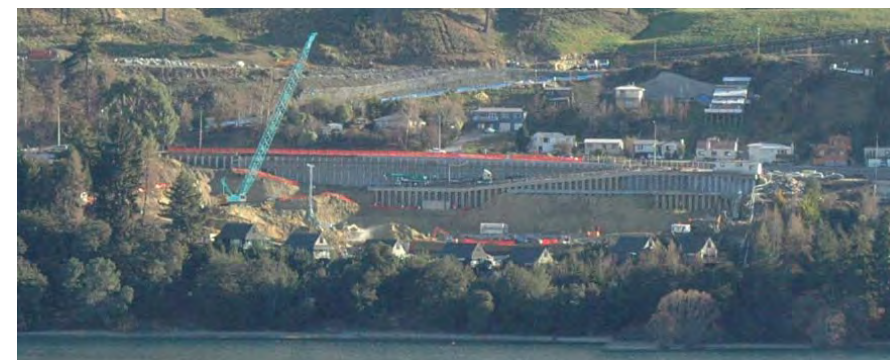
Representative Photos

- Extensive earthworks comprising steep access ramps, benched platforms and large engineered retention structures cut into steep lakeside embankments.
- Sites largely cleared of vegetation with only large mature trees and lake edge planting retained.
- Whilst many of the new buildings are almost complete in Unit 27A, construction is not as advanced on the others, except for earthworks, retaining structures, small scale temporary accommodation, and security boundary fencing
