# E. coli monitoring

## Shotover & Kawarau Rivers

Shotover WWTP E. coli results									
Parameter		E. coli							
Unit		cfu/100mL							
Location		EFF Final discharge from Shotover WWTP	RS15 End of drainage trench	RS04 B Shotover River upstream of discharge to provide baseline water quality	RS16 Shotover River immediately downstream from discharge channel	RS06 B Shotover River 50m downstream of discharge	RS09 Shotover River 300m downstream of discharge site	RS11 Kawarau River upstream of confluence	RS10 Kawarau River downstream of confluence
Date	1 July	15	65.9	6.4	*	13.7	9.9	9.9	6.4
	9 July	29	60	1	*	13	15	1	1
	16 July	160	190	6	*	30	21	2	2
	24 July	900	750	<1	*	130	69	1	<1
	31 July	70	70	2	*	10	7	<1	2

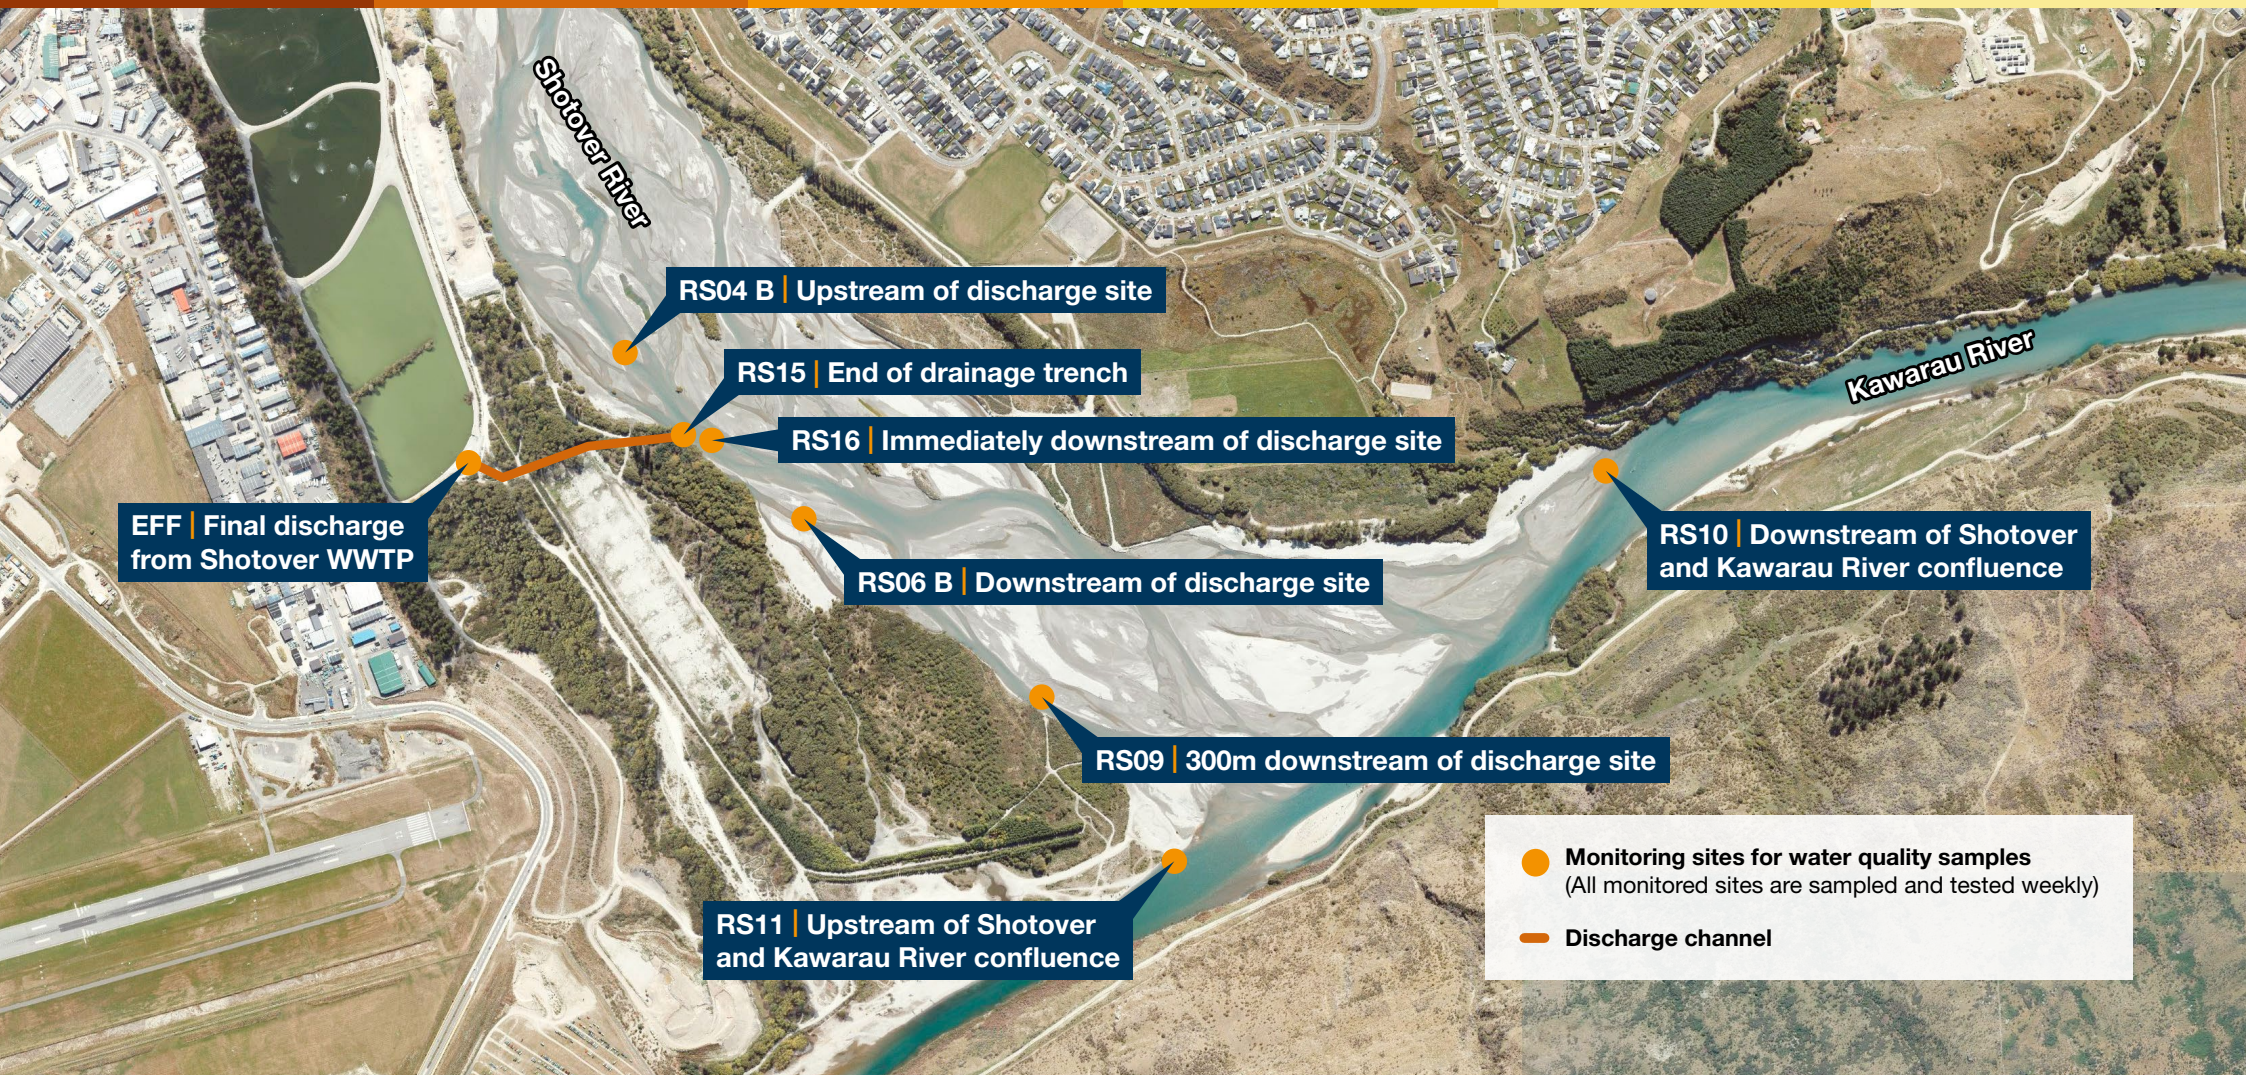
# Water quality sampling locations

## Shotover & Kawarau Rivers
