APPLICATION AS NOTIFIED

(RM240855)

Application for consent to establish two residential units in breach of height standards, with associated earthwork and transport non compliances.

359 Frankton Road, Queenstown

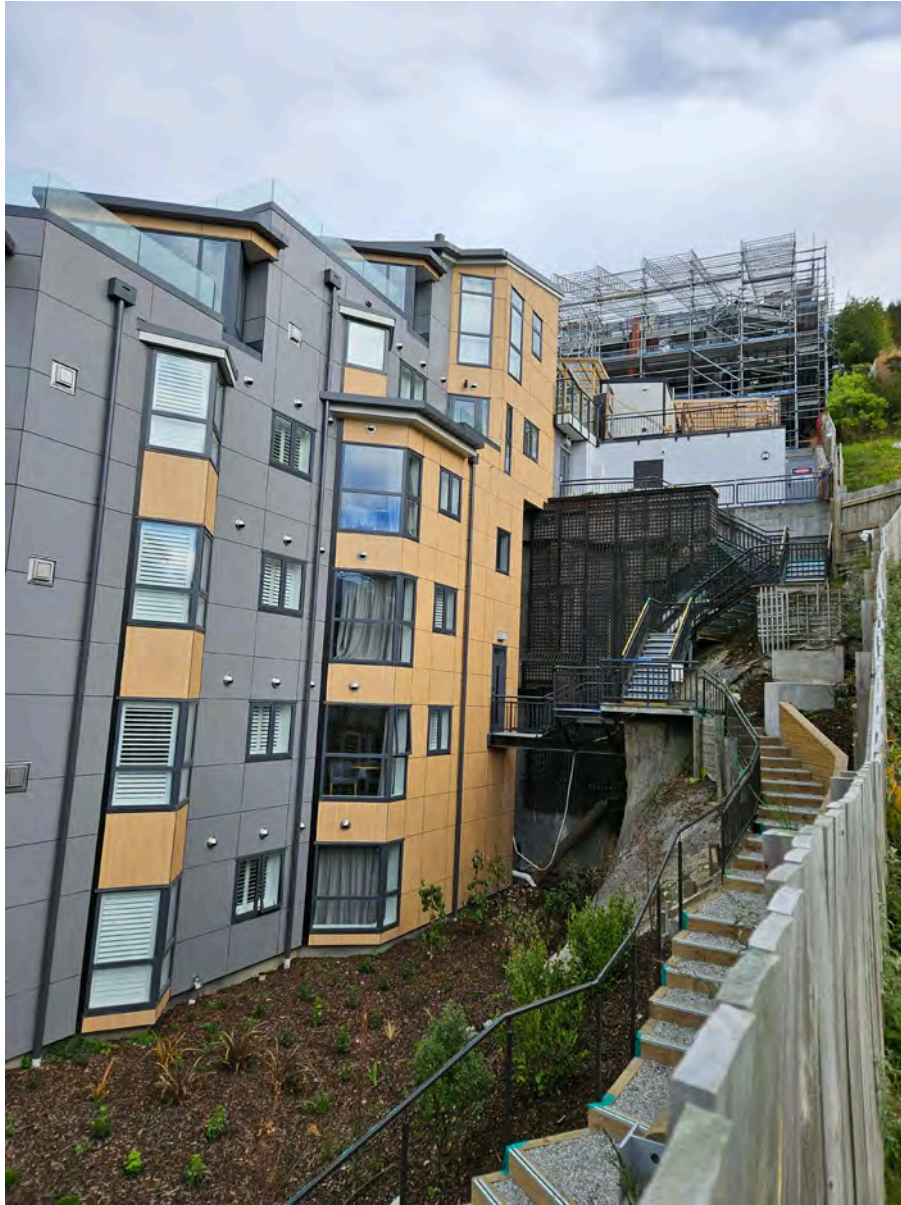
Figure 2: Oaks Queenstown Shores Resort Eastern Boundary Treatment

32. In regards potential adverse shading/sunlight access, there are two notable features of the Resort building that serve to reduce sensitivity of the building. The first is that the area of land

between the Resort building and the shared property boundary contains only a pedestrian pathway and landscaped areas, i.e. not areas intended for lingering. This is illustrated in the photograph in Figure 2 below.

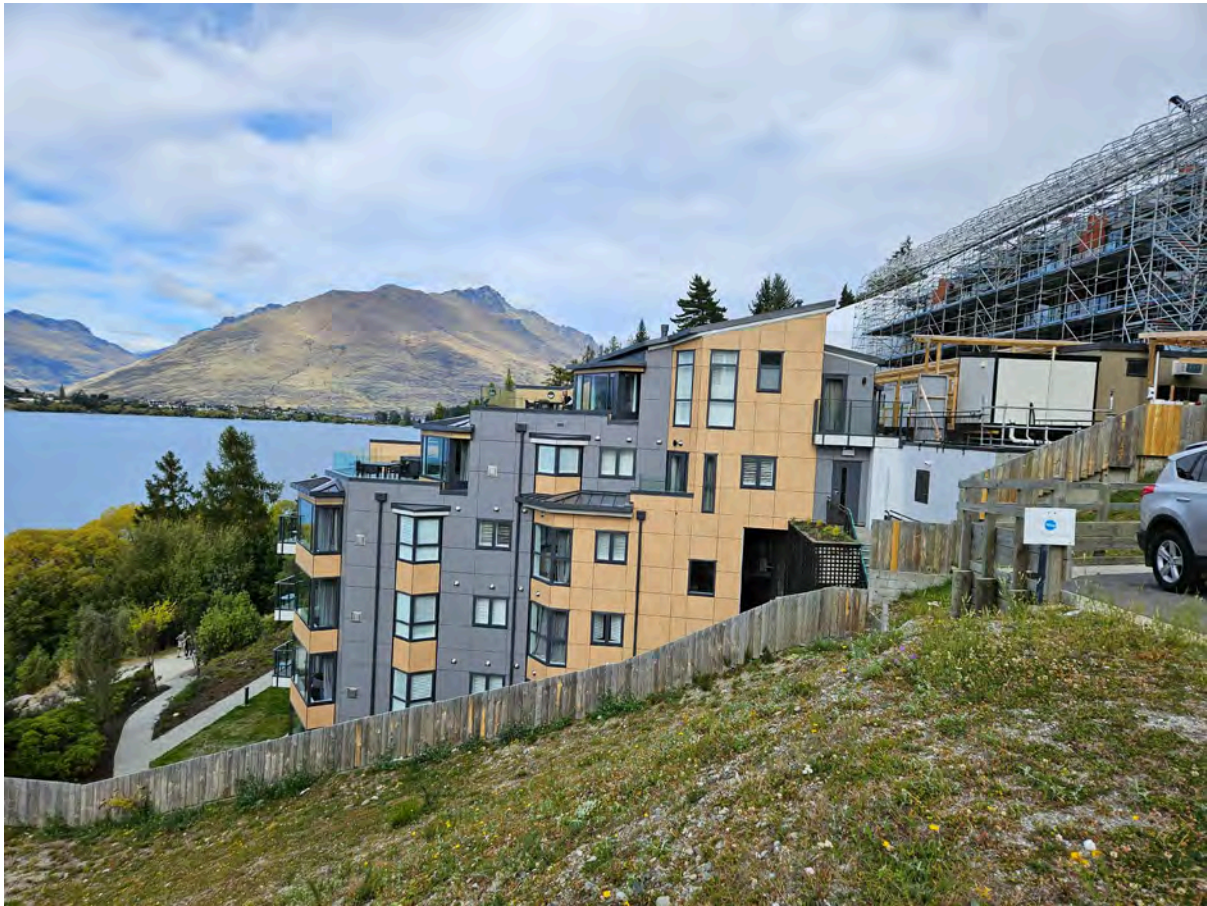
Figure 3: Oaks Queenstown Shores Resort Eastern Façade

33. The second notable feature is that many of the windows on this façade appear to be shuttered, servicing either bedrooms or bathroom-type rooms, i.e. rooms where privacy is of greater concern to occupants than sunlight admission. For those units fronting the Lake, views and unscreened windows are oriented towards the Lake and away from the applicant's site. This is best viewed in Figure 3 below. The Resort unit rooms most likely to be sensitive to shading are those that can be seen centrally in Figure 2, which are not shuttered and contain "living" areas, as well as the rooftop deck areas visible in Figure 3. Potential impacts on those areas are considered now.

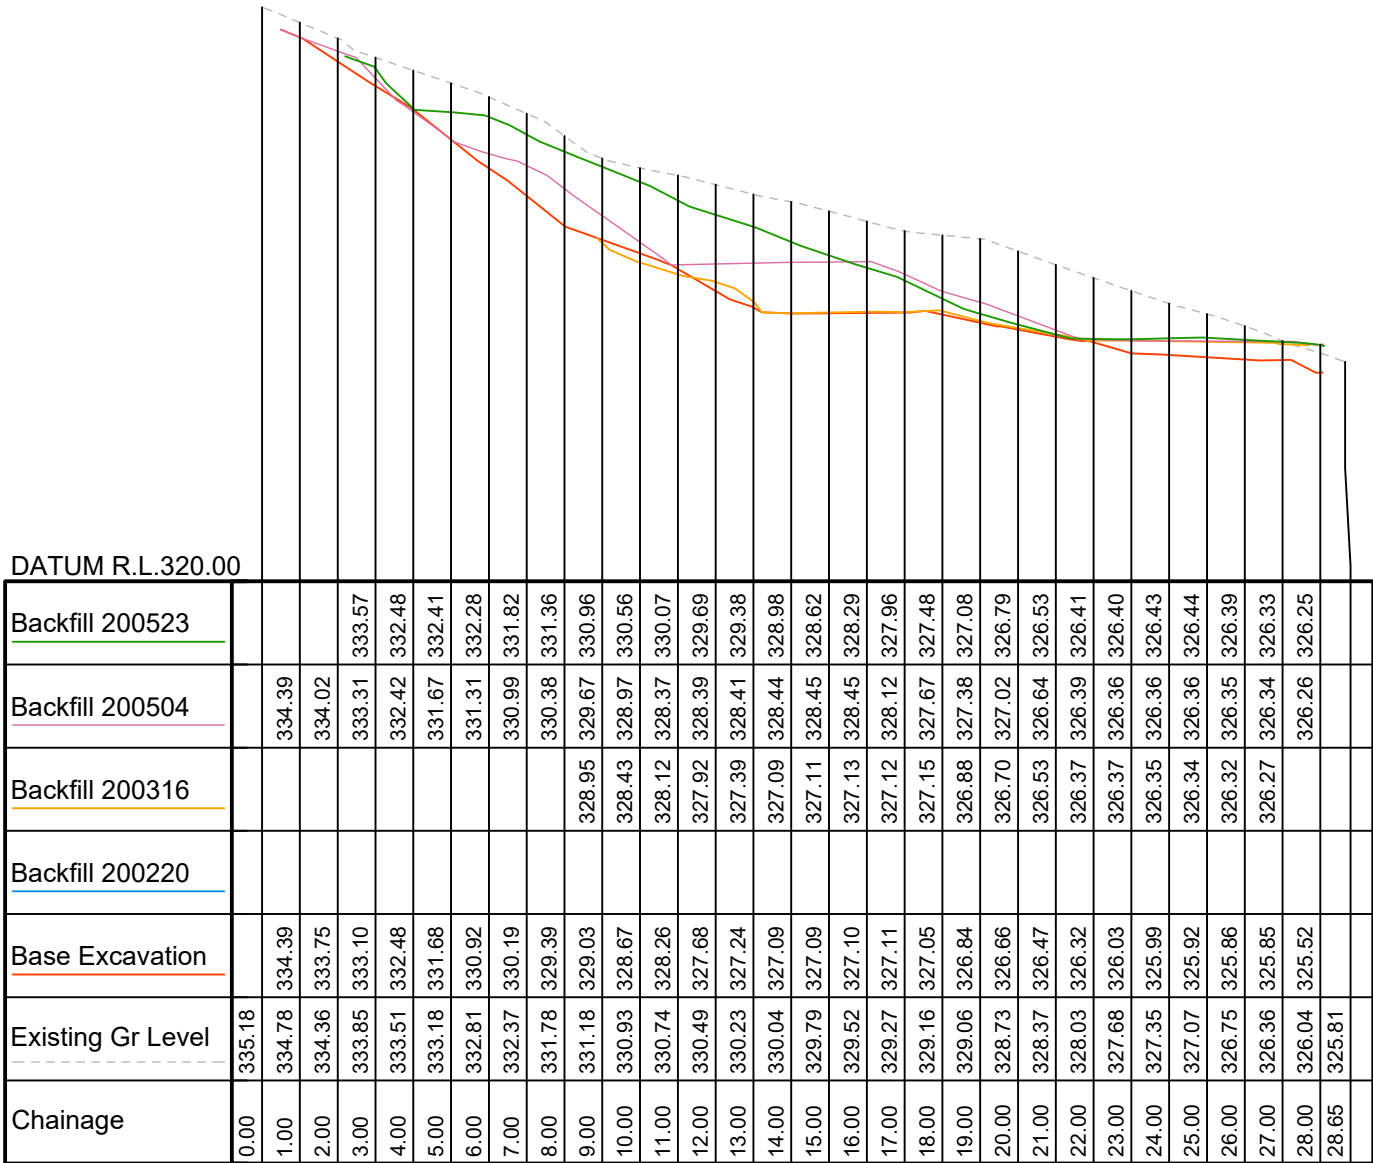
Profile D - D1

SCALE 1:200 horizontal
1:200 vertical

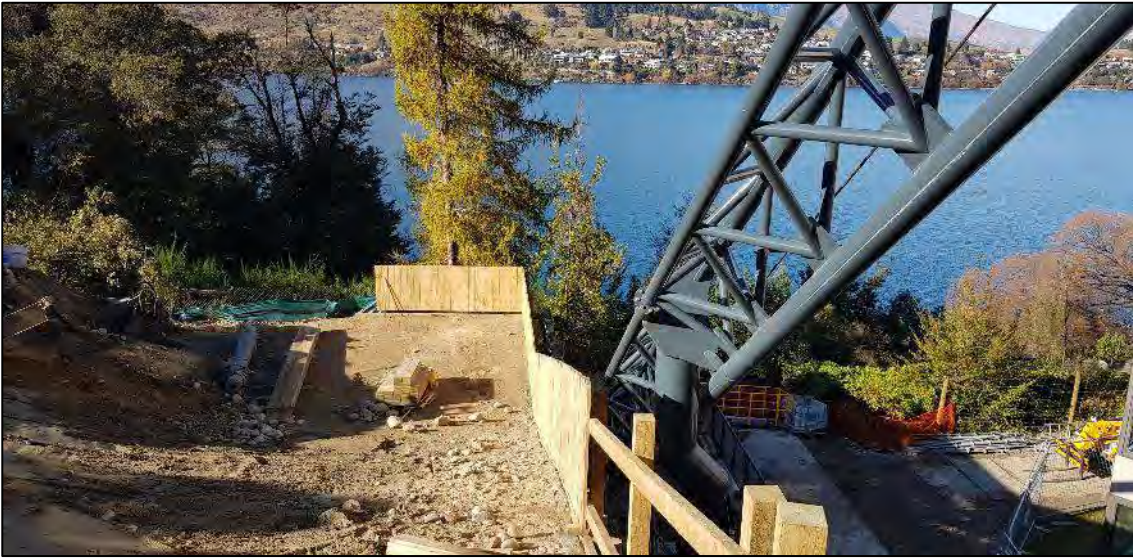
Photo 1: Looking south-east across the fill placed behind the timber retaining wall.

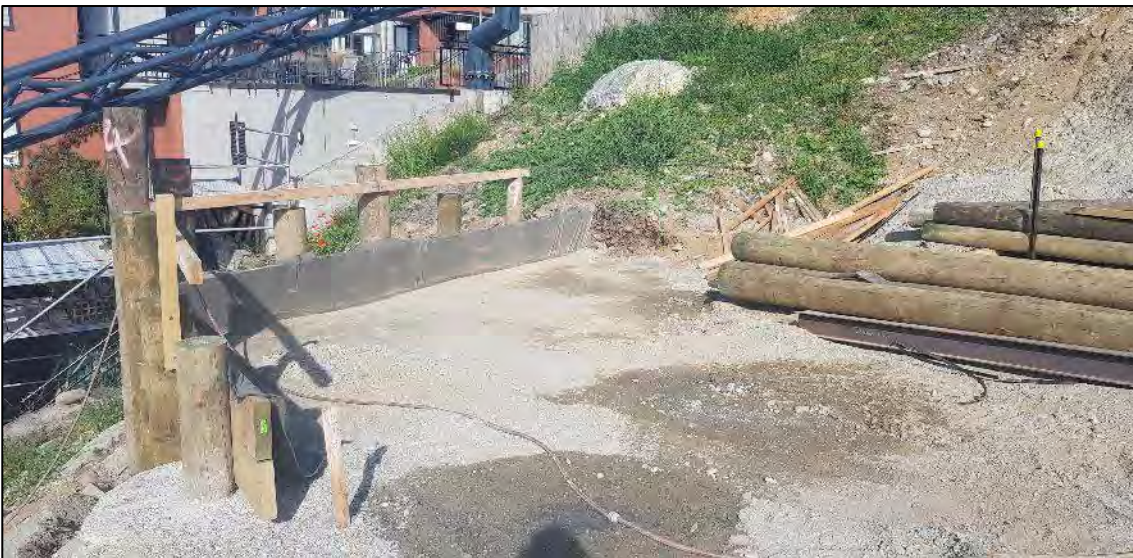
Photo 2: Looking west across the fill placed behind the timber retaining wall located along the access way.

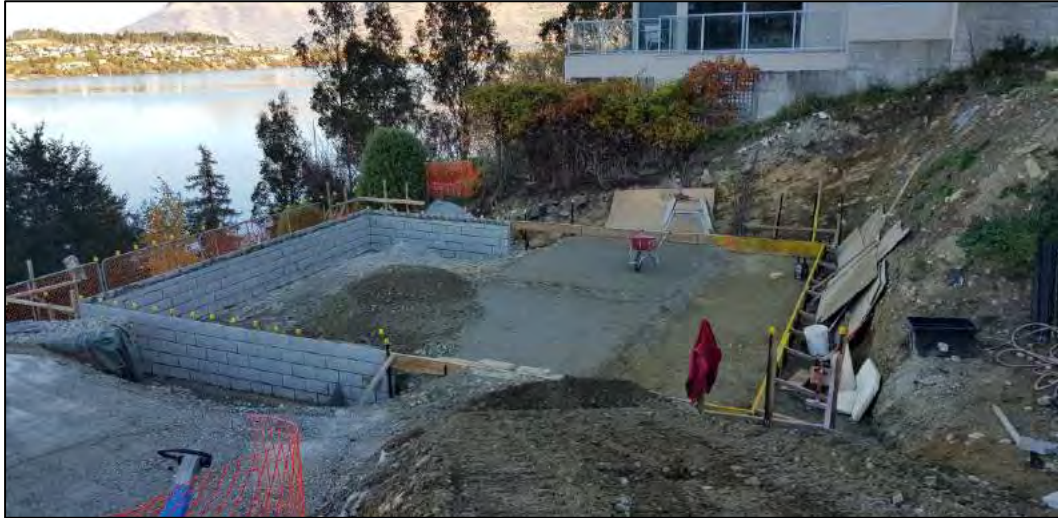
Photo 1: Looking across the building footprint of Unit 6. The western portion of the building footprint is founded on natural ground.

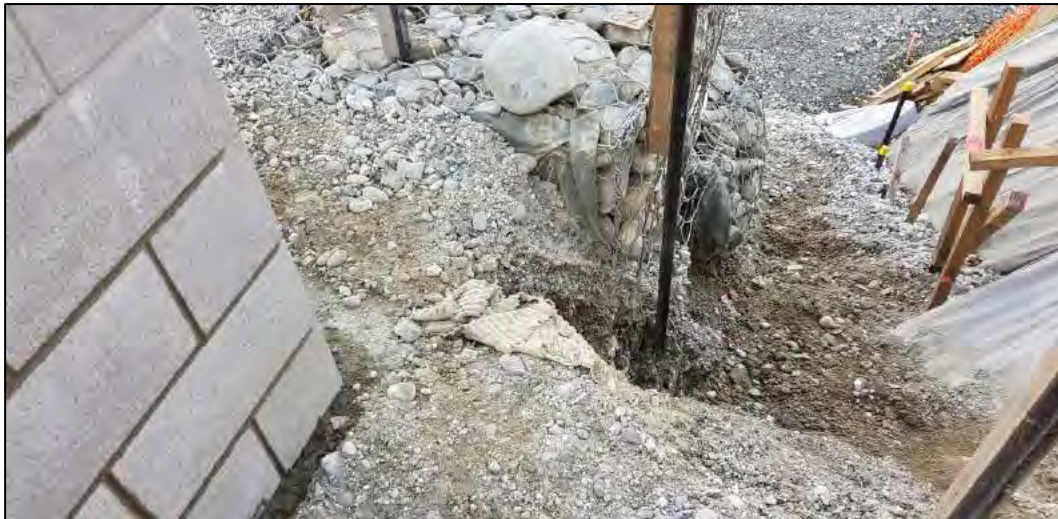
Photo 2: Looking at the southern corner of Unit 6 and the end of the gabion wall. The fill along the end had started eroding due to rainfall.

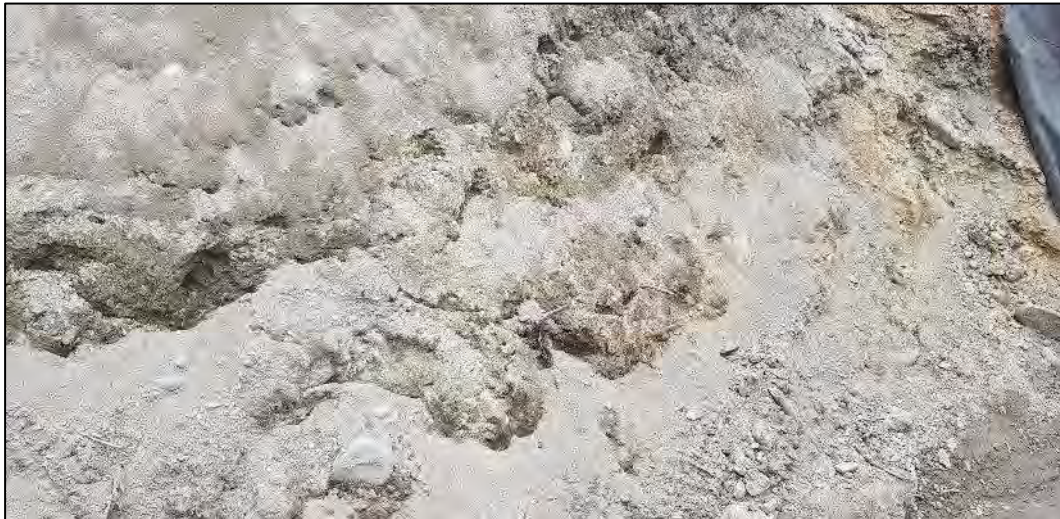
Photo 3: Tree roots were observed within the soil batter next to the lower pad.

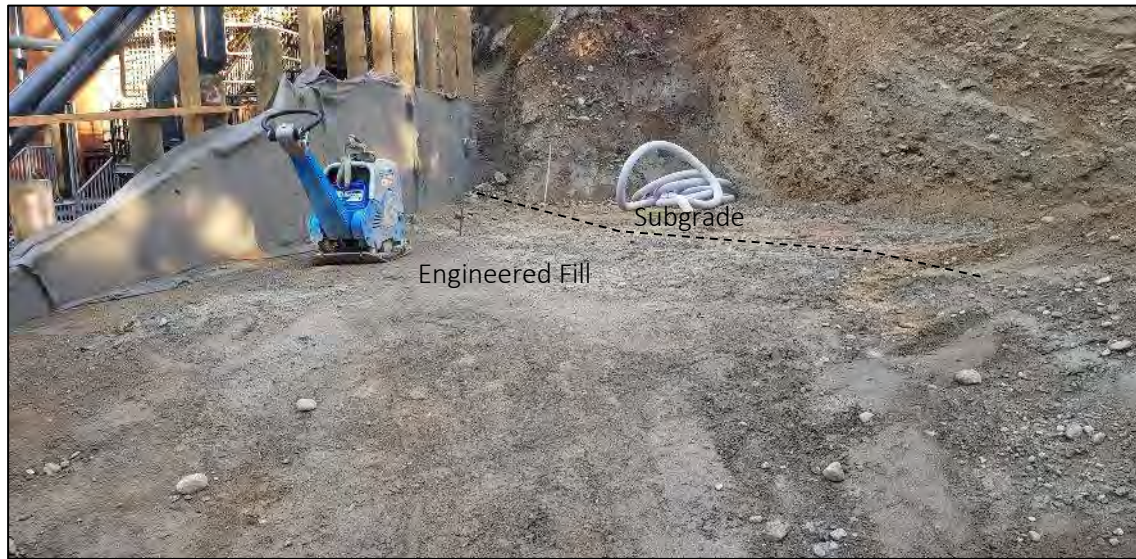
Photo 1: Looking north across the lower pad. 3.5 m of fill placed in total with natural subgrade exposed at the northern end.

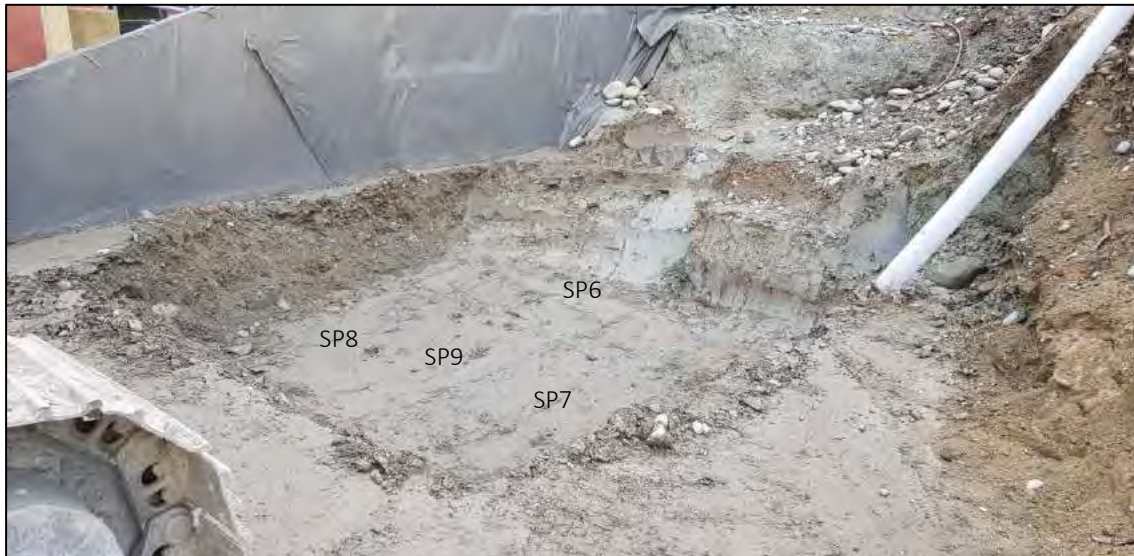
Photo 2: 600 mm of fill had been undercut.

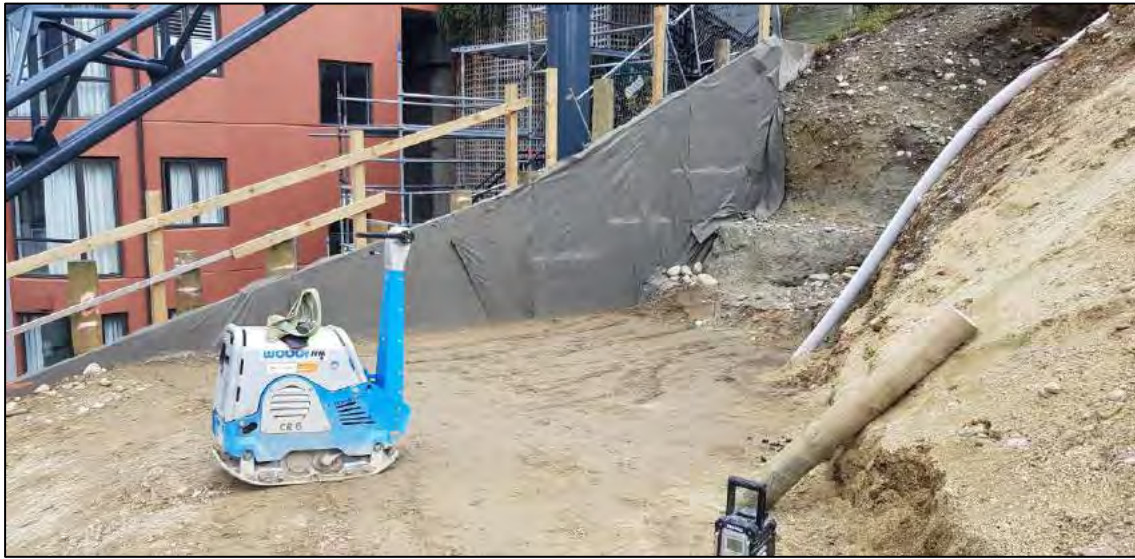
Photo 1: The northern portion of the fill did not achieve required compaction and had a high water content.

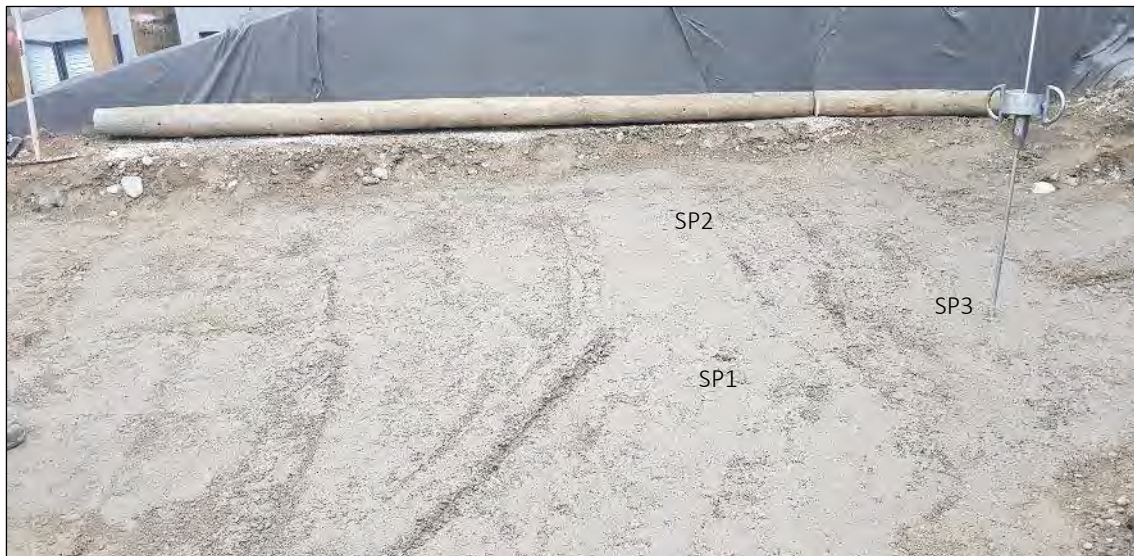
Photo 1: The moisture content of the fill had reduced over the weekend and the required compaction has met.

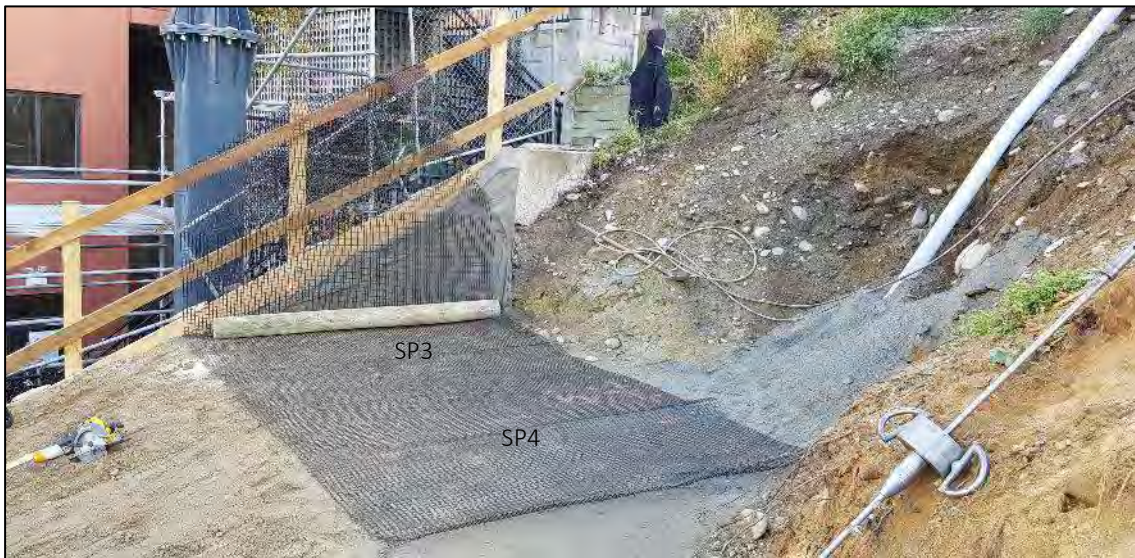
Photo 2: Fill testing following placement of additional 500 mm of fill. Test locations indicated on the photo.

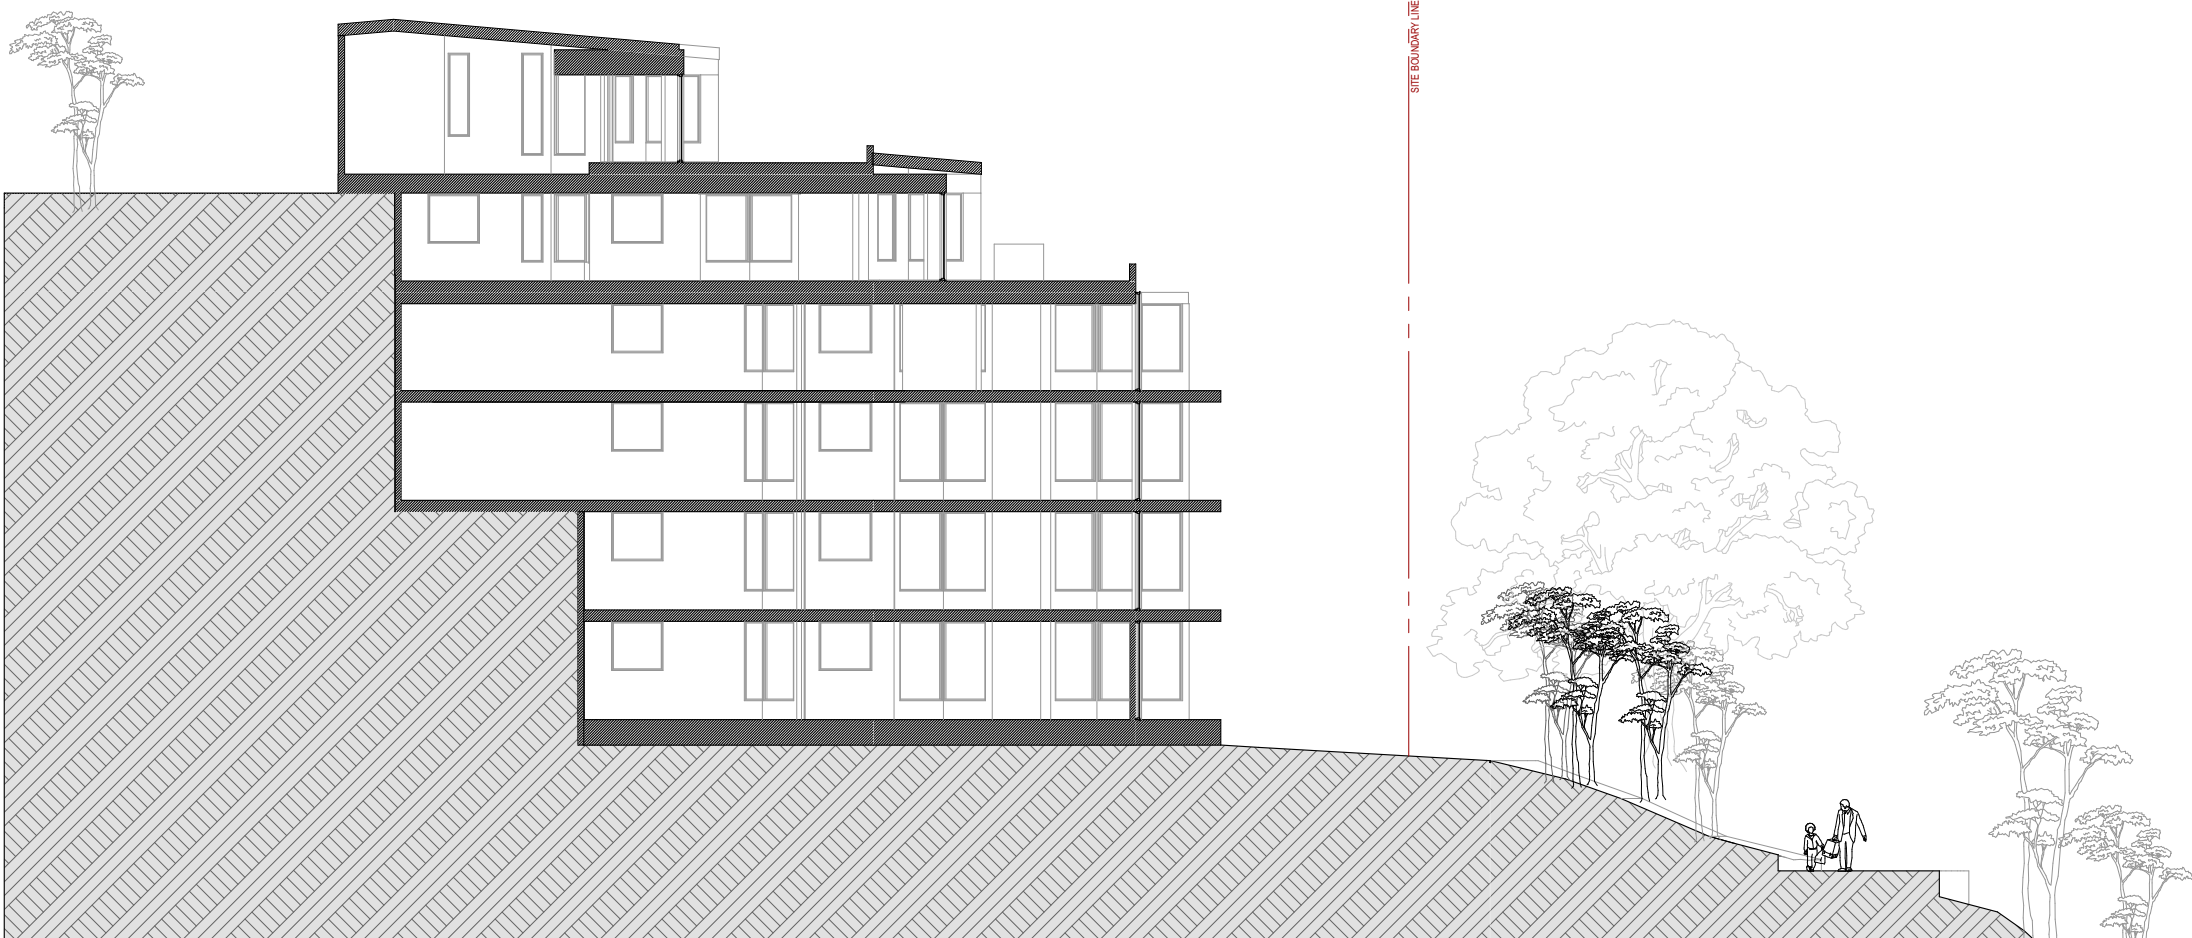
WEST SECTION OAKS AA-AA | SCALE 1:200

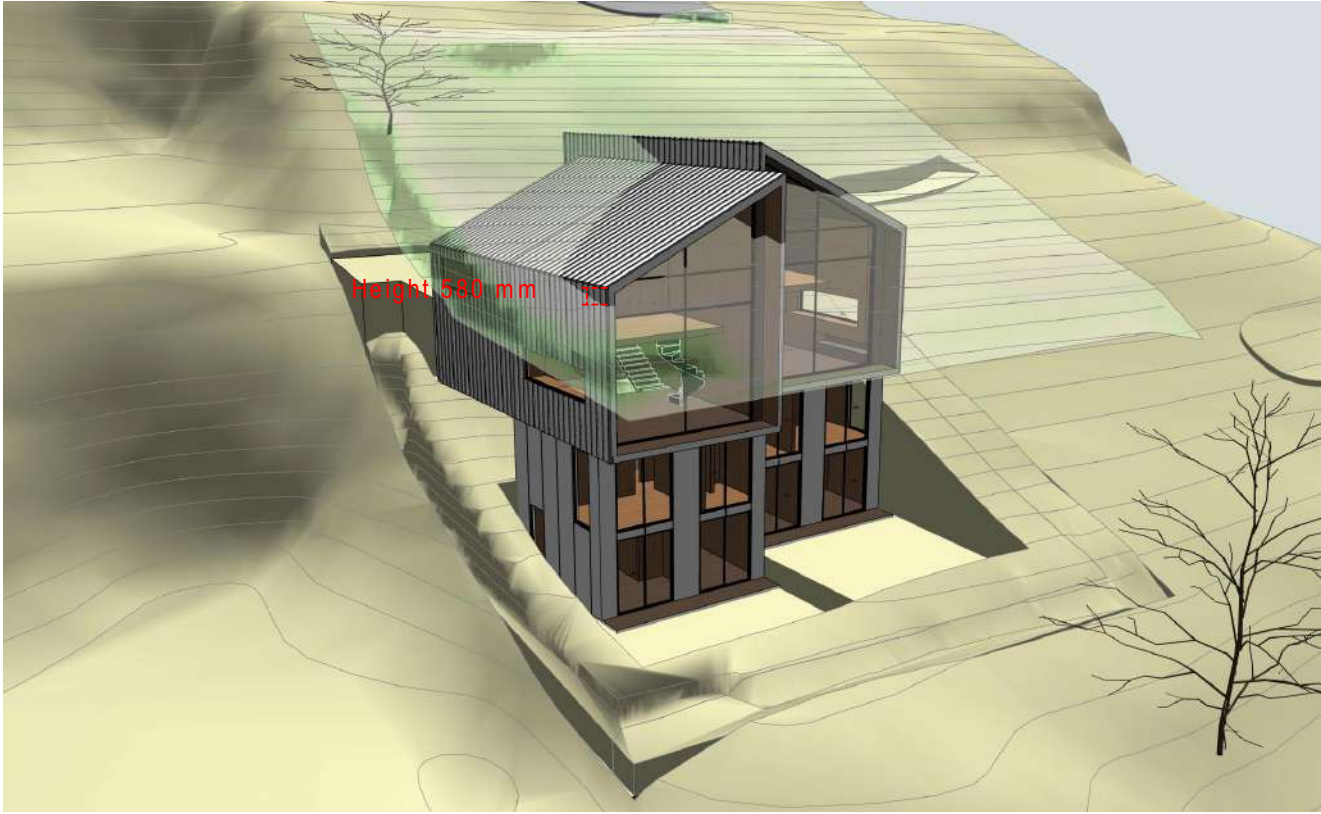
HEIGHT PLANE - 10m
CURRENT CONTOURS
