# Geotechnical Report for Plan Change

Corbridge Estate, Wanaka

**GeoSolve Ref: 250417**

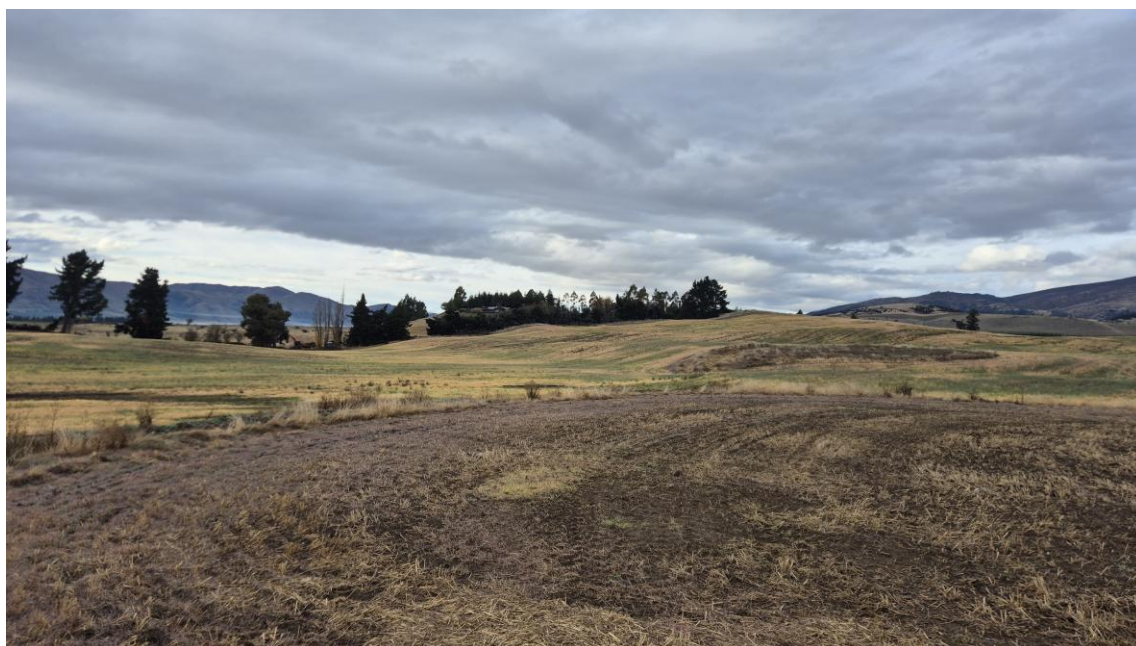
Photo 1.1 – Looking southeast over a section of the proposed plan change area.

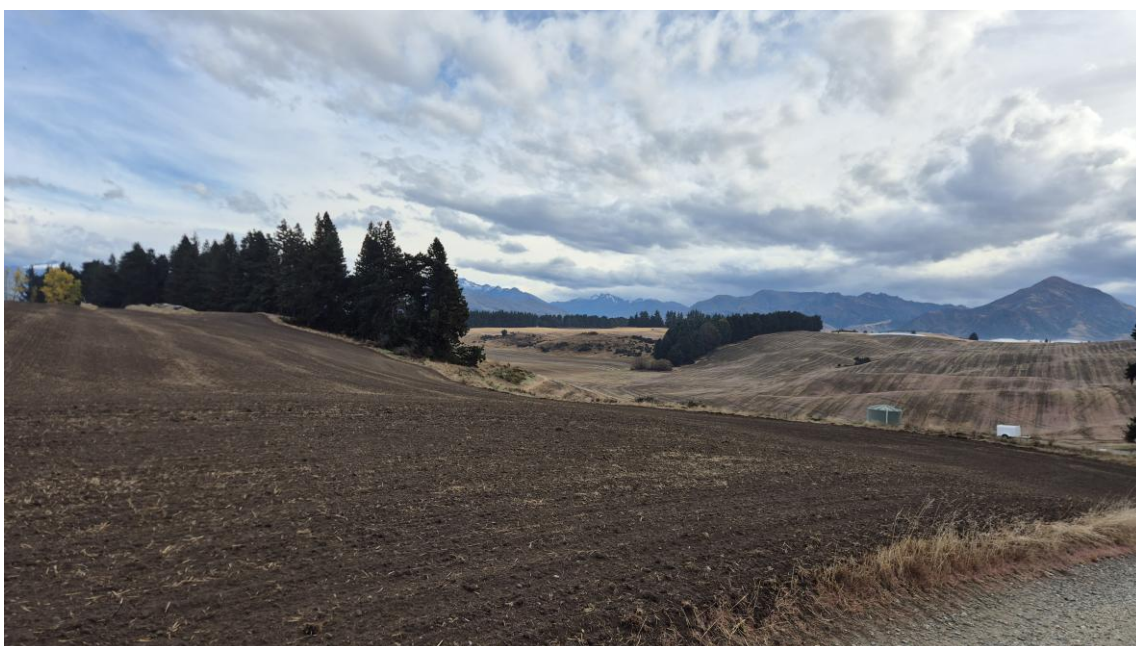
Photo 1.2 – Looking northwest over a section of the proposed plan change area.

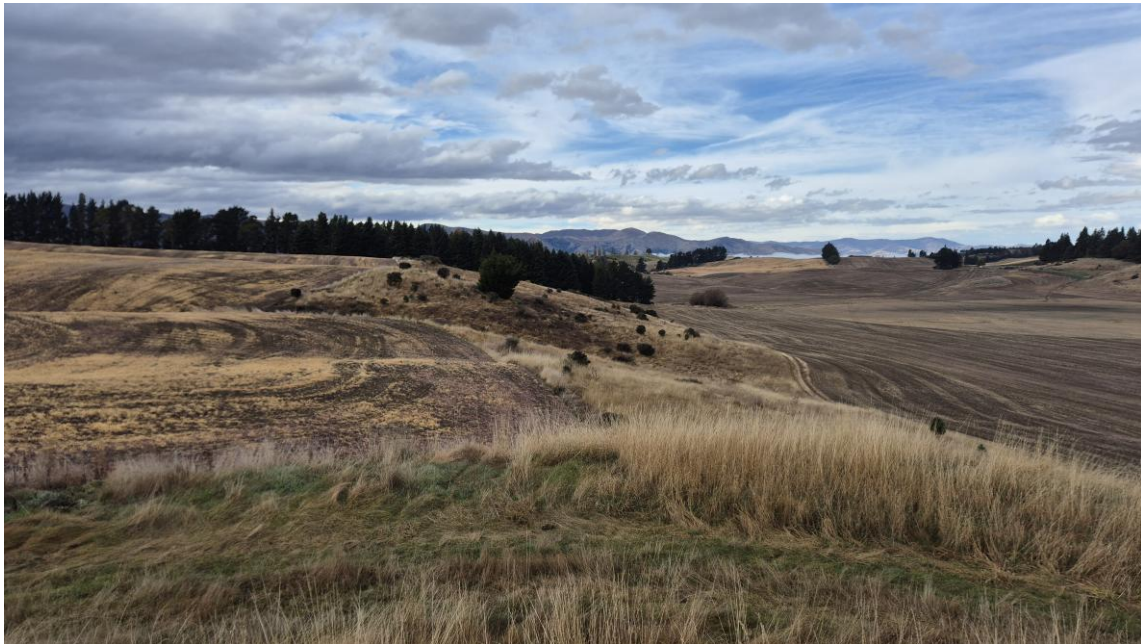
Photo 1.3 – Looking southeast over a section of the proposed plan change area.

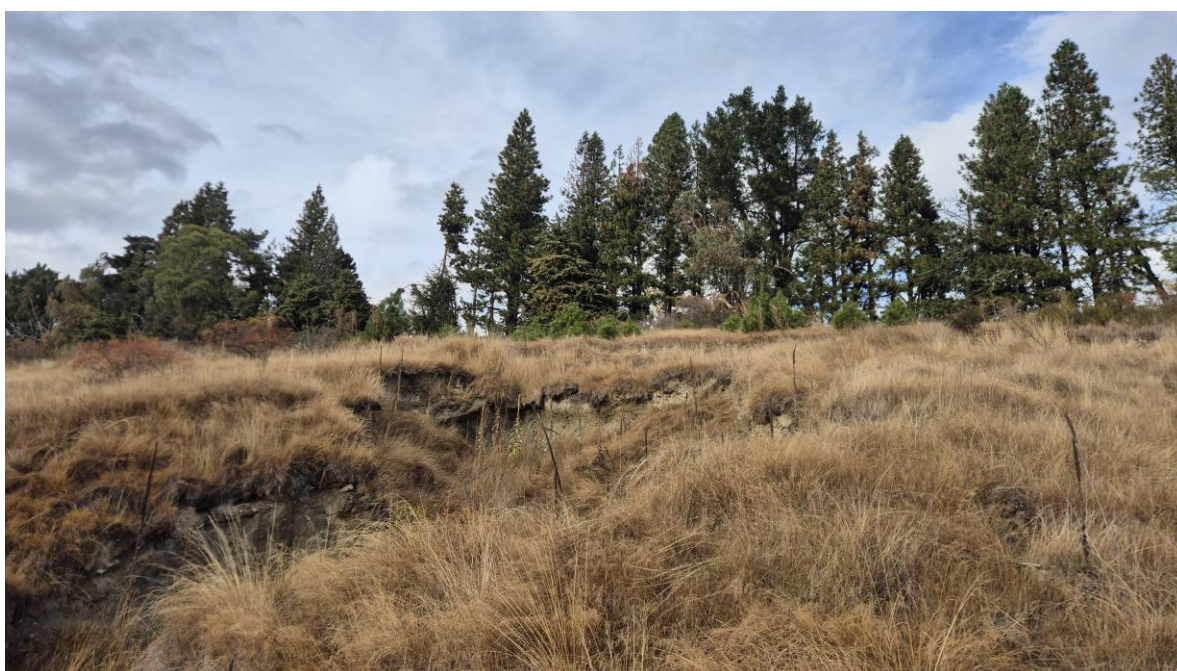
Photo 5.1 – Photo showing the erosion scouring below the water race on the southern side of the central depression.

Aside from the proposed works along the northern site boundary, several of the proposed residential lots and structures are on or adjacent to sloping ground. The locations are considered preliminarily acceptable; however, the slope stability will require assessment as part of the Resource Consent works. We consider that the extent and degree of any slope instability will be minor, such that they can be readily mitigated by standard planning and engineering measures. Erosion scouring was observed within the channel of the water race along the southern side of the central depression. In one location the water race had collapse causing considerable scouring of the slopes below. Armouring/lining of the water race channel is recommended where slope gradients exceed 4% in fine grained soils if the water race is to remain.

- No evidence of existing slope instability has been identified on site. However, evidence was observed on the slope crest and slope above the Clutha River/Mata-au during the site inspection. Minor scouring of the terrace slope on the alignment of the water race was also observed during a site walkover inspection.
