## Queenstown 16

# Queenstown 17

# Queenstown 18

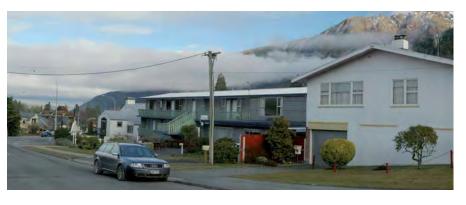
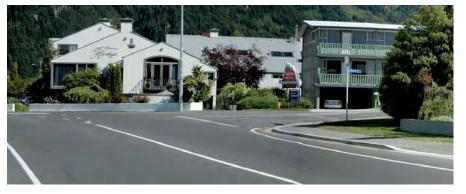
### **Representative Photos**

- A mix of detached buildings and multi-unit developments orientated to the formal grid on regular, moderately sized sites
- Buildings situated on gently undulating land with consistent road boundary setbacks and side boundary access
- Small tree and shub planting around large lawn areas or car parking with minimal boundary

- A strong contrast between some isolated single storey cottages and relatively small multiunit visitor accommodation with very few duplex residential units present
- There is a cluster of heritage buildings around St Joseph's church and school contrasted by several undeveloped sites at the opposite end of the unit along Frankton Road

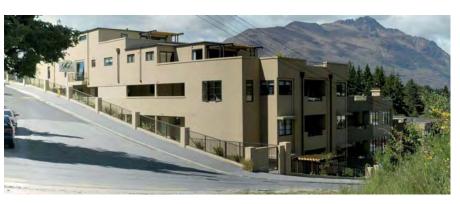
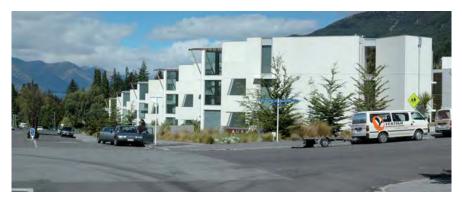
### **Representative Photos**

- Large multi-unit developments on large aggregated sites with short road setbacks, high site coverage and some external drop-off and rear surface car parking areas associated with access ways to basement parking
- Low shrub and ground cover vegetation with minimal tree planting
- Extensive ground modification with buildings sunken or stepped into embankment slopes or use of large retaining structures on hilly topography

- Several sites that are either vacant or with detached residential buildings are located centrally within the character unit
- Two large mature Sequoia trees are prominent in the unit and act to reduce the visual scale of development
