**BEFORE THE HEARINGS PANEL  
FOR THE PROPOSED QUEENSTOWN LAKES DISTRICT PLAN**

**STATEMENT OF EVIDENCE OF NICHOLAS KARL GEDDES  
ON BEHALF OF**

**Middleton Family Trust**

**Dated 2<sup>nd</sup> June 2017**

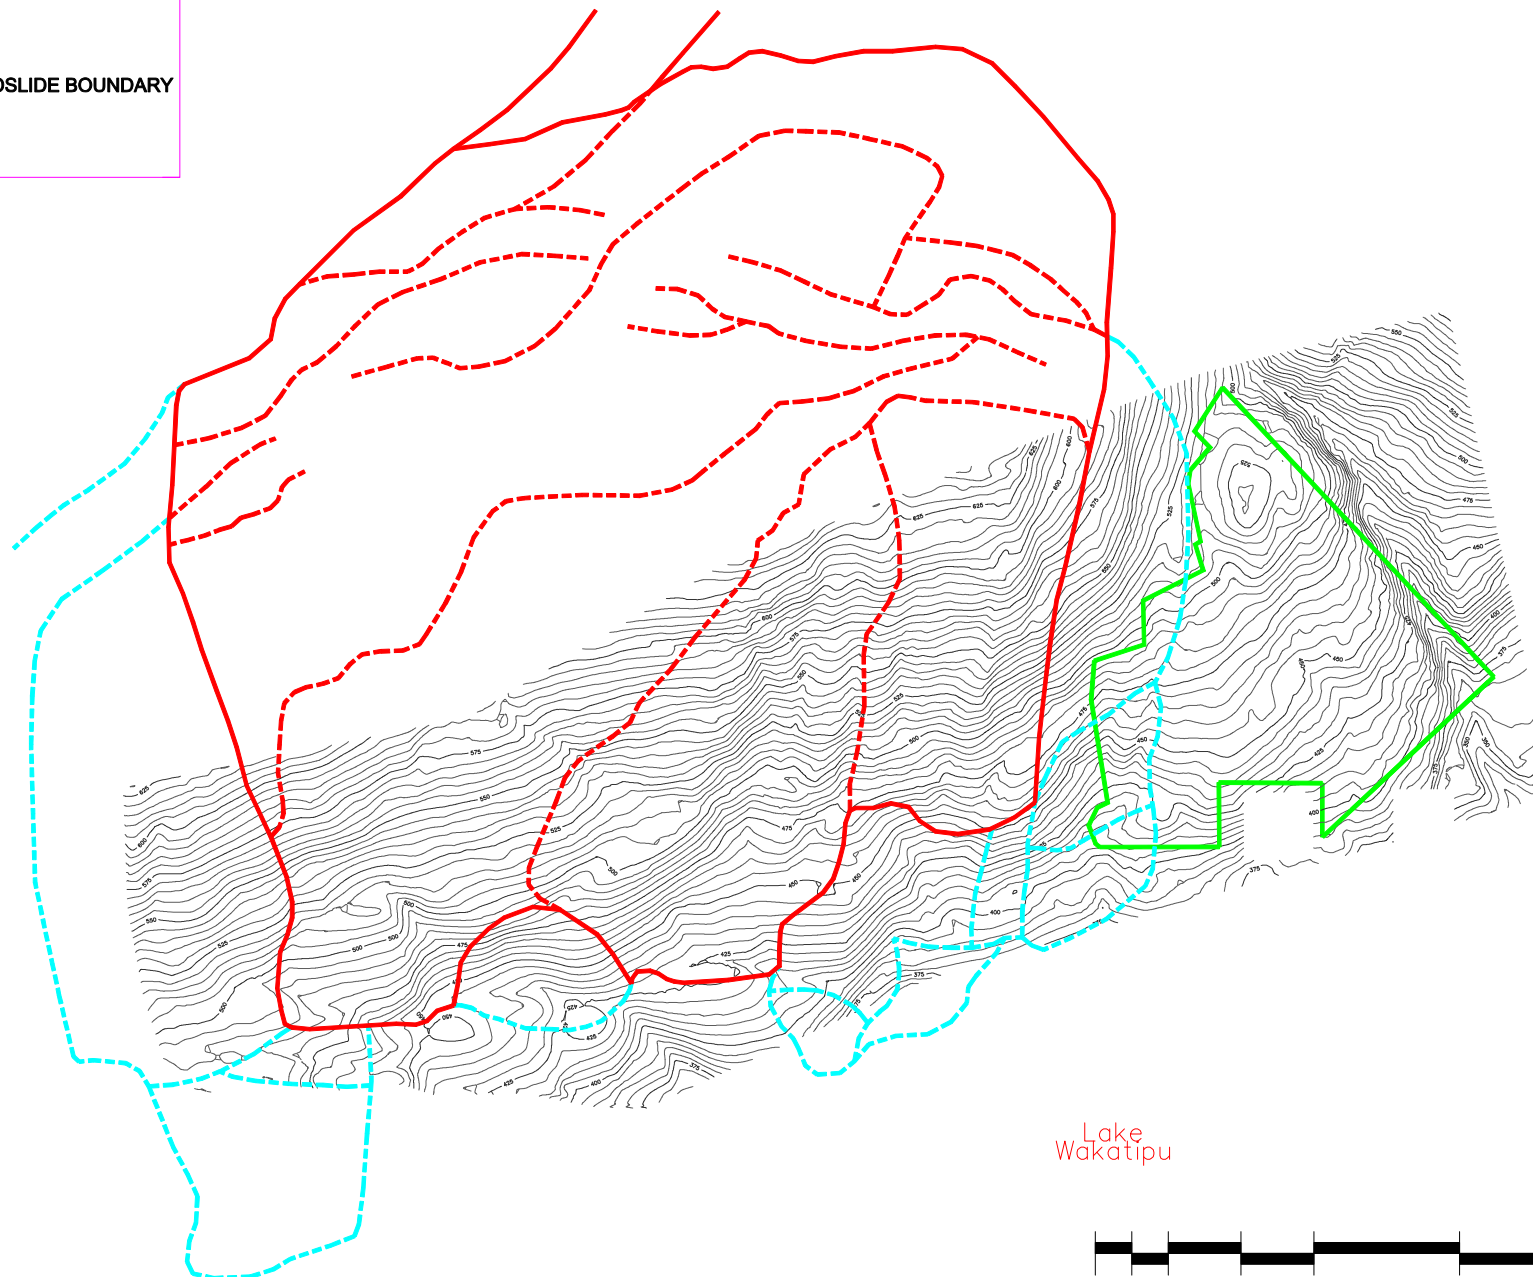
FIG. No. Fig. 1e

Historic aerial photographs (about 1950) and field mapping show the Queenstown Hill Landslide immediately to the west of the proposed subdivision. The Queenstown Hill Landslide is well documented and is recorded on the QLDC Hazard Register. Historical aerial photography provides an image of the hillside prior to the growth of the dense vegetation cover which currently covers the landslide. A historical aerial photograph of the site is provided as Figure 1e in Appendix A.
