# Geotechnical Report for Private Plan Change

8 Brodie Avenue, Arrowtown

**GeoSolve Ref: 170605.02**

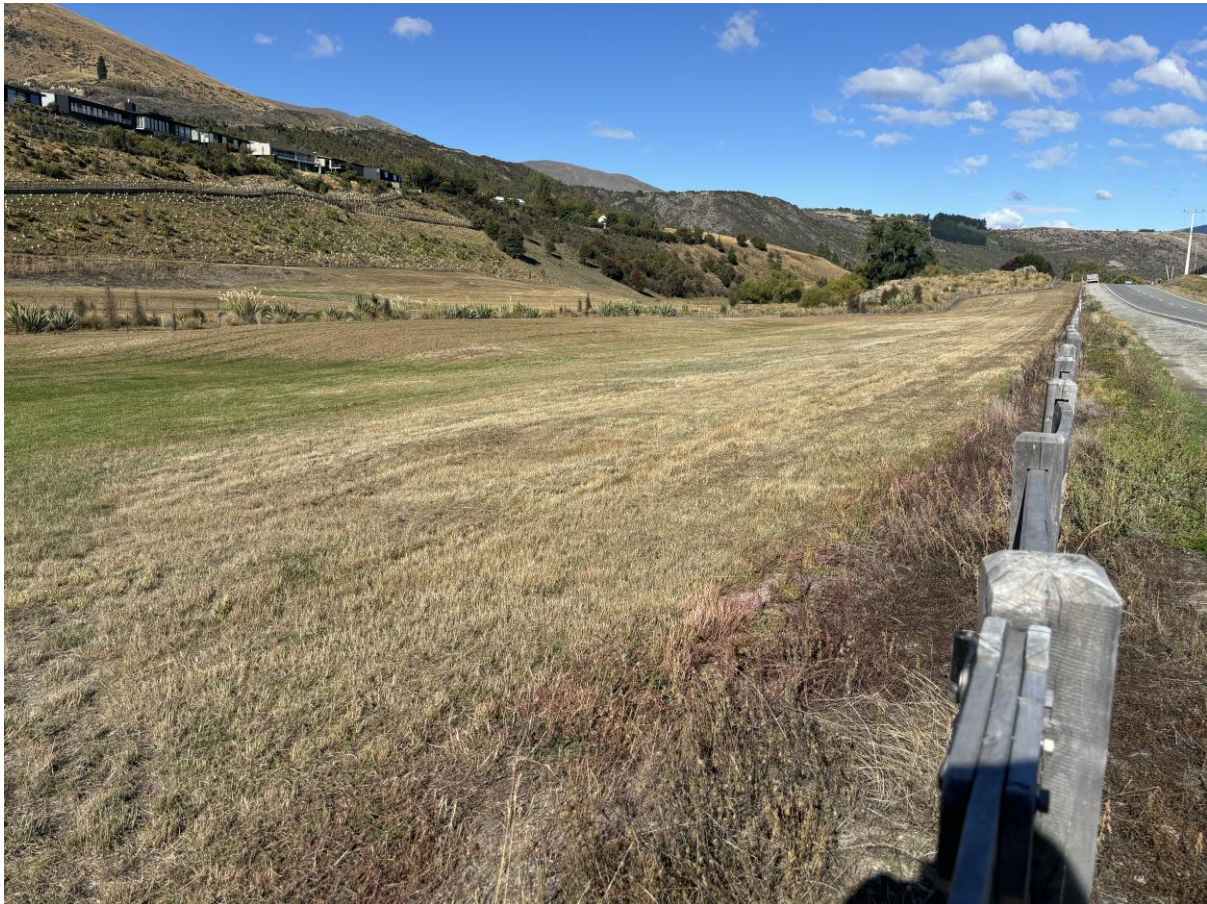
**Photo 1.1 – Looking southeast across the land subject to private plan change.**

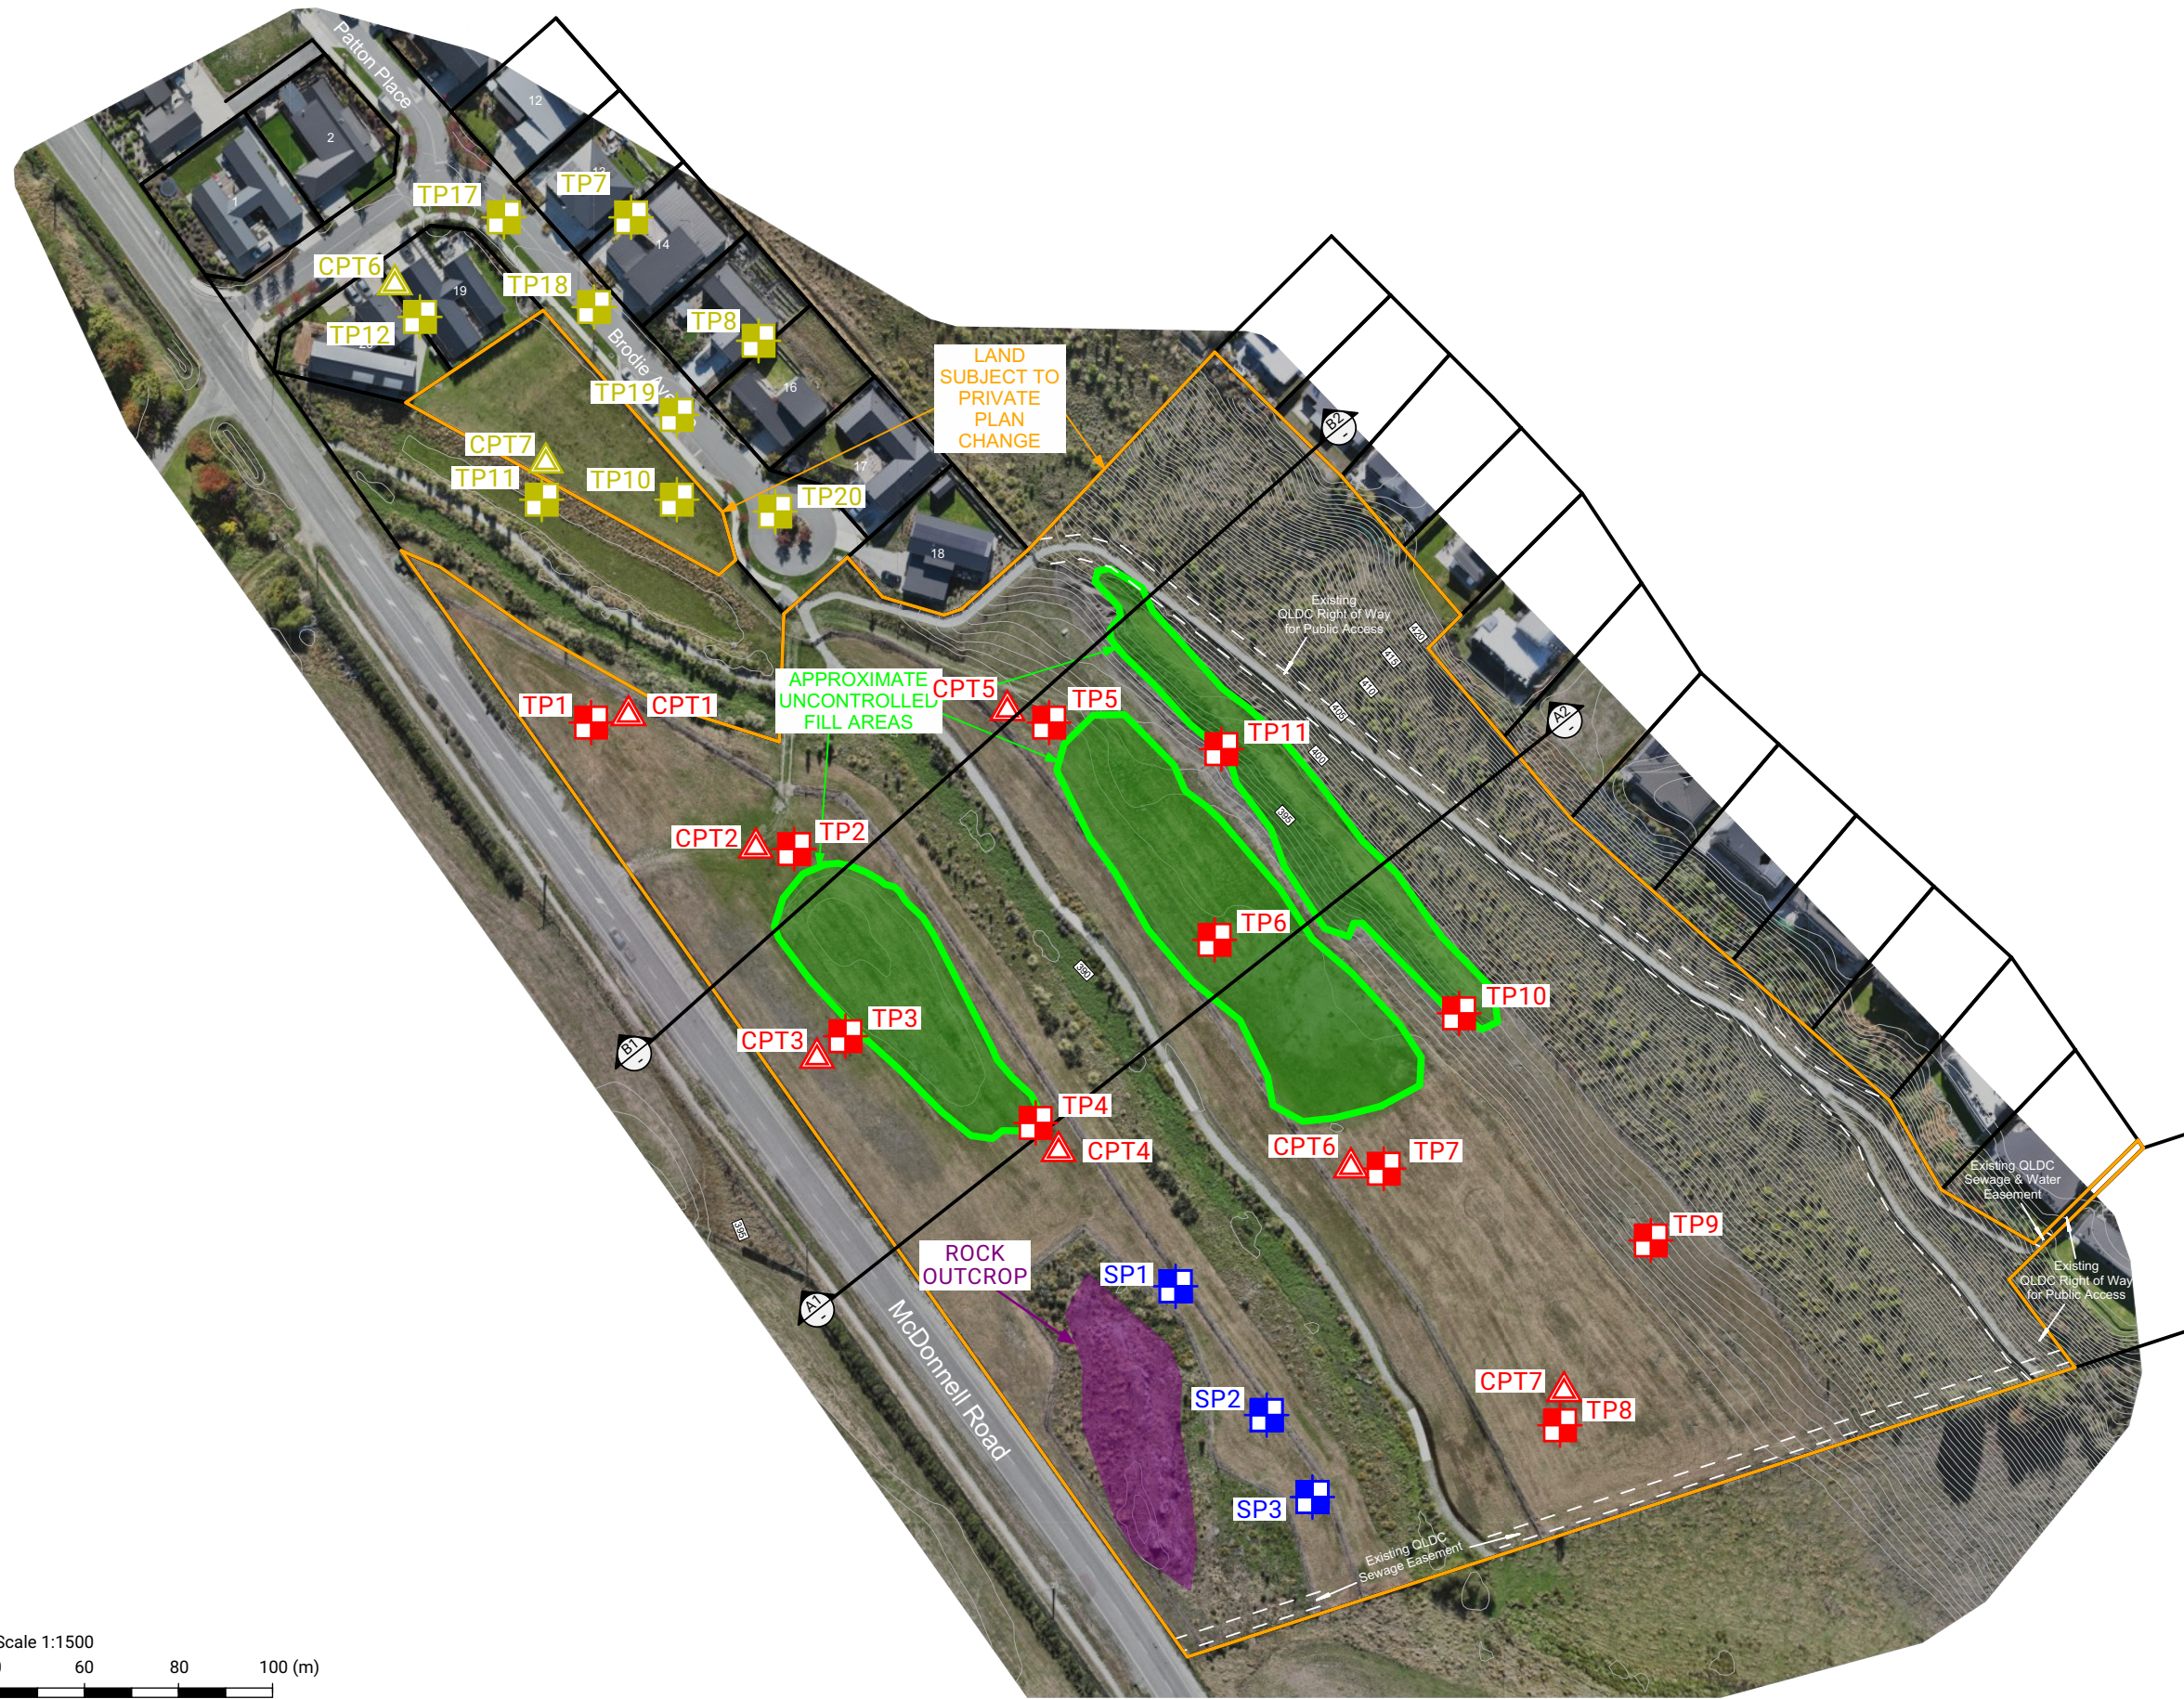
FIG No:  
APPENDIX A, FIGURE 1

| Key | | | |
| = Cone Penetrometer Test | = Test Pit | = Approximate area of Uncontrolled fill | |

Figure 1, Appendix A illustrates the land subject to private plan change and Figures 2a and 2b, Appendix A illustrates a cross-section ground model.

Previously placed uncontrolled fill is located across the proposed private plan change area. The approximate extent of the fill areas is shown in Appendix A, Figure 1.

Test pit and CPT locations and logs are contained in Appendix A and B respectively.

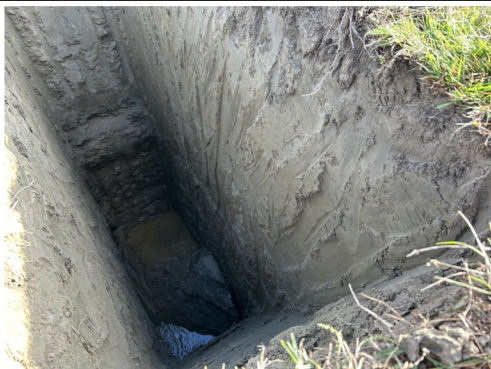
The test pit walls collapsed below the groundwater table

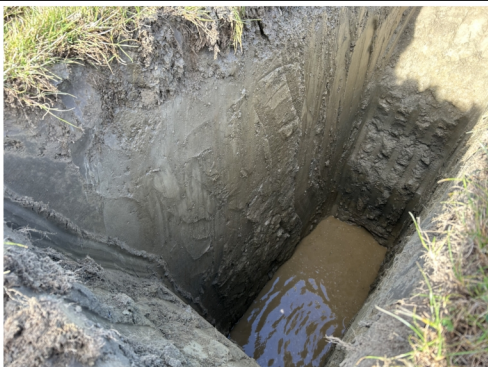
The test pit walls collapsed below the groundwater table

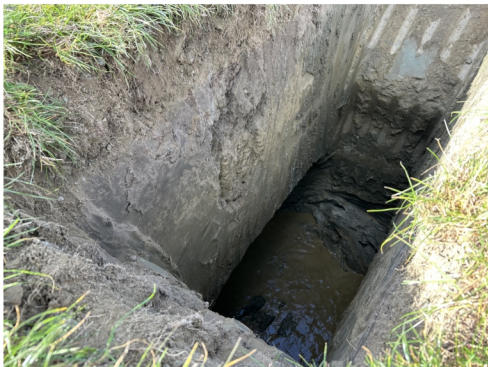
The test pit walls collapsed below the groundwater table

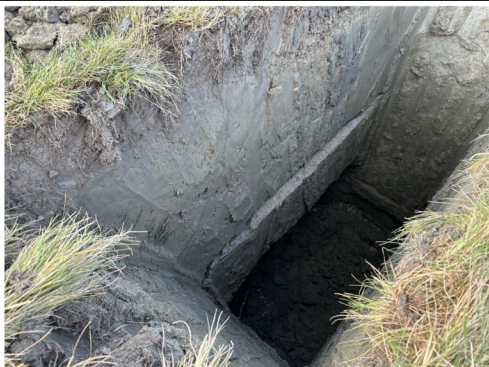
The test pit walls collapsed below the groundwater table

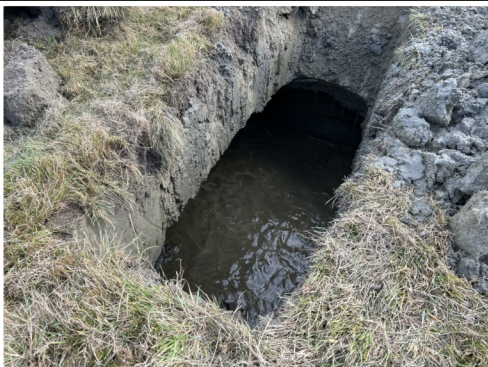
The test pit walls collapsed below the groundwater table

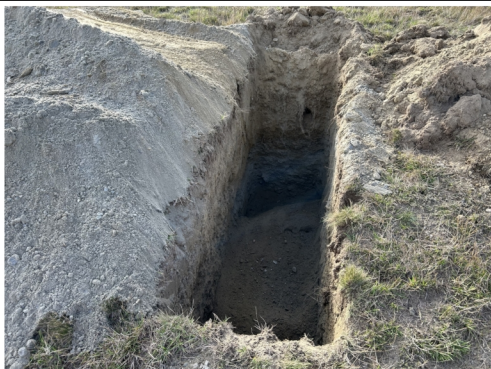
No groundwater observed.

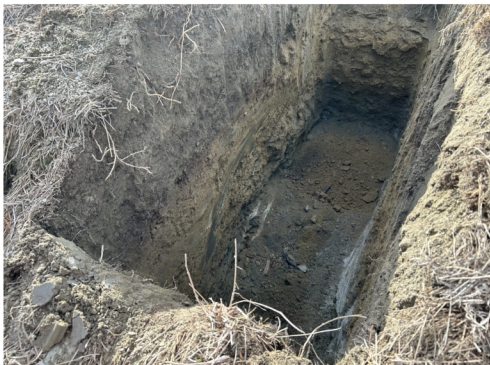
No groundwater observed.
