Title: **Slope Stability Annual Individual Life Risk Contours**
 Brewery Creek Fan Residential Zone

Client: Queenstown Lakes District Council
 Project: Natural Hazards Affecting Gorge Road

Discipline: GIS
 Drawing No: 3209881-J013

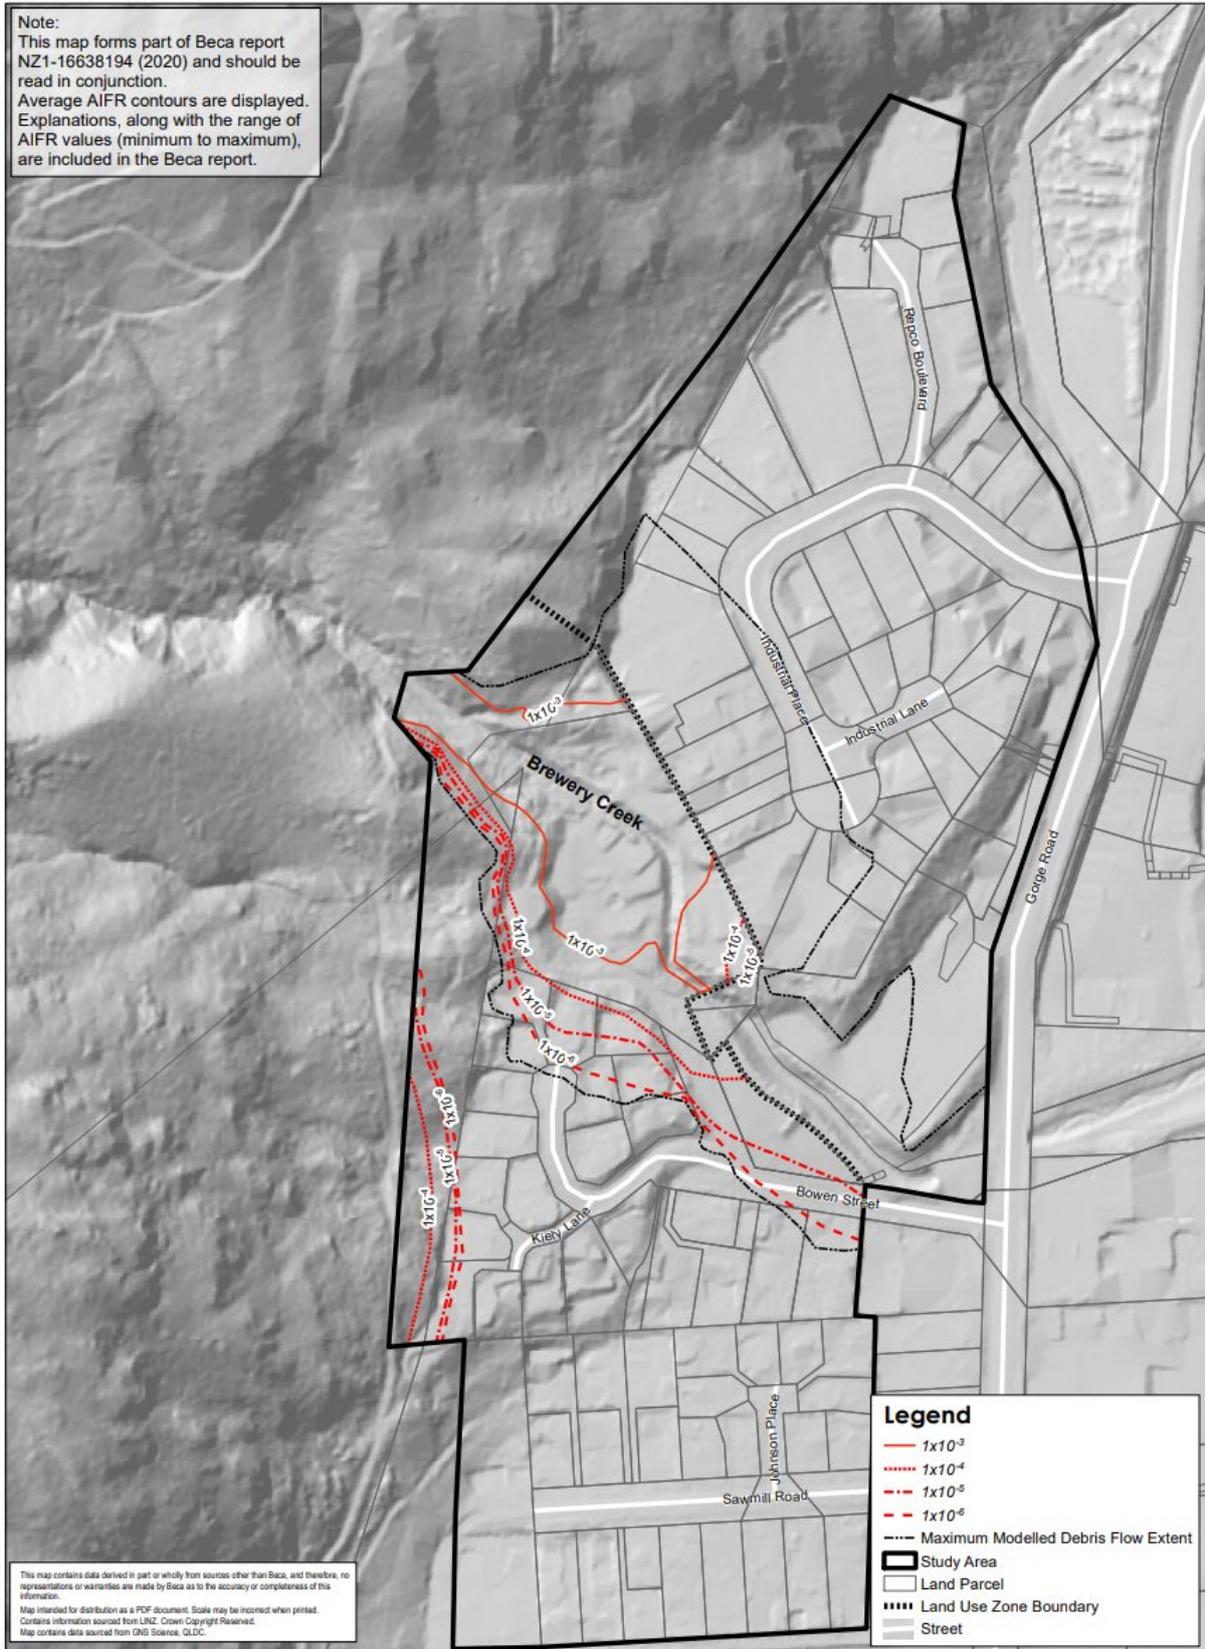
Note:
 This map forms part of Beca report NZ1-16638194 (2020) and should be read in conjunction.
 Average AIFR contours are displayed. Explanations, along with the range of AIFR values (minimum to maximum), are included in the Beca report.

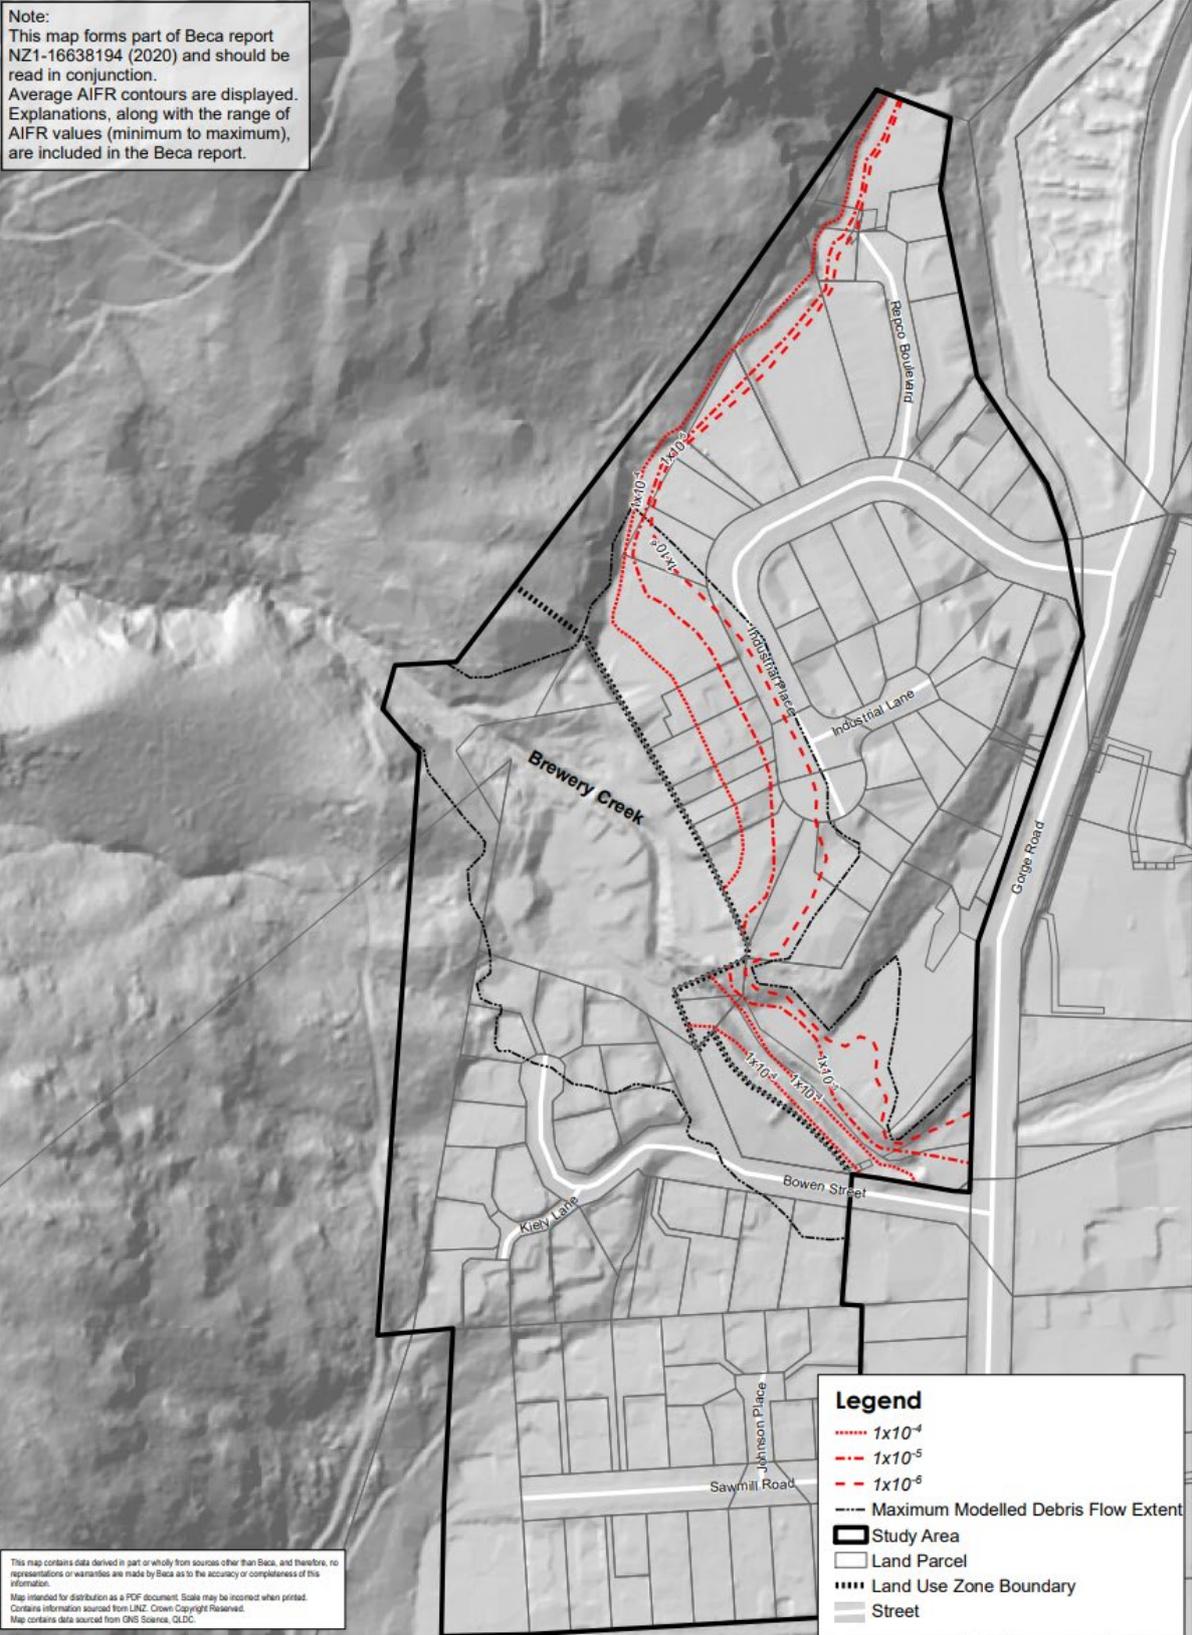
Discipline: GIS
Drawing No: 3209881-J014

Note:
 This map forms part of Beca report NZ1-16638194 (2020) and should be read in conjunction.
 Average AIFR contours are displayed.
 Explanations, along with the range of AIFR values (minimum to maximum), are included in the Beca report.

Title: **Slope Stability Annual Individual Life Risk Contours**
 Brewery Creek Fan Business Zone

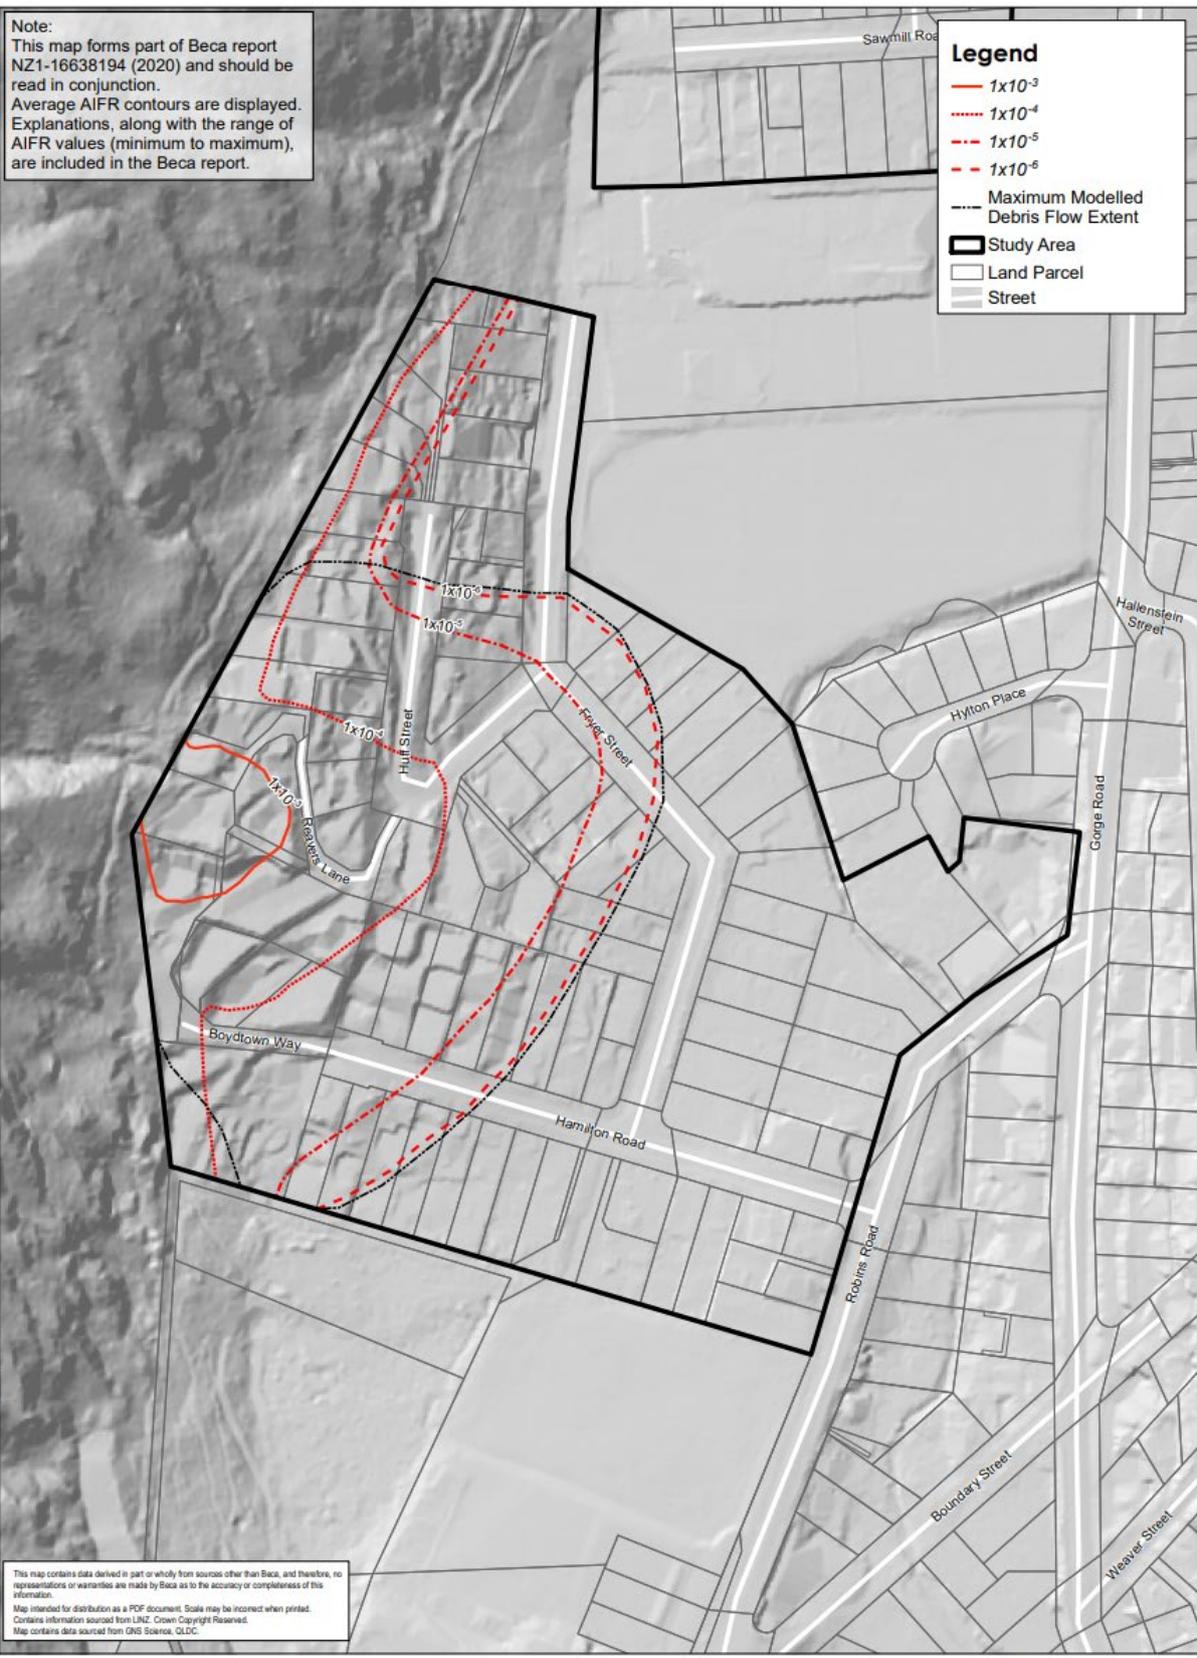
Discipline: GIS
Drawing No: 3209881-J015

Note:
 This map forms part of Beca report NZ1-16638194 (2020) and should be read in conjunction.
 Average AIFR contours are displayed.
 Explanations, along with the range of AIFR values (minimum to maximum), are included in the Beca report.

Title: **Slope Stability Annual Individual Life Risk Contours**
 Reavers Fan
