Cottage and Curtilage

Site F41/611

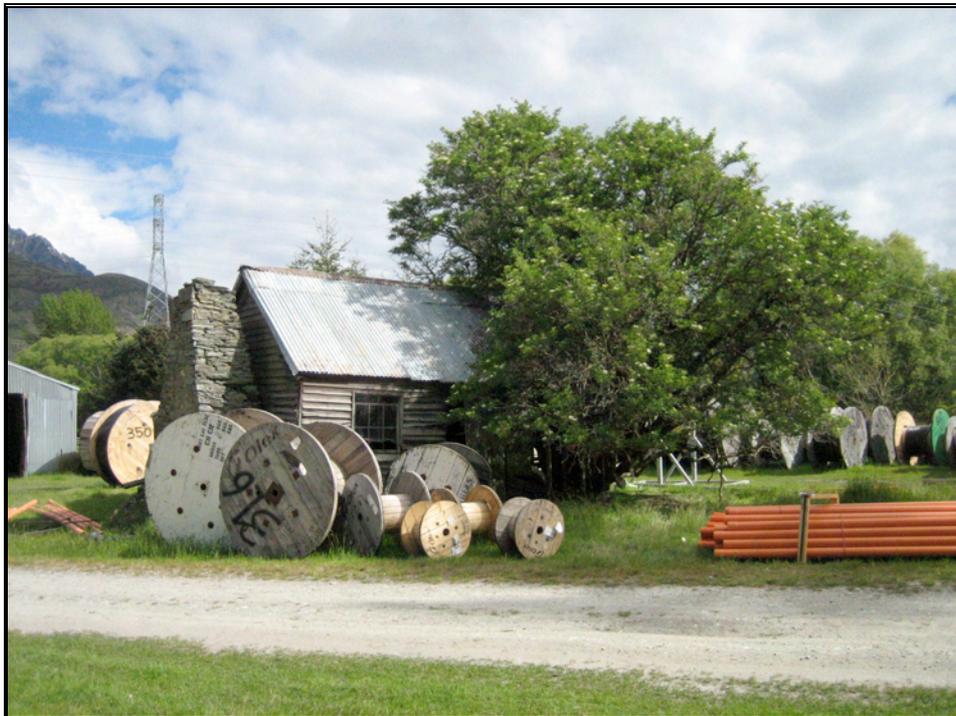
Figure 7

The cottage is a small weatherboard single-storey building with a large stone chimney. The roof is corrugated iron, beneath which are the original timber shingles. One original window is in the front wall, but the other window and the original front door are missing. At the rear is a more recent land-to addition, which is in poor condition. The original floor has been replaced with a poured concrete floor. The construction details of the cottage are discussed further below.

The small cottage, front view, showing the remaining original window.

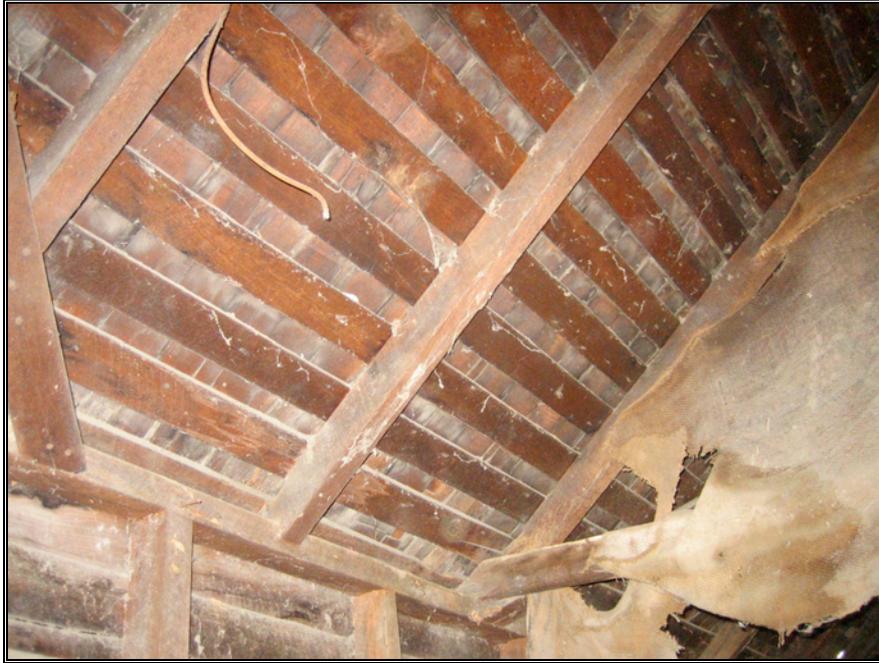
Figure 8

The roof of the cottage is corrugated iron, but beneath this the original timber shingles are still in place (Figure 8). Shingles, while easy to make and transport, were relatively expensive, labour-intensive, short-lived and potentially leaky (Thomson 2005: 36). Corrugated iron, on the other hand, was relatively light, long-lasting and waterproof. It also had the distinct advantage of integral structural strength (Thomson 2005), something seen in this cottage, where the building would probably have collapsed if the roof had only been shingles.

Interior view of the cottage, showing the wall and roof framing, and the timber shingles still intact beneath the roofing iron.

The wall framing is constructed using mortice and tenon joints between the studs and the top and bottom plates. Salmond (1986: 113) stated that mortice and tenon joints in wall framing ceased to be used from about 1890, while Arden & Bowman (2004: 38) suggest a pre-1910 date for this feature. The framing itself is light, with only a limited number of diagonal braces. The existing front door is not original, and examination of the top plate shows that the original doorway has been widened by the removal of one side of the frame, and the insertion of a new stud.

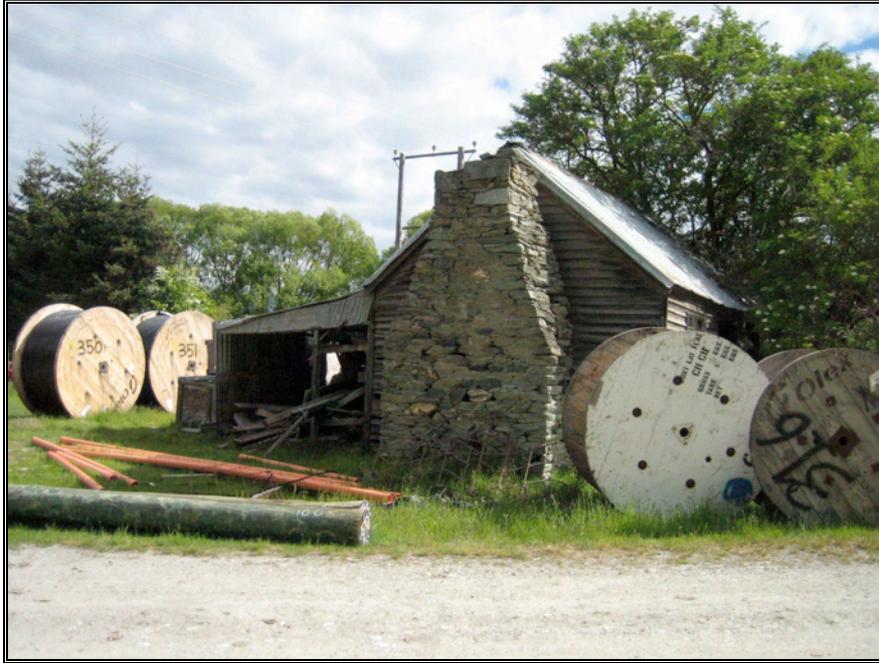
The chimney is a large stone structure, largely built from schist, but with some water-worn cobbles also included. There are some cracks in the stonework, and the top courses are missing, but overall it appears to be in reasonably good condition. It is of substantial construction, and is matched by a large internal fireplace. This fireplace may have held a coal range, but determination of this will require a more detailed examination.

Figure 9
End view of the cottage, showing the large stone chimney.

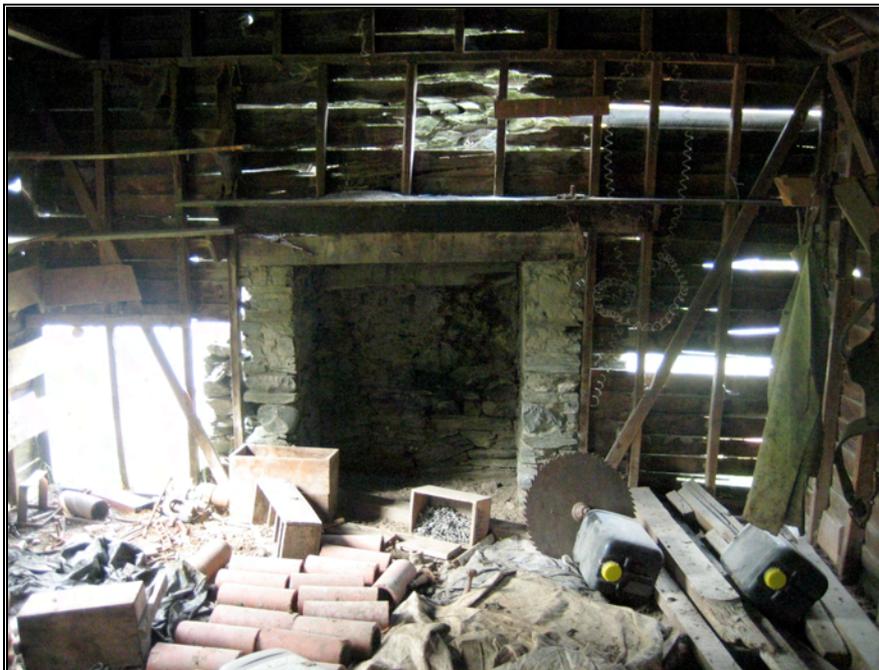
Figure 10
The interior of the cottage, showing the large fireplace.

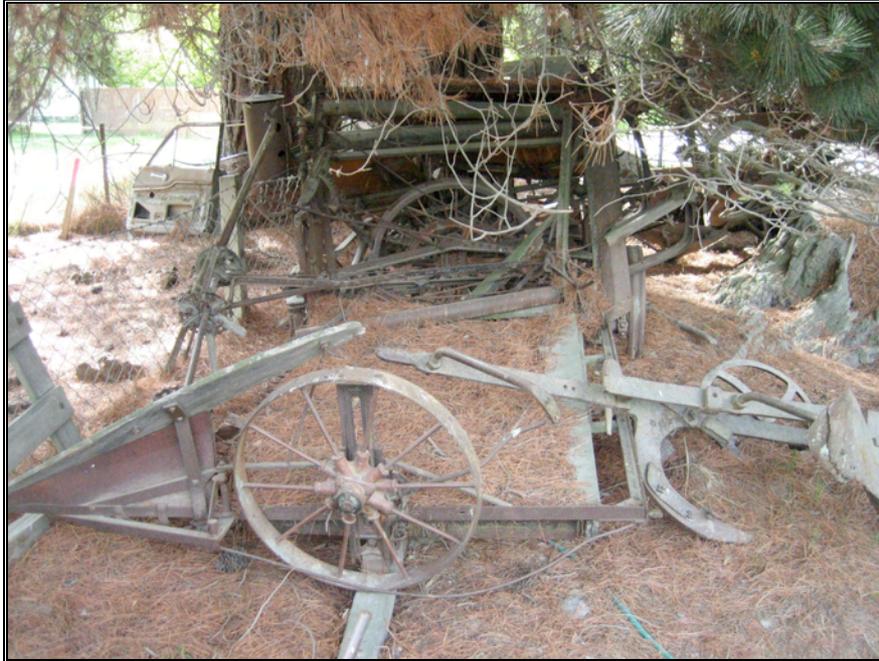
Figure 11

The cottage is associated with several other farm buildings and a number of mature exotic trees. The other buildings are utilitarian in design, and of twentieth century construction. The age of the trees was not estimated,³ but beneath one pine tree at the entrance to the property is an old reaper-binder and other farm equipment (Figure 11). The significance of this is discussed below.

The reaper-binder sitting underneath a pine tree beside the entrance to the property.
