**Central Otago Queenstown Trail Network Trust: Kawarau Gorge**

The following comments relate to our joint field trip to various places along the proposed Kawarau Gorge Trail undertaken on 20 June 2019. The purpose of the field trip was to inspect critical trail sections requiring geotechnical assessment as identified in emails dated 14 & 15/05/19.

# Archaeological Assessment for the Kawarau Gorge Cycle Trail

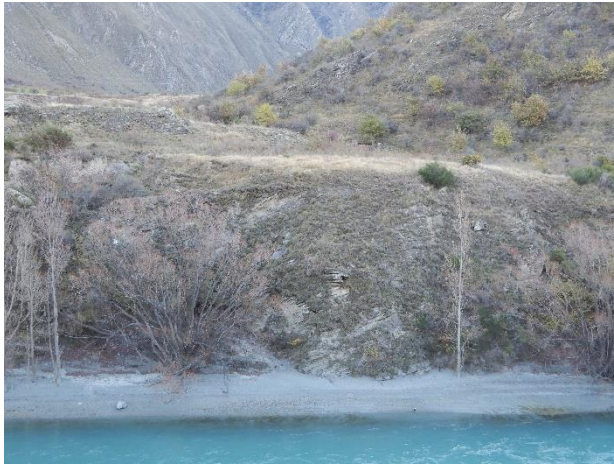
*Photo 1: True right abutment, Wentworth Station bridge.*

1. Wentworth Station bridge (Distance station not established): The bridge (approximately 100 m) extends from edge of terrace to edge of terrace (Photos 1 & 2). The terraces are underlain by alluvial gravels although *in situ* schist

underlies gravel at shallow depth (around 3 m) on the true left side. No evidence was found for slope instability or active erosion.

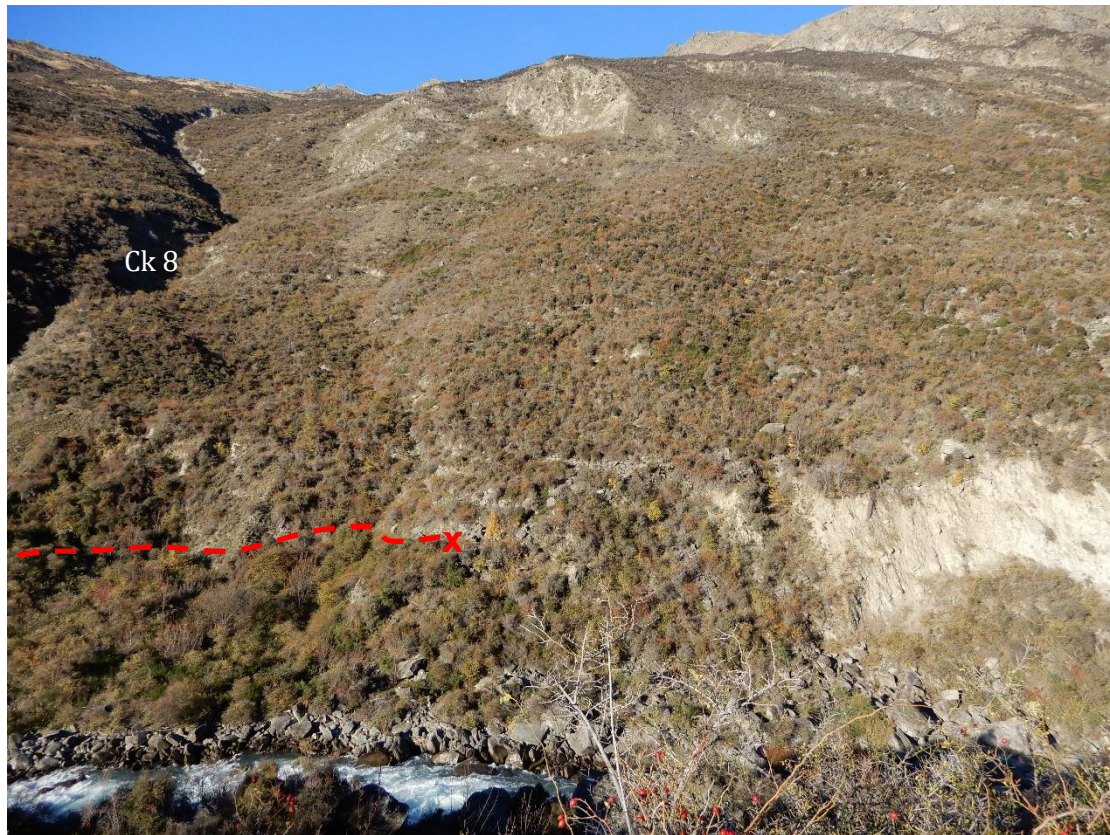
the bridge abutment (true right side) and Creek 8, a major gully about 130 m downstream from the true left abutment (Photo 3). Boulders have accumulated in the back-tilted steps formed beneath these incipient scarps.

*Photo 3: Section of trail between proposed Citroen Rapid Bridge true right abutment (red cross) and Creek 8. Note active scarps just below skyline and upstream of site and also incipient scarps just above abutment.*

Construction through this section will be challenging due to the very loose and unstable nature of the terrain and will be the subject of more detailed investigations in collaboration with the bridge designers.

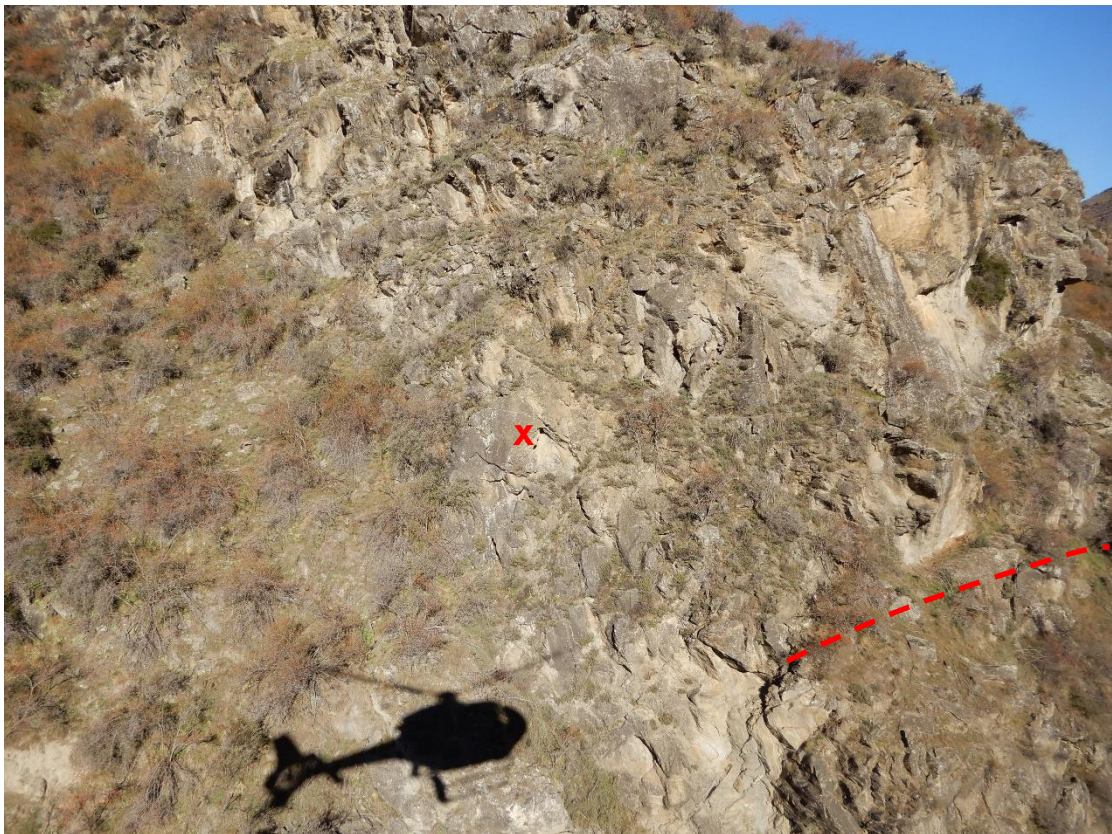
6. Skull Bluff, 4.0 km: The trail traverses a broad rock spur with the downstream side requiring either a fill slope or some form of structure (Photo 6). Scaling will be required on the rock slopes above the trail including a loose slab marked with an X on Photo 6.

*Photo 6: Skull Bluff showing steep rocky slopes and loose slab marked with red cross.*

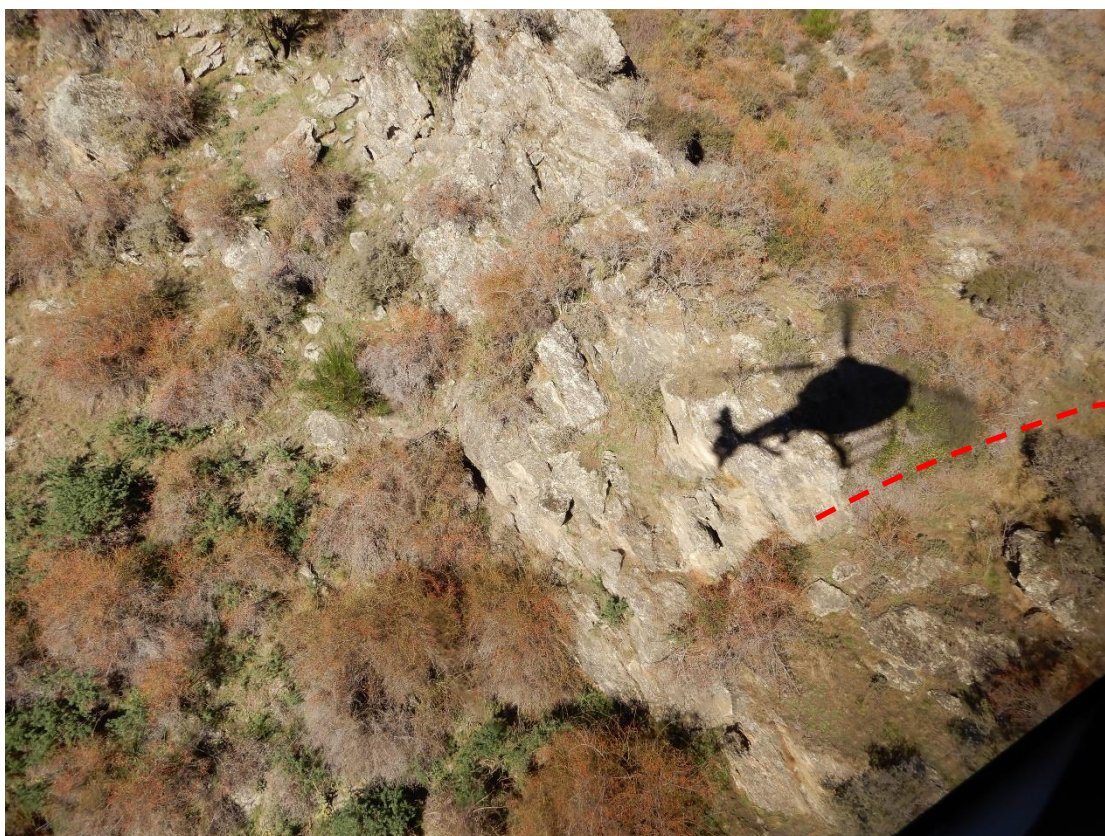
*Photo 7: The Notch with steep rocky slopes on downstream side.*

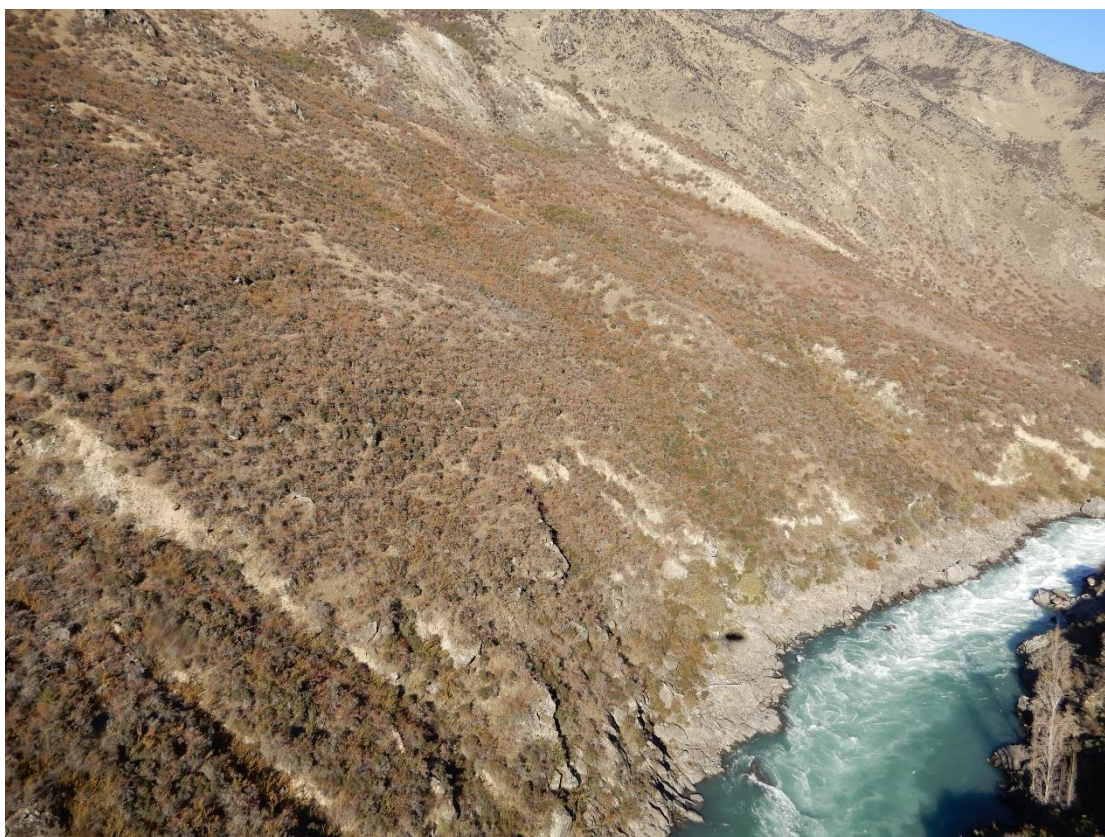
*Photo 8: Lower slopes of unnamed landslide showing active lobes.*

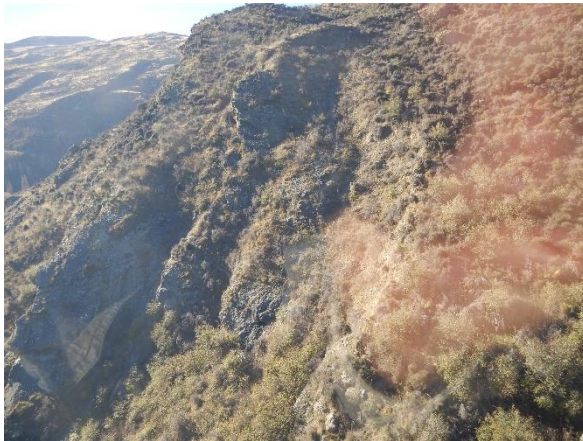
9. Chalmers Leap, 7.4-7.8 km: This section involves traversing round a series of rocky slabs dipping steeply upstream and only viewed during fly-past. The exact route hasn't been able to be verified from photographic inspection but views of upstream (Photo 9) and downstream (Photo 10) give some indication of the terrain to be covered. A bench cut into the rock slabs is considered the most secure way of establishing a track through here. The steepness of the slabs would not be amenable to fill construction.

*Photo 9: Upstream portion of Chalmer's Leap*

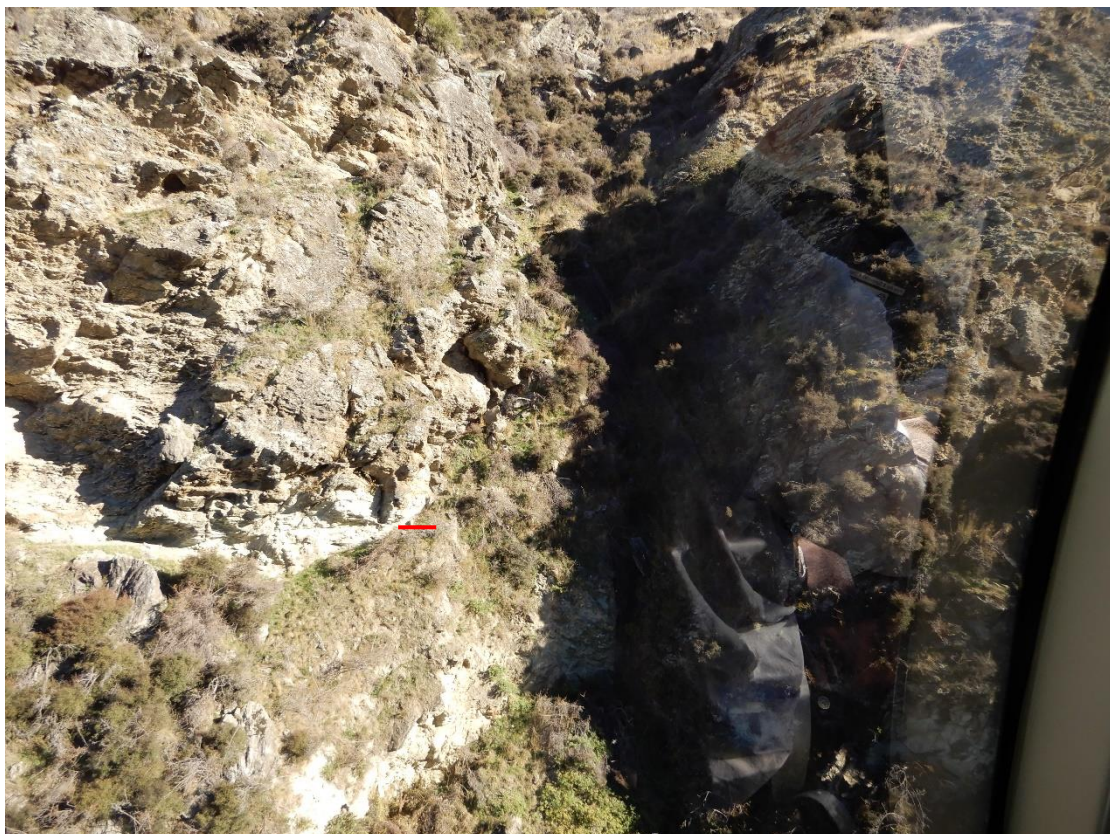
Passing Lane Bluff, 9.3 km: This section only observed during fly-past. The route traverses a narrow gully flanked by rock bluffs (Photo 11). It is uncertain what the method of trail construction is preferred here (structure or cut and fill) but either method would need to safeguard against flash floods and debris flows concentrated in the gully. Bridging would be the preferred solution as it can provide a greater clearance above flood flows. There is also a potential for rock falls on either side of the gully and this threat would need to be mitigated prior to trail construction.

*Photo 11: Gully at Passing Lane Bluff. Red mark approximately where track is believed to be (pink marking tape).*

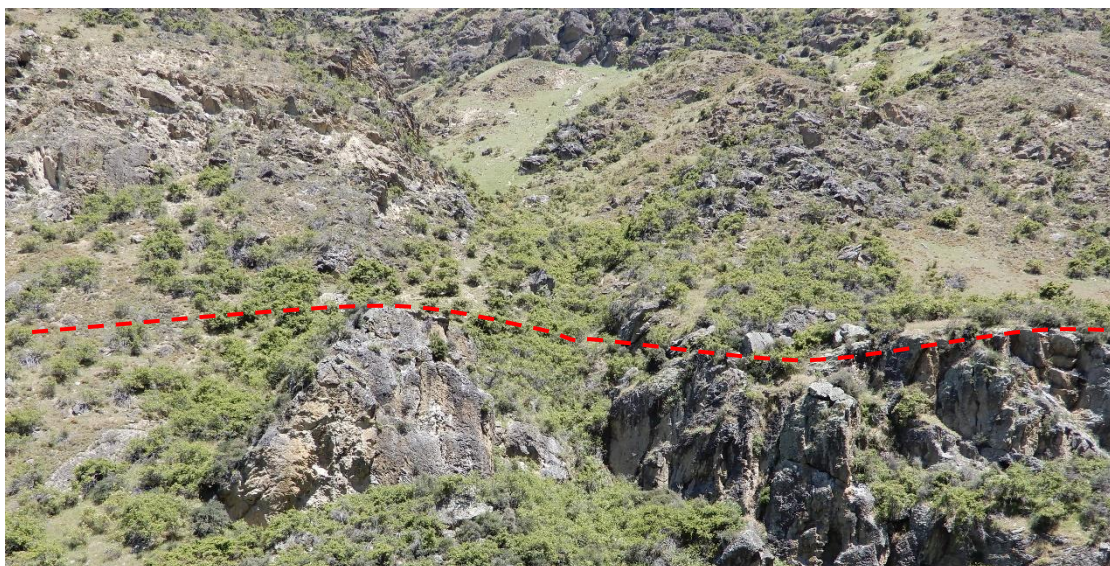
10. Bluff 7 (The Drop), 11.0 km: This section only observed during fly-past. The route also traverses a narrow gully flanked by rock bluffs, however, the track sidles above the bluff on the downstream side (Photo 12). Similar comments provided above for Passing Lane Bluff also apply here although rock fall from the adjacent bluffs is less of a concern.
11. Pixie Hollow to Scrubby Stream Bluff, 12.2-12.7 km: This section of alignment was walked over to inspect:
- Pixie Hollow, 12160: The alignment passes through a hollow between two large rock outcrops which probably owes its formation to past gold mining. The bluff on the upper side provides some protection against rock fall from the prominent bluff upslope.

*Photo12: Bluff 7 (The Drop) showing approximate track position.*

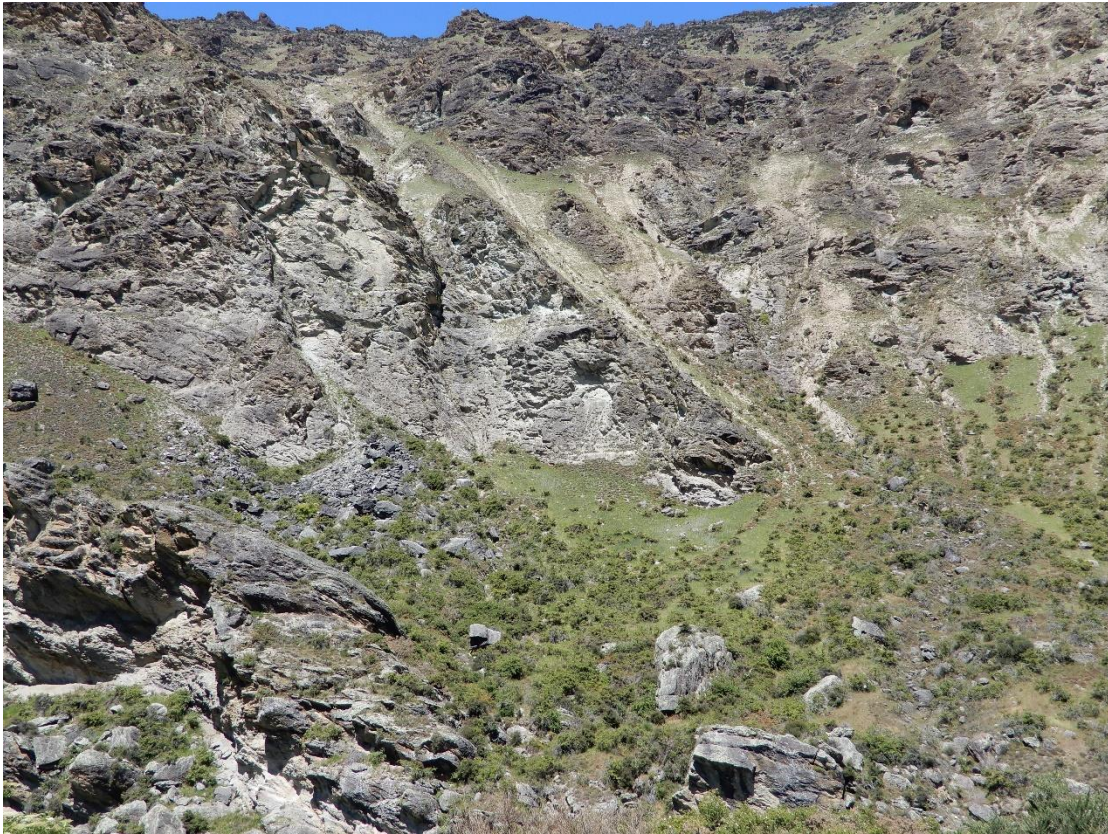
- The rock slide, 12120-12170 (Photo 12): The alignment passes close to the base of the debris cone the larger blocks of which will provide some protection. However, the source area and the surrounding bluffs will need close examination to assess the risk of further rock fall. Added protection could be gained by moving the alignment closer to the river

*Photo 13: Rock slide and debris cone extending as far down as proposed alignment (just below photograph).*

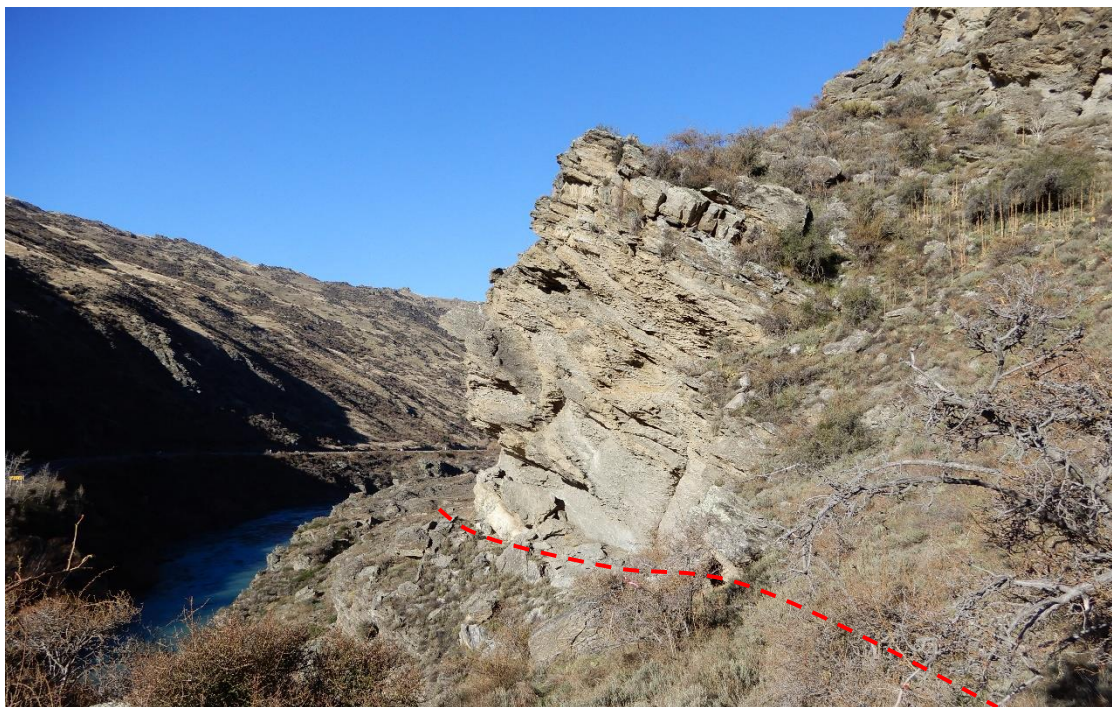
- Bluff 9, Metaquartzite Bluff, 12.7 km: An area of geological interest due to the bands of metaquartzite outcropping on the bluffs (see Photo 16). A number of overhangs and loose blocks will require treatment to mitigate rock falls.

*Photo 16: Trail around west side of Metaquartzite Bluff.*

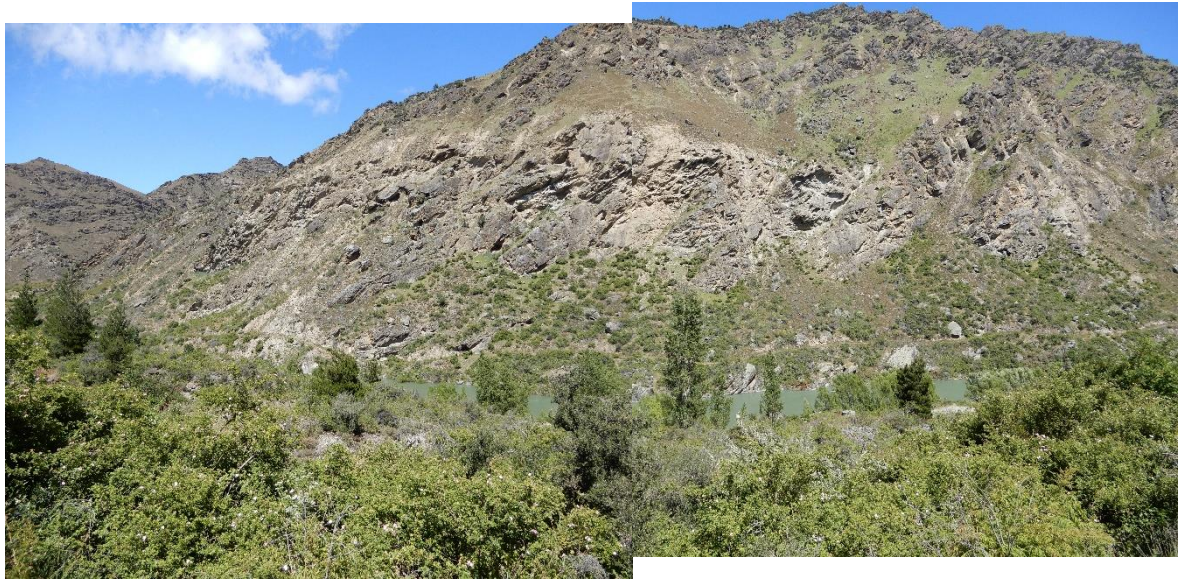
12. Goldfields access road, 15.5 – 16.4 km: This section extends from Honeycomb Gully to Walker Creek and roughly follows the existing access road except where a change of alignment to a higher level is required to minimise grade changes (Photo 17). Steep rock bluffs extend above the scree slope above the access road. There is fresh evidence for recent rock fall on or about this road suggesting the bluffs are actively shedding rocks. The bluffs will be targeted for scaling or securing of loose rocks prior to trail construction.

*Photo 17: Panorama of slopes above Goldfields access road, Walker Creek on left, Honeycomb Gully on right.*

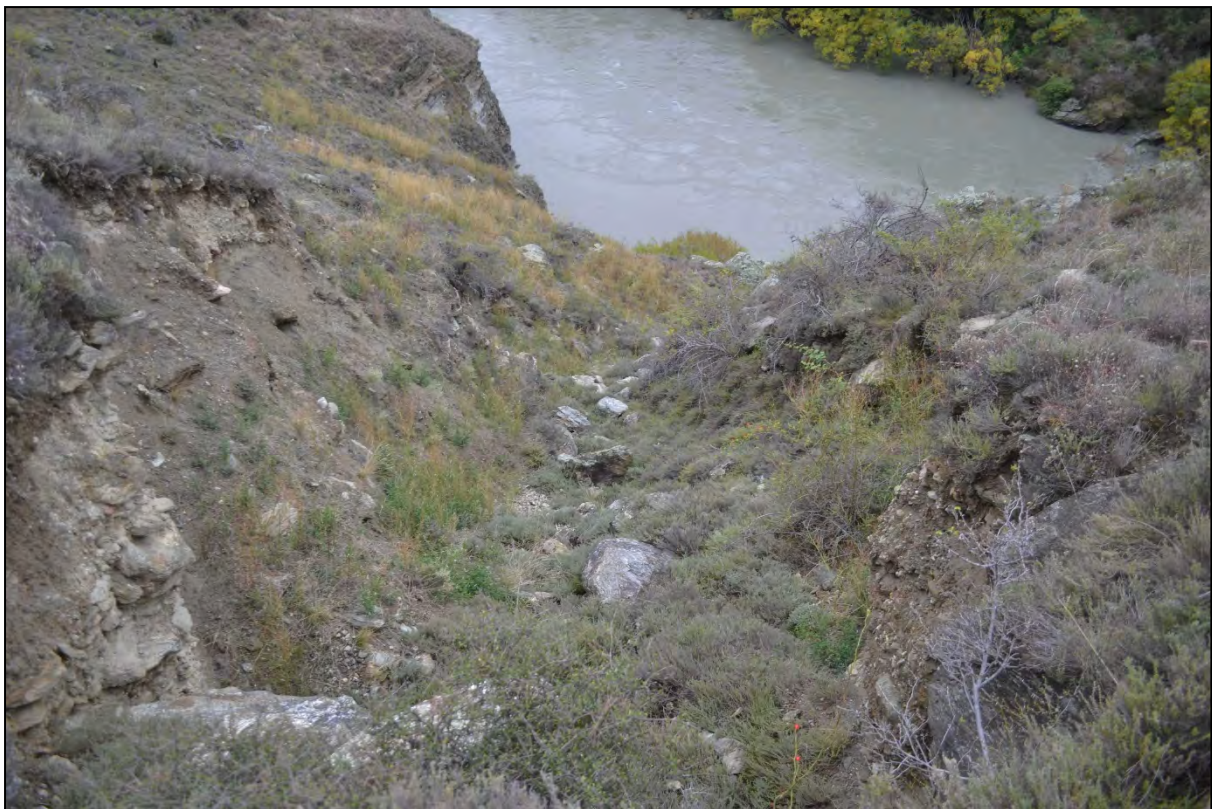
As well as the sites noted below, the survey also encountered numerous small dry gullies along the course of the route (Figure 17). It was not completely clear if these are natural features created by abnormally high flow levels during periods of heavy rainfall, or mining features: small-scale sluicings undertaken opportunistically when a stream was flowing. Though it is suspected that the former is the case, future research should investigate whether these are natural or cultural features. The trail will have a minor effect on these features, only cutting across a small portion where they run down the hillside.

Figure 17. Looking towards the Kawarau down a dry gully near the northern end of Gees Flat.

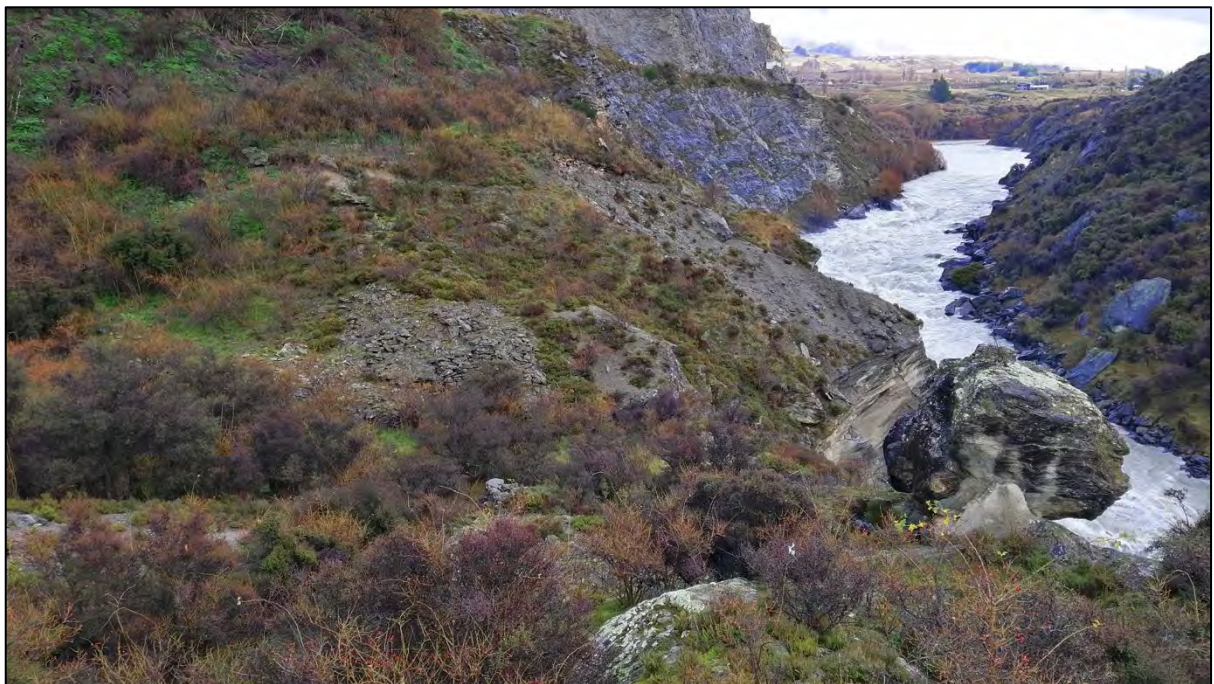
Figure 20. F41/211; looking west across the sluiced area. A tailings pile is visible at the centre left of the image.

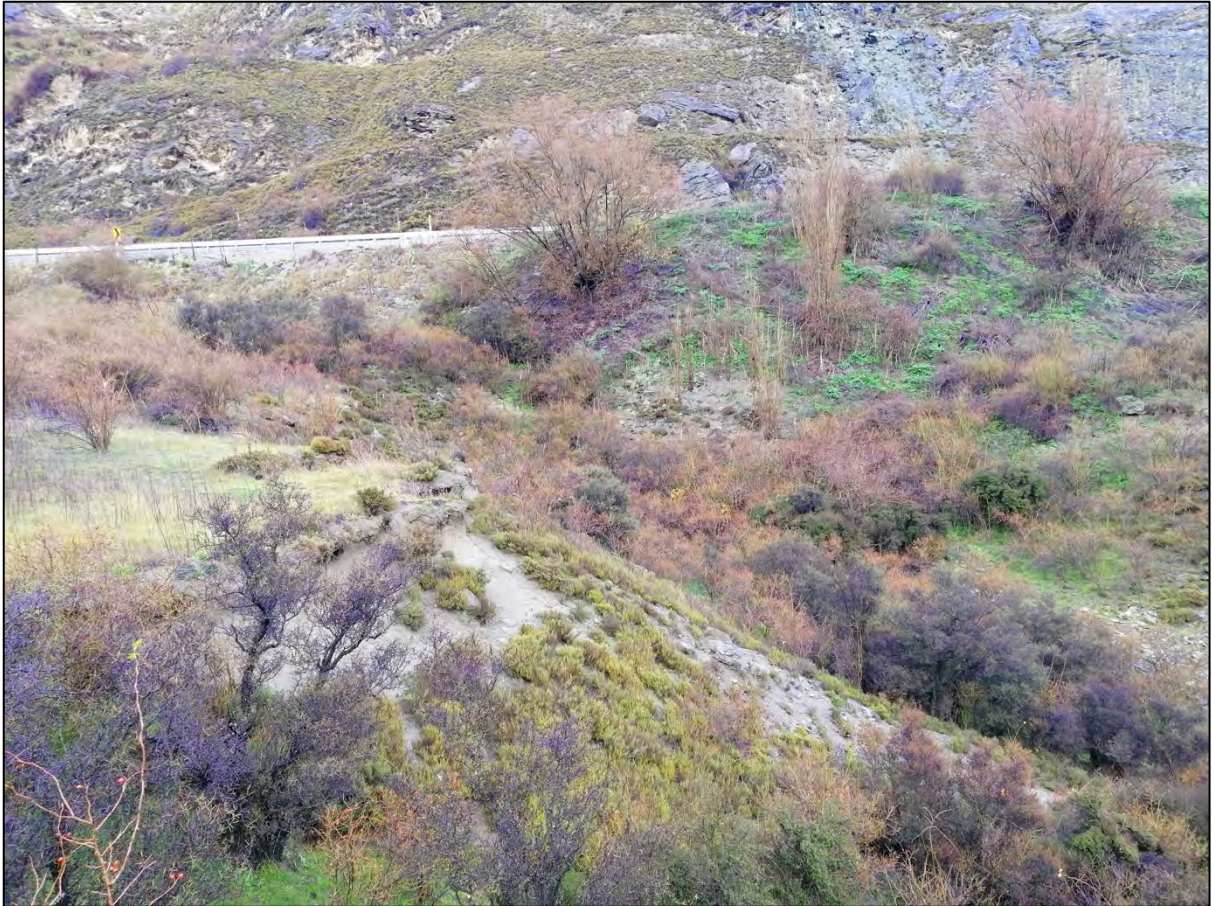
Figure 21. F41/211; looking south across the sluiced area.

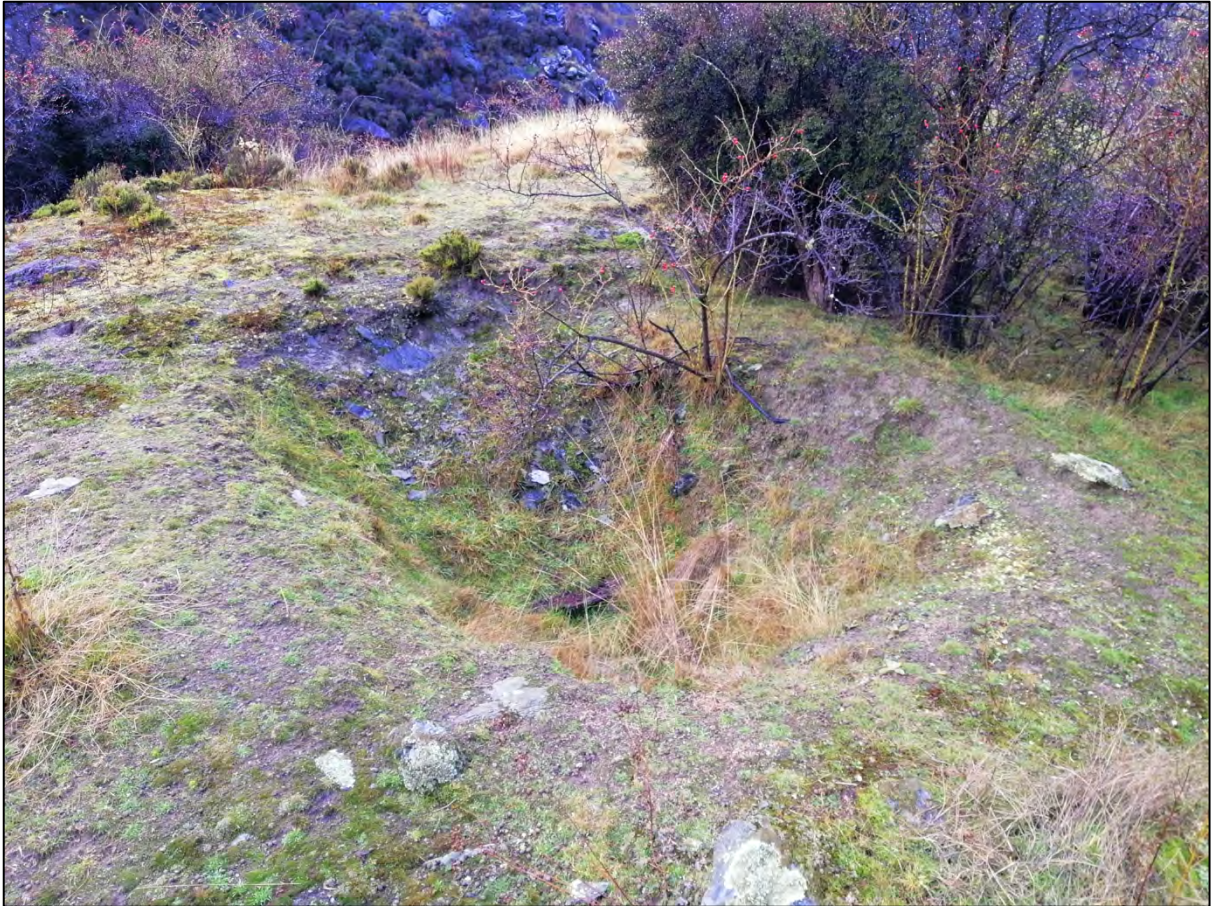
Figure 23. F41/840; looking north over the feature.

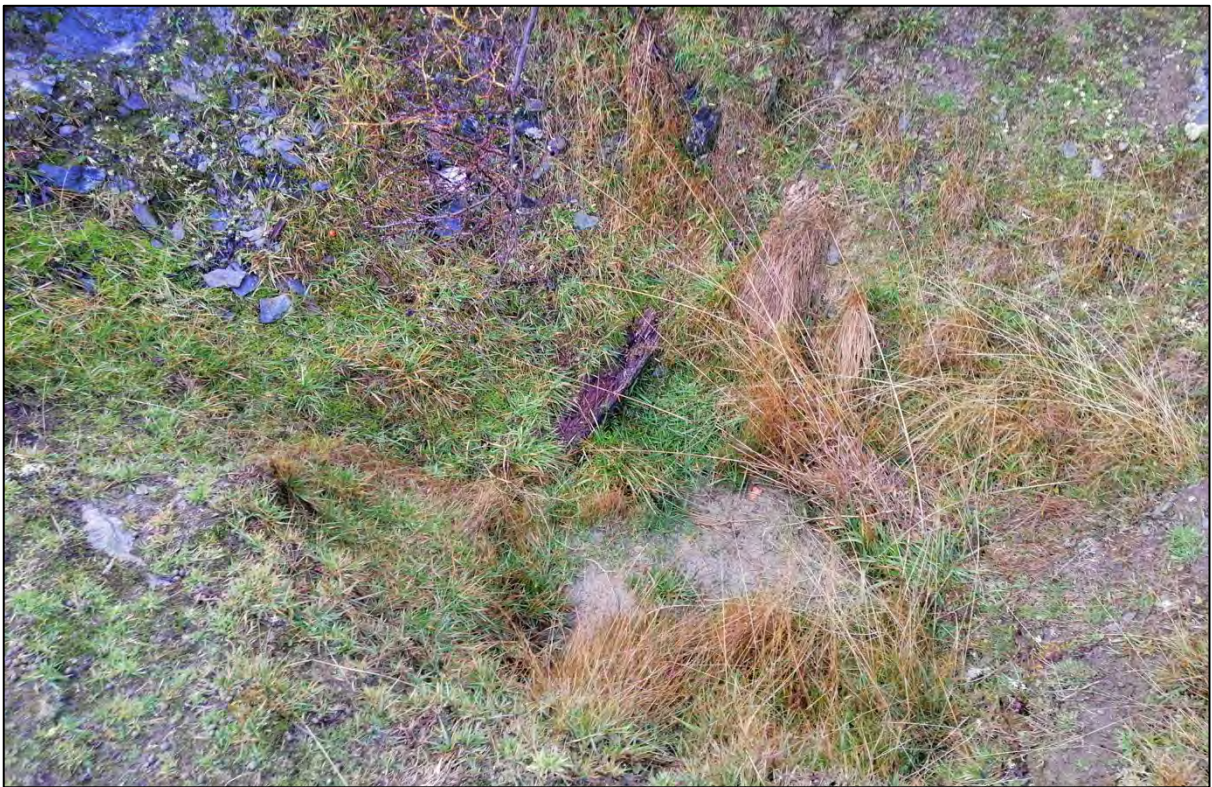
Figure 24. F41/840; showing the possible framing timber at the base of the feature.

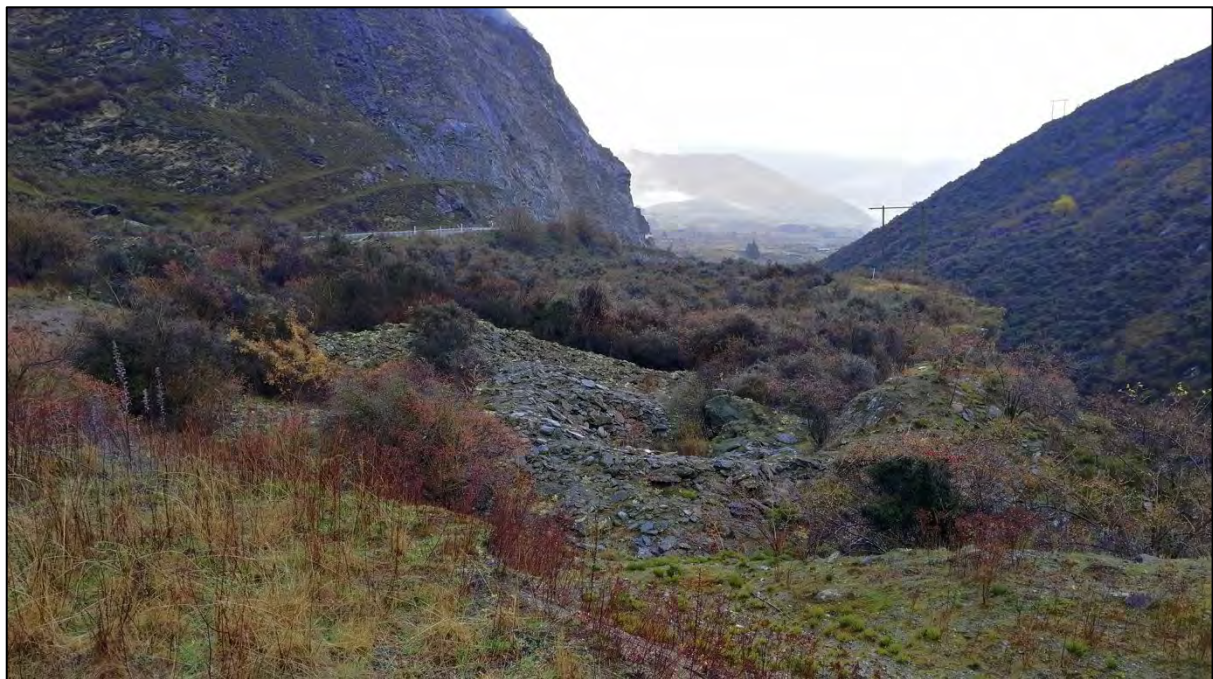
Figure 26. F41/210; looking west over the sluicings and tailings.

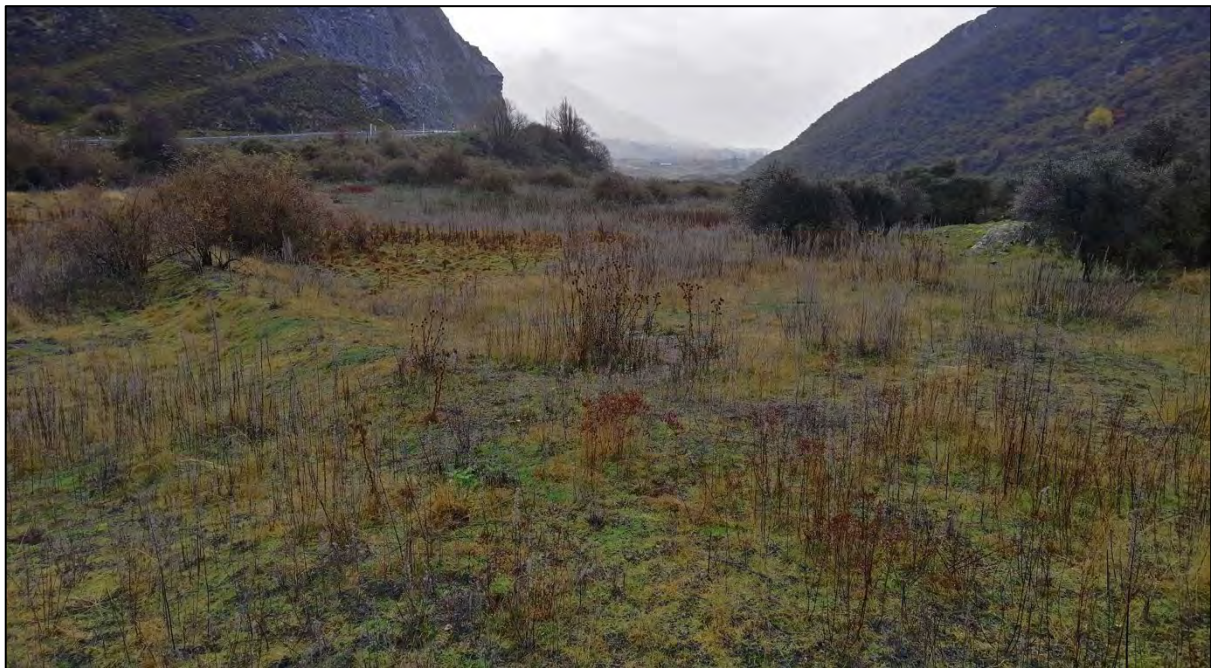
Figure 28. F41/839; looking west over the earth bund/bank running from the centre to the left of the image.

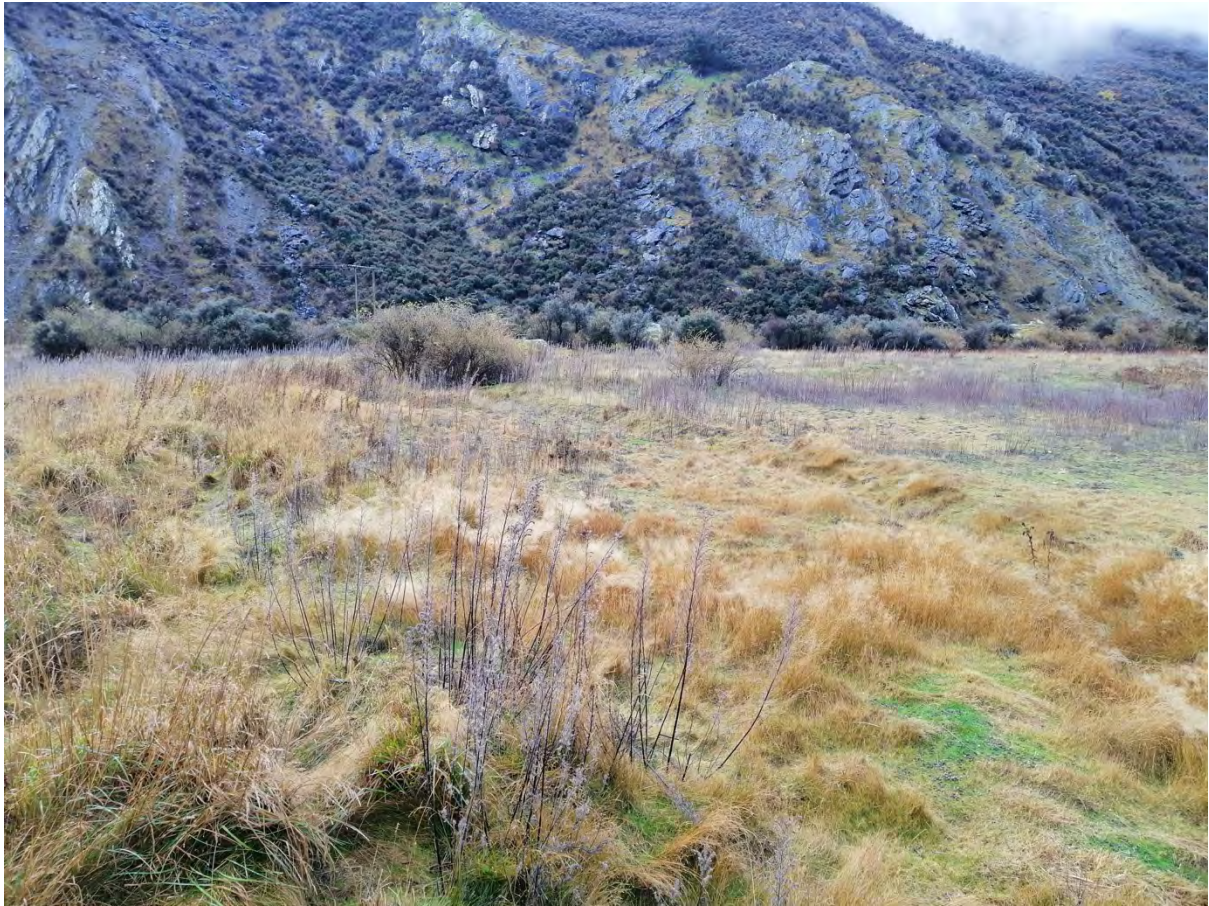
Figure 29. F41/839; looking north between the two overgrown races.

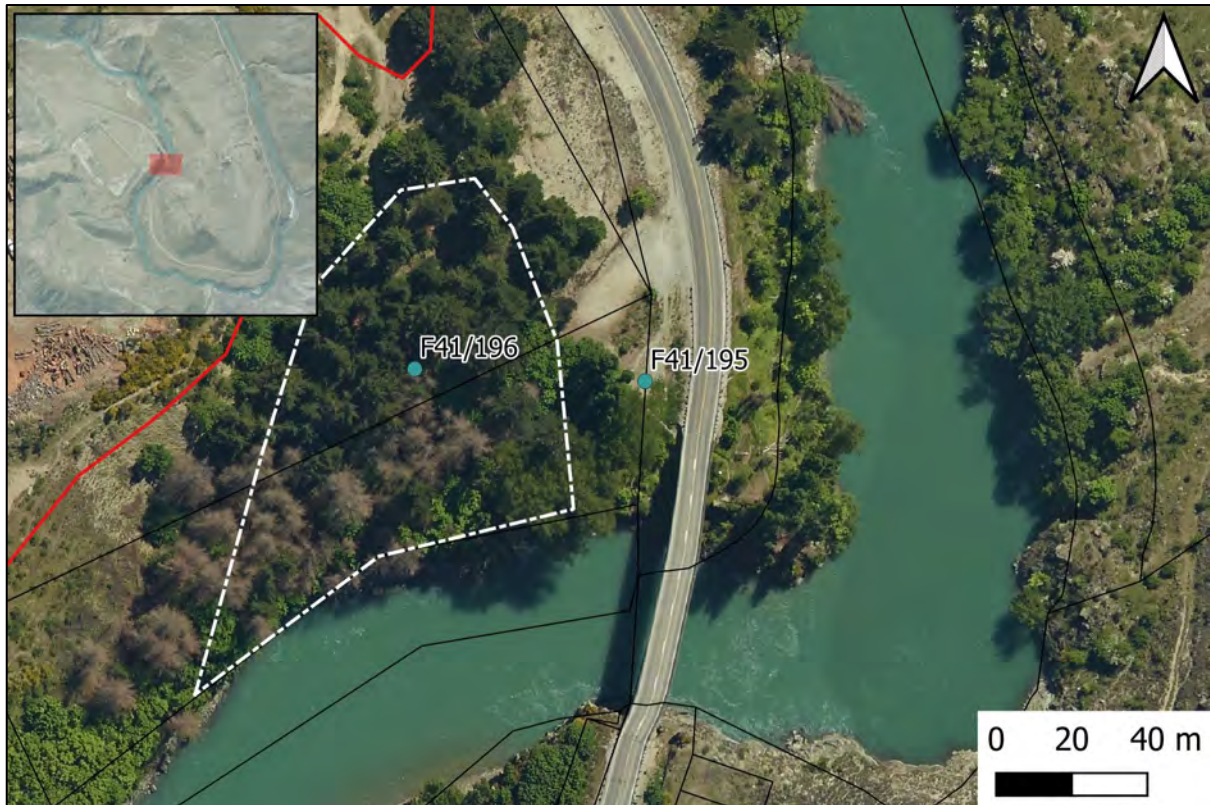
Figure 30. F41/195.

Hotel site immediately adjacent to the Victoria Bridge. The hotel was demolished at some point prior to 1949. The area has recently been used for marshalling machinery for works at the Victoria Bridge. Subsurface features possibly remain but nothing was evident at ground level.

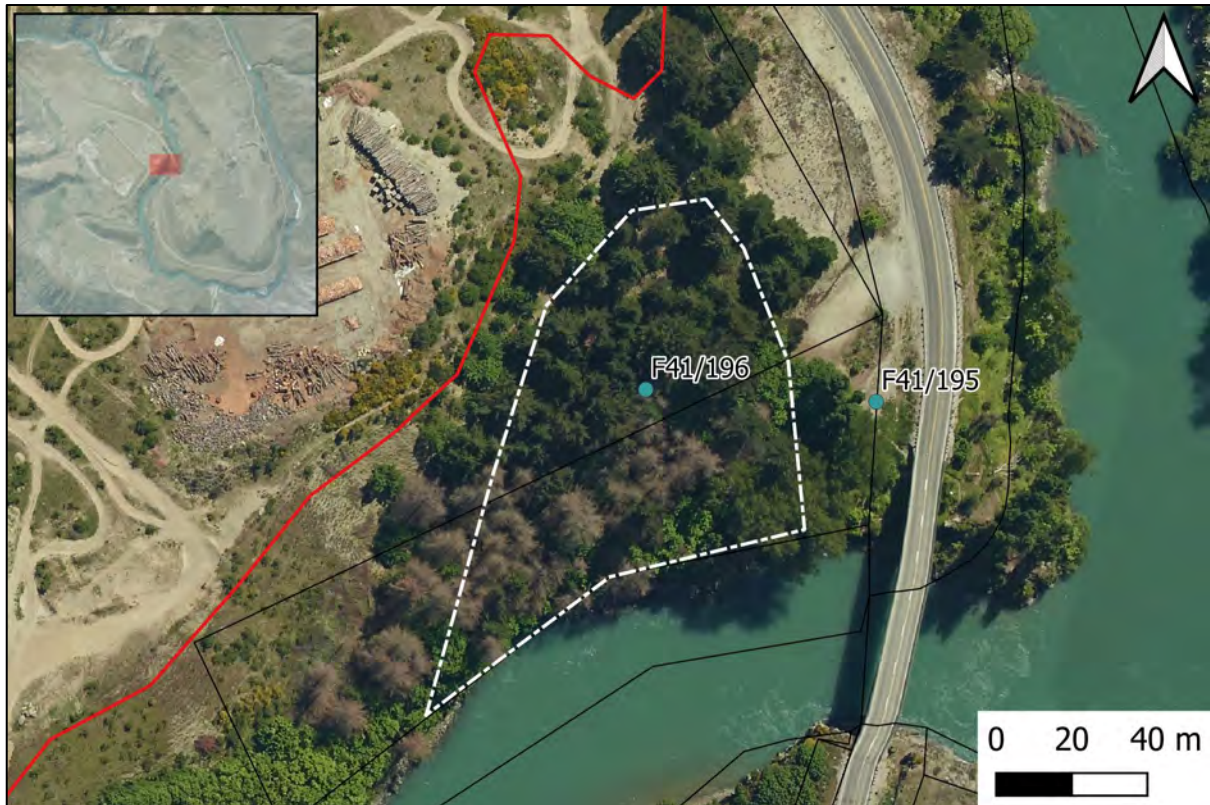
Area of sluicings and tailings close to the Victoria Hotel Site (F41/195). Pine trees and quad bike trails have damaged much of the site, but some piles of hand stacked tailings and sludge channel segments remain intact.

Figure 31. F41/196; the white dashed line indicates the approximate site boundary.

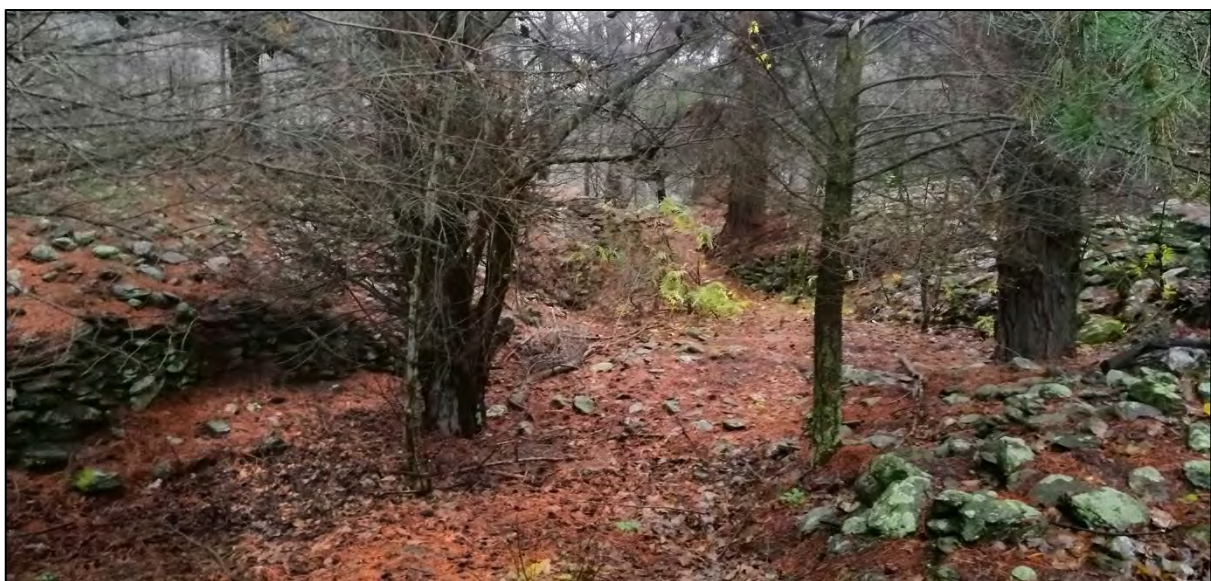
Figure 32. F41/196, looking south through the site's tailings.

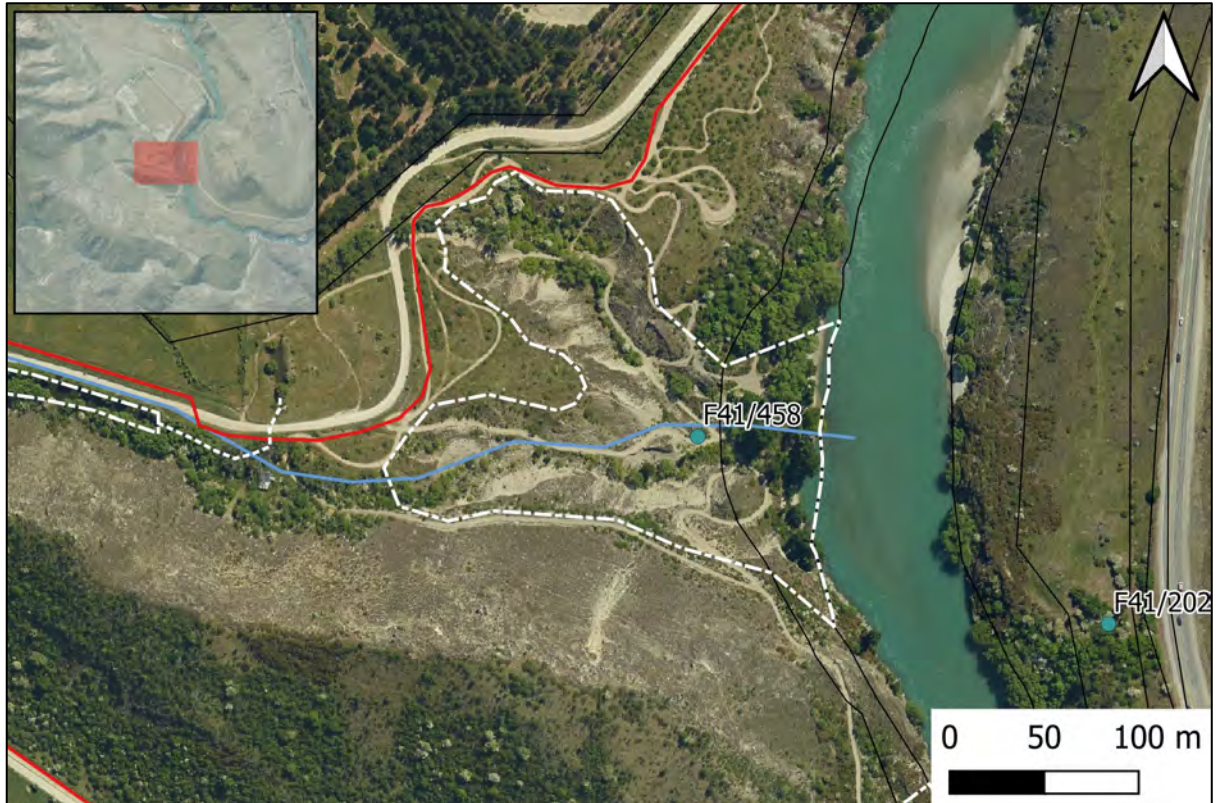
Large area of sluicings adjacent to the Nevis Ferry site. Damaged by quad-bike trails.

Figure 33. F41/458; the white dashed line indicates the approximate site boundary.

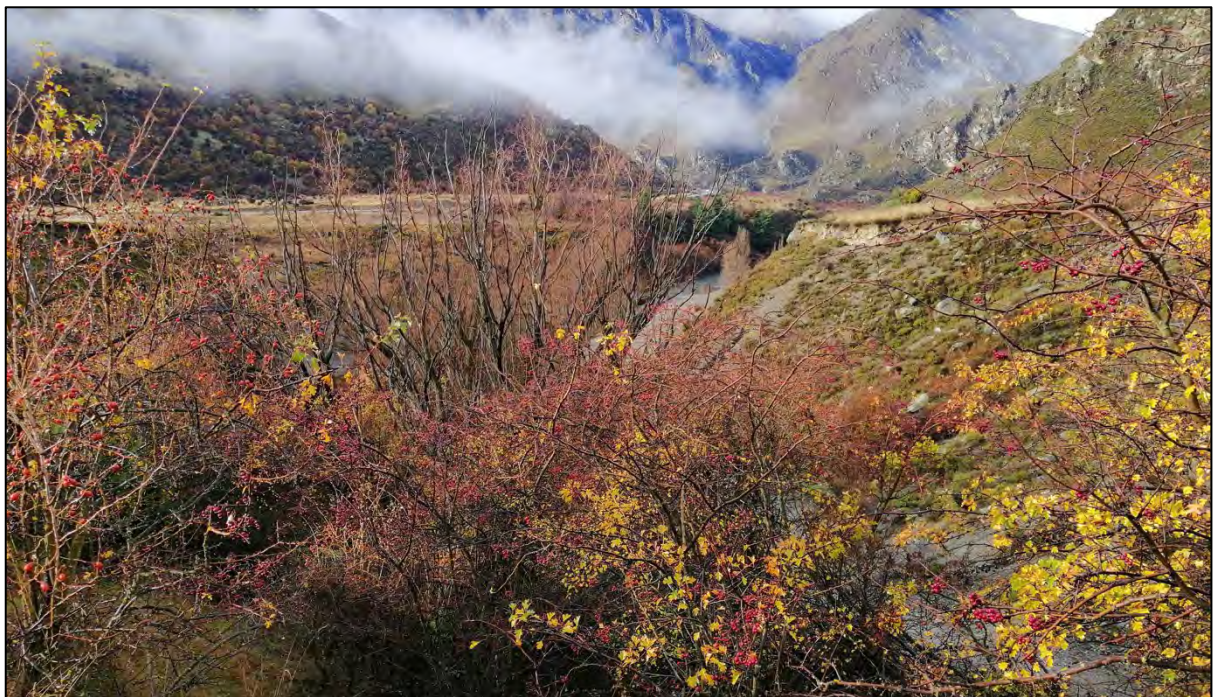
Figure 34. F41/458, looking east over the sluicings.
