**Central Otago Queenstown Trail Network Trust: Kawarau Gorge**

The following comments relate to our joint field trip to various places along the proposed Kawarau Gorge Trail undertaken on 20 June 2019. The purpose of the field trip was to inspect critical trail sections requiring geotechnical assessment as identified in emails dated 14 & 15/05/19.

# Archaeological Assessment for the Kawarau Gorge Cycle Trail

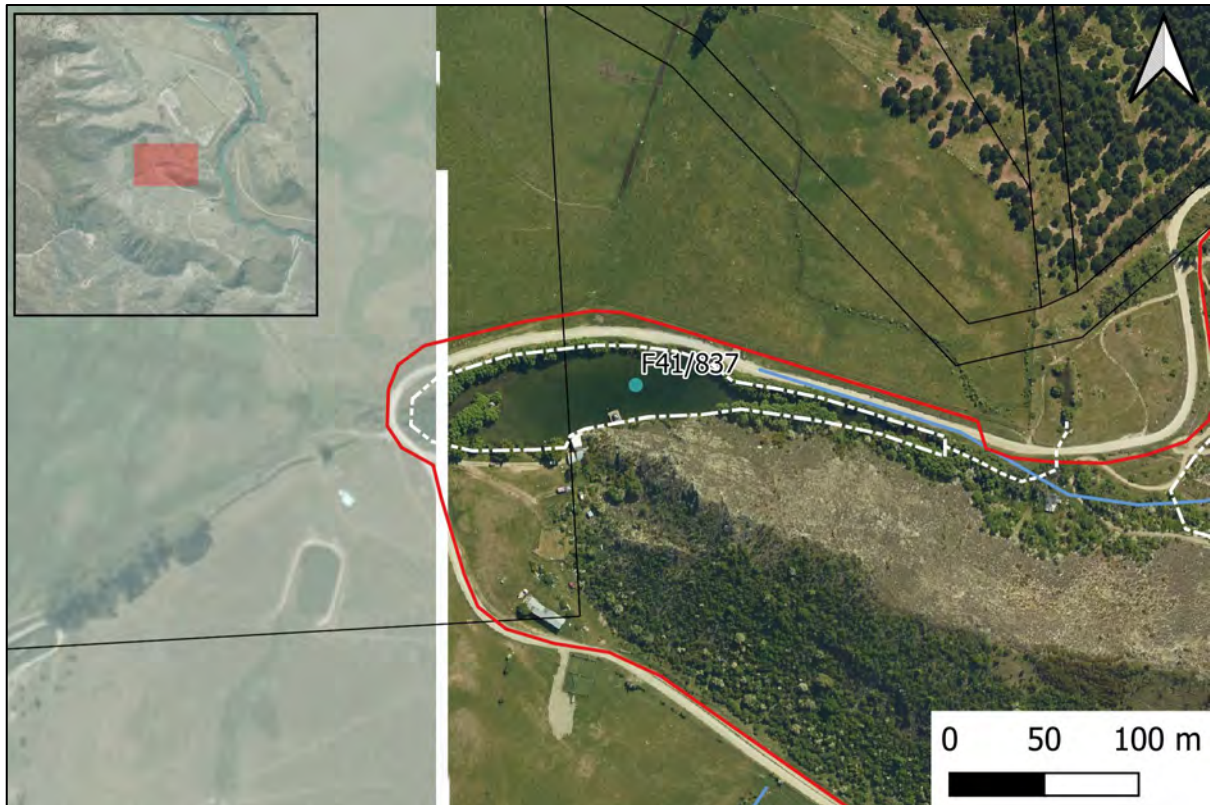
A circa 40m x 180m reservoir beside the Victoria Flat Road. Appears to have been part of the 1920s mining water diversion tunnel from Doolans Creek (F41/208). Held water for workings at F41/458 and possibly F41/196.

Figure 35. F41/837; the white dashed line indicates the approximate site boundary and the dotted lines mark a water race segment.

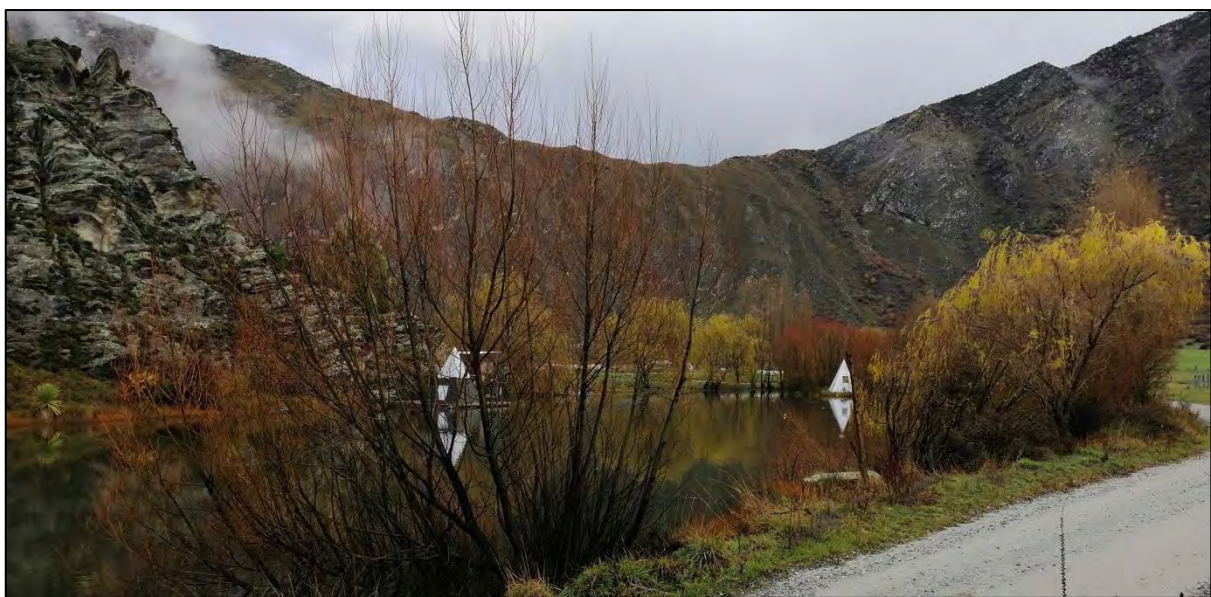
Figure 36. F41/837; looking west across the reservoir.

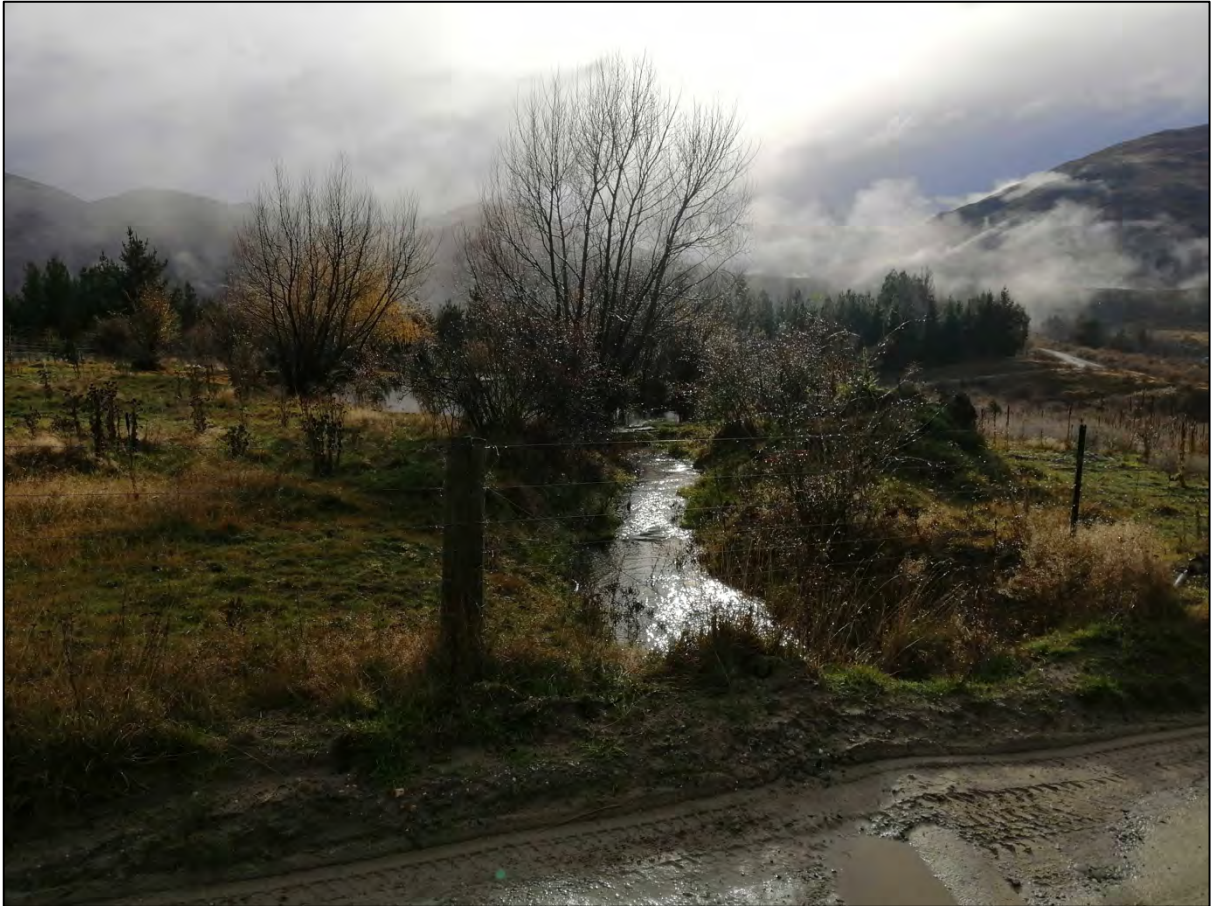
Figure 37. F41/837; looking north along the water race running beneath the road.

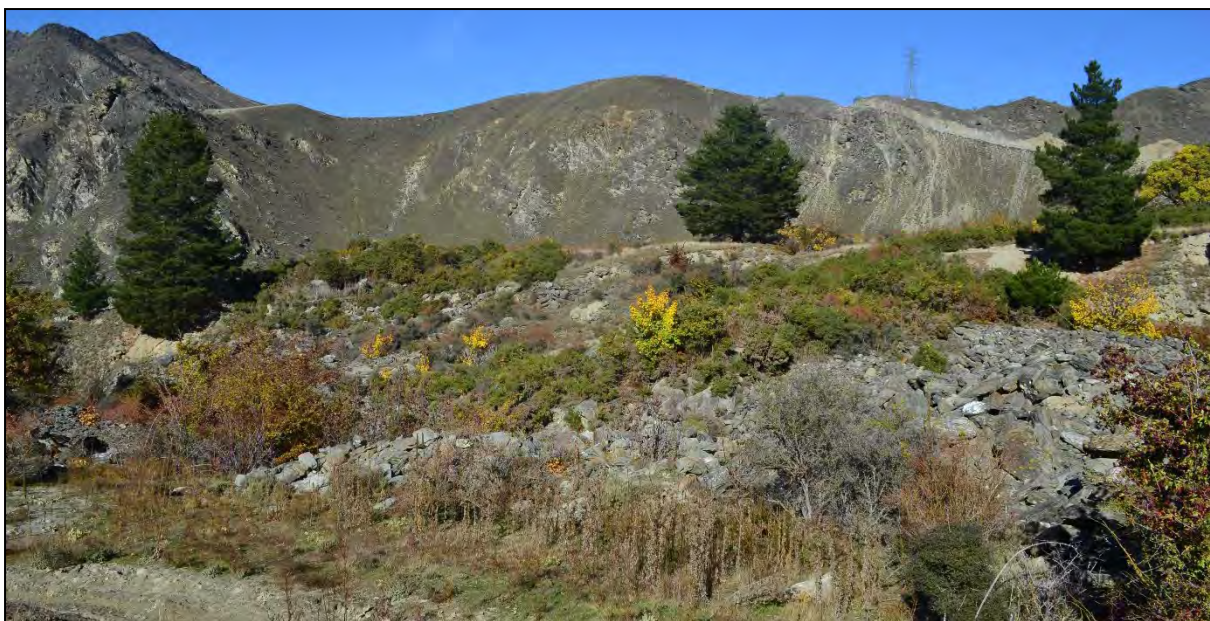
Figure 41. F41/817; looking south across the site.

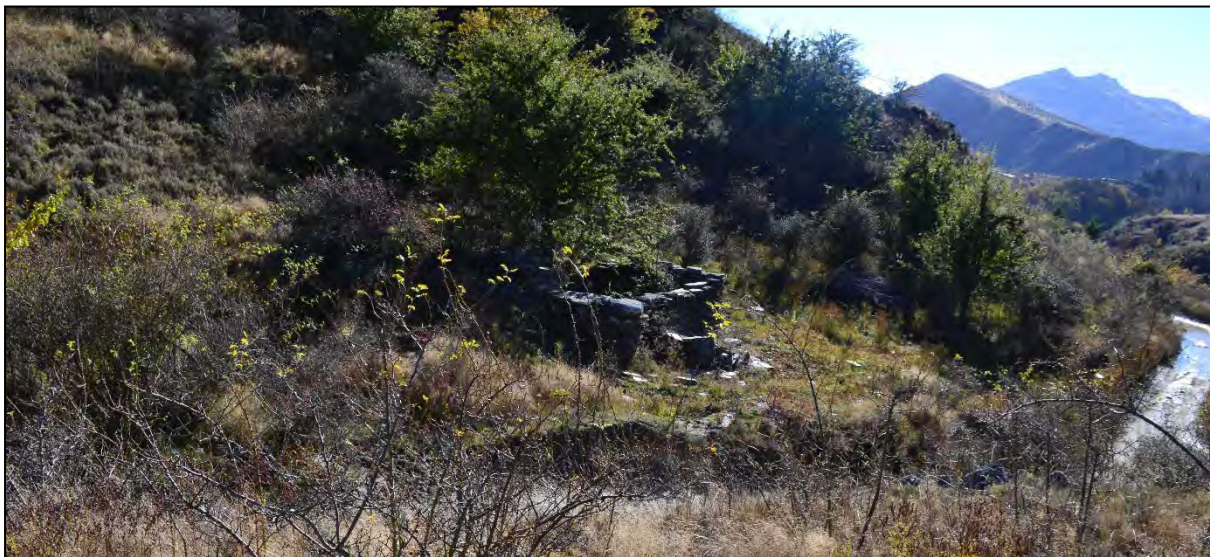
Figure 43. F41/206; looking north at the site.

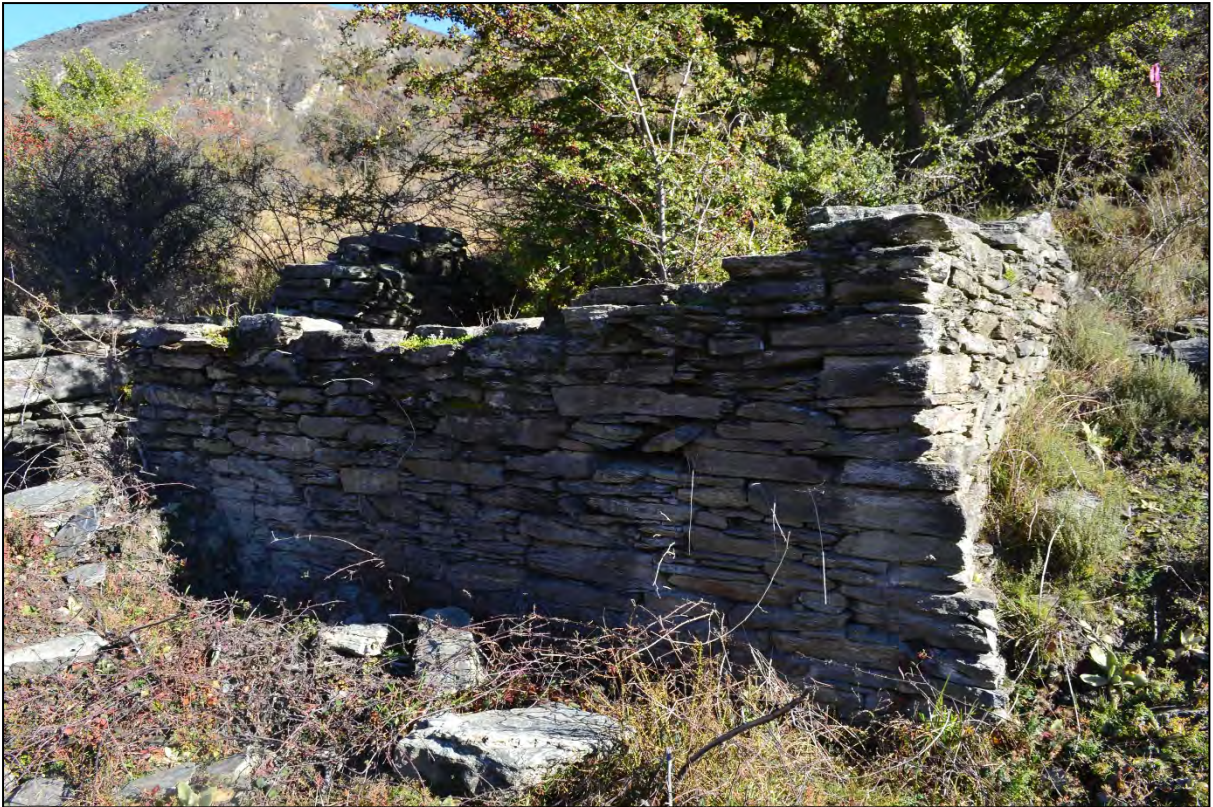
Figure 44. F41/206; showing the stonework at the structure's north-east corner.

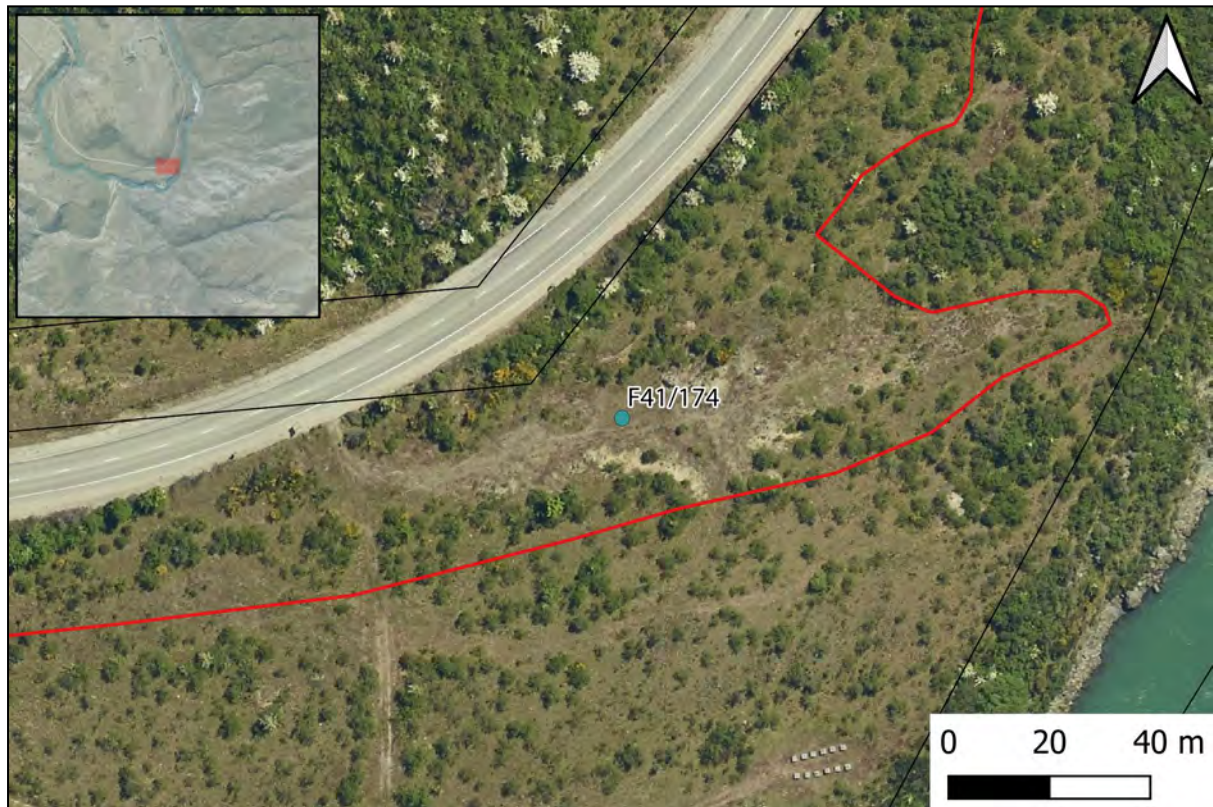
Figure 49. F41/174.

Remains of large unidentified earthwork feature located by Ritchie and visible on a historic aerial photograph from 1964. This was possibly a dam. This feature has now been largely destroyed, likely by roading contractors using it as a machinery base/gravel pit.

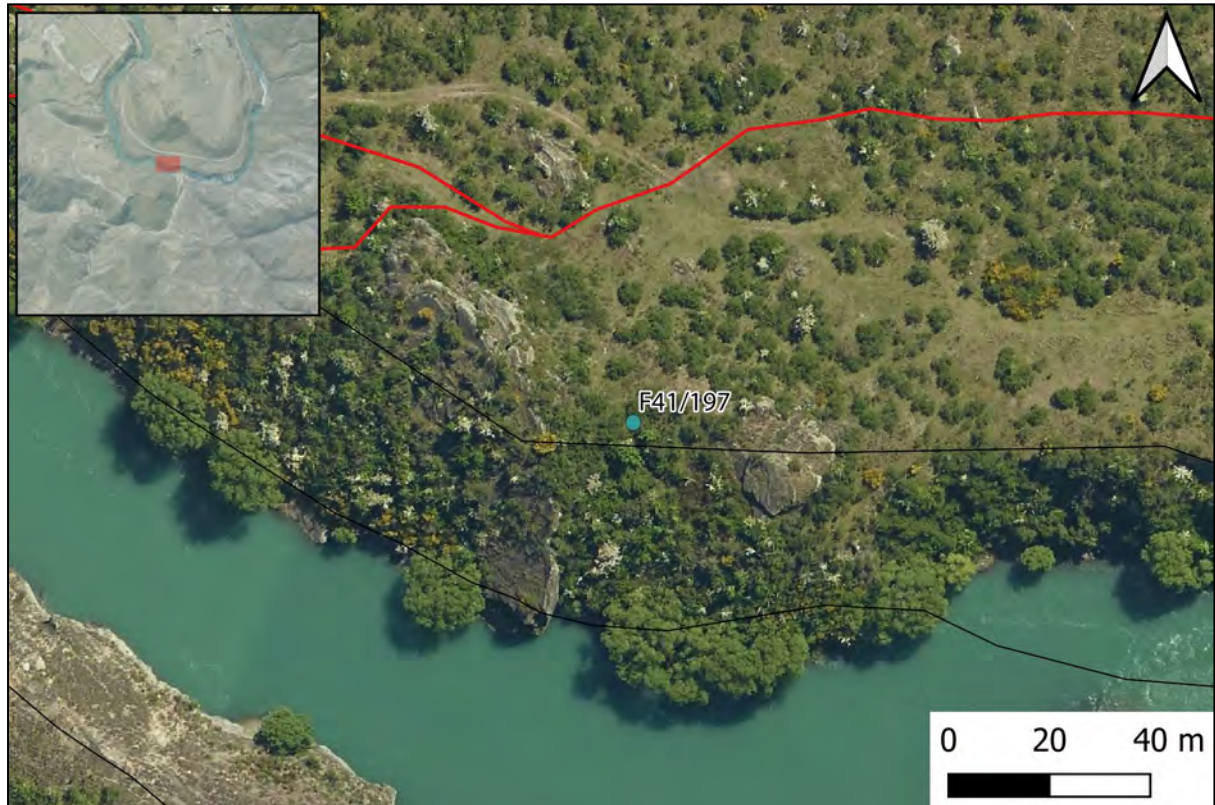
Figure 50. F41/197.

ArchSite records note that the remains of a miners' hamlet are present in an overgrown rock outcrop area opposite the outflow of the Nevis River. This site was not relocated during the survey, though its approximate position is noted.

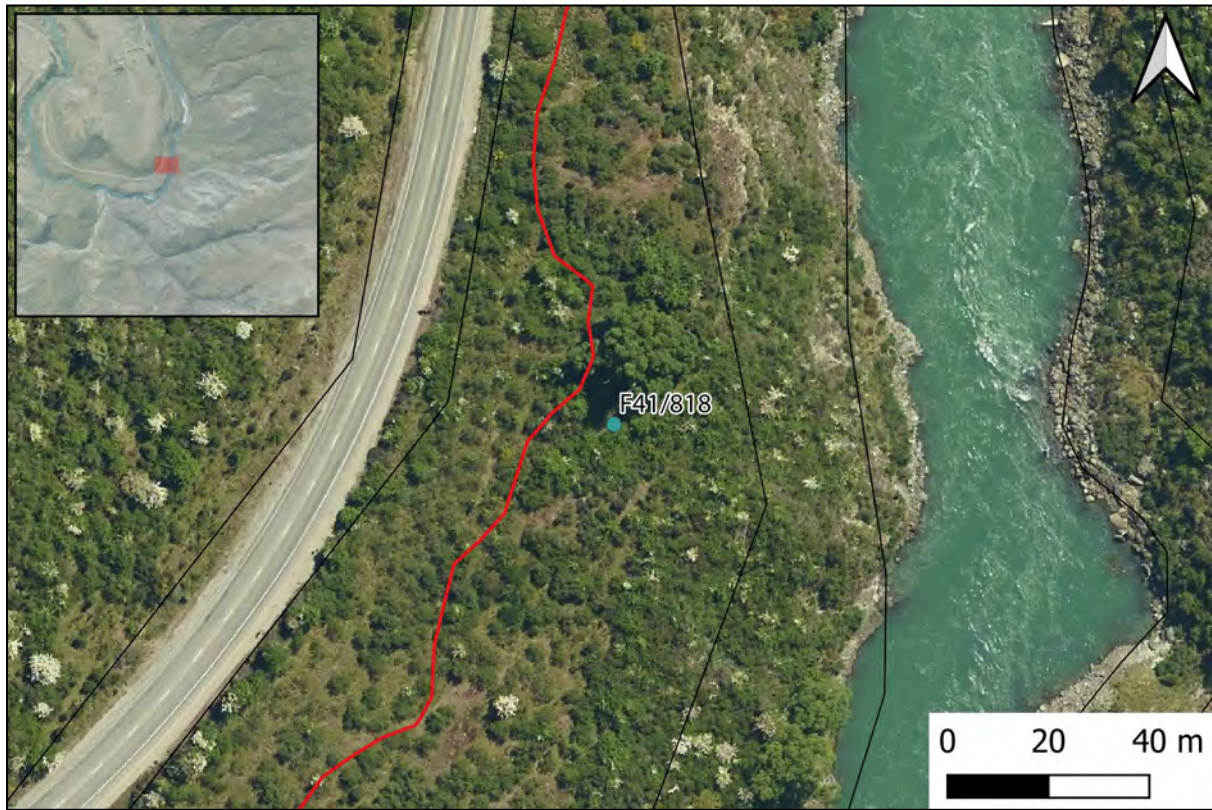
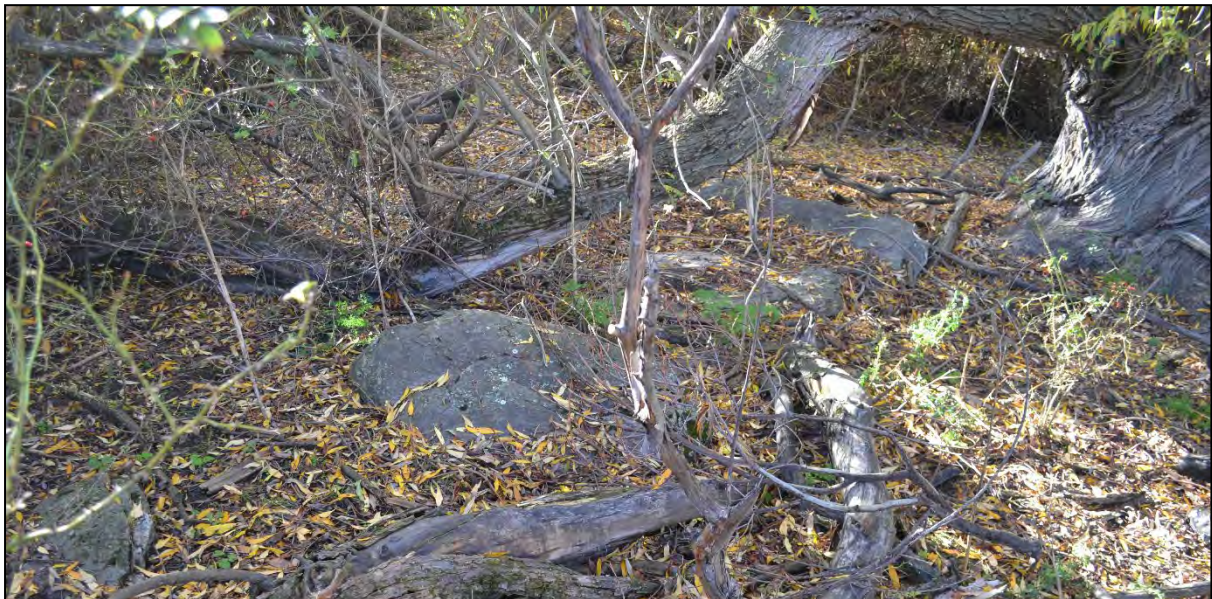
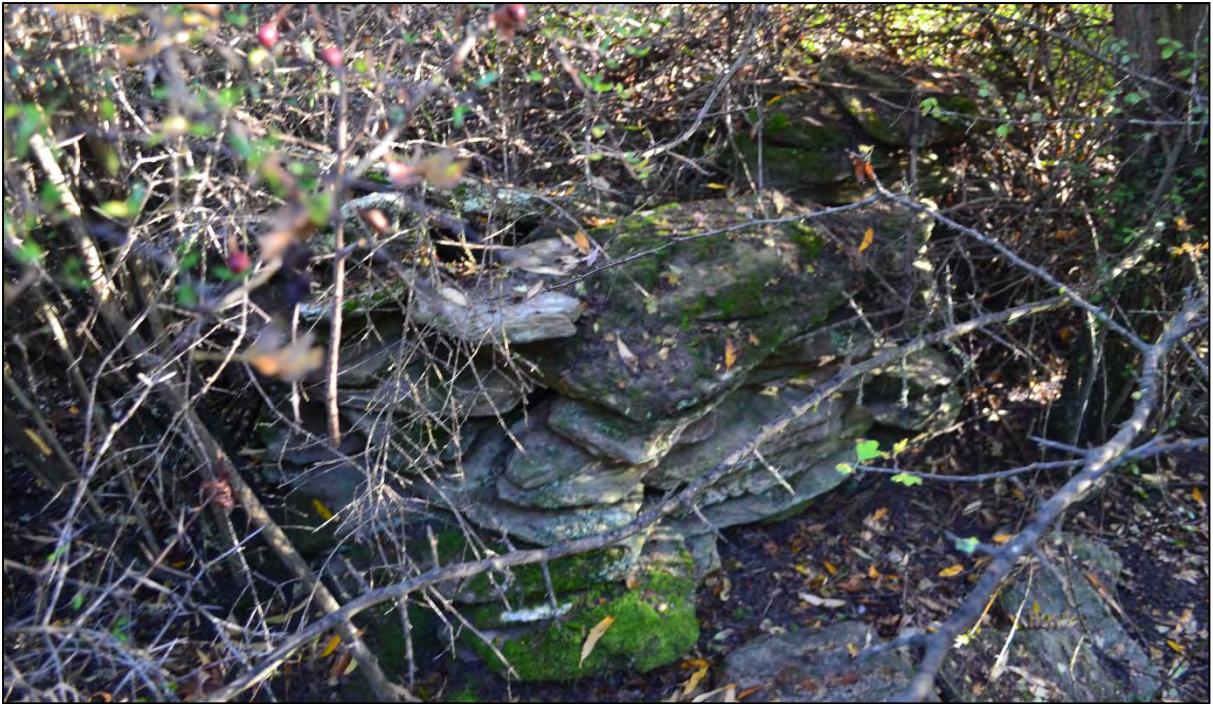
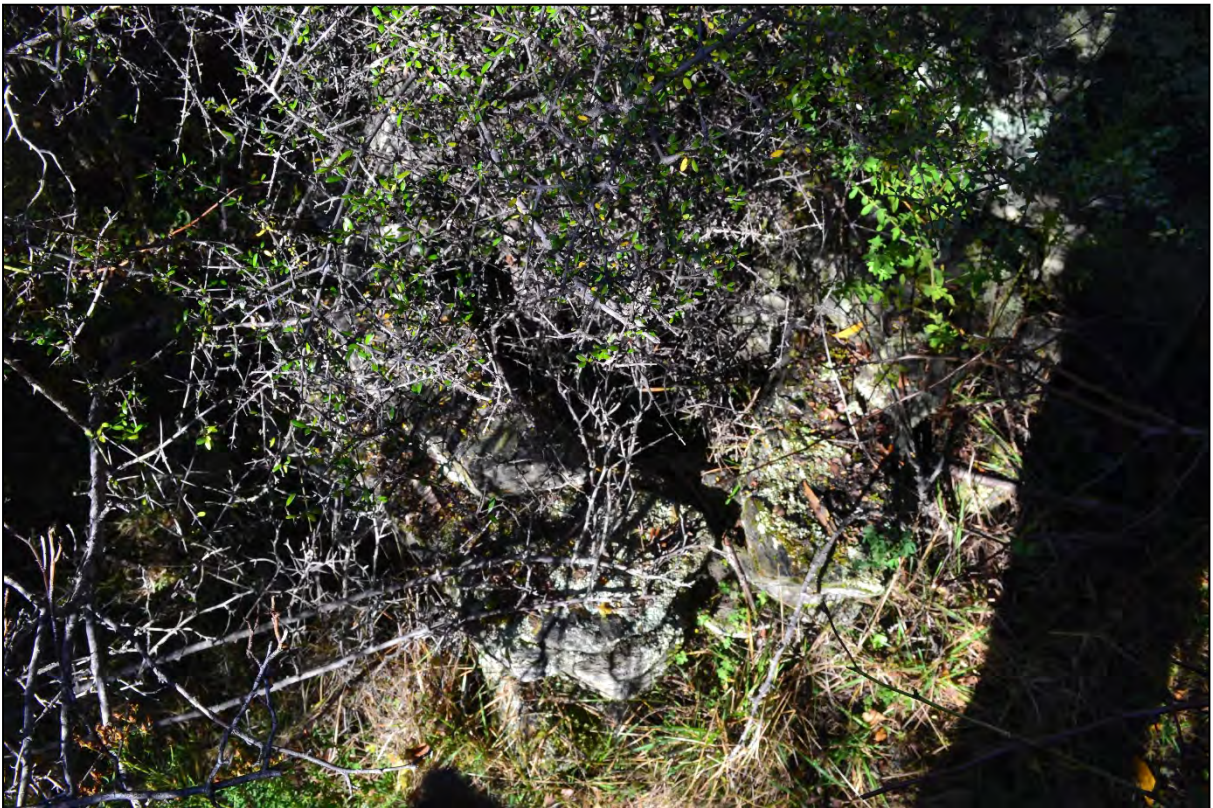
F41/818 – Occupation Site

Small stone hut – c. 2m x 2m – associated with a possible stone well to the east and other indeterminate stone ruins to the north towards a very large willow tree. The structures are very overgrown with briar.

Figure 52. F41/818; looking east at a stone row beneath the willow tree.

Figure 53. F41/818; a corner of the stone structure to the south of the willow tree.

Figure 54. F41/818; a possible well to the south of the willow tree.

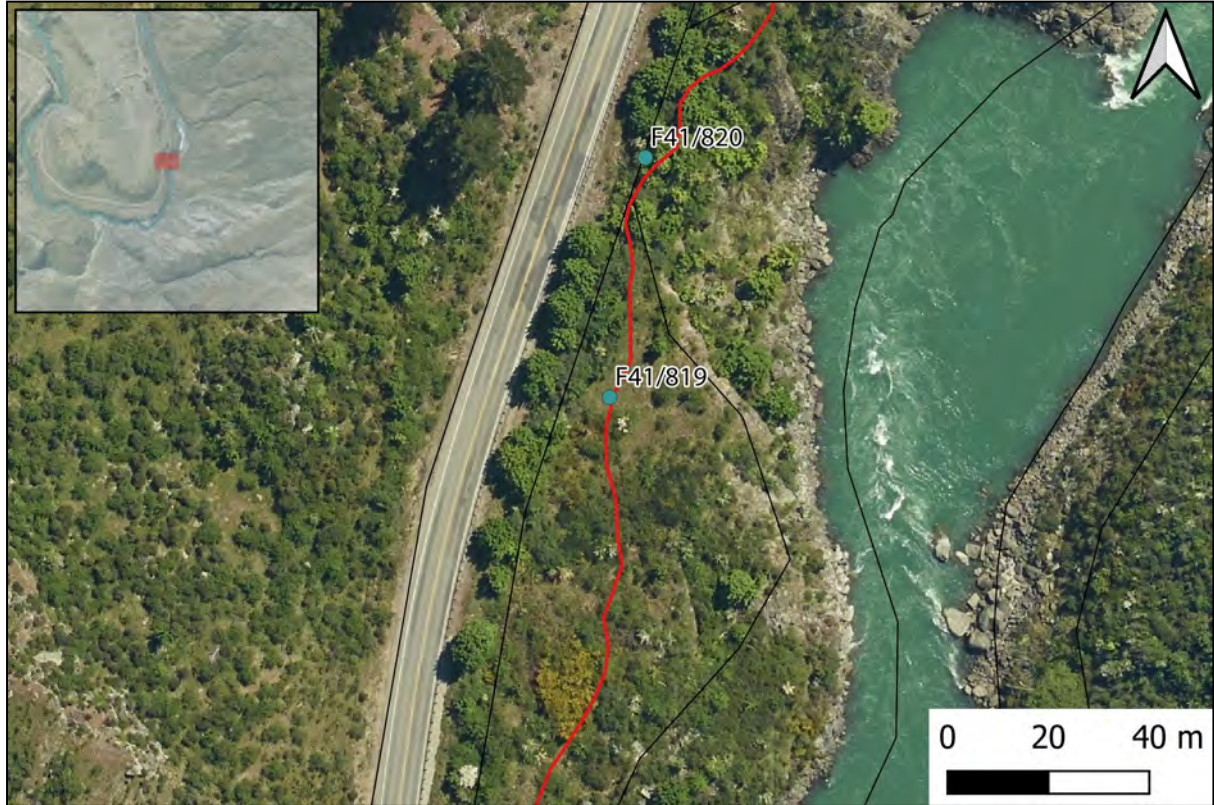
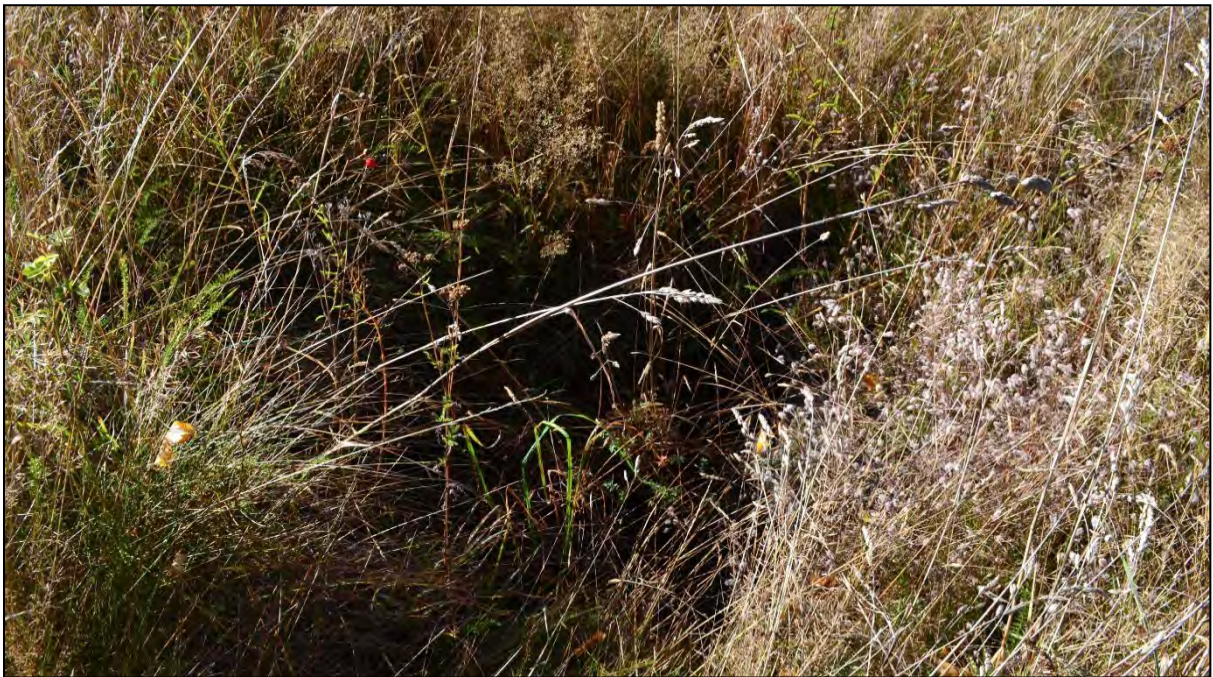
F41/819 – Shaft?

Possible collapsed mining shaft, c. 1m deep. May be natural feature.

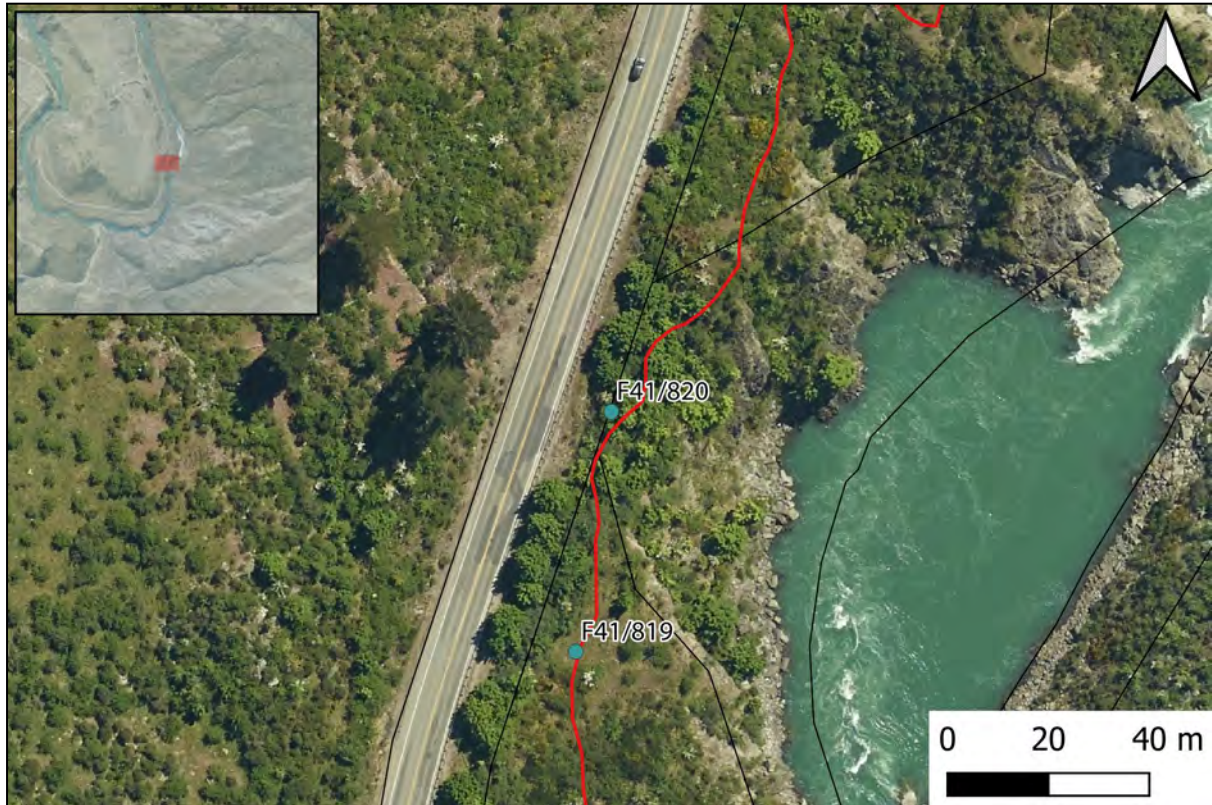
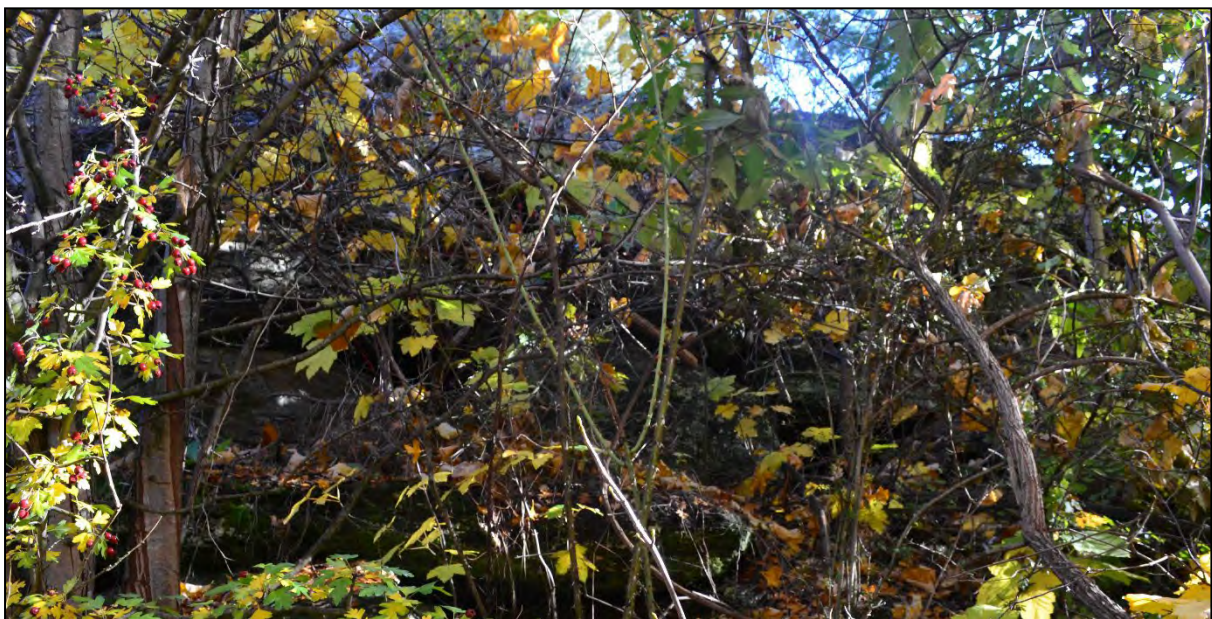
F41/820 – Road Revetment

Large (c. 50-100cm diameter) schist boulders supporting adjacent road formation. Size suggests that they are a 20th century feature put in place by machinery. Later confirmed by Design Engineer (Dave Howard, pers. comm.)

Figure 58. F41/820; looking west – through briar – at the stone road revetment.

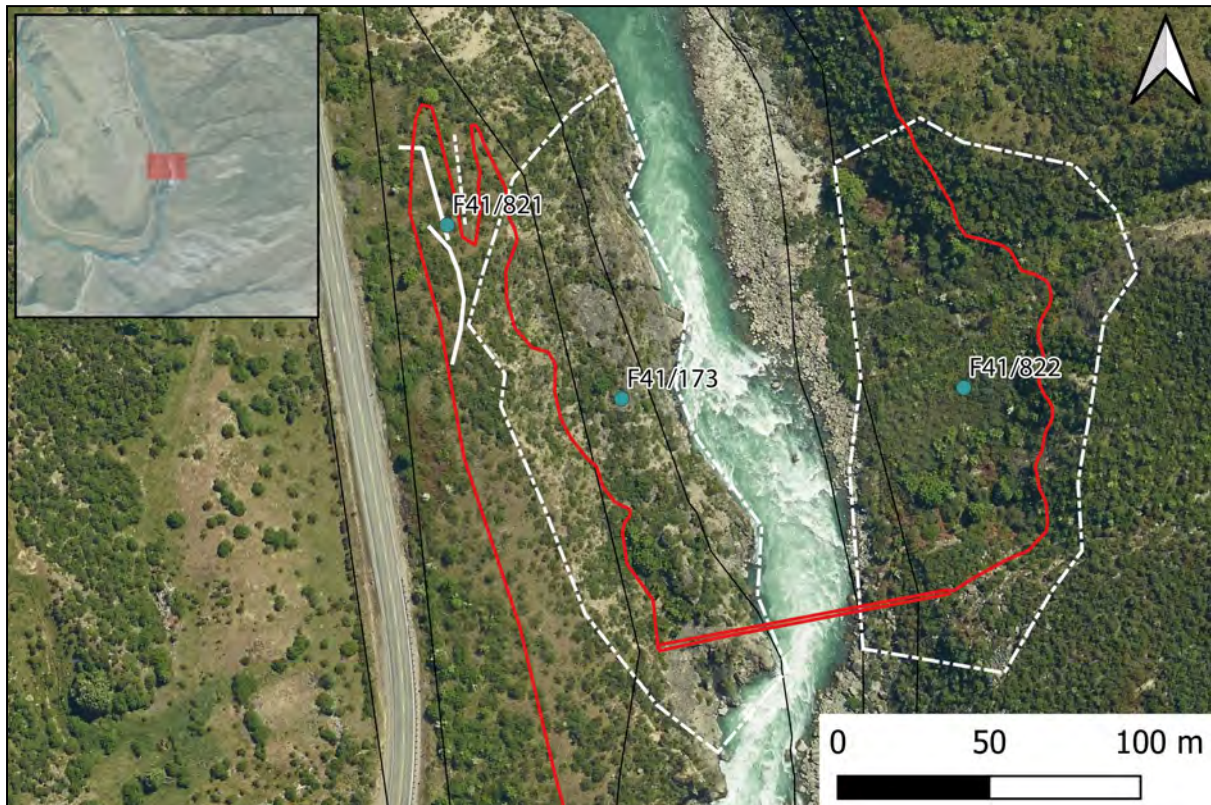
The bridge piers are expected to damage the tailings and suspected channel at the southern end of the site. The route of the trail up from the river will damage sluice faces.

Figure 59. F41/173; the white dashed line indicates the approximate site boundary.

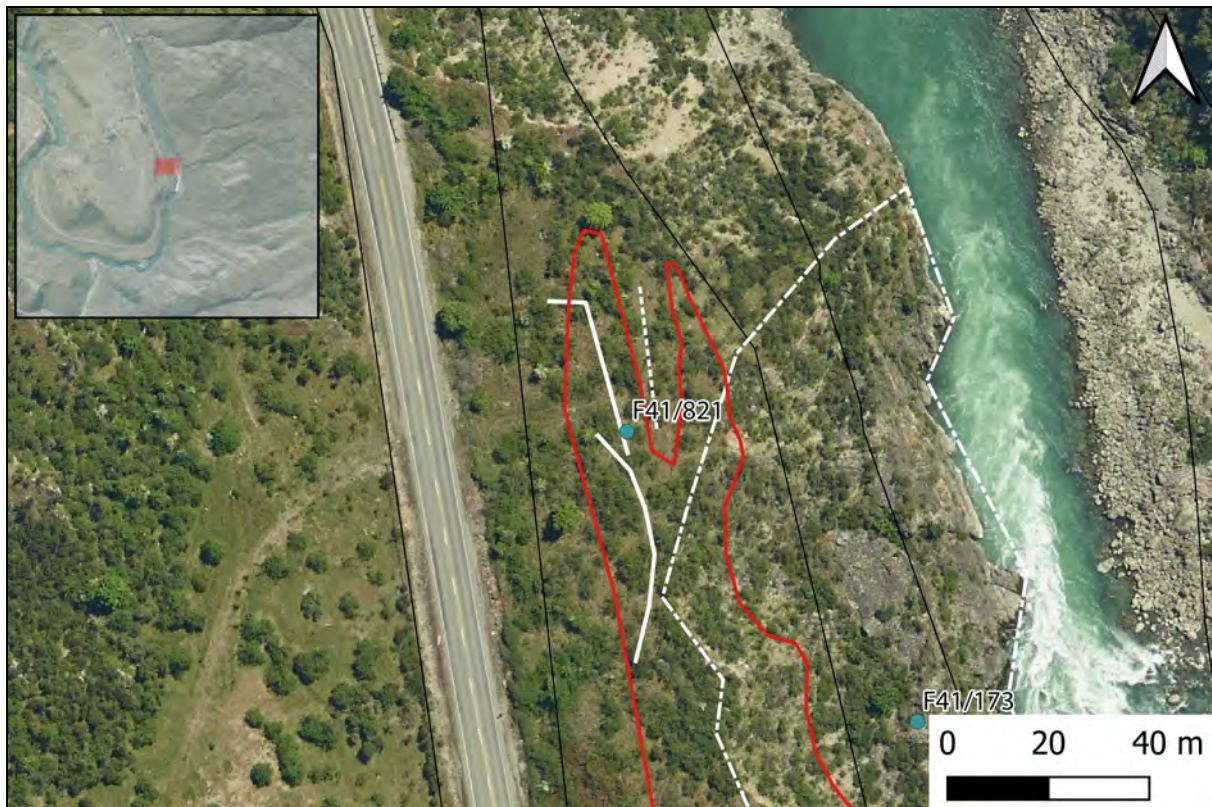
Figure 61. F41/821; the white solid lines indicate the approximate position of dam walls and the dotted line marks a water race segment.

It is likely that the trail route will damage elements of the dam and race earthworks. While some impact is likely unavoidable, the repositioning of the upper portion of the trail c. 5m closer to the road should limit the damage.

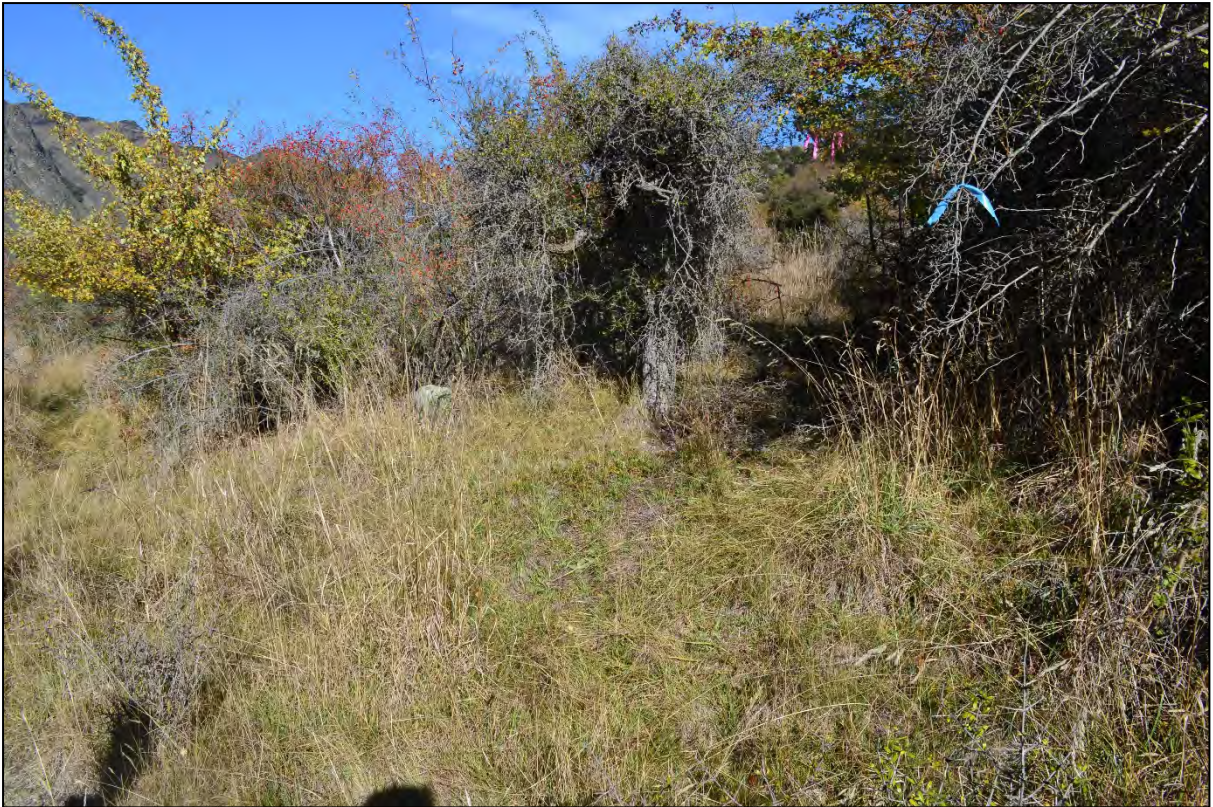
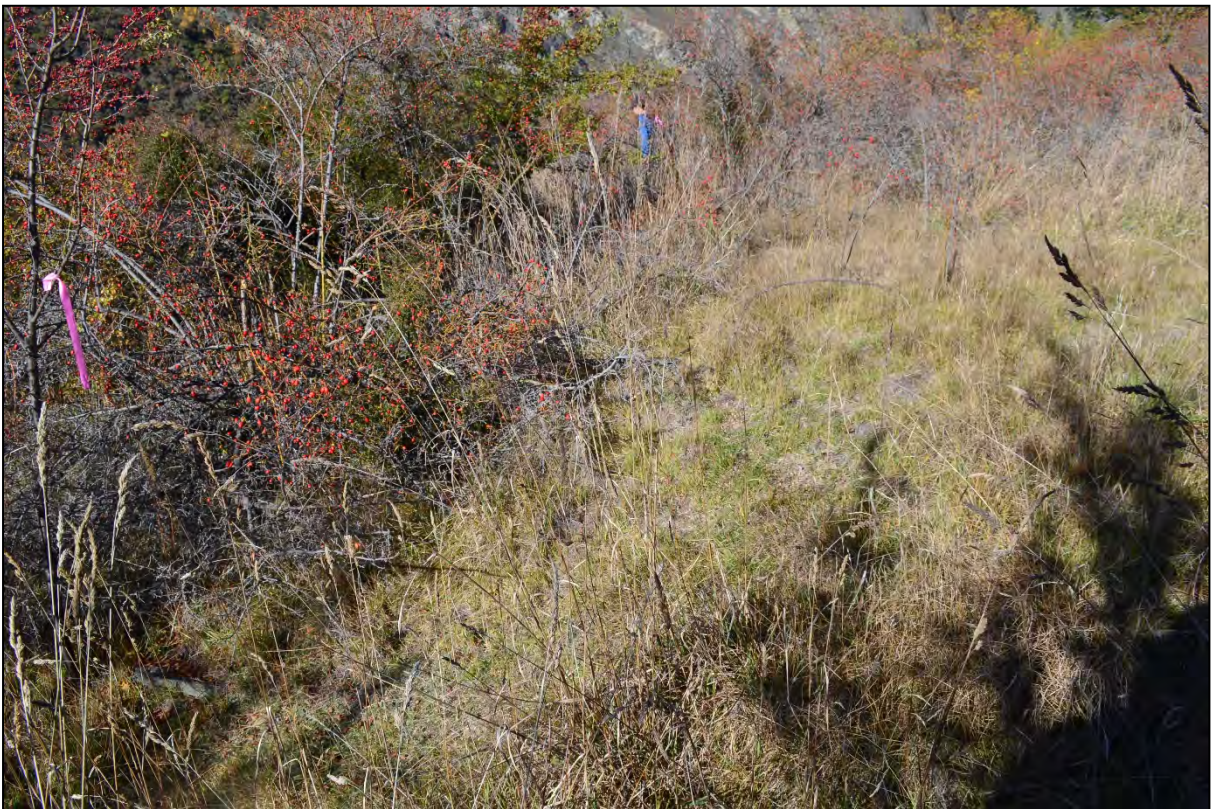
F41/821 – Dams

Figure 62. F41/821; looking south-west at the northern dam wall with the race segment visible at the left of the image.

Figure 63. F41/821; looking south on top of the northern dam.

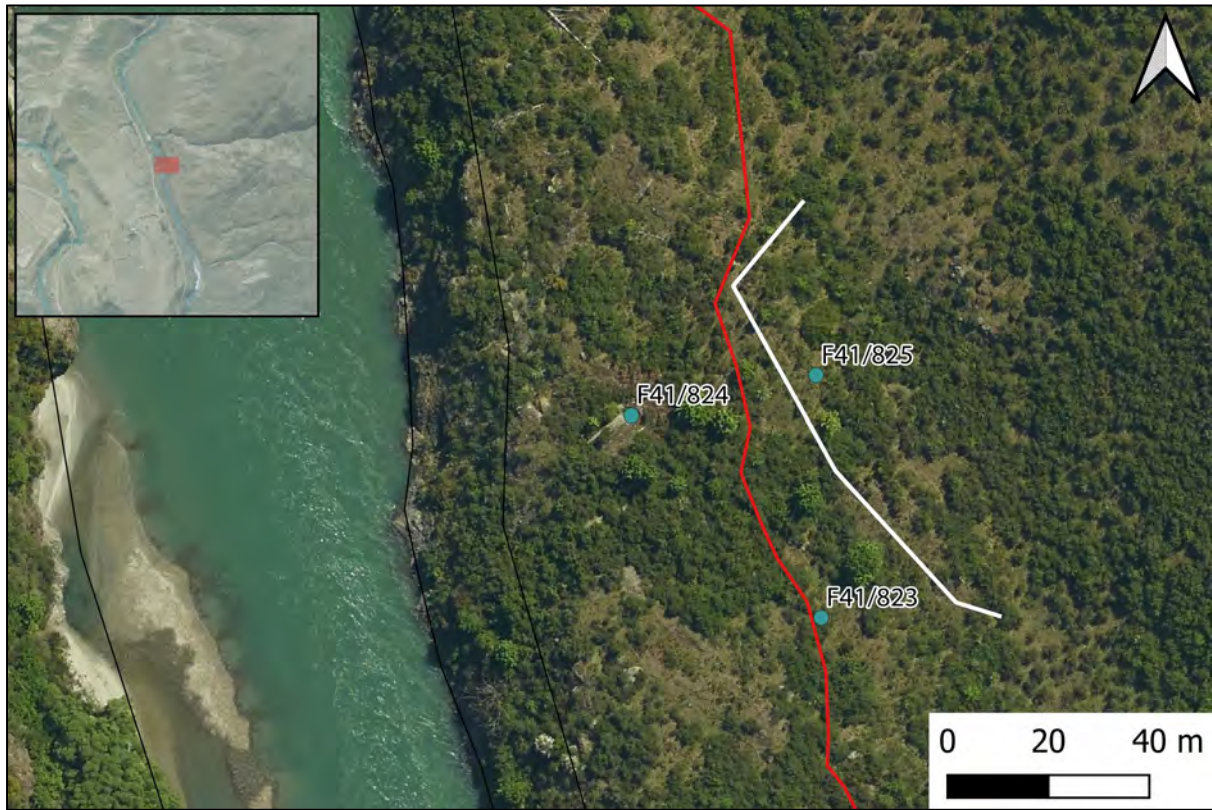
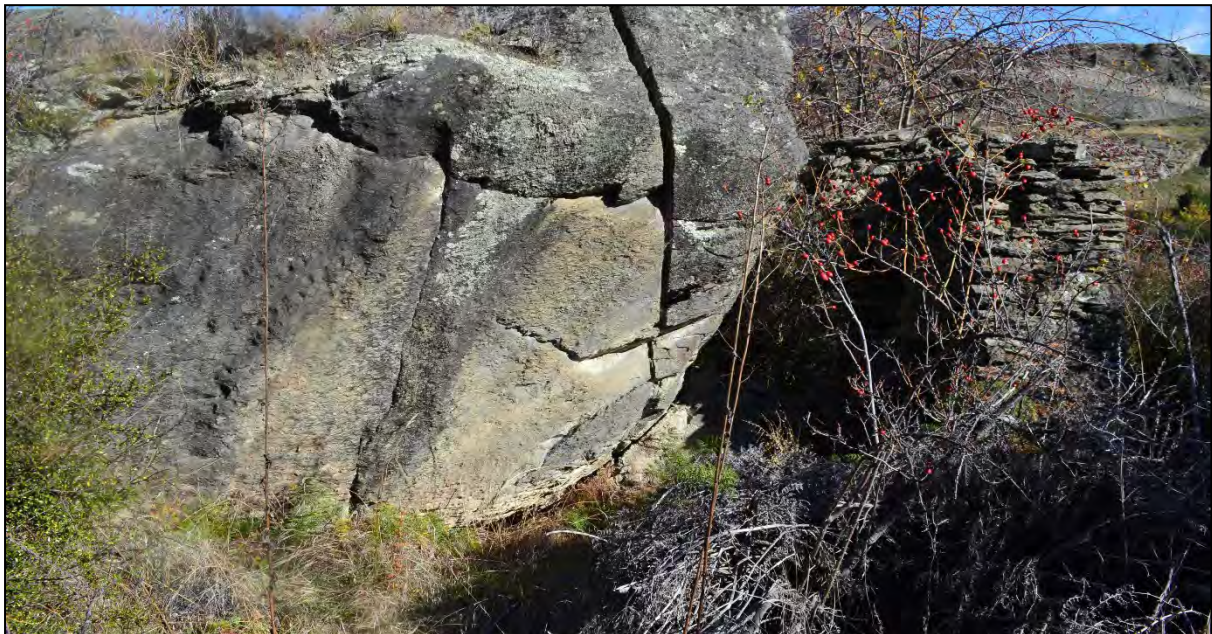
F41/824 – Stone Hut

Stone walled hut – measuring c. 5m x 3m – a large boulder forming the east wall. Low mud mortar stone walls appear to be original height; presumably these were topped with a canvas tent roof.

Figure 68. F41/824; looking south west at the hut site, with the chimney structure visible at the right of the image.

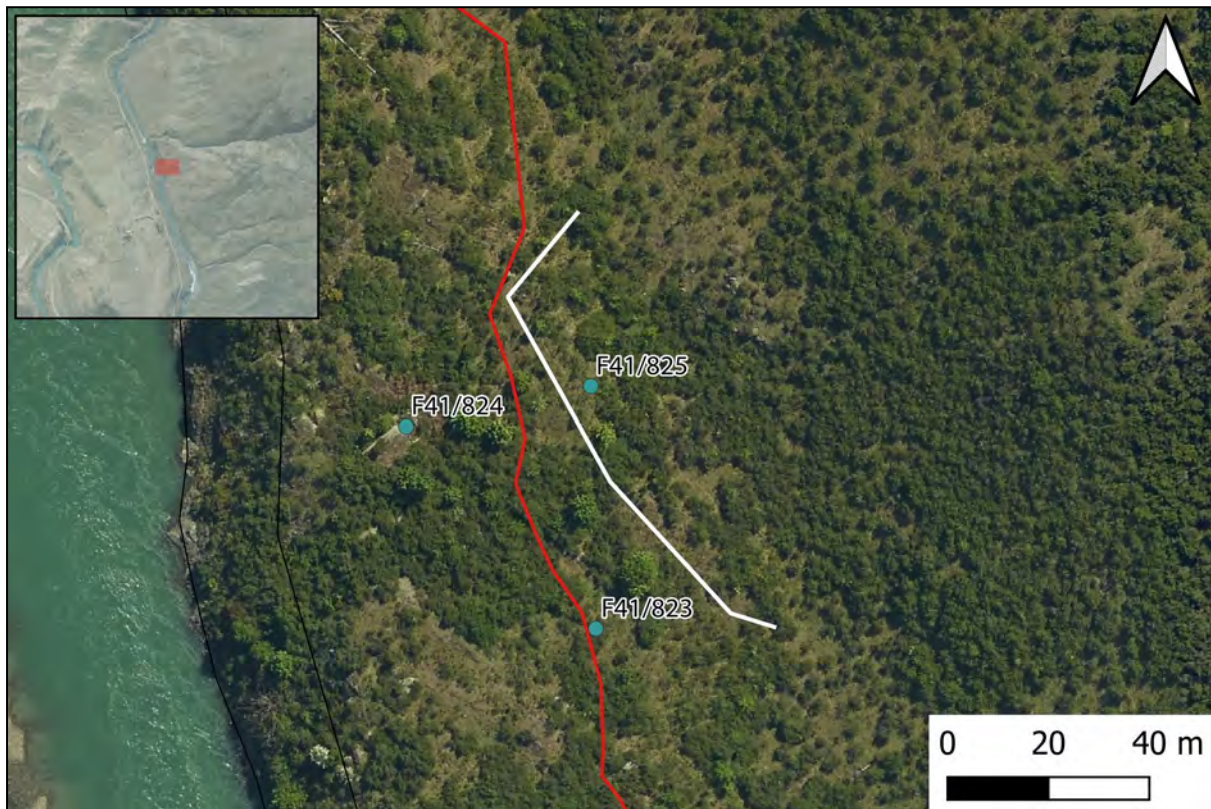
Figure 69. F41/825; the white solid lines indicate the approximate position of the dam walls.

If possible, the adjacent trail route should be moved slightly westwards to ensure that this feature is not damaged.

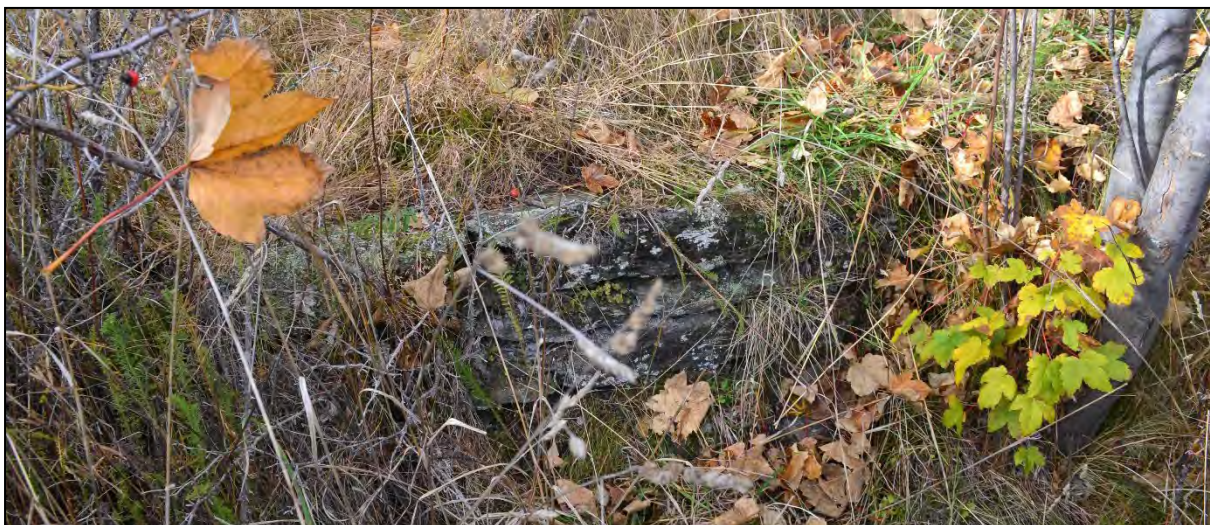
Figure 70. F41/825; an element of stone facing at the northern end of the dam.

Large earth dam with sections of stone facing. Currently overgrown and indistinct, but clear on 1964 aerial photographs. It appears that water flow from the channel behind has broken through the original dam wall.
