**Central Otago Queenstown Trail Network Trust: Kawarau Gorge**

The following comments relate to our joint field trip to various places along the proposed Kawarau Gorge Trail undertaken on 20 June 2019. The purpose of the field trip was to inspect critical trail sections requiring geotechnical assessment as identified in emails dated 14 & 15/05/19.

# Archaeological Assessment for the Kawarau Gorge Cycle Trail

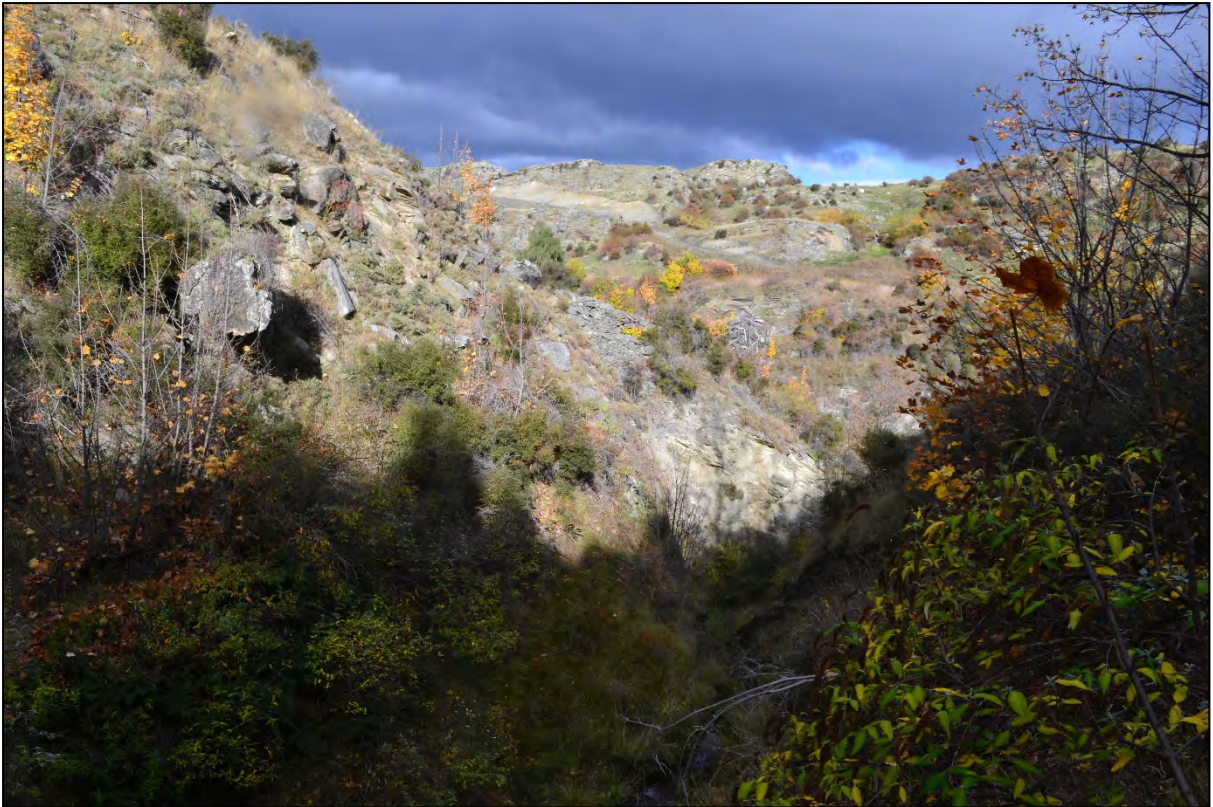
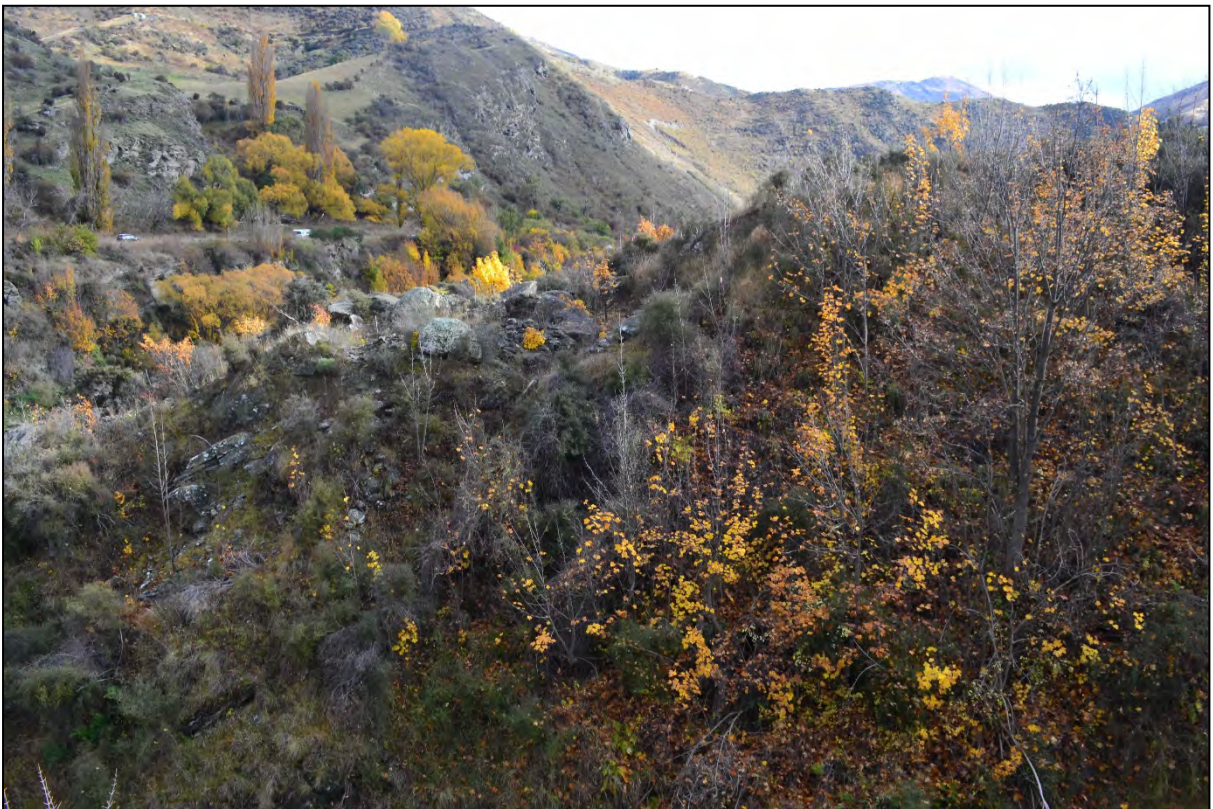
F41/826 – Sluicings and Tailings

Figure 72. F41/826; looking east up the sluiced gully with a tailings pile at the centre of the image.

Figure 73. F41/826; looking north across the gully mouth at a sluiced area filled with tailings piles.

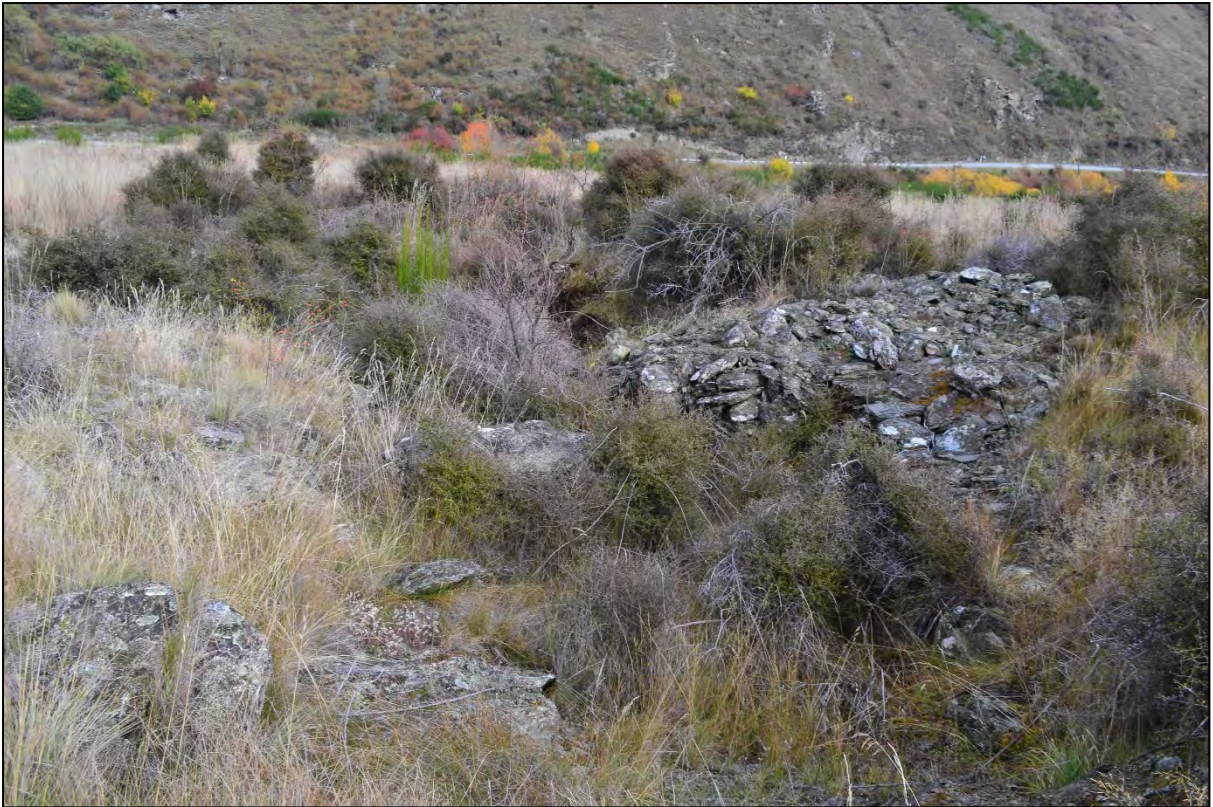
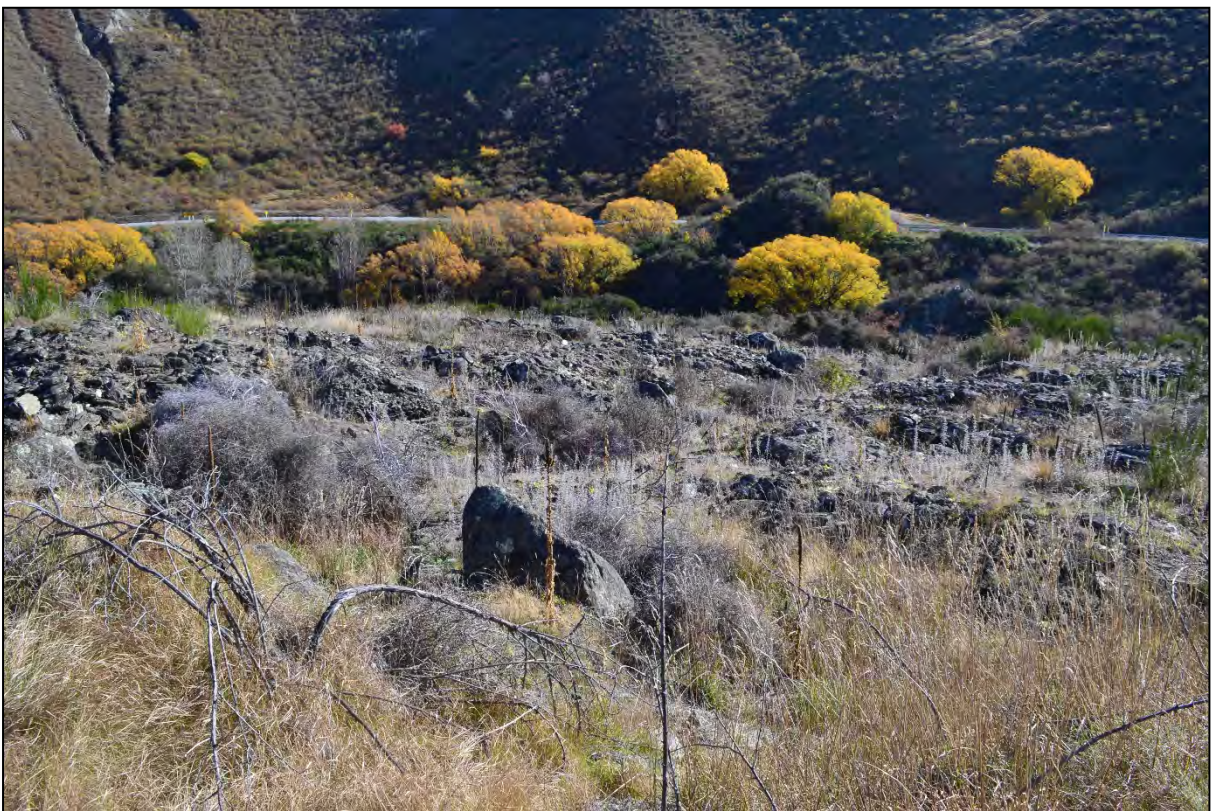
F41/432 – Sluicings and Tailings

Figure 75. F41/432; looking east across the sluicings and tailings at the southern end of the site area.

Figure 76. F41/432; looking north-east along the herringbone tailings at the northern end of the site.

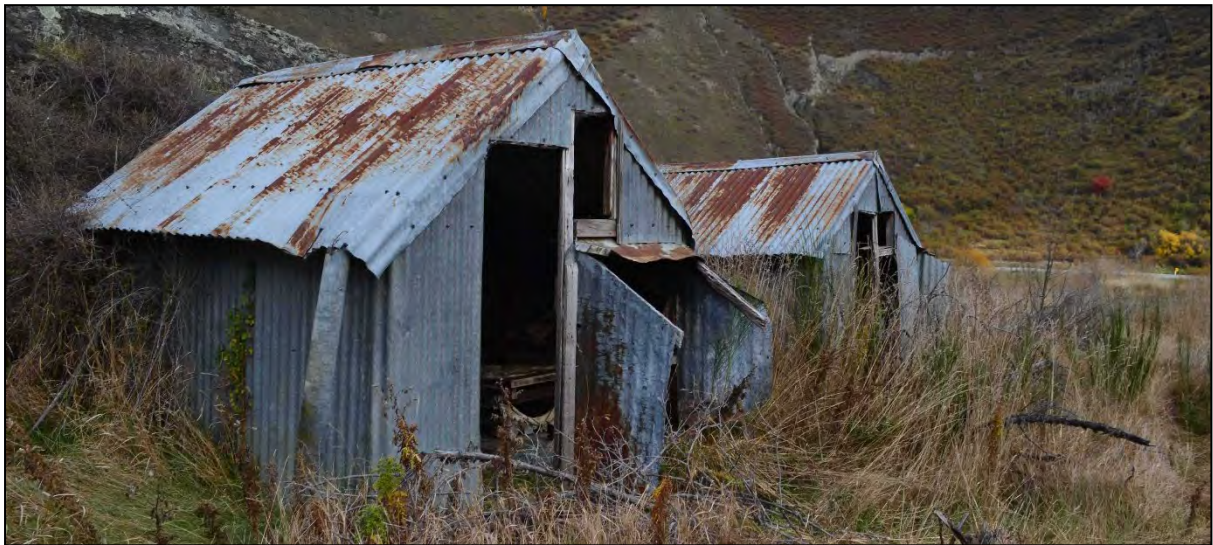
Figure 78. F41/433; looking west at the rabbiters' huts.

Two 2.5m x 3m rabbiters' huts clad in corrugated iron. In poor condition with floors collapsing and other building elements missing. Thought to date to the 1920s-1930s.

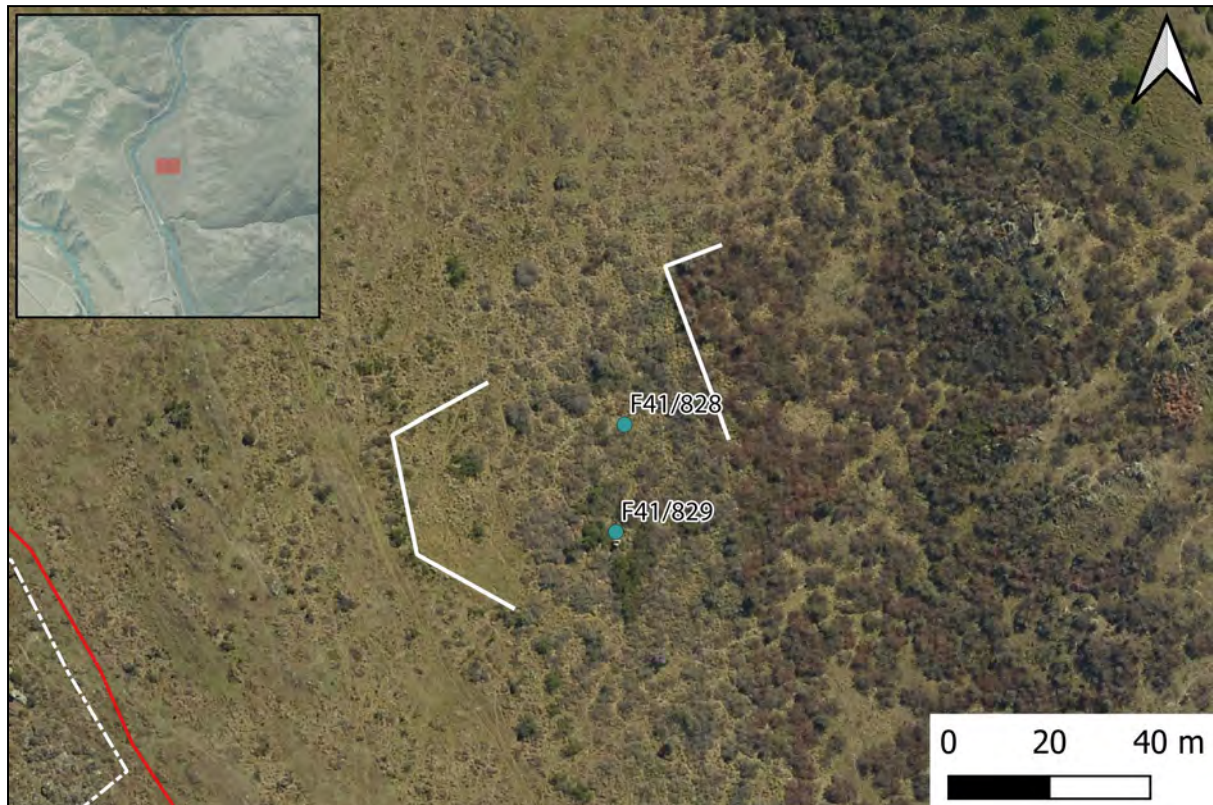
Figure 79. F41/828; the white solid lines indicate the approximate position of the dam walls.

The lower dam is in close proximity to the 4WD track coming down from Mt Difficulty. Care should be taken not to damage it if bringing vehicles and machinery onto the flat via this route.

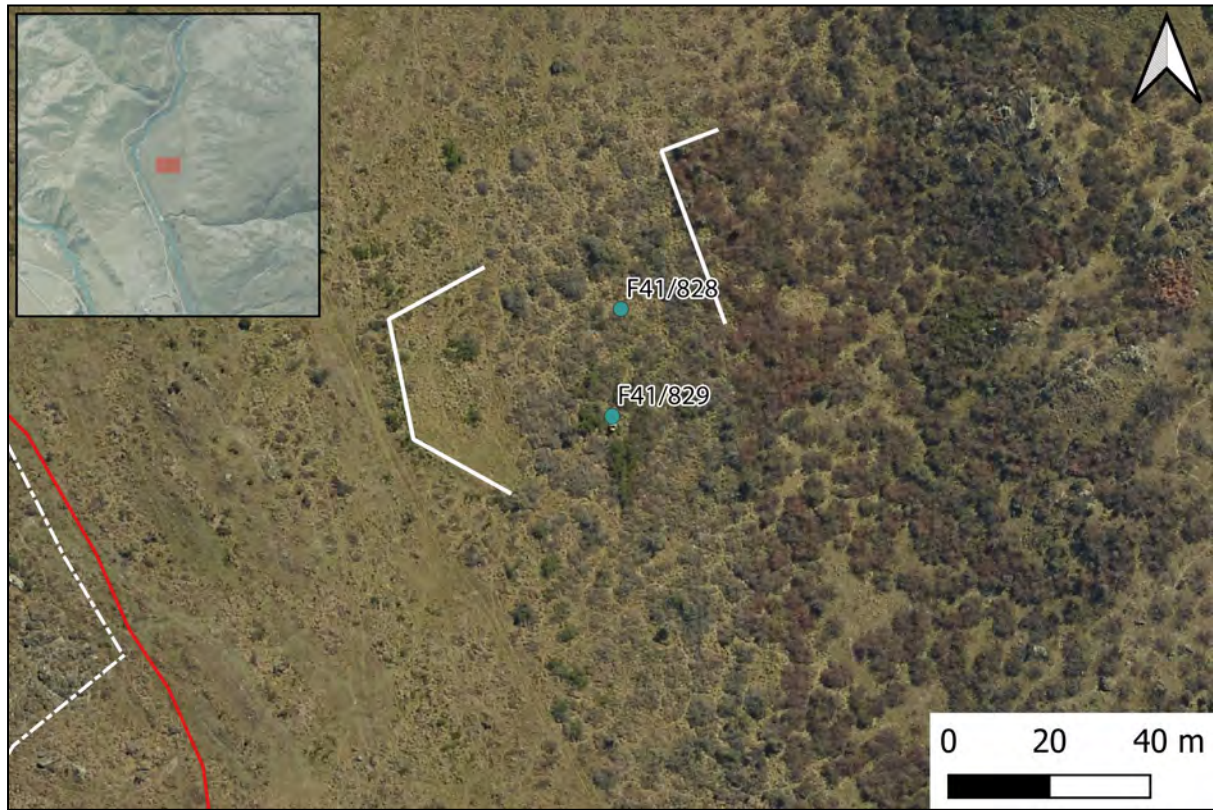
Figure 80. F41/829.

Stone structure flanked by the two dams at F41/828. Likely associated with the sluicings at F41/432 and possibly F41/827. Identified from 1964 and modern aerial photographs, not located on the ground.

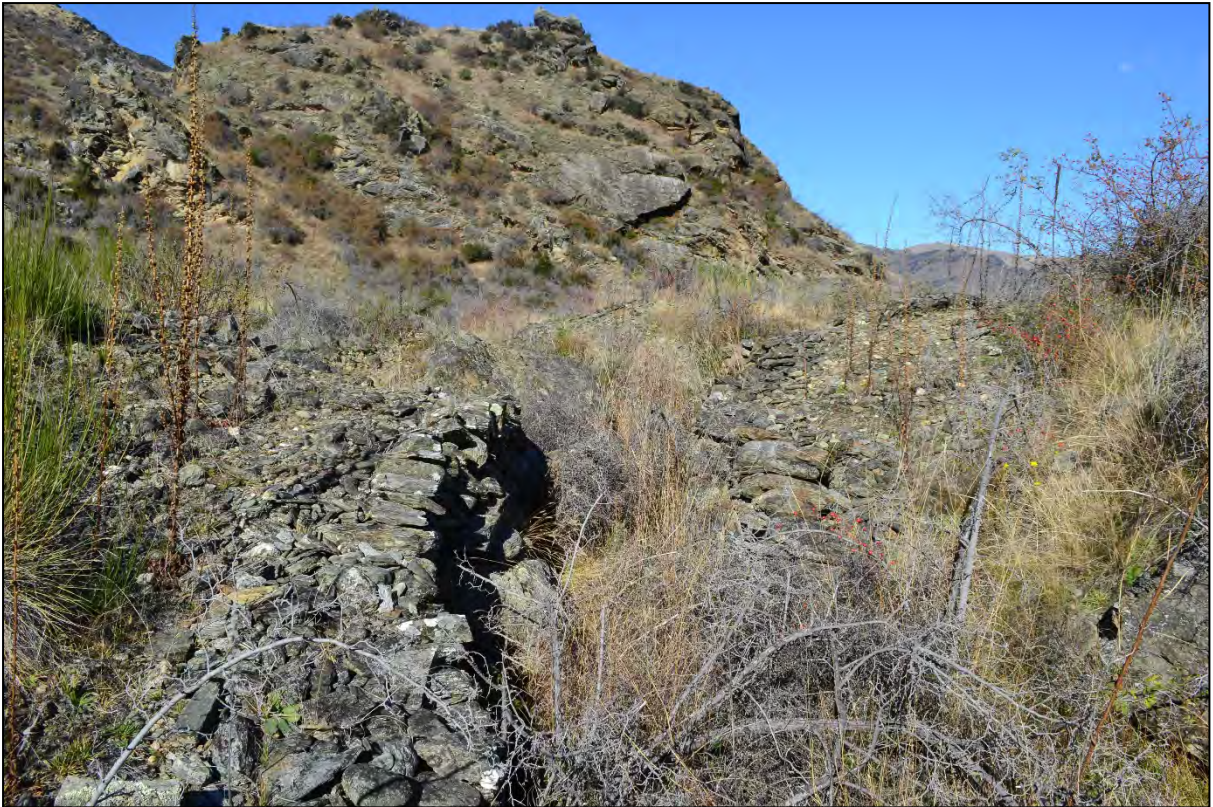
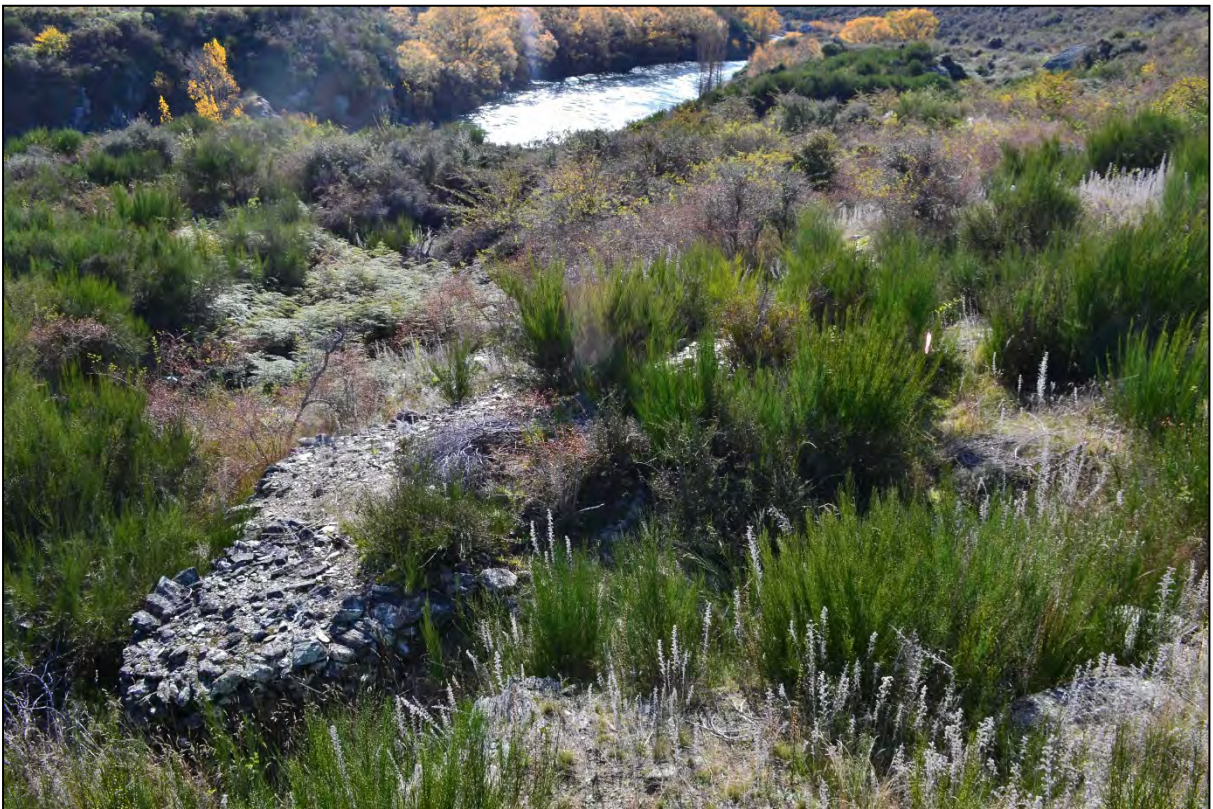
F41/827 – Sluicings and Tailings

Figure 82. F41/827; looking south along one of the well-formed sludge channels.

Figure 83. F41/827; looking north at the stone feature avoided by the lowered trail route.

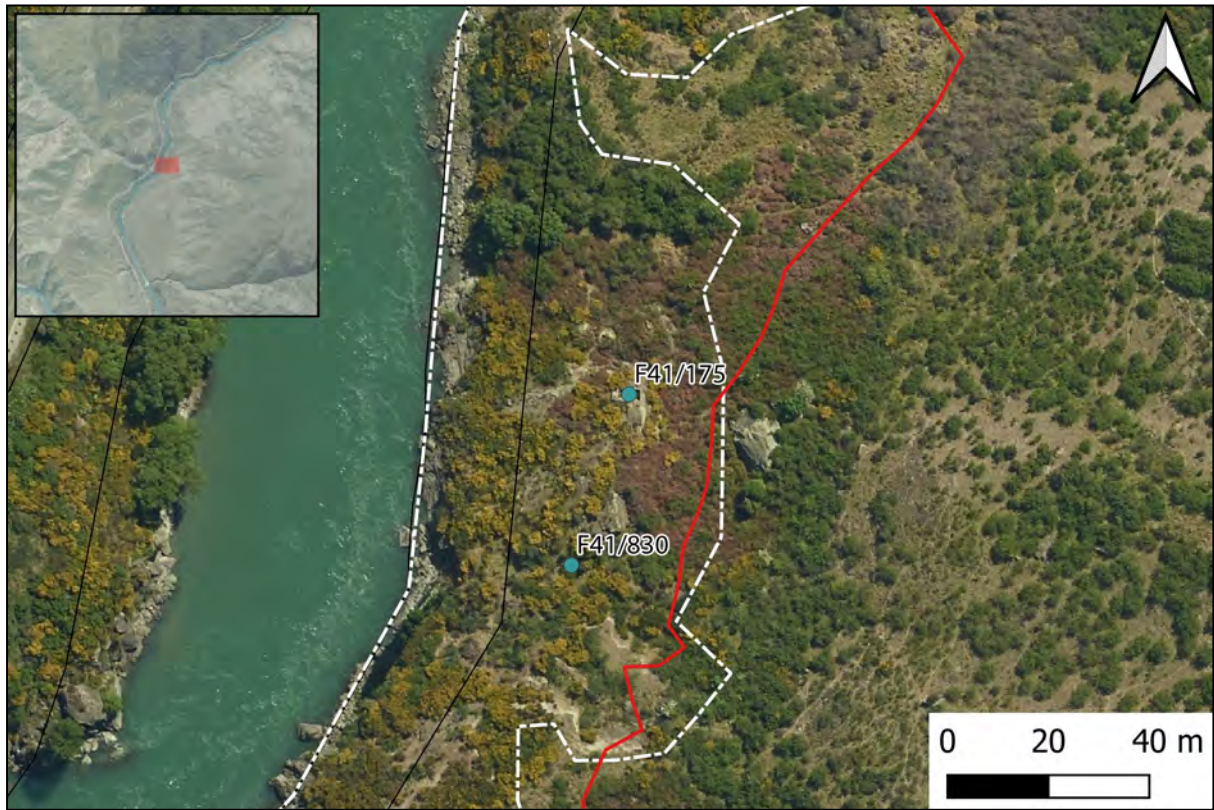
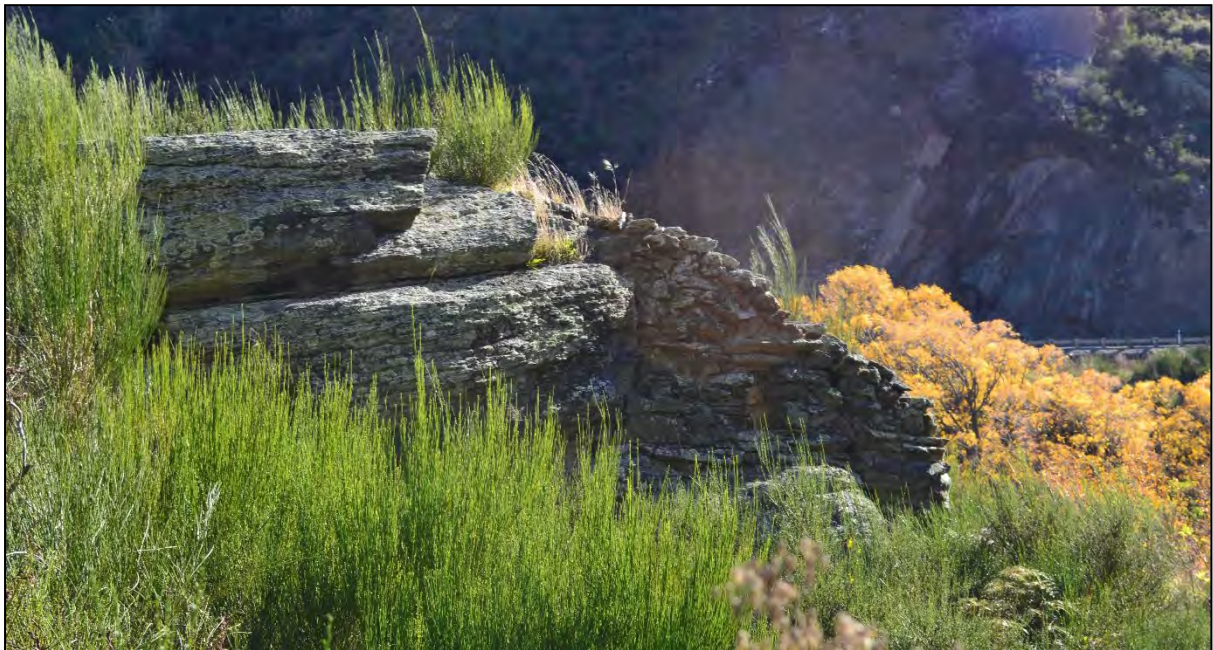
F41/175 – Stone House

Mud-mortared, c. 3m x 4m stone structure sitting on a dry stacked stone plinth. In excellent condition. Likely associated with the sluicings at F41/830.

Figure 87. F41/175; the east exterior wall of the house.

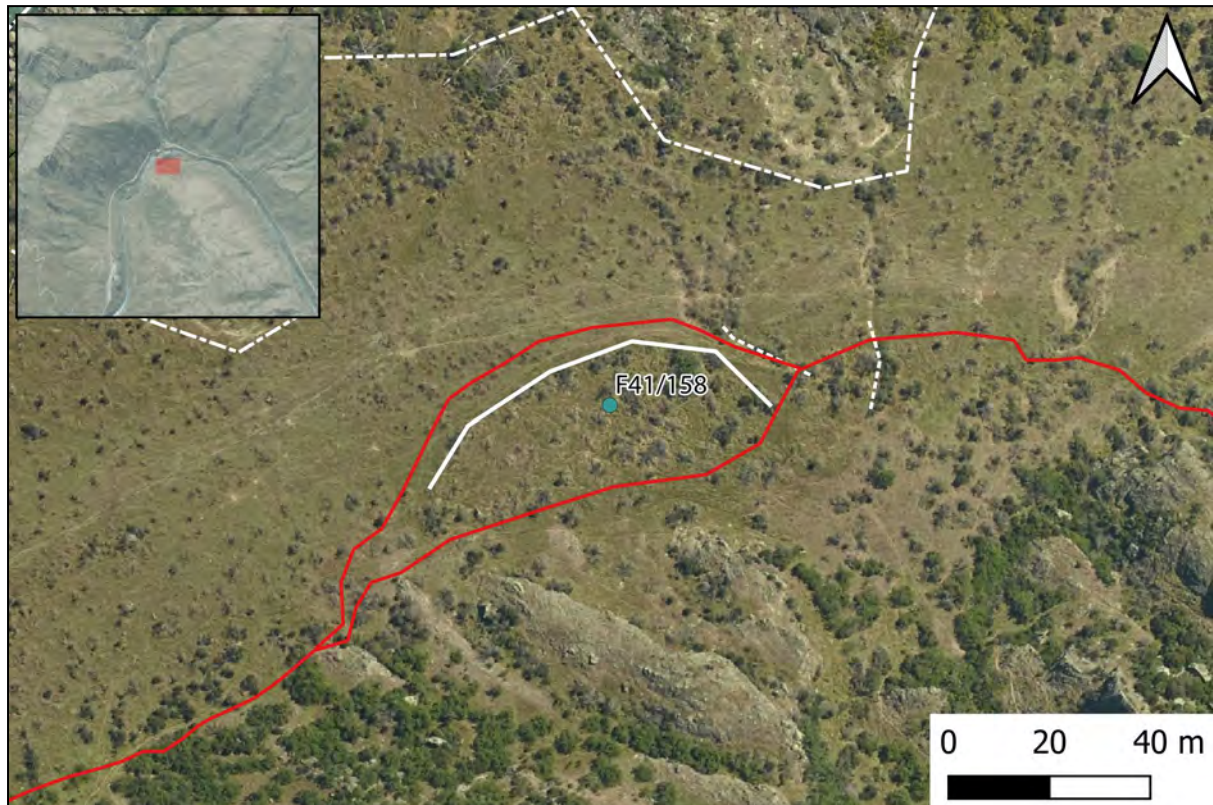
Figure 94. F41/158; the white solid lines indicate the approximate position of the dam walls and the dotted line marks a water race segment.

The southern route option along the rear of the dam is preferred to reduce visibility from the Roaring Meg look out and keep earthworks mostly away from the dam wall. A fragment of dam wall and the two races will be damaged by the route.

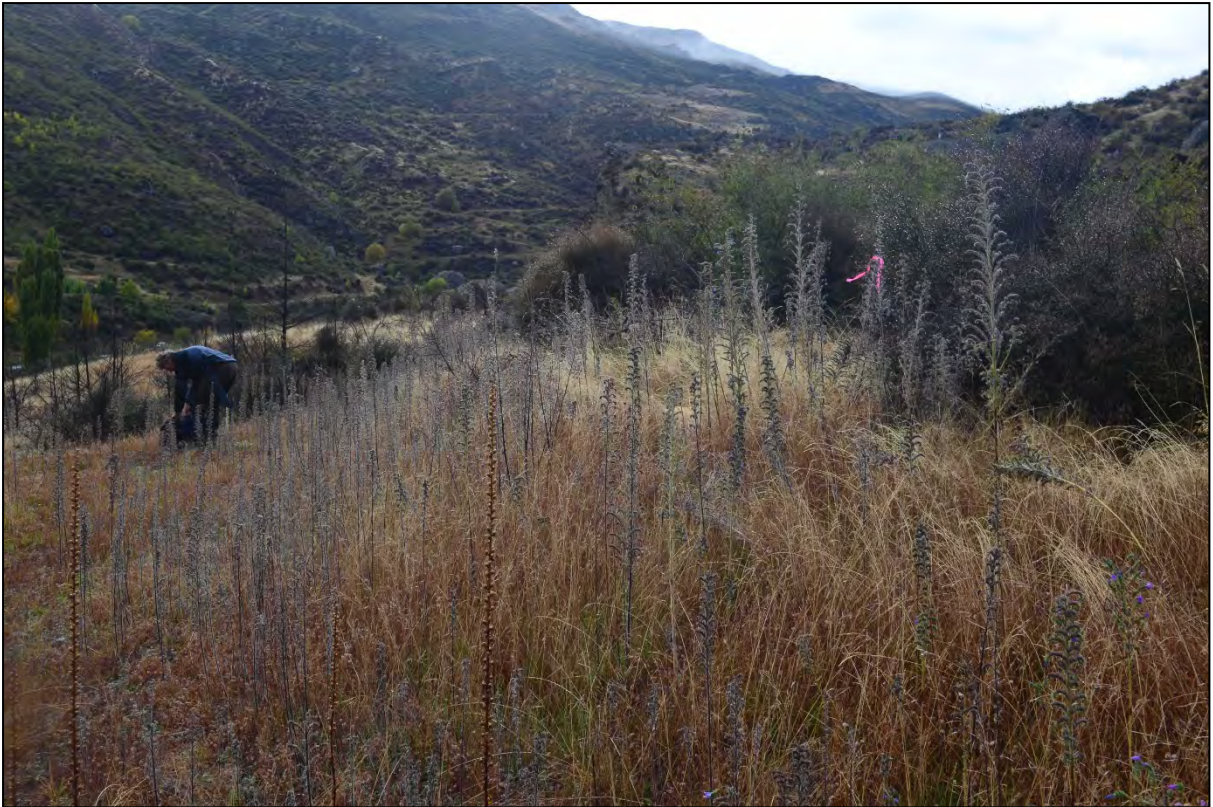
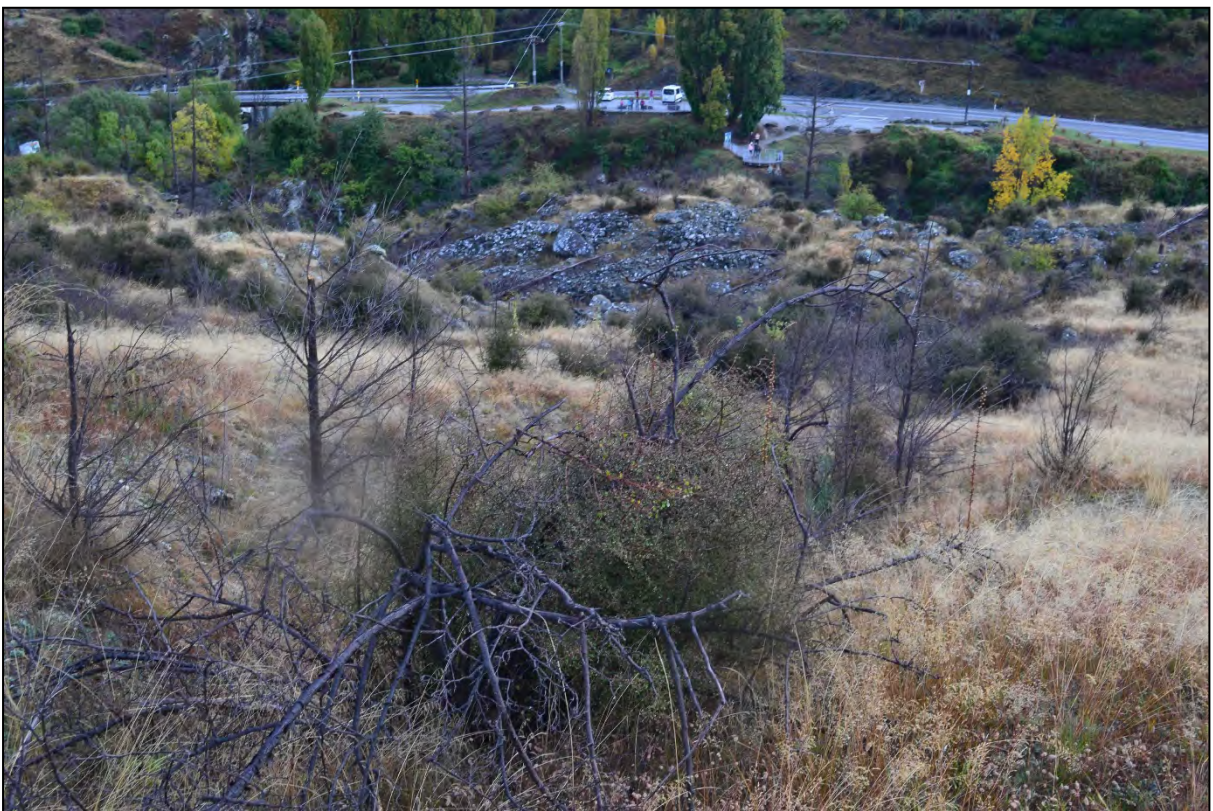
Figure 95. F41/158; looking east along the edge of the dam embankment.

Figure 96. F41/158; looking along the westernmost race towards F41/161.

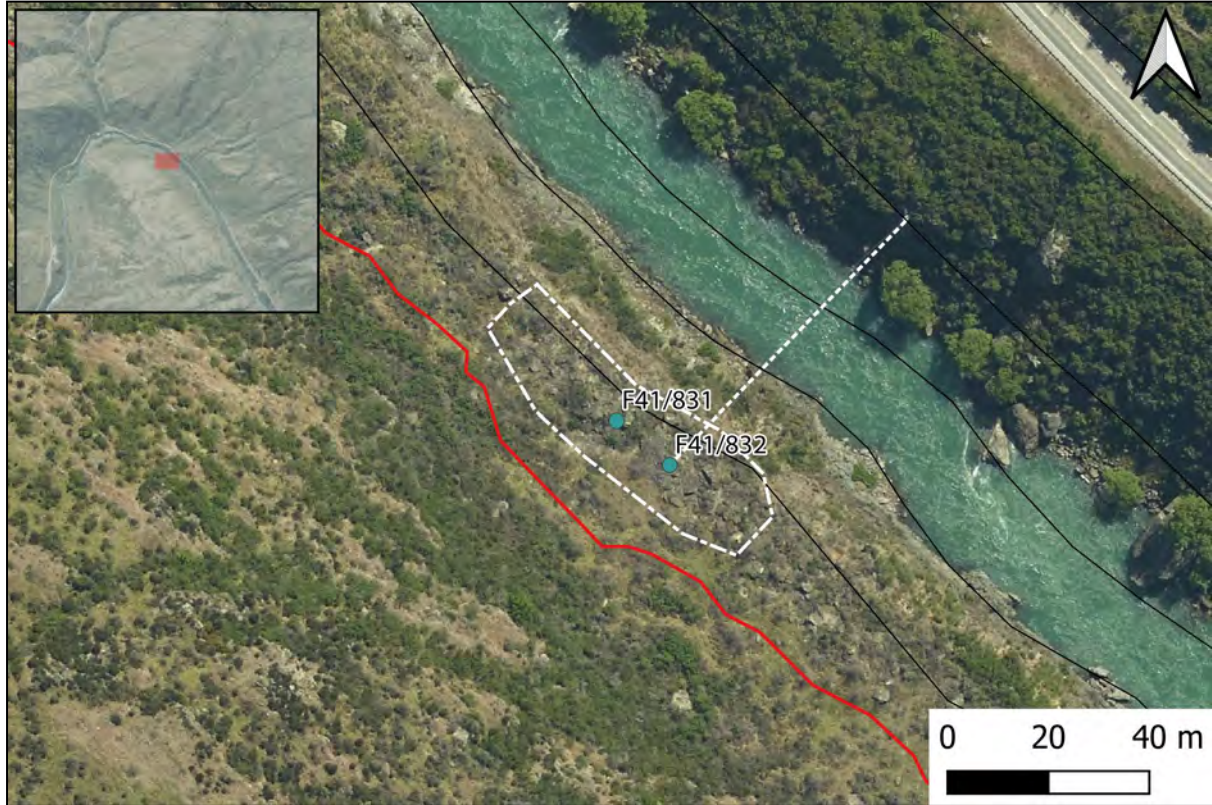
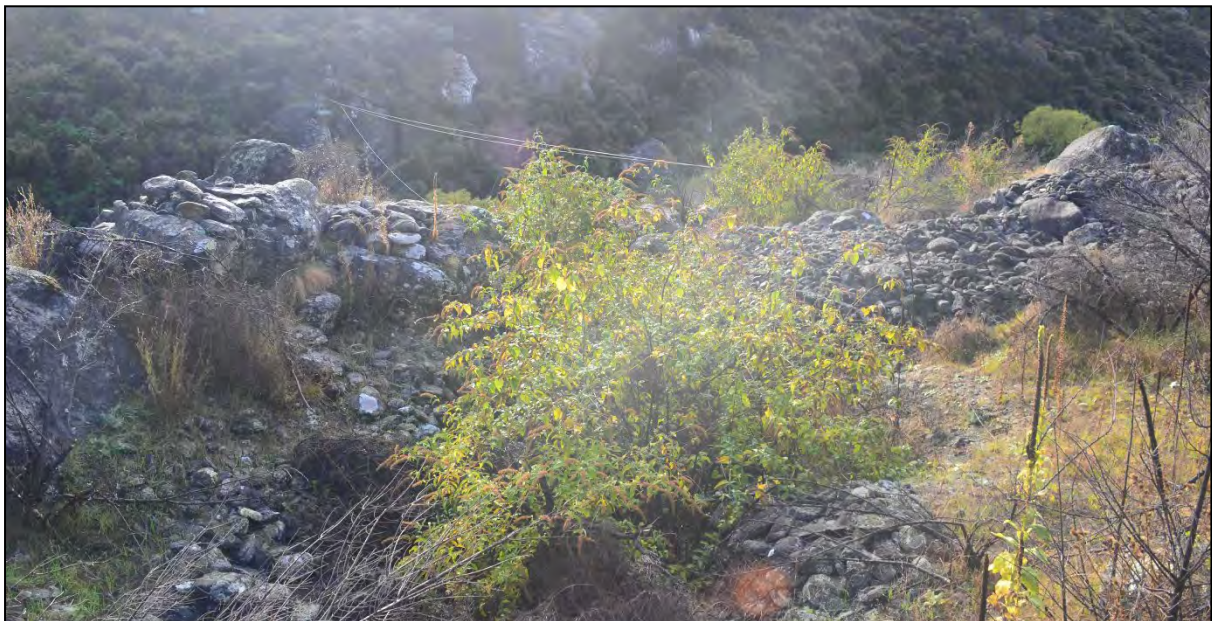
F41/831 – Tailings

Area of amorphous tailings – circa 70m x 20m – on a small terrace above the Kawarau.

Figure 99. F41/831; the white dashed line indicates the approximate site boundary.

Figure 100. F41/831; looking east across the tailings with the cableway visible in the background.

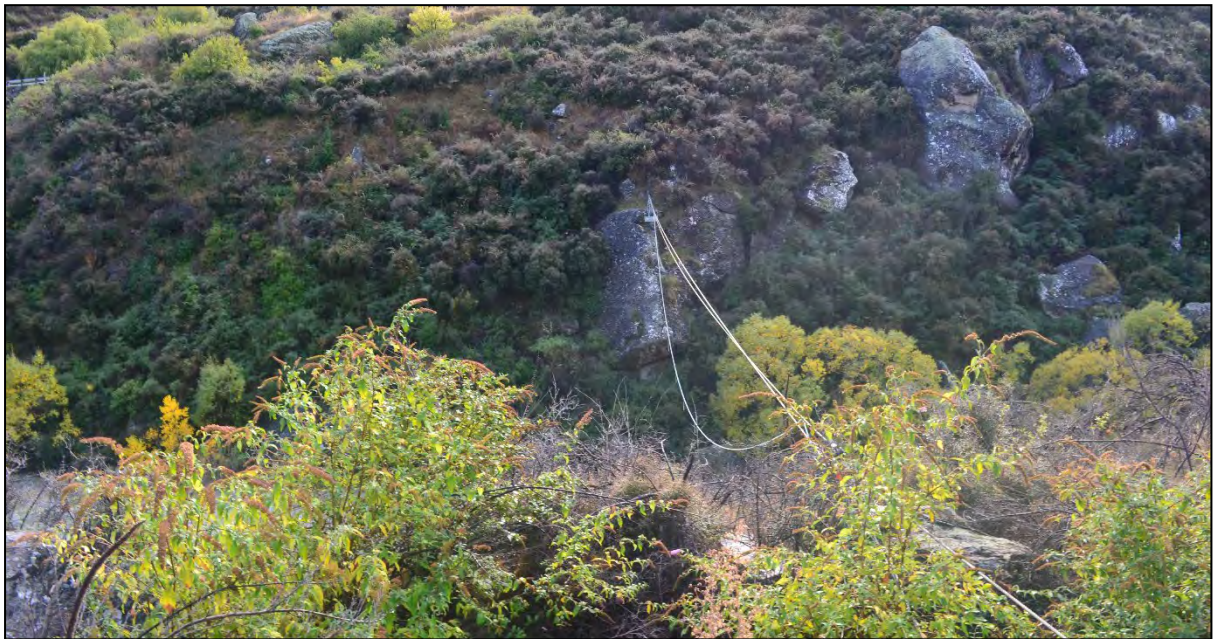
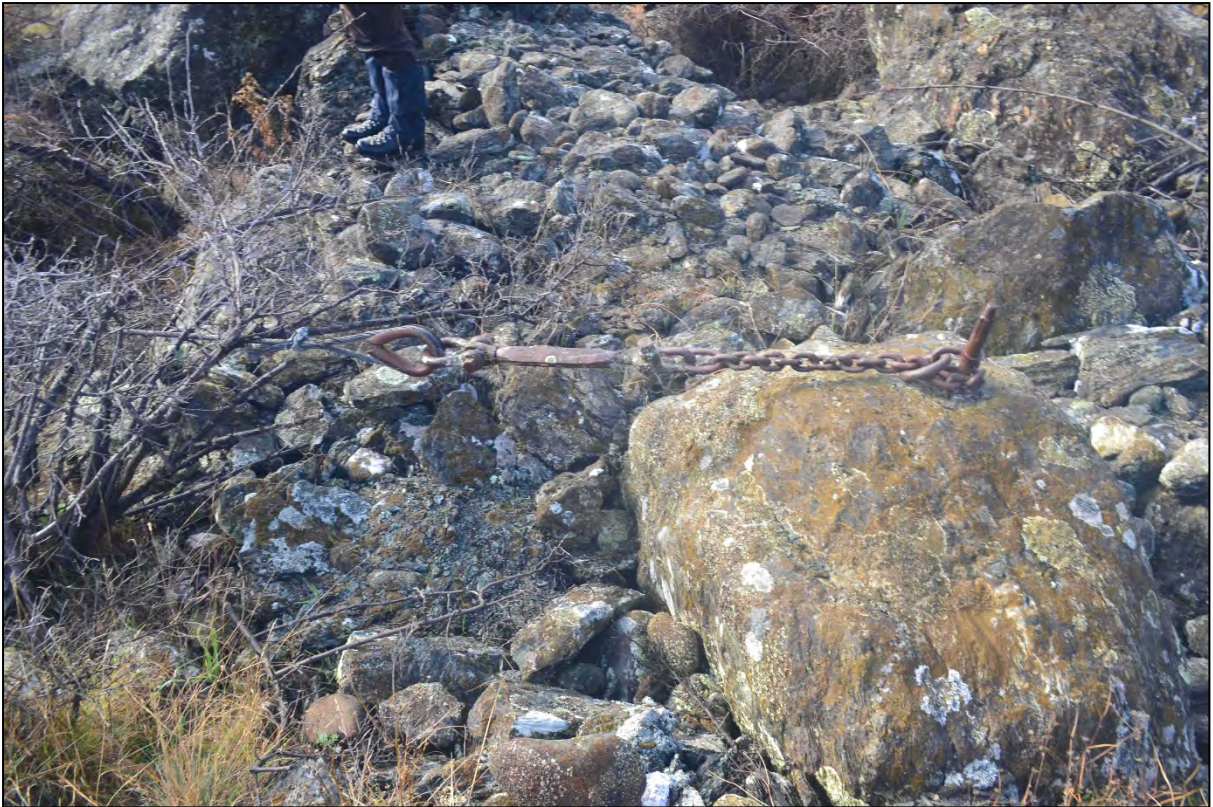
F41/832 - Cableway

Figure 102. F41/832; looking north-east at the cableway across the Kawarau.

Figure 103. F41/832; cableway anchor.

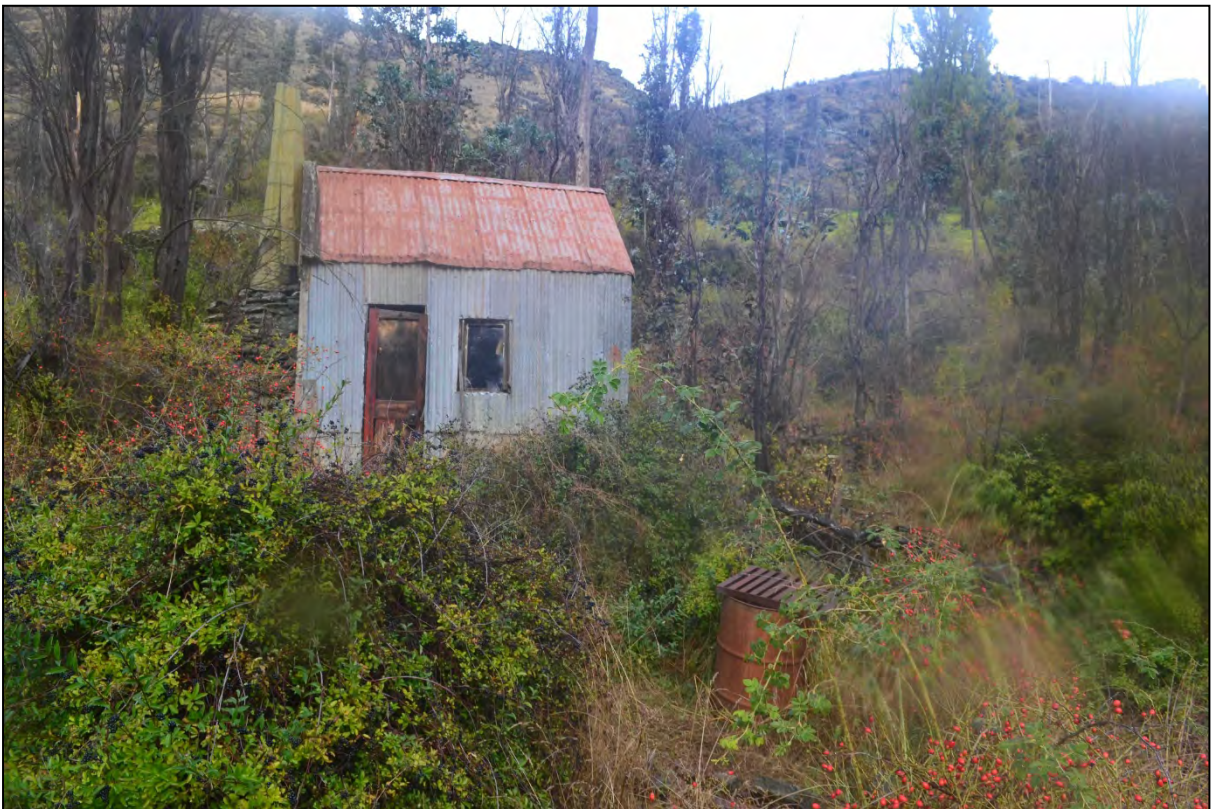
Figure 106. F41/429; looking south-west at Cleghorn's hut across a sluiced area.

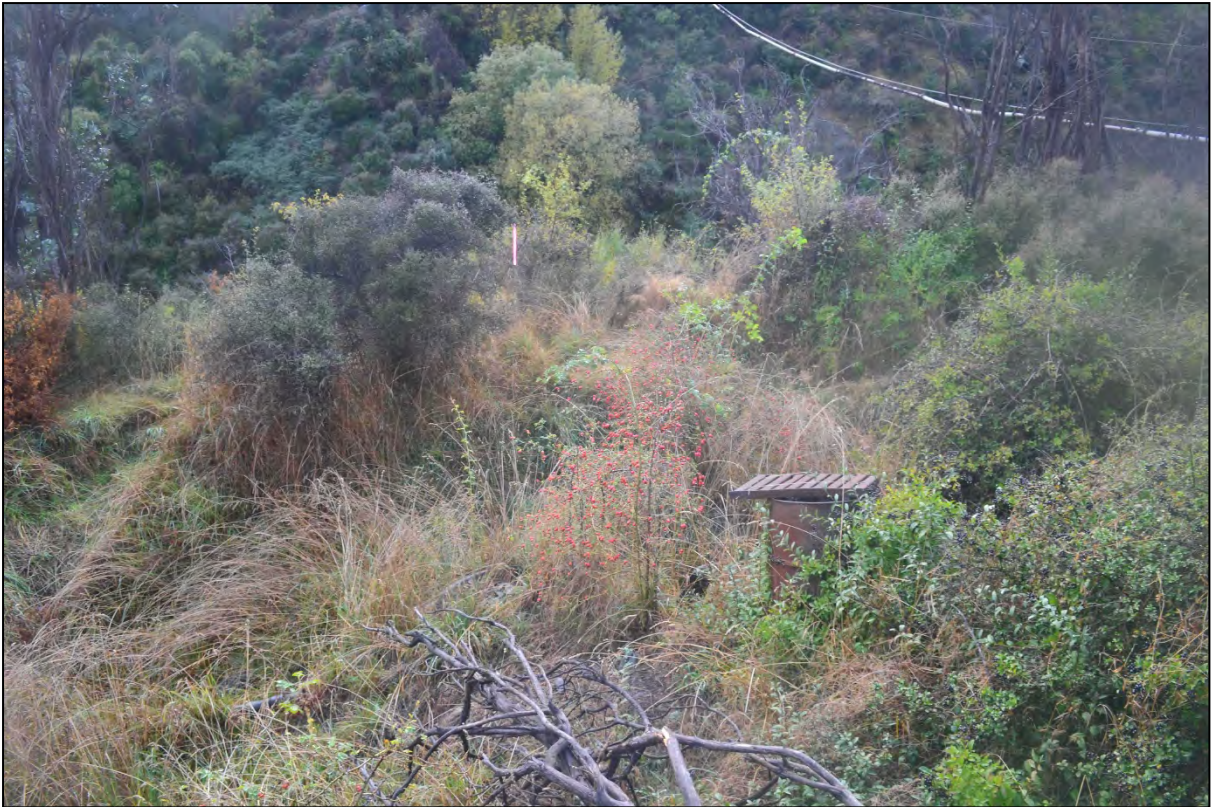
Figure 107. F41/429; looking north-east from Cleghorn's Hut with the suspended sluice pipe visible in the background.

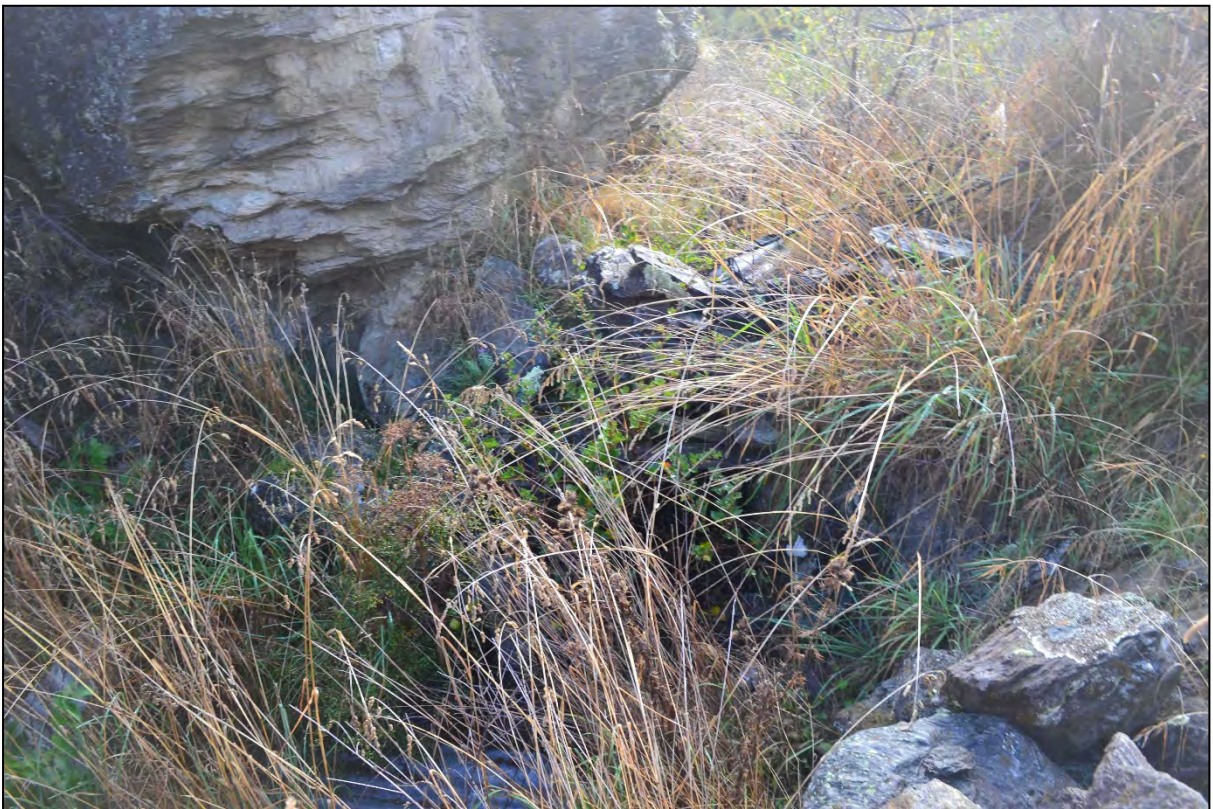
Figure 108. F41/429; looking north-east at the small dam.

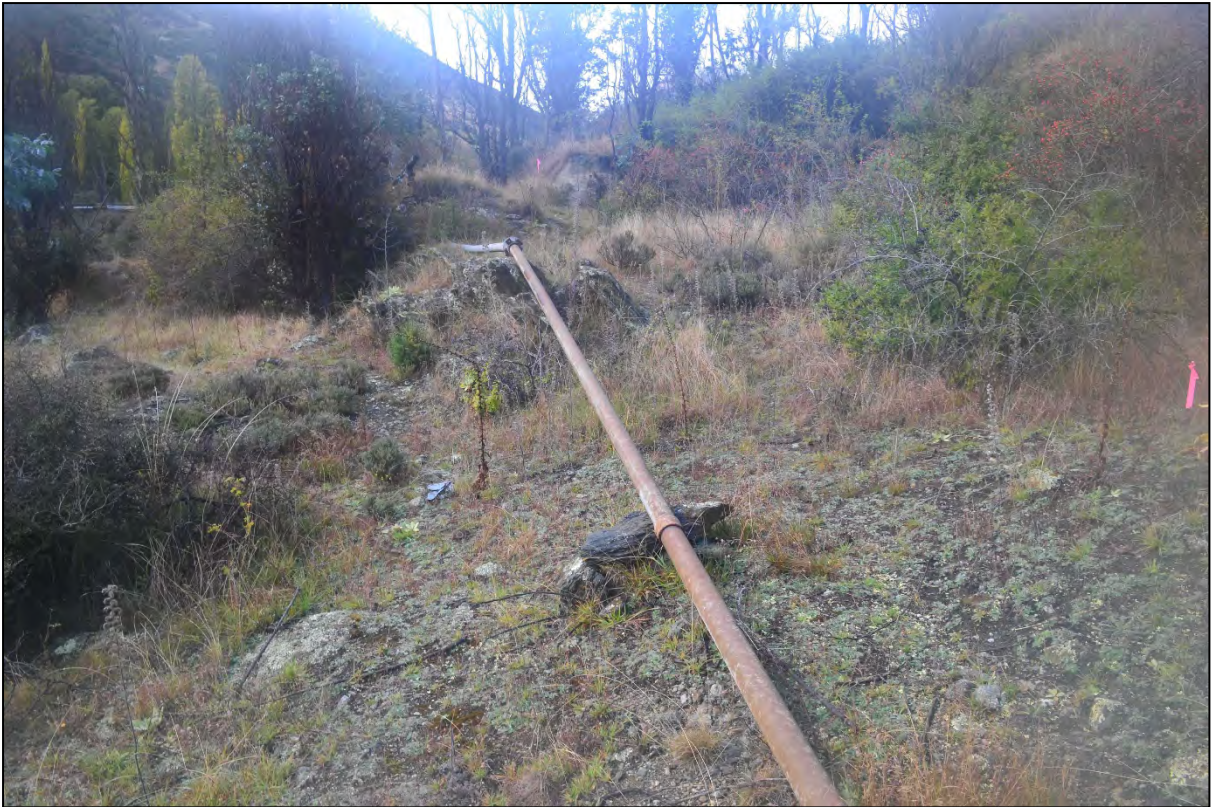
Figure 109. F41/429; looking south-east along the flume pipe segment to the north-west of the hut.

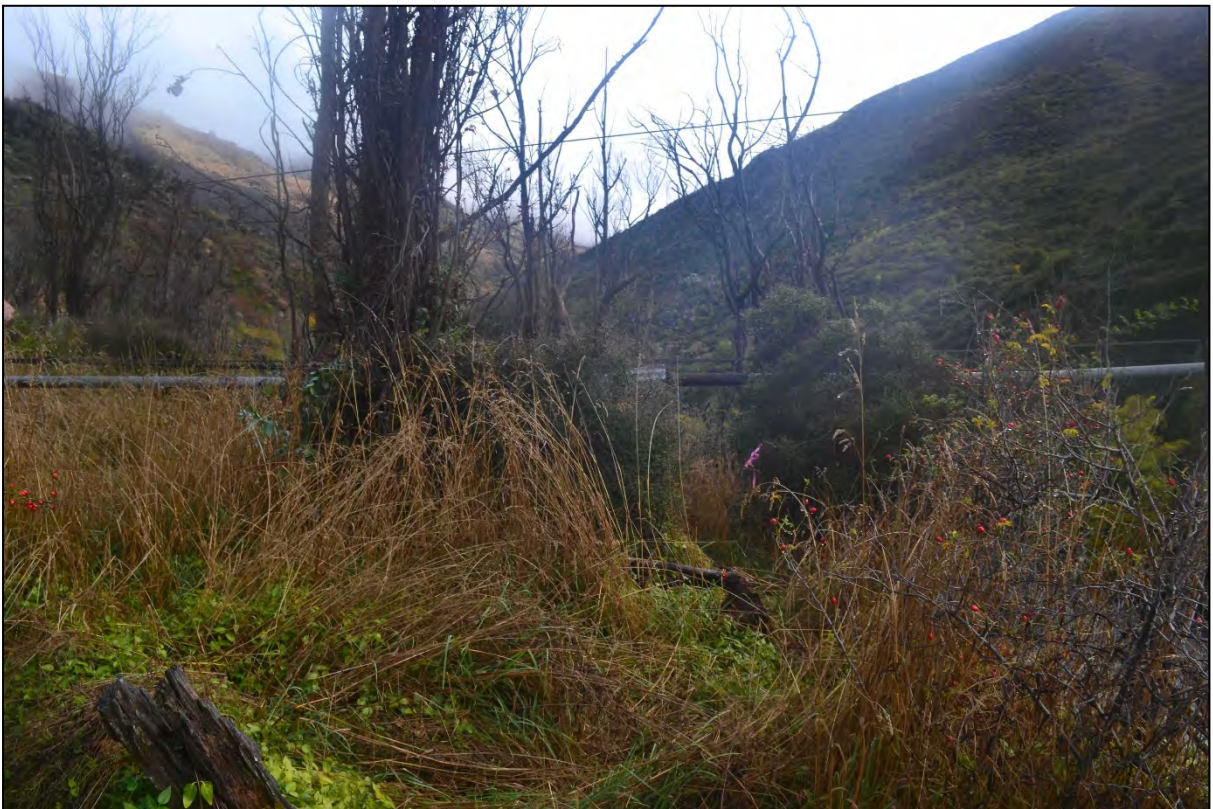
Figure 110. F41/429; looking north-west along the trail route where it runs across the suspended flume pipe to the east of the hut.

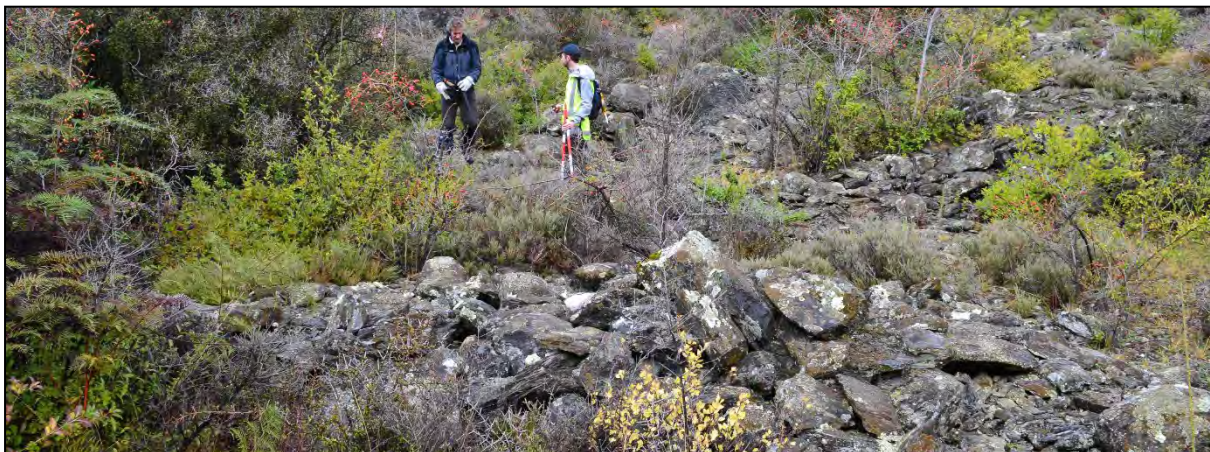
Figure 112. F41/154; looking south-west across the tailings at the north end of the site.
