**Central Otago Queenstown Trail Network Trust: Kawarau Gorge**

The following comments relate to our joint field trip to various places along the proposed Kawarau Gorge Trail undertaken on 20 June 2019. The purpose of the field trip was to inspect critical trail sections requiring geotechnical assessment as identified in emails dated 14 & 15/05/19.

# Archaeological Assessment for the Kawarau Gorge Cycle Trail

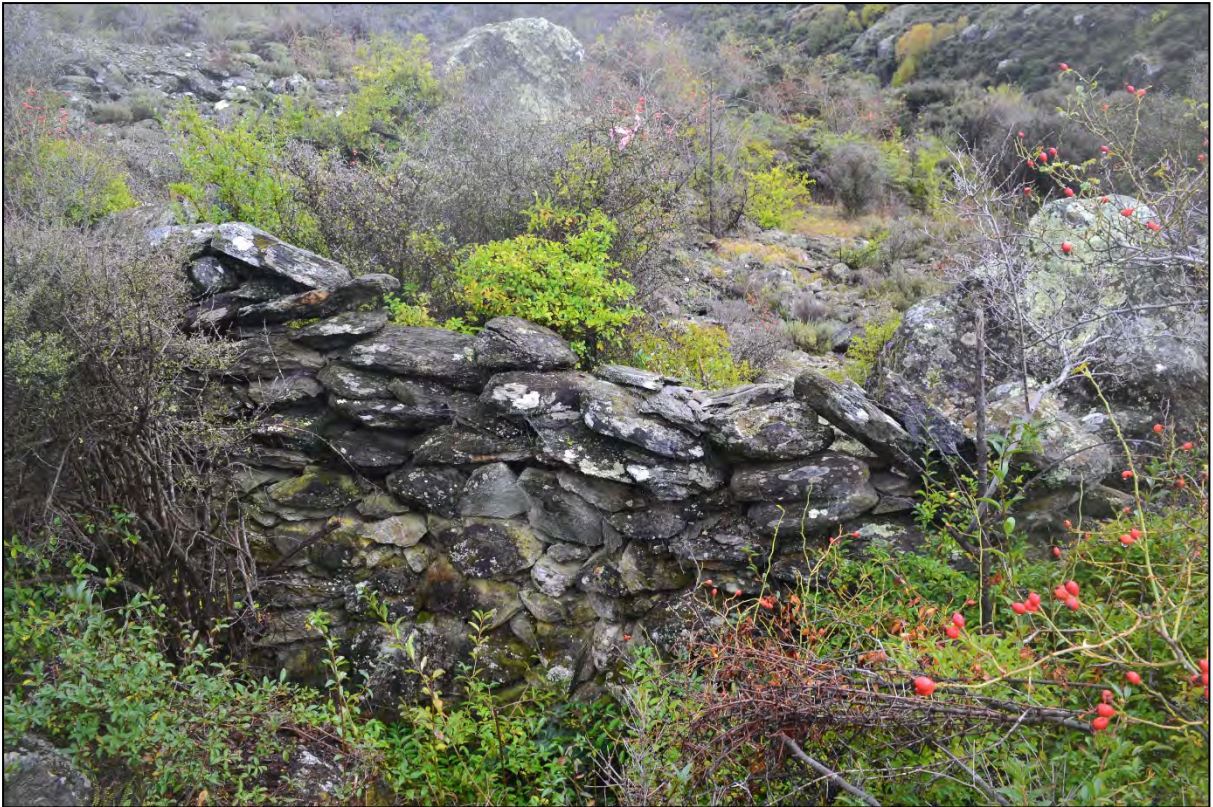
Figure 113. F41/154; looking north at the sludge channel wall.

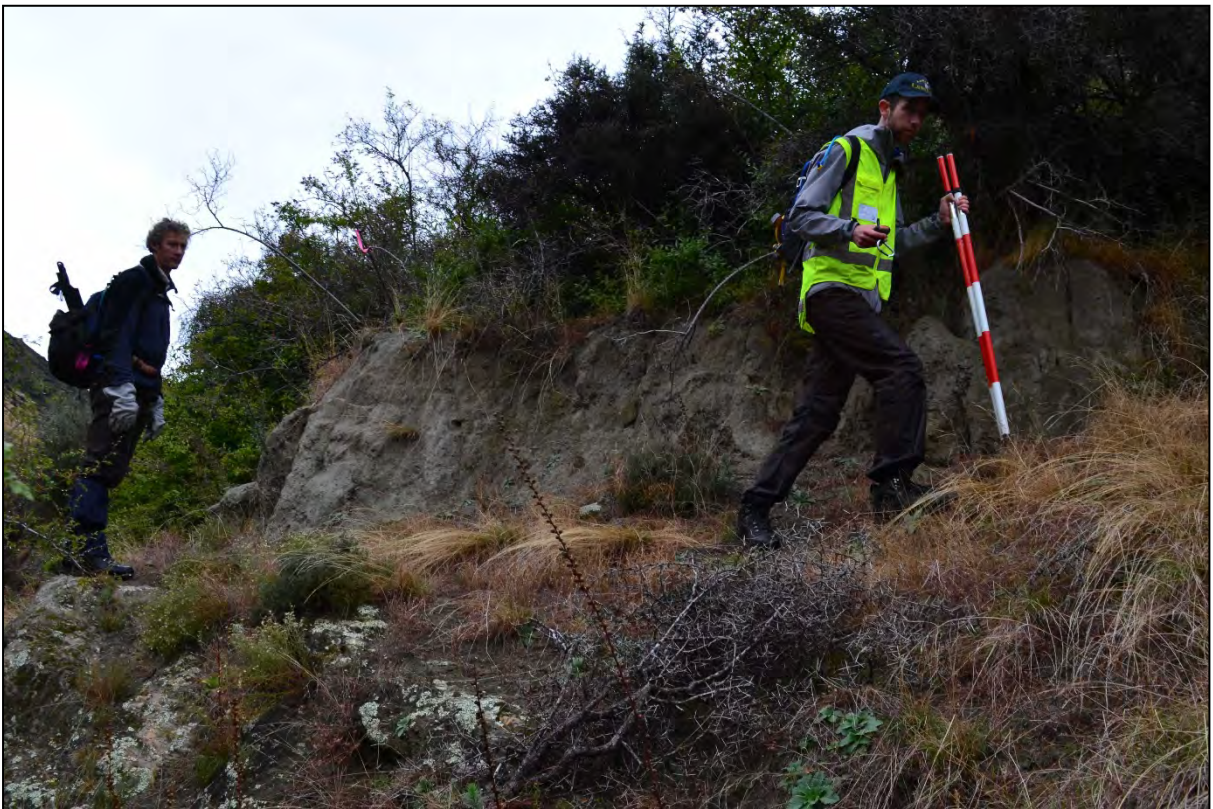
Figure 114. F41/154; looking south at sluice faces at the southern end of the site.

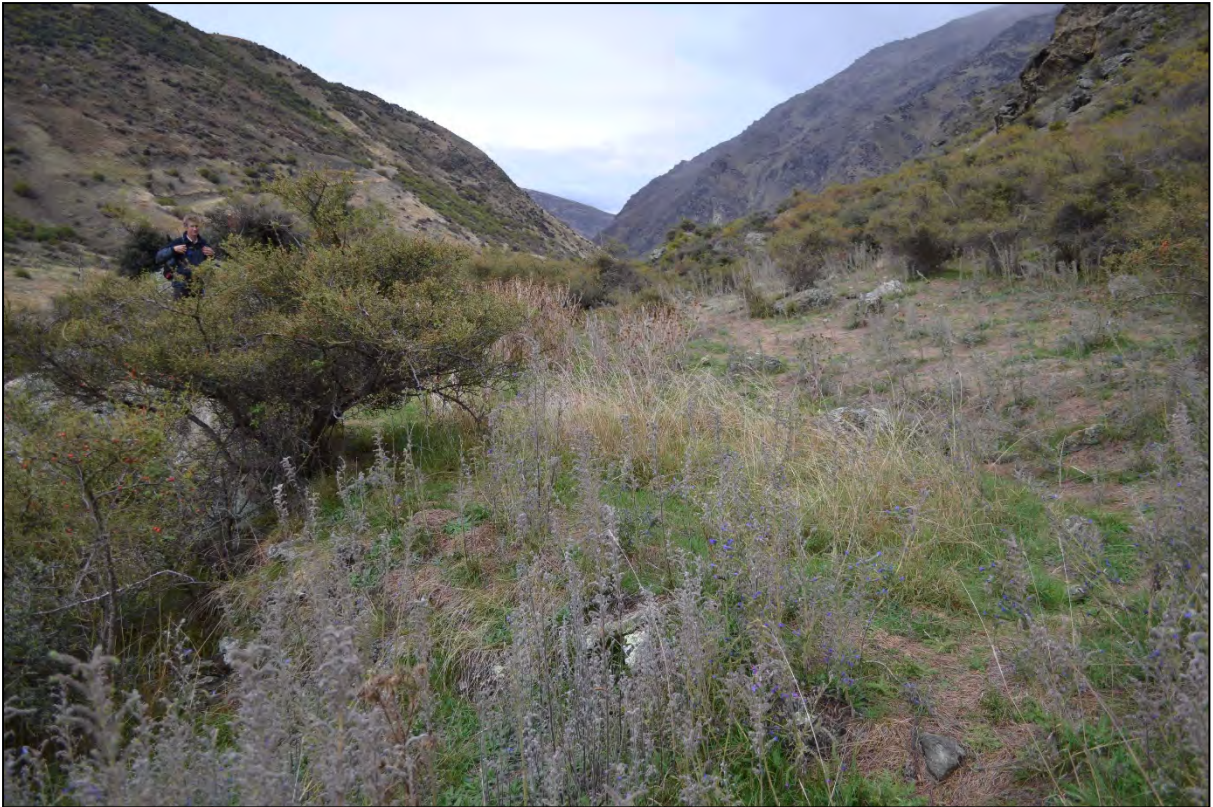
Figure 118. F41/145; looking south across the upper dam.

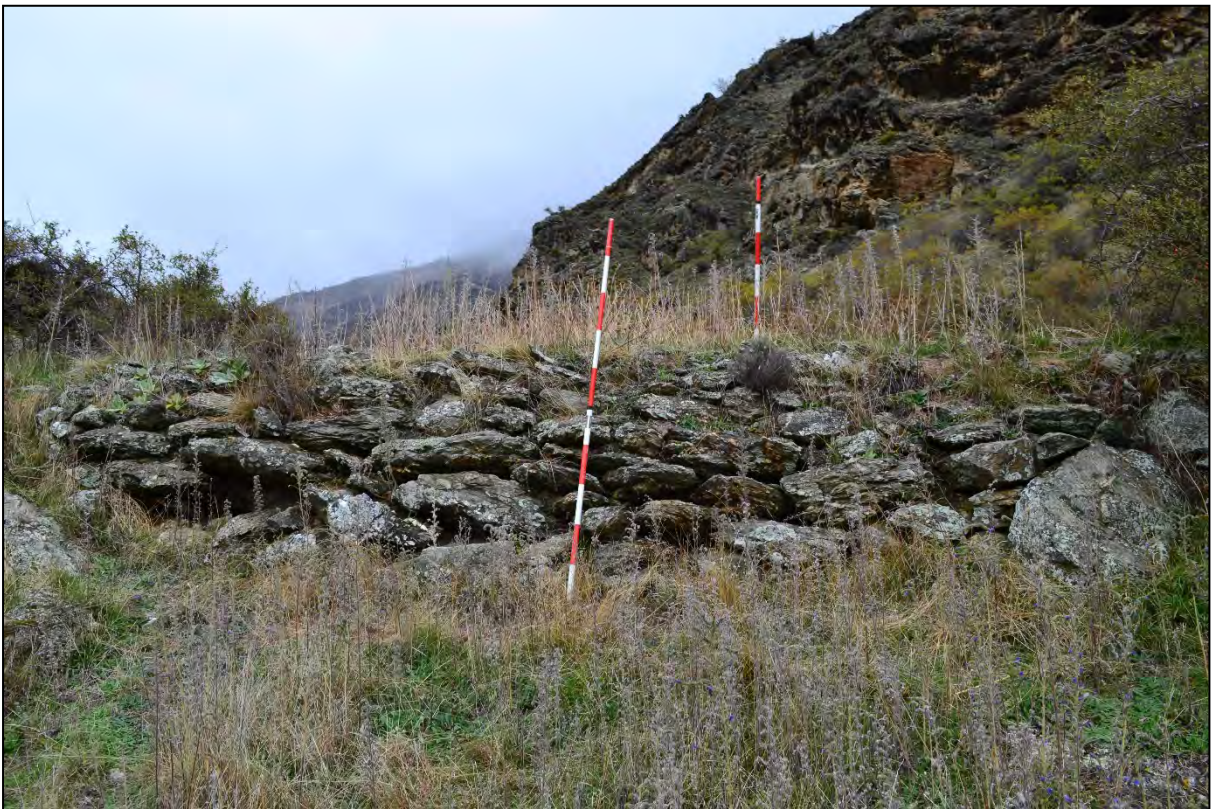
Figure 119. F41/145; looking south at the stone facing at the north end of the upper dam.

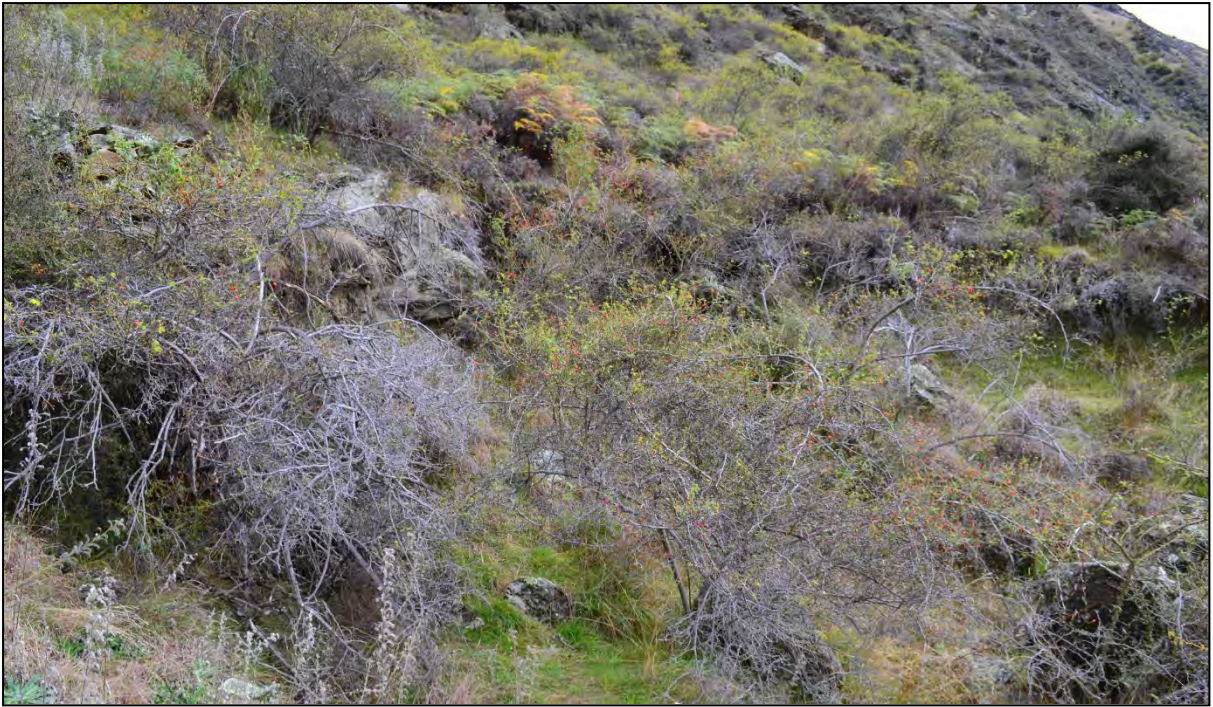
Figure 121. F41/833; looking north-west across the sluiced area.

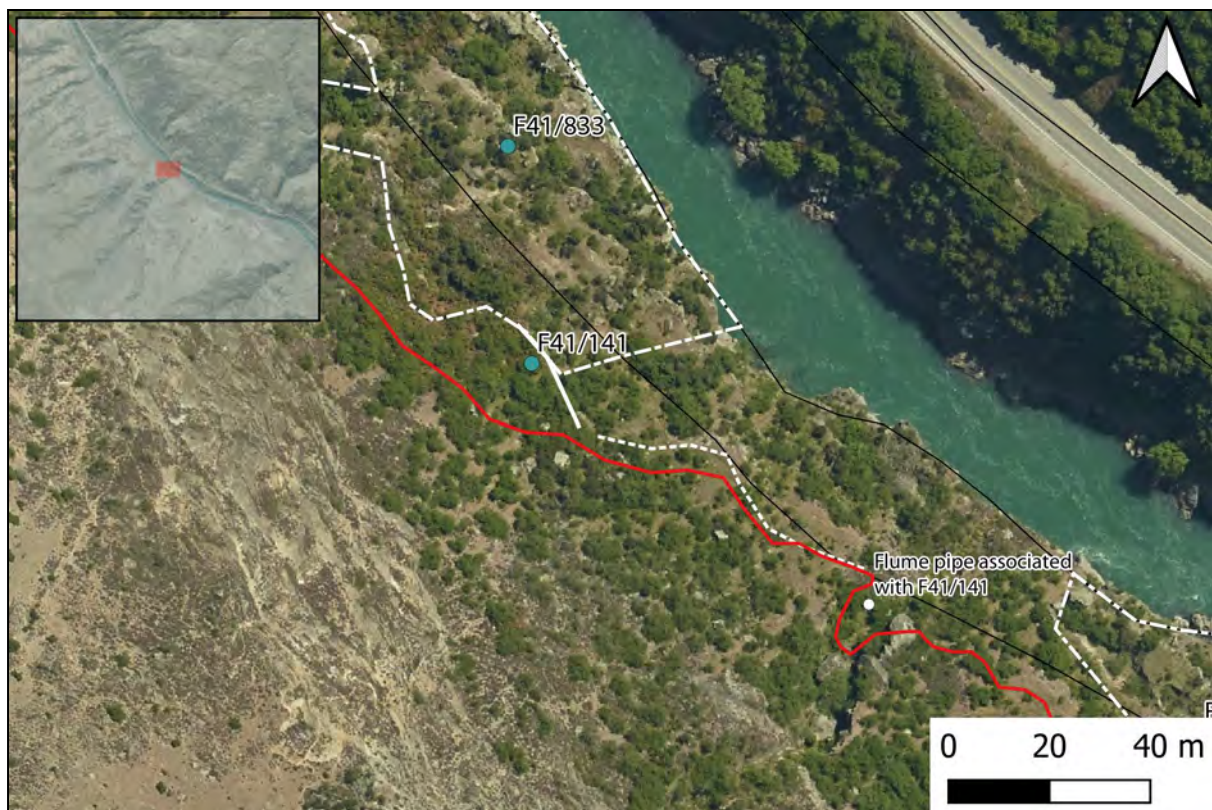
Figure 122. F41/141; the white solid line indicates the dam walls and the dotted line marks the water race segment.

If possible the trail should be relocated slightly further up the hillslope to avoid the race and care should be taken not to damage the flume pipe in the bank.

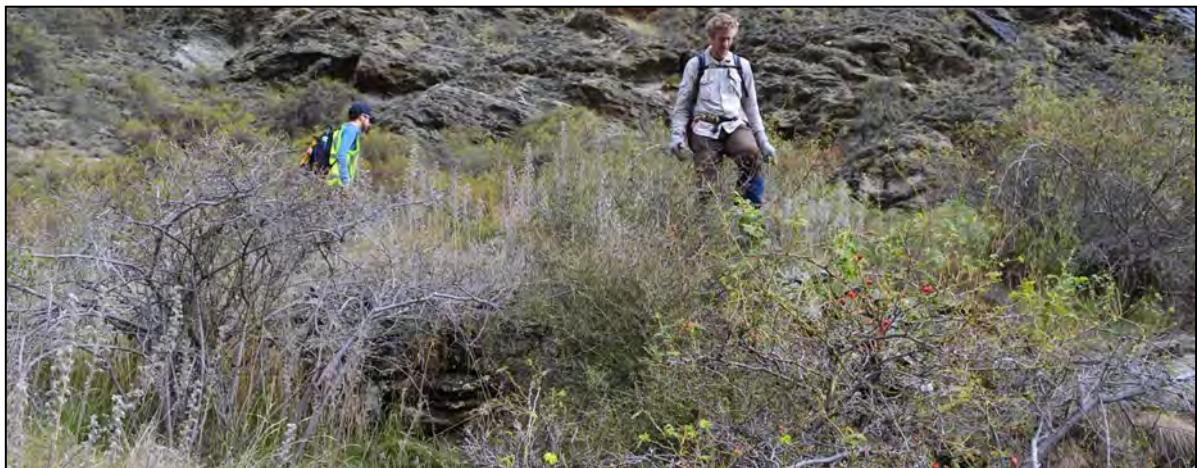
Figure 123. F41/141; looking west at the overgrown stone facing on the dam wall.

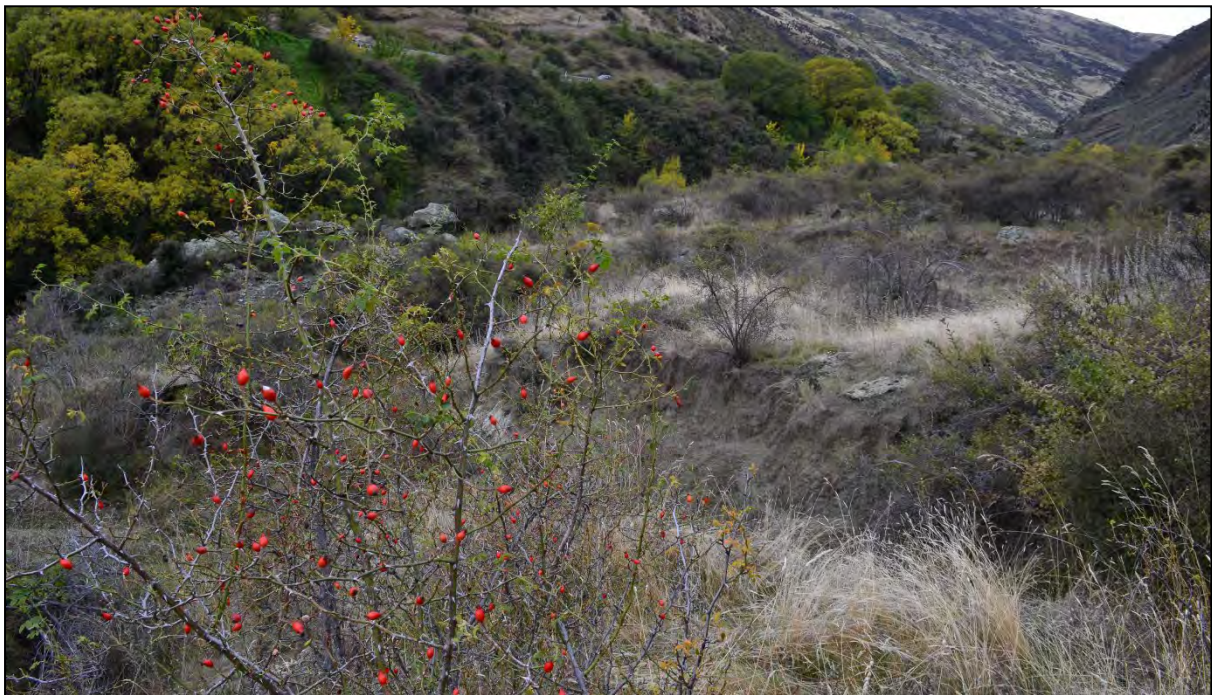
Figure 125. F41/834; looking south-east across the sluiced area.

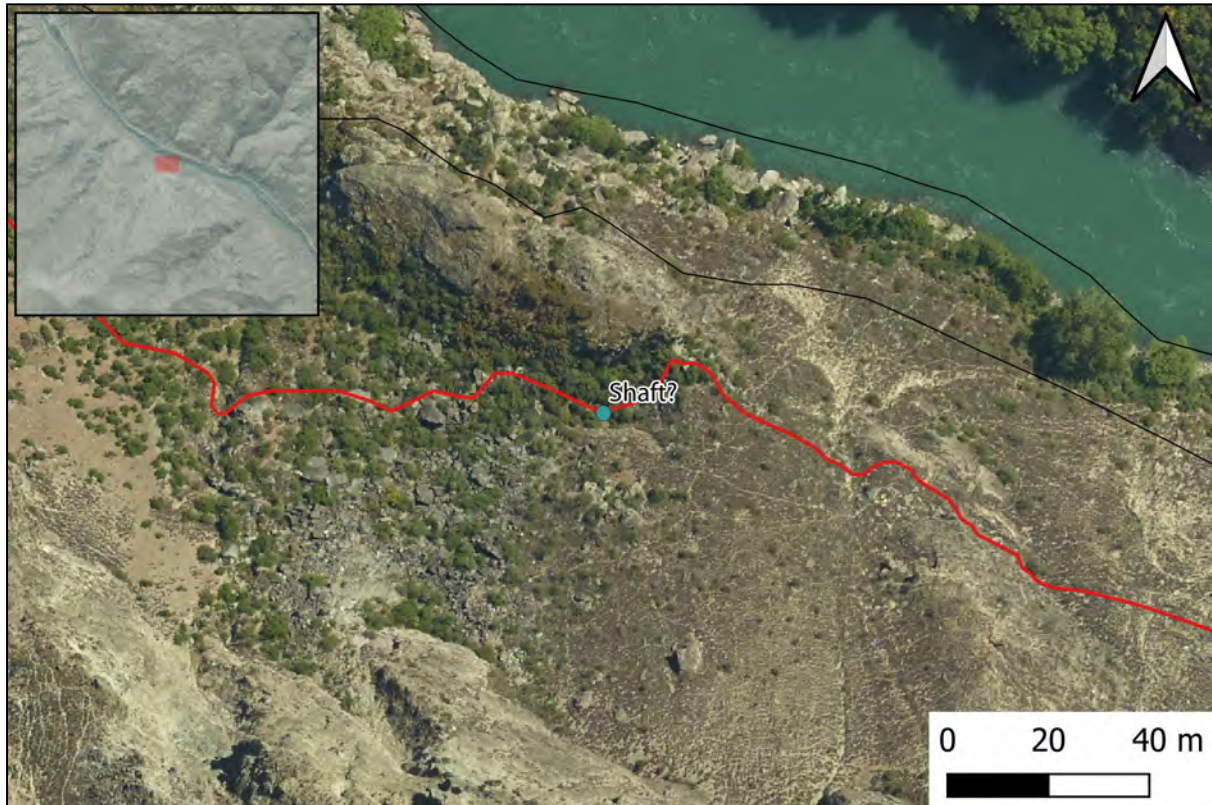
2m deep void to the south of the trail route. This is presently thought to be a natural feature formed by a large rock fall from the cliff face above, but further investigation may show it to be the remains of a mining shaft. Ritchie's earlier survey did not record any sites in the vicinity. Not recorded on ArchSite.

Figure 126. Possible shaft site.

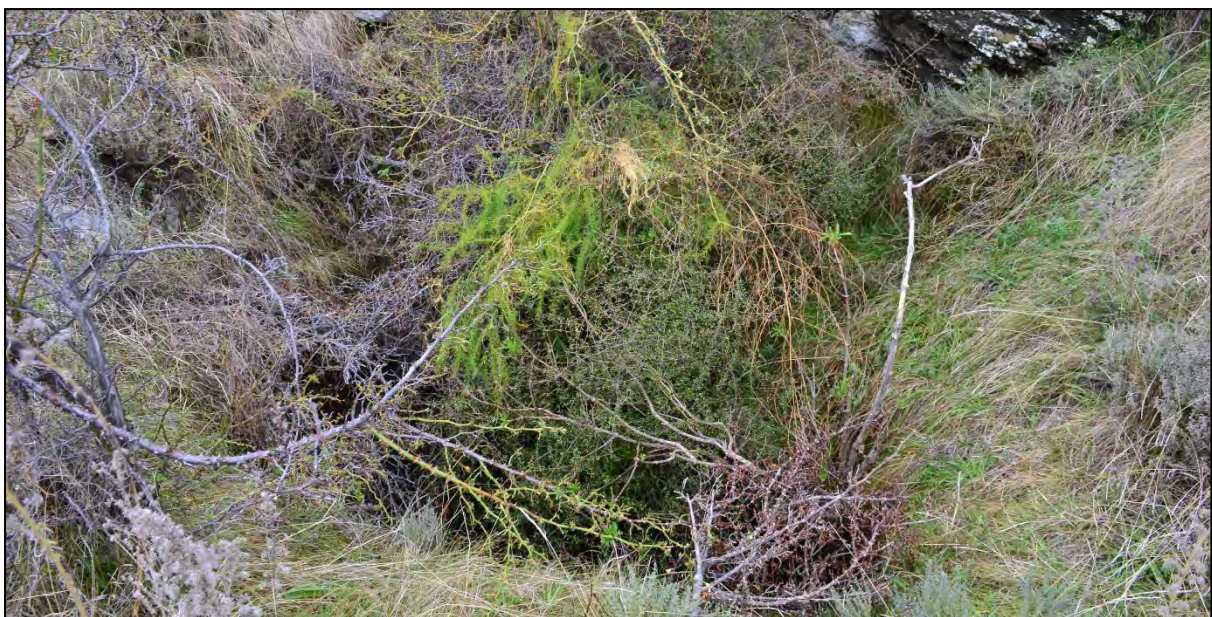
Figure 127. The possible shaft, overgrown with scrub.

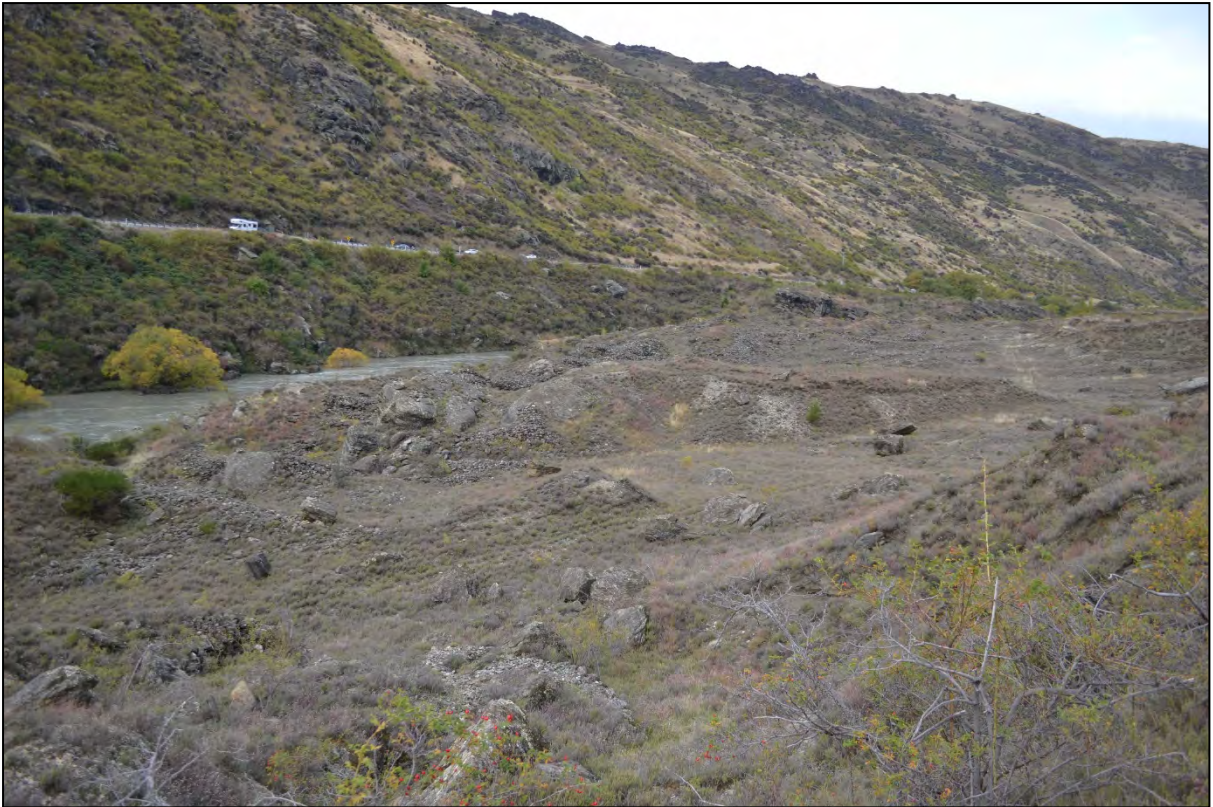
Figure 129. F41/139; looking south-east across the sluicings and tailings from the north-west edge of the site.

Though the trail runs through this site it should only have a limited impact on the archaeological features present. It will damage a small area of sluice face at the point where it descends into the sluiced area, and it is likely that the route up out of the sluicings will also have limited impact on some sluice faces. However, it will mostly avoid features by running in-between the tailings and sluice faces, largely following an existing 4WD track.

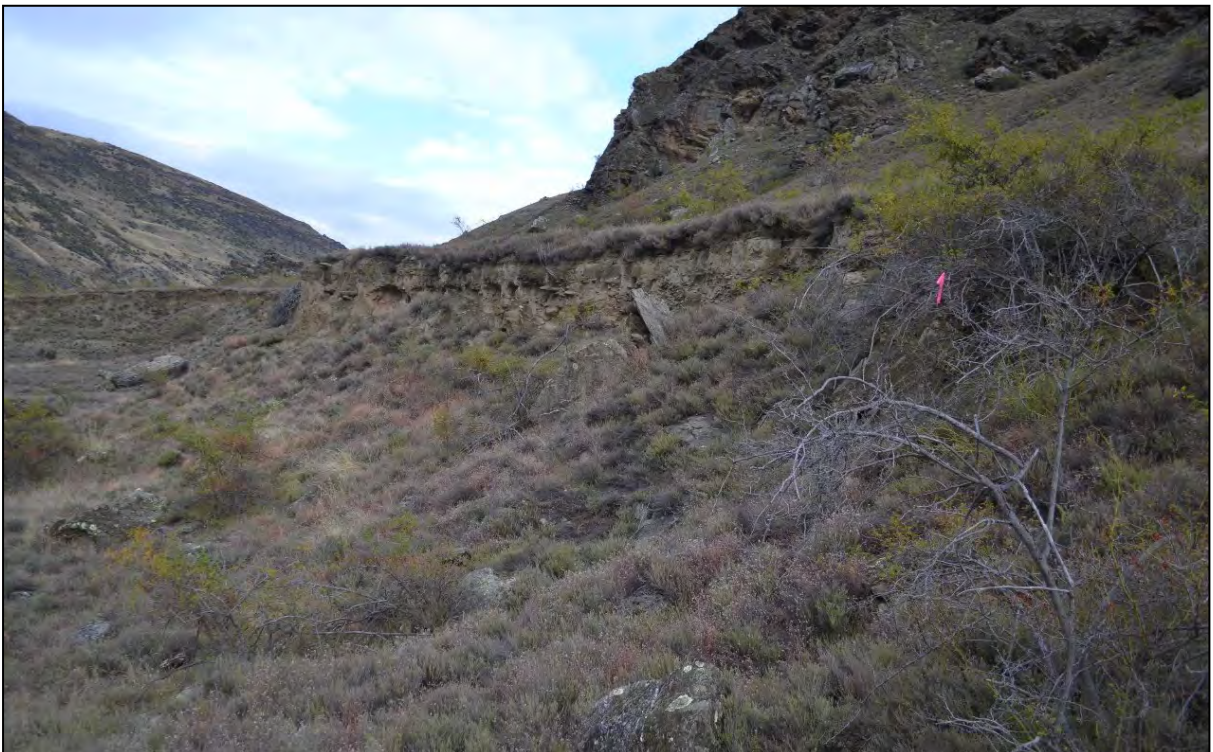
Figure 130. F41/139; looking south at the large sluice faces near the north-west edge of the site. The trail will run along the base of these features.

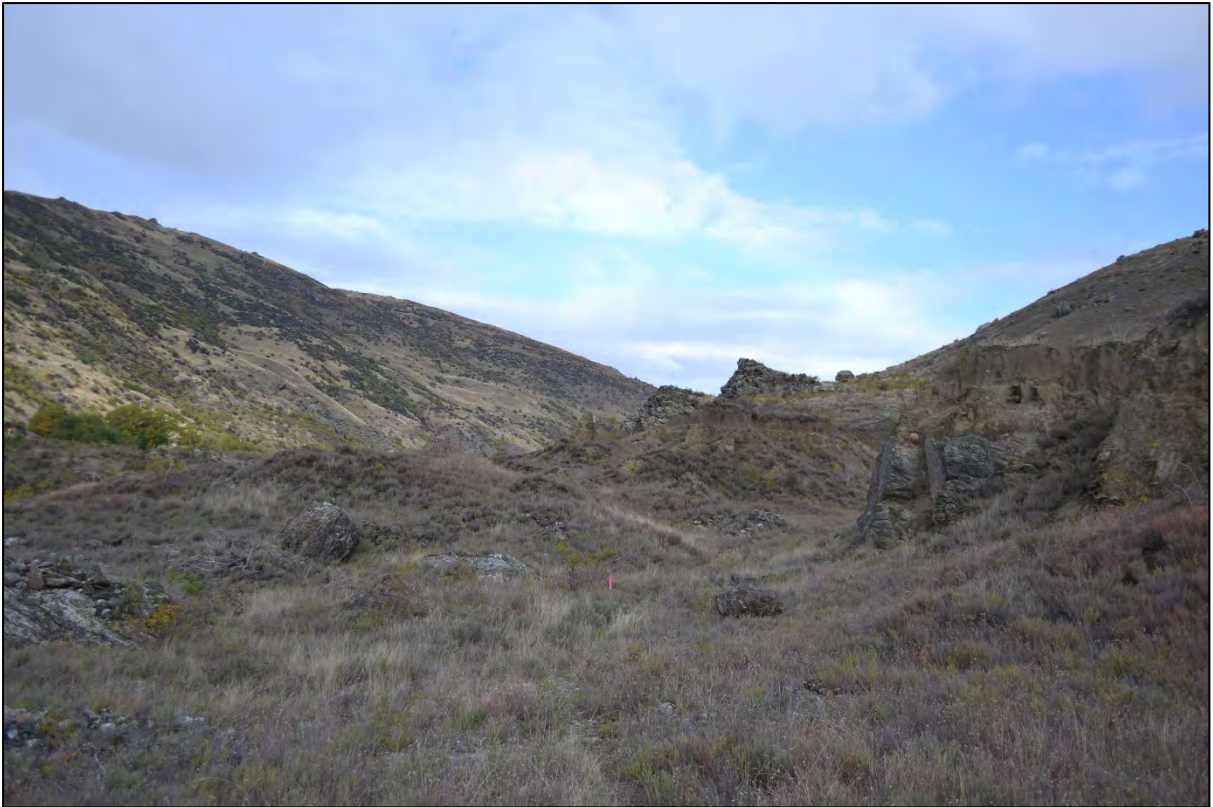
Figure 131. F41/139; looking south-east on the trail route where it runs along the existing 4WD track.

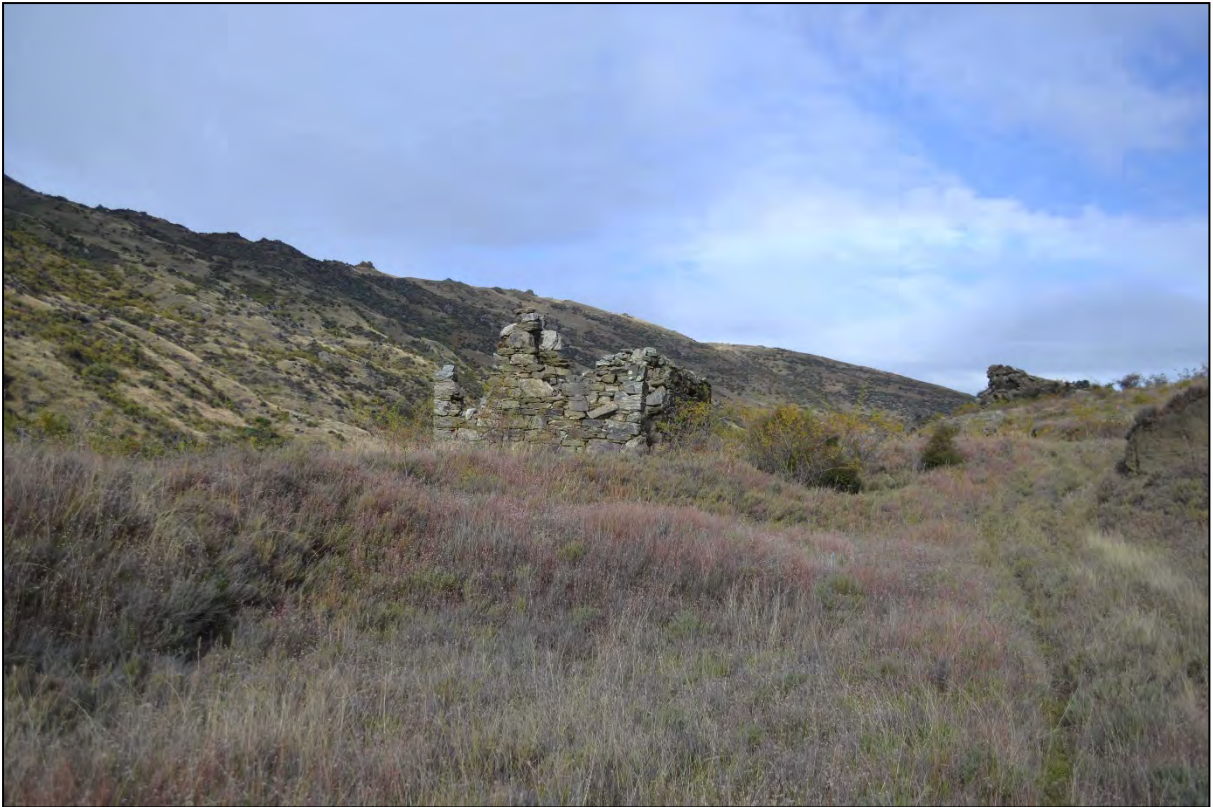
Figure 133. F41/134; looking south-east at the ruin with the route of the trail along the 4WD track to the right of the image.

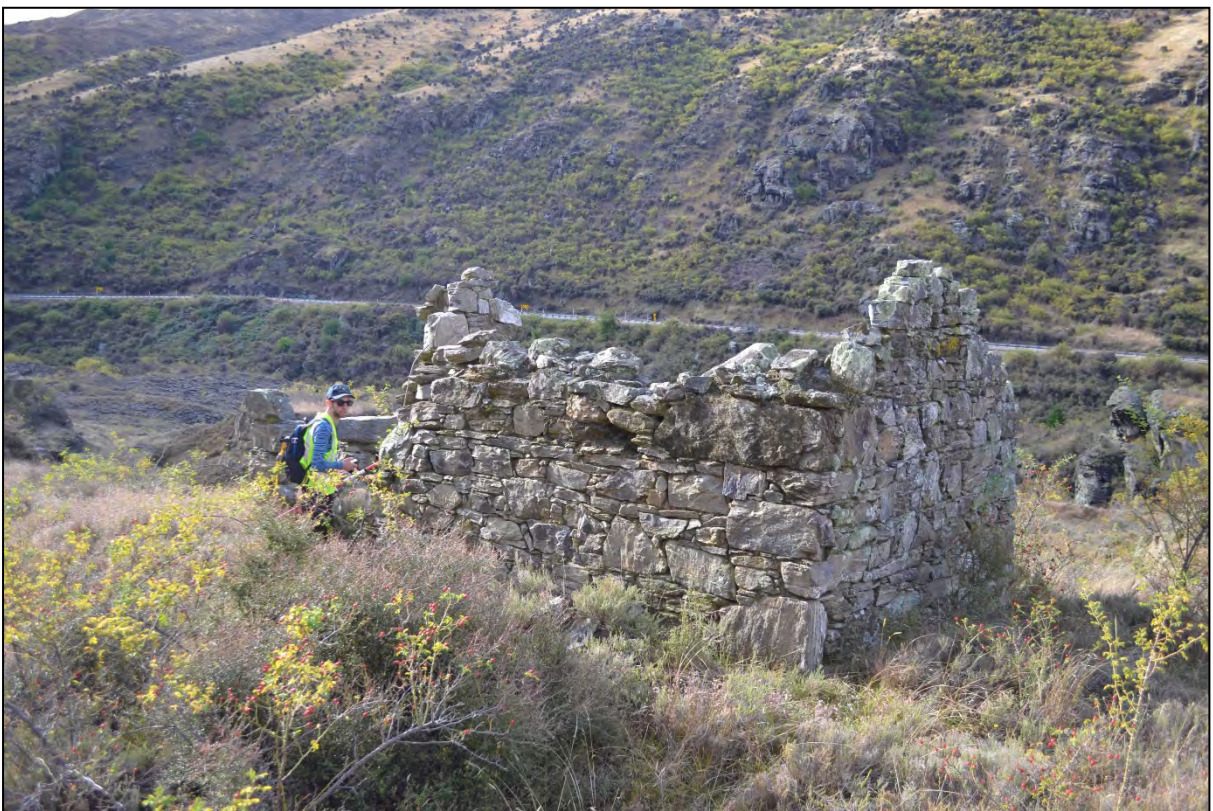
Figure 134. F41/134; looking north at the ruin.

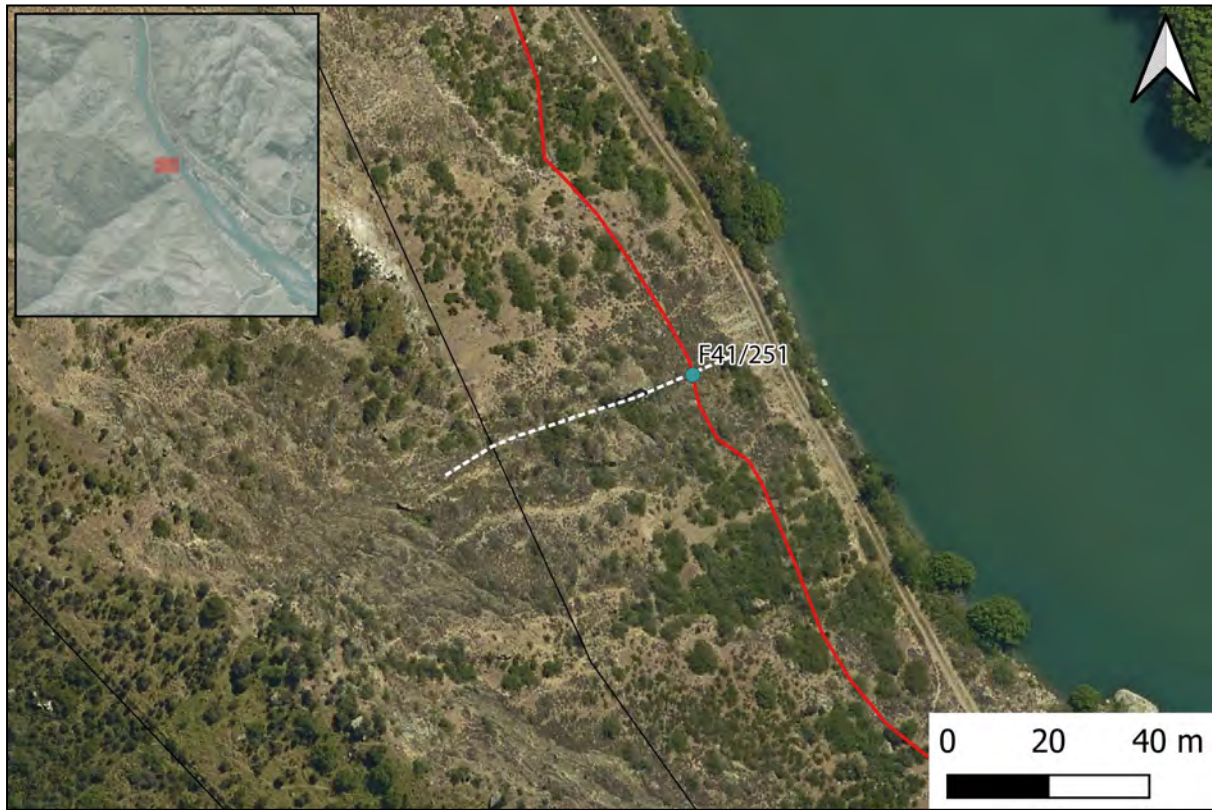
Diverts off the upper reaches of walkers creek and runs steeply down the hillside in a metal flume pipe. Formally conveyed water across the Kawarau in a suspended pipeline. Likely a 20<sup>th</sup> century site.

Figure 139. F41/251; the white dotted line marks a water race segment.

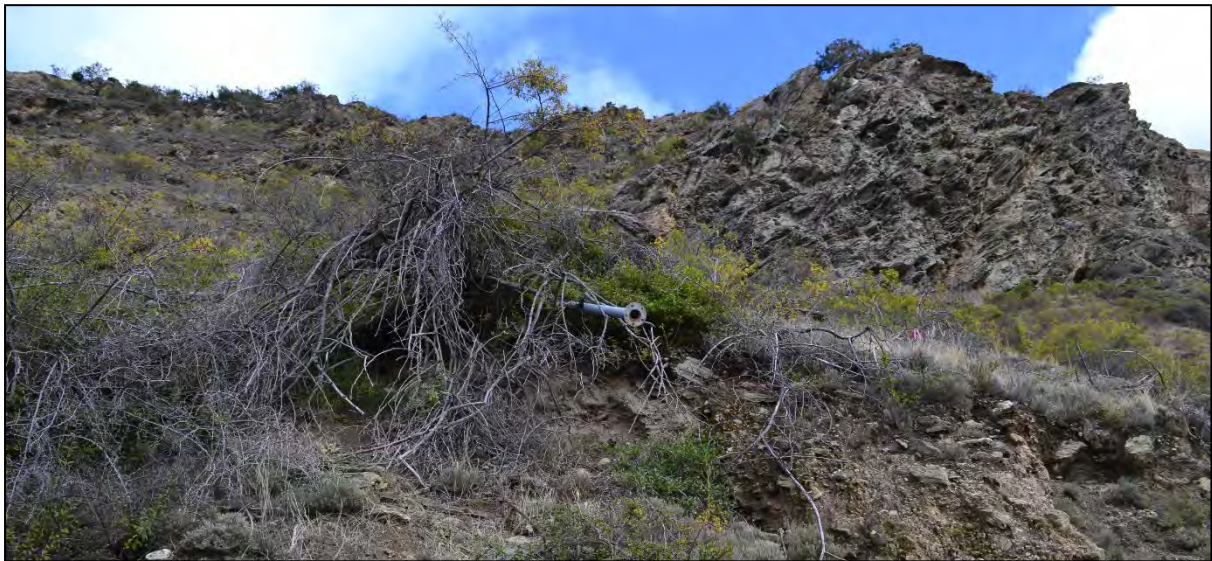
Figure 140. F41/251; the exposed lower end of the flume pipe.

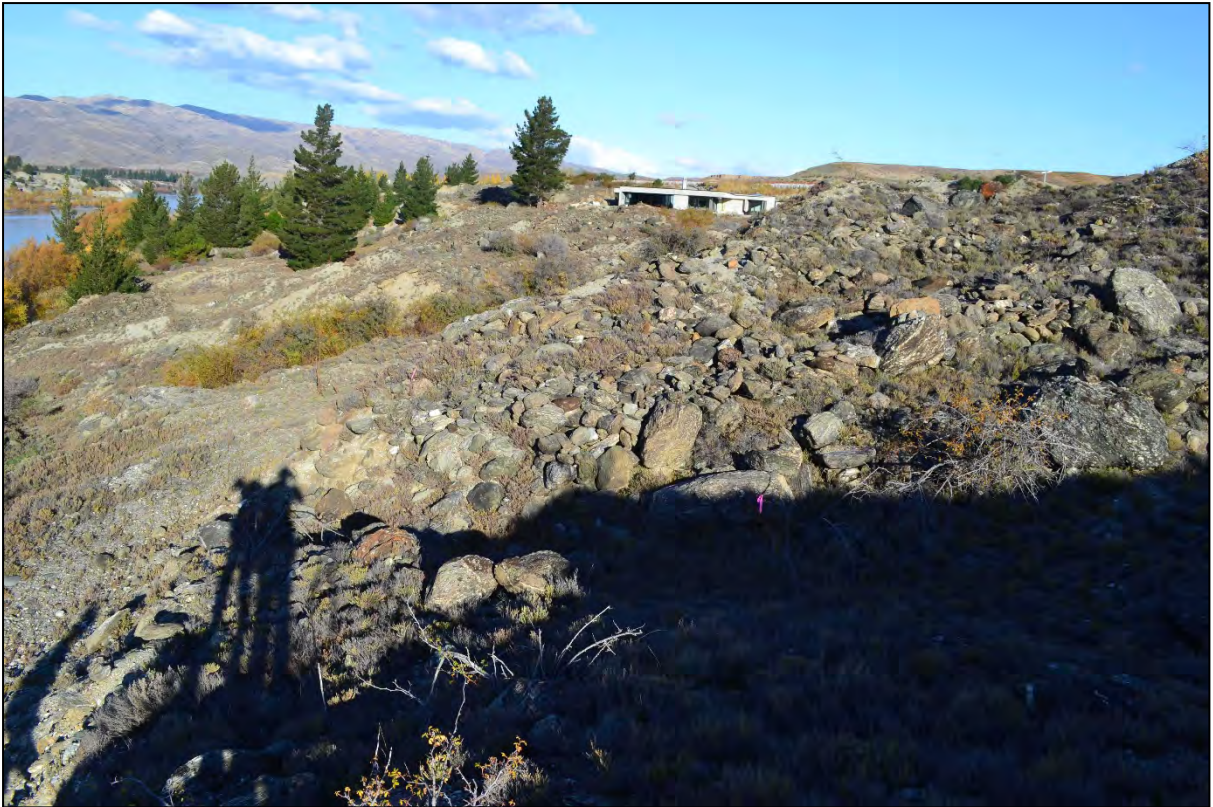
Figure 142. F41/456; looking south-east adjacent to the house at the centre of the site. The trail route runs from the pine trees at the left of the image.

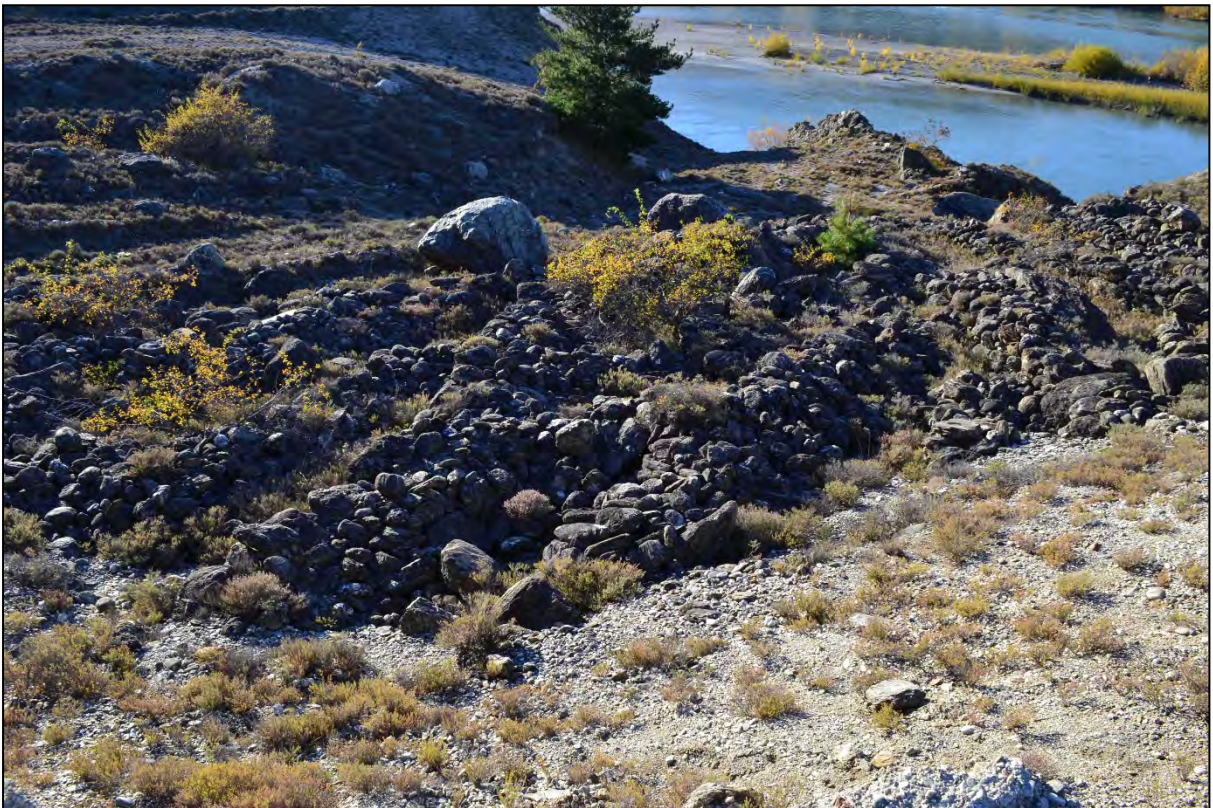
Figure 143. F41/456; looking north-east over tailings from the trail route close to the centre of the site.

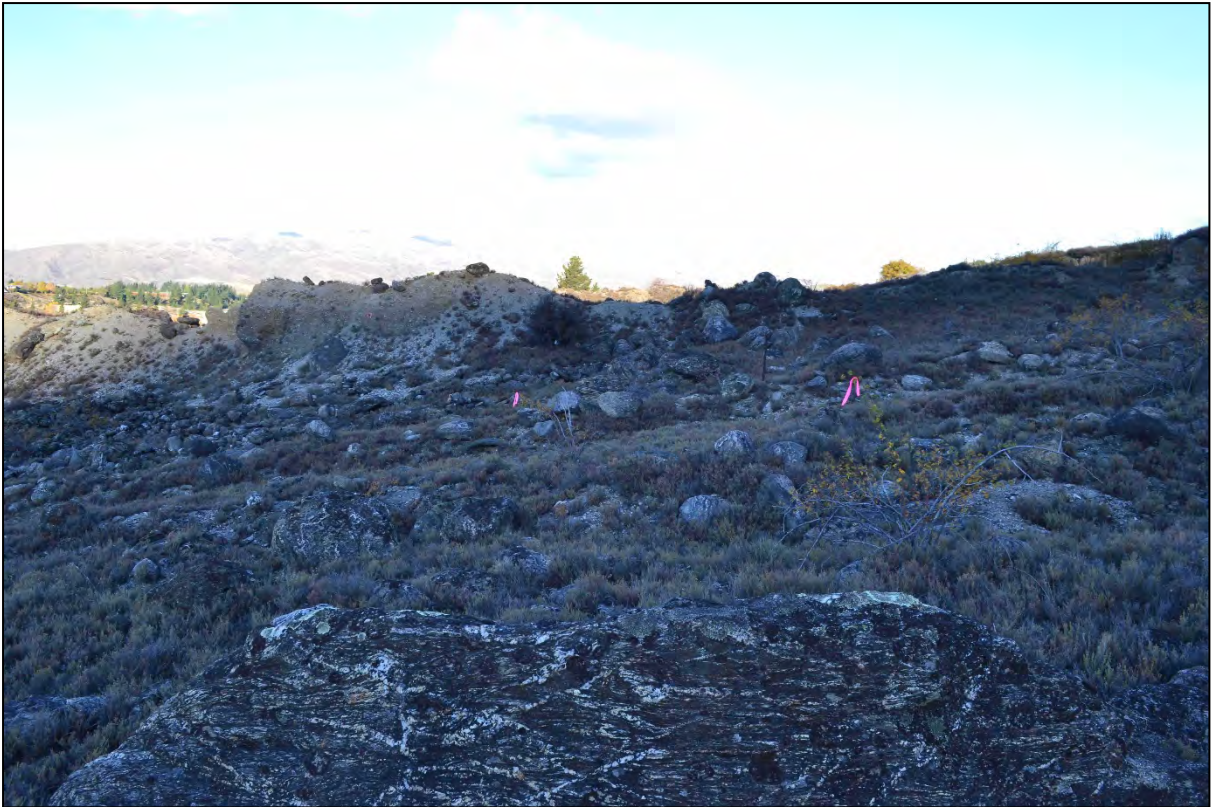
Figure 144. F41/456; looking south-east along a section of the trail route through the site. The trail will pass over the slued ridge to the right of the image.

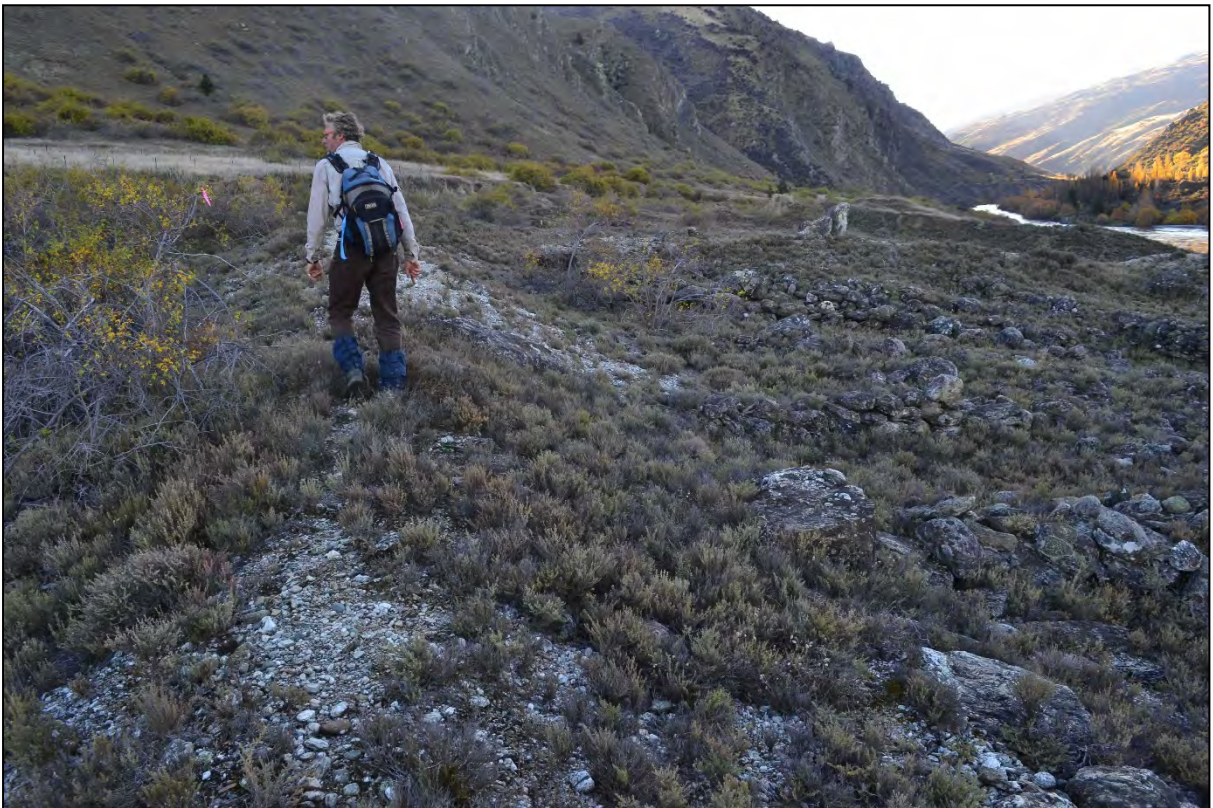
Figure 145. F41/456; looking north-west along a section of the trail route through the site. The trail will run along the small ridge at the centre left of the image, avoiding the well-preserved tailings to the right of the image.

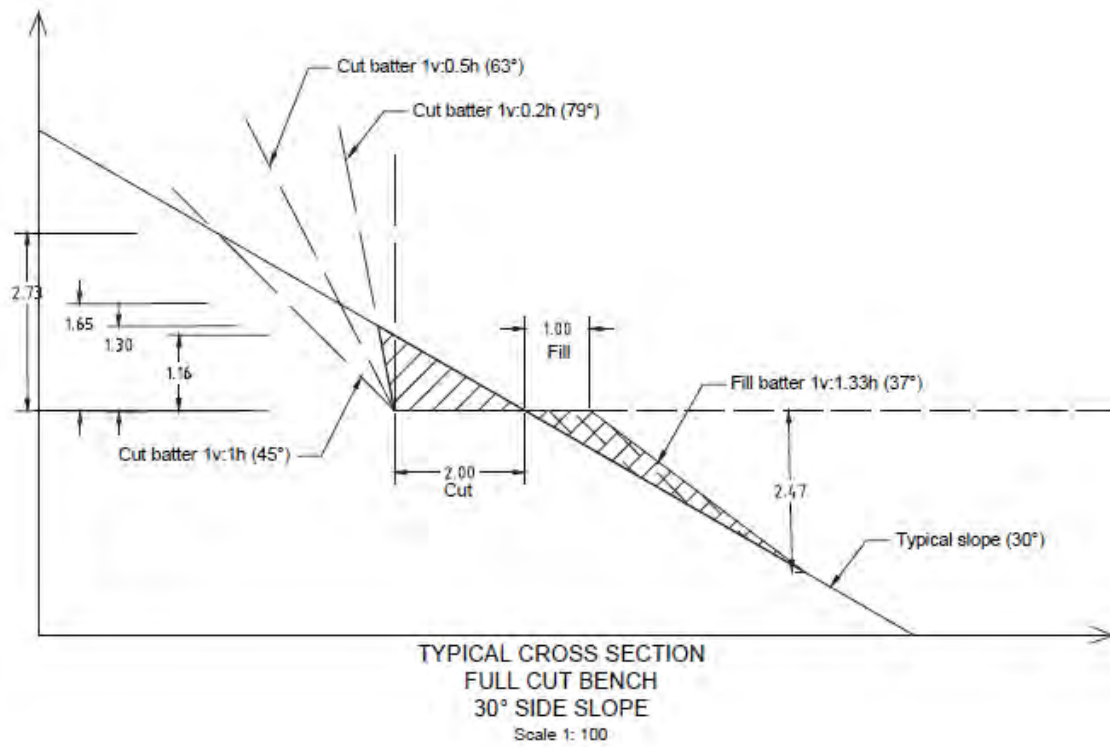
Figure 146. Cross section for 3m wide trail (Southern Land).

Typical trail profiles are shown in Figure 146 and Figure 147. Further examples can be found in Appendix C.

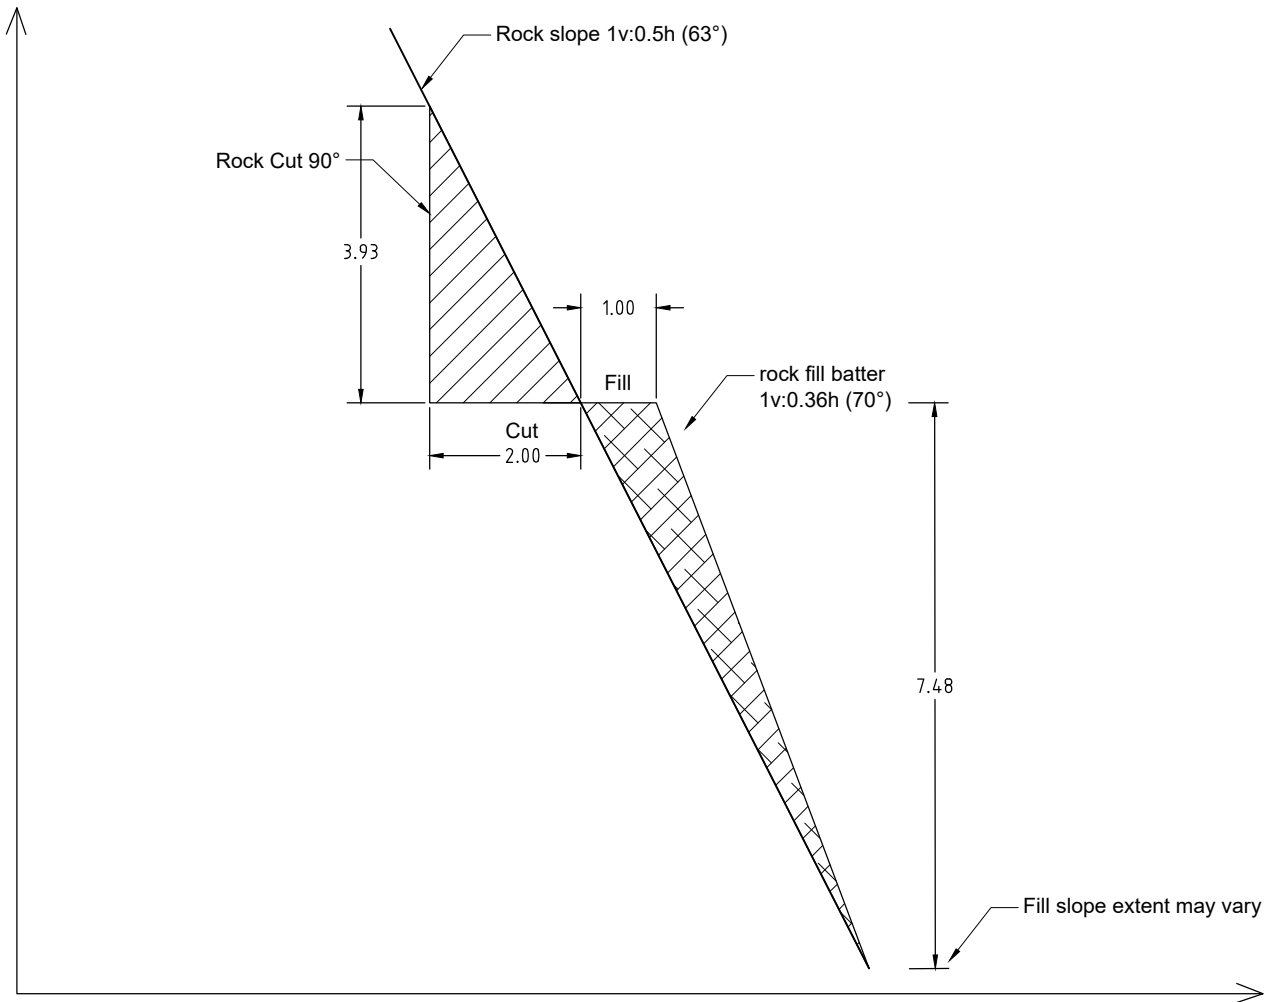
TYPICAL CROSS SECTION - A  
SOLID ROCK CUT BENCH  
63° SIDE SLOPE  
Scale 1: 100
