**Central Otago Queenstown Trail Network Trust: Kawarau Gorge**

The following comments relate to our joint field trip to various places along the proposed Kawarau Gorge Trail undertaken on 20 June 2019. The purpose of the field trip was to inspect critical trail sections requiring geotechnical assessment as identified in emails dated 14 & 15/05/19.

# Archaeological Assessment for the Kawarau Gorge Cycle Trail

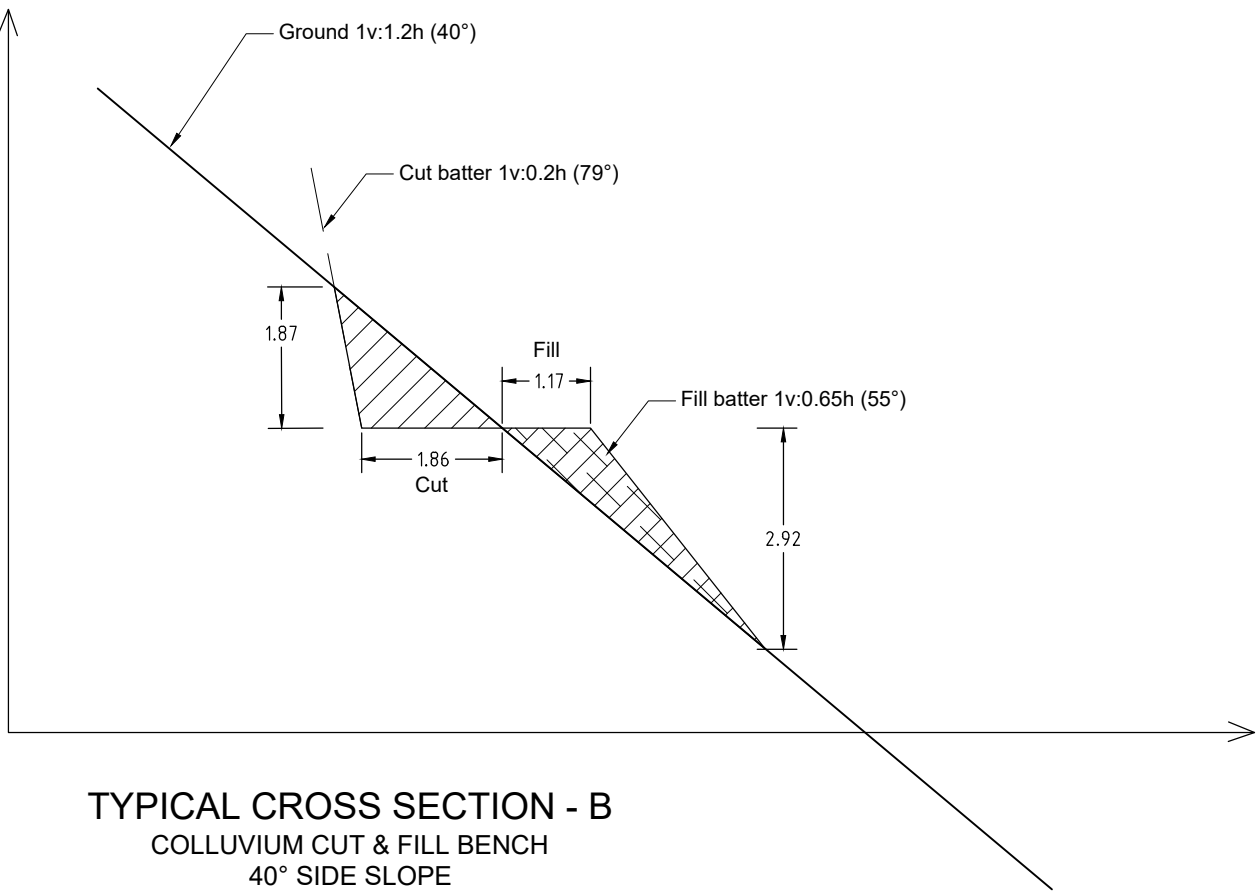
TYPICAL CROSS SECTION - B  
COLLUVIUM CUT & FILL BENCH  
40° SIDE SLOPE  
Scale 1: 100
