Landscape Assessment Report

Robertson Speargrass Farm, Queenstown 31 January 2022

125 Hunter Road, Dalefield Preliminary Site (HAIL) Assessment Report

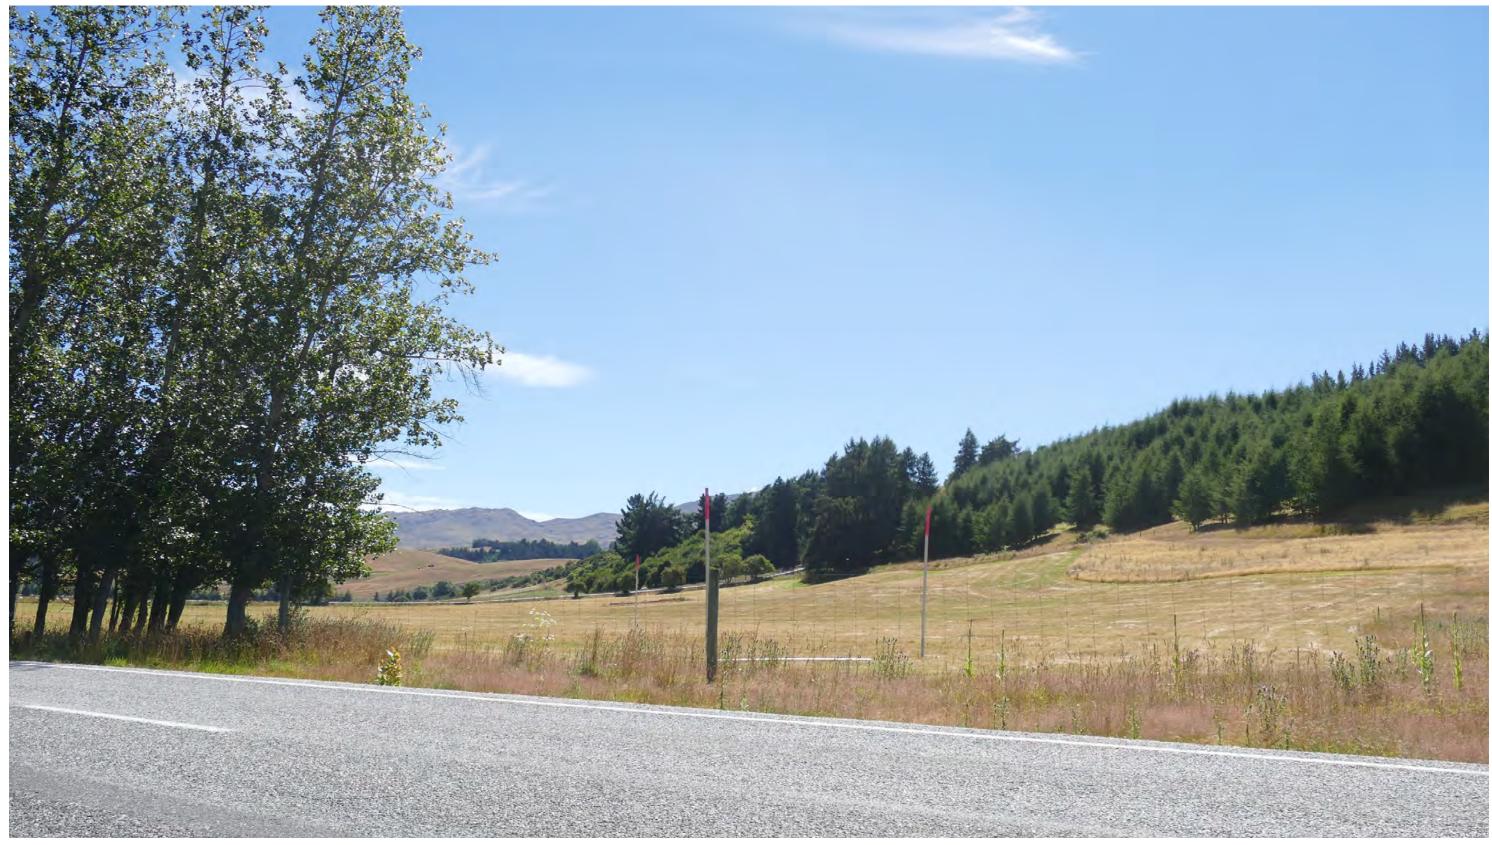
Image 3

50mm - 21 January 2022 at 4:17pm

- 4.9. When approaching the site in an east to west direction along Speargrass Flat Road, intervening landform to the east of the subject site will screen all proposed built development until the receptor is approximately 520m from the site (Image 1). Proposed vegetation to the south and east of the proposed BP's will provide a very high level of screening. Only the entrance to Lot 2 will be visible between Images 1 & 3, and from these views all built development will be well screened behind the proposed landscaping.

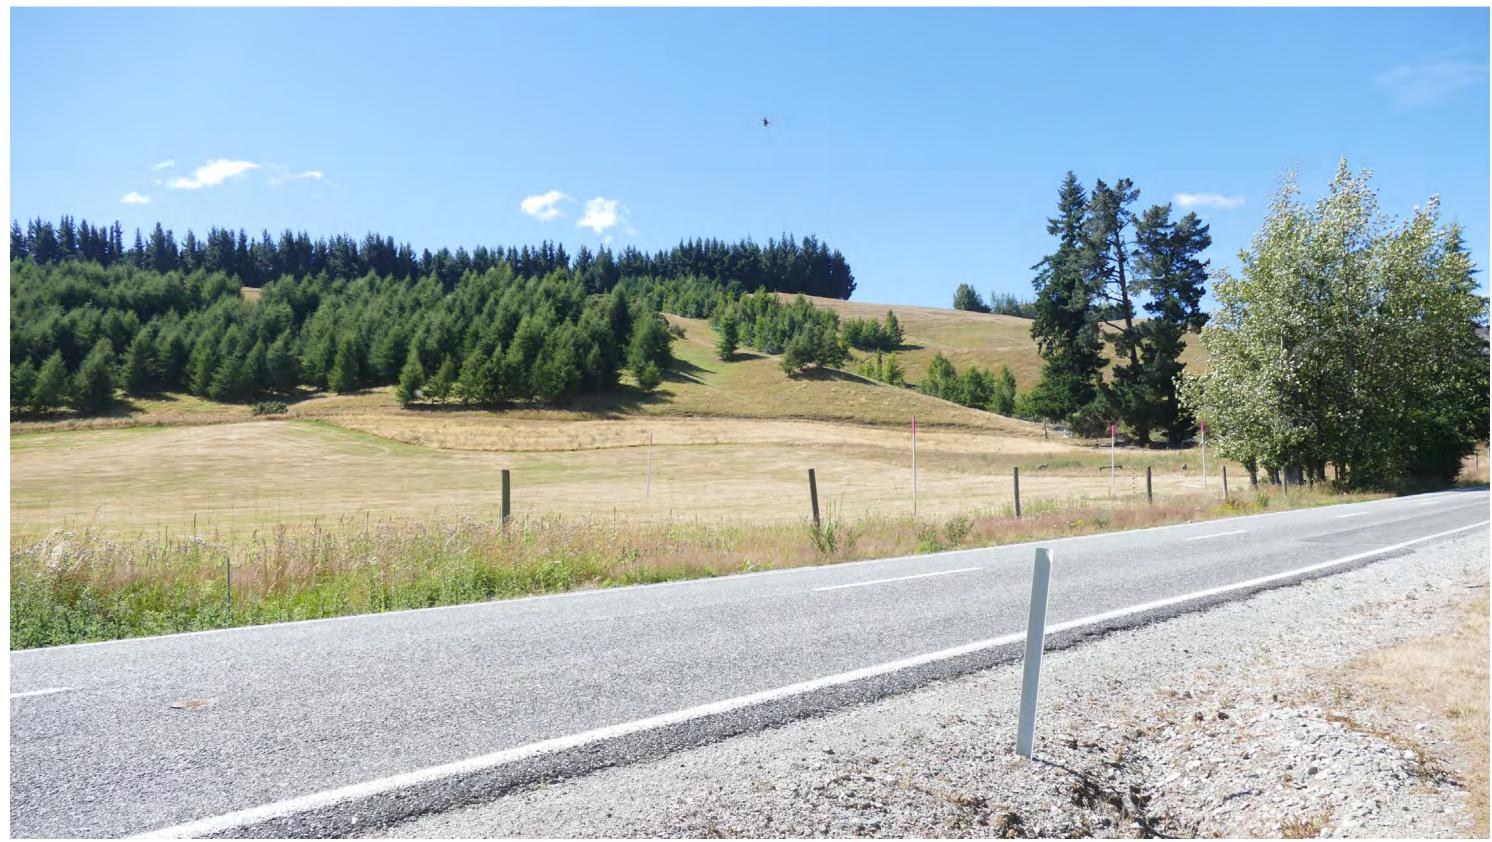
Image 4 - Lot 3

25mm photo - 21 January 2022 at 4:19pm

- 4.10. A receptor in the immediate vicinity of the site (Images 4 & 5) may be able to see the upper parts of a future roof of a building in proposed Lot 2 and 3, but those views will be well buffered by proposed landscaping. This potential view of a future budling's roof may remain until the receptor moves farther west where parts of built development may become visible in Lot 2 (Images 6 9) from a distance of between 450m (Image 6) to 1.1km (Image 9).

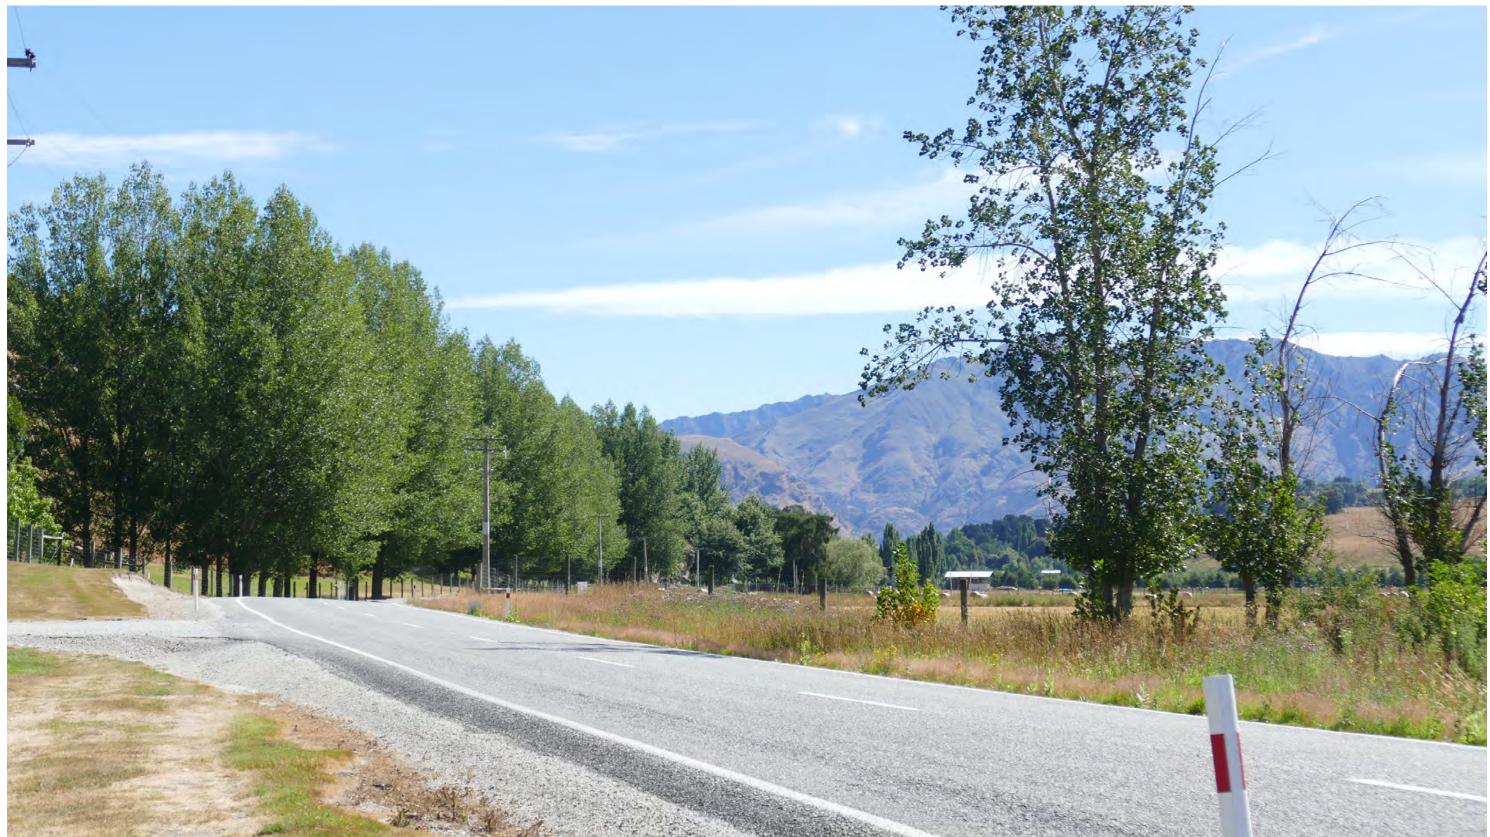
Image 5 - **Lot 2**

50mm photo - 21 January 2022 at 4:20pm

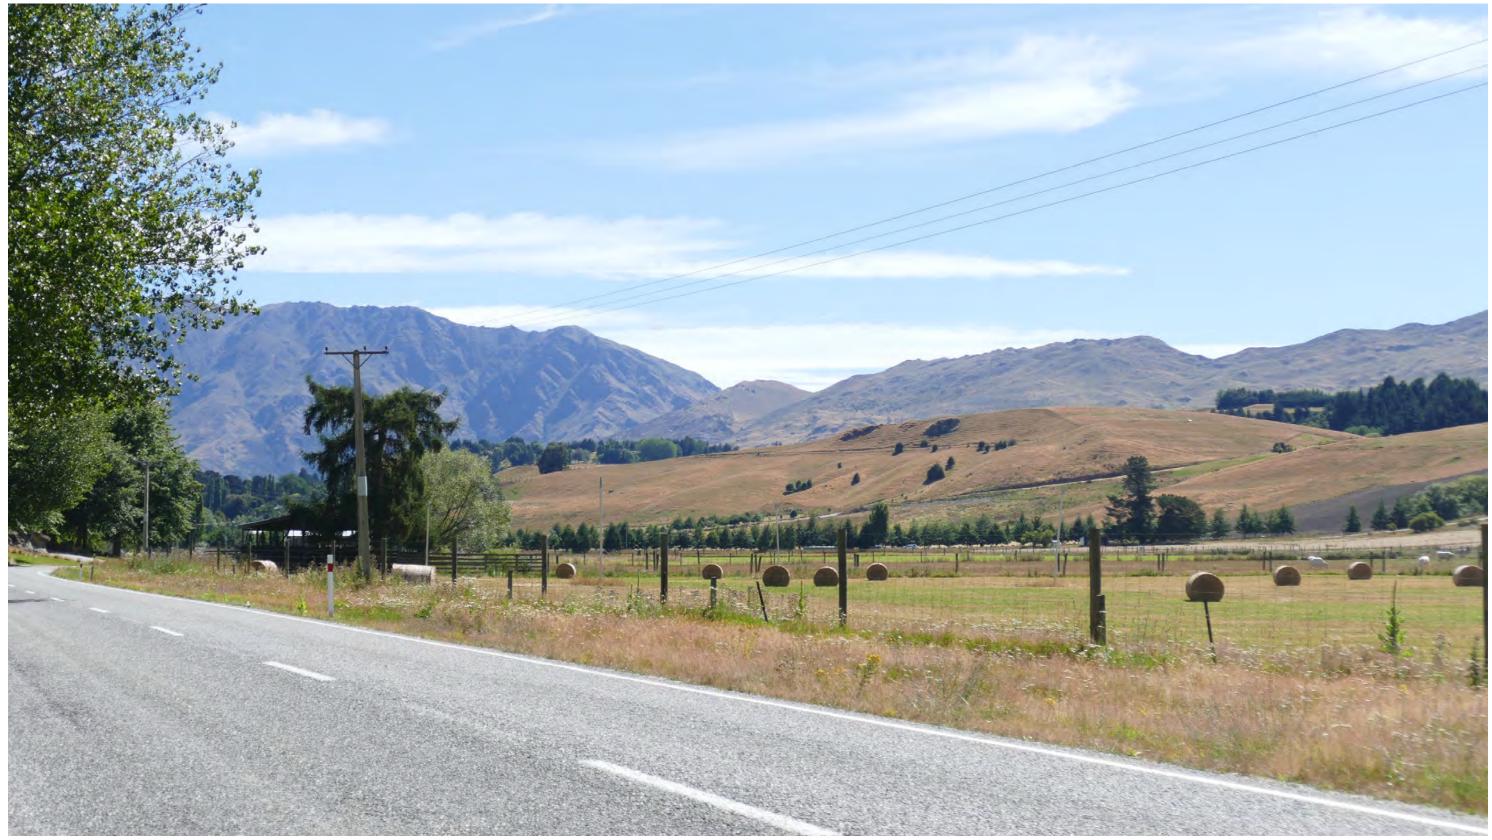
Image 6 - Lot 2

50mm photo - 21 January 2022 at 4:21pm

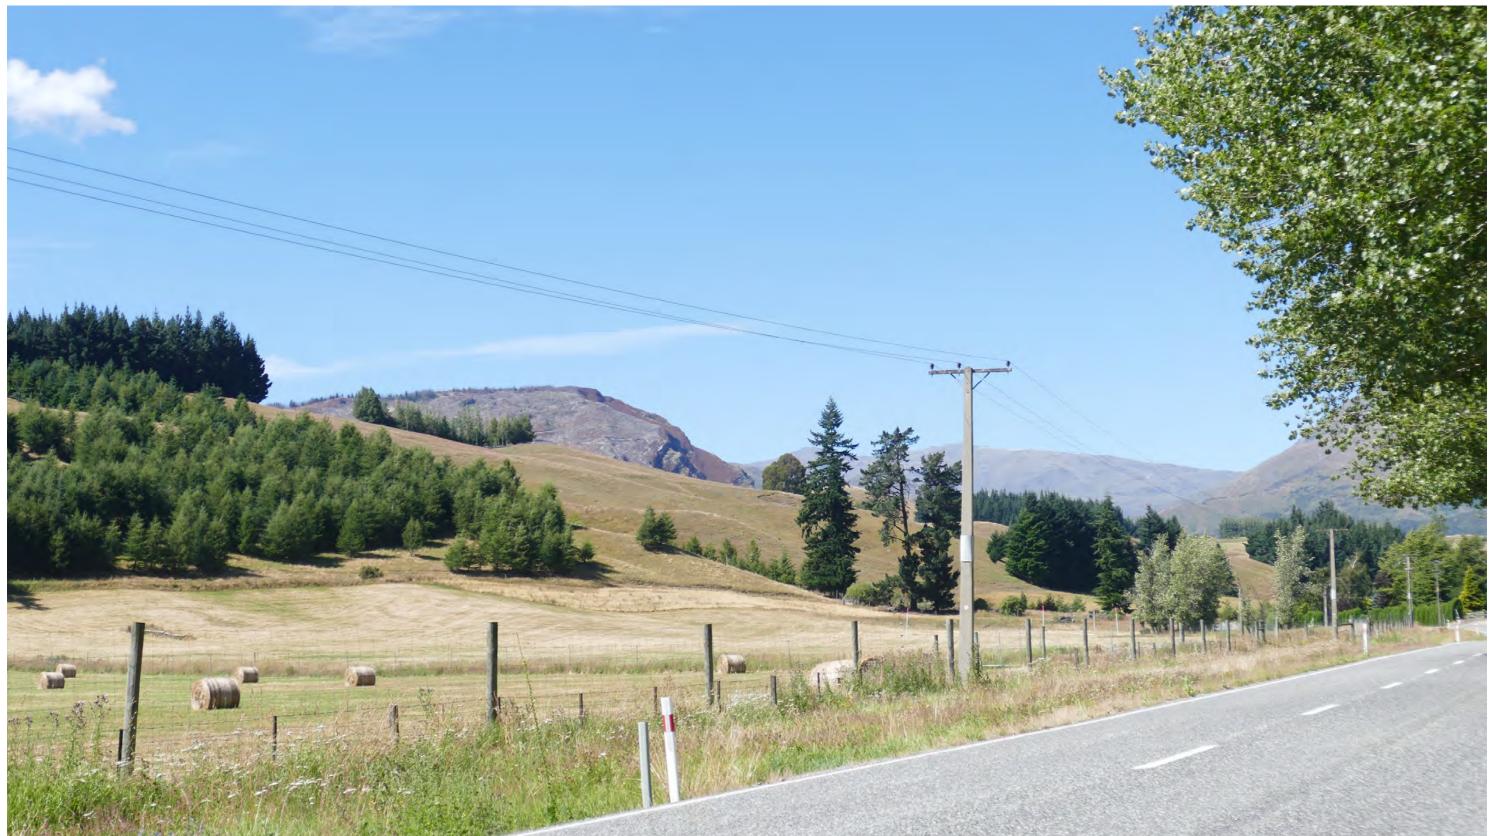
Image 6 - Lot 3

50mm photo - 21 January 2022 at 4:22pm

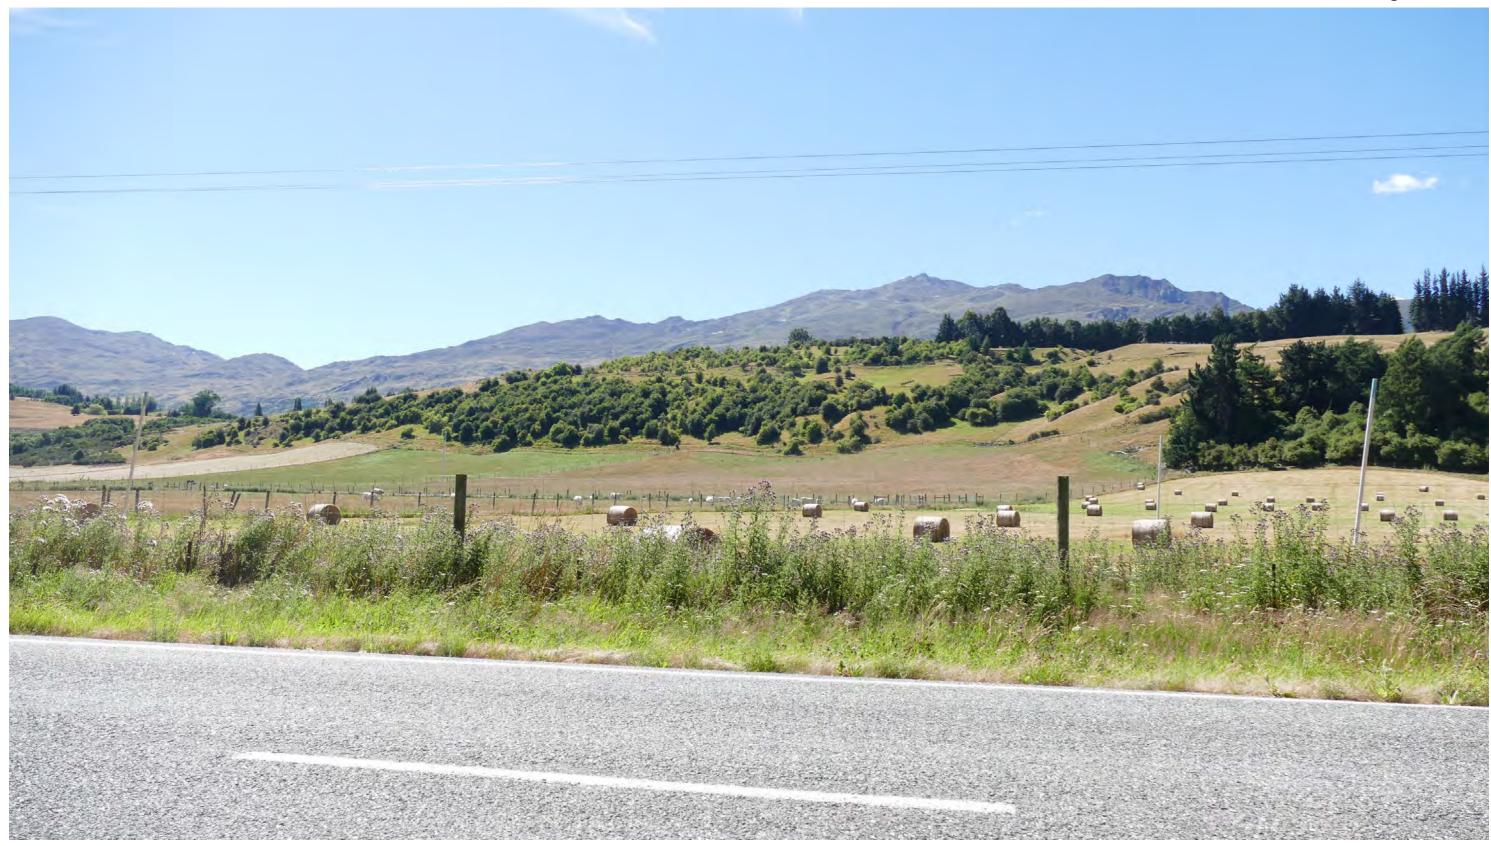
Image 7 - **Lot 2**

25mm photo - 21 January 2022 at 4:22pm

- 4.12. No part of the proposed development will be visible from the Speargrass Road corridor west of the Hunter Road intersection.
- 4.13. Overall, there will be some limited potential visibility of a future roof in the BP on Lot 2 for an approximately 500m long portion of Speargrass Flat Road between Images 4 6. Visibility of built development on Lot 2 will become more apparent from receptors farther west along Speargrass Flat Road (Images 8 & 9) but built development within Lot 3 will be well screened by proposed landscaping.

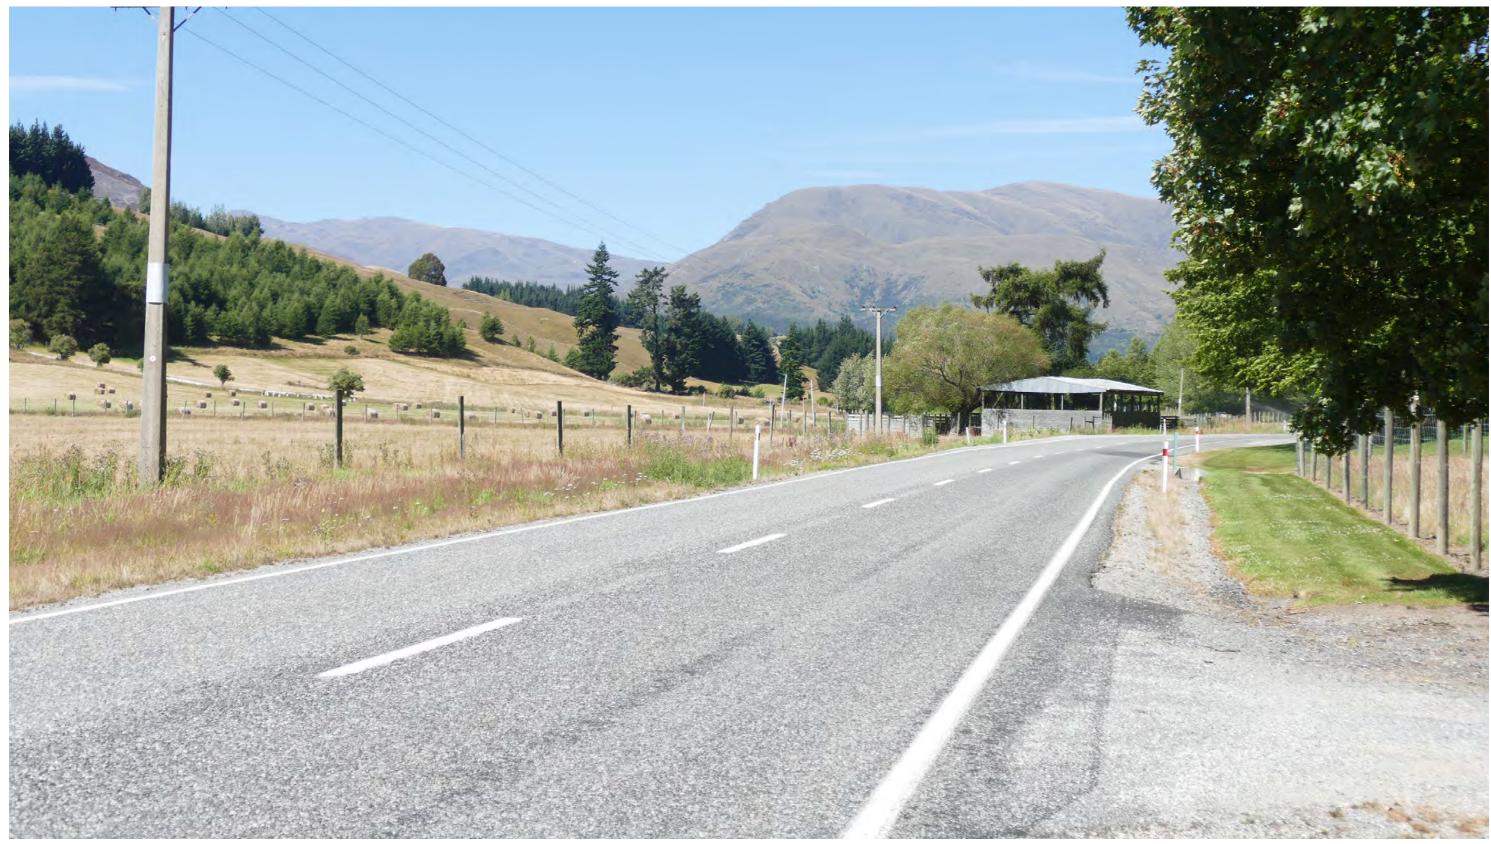
Image 7 - **Lot 3**

50mm photo - 21 January 2022 at 4:23pm

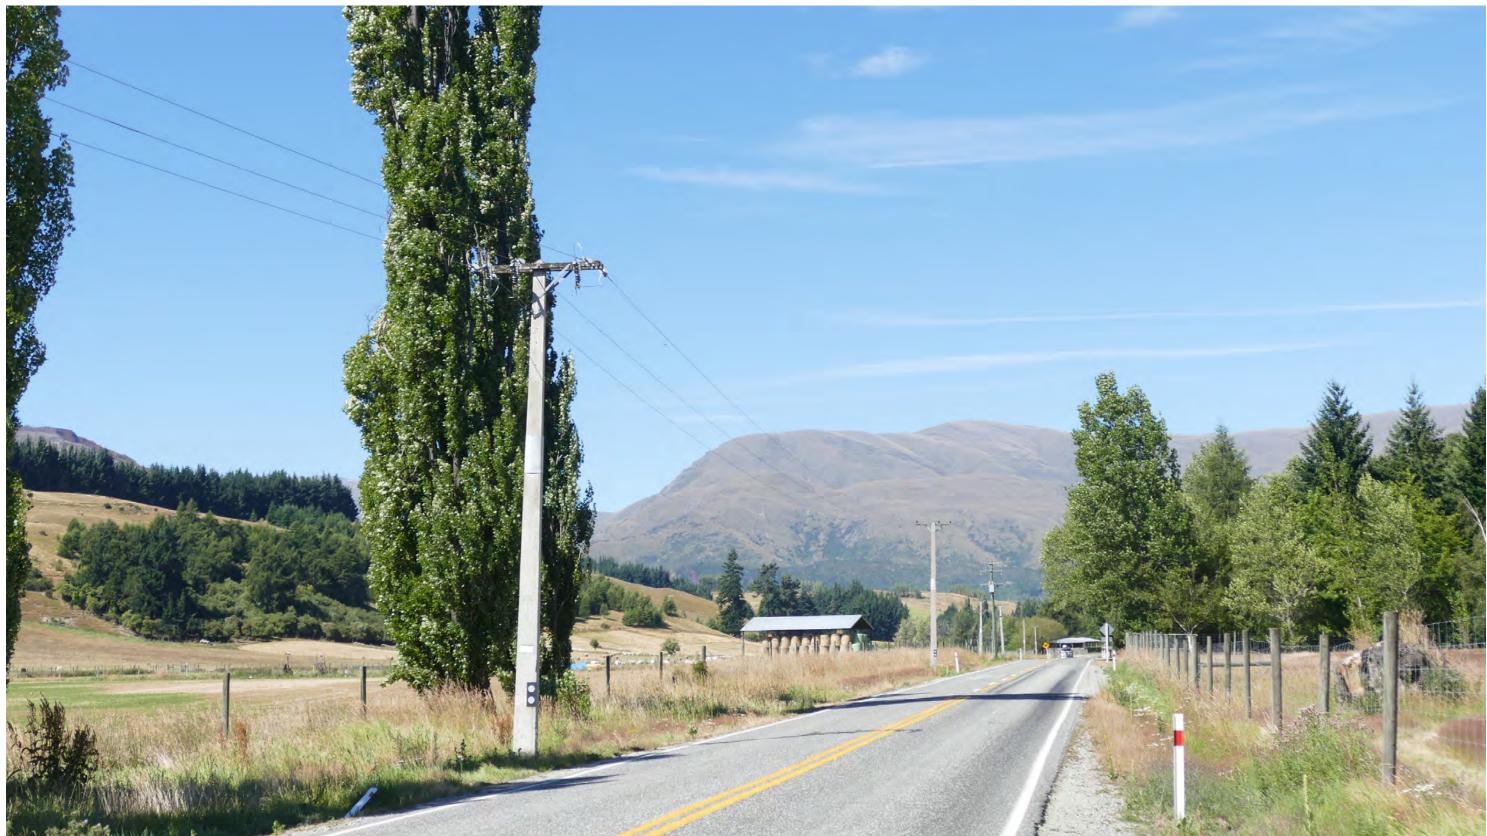
Image 8

50mm photo - 21 January 2022 at 4:25pm

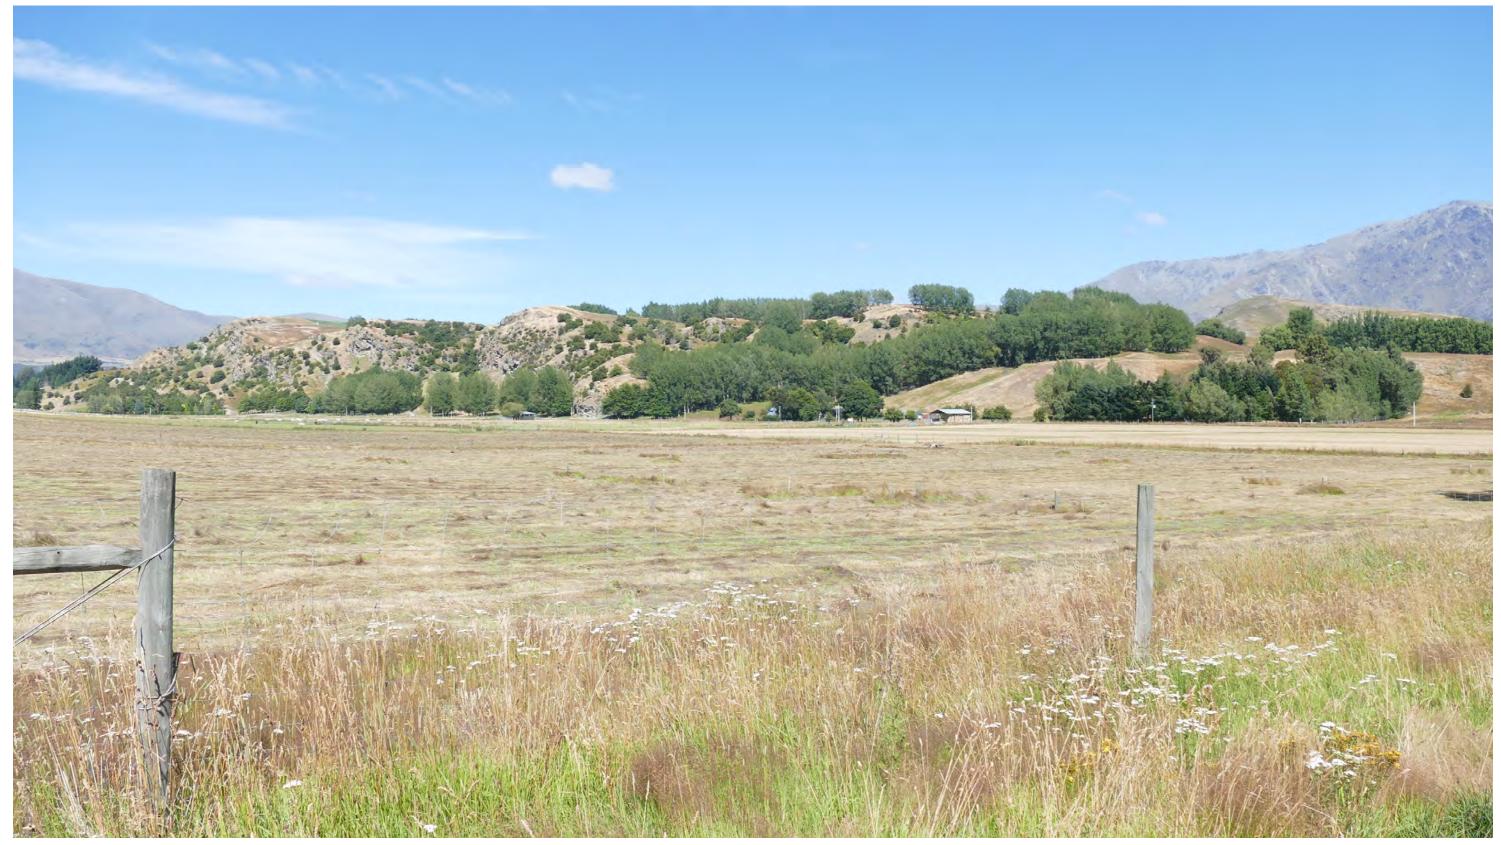
Image 12

25mm photo - 21 January 2022 at 4:29pm

- 4.14. Hunter Road crosses the Speargrass Flats in a north south direction. South of Speargrass Flat, the road is called Lower Shotover Road and the proposed development will not be visible south of this intersection.
- 4.15. There may be some limited visibility of built development in proposed Lot 2 from near the southern extents of Hunter Road intersection (Image 11) from a distance of approximately 1.2 km. This level of visibility will continue as the receptor moves to the north, where future built development on Lots 2 and 3 will be visible for a short portion of the road (Images 12 13). As the receptor moves farther north, the proposed lots will be screened by landform, north of Image 14.
- 4.16. Overall, there will be some limited, distant views of the proposed development for an approximately 500m long portion of Hunter Road between **Images 11 & 14**.

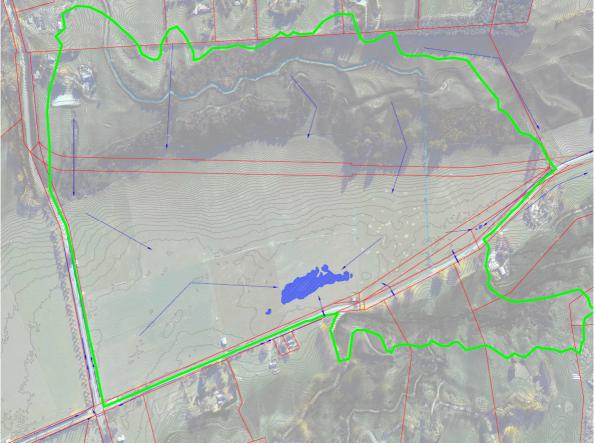
It is noted that the Arrow Irrigation race also bisects part of the catchment and acts as a cut off drain. This feature may not act as a cut off as the race may be piped in future allowing run-off to return to pre-development flows. It is also noted the race is not specifically designed to take storm water flows and in extreme events could overtop or breach.

Catchment diagram (enlargement in appendix)

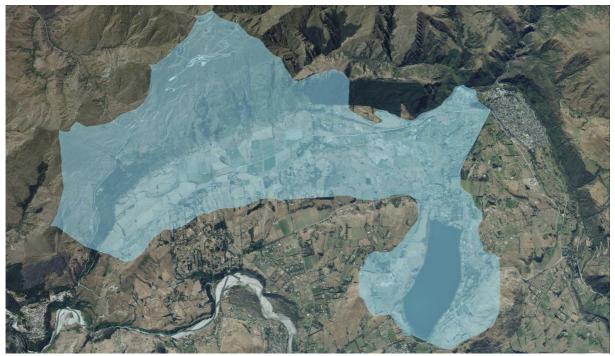
Lake Hayes Catchment

Proposed Lot 4 is situated closest to the basin or area of ponding. The existing ground level at the building site is at RL 368.00m or 0.5m above the lowest part of the site. It is recommended that any proposed building is located above this level to ensure no stormwater nuisance is experienced. It is noted that Building Code requires finished floor level to be a further 225mm above existing ground level as a further protection against stormwater.

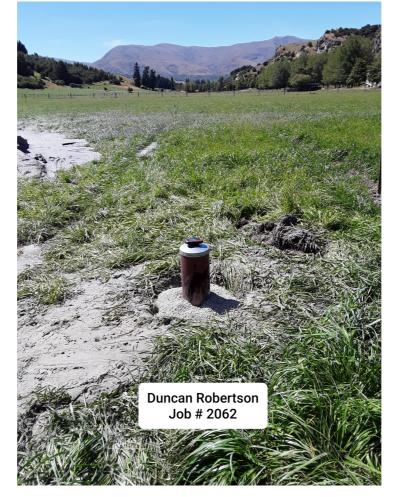
A new 150mmØ bore was constructed within the property by Southdrill in February 2021.

The bore log is attached to the appendix of this report. The total bore depth is 32.61m and water was encountered at 7.21m below the top of the casing. The bore was test pumped for 3 hours at 1.66 litres/sec (~18,000l) and the drawdown was 4.32m.

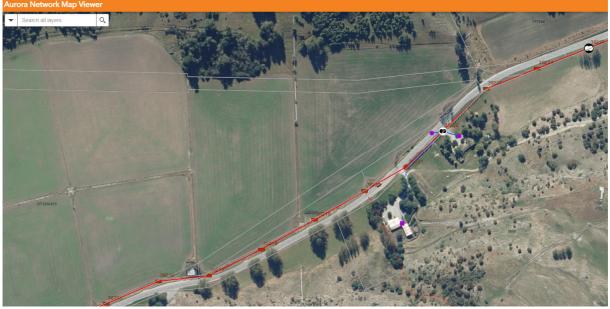
There is existing 11KvA overhead electricity network adjoining the boundary of the property that runs within the road reserve. There are two existing pole mount transformers nearby that may be suitable as shown in the Aurora GIS screen shot below.

Aurora GIS screenshot.

It is anticipated that this can supply the proposed dwelling. Confirmation from the network owner that supply is available is attached. If necessary, depending on the electrical demand for the dwelling a minor upgrade to the transformer may be necessary or new pole mount transformers could in installed on any of the poles adjoining the property. From the network connection point all new internal reticulation the allotments will be underground.

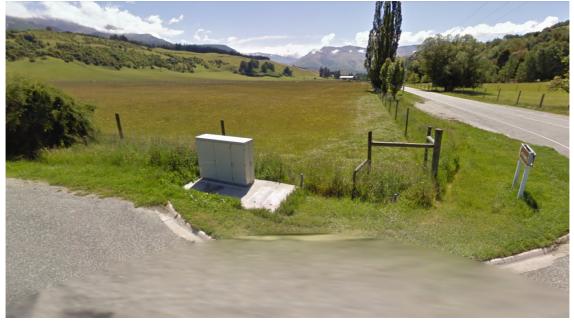
At the intersection of these roads is an existing telecommunication distribution cabinet.

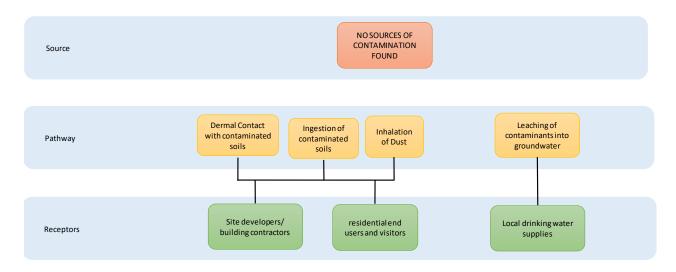
Figure 3: Conceptual Site Model

For there to be an effect on receptors there must be a contamination source and a mechanism (pathway) for contamination to affect human health or the environment (receptor).

As no source of potential contamination have been found to exist on the site, the conceptual site model shows that there is no risk to human health from soil borne contaminants.

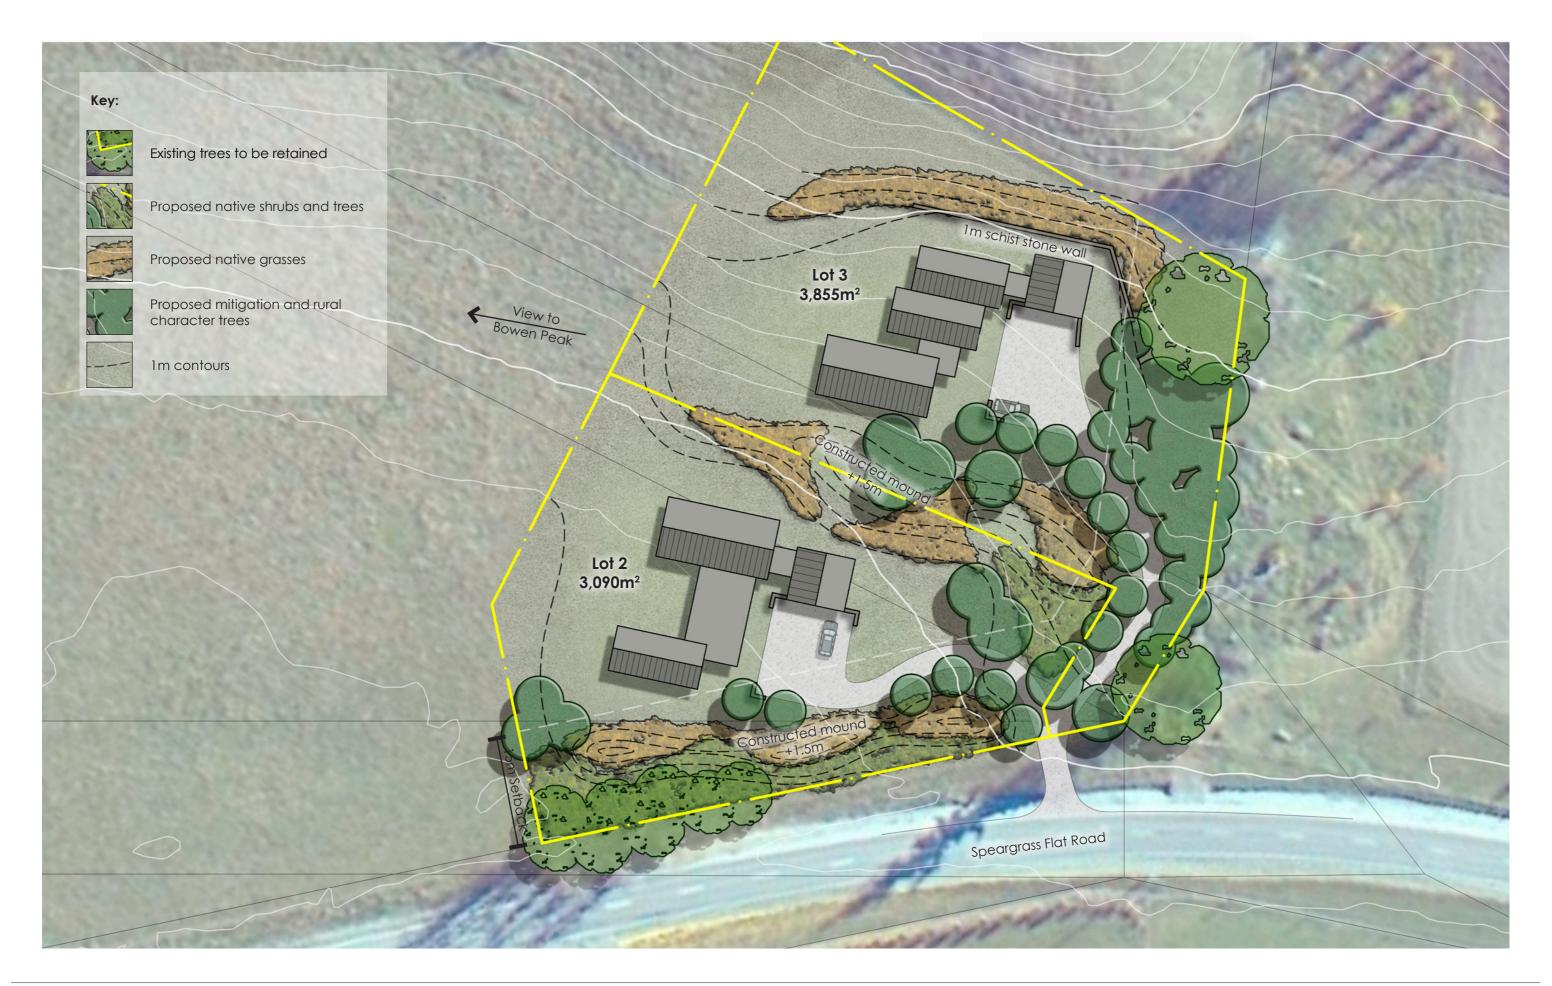
Document Set ID: 6999224 Version: 1, Version Date: 13/09/2021 Speargrass Farm Lot 2 & 3 Landscape Plan - 8 July 2020

Landscape - Reference : PA20412 IS03 Scale 1:250 @ A1 - 1:500 @ A3
