Section 32 Evaluation Report

Millbrook Resort Zone

Wharehuanui Landscape Study

DISCUSSION DOCUMENT

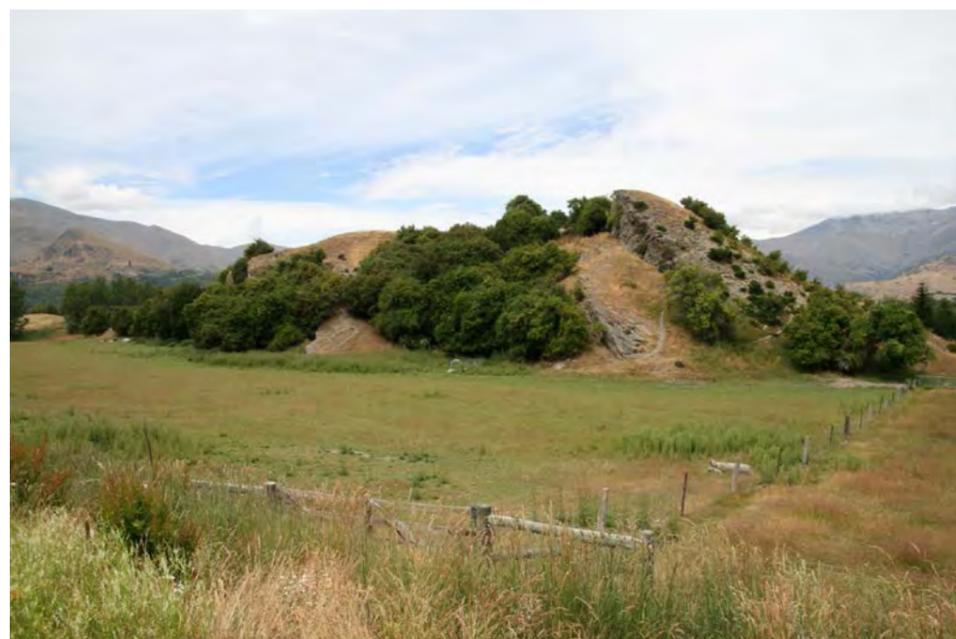
Figure 8: A distinct geologic feature near Malaghans Road.

Geologically speaking the Wharehuanui is part of a glacially sculpted valley and ridge complex west of Arrowtown. It consists of two valleys bisected by steep banks which lead up to elevated plateaus. The floodplain valleys are in part mantled by alluvial fans constructed by ephemeral tributary streams leading in to the valleys from the slopes of Coronet Peak and the associated central plateau referred to in this report as the Wharehuanui Hills.

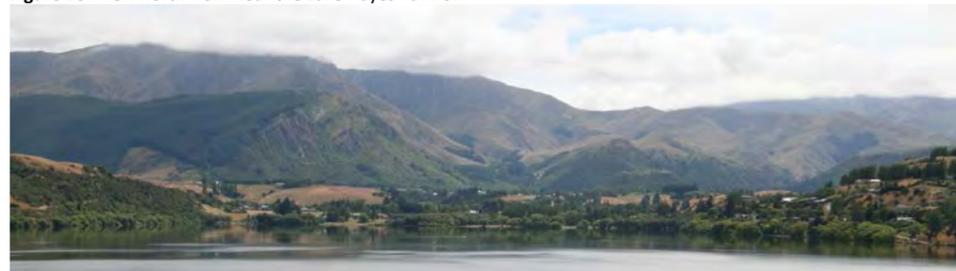
Figure 10: View north from near the Lake Hayes Pavilion.

The Lake Hayes Pavilion (Fig 10) is approximately 3.5km in distance from the southern edge of the Wharehuanui area. Lake Hayes itself forms the foreground of this northerly view while the Rural Residential - North Lake Hayes Zone is visible in the mid-ground. Behind this area, the slopes leading up the Wharehuanui Hills and Rural Resort are moderately visible before the ONL slopes dominate the background.

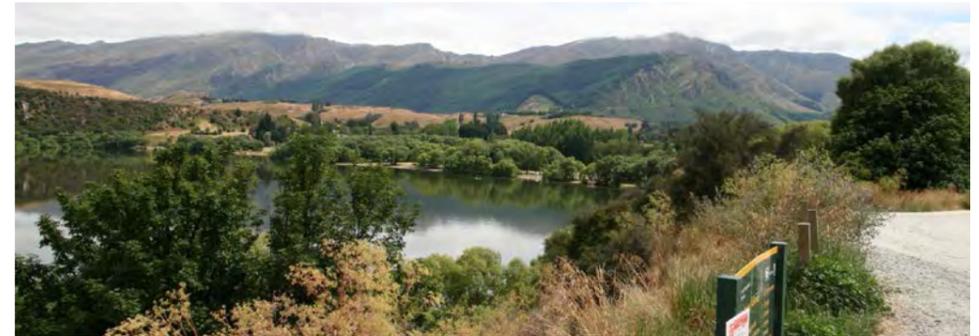
Figure 11: View north from the entrance to the Lake Hayes recreation area.

The entrance to the Lake Hayes recreation area (Fig 11) is approximately 800m from the southern edge of the Wharehuanui. From here the Upper Hills are visible as are much of the Speargrass South Facing Escarpment and the edge of the Rural Resort area. Much of the Speargrass Valley is obscured from view by mature vegetation.

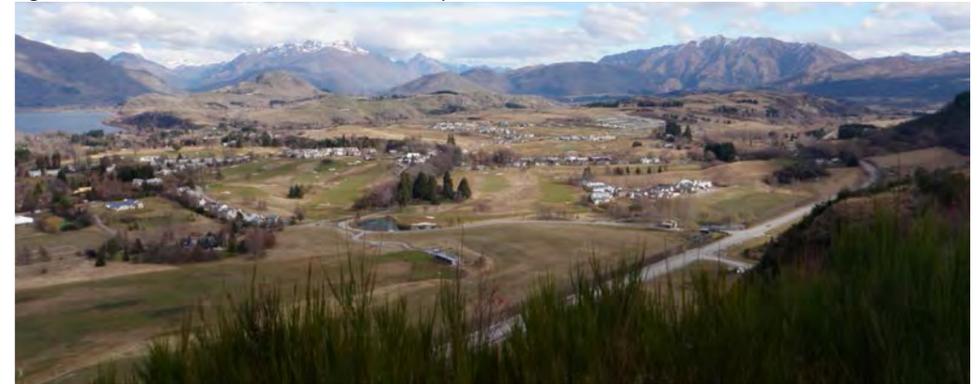
Figure 12: View southwest from the summit of Feeley Hill.

Feeley Hill (Fig 12) is immediately north of the Wharehuanui area and is considered to be an ONL. From the summit of Feeley Hill much of the study area is visible including most of the Mill Creek Catchment, portions of the Wharehuanui Hills and limited parts of the Speargrass Flats.

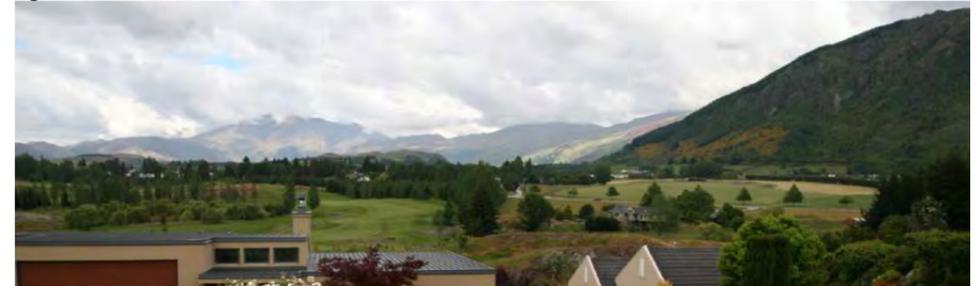
Figure 13: View West from Cotter Ave.

Cotter Ave (Fig 13) is a residential street atop a terrace in Arrowtown. Much of the rise that separates the Mill Creek Catchment from the McDonnell Road area is heavily vegetated and this vegetation obscures views into much of the Study Area. Small portion of the Mill Creek Catchment are visible as are the uppermost portions of the Wharehuanui Hills

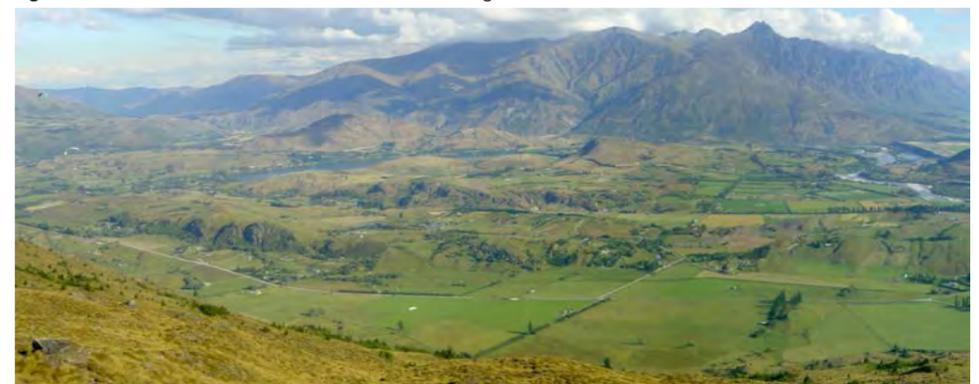
Figure 14: View south from the Coronet Peak Base Building.

Coronet Peak Base Building (Fig 14) offers views across most of the Wakatipu Basin, ranging from Gorge Road to the far eastern edge of the Wharehuanui. A ridge that separates the Base Building from the area known as Rocky Gully obscures views to the more northeasterly portions of the Wakatipu.

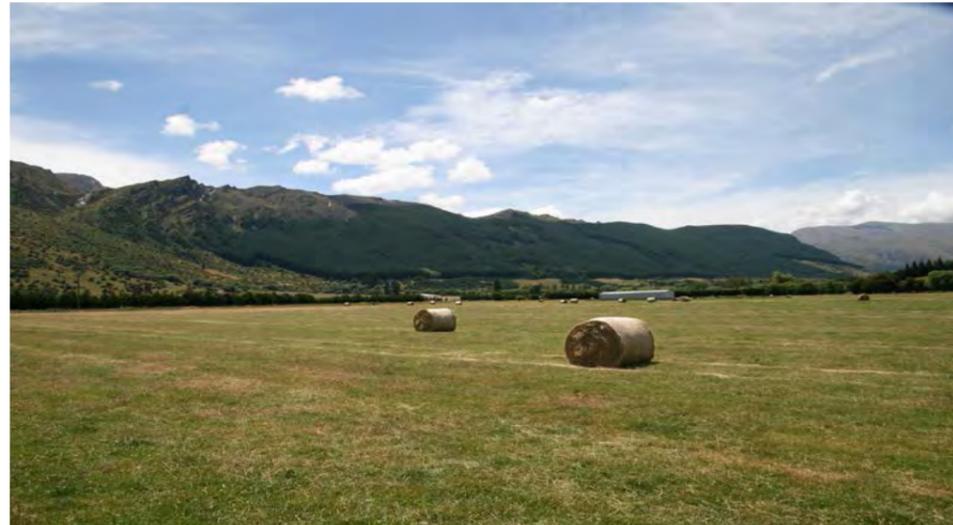
Figure 23: Near Hunter Road looking northeast across Millers Flat.

Development Issues and Opportunities	<ul style="list-style-type: none"> Strong rural character susceptible to degradation within the flatlands. Flat open land provides distinct views across them to the more dramatic mountains of the District. North facing escarpment allows development at it's base to be better absorbed.
Landscape Management Strategies	<ul style="list-style-type: none"> Development potential on the flat, open lands is limited and should be subject to the scale of open space retention. Planting which could impede views across the wider landscape should be restricted. Continued and accelerated management of wilding species.

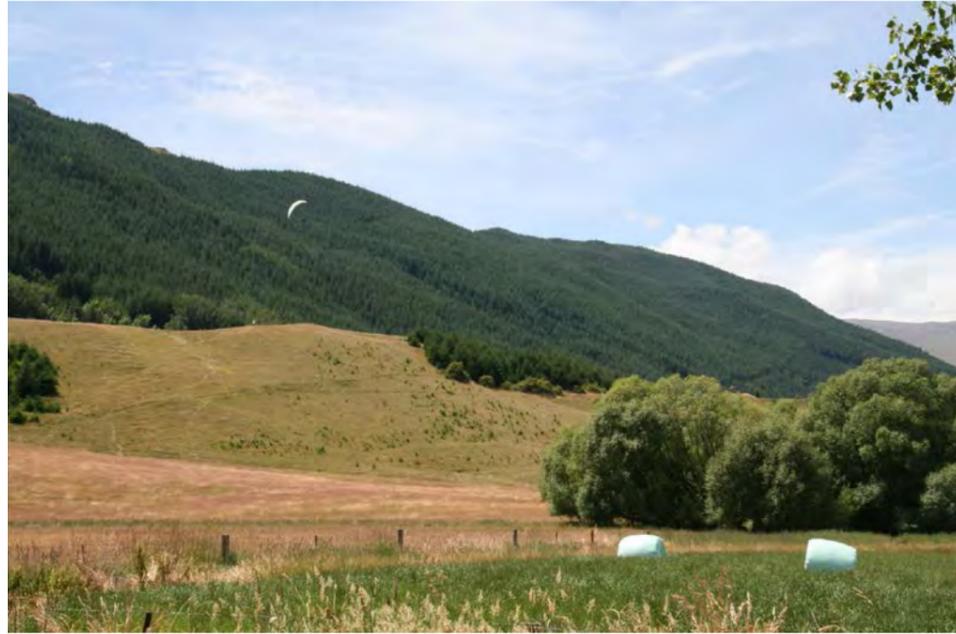
Figure 24: Near Malaghans Road looking north-northeast towards Flight Park.

Development Issues and Opportunities	<ul style="list-style-type: none"> A higher density of ecological planting could enhance the ecological values of the gullies. Exotic weed management is vital to the retention of open spaces. Residential density located within the visually isolated plateaus could increase without significant degradation to the landscape. Integrity of existing skylines and ridge-lines should be maintained.
Landscape Management Strategies	<ul style="list-style-type: none"> Continued productive use, especially on the south facing slopes. Ecological planting within the gullies and areas of existing native patches. Continued and accelerated management of wilding species.

- The slopes leading up The Foothills landscape unit are also deemed to have a **low** ability to absorb change. These slopes display a distinct rolling hills land form similar to the escarpment faces. They form a ridge complex between Malaghans Road and the ONL slopes. A roche moutonnée feature to the south of Malaghans Road is included in this area. The landforms have a moderately strong rural character with patches of vegetation. They are highly visible and legible and any inappropriate development would likely lead to the degradation of this area's values and quality.

- The flatter more northerly portions of The Foothills are considered to have a **moderate to high** ability to absorb change. These flatter portions, while displaying a strong rural character are not visible from the most public places. It is considered that appropriate development could occur in this area without degrading the quality or character of the landscape.

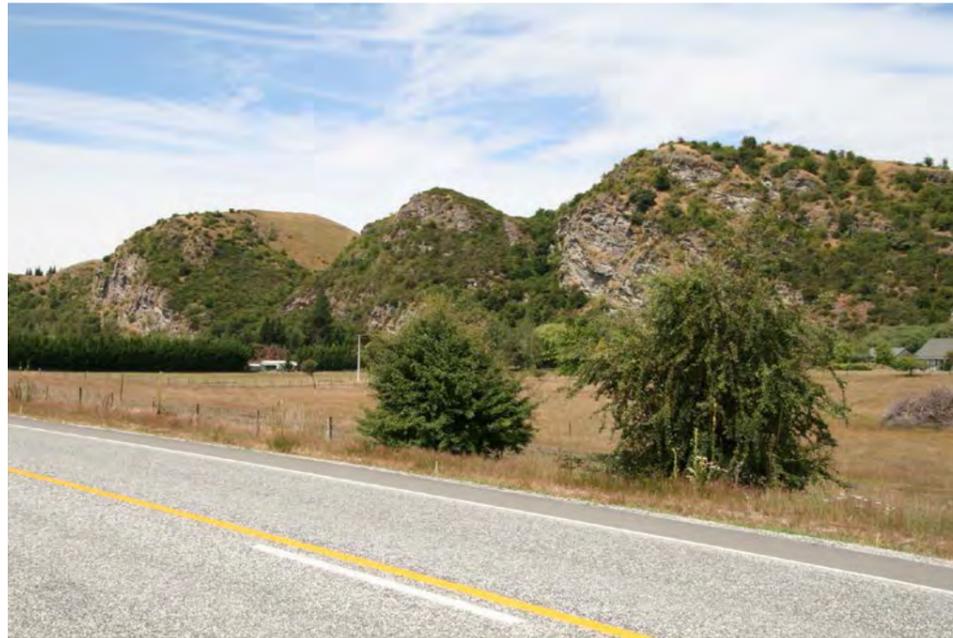
Figure 26: From Malaghans Road looking southeast.

Development Issues and Opportunities	<ul style="list-style-type: none"> The more natural character of these faces leave them susceptible to degradation. Pastoral farming is limited to portions of the escarpment faces. Integrity of existing skylines and ridge-lines should be maintained.
Landscape Management Strategies	<ul style="list-style-type: none"> Continued and accelerated management of wilding species. Nurture re-vegetation, especially within the gullies. Protection and enhancement of existing native vegetation.

- Escarpment faces, including Malaghans North Facing Escarpment and Speargrass South and North Facing Escarpments are considered to have a **low** ability to absorb change. These escarpment faces are susceptible to degradation as they are highly visible, often form a ridge or skyline and contain a high degree of natural character.

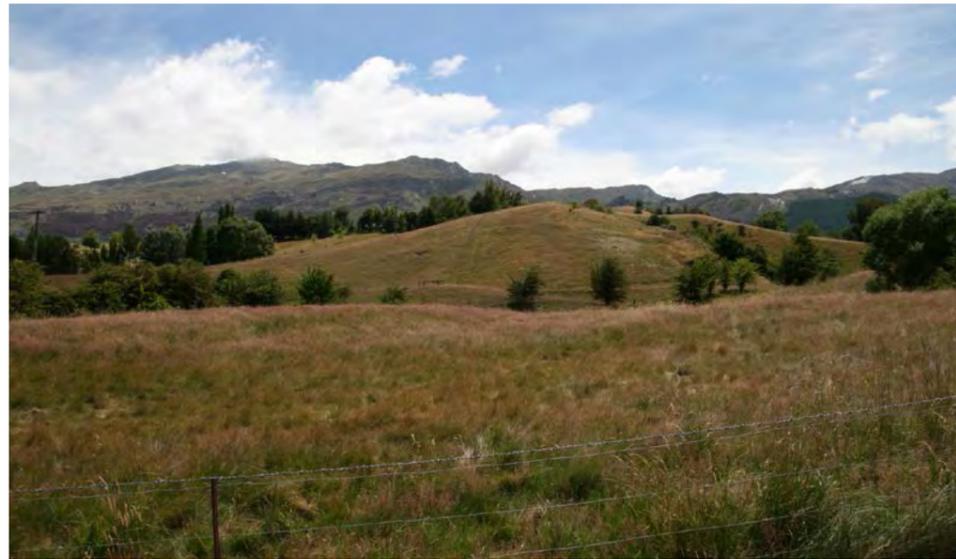
Figure 27: Near Mooney Road looking south across the Wharehuanui Plateau.

Land Use	<ul style="list-style-type: none"> Rural living. Pastoral farming.
EVALUATION AND RECOMMENDATIONS	
Ability to Absorb Change	<ul style="list-style-type: none"> 1 - High ability to absorb further appropriate development on the lower portions of the Wharehuanui Plateau. 3 - Moderate potential to absorb further development on the more elevated portions of the unit.
Development Issues and Opportunities	<ul style="list-style-type: none"> Avoid any adverse visual effects of development on the surrounding public roads, especially Malaghans Road and Speargrass Flat Road. Enhance ecological corridors on the margins of riparian areas. Residential development should maintain existing rural character.
Landscape Management Strategies	<ul style="list-style-type: none"> Rural residential living densities could increase in appropriate locations Existing rural elements should be repeated. Continued and accelerated management of wilding species.

- A portion of land in the Wharehuanui Plateau unit adjacent to Hunter Road is considered to have a **moderate** ability to absorb change. Existing development in this area has degraded the rural character to a moderate degree. Appropriate development could occur in this area, however it's capacity to absorb change is limited.

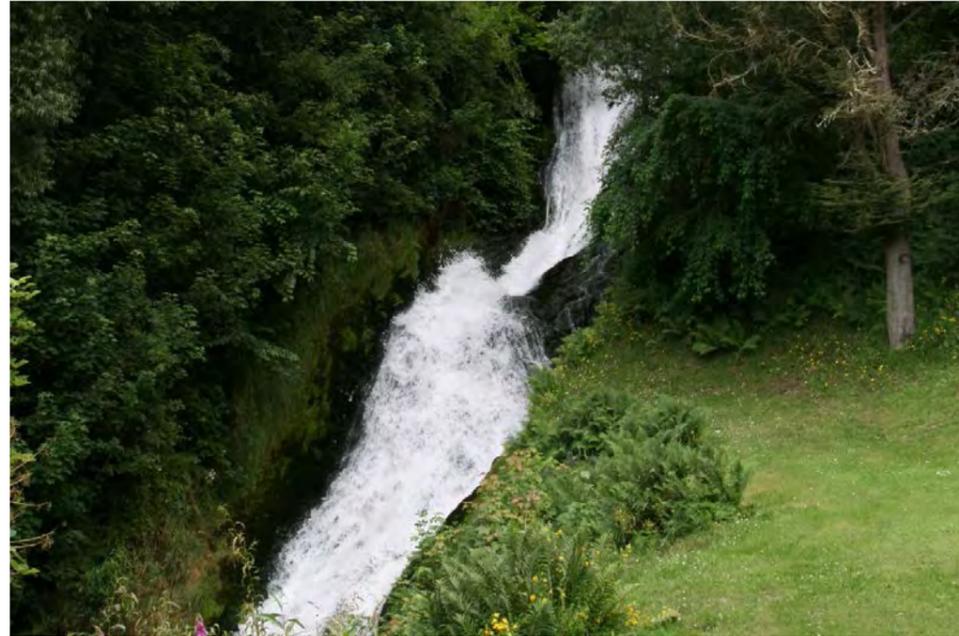
Figure 31: The waterfall in Waterfall Park.

Development Issues and Opportunities	<ul style="list-style-type: none"> • Visually cut off from the rest of the valley. • Natural character is stronger than rural character. • Flooding potential
Landscape Management Strategies	<ul style="list-style-type: none"> • Clearance of selected wilding exotics. • Highlight distinct heritage. • Retention and enhancement of natural values.

- Waterfall Park is a small, isolated landscape unit deemed to have a **high** ability to absorb change. It's surrounding land form and vegetation visually encloses it. Its character is more natural than rural and it is considered that appropriate development could occur without degrading and perhaps enhancing this landscape unit's values.

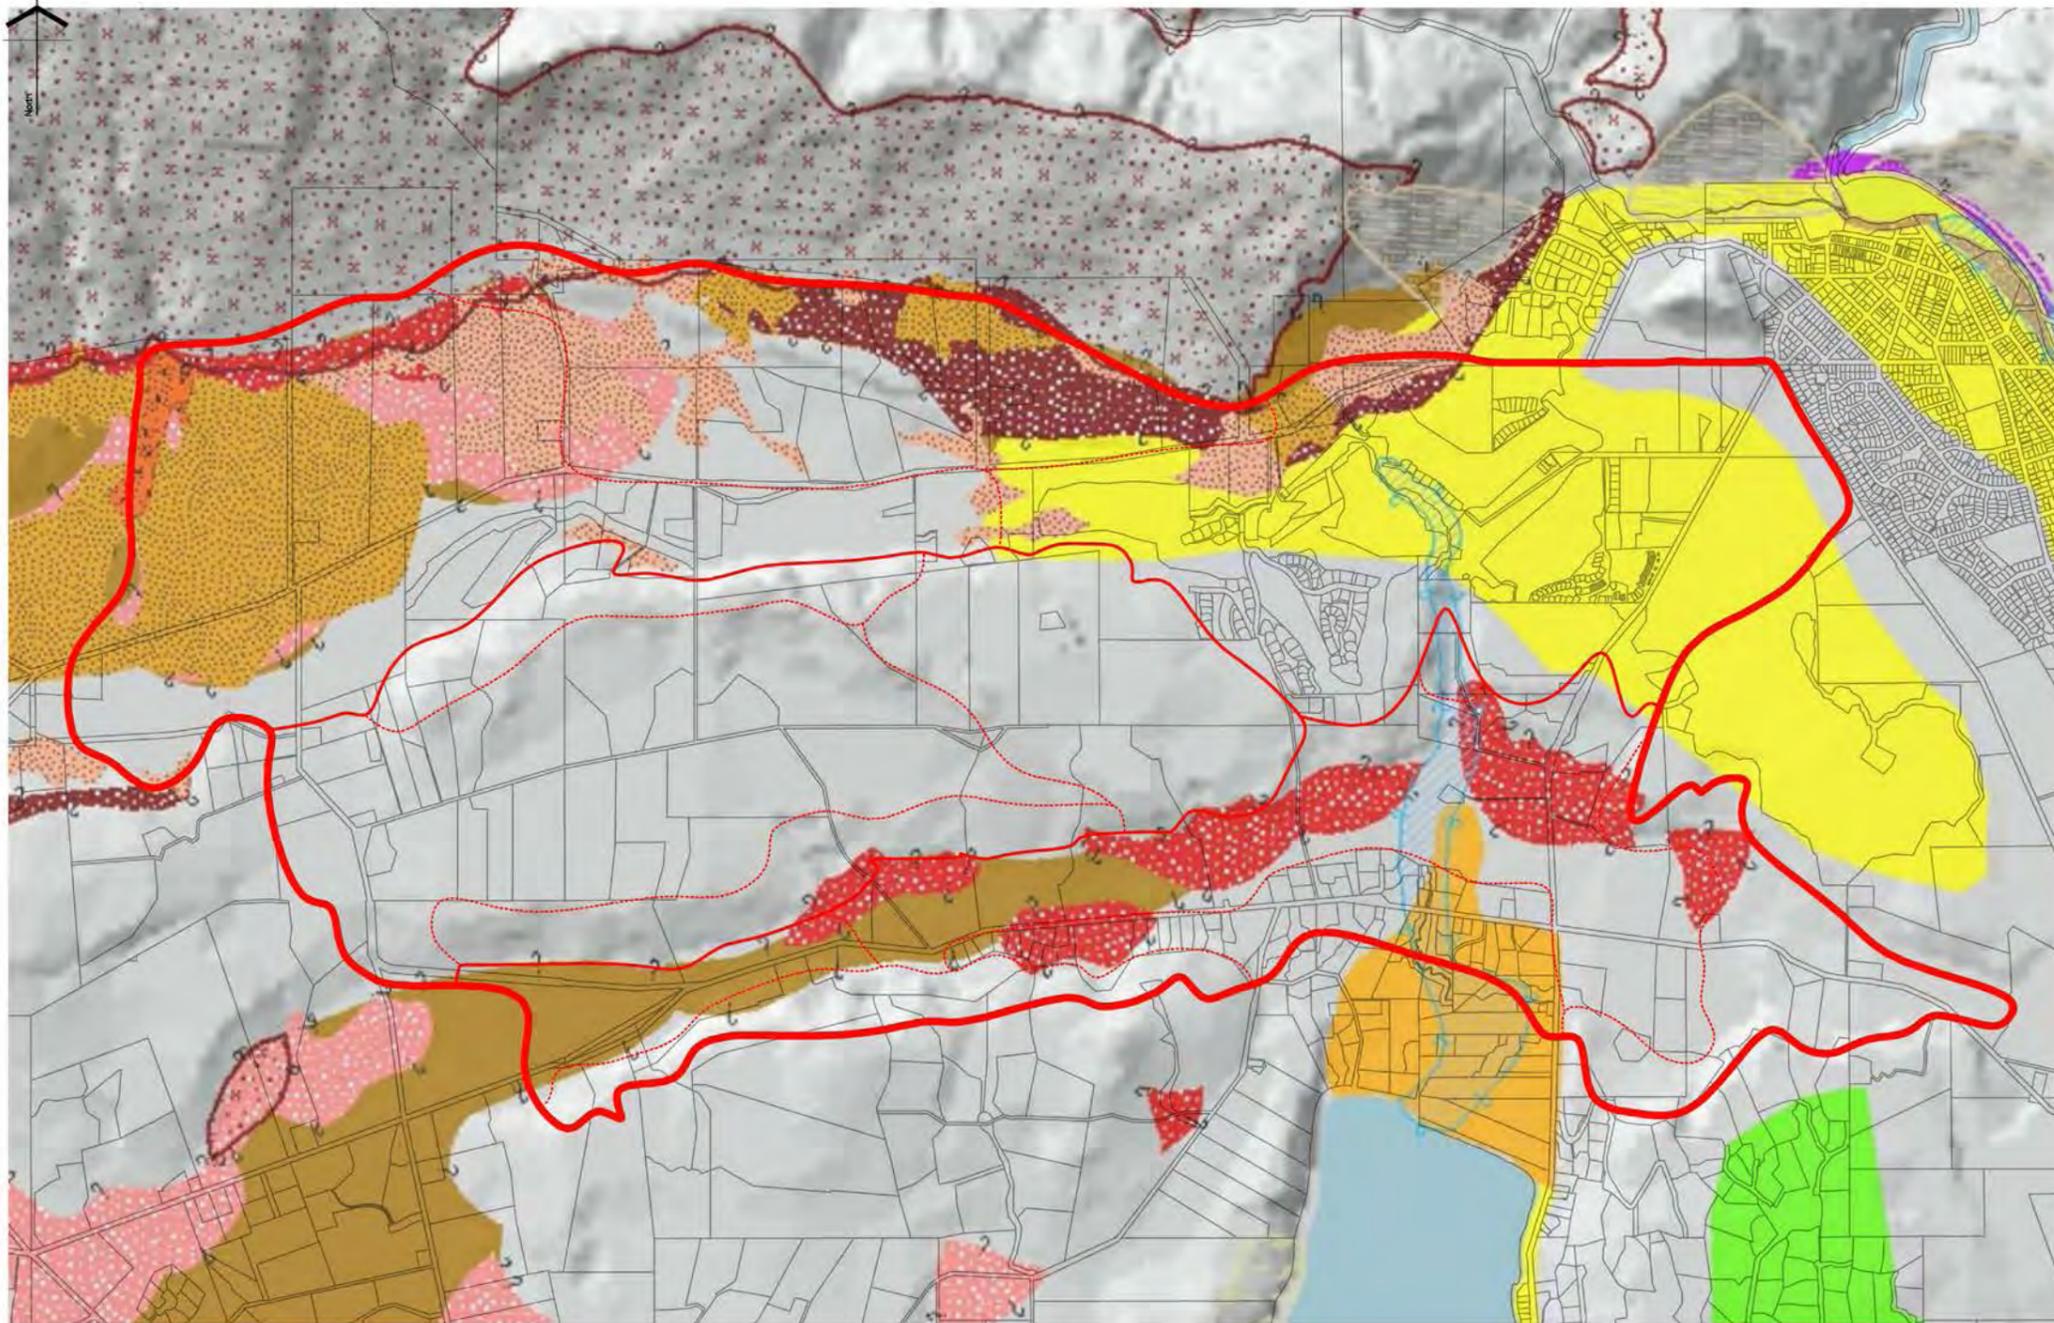
QLDC Hazards Key

Map adapted from QLDC Webmaps Hazard data. Davis Consulting Group.
 Note: Hazards may not be comprehensive

Several geologic hazards have been identified in the areas. These hazards are shown in the Geologic Hazards map in Appendix F.

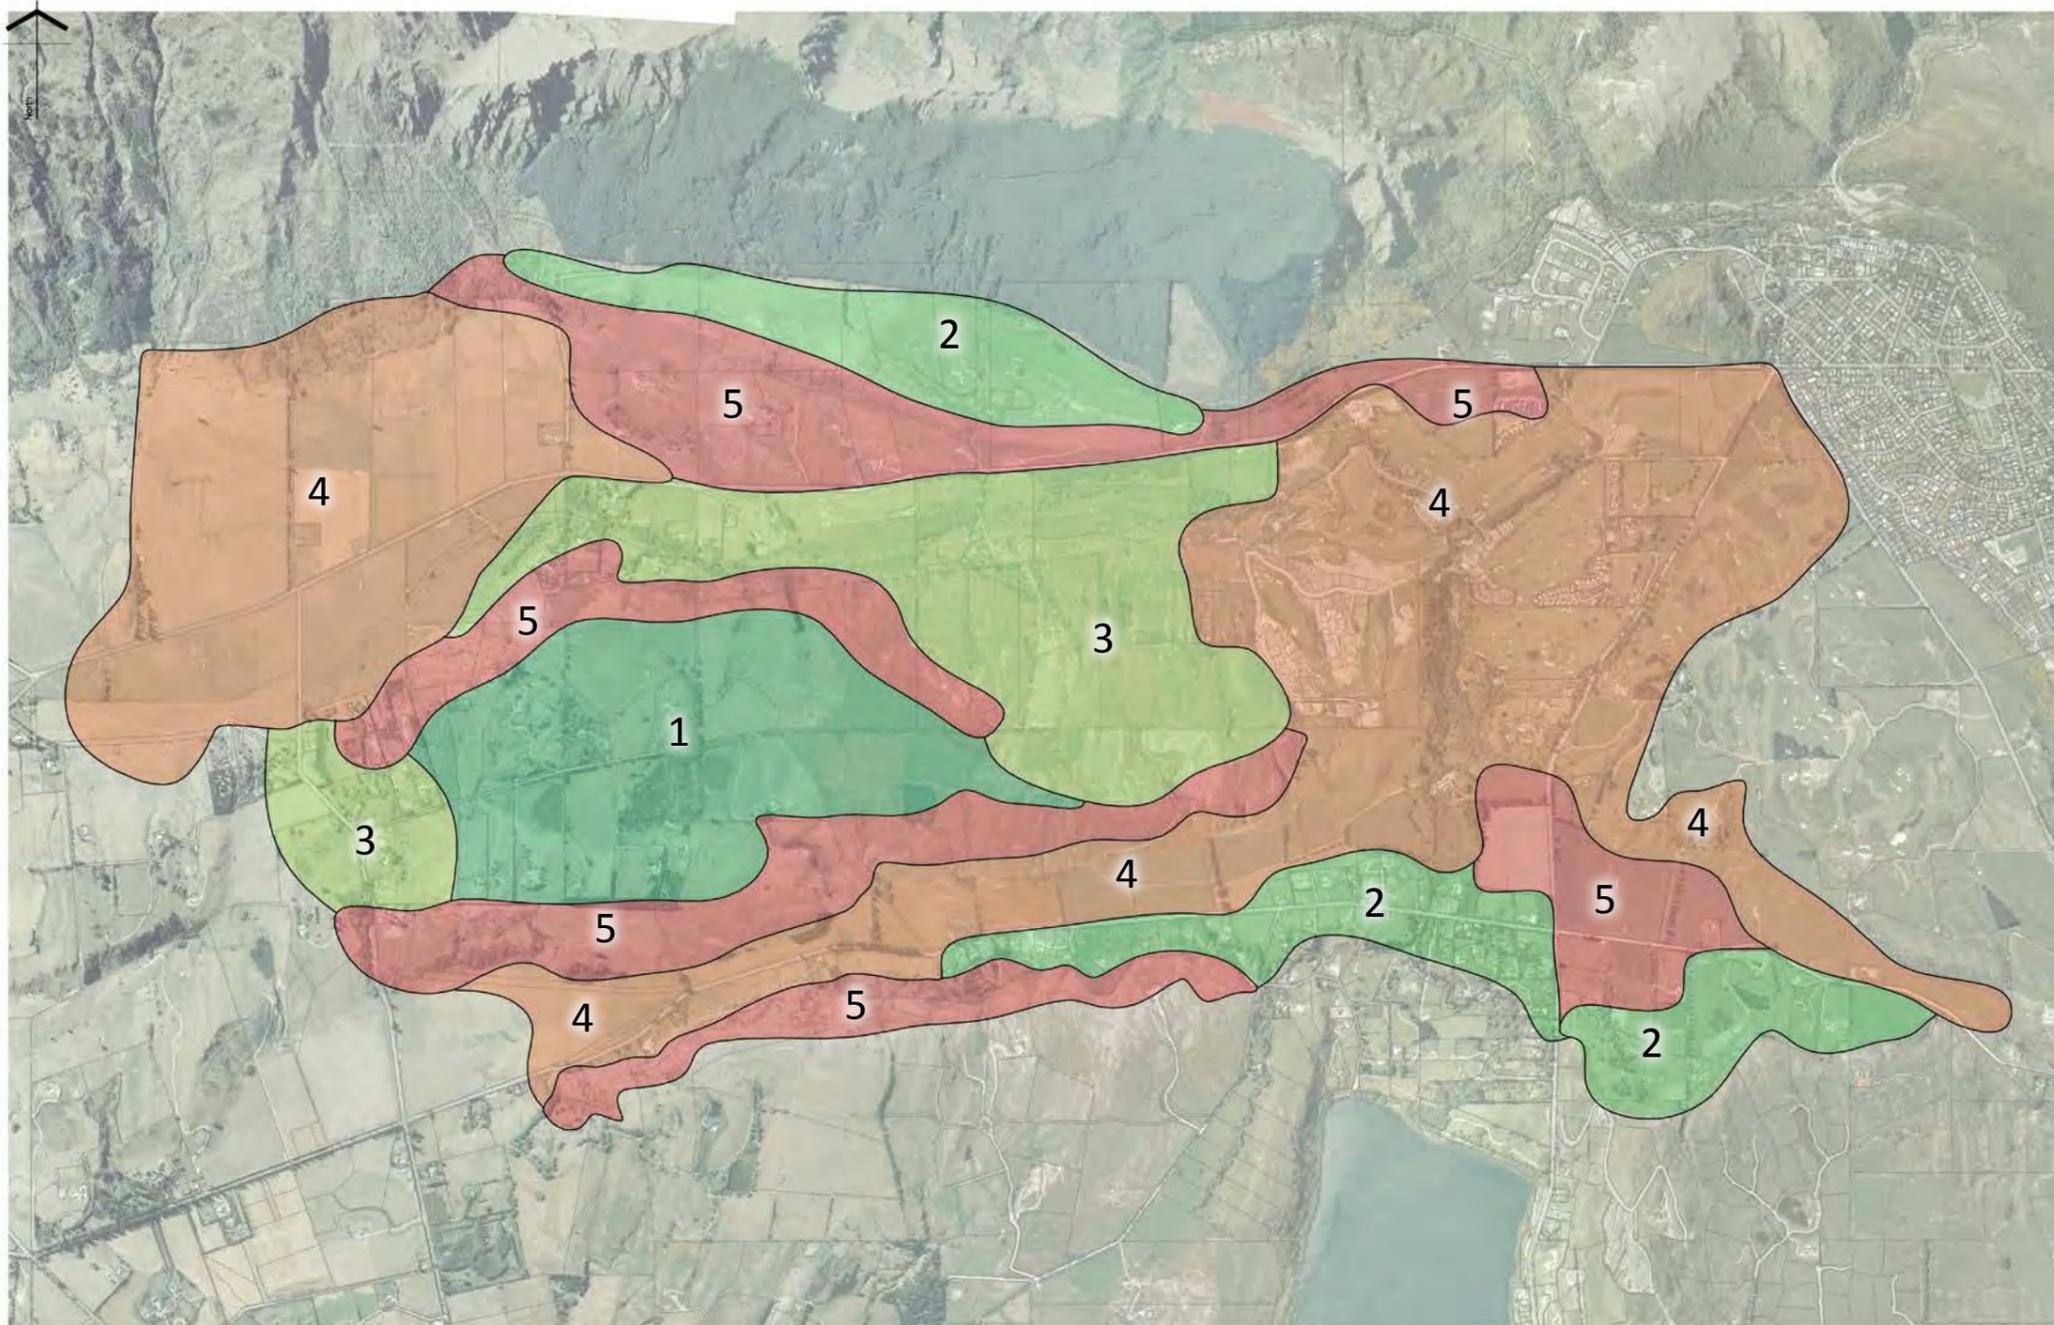
Ability To Absorb Change

- 1 High
- 2 Moderate to High
- 3 Moderate
- 4 Moderate to Low
- 5 Low

The following is a summary of the findings in terms of the landscapes ability to absorb change.

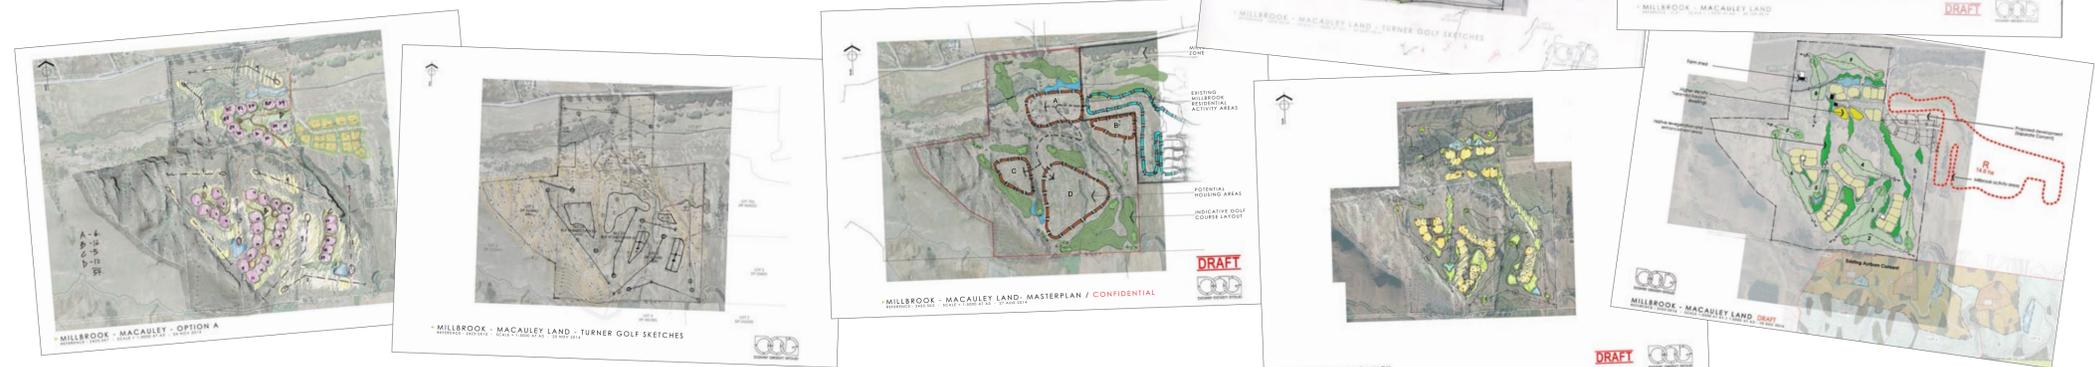
The design process follows a creative path of investigation and elimination, developing rough concepts that explore design options and alternatives, and testing those against variables such as landform, visibility, retention of character, access and the rural guidelines of the District Plan. Some early concepts are shown below, by way of example.

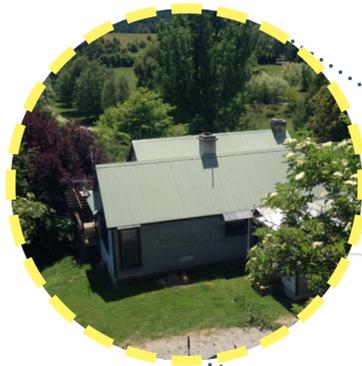
'WESTERN BLOCK'

Dwelling cluster limited to 5.5 and 6.5 metres in height, dark recessive colours for both roof and wall materials, gabled roof forms, setbacks and restrictions to avoid skyline intrusion from Malaghans Road views. Stand-alone dwellings on generous lots

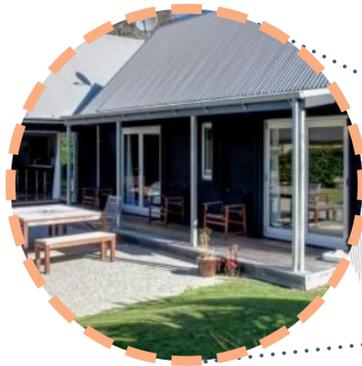
CENTRAL 'CLUSTER'

Dwelling cluster on northern and eastern visible edges restricted to 5.5 metres in height, allowance for 6.5 metres as loft space over garage at western edges with single level over rest of dwelling. Recessive colours, large hillock form substantially retained. Stand-alone dwellings on generous lots with gabled roof forms

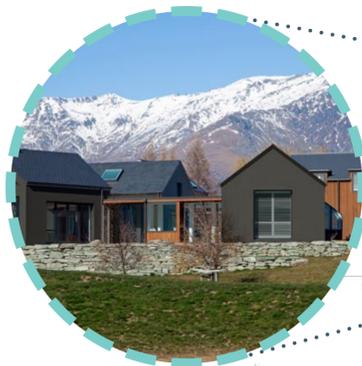
VALLEY FLOOR & EDGE 'CLUSTERS'

Dwellings to be viewed as an extension of the existing established Millbrook character, adopting existing Millbrook design guidelines. Mill Creek to be enhanced through ecological planting as already established in Millbrook, and maintenance of grazing patterns on retained open spaces.

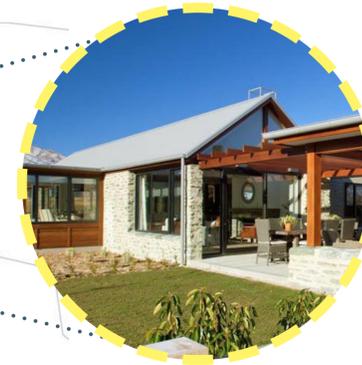
EASTERN 'CLUSTER'

A single row of stand-alone dwellings on generous lots. Dwelling heights limited to 5.5 metres, dark recessive colours and gabled roof forms.

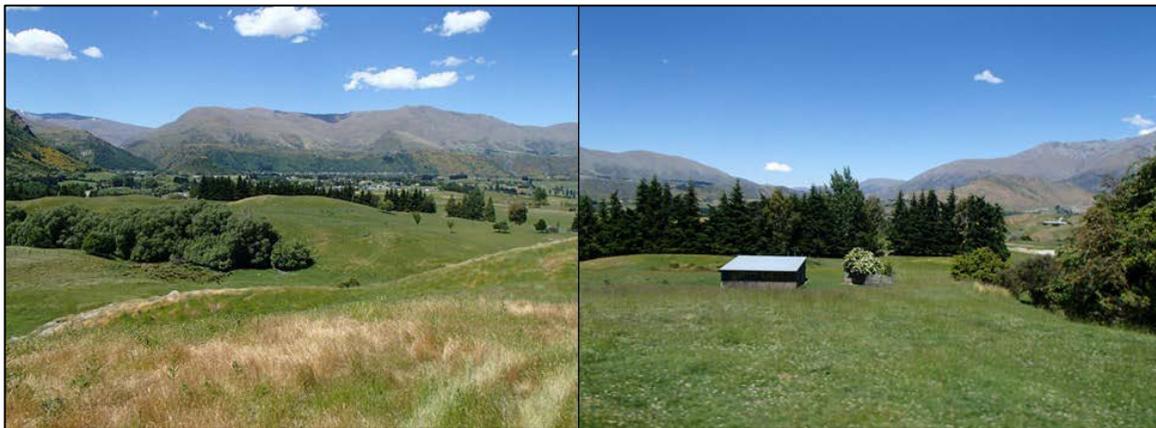
Figure 2: Site Layout Plan

Figure 2 presents the current site layout plan. The site contains one dwelling, a hay shed, sheep yards, footbath and a woolshed with the remaining area consisting of hummocky grassland dominated by short exotic pasture grass species (Plate 1). Proposed plans for the site can be found in Figure 3 and include proposed residential housing and a golf course.

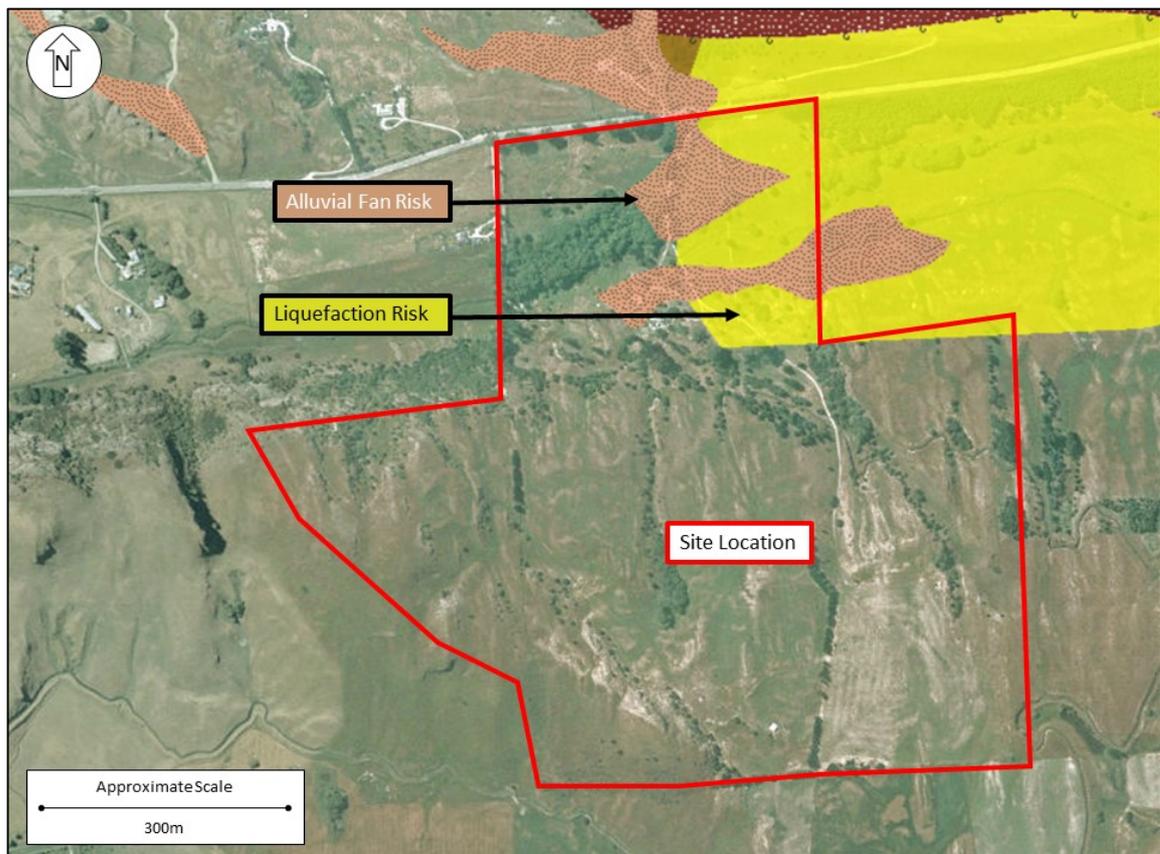
Figure 4: Site Hazard Plan.

According to the QLDC hazard maps, an active alluvial fan runs through the north of the site as well as risk of liquefaction as indicated in Figure 4.

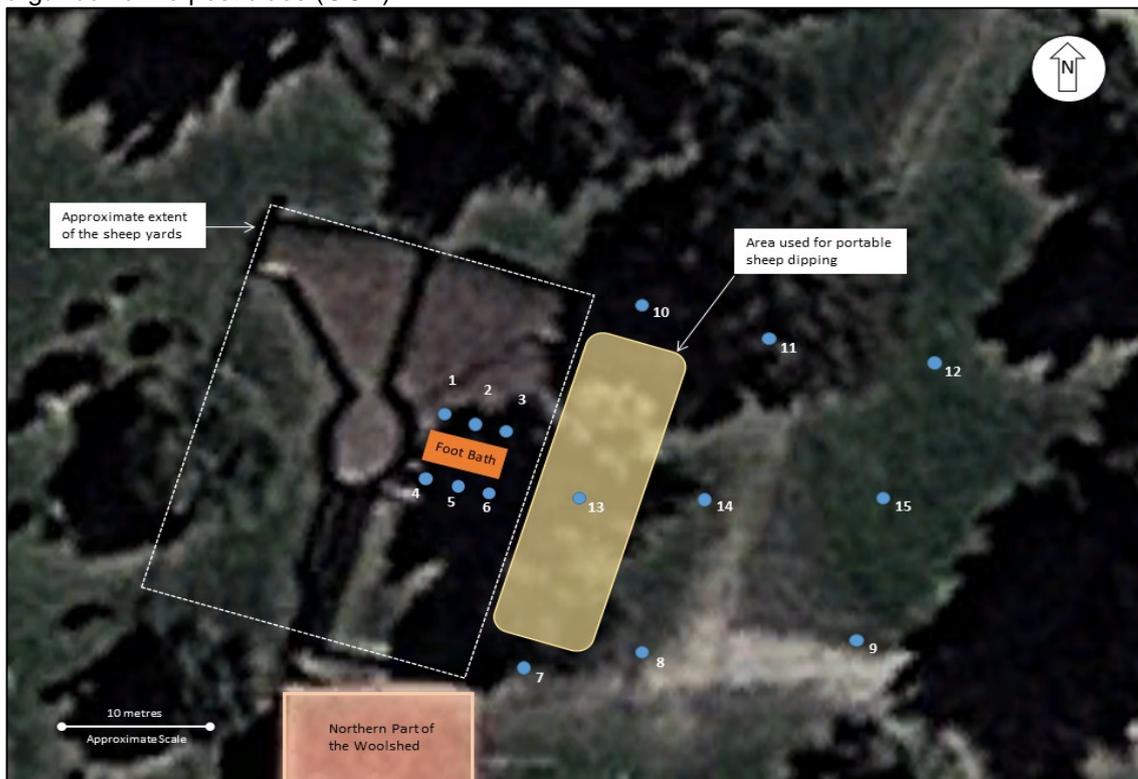
Figure 6: Sample Location Plan

The sampling and analysis plan was designed to address the specific objectives, namely the characterisation of contaminants in soil adjacent to the foot bath and sheep yards where a portable sheep dip was historically used. Figure 6 shows the location of soil samples collected adjacent to the yards and foot bath; these samples were analysed for arsenic, copper and organochlorine pesticides (OCP).

Samples from each of the 15 locations in Figure 6 were analysed individually for arsenic and copper then composited into 5 groups for OCP analysis. The sampling depth of 0-0.1m for these sample sites is considered appropriate due to the nature of the potential contaminants present, such as organochlorine pesticides and heavy metals, which generally bind strongly to soils and are unlikely to leach to significant depths.

The soil sample locations are provided in Figure 6 and summarised in Table 3 below.

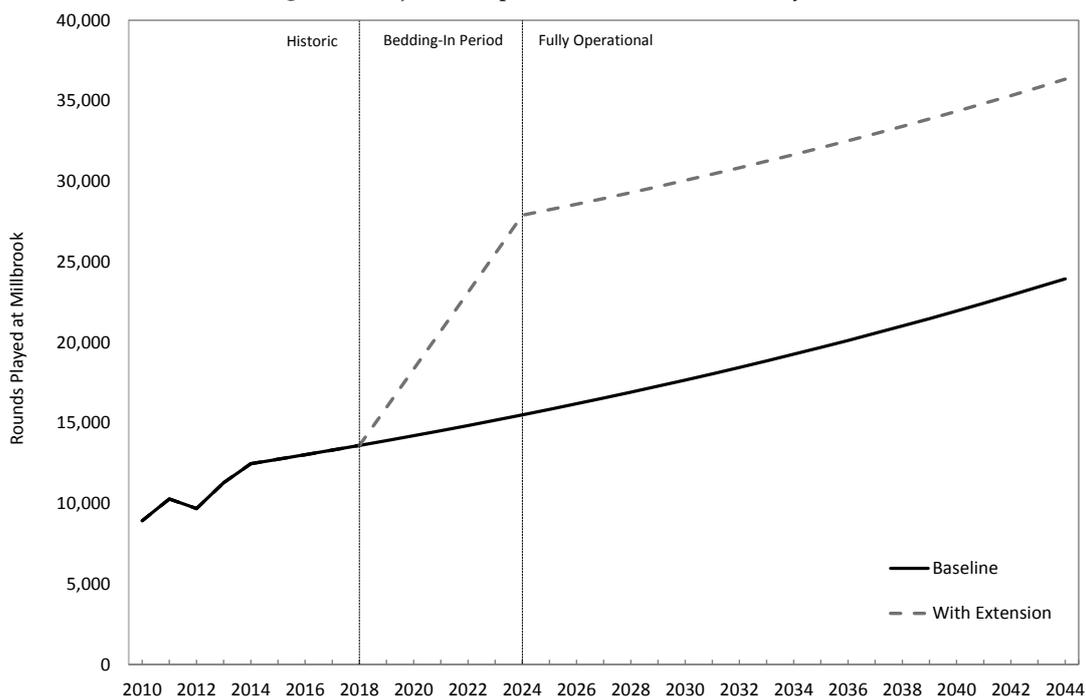
Figure 5: Projected Impact on Annual Rounds Played

To estimate the number of rounds expected to occur under the status quo, we assumed that they would grow at 2.2% per annum, which is four times slower than the actual rate over the last 4 years. While this may seem pessimistic, we consider it reasonable given that the course will eventually hit capacity constraints that limit further growth anyway.

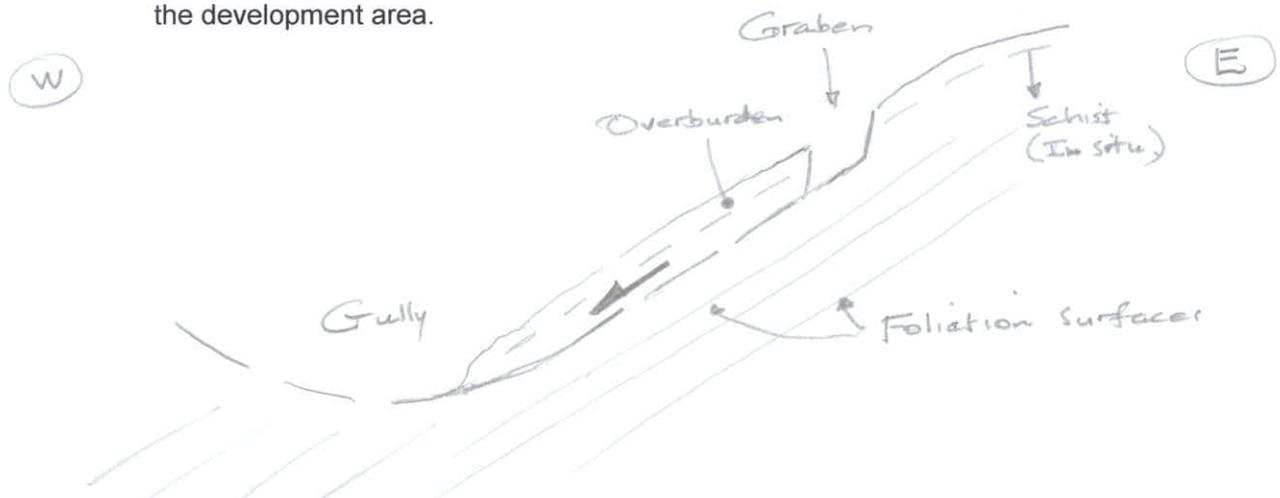
- There is a small, recent landslide on the east flank of a deep gully in the western region of the development area.

- The foliation failure is not going to impact on any proposed construction area but is a good example of a dip slope failure in schist in a specific terrain. (Note also the potential for a like failure in any major dwelling excavations).
- On the gully wall opposing the above there is evidence for an old failure in a schist scarp slope. I have annotated the approximate vacated outline, and it is unlikely to regress, but it proves that scarp slopes are not necessarily absolutely stable, in the long term.
- Approximately 100m south-west of the above slide feature there is an assessed area of soil creep; probably a till capping on schist, creeping under wet conditions. Of no significance in a development context.

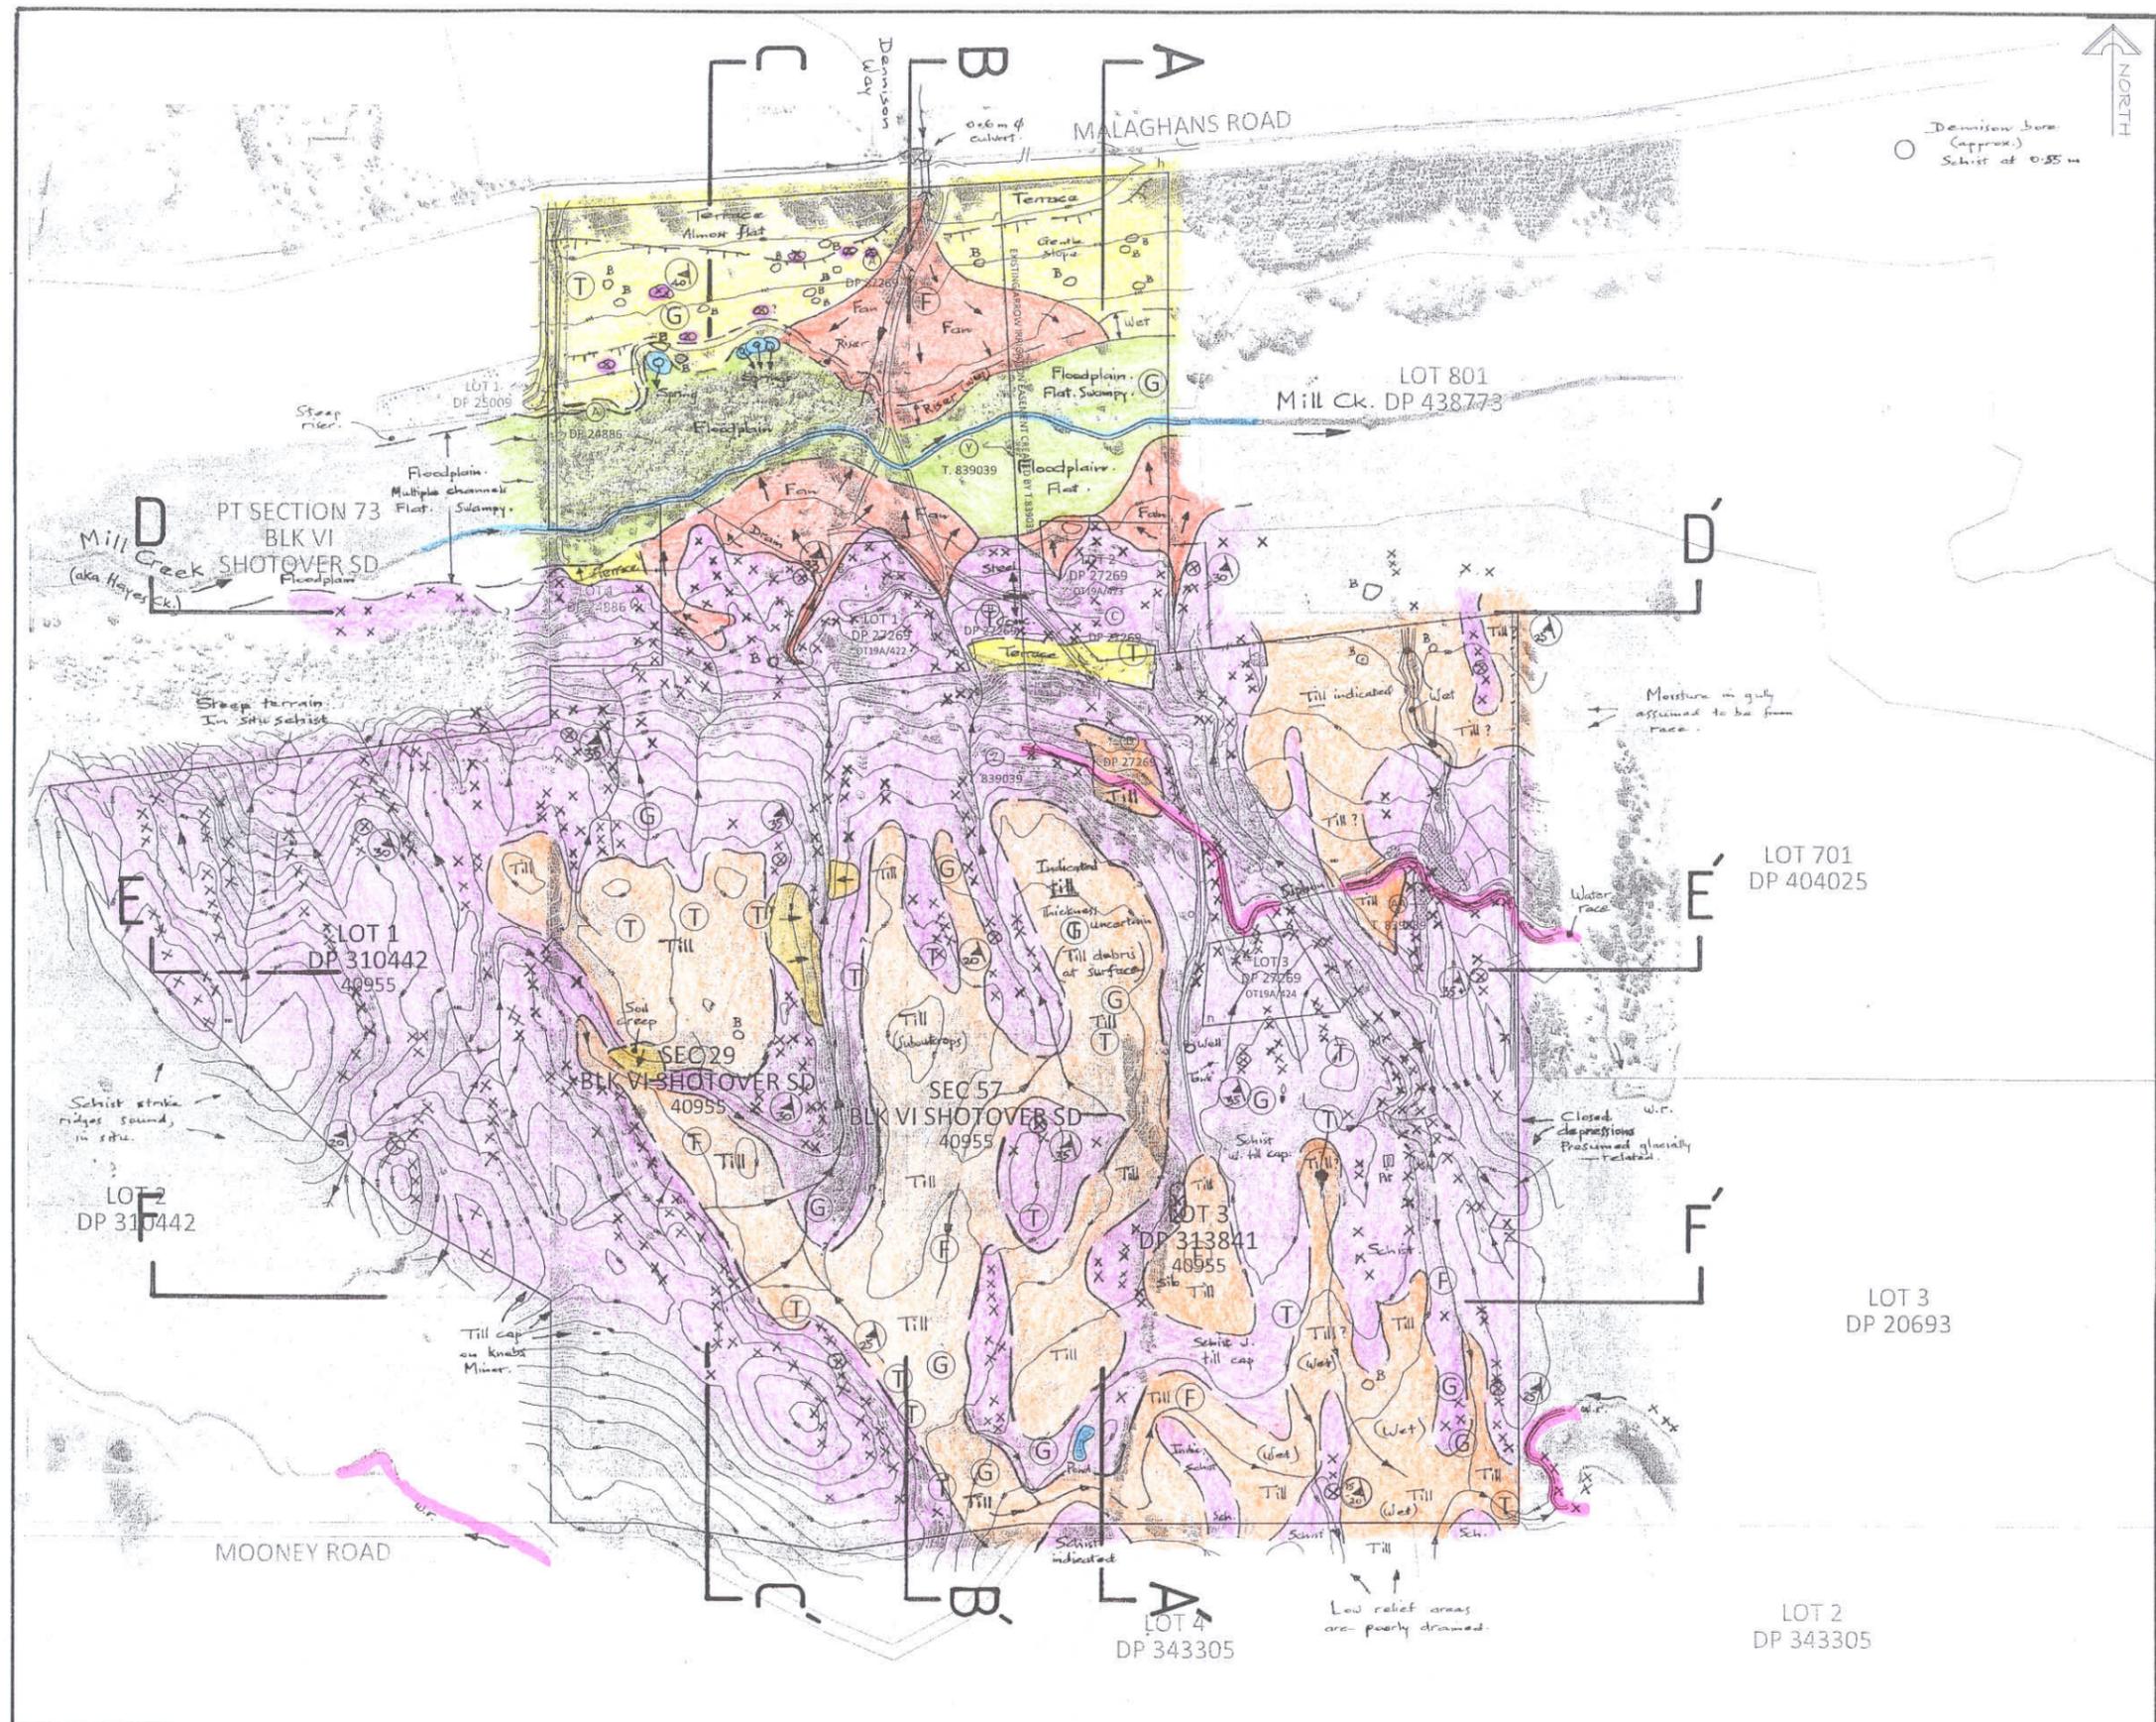
Fig. 2a

Schist. An applied cross denotes outcrop visited or remotely observed.		Landslide		Boulder at surface.
	Glacial fill (ablation)		River alluvium (assumed).		Spring
	Stream fan		Water race (open)		Schist foliation attitude.
	Floodplain (Mill Creek)				
					Geological cross section.
