Section 32 Evaluation Report

Millbrook Resort Zone

Wharehuanui Landscape Study

DISCUSSION DOCUMENT

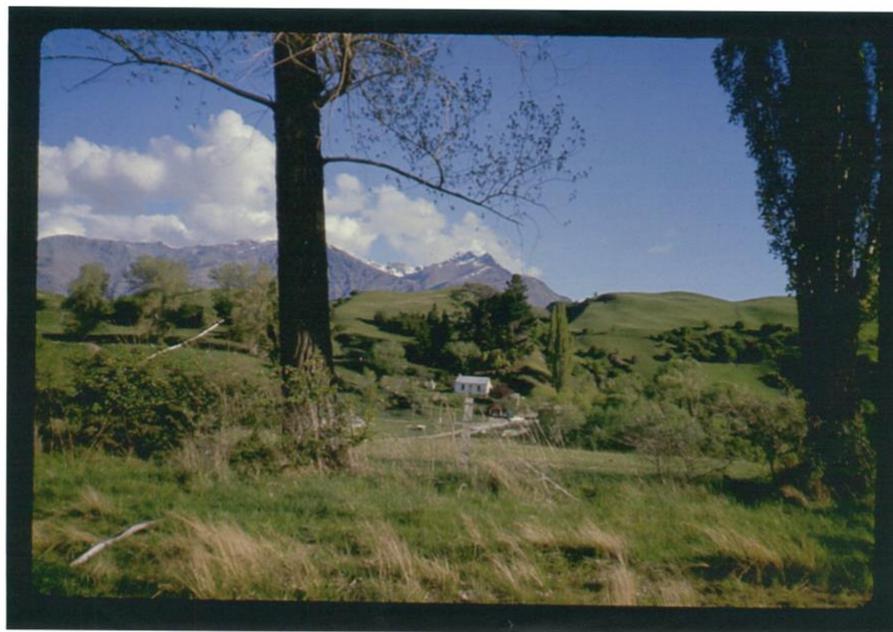
Figure 5 A photograph (courtesy of Lakes District Museum) of the cottage taken from Malaghans Road. The photograph is undated, but probably dates from the 1970s.

The photograph in figure 5 shows the cottage from Malaghans Road before the existing rear extension was built. Close examination of the photograph shows a garage below and in front

of the cottage and the shearer's quarters on the righthand side of the cottage. It also shows a section of drive in front of the cottage that no longer exists and what appears to be yards close to the woolshed. The front of the cottage is not obscured by the walnut tree that presently hides it from view and which was probably planted in the 1970s.

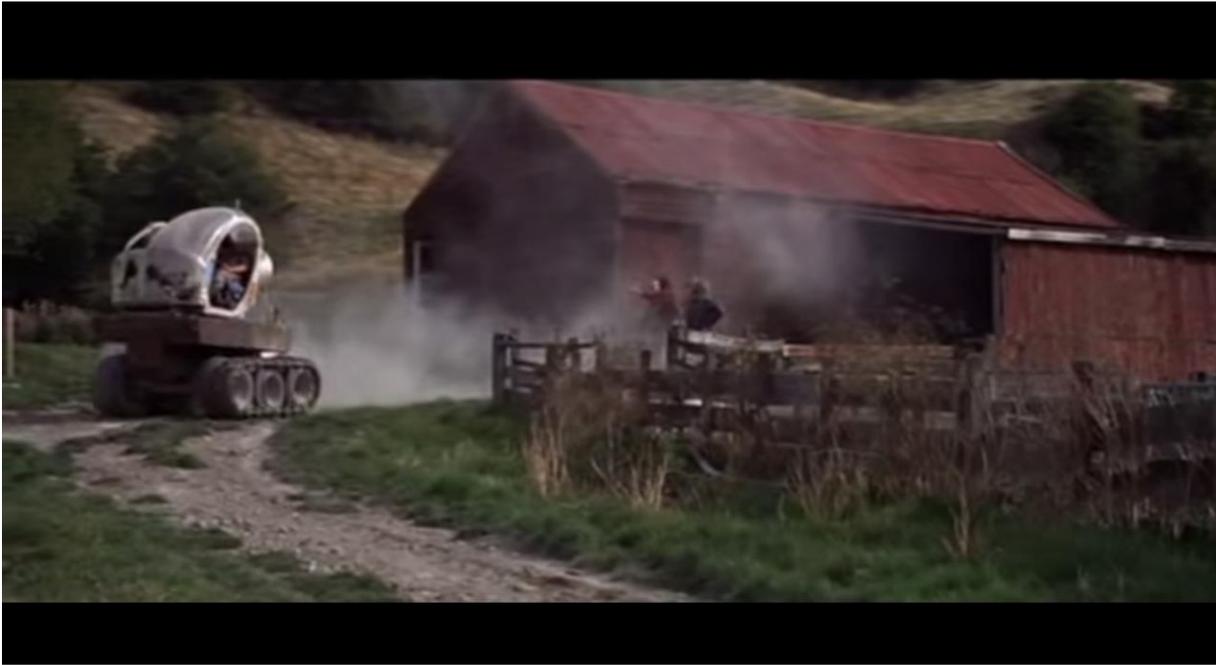
Figure 6 A scene from 'Race for the Yankee Zephyr'⁴⁰ which is believed to show the barn/woolshed at Dalgleish Farm in about 1980. There was a small, old lean-to on the creek side. Without the modern extensions the barn/woolshed has a much more appealing, traditional Central Otago form.

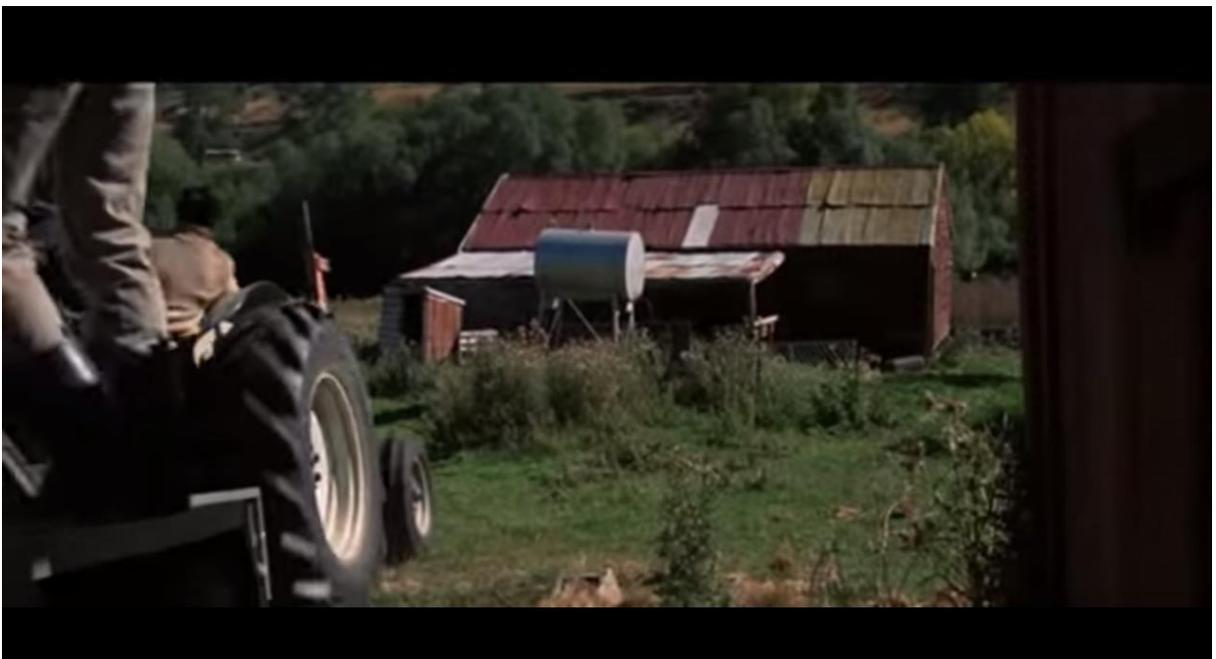
Figure 7 A second scene from the same film showing the south elevation of the barn/woolshed with a lean-to but not the extension for the Wool Room.

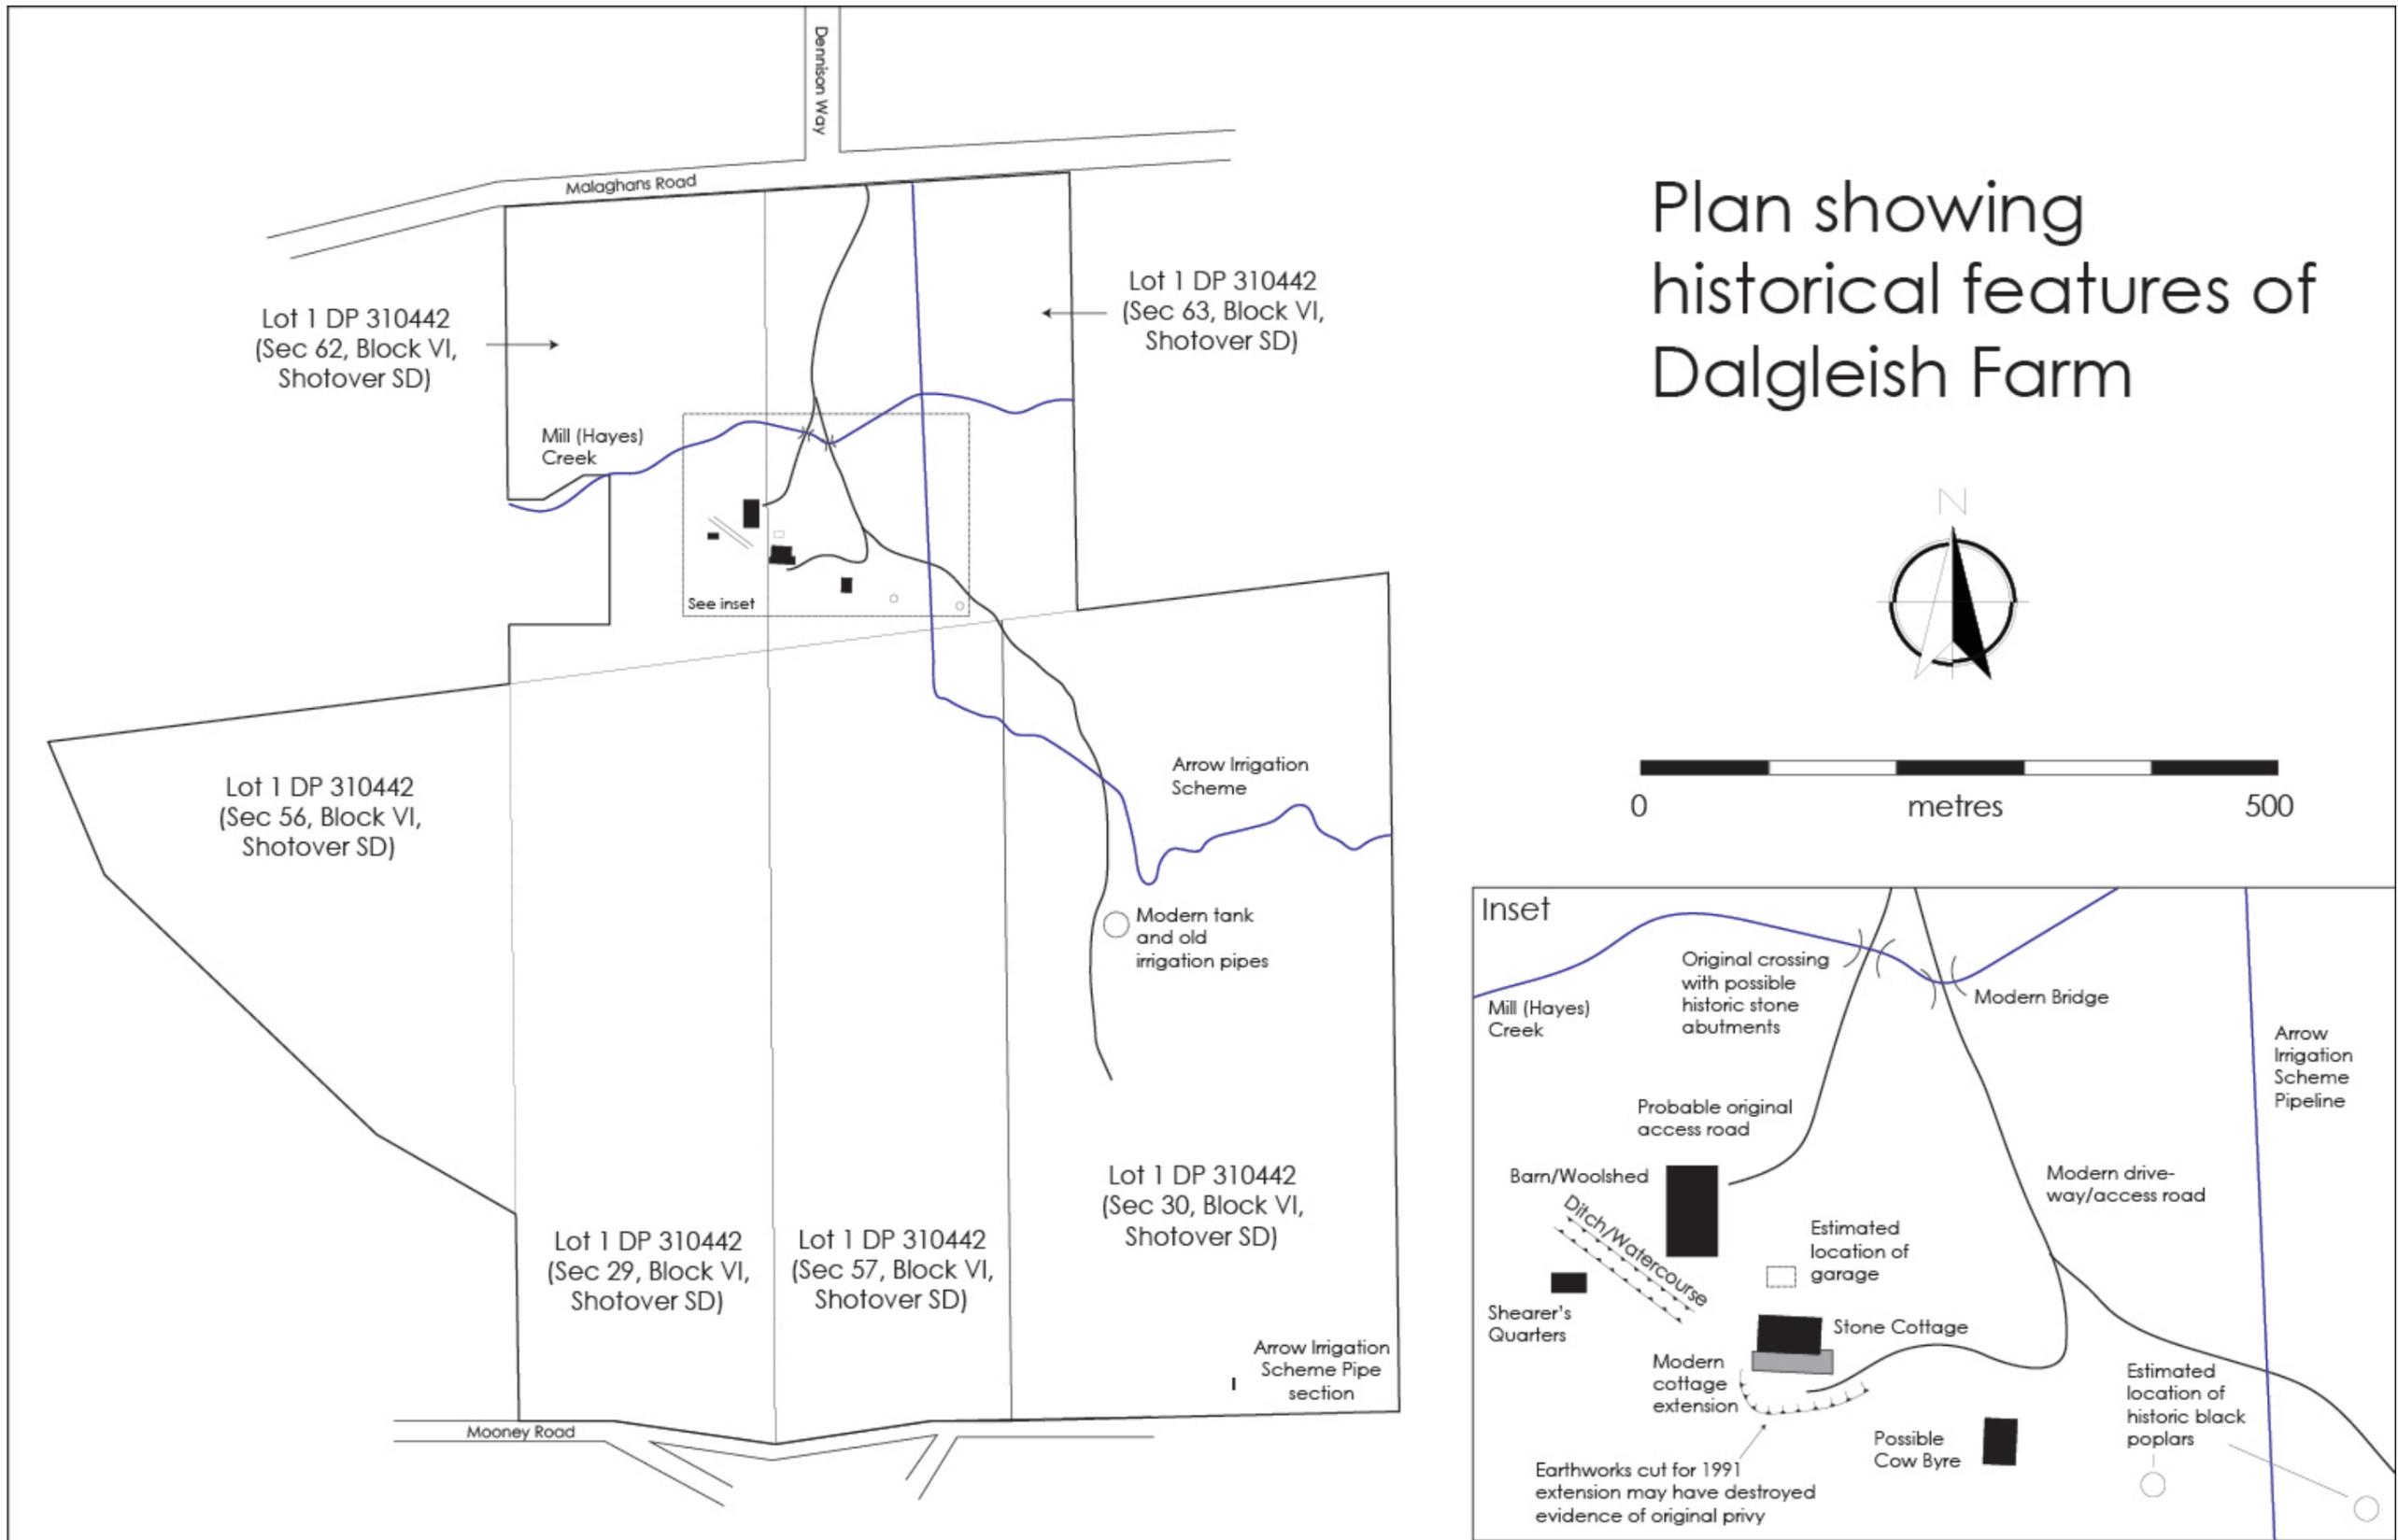
Plan of area with elevated likelihood of archaeological material

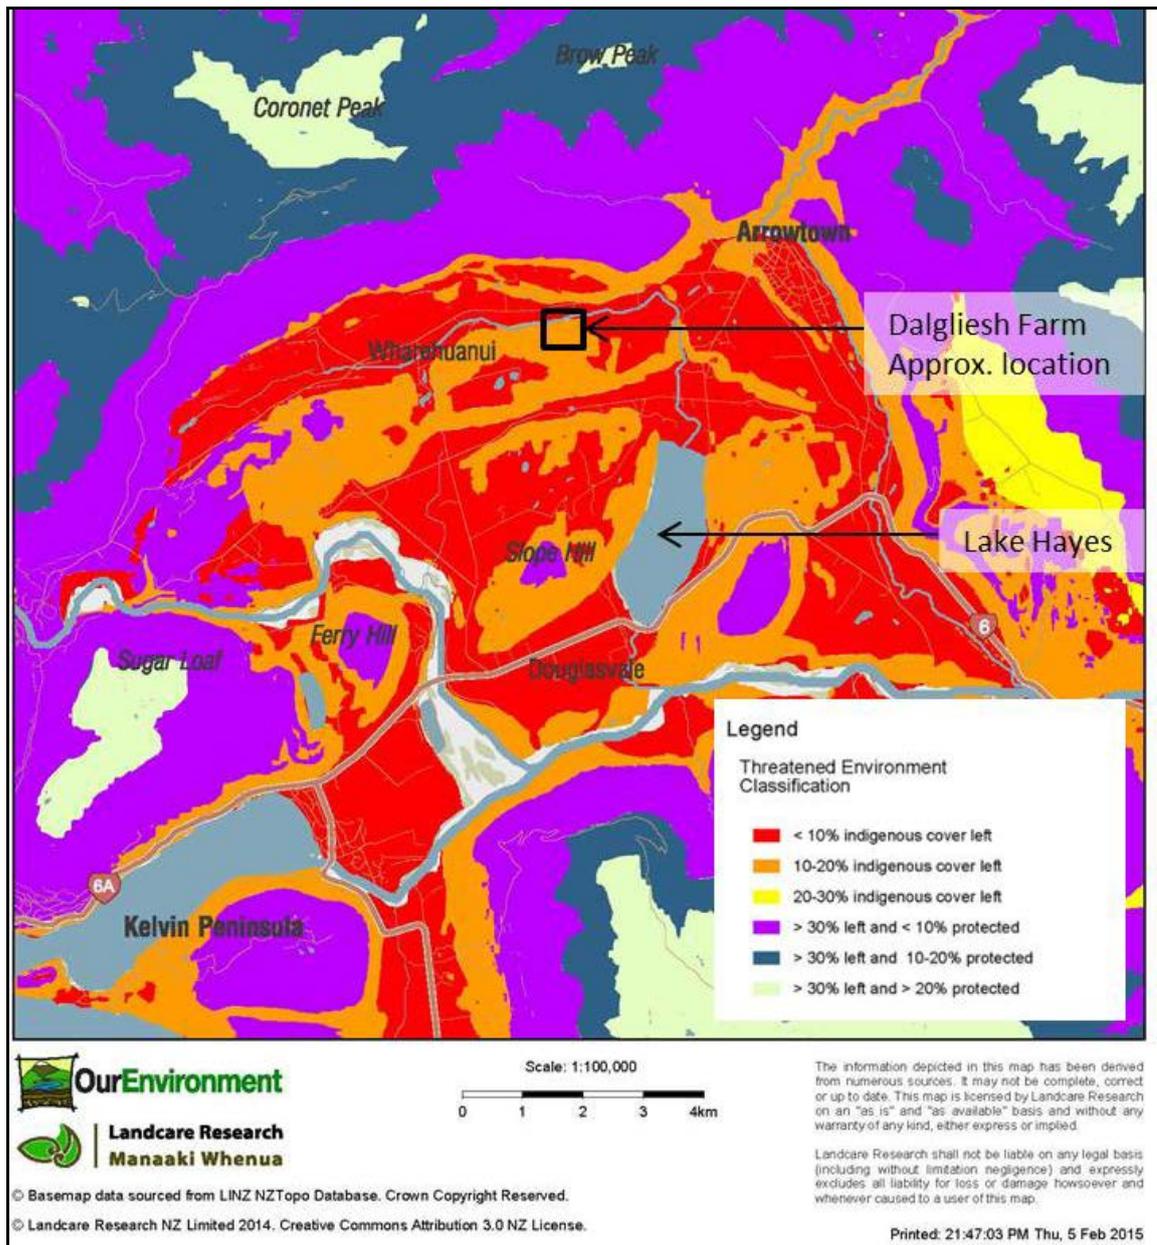
Figure 3: Threatened Environment Classification (reproduced from “Our Environment” website (www.ourevironment.scinfo.org.nz))

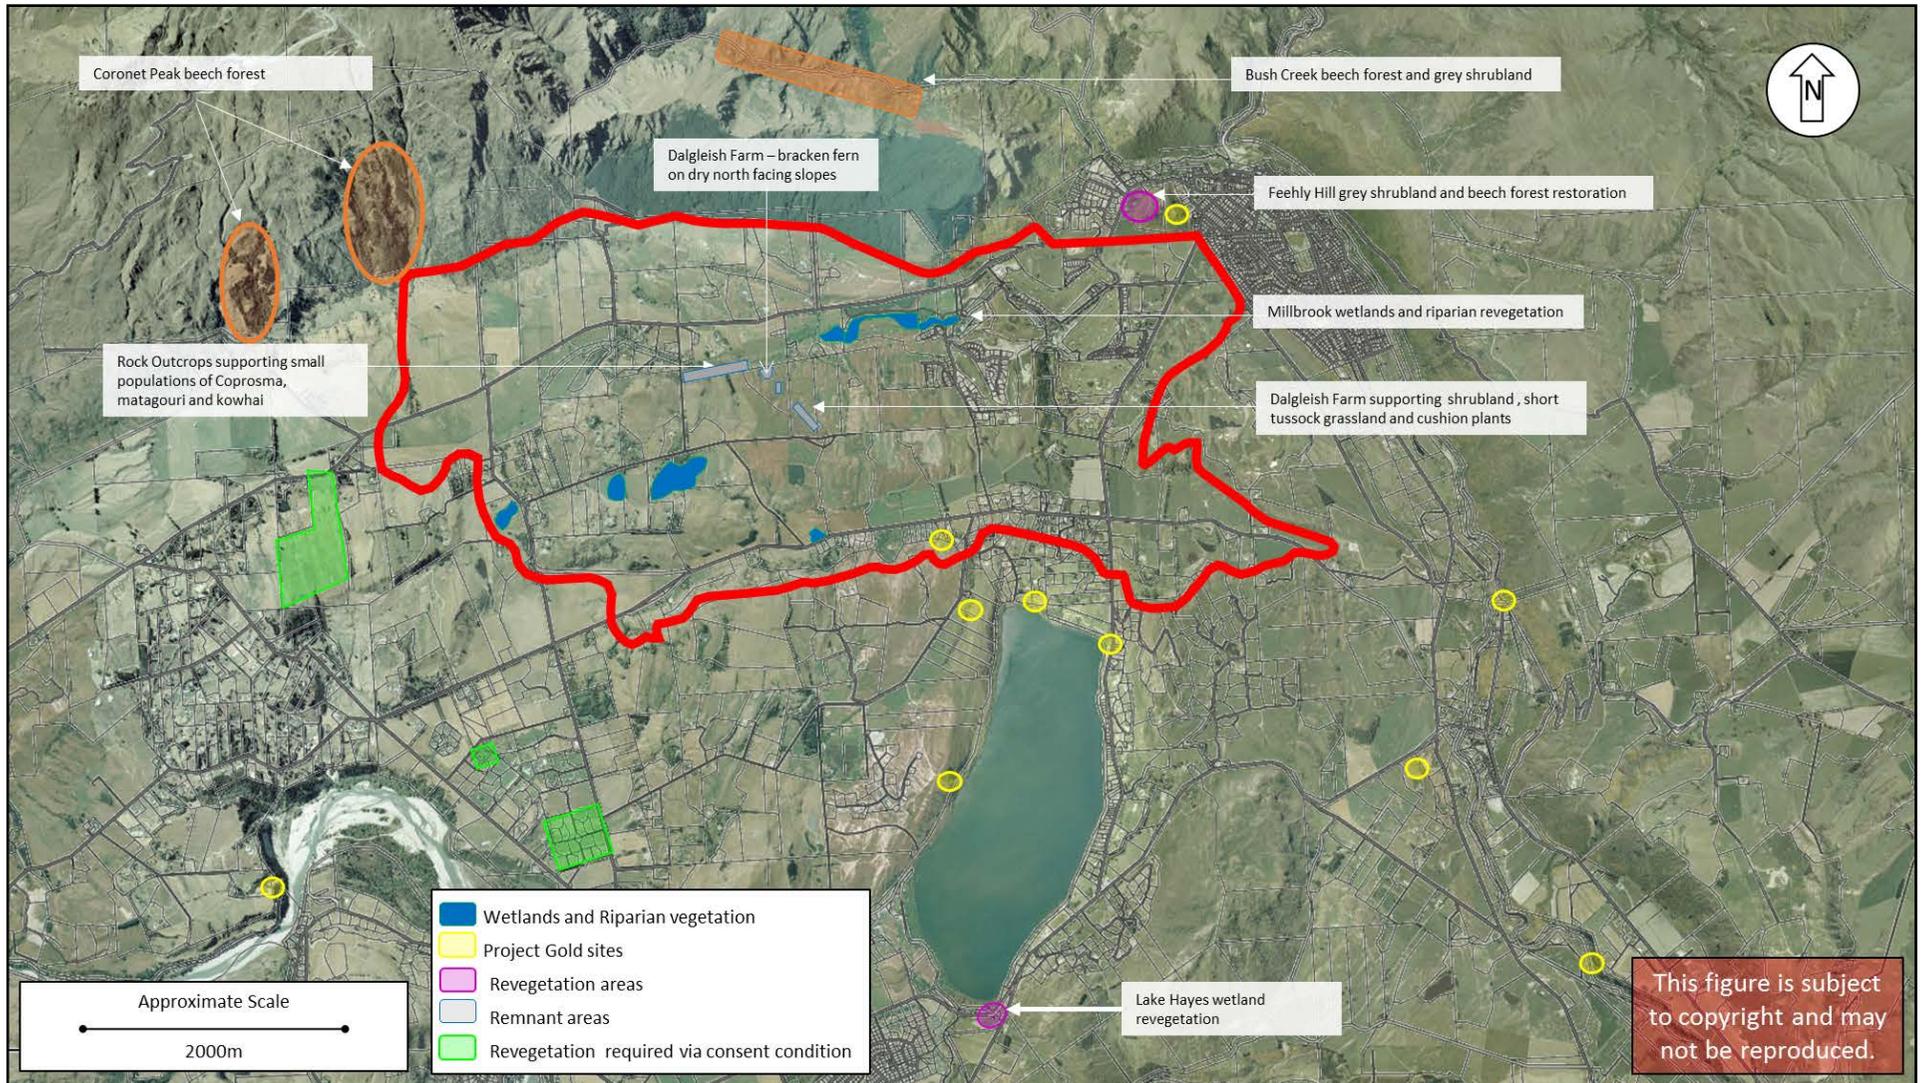
Figure 4: Wharehuanui Resource Study Area – Indigenous Vegetation and Habitat

Existing indigenous vegetation and habitat within the study area and neighbouring areas are shown in Figure 4. The largest indigenous ecosystem in the vicinity of the study area consists of beech forest remnants on the lower south facing slopes of Coronet Peak and shrubland communities within the catchment of Bush Creek. These areas house the greatest biodiversity values in the vicinity of the study area and support bird populations that will utilise habitat in the Wakatipu Basin largely for feeding purposes.

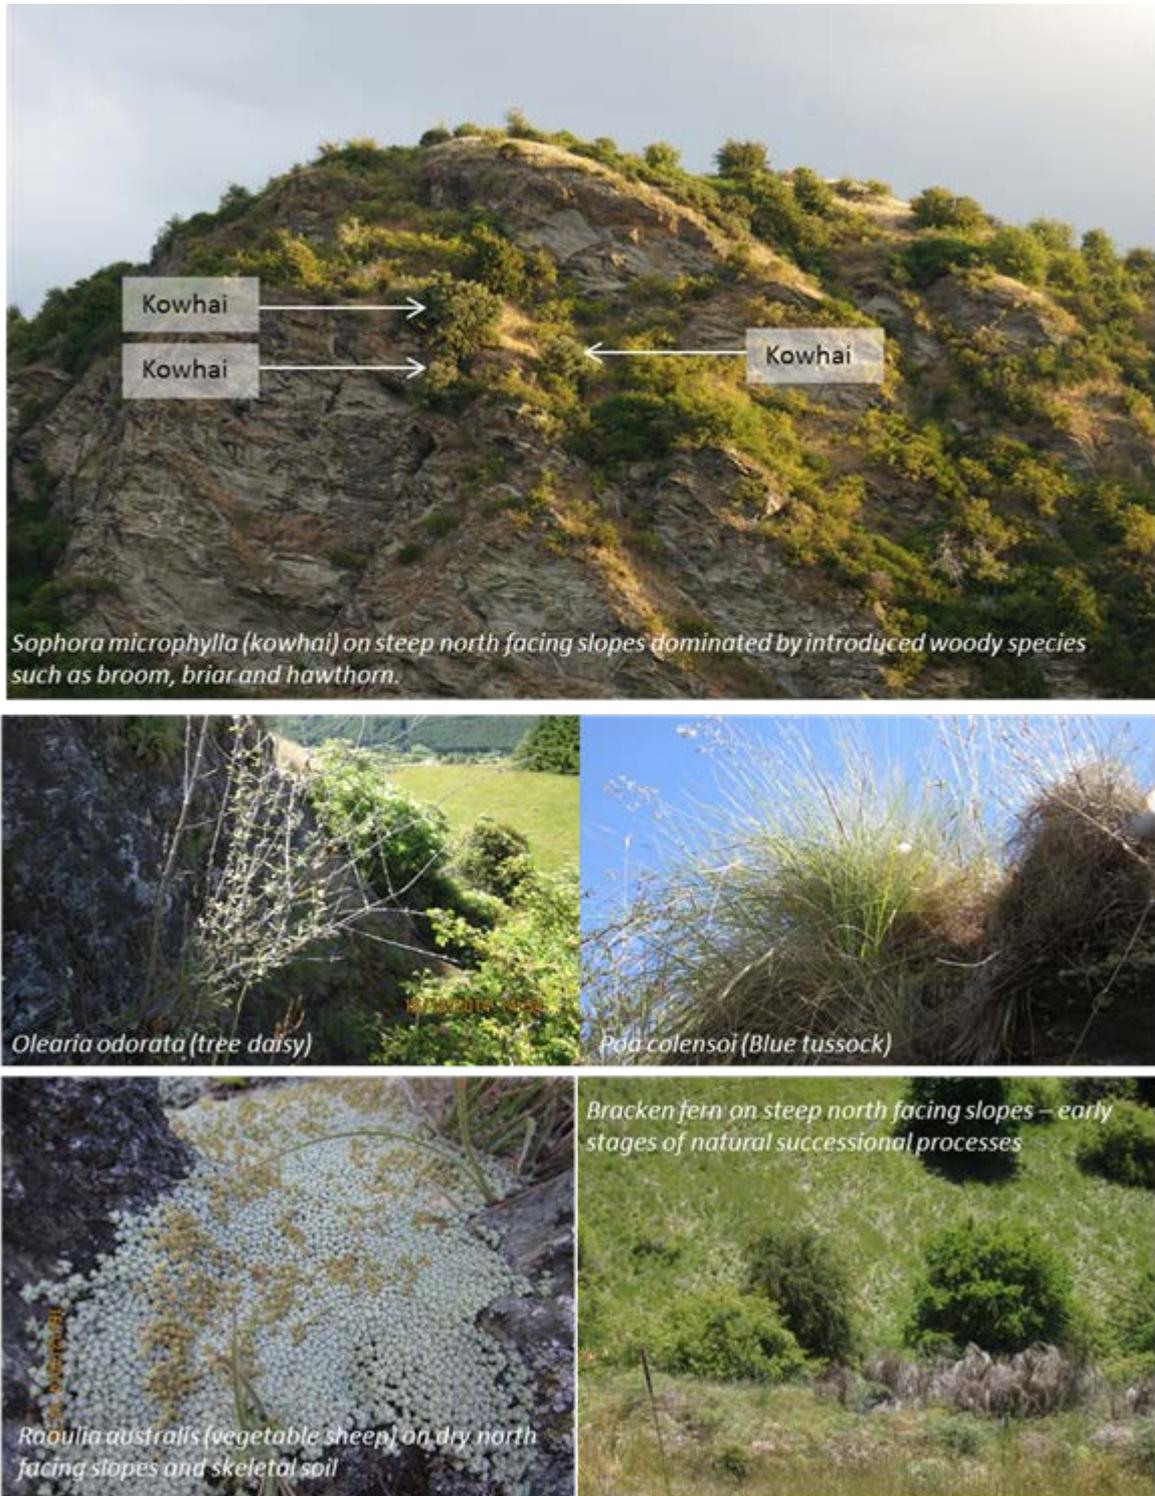
Rock outcrops situated on the ridge plateau and north facing slopes of the study area have provided some protection from historical disturbance with indigenous shrubs, short tussock and cushion plants persisting on some of these sites. Plate 1 presents photographs of existing indigenous species and communities on these dry sites that generally have thin skeletal soils.

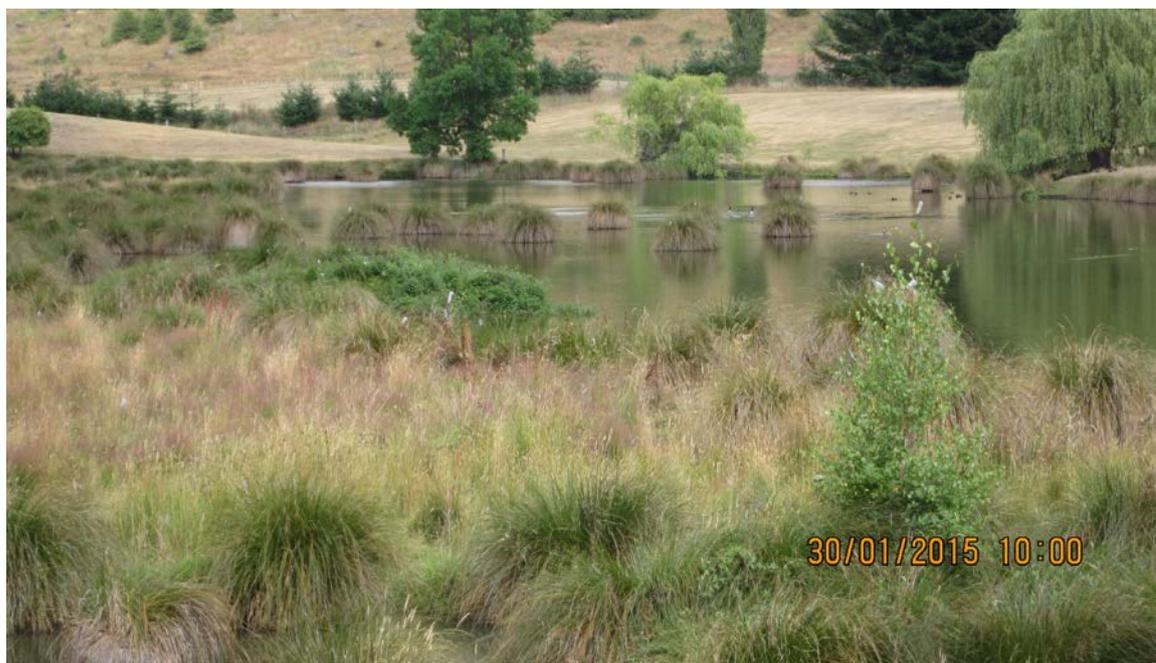
Plate 2: Hunter Road Wetland.

Historically a range of wetlands would have been present in the study area, mainly associated with poor drainage sites and landscape depressions on the ridge plateau and the flood plain of Mill Creek. Plate 2 shows an example of a wetland to the west of Hunter Road that has open water habitat fringed by pedestal tussock (*Carex secta*). Whilst viewing this wetland from the road DCG recorded a range of wildlife present in and around the wetland including Canada geese, pukeko, mallard ducks and black swans.

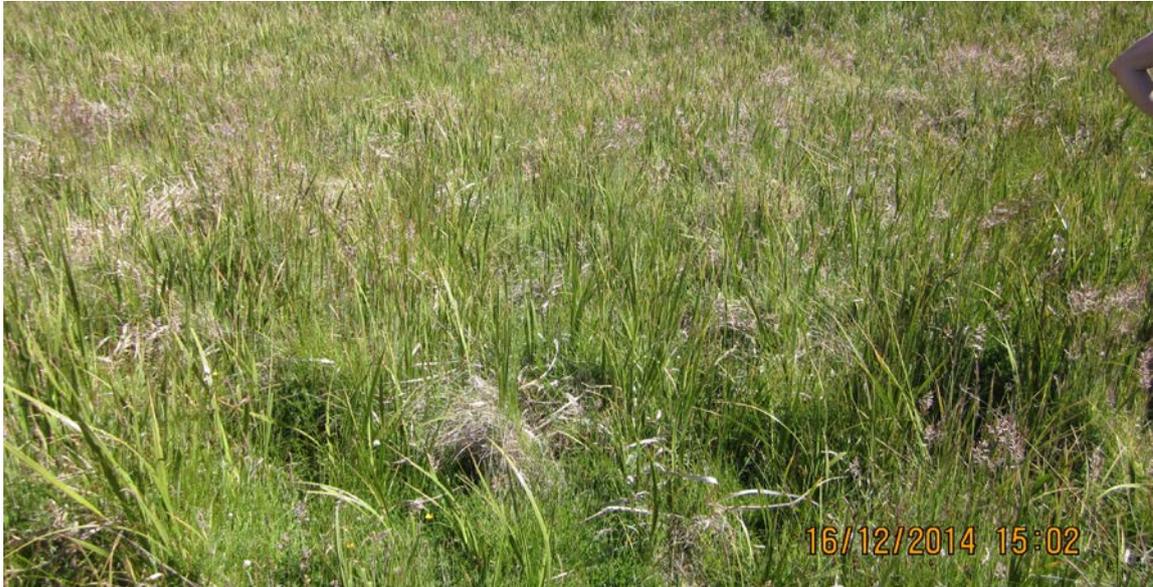
Plate 3: Sedgeland on ridge plateau to the west of Dalglish Farm

There are a number of wetlands located within landscape depressions on the ridge plateau (see Plate 3) These wetlands are dominated by the introduced soft rush (*Juncus effusus*), however sedgeland are also present that contain the indigenous sedge *Carex gaugichaudiana* within a sward of introduced grasses.

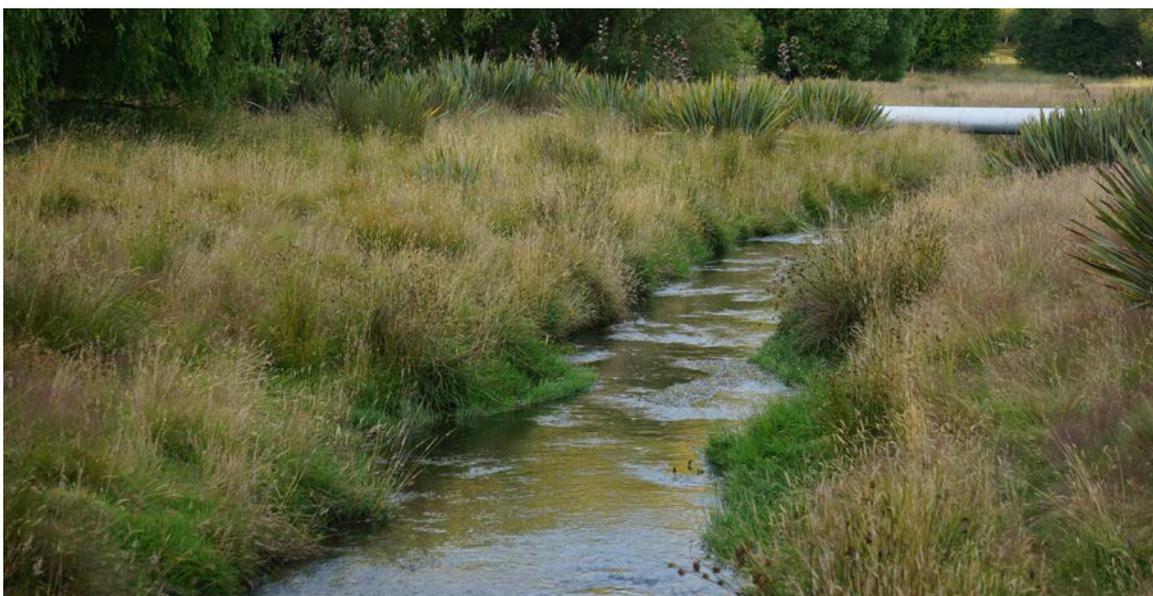
Plate 4: Wetland and riparian vegetation adjacent to Mill Creek on Dalglish Farm

Wetlands and riparian margins associated with the flood plain of Mill Creek (see Plate 4) are largely dominated by introduced species including the soft rush (*Juncus effusus*) and introduced grasses browntop (*Agrostis capillaris*), cocksfoot (*Dactylus glomerata*) and sweet vernal (*Anthoxanthum odoratum*). In addition willow trees are also a significant element of the vegetation adjacent to Mill Creek.

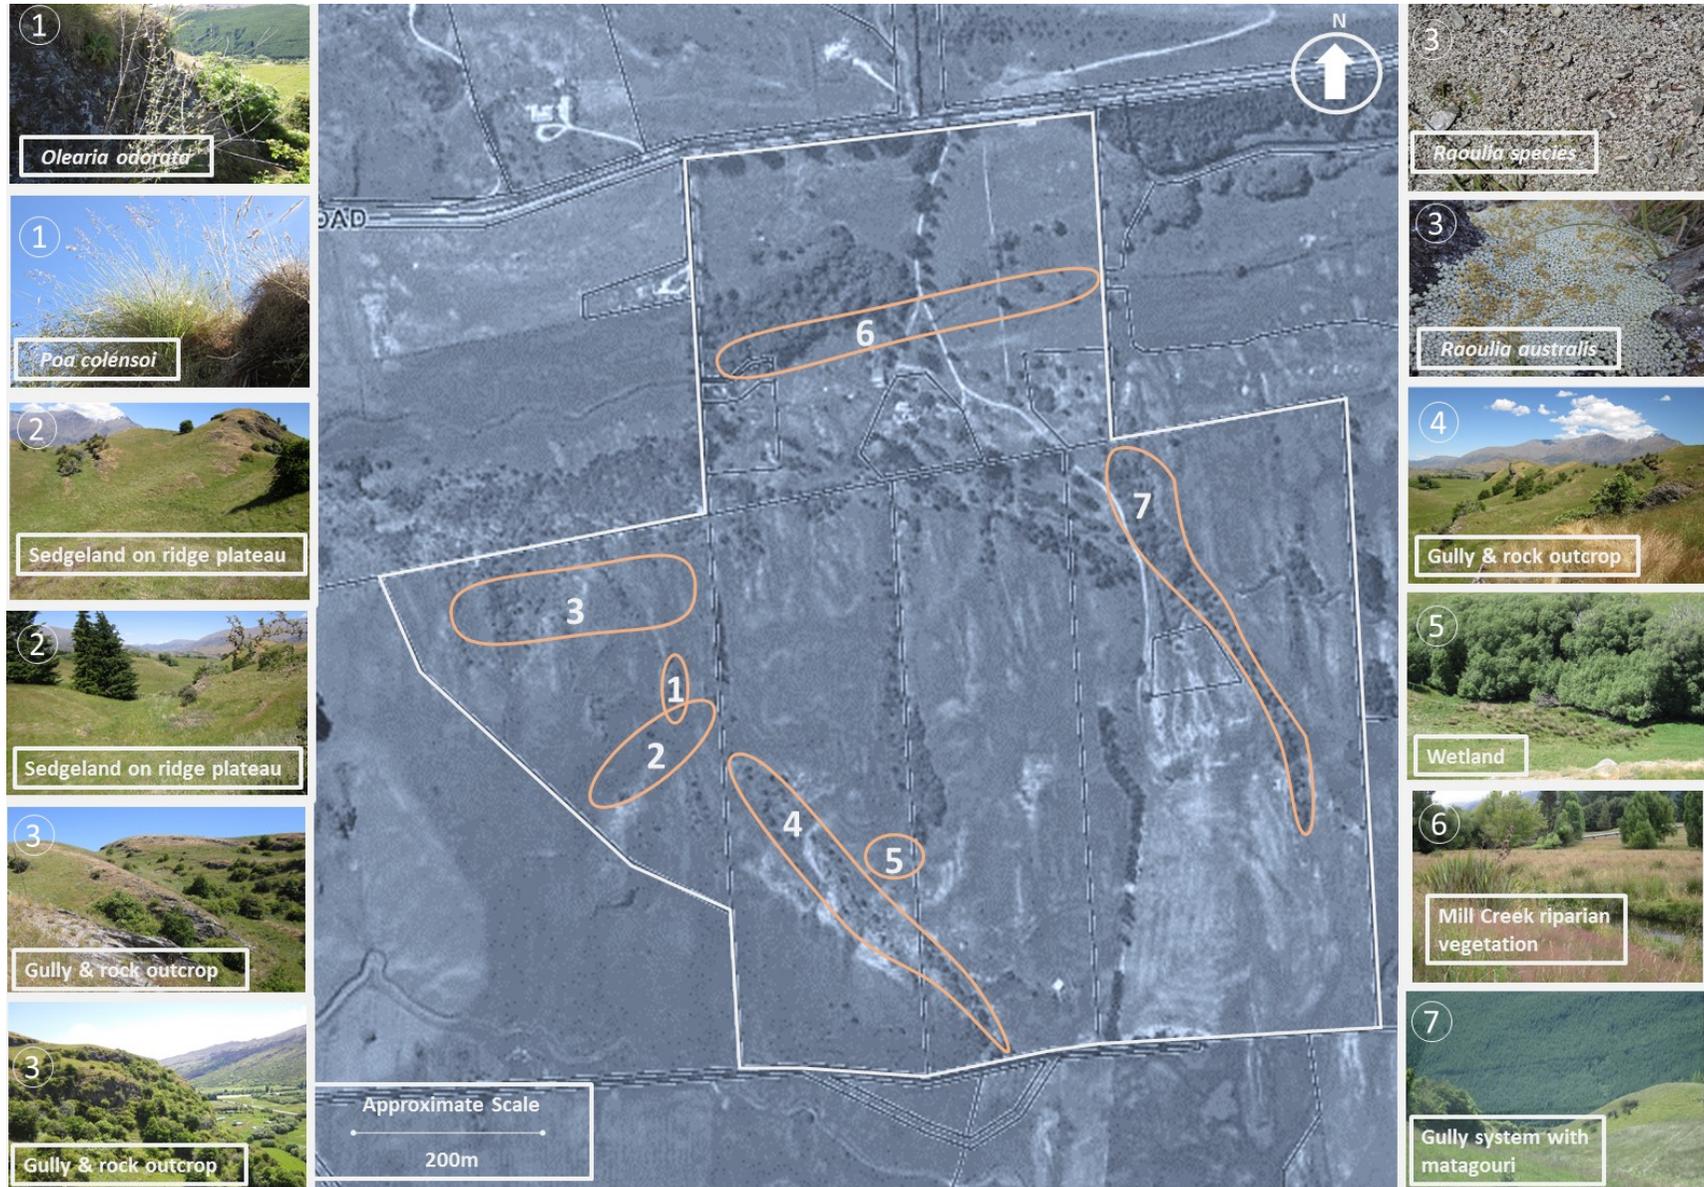
Figure 5: Ecological Values of Dalgleish Farm

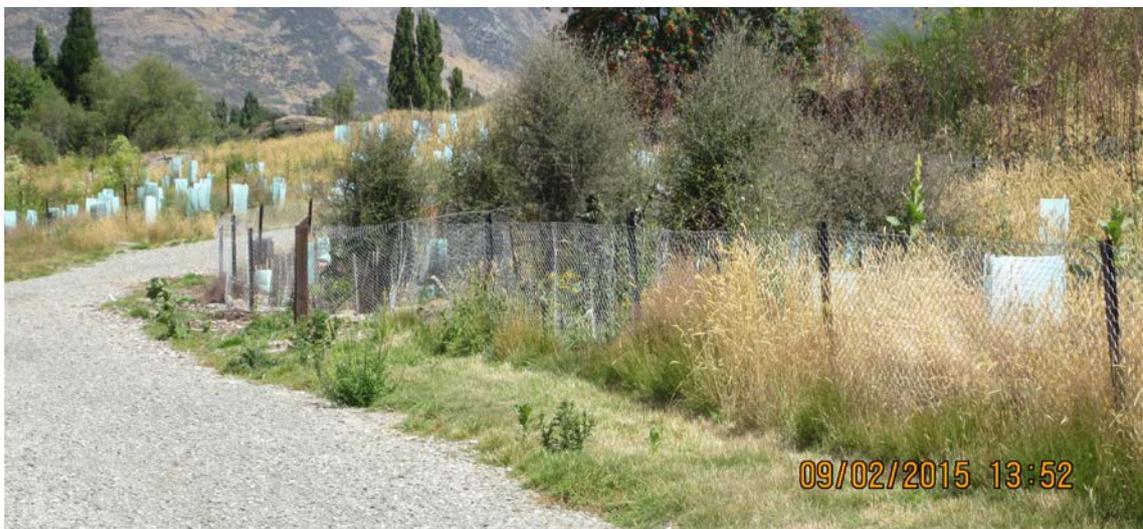
Plate 5: Project Gold shrubland restoration, Whitechapel Road

Areas of existing terrestrial ecological values are predominantly found around the rocky outcrops to the west of Dalgleish Farm. DCG recommends the pocket planting of shrubland species to provide a food source for invertebrates, lizards and birds in these areas. The rock outcrops are lacking some key species known to support lizard species such as coprosmas and porcupine shrub (*Melicytus alpinus*) and these species along with kowhai and tree daisies should be utilised to support these existing values. An example of similar planting at a Project Gold site on Whitechapel Road is provided in Plate 5.

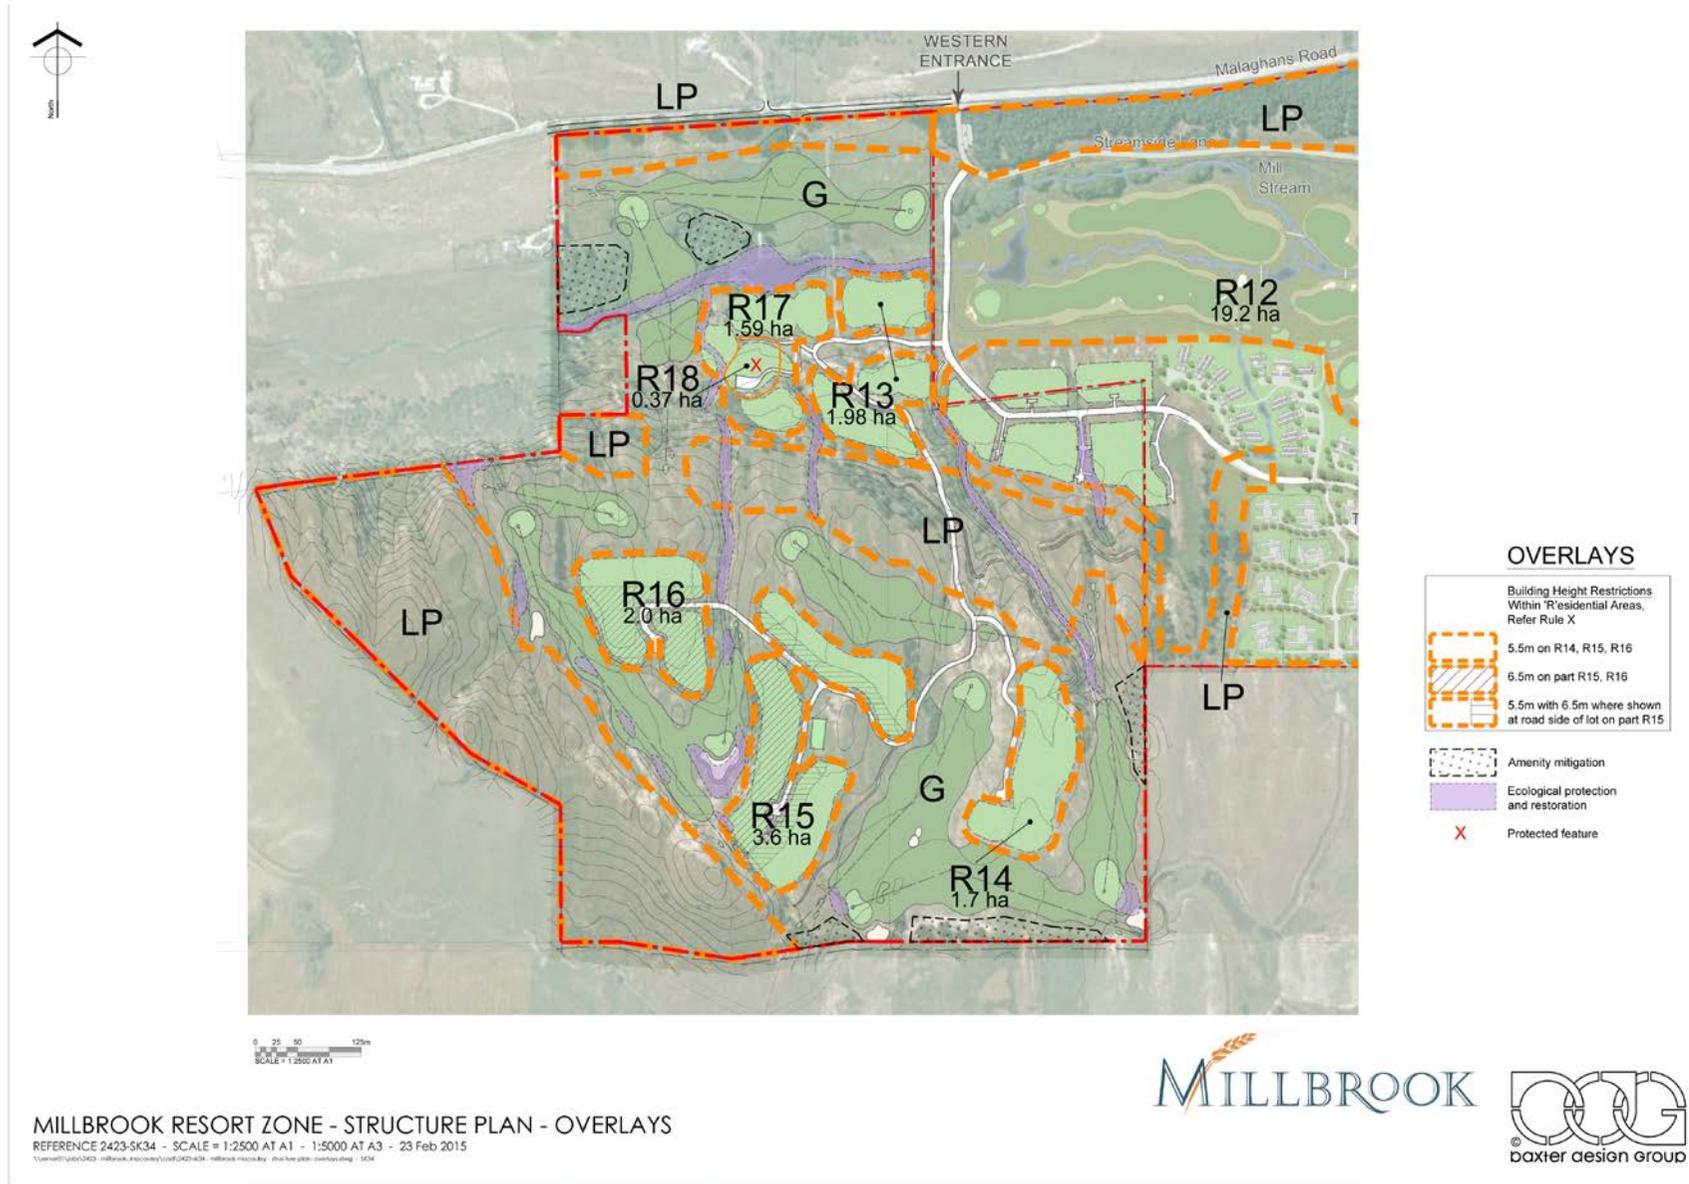
Figure 6: Dalglish Farm Ecological Restoration Concept Plan

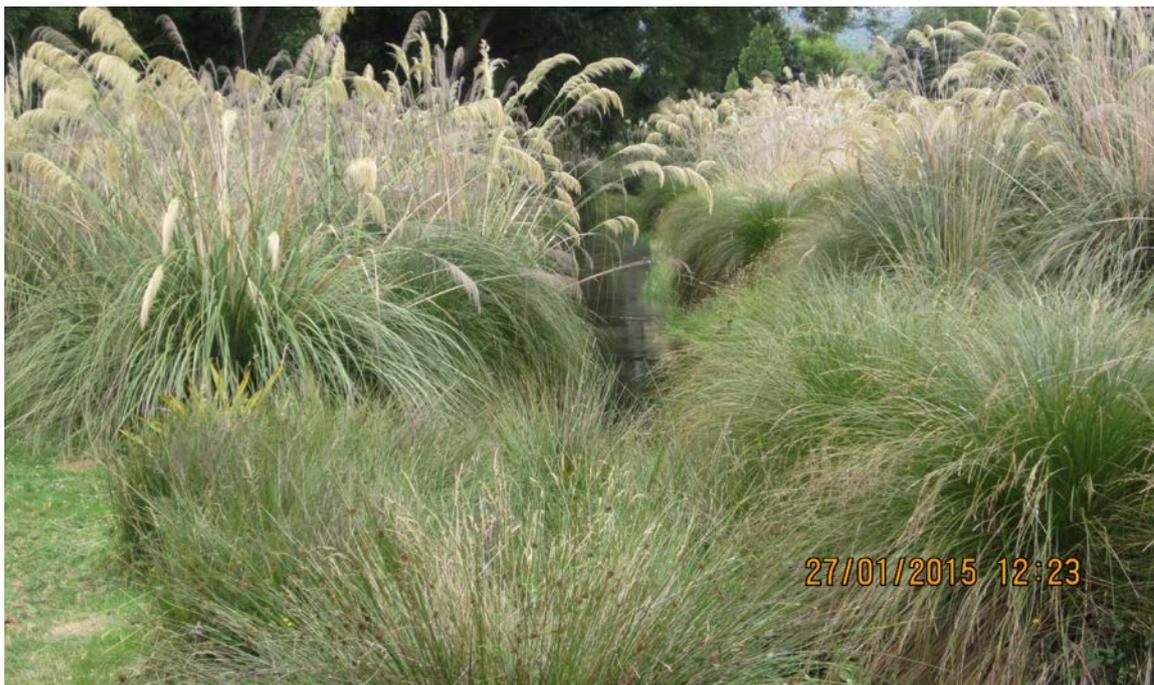
Plate 6: Established Riparian Planting of Mill Creek completed by MCC.

MCC has completed some quality riparian planting adjacent to Mill Creek as shown in Plate 6. A continuation of this planting along the length of Mill Creek in addition to the control of willow trees will enhance the habitat values of Mill Creek.

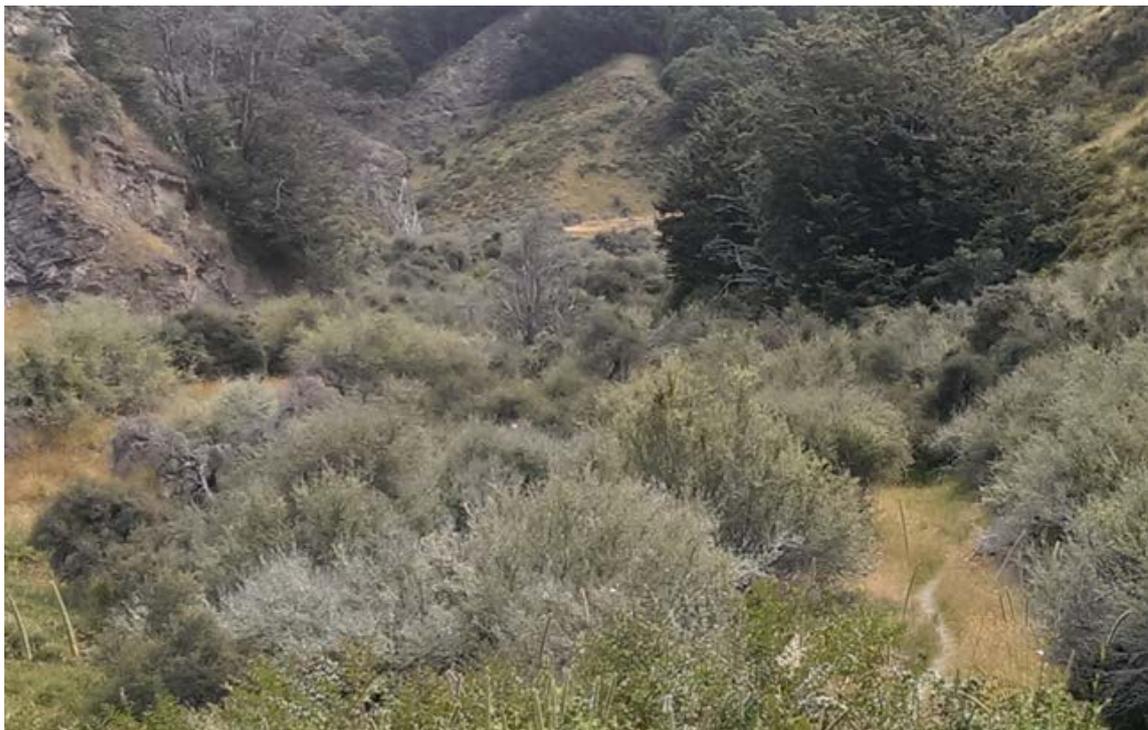
Plate 7: Tree Daisy (*Olearia odorata*) dominated shrubland in Bush Creek

A total of four gullies that bisect the ridge plateau and drain towards Mill Creek have been identified as excellent sites for planting of shrubland species. Historically DCG understands these gullies would have supported shrubland communities but are now dominated by pasture grasses and woody weeds (particularly hawthorn). The gullies do contain some isolated mature matagouri shrubs and DCG considers these areas are ideal for re-establishing shrubland that can make an important contribution to the natural heritage of the site. Plate 7 shows a tree daisy dominated shrubland in the Bush Creek catchment (see Figure 4). DCG considers the natural regeneration of a tree daisy and coprosma dominated shrubland that is ongoing within the Bush Creek catchment can be used as a guide for restoration work within the gullies.

The planting of a range of tree daisy species, coprosmas and kowhai into these gullies will provide habitat for invertebrates and a food supply for native birds. Furthermore, it will also be possible to connect the gully plantings with Mill Creek that will support the movement of invertebrates and birds through the site.
