## ATTACHMENT B

Test pit logs and photos of representative lake sediment units exposed in excavations.

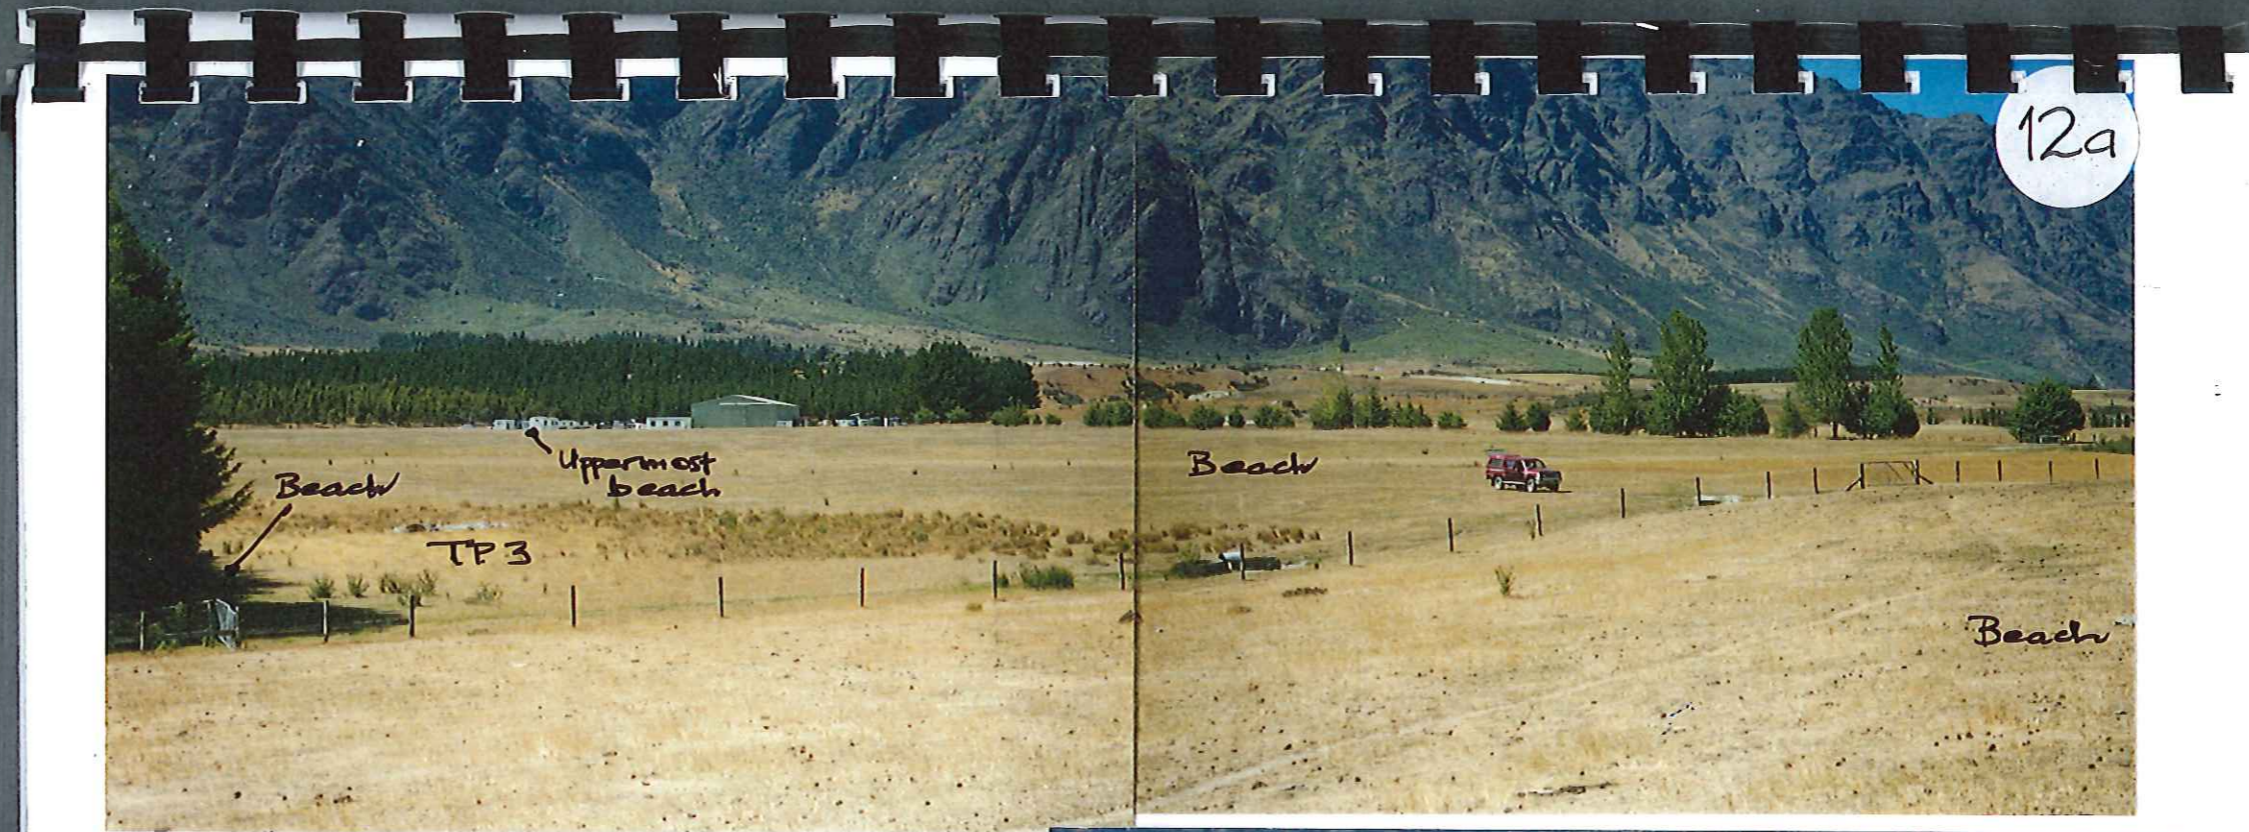
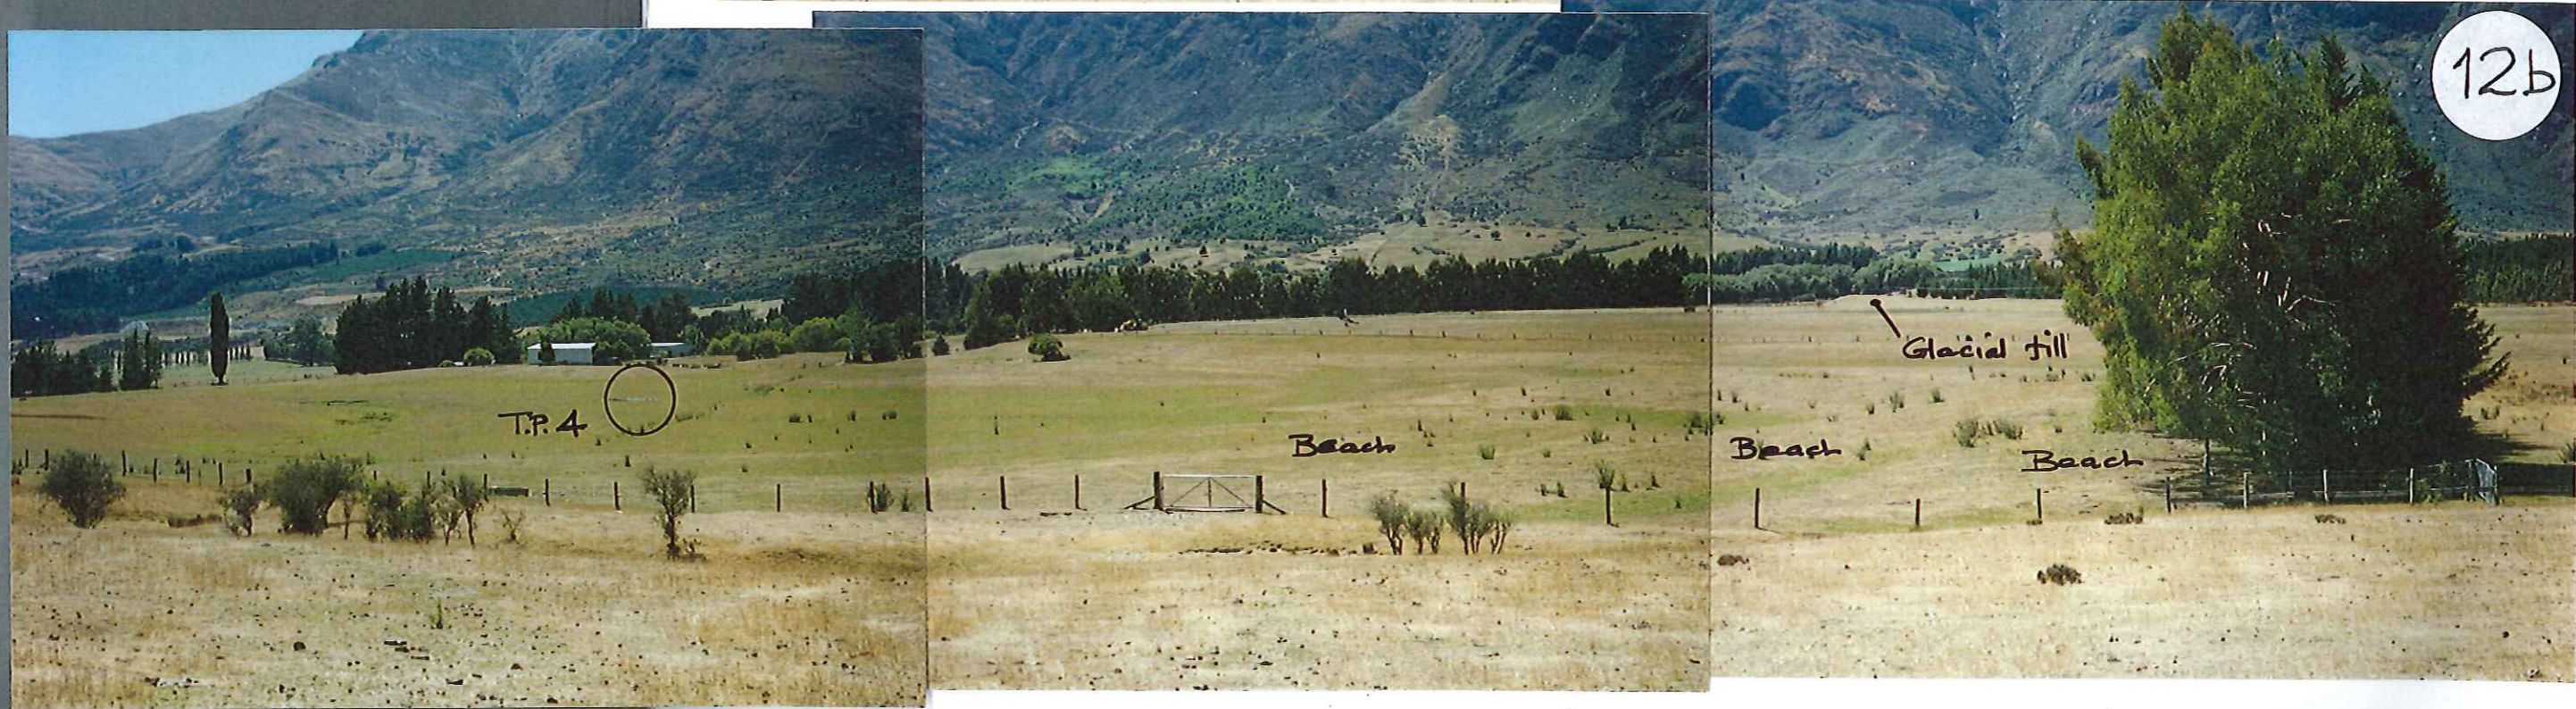
### TP1

Nbr	Test Pit	Description
A1 A2	1	Soil profile at top, is within shallow depression behind storm beach. Sedimentary units comprise silty sand (brownish grey) overlying variably bedded silt to sandy silt. Oxidised "gravel" intersected at base of pit.
A3	1	Thinly bedded sediment from the lower part of the "lake" sequence. Patchy oxidation evident.
A4	2	General view of exposure in pit. Indicated alluvium encountered at total depth.
A5	2	Lake sediments in upper half of pit. Tends firm, with slight to moderate pervasive oxidation.
A6	2	Rather massive, unweathered lake sediments overlying alluvium.
A7	2	Sample of basal, massive sediment which can be easily penetrated with a rigid finger.
A8	4	Overall pit exposure.
A9	4	Upper part of lake sediment sequence. The silt/sandy silt tends to be slight to moderately weathered, massive and firm.
A10	4	Mid depth sedimentary sequence.
A11, 12	4	Laminated silt/sandy silt from near the base. Patchy oxidation evident.

Note a) Site in shallow depression behind stormbeach  
b) Sample off muckpile

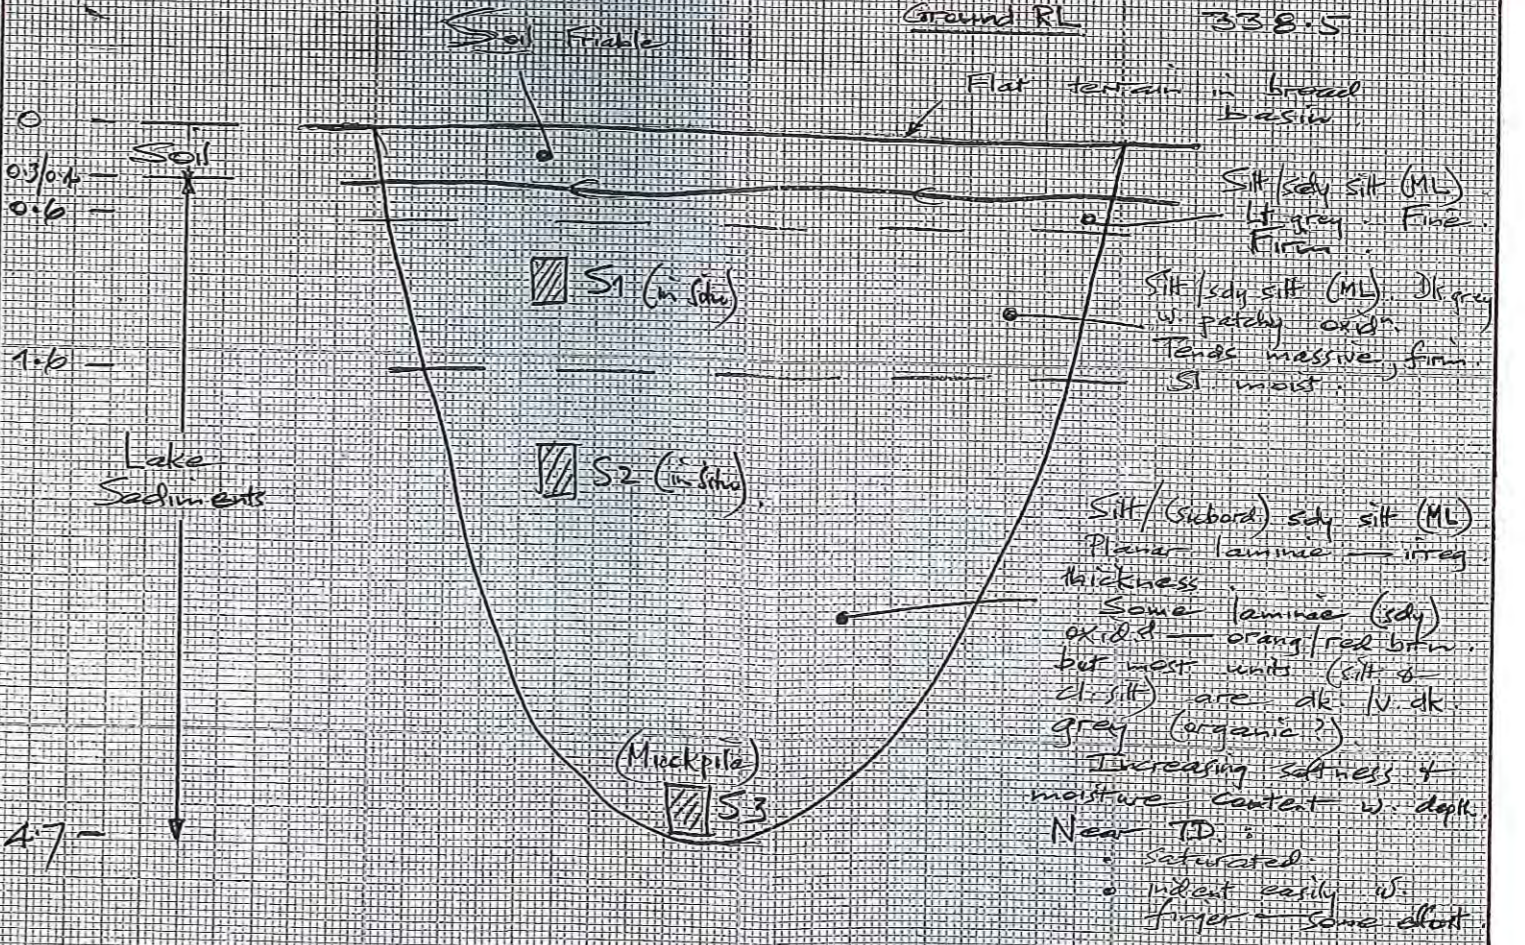
### TP4

Note  
a) Progressive softening w. depth.  
b) Progressive increase in moisture content w. depth.

GPS Coords E 217 503  
N 556 3145  
Ground RL 338.5
