466 Frankton-Ladies Mile Highway, Residential Subdivision Transport Assessment

The purpose of this letter is to provide a transport assessment for a proposed subdivision at 466 Frankton-Ladies Mile Highway (SH6) at Lake Hayes Estate. This assessment considers the access from the local road network and the onsite road network serving the proposed residential lots.

This report presents the results of a geotechnical investigation and assessment undertaken by GeoSolve Ltd to determine the subsoil conditions and provide geotechnical inputs for a proposed subdivision at 466 Frankton-Ladies Mile Highway, Queenstown.

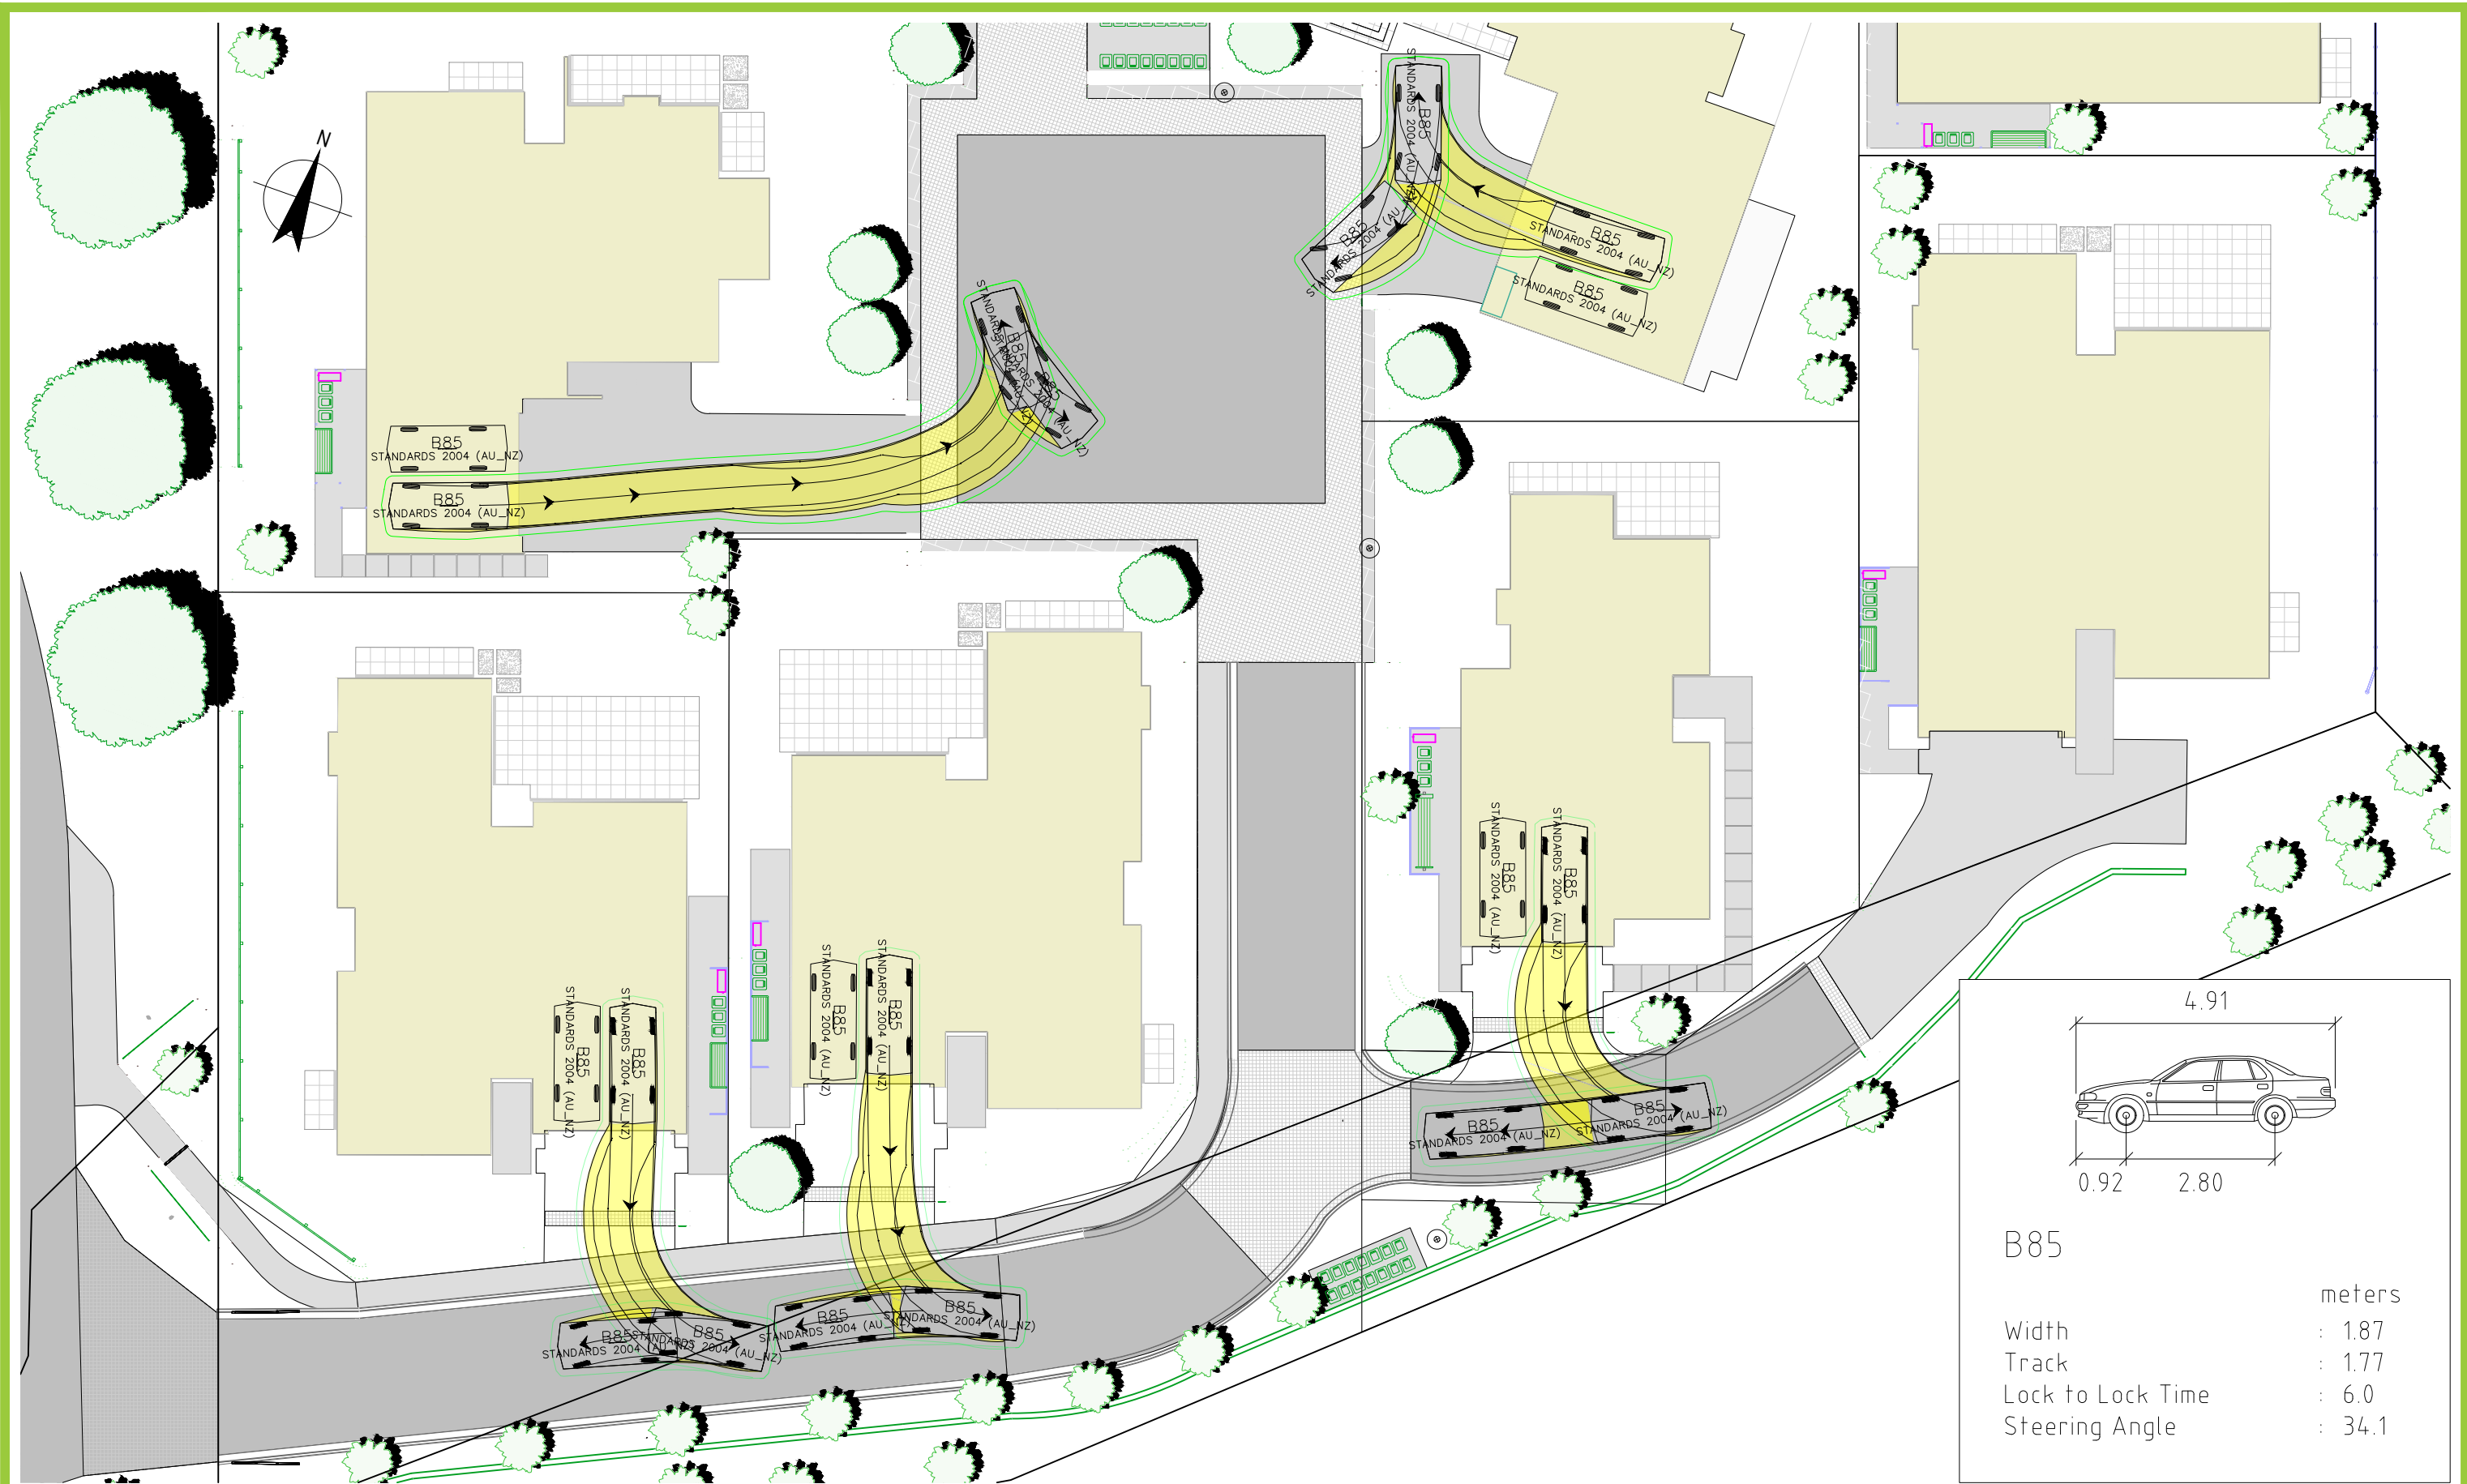
Job Number | QCO-001
Revision | C
Date | OCT 2020
Figure 02

VEHICLE ACCESS REQUIREMENTS
NZS B85 CAR

- Figure 01, Vehicle Access Requirements, NZS B85 and B99 Car,
- Figure 02, Vehicle Access Requirements, NZS B85 Car, and
- Figure 03, Vehicle Access Requirements, RTS-18 and QLDC Medium Rigid Truck.

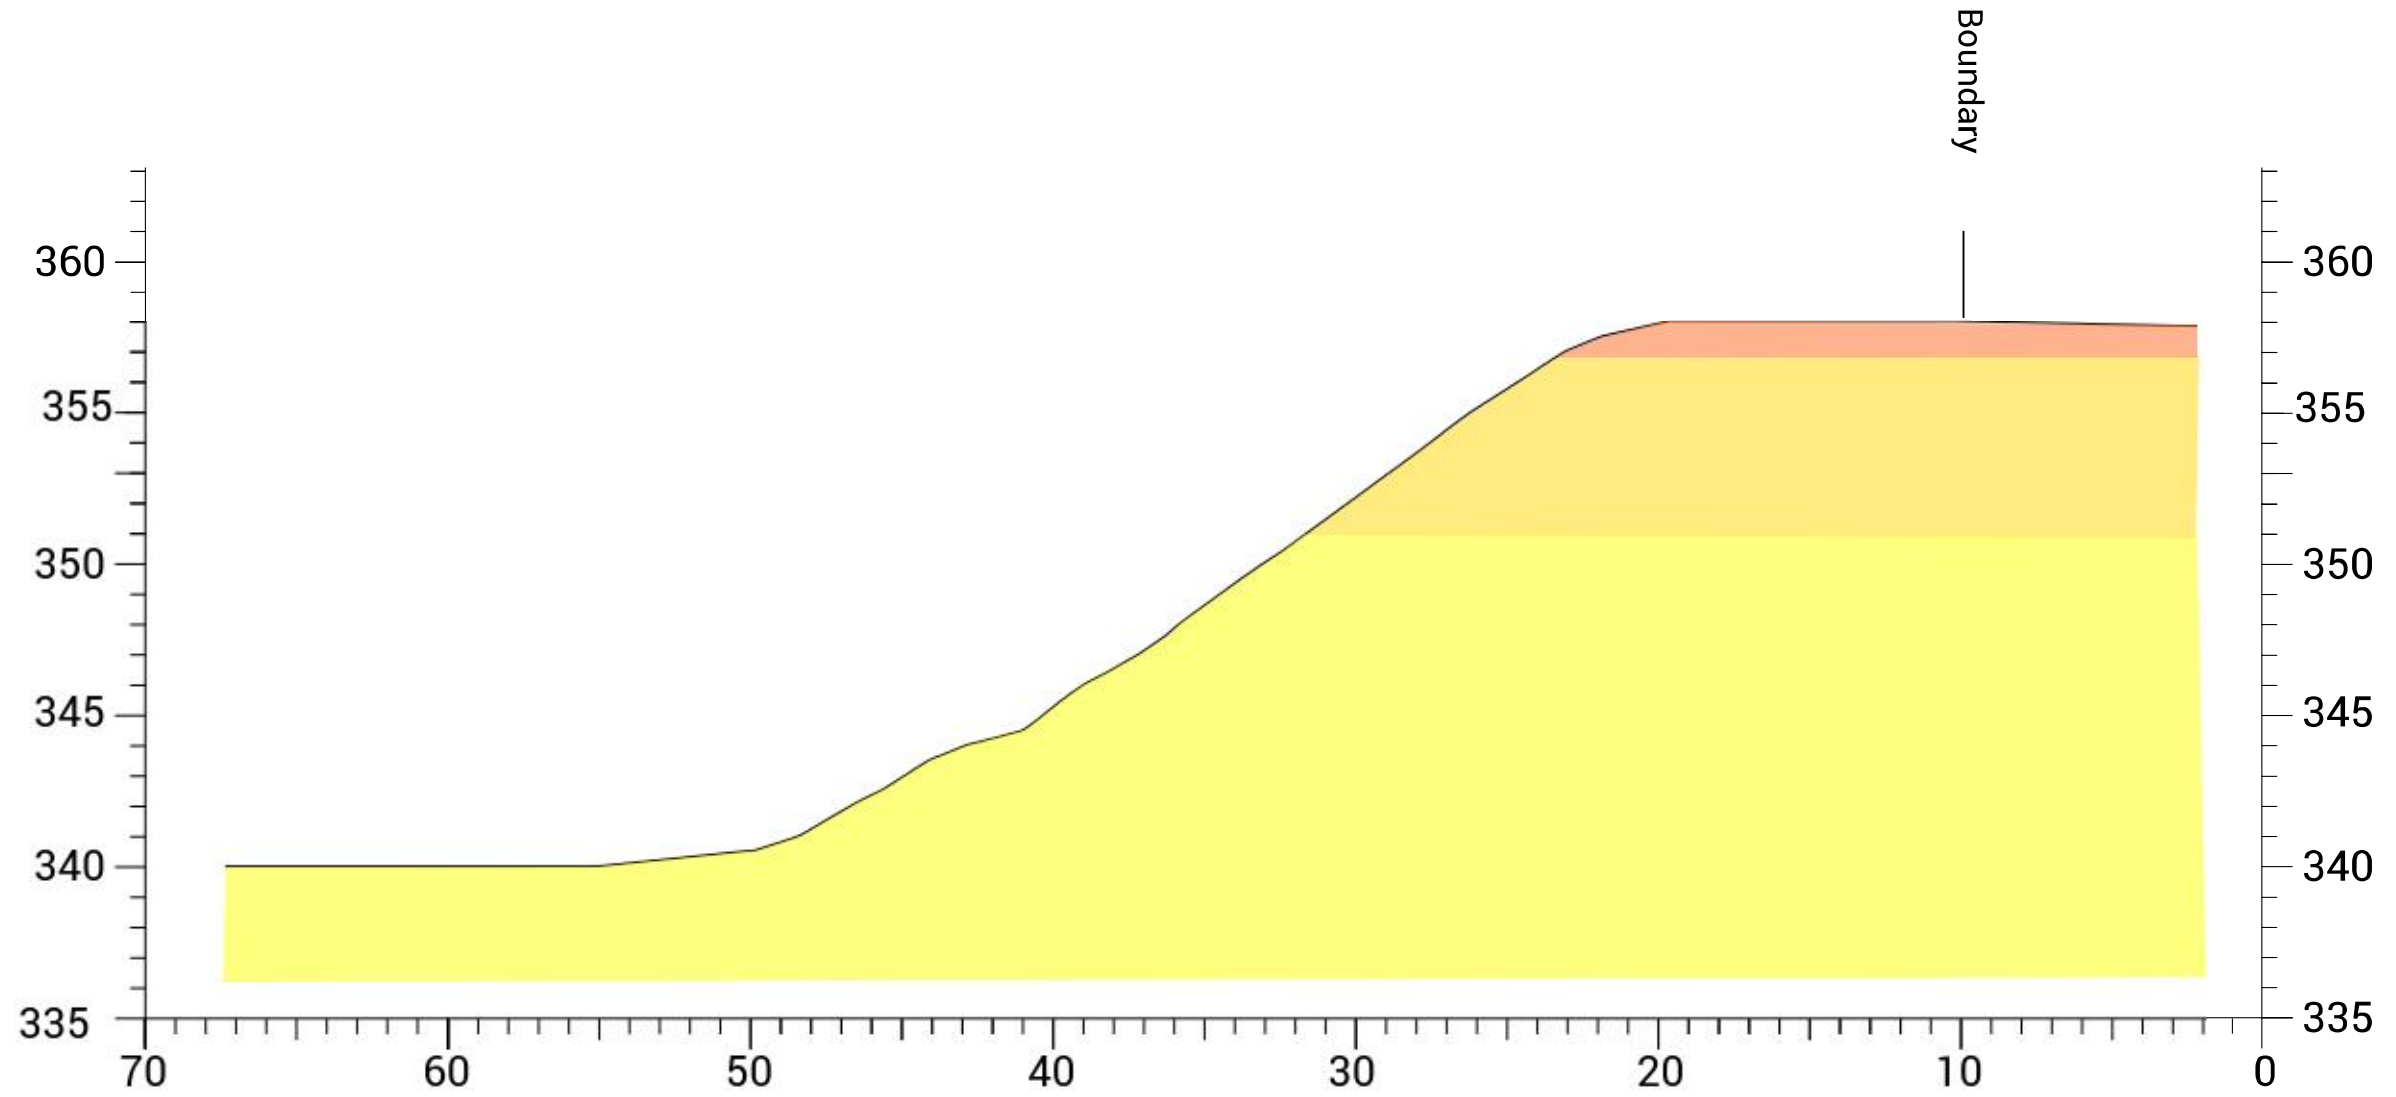
- Topsoil/Loess
- Loose to medium dense alluvial sand and gravel
- Medium dense to dense alluvial sand and gravel

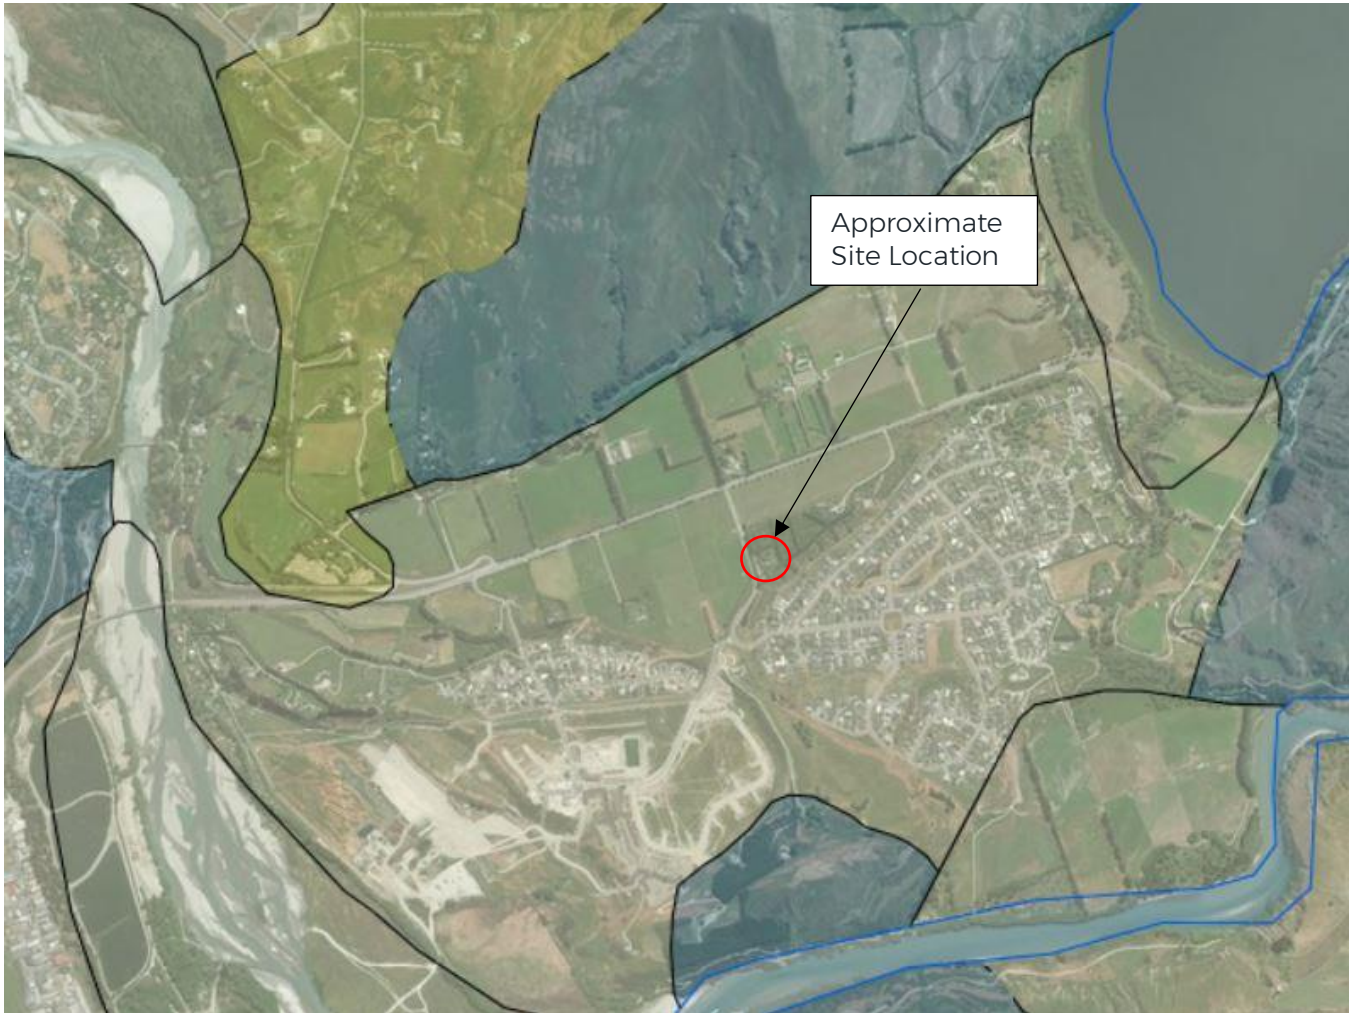
Figure 3 Site geology (Base map GNS web map, accessed 2020)
