ROYDEN THOMSON, GEOLOGIST

13 February '06

**HENLEY DOWNS: GI**

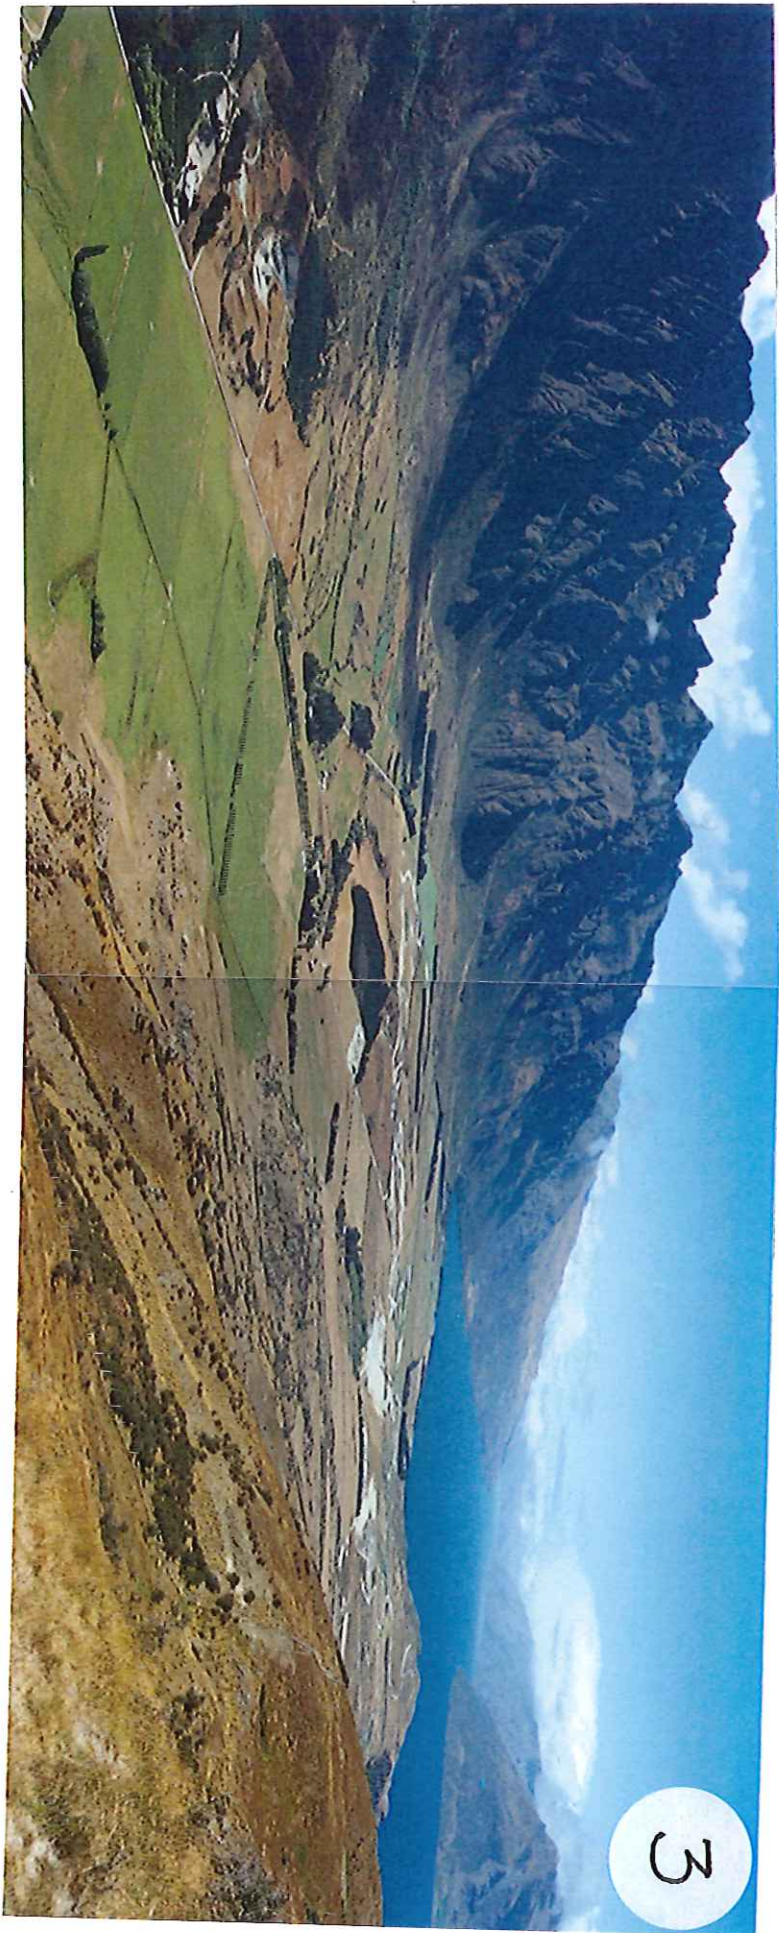
2

The hilly terrain west of the central valley is schist with a patchy cover of glacial till (Fig. 2). Foliation in the schist strikes approximately east-west and dips to the south at moderate angles. Schist outcrops appear competent.

- No observed mass movement features on property.
- One small slide on the western lakeshore (Fig. 2) lies south of the property.
