Queenstown Lakes District Council
c/o Edward Guerreiro
Stantec
Unit D1.03
19 Grant Road
Frankton
Queenstown 9300

Heritage Assessment: Butler's Green Retaining Wall (Road Reserve, Town of Arrowtown)

This heritage assessment has been prepared for Queenstown Lakes District Council (QLDC), c/o Stantec, in relation to the proposed remediation of the stone retaining wall located adjacent to Butler's Green.

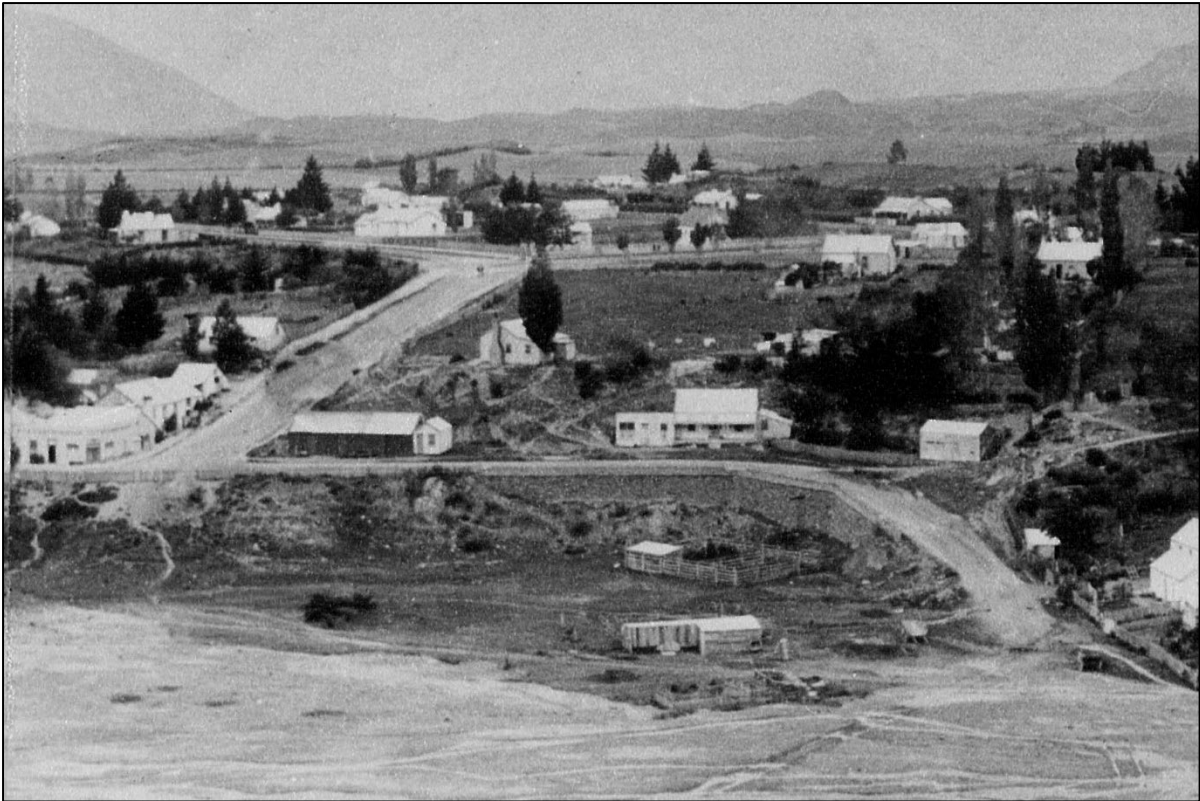
Figure 5. Butler's Green wall soon after its completion in 1887.²⁶

The eastern-most section of the wall was not constructed as part of the original retaining wall. It is not visible in the historic photos below (Figure 5-Figure 6). Its construction date is unclear.
