Geotechnical Report for Resource Consent

This report presents the results of a geotechnical investigation carried out by GeoSolve Ltd in order to assess natural hazard risk and provide geotechnical inputs for a proposed subdivision, McDougall's Block, consisting of 15 additional lots within Lot 6 DP 344432 and Lot 1 DP 425263, Cardrona Valley. An existing dwelling is present within Lot 6 DP 344432 and a previously consented building platform is present within Lot 1 DP 425263, which is labelled Lot 16 as part of this investigation.

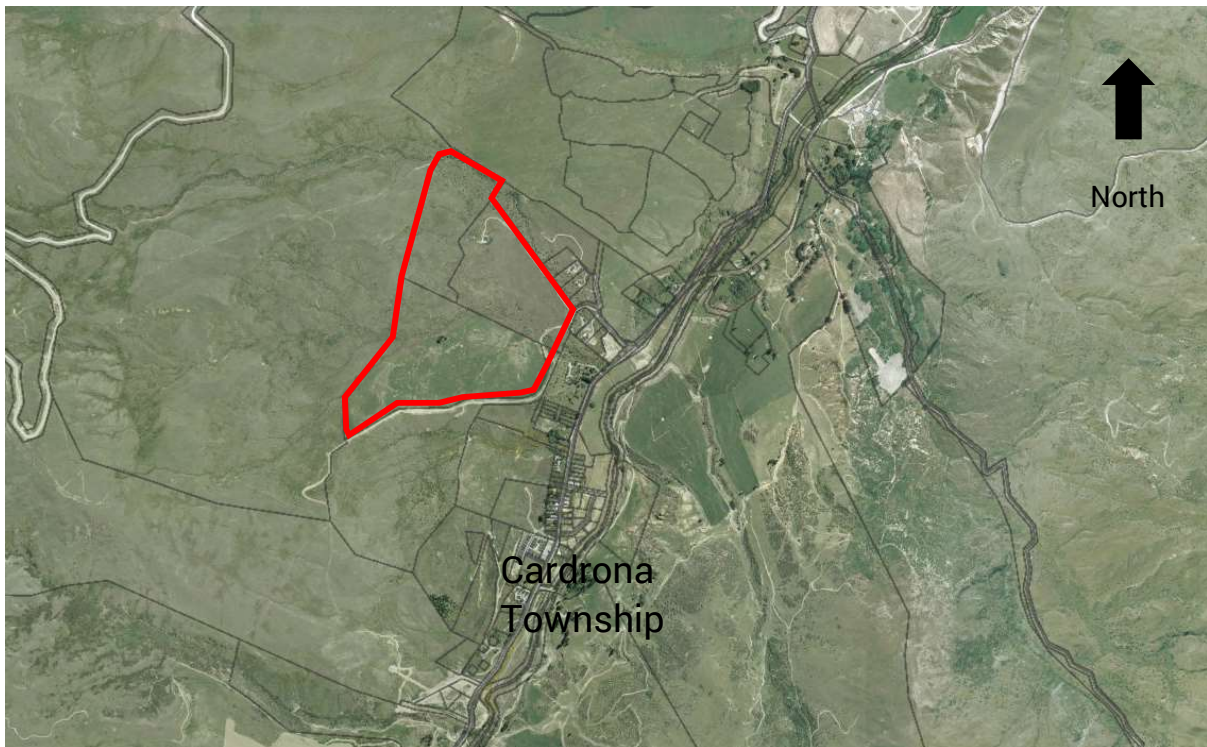
Figure 1. Site location (indicated by red outline) in relation to the Cardrona Township (Source: <http://maps.qldc.govt.nz/qldcviewer/>).

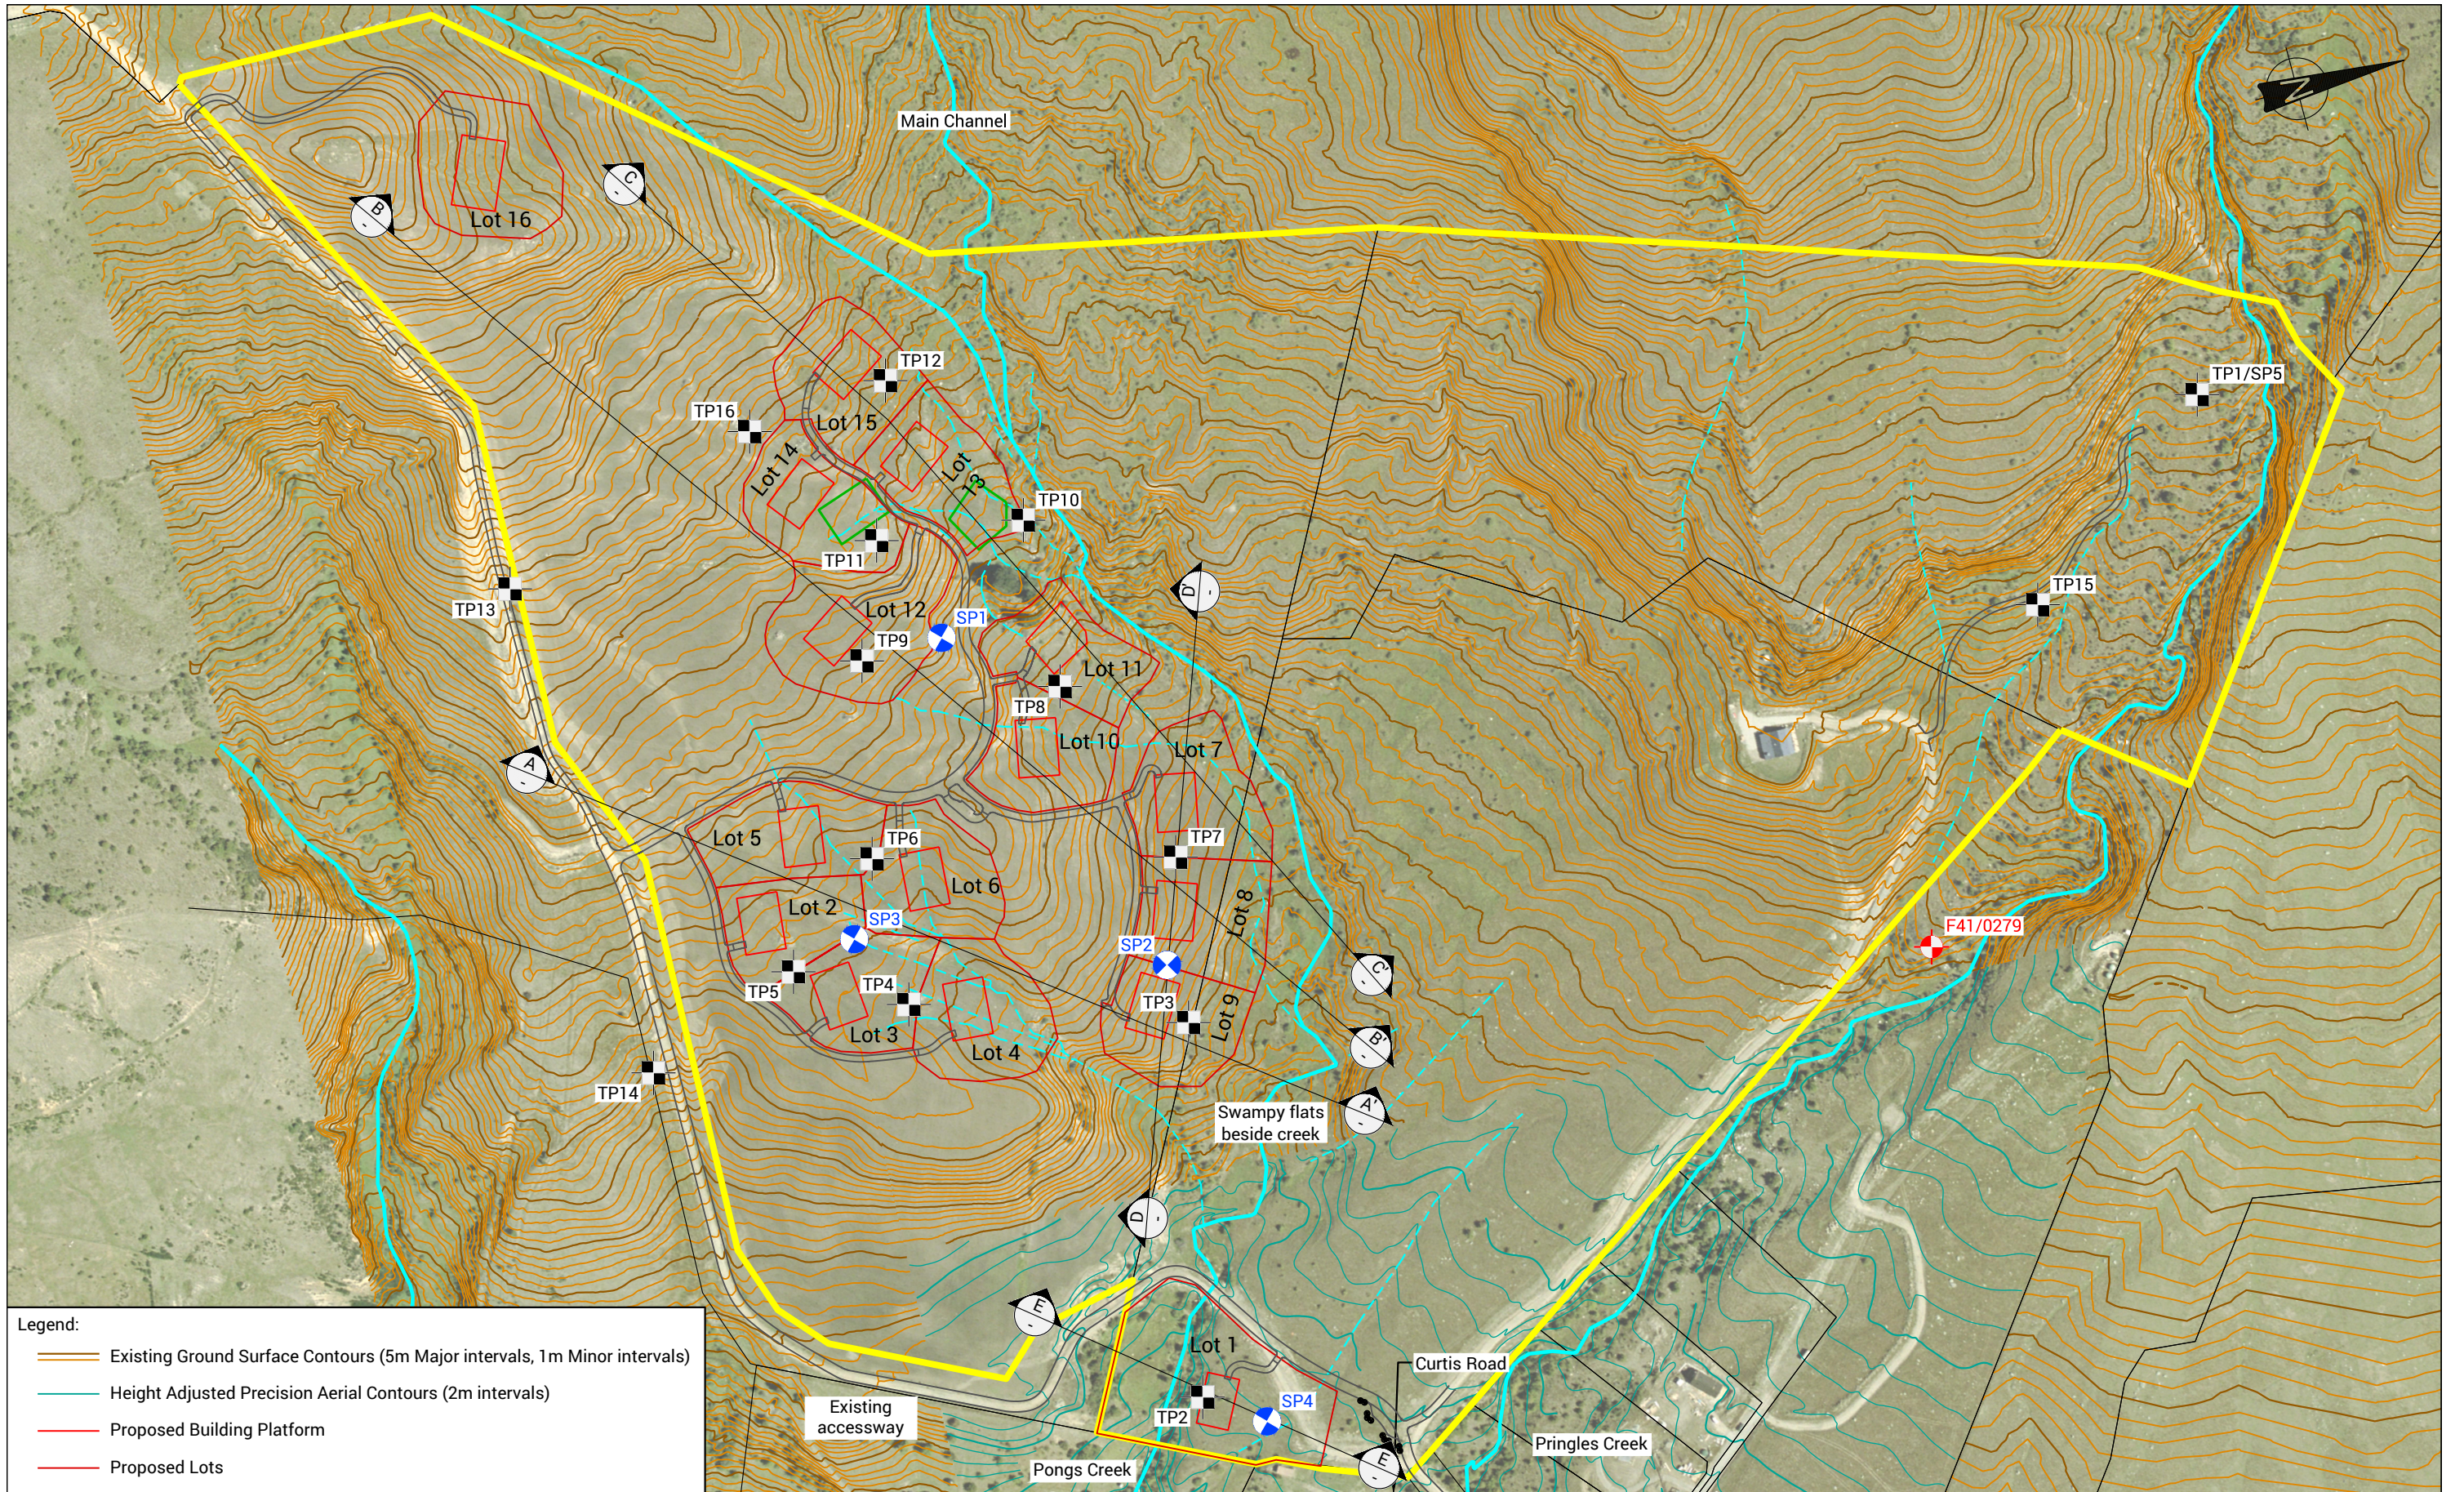
FIG No:
Figure 1b

A spring flow (as marked on Figure 1b, Appendix A) was observed directly to the east of Lot 13 while onsite, the flow was aided by an overland flow path that intercepted Lot 14. The spring is inferred to occur where an impermeable fan alluvium horizon daylight at the ground surface.

An area of inferred landslide activity, which is shown on the QLDC hazard maps, lies within the site boundary. This landslide is classed by QLDC as "areas of fine-grained soils susceptible to sliding". This is sourced from IGNS QMAP 1:50,000 Compilation Sheets. This landslide feature is shown to affect Lots 2 to 16 inclusive, as shown on Figure 1b, Appendix A.

Additionally, isolated small volume shallow seated slope failures were also identified on steep slopes within the site, as shown in Figure 1b, Appendix A. One of these features is located in close proximity to the building platform of Lot 1 and further information regarding the slope stability of Lot 1 is discussed in Section 6.8 of this report.

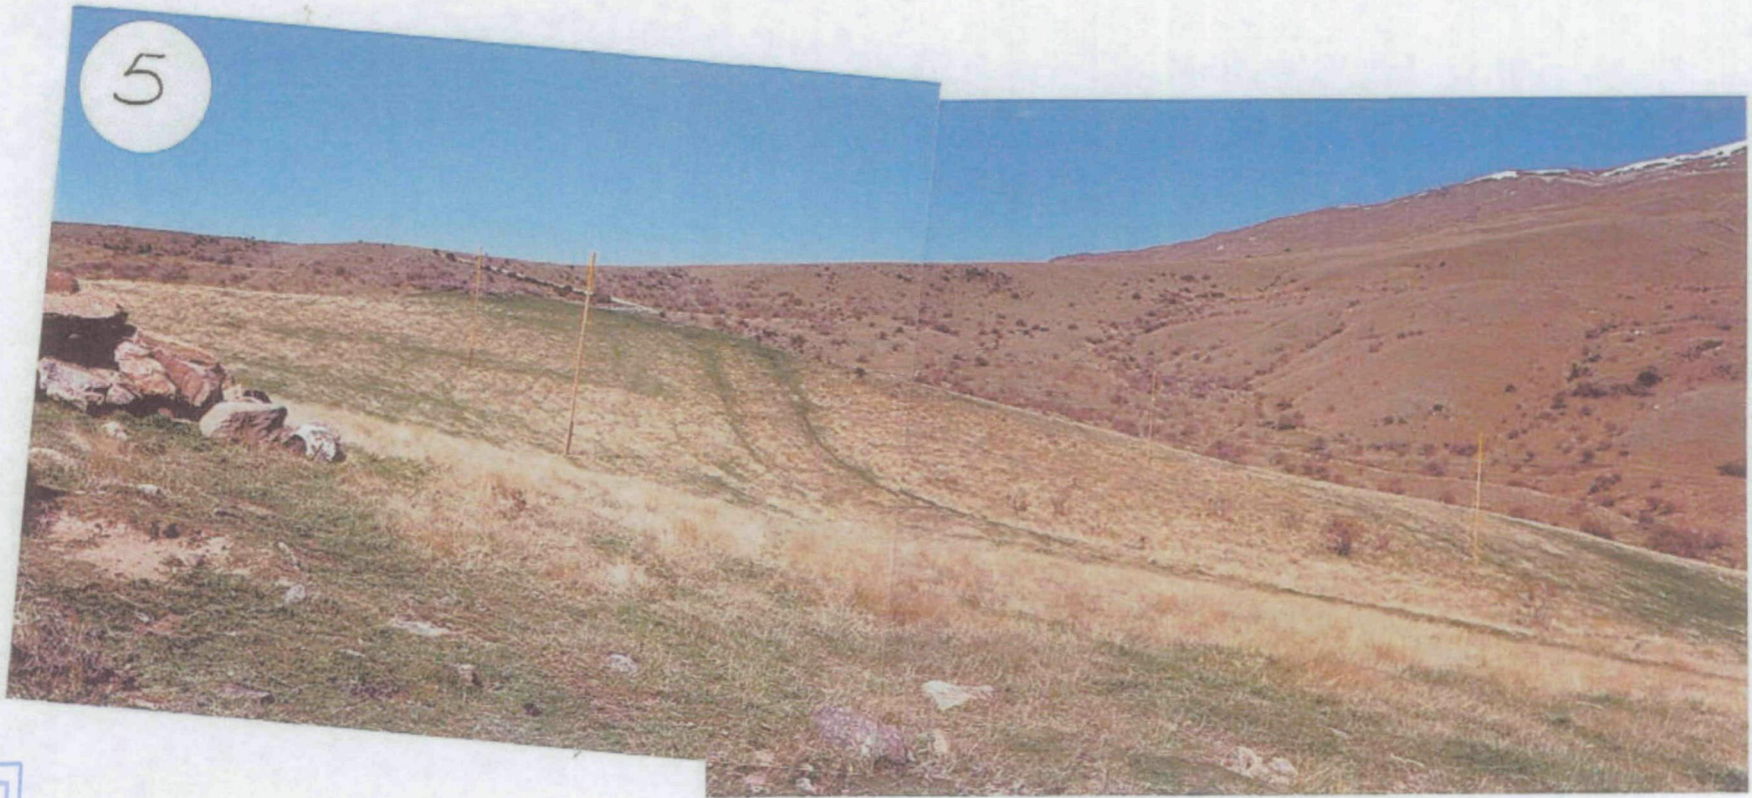
| Photo | Description |
|---|--|
| 5 | <p>Looking SW to the proposed site. The centroid of the platform would be approximately at photo centre.</p> |
