Environmental Consultants Otago Ltd

**Preliminary Site Investigation
For Soil Contamination
Ayrburn Farm and Waterfall Park
Residential Development
341 -345 Arrowtown – Lakes Hayes Road, Wakatipu**

November 2016

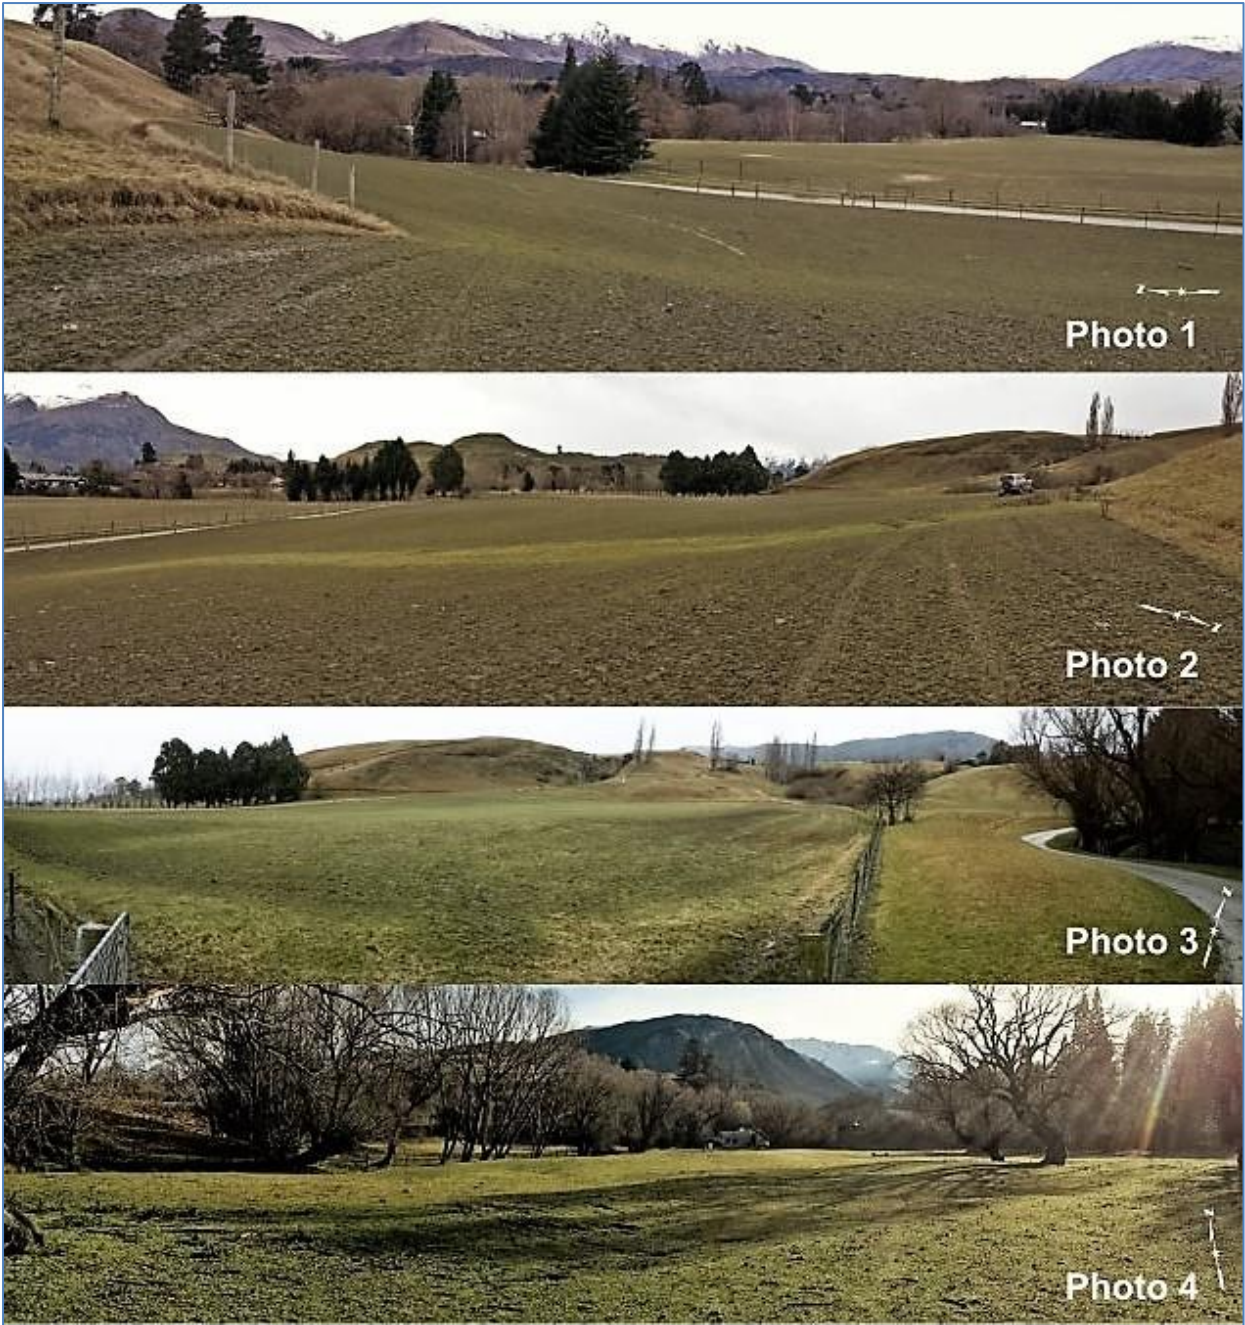
Creek as it formed the flat gully floor that represents its historic erosional surface. The main terrace landform that is within the site is shown in Figure 12, Photos 1 – 3. Photo 4 was taken from the flat gully floor that represents the Mill Creek historic erosional surface. This part of the site is heavily close-cropped cultivated pasture that is traversed by a well-constructed farm road and is largely devoid of minor features, as can be seen in Photos 1 and 2. This cultivation has obliterated any potential evidence of earlier activity. A swale runs across the terrace, as marked by the light blue dashed line in Figure 11. This is an ephemeral channel that drains an area of 15 – 20ha of the terrace face and the upper terrace to the north of the site, and so can be expected to carry an intermittent flow during heavy rains. This swale discharges to Mill Creek. The land forming the valley floor of the gully in which the Mill Creek flows is also cultivated pasture, but not to the intensive level that is evident on the terrace land. Fossil meanders and flood channels created a gently undulating landform with mature willows lining the creek, which flows against the foot of the terrace on the southern side of the gully. A few scattered willows are present in the valley floor and the containing terrace slope on the northern side of the gully is covered in mixed woodland that forms a part of the farm homestead planting.

Figure 12: Panorama views of the main part of the Speargrass Flat Terrace at site in Photos 1 and 2. Photo 3 shows the western-most end of the site and Photo 4 shows the Mill Creek Gully looking north from the lower part of the site, with the farm manager's house in the centre of this view. The Mill Creek flows by the willows on the left of Photo 4. The terrace faces are approximately 5m high, as can be seen on the left of Photo 4.

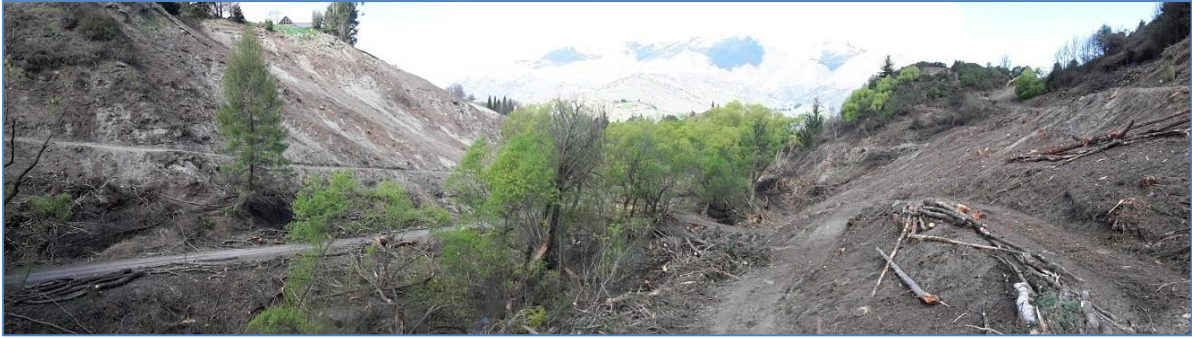
Waterfall Park and the two Mill Creek Gorge blocks cover an area of almost 15ha, the majority of which area falls within a steep-sided valley (the Mill Creek Gorge) that runs roughly north-south and is incised to a depth of approximately 50m in the higher terrace to the north of the site. The floor of the Mill Creek Gorge Landform (ref Figure 11) comprises an area of some 8ha in addition to the 4ha of the Waterfall Park block. The floor of the gorge was until recently filled with mature willows, with a gravel road cut through to the waterfall at its upstream/northern end. The willows have now been cleared as is evident in the view downstream in Photo 5 in Figure 13; this clearance activity occurred between the two site inspections.

Figure 13. Photo 5 – view downstream from the upstream western slopes of the Mill Creek Gorge showing the cleared valley floor and slopes and remnants of the willow woodland that until recently filled much of the valley floor.

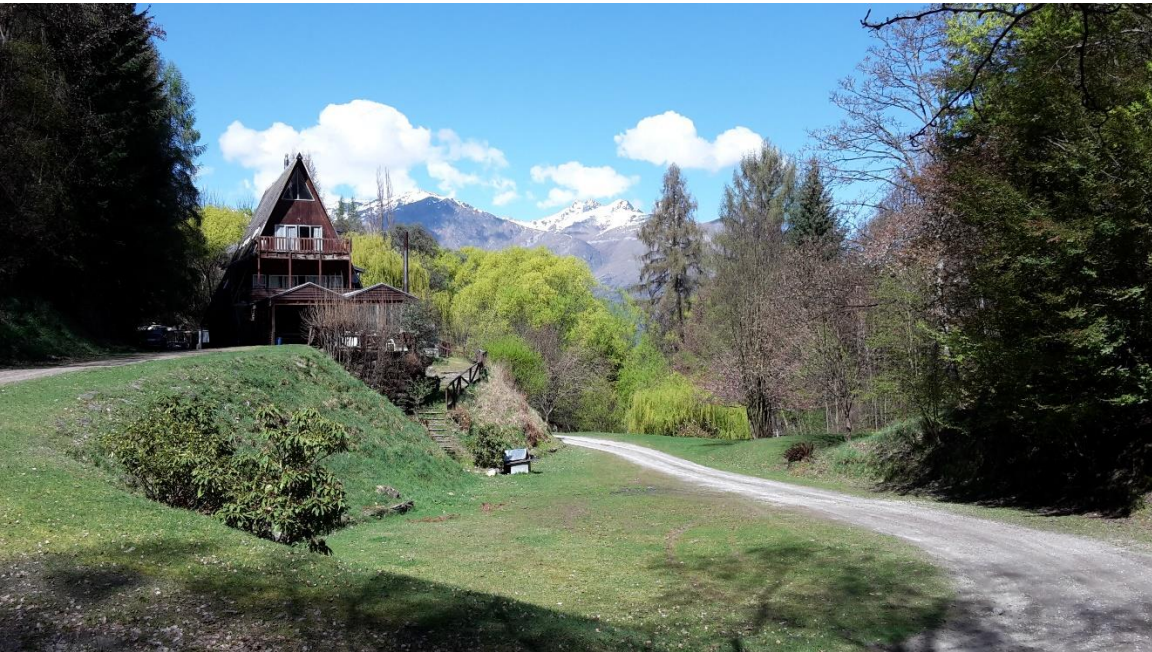
The clearing at the upstream end of the Mill Creek Gorge, by the base of the waterfall, is landscaped, grassed and paved, with a large A-Frame building located on an excavated bench above the valley floor, as shown in Photo 6 in Figure 14. This area at the base of the waterfall has been developed to host gatherings within several levelled areas in the valley floor. The grass appears well mown. All of the open spaces adjoining the stream and waterfall appear to have been cut into the natural surface, presumably at the time the road and the A-frame building were constructed. As such, the site surface will have been heavily disturbed, and is inferred to only have been exposed to human activity since this part of the site was developed in the mid-1970's.

Figure 14: Photo 6, taken at the head of the Mill Creek Gorge and showing the A-Frame "lodge" and the grounds adjacent to the building. The Mill Creek Falls are immediately to the right in the photo.

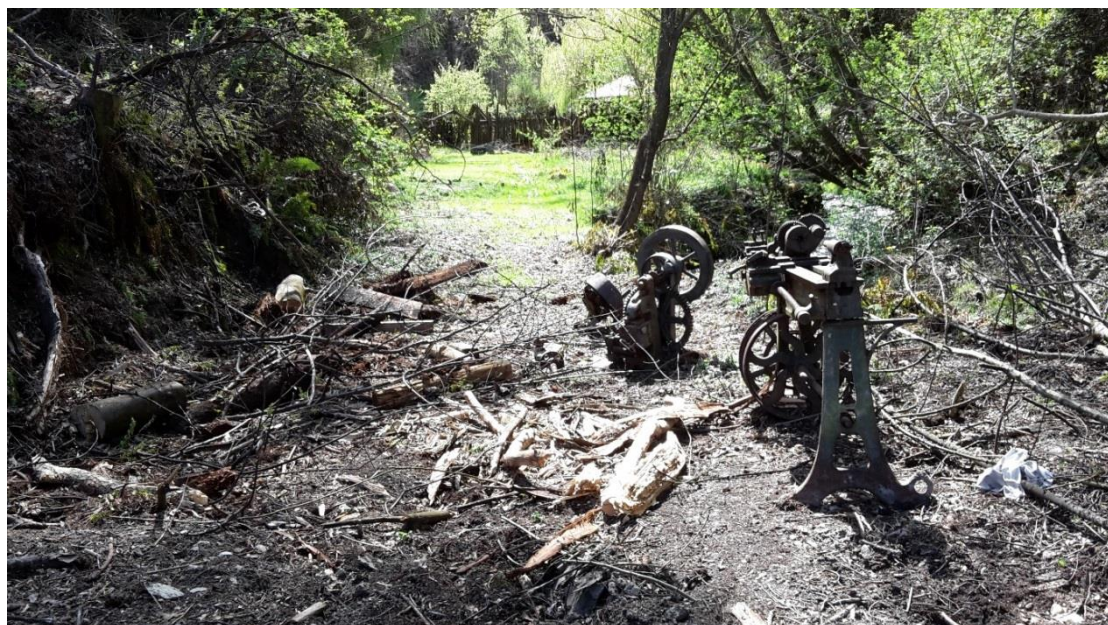
As a result of the willow clearance, an historic waterwheel-driven engineering workshop was discovered during the second site inspection at a location a little way downstream of the A-Frame building, near the base of the waterfall on the western bank of Mill Creek and on the western side of the valley floor. Some of the equipment that included a lathe is shown in Photo 9 in Figure 16. This equipment was driven by water from the Mill Creek water race that crosses the upper slopes of the valley on the western edge of the site. The fluming and the waterwheel that drove the equipment also remains. There is no historical record relating to this workshop. An engineering workshop from this era would be expected to be associated with the use of solder, thus lead contamination may be present at this site.

Figure 16: Photo 9 Equipment from the historic water powered engineering workshop located downstream of the Mill Creek Falls; the water wheel and fluming is located a little further upstream.

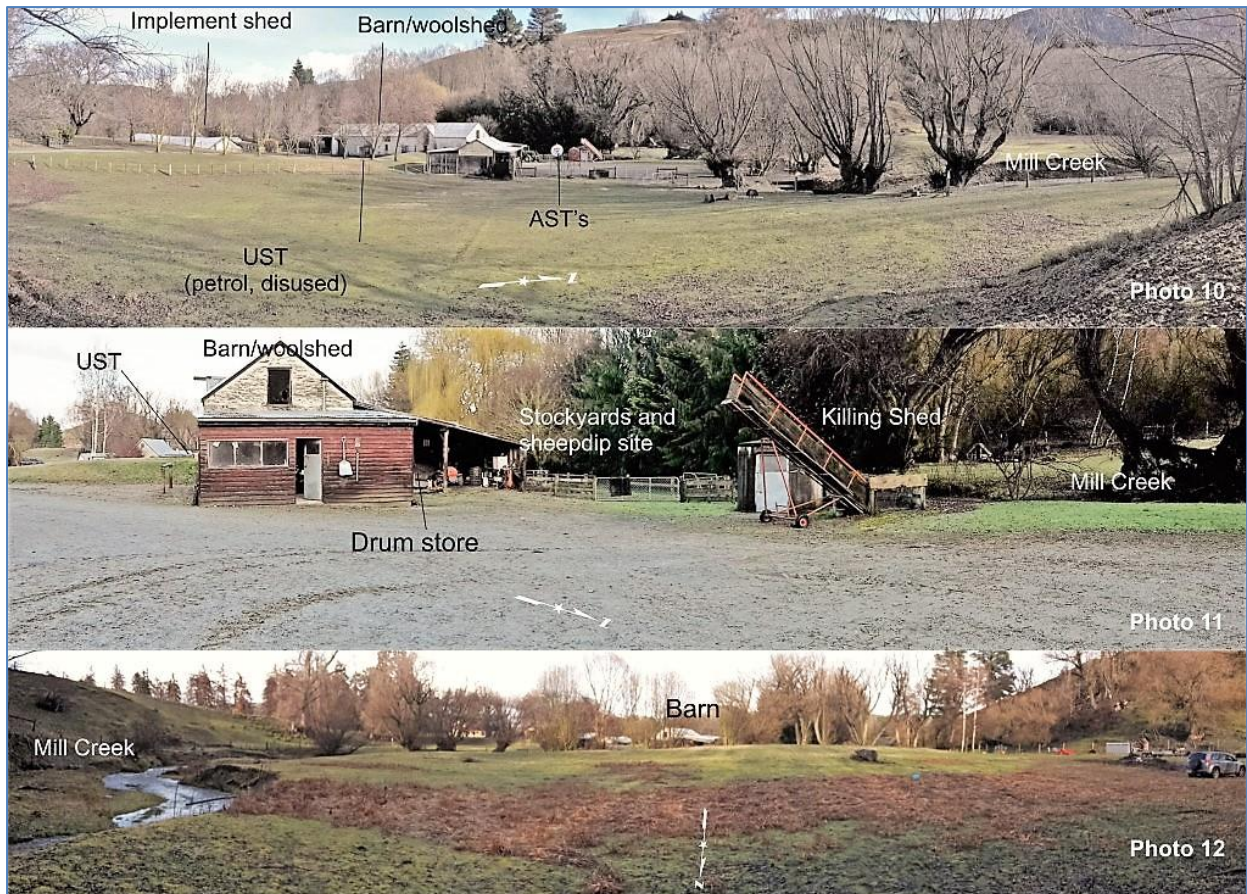
Figure 17 includes several photos of the upstream (northern) end of the farmyard as viewed from afar; the locations from which these photos were taken are given in Figure 11. While the homestead is proximal to the farmyard, it not in the view of some of these shots and/or is to the south of the main features in view. Photo 10 shows the farmyard area viewed from the top of the terrace face to the east of the farmyard; the features labelled correspond to those appearing in Figure 2 or otherwise mentioned in the desk-top study. Photo 11 is a view looking south and showing the northern end of the Barn/woolshed & Yards (per Figure 4 labels) overlooking the area where the old plunge-style sheep dip was located.

Other features labelled and discussed further below include a UST and the drum store. Photo 12 is a view to the south overlooking the paddock immediately upstream of the farmyard. This area contains a trailer and mower and isolated piles of miscellaneous material including fencing, timber, and an unused dog kennel.

Figure 17; Photos taken from upstream of the farmyard area (immediately proximal to the homestead). Photo 10 shows the farmyard area from the top of the terrace to the east. Photo 11 shows the land to the north of the Barn/woolshed that contains the former sheep dip site, while Photo 12 shows the valley floor upstream of the farmyard. The paddock in Photo 12 has some implements and materials stored in it and the farm manager confirmed that there may be a small farm landfill in a meander at the lower end of this flat immediately upstream from the barn.

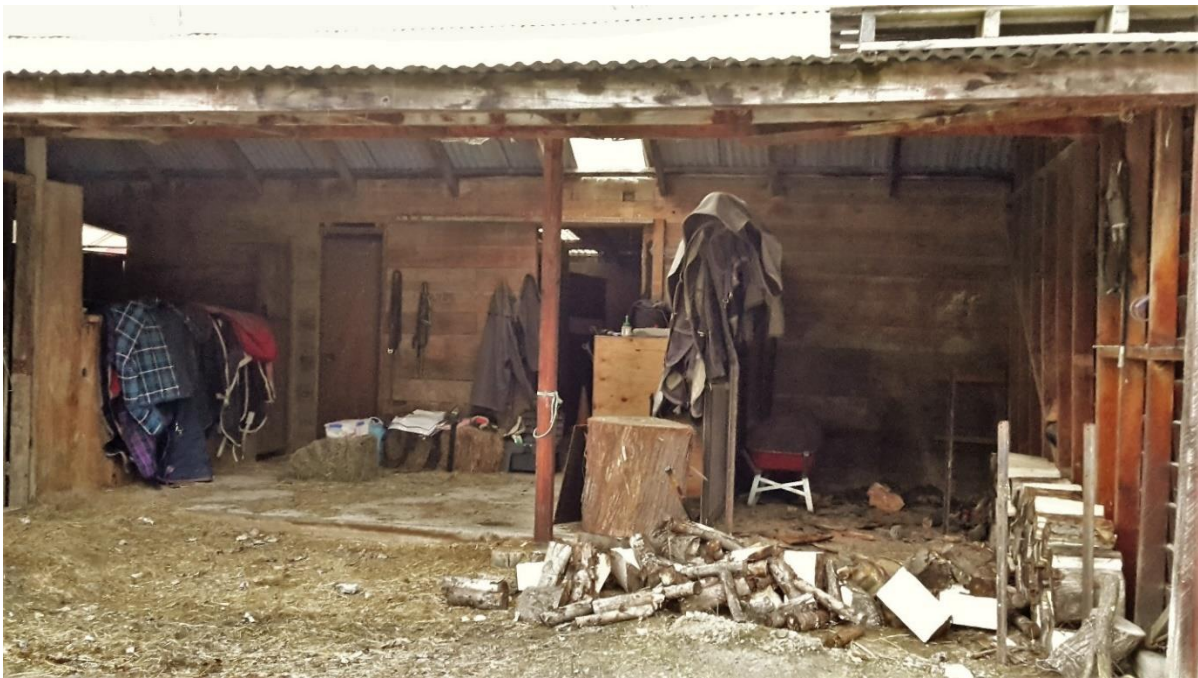
Figure 19: Interior of Shed/Stables showing equestrian equipment and general condition of shed interior.

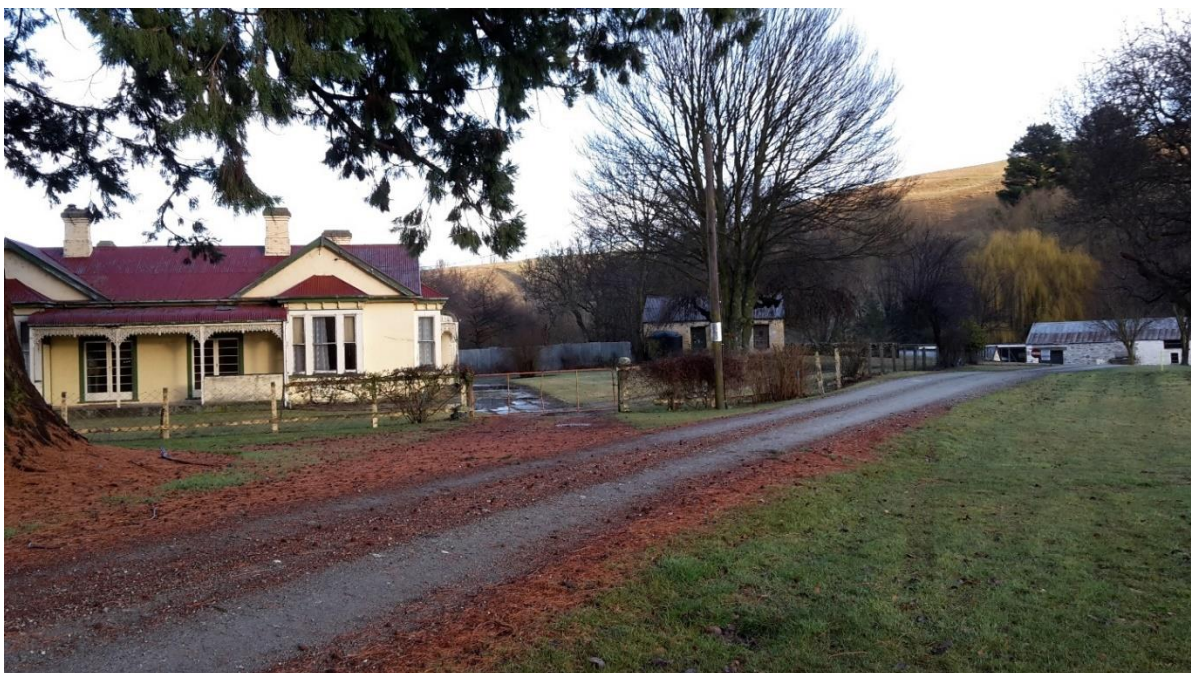
The farm homestead, its grounds and front garden are shown in Figure 20. The homestead is fenced off from the farm and has been a separate lot since it was subdivided from the farm in 1985. It is not proposed to be subdivide the homestead title or to change the use of the building and is therefore not technically required to be included in the site investigation report, it has however been included as its restoration will form part of the proposed development and it is necessary to appraise its status with regard to ground contamination accordingly. The homestead has not been occupied in recent years, but remains in a well-maintained state and the grounds surrounding it are also well maintained. An oil burner installation that was noted in the building consent records and a 500l above-ground heating fuel tank was confirmed during inspection to be located at the rear of the building. The location of this tank is shown in Figure 21. The ground under the tank shows evidence of localised oil staining.

Figure 20: The Ayrburn homestead with the farm's original cottage to its right and the Barn/woolshed on the right-hand side of the photo. The main entrance to the site from Arrowtown – Lake Hayes Road crosses the foreground of the photo.

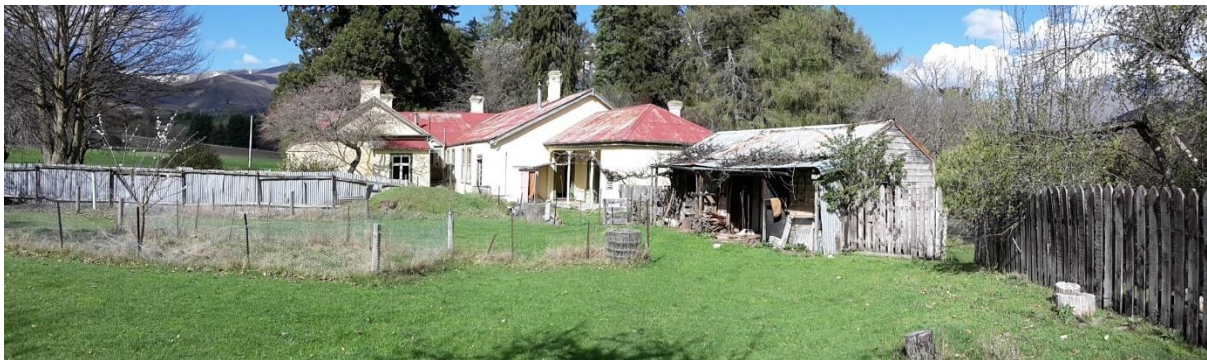
A wooden outbuilding is located behind the homestead as shown in Figure 22. This building appears to be very old (is shown on both Figures 4 and 7) and comprises three rooms, all of which open to the outside. This building appears to have been used as a store shed and tool shed. One bay still contains an old 12gallon lubricant drum and a 20l container of Talon rodenticide.

Figure 22: The homestead rear garden with outbuilding (to the right of the homestead in the photo).

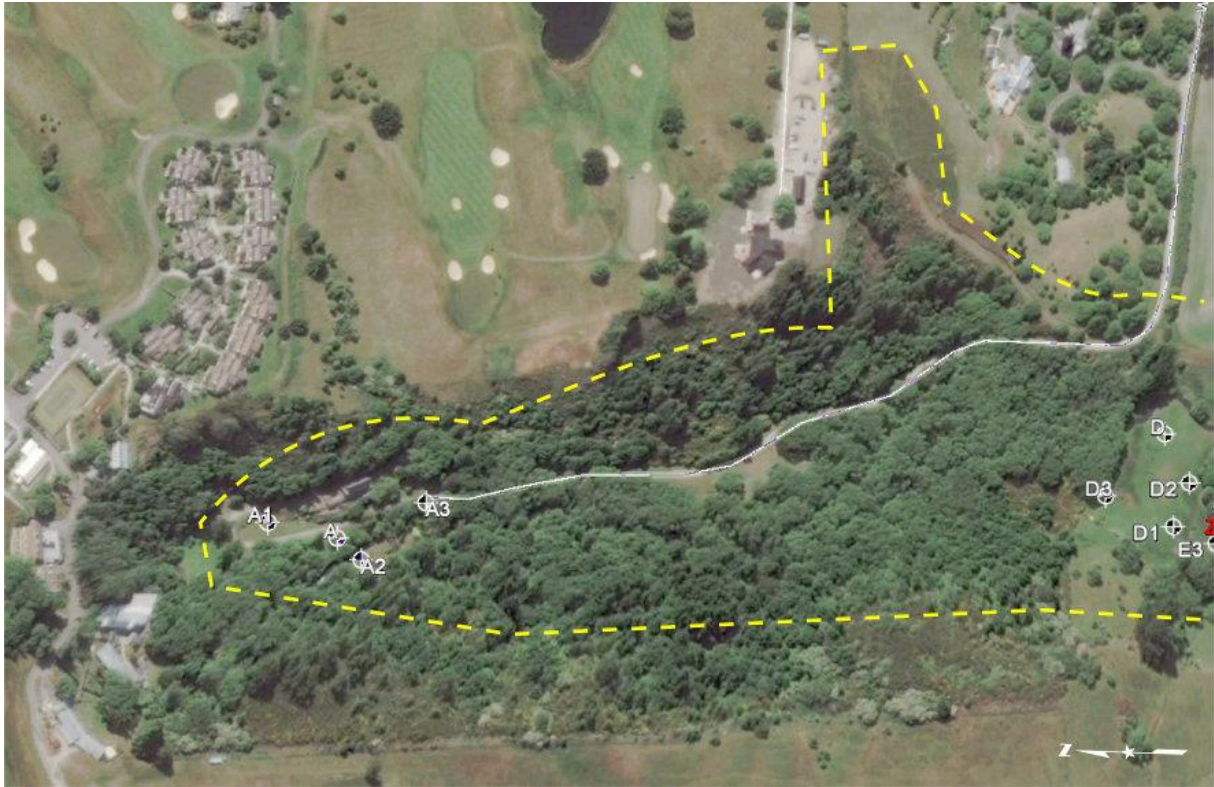
Figure 29: Site sampling plan, first sampling round, showing the Mill Creek Gorge/Waterfall Park area soil sampling locations. The original sampling plan had proposed taking another two sample sets (sets B and C) however this was not possible for reasons described in the text. Sample and subsample locations in the figure are marked with a white circle with quadrants and the site boundary is marked with a yellow dashed line. Sample A was scheduled for individual analysis and subsamples A1-3 were lab composited (Google Earth Image).

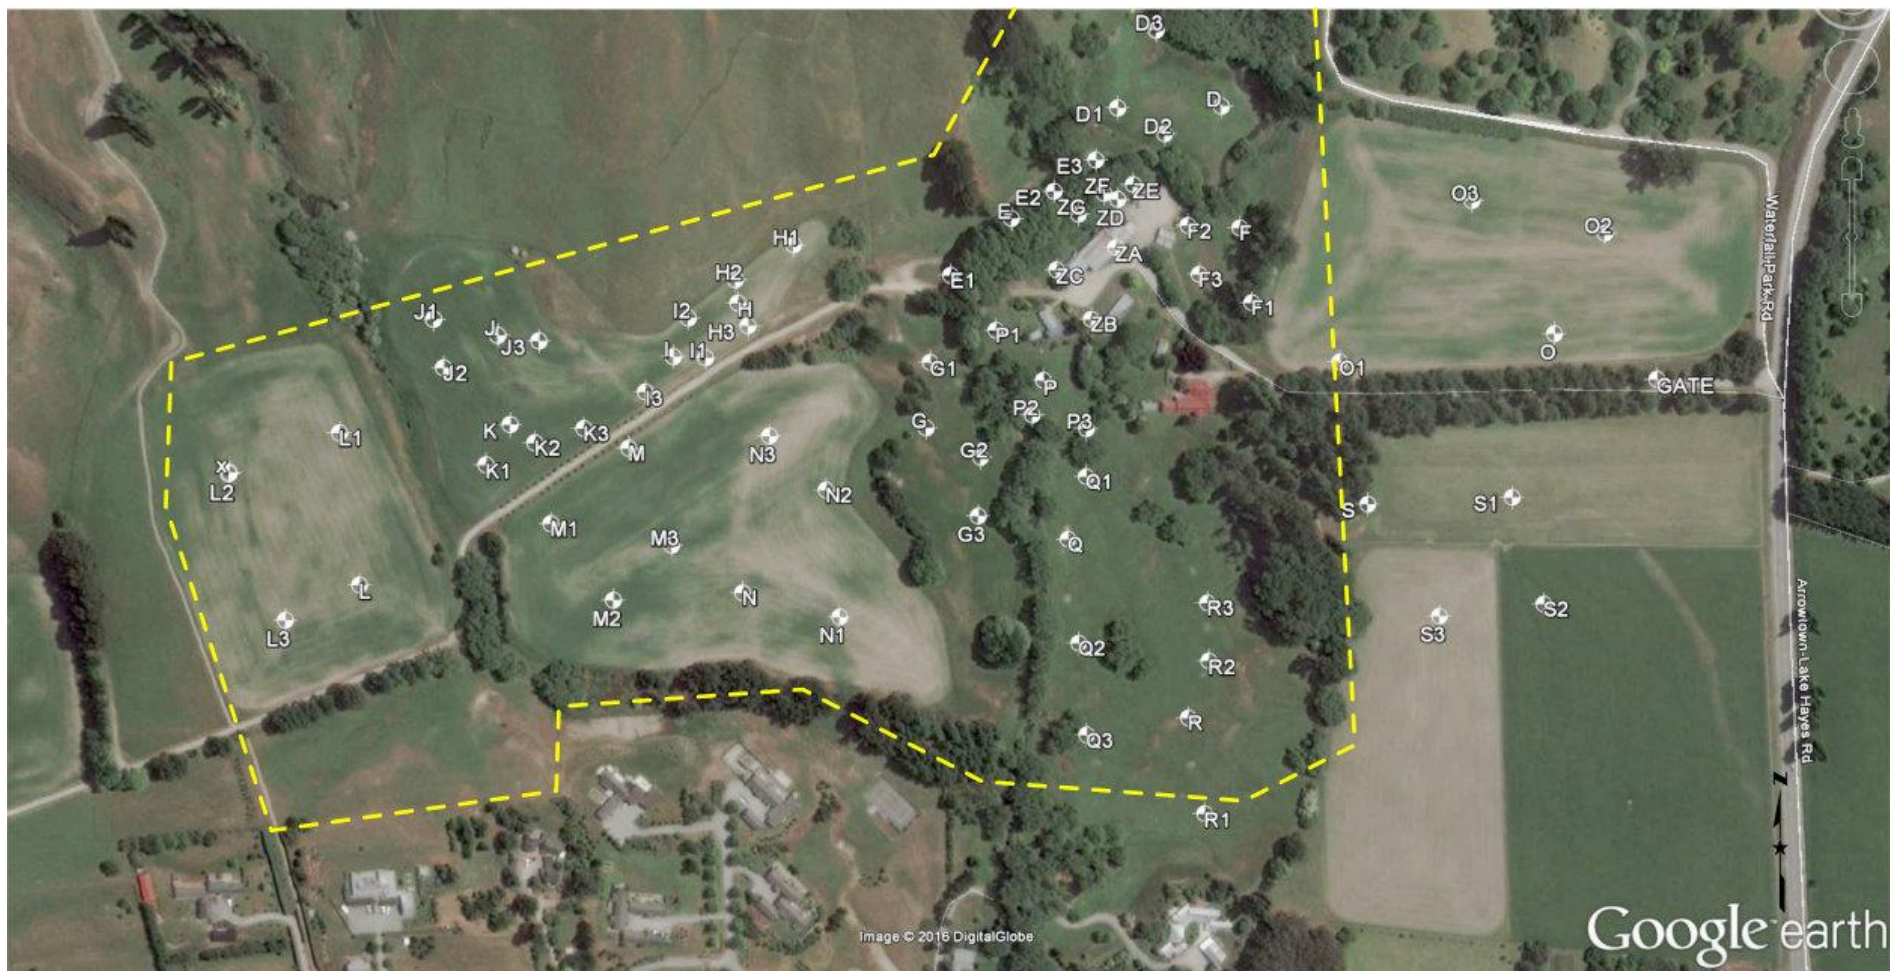
Figure 30: Site sampling plan, first sampling round, showing sampling locations across the Farm Proper (Ayrburn Farm) and Homestead Area parts of the site, as well as two areas on adjacent land. Sample and subsample locations in the figure are marked with a white circle with quadrants and the site boundary is marked with a yellow dashed line. Sample names are indicated, where a letter represents a sample scheduled for individual analysis and a letter with a number indicates a subsample used in lab sample compositing (Google Earth Image). Sample series D through N and P-R are from the areas described herein as the Farm Proper and the Homestead/farmyard areas; sample series O and S are from adjacent land.

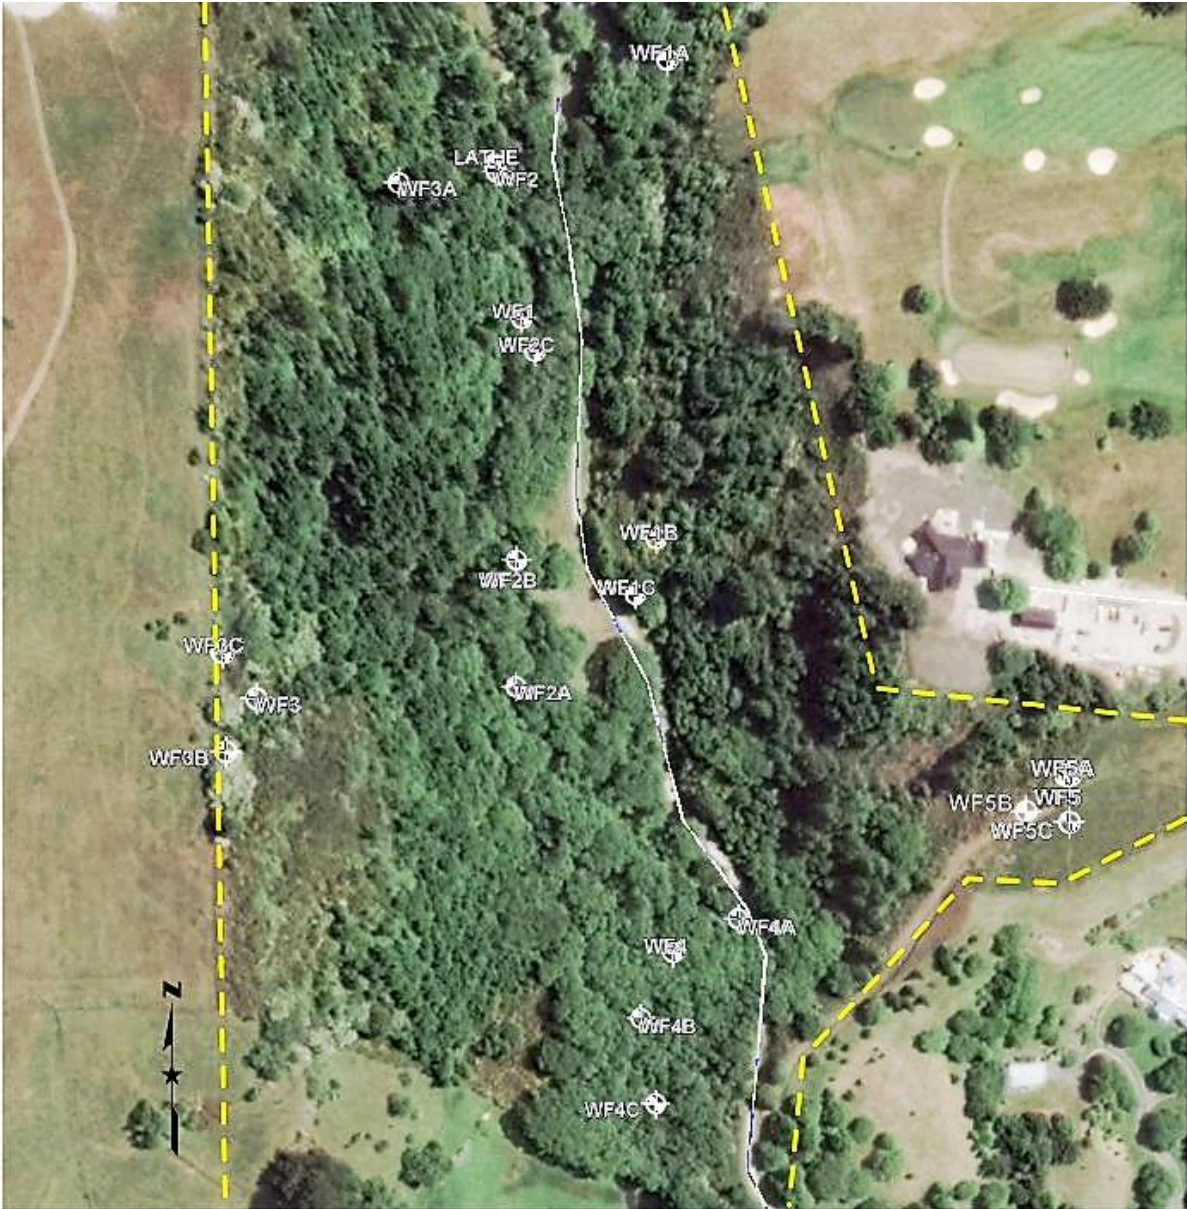
Figure 31: Partial site sampling plan, second sampling round, showing the Mill Creek Gorge/Waterfall Park area soil sampling locations. Sample and subsample locations in the figure are marked with a white circle with quadrants and the site boundary is marked with a yellow dashed line; sample names appear in white alongside quadrant markers. The label "lathe" is added for reference as the location of the engineering workshop that was found on the second site inspection.

For the Mill Creek Gorge/Waterfall Park samples the results from both the initial and second round of sampling in this part of the site reflect an unmodified state with results for metals being within a range likely to be at or, at least close to, natural background values. Precision (as RSD) for these varies, and RSDs, which vary from 29 to 62%, might normally be expected to be lower if these values do indicate geochemical background, however, in view of the low levels, it the higher RSDs may result from the variable depositional environment across locations tested. It should be noted that arsenic background in this area might normally be expected to be higher than in some other areas of New Zealand due to the proportion of schists present as parent rock. There are several exceedances for arsenic in composite samples, however, the composite average closely resembles the individual sample average, hence these are most likely technical exceedances.

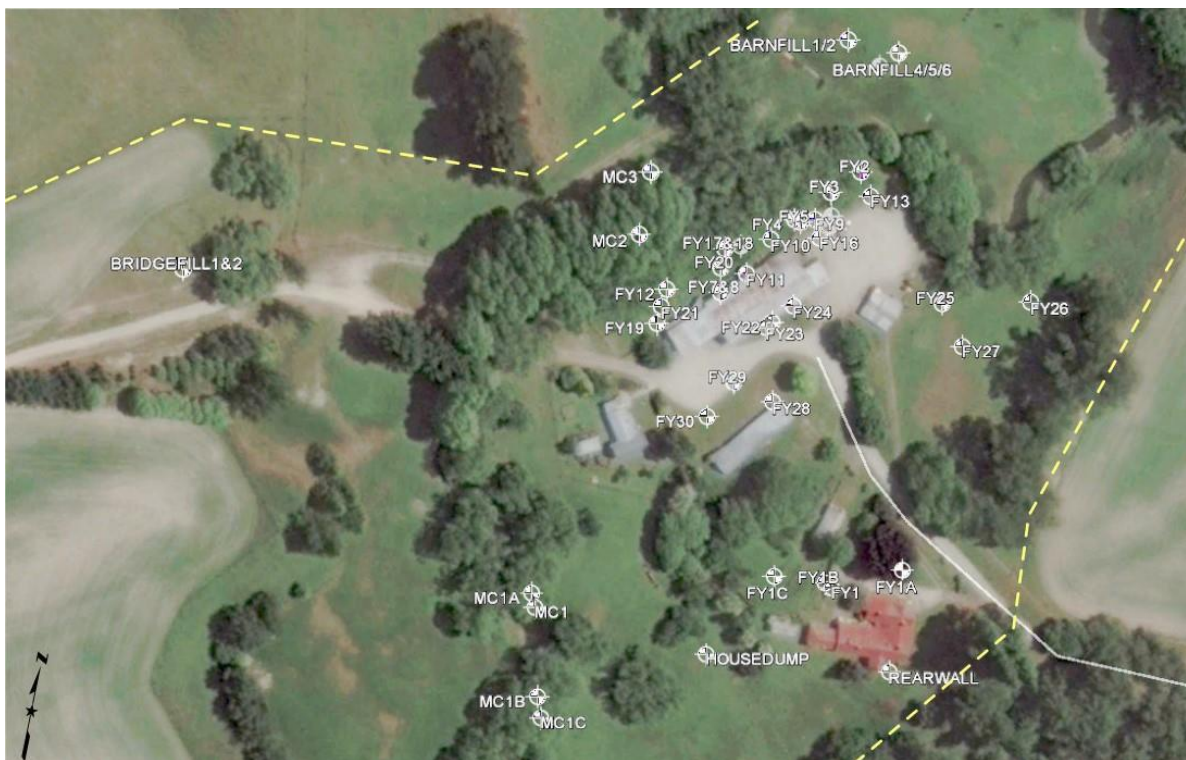
Figure 32: Partial site sampling plan, second sampling round, showing remaining sampling locations outside of the Mill Creek Gorge/Waterfall Park, parts of the site. Sample locations in the figure are marked with a white circle with quadrants and the site boundary is marked with a yellow dashed line. Sample and subsample locations in the figure are marked with a white circle with quadrants and the site boundary is marked with a yellow dashed line; sample names appear in white alongside quadrant markers. A more detailed view of sampling in the Barn/woolshed & Yards area is shown in Figure 33 below (Google Earth Image).

A total of six samples were taken from surficial (0-20cm) soils in the area immediately surrounding the homestead, including one set of samples (an individual sample and three subsamples for compositing, series FY1) randomly distributed to the north of the homestead, as well as two additional individual samples, "Rearwall" and "Housedump", taken for preliminary assessment of the areas around the homestead rear wall to assess the effects of paint weathering and the area wherein rubbish was observed scattered across the bank below the homestead, respectively (ref Section 3). The locations of these samples are shown in Figure 32.

A preliminary investigation was made of the sediments in Mill Creek comprising six samples were collected (ref Figure 32). One sample set (MC1 and MC1A-C, the latter being a composite of three subsamples), and two additional individual samples (MC2 and MC3) were collected. The latter two individual samples were located in Mill Creek abeam and proximal to the inferred location of the former sheep dip, whereas the other samples were collected downstream of the farmyard area.

Sampling in the Homestead immediate curtilage found significant exceedances of the Residential SCS for lead in all the samples, locations for which cover a large part of the garden area surrounding the homestead. The results also show cadmium and zinc approaching the Residential SCS at one location. Cadmium and lead are used as pigments in older paints and lead was also used in primers. The limited sampling adjacent to the homestead does however suggest that the lead contamination is far more extensive than a "paint shadow" usually is, even for an old site. More detailed sampling and analysis, including sampling at depth, would be required to provide any more substantive conclusion with regards to the site conditions adjacent to the homestead.

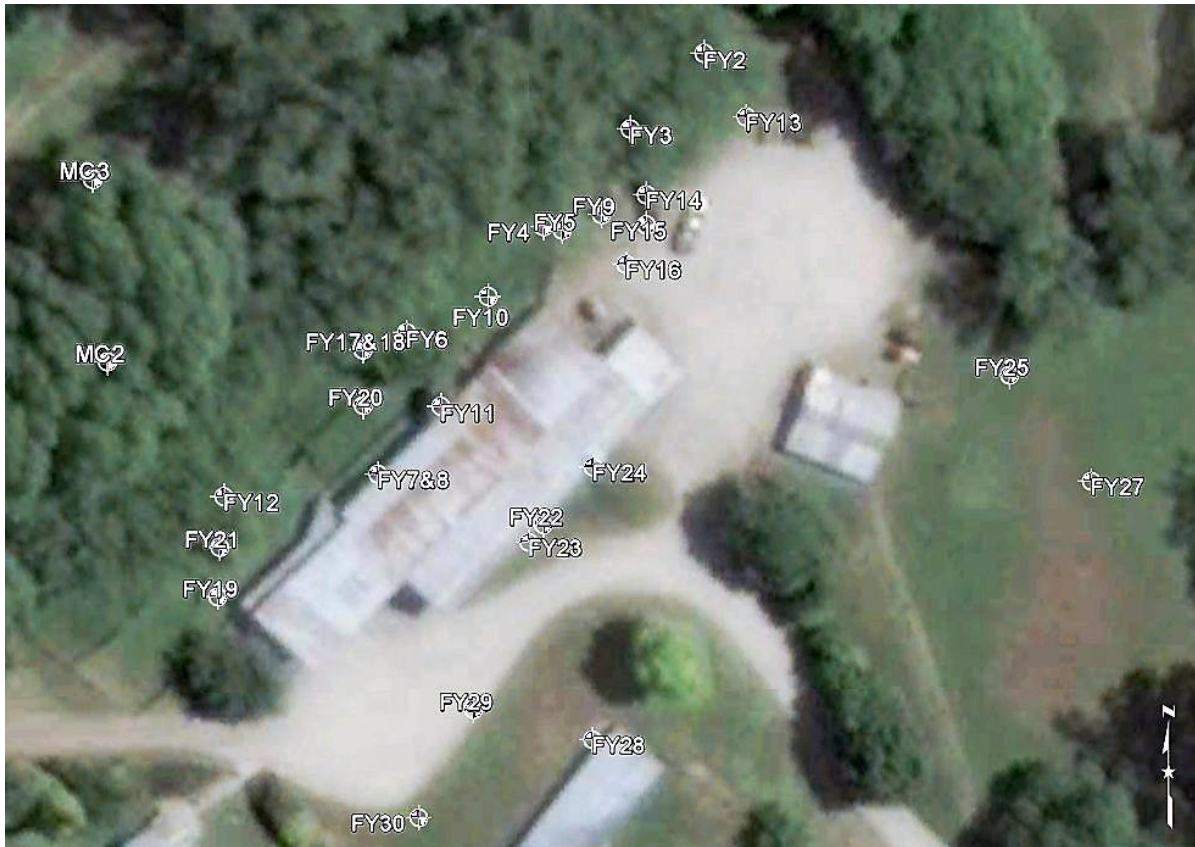
Figure 33: Closer view of sampling locations around the Barn/woolshed & Yards environs showing the sampling pattern in the inferred/most likely location of the former sheep dip. Sample locations in the figure are marked with a white circle with quadrants and sample names appear in white alongside quadrant markers (Google Earth Image).

OCP results for the second round of sampling and analysis were mainly below limits of detection, except for occasional low levels of dieldrin, the highest of which was 0.113 mg/kg in surface sample FY10 near the former sheep dip and suggesting that dieldrin was used as an animal treatment at some time in the past. The levels found provide no trigger to indicate further investigation for OCPs is warranted.
