Title | Taitara: September / October 2024 Weather Event

A Weather Event Network Damage Report – Sept / Oct 2024 v3

Reference: Crown Range Road Multiple failures between gates and summit Queenstown side

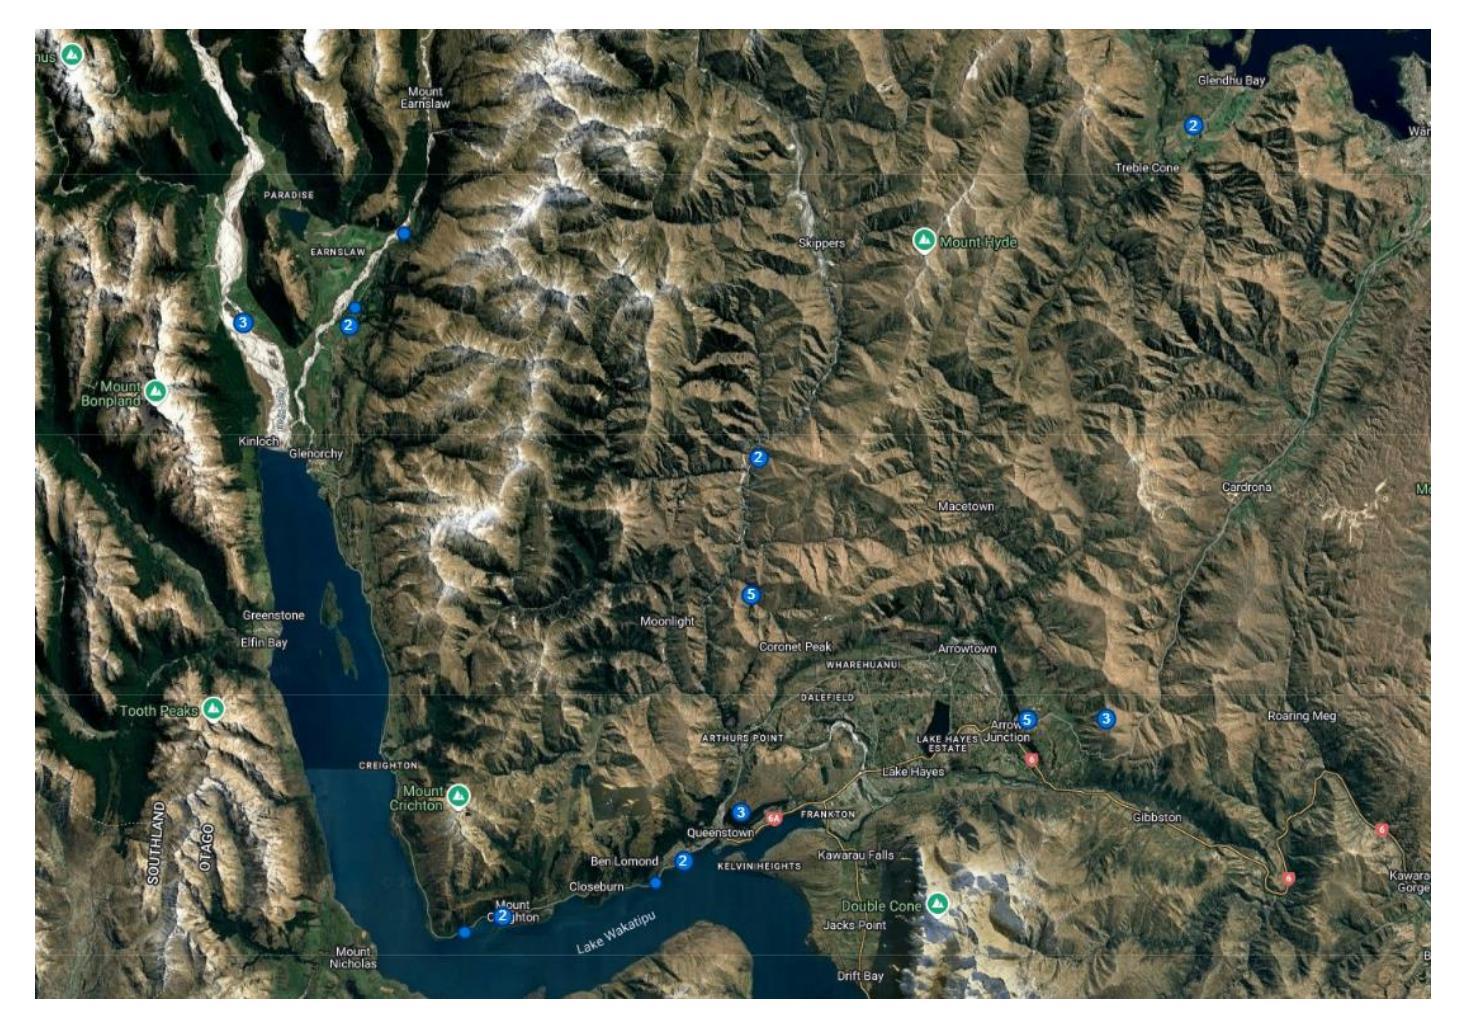
Storm Event Defects Identified plotted over map area:

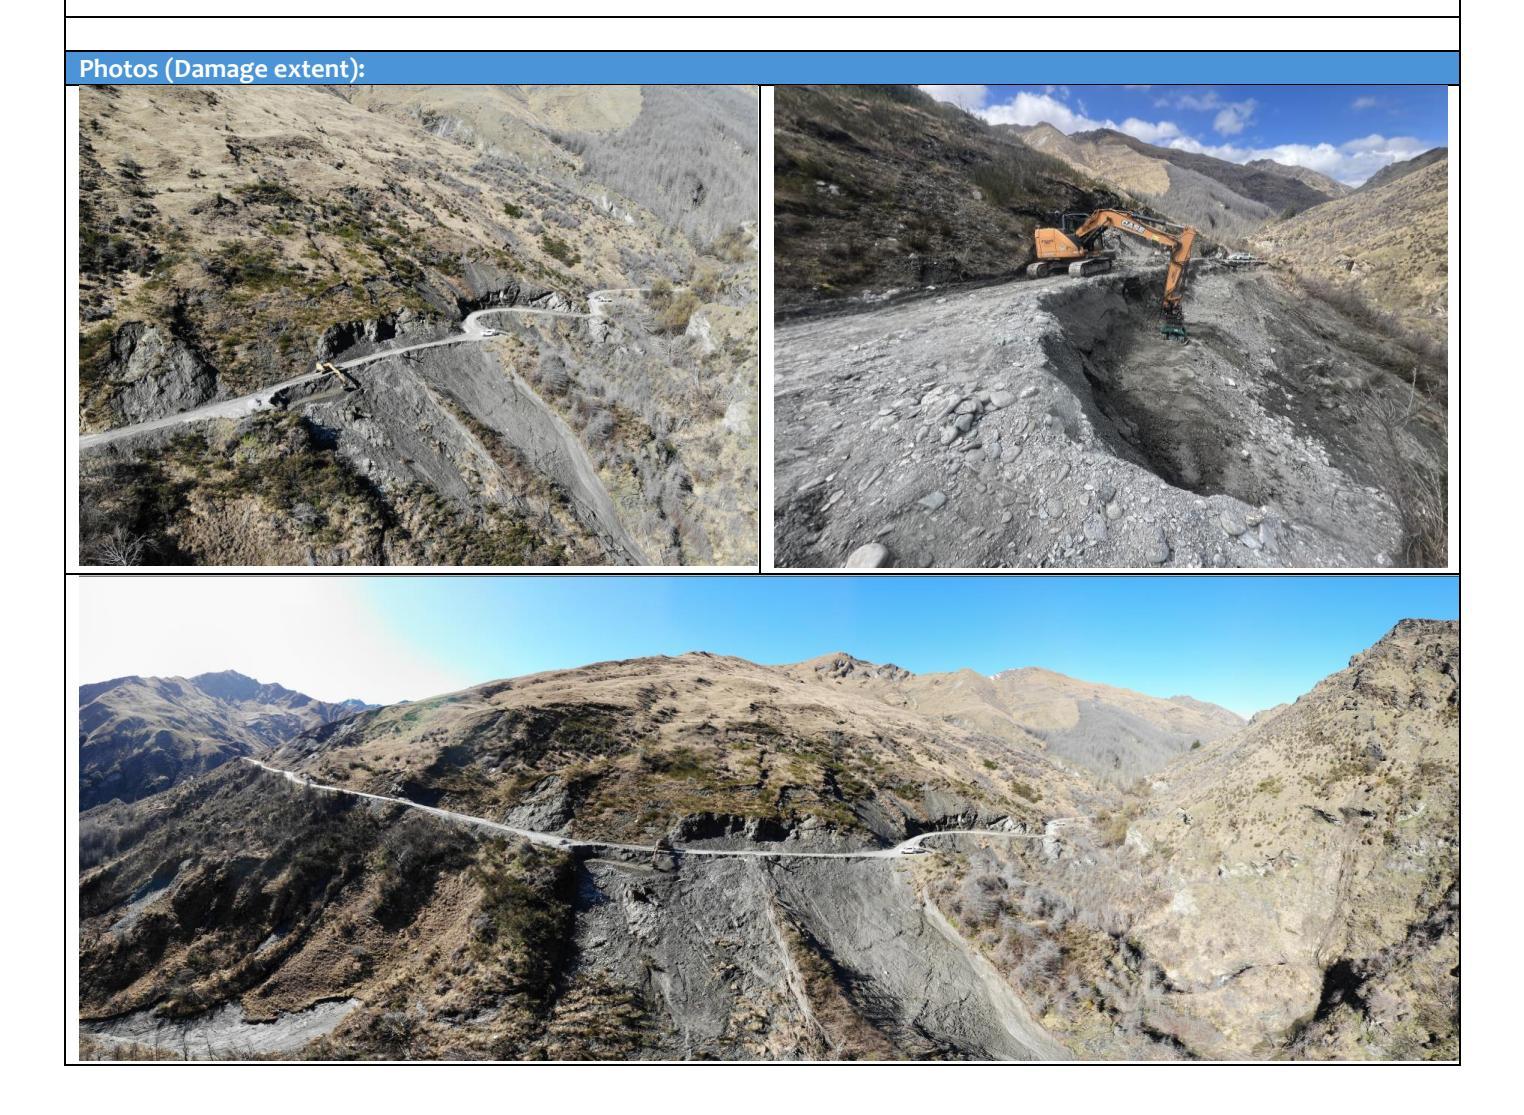
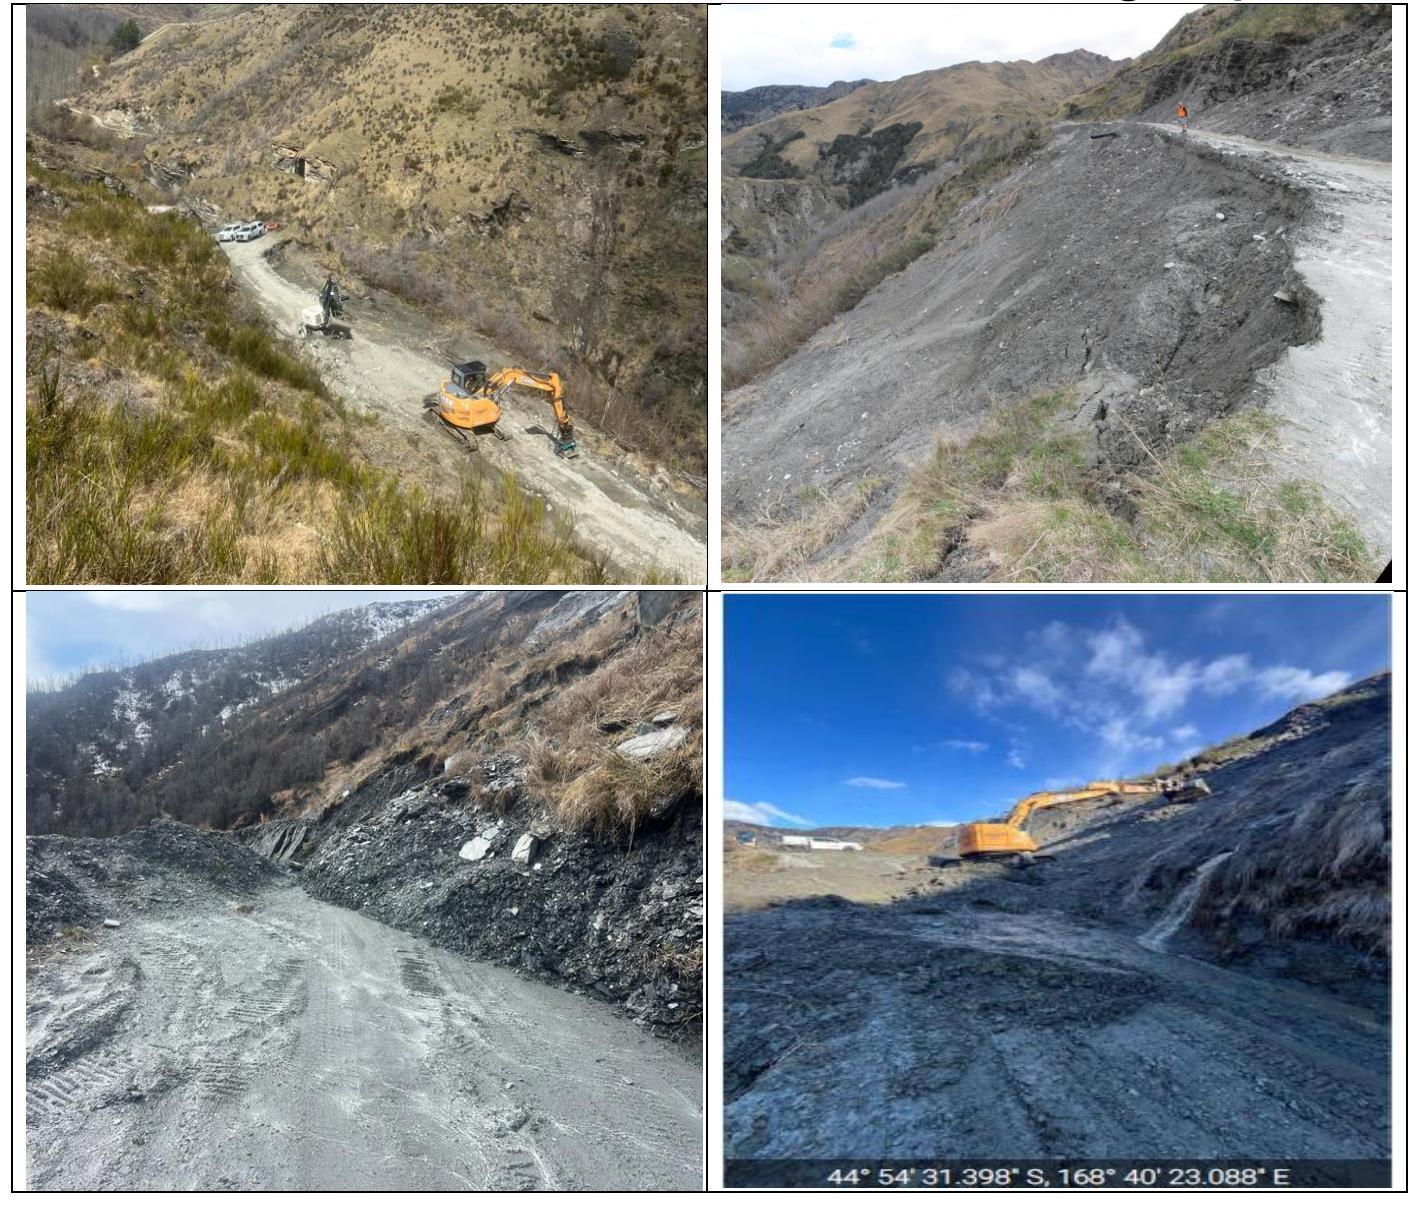
Skippers Road and Branches Road endured the significant duress and with a large number of defects across the length of the road section. Downer Teams have been able to identify all the defects and/or estimated due to access restrictions (Road Washouts). We have received some photos from local resident that are isolated on the other side of the road washouts but have not been able to inspect and estimate total impact on Skippers Road that then lead into Branches Road. Skippers and Branches severely impacted by weather event and resulted in slips, dropouts and large washouts along the full sections of Skippers and The Branches Road.

Both sections of road have been opened to road access, however the road sections are still in vulnerable conditions in the event of another weather event. Long – Term remediation repairs could consist of upgrading drainage structures, completing some retreat works on banks. Some areas would not be viable to attempt long-term repairs as hillsides are extremely high and steep elevation.

Road has been fully opened. The surface after the branches intersection to the bridge could benefit from a grade. We will look to grade before the holidays. There is a weeping patch after wong gongs which needs some rock in it to future proof it. This will be done in the coming fortnight. Drainage work is still required along the length of the road where little slips and slumps have fallen into the water tables. I envisage this being another 1 week to 10 days on the wheeled excavator.

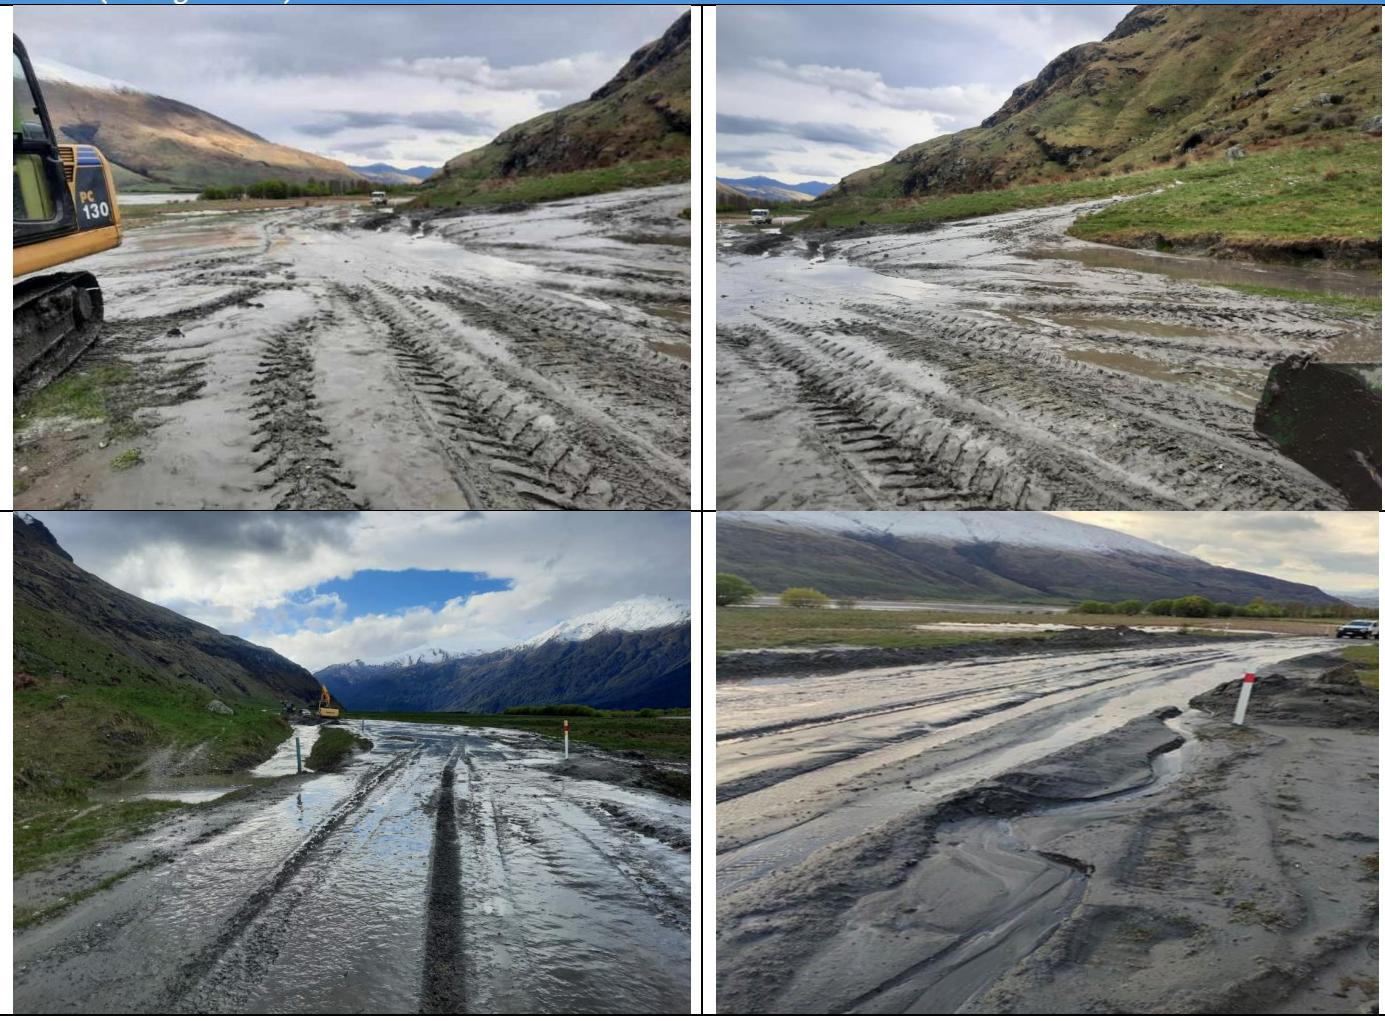
Temporary Road have been built through private property adjacent to the road. Access for Local residents have been reinstated until long-term planned works are approved and initiated.

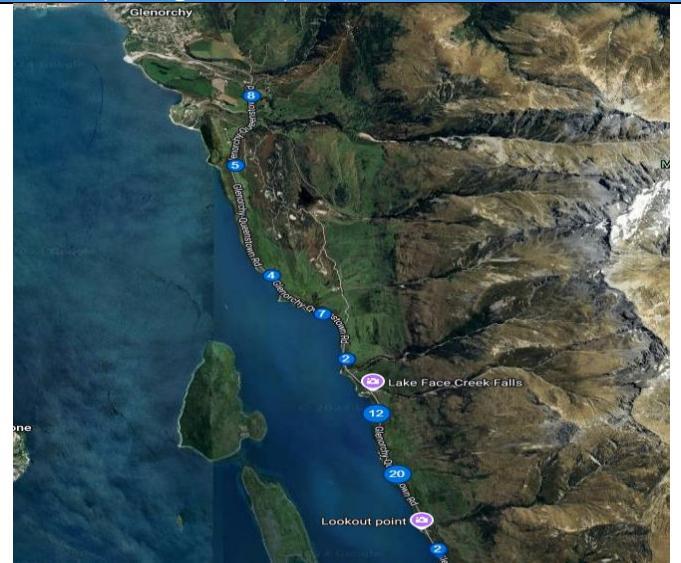
Severy scouring formed along road shoulder and very deep and dangerous. Team has responded and repaired road. Shoulder shaped and collapsed, materials imported and packed in layers and compacted. Drainage cleaned, formed and reinstated.

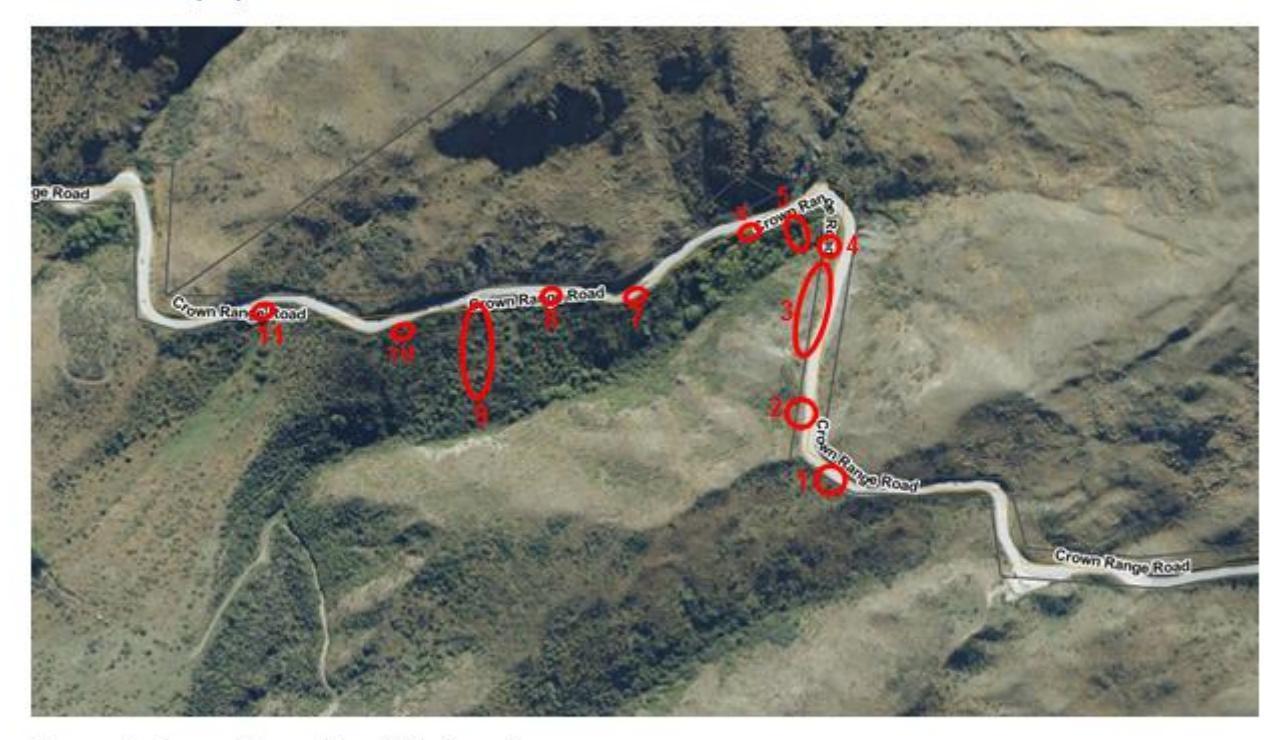
Figure 1. Crown Range Road Site Locations

The purpose of this memo is to record my inspection of multiple shoulder failures on the Crown Range Road following the unseasonally heavy rain during October. Eleven areas of instability have been identified on the length of the road between the 'viewing area' and the gates. This document describes each site and proposes a solution for discussion.

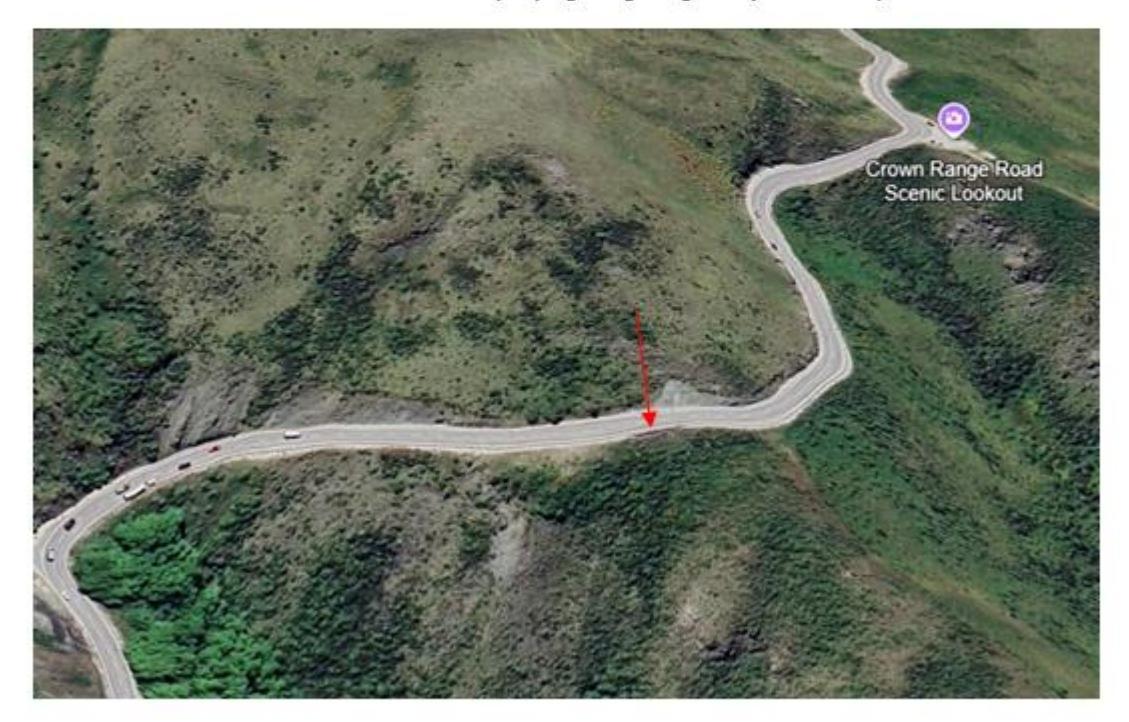
Figure 3. Site 2 location from Google Earth

Site 2 is an existing steel pile and timber lagging wall tied back with self-drilling anchors with timber post walers. The wall was constructed 11 years ago. A significant portion of the hillside has mobilised immediately below the wall. The soil from the toe of the wall has moved out and down approximately 1m and this movement has left the bottom section of the piles exposed. The slip appears to be extensive and there are tension cracks propagating diagonally down slope on both sides of the wall.

2.	Existing tied back post wall, slope failing from toe	Urgent	Add additional row of lower anchors and walers between exposed posts before wall is damaged

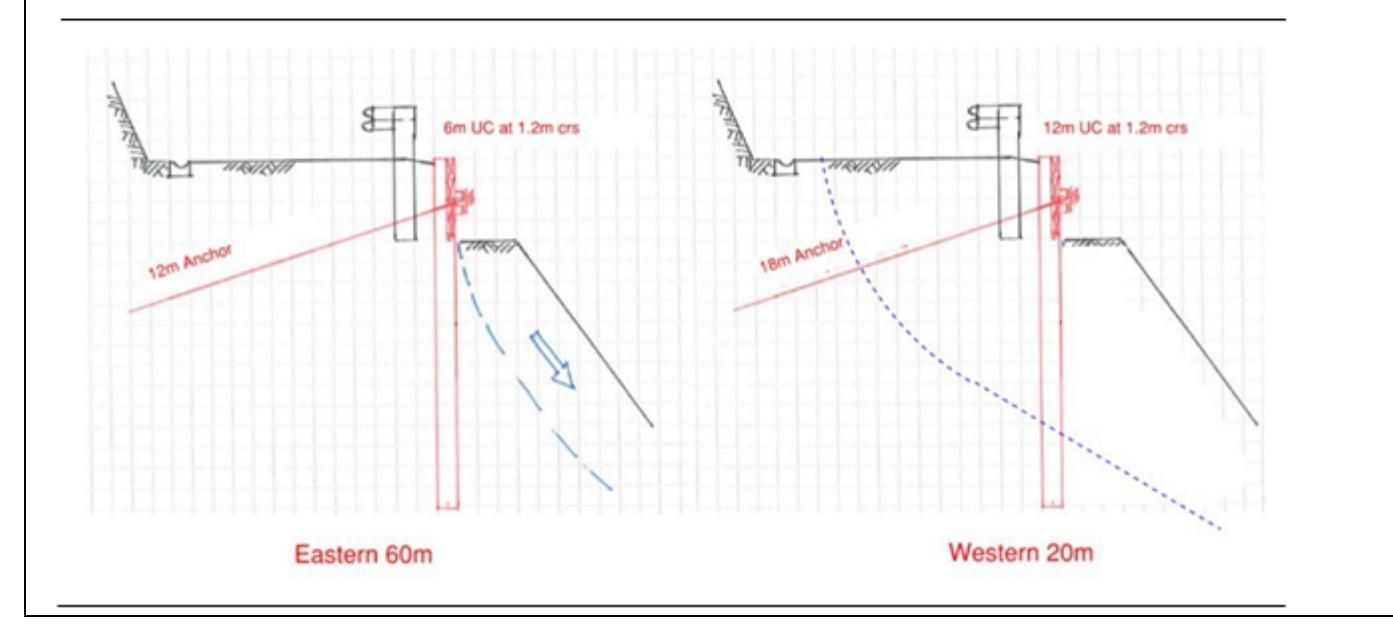
West As per the east side but with longer piles and ground anchors to address potential depth of side the failure plane. This has a greater risk of poor performance than the east side because the slip plane would intersect the <u>piles</u> and the structure would be required to support unstable ground

- Excavate a working platform
- side
- ____
- Drive 6m long UC piles at approximately 1.2m crs
- Drill 12m long ground anchors between piles at bench level
- · Place timber lagging between piles, above the level of the ground anchors
- Weld SHS walers above and below the ground anchors and fix anchor to walers with steel anchor plate.
- · Backfill against timber and reinstate guard rail

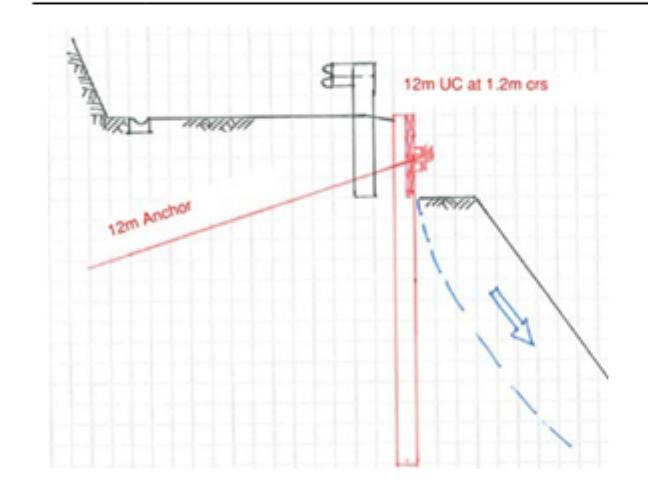
- · Further failures occur and remove support from the soldier piles
- Rock anchors are over stressed and pull out
- · Driven soldier piles hit rock and cannot be driven to the desired depth
- · Failure extends before the repair can be implemented

- · Excavate a working platform
- Drive 12m long UC piles at approximately 1.2m crs
- Drill 12m long ground anchors between piles at bench level
- · Place timber lagging between piles, above the level of the ground anchors
- Weld SHS walers above and below the ground anchors and fix anchor to walers with steel anchor plate.
- · Backfill against timber and reinstate guard rail
